Appendix to Appropriate Assessment Report

Appendix A4: Aquatic Habitats & Species Fieldwork & Survey Results

AA4.2 Survey Results - Inventory & Classification of Watercourses at Crossing Locations

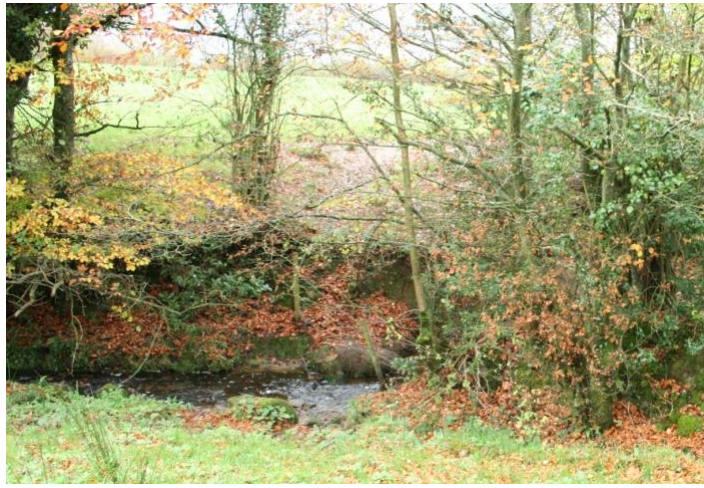
<p>Watercrossing Structure W1 (<i>Temporary Crossing</i>)</p> <p>Type: 1st Order Stream</p> <p>Fisheries: Class 2, Optimal Fisheries</p> <p>Location: Mountphilips Substation Site</p> <p>Existing Structure: No existing crossing structure</p> <p>Works at Crossing: Cable trenching under stream bed using dam & pump (flume) method. Temporary Bailey Bridge.</p> <p>Ecology Notes: c. 2 m wide, c. 10 cm deep, gravel (70), cobbles (5), boulders (5), sands/silts (20)</p>

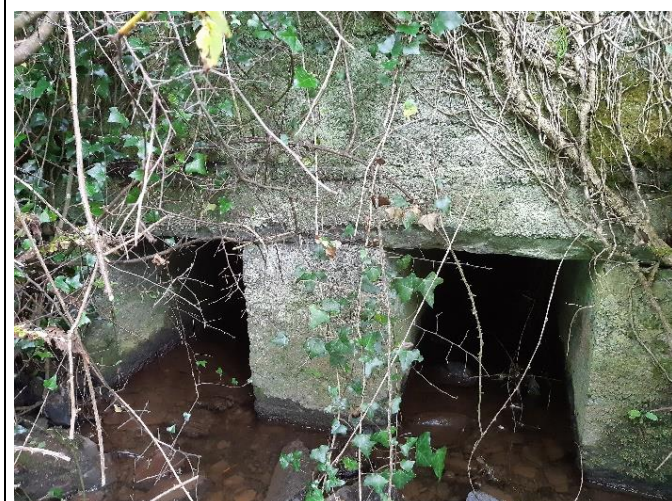
Watercrossing Structure W4

Type: Stream

Fisheries: Class 3, Sub-optimal Fisheries

Existing Structure: Concrete Block Box Culvert

Works at the Crossing: Cable trenching under structure

Ecology Notes: Downstream - Slow flowing, Coble (60), Gravel (40). Overgrown, vegetation shading. 1 metre wide and ~30cm deep.

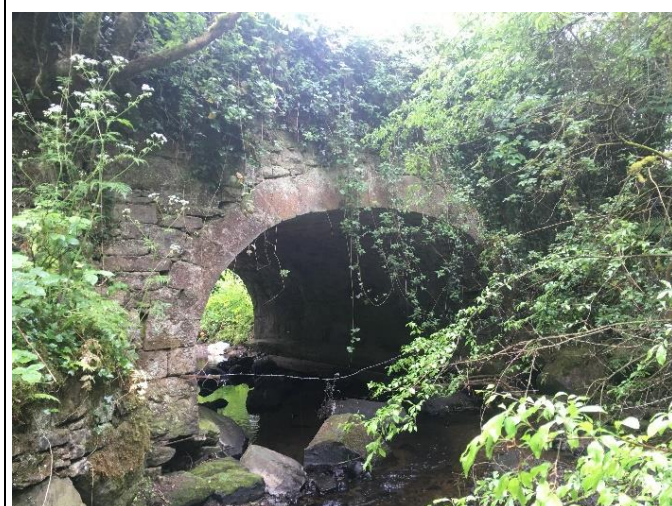
Watercrossing Structure W5

Type: River

Fisheries: Class1, Optimal Fisheries

Existing Structure: Masonry Single Arch Bridge

Works at the Crossing: Cable trenching over structure

Ecology Notes: Upstream - riffle/glide sequence and pool. Bolder (30), cobble (30), sand/gravel (40). Culvert pipe also flowing into river. Downstream - Riffle and pool present. Sand gravel under bridge (60), boulders/cobble(40).

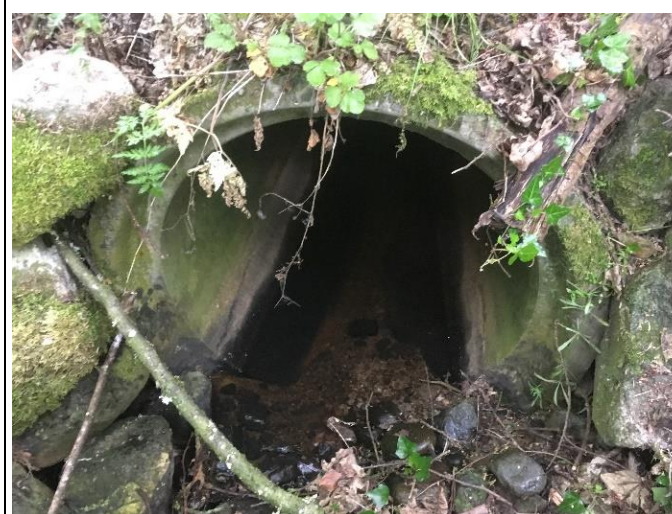
Watercrossing Structure W6

Type: Stream

Fisheries: Class 3, Sub-Optimal Fisheries

Existing Structure: Concrete Circular Culvert

Works at the Crossing: Cable trenching over structure

Ecology Notes: Pipe culvert with stream through it. Bolder (50), mud/gravel (50).

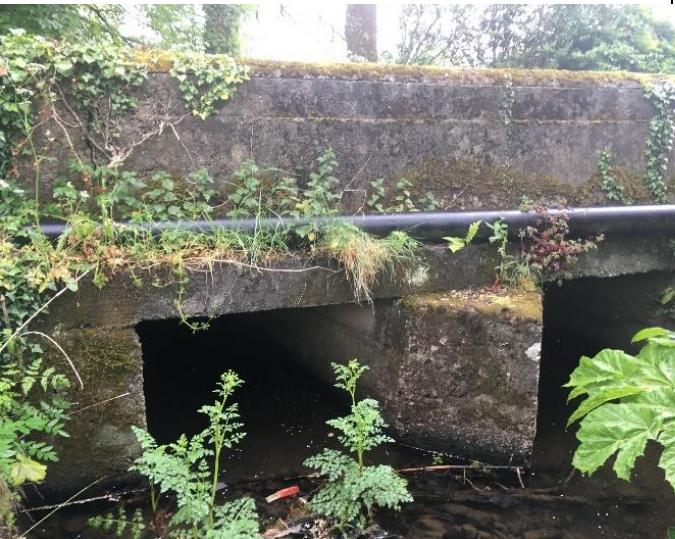
<p>Watercrossing Structure W8</p> <p>Type: Stream</p> <p>Fisheries: Class1, Optimal Fisheries</p> <p>Location/Townland: L6009-0, Ahane/Castlewaller</p> <p>Existing Structure: Concrete Slab Bridge</p> <p>Works at the Crossing: Directional Drill under stream bed.</p> <p>Ecology Notes: Upstream - small riffle and glide. Pooling. Moderate flow. Cobble (70), gravel (30). Downstream - riffle and glide, pool at bridge. Cobble (60), gravel (40).</p>

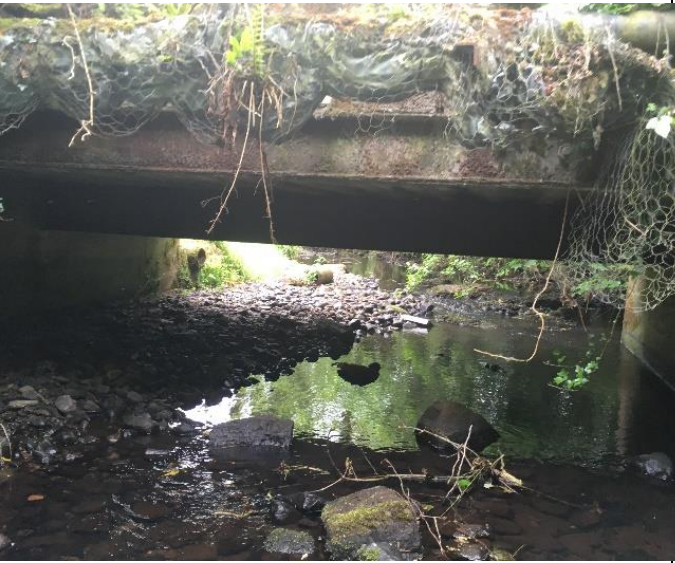
<p>Watercrossing Structure W9</p> <p>Type: Stream</p> <p>Fisheries: Class 1, Optimal Fisheries</p> <p>Location/Townland: L6009-0, Castlewaller/Carrowkeale</p> <p>Existing Structure: Concrete Slab Bridge</p> <p>Works at the Crossing: Directional Drill under stream bed.</p> <p>Ecology Notes: Upstream - riffle and glide and pool (with sand). Sand (30), cobble (50), gravel (20). Downstream - flat rock (40), boulders (30), cobble (30), riffle. Some pooling at edge, no visible build-up of sand. Fast flowing.</p>

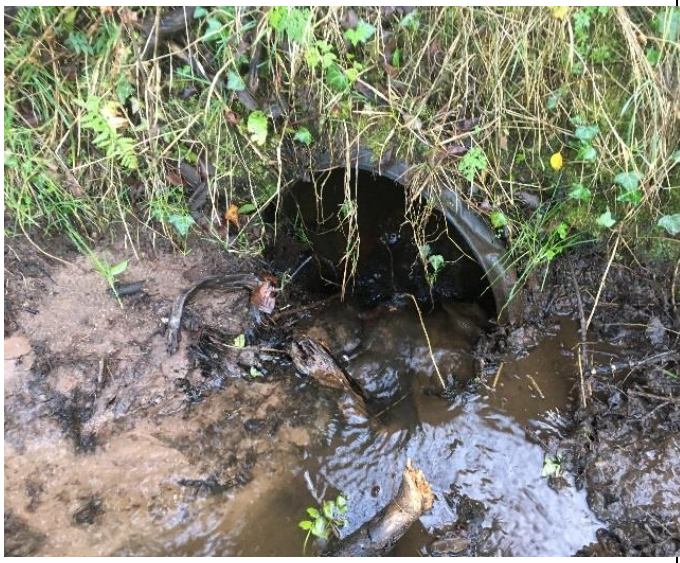
<p>Watercrossing Structure W10 Type: Stream, 1st Order Fisheries: Class 3, Sub-optimal Fisheries Location/Townland: R503, Kilnacappagh</p> <p>Existing Structure: HDPE Plastic Circular Culvert Works at the Crossing: Cable trenching over structure</p> <p>Ecology Notes: deep, drained, flow</p>

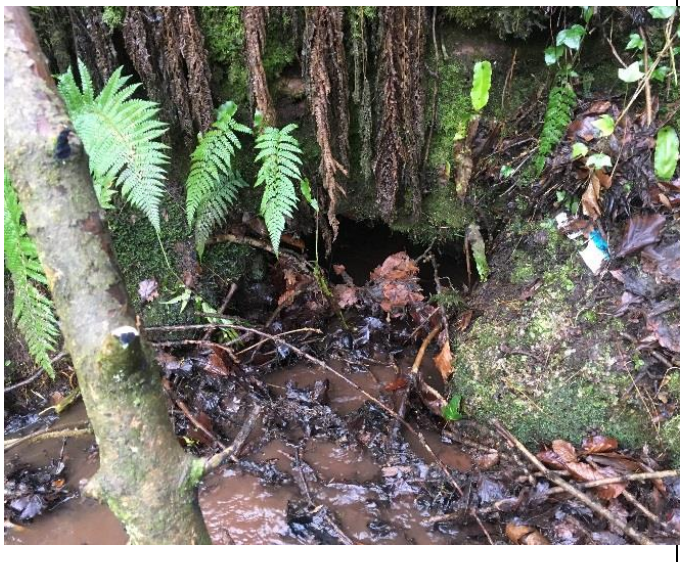
<p>Watercrossing Structure W11 Type: Stream Fisheries: Class 3, Sub-optimal Fisheries Location/Townland: R503, Scrageen/Derrygareen</p> <p>Existing Structure: Masonry Box Culvert Works at the Crossing: Cable trenching over structure</p> <p>Ecology Notes: c. 1 m wide, c. 20 cm deep</p>

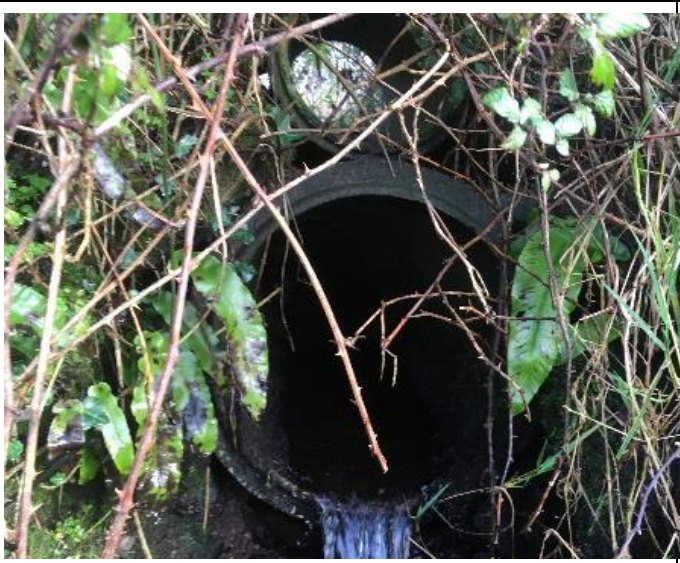
<p>Watercrossing Structure W12 Type: Drain Fisheries: Class 4, Poor Fisheries Location/Townland: R503, Derrygareen</p> <p>Existing Structure: Masonry Box Culvert & Circular Concrete Culvert Works at the Crossing: Cable trenching under structure</p> <p>Ecology Notes: c. 0.8m wide, c. 15 cm deep</p>

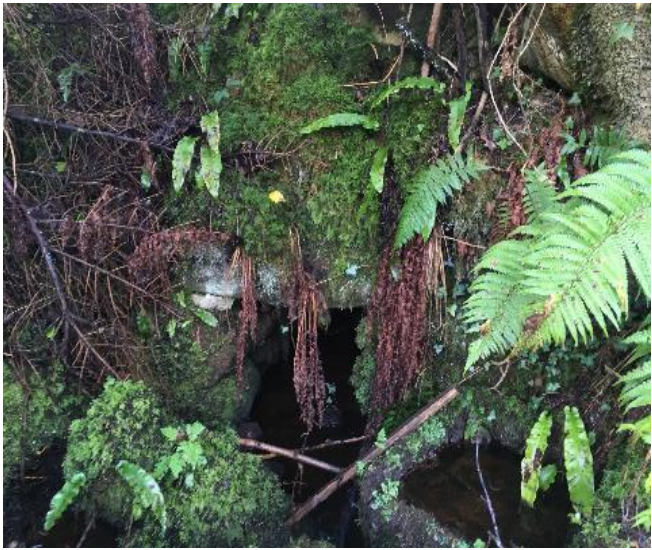
<p>Watercrossing Structure W13</p> <p>Type: Stream, 1st Order</p> <p>Fisheries: Class 4, Poor Fisheries</p> <p>Location/Townland: R503, Knockancullenagh</p> <p>Existing Structure: Masonry Box Culvert</p> <p>Works at the Crossing: Cable trenching under structure. Culvert may need replacing.</p> <p>Ecology Notes: No Fisheries Potential</p>

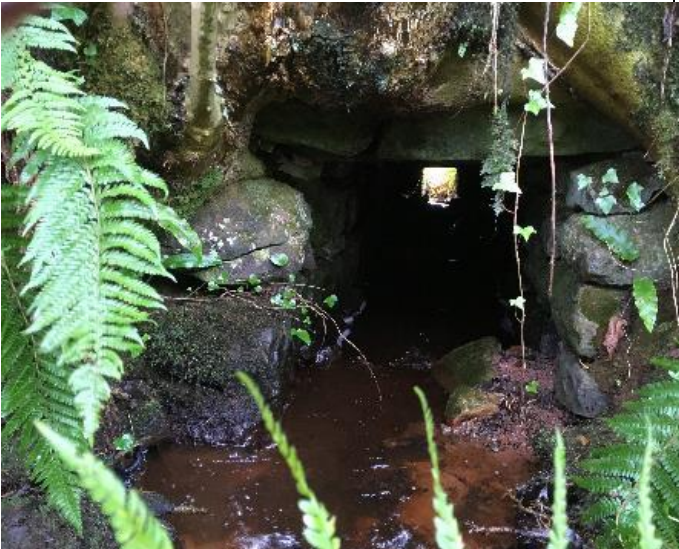
<p>Watercrossing Structure W15</p> <p>Type: Stream, 1st Order</p> <p>Fisheries: Class 3, Sub-optimal Fisheries</p> <p>Location/Townland: R503, Knockancullenagh</p> <p>Existing Structure: Masonry Box Culvert</p> <p>Works at the Crossing: Cable trenching under structure. Culvert may need replacing.</p> <p>Ecology Notes: No Fisheries Potential</p>

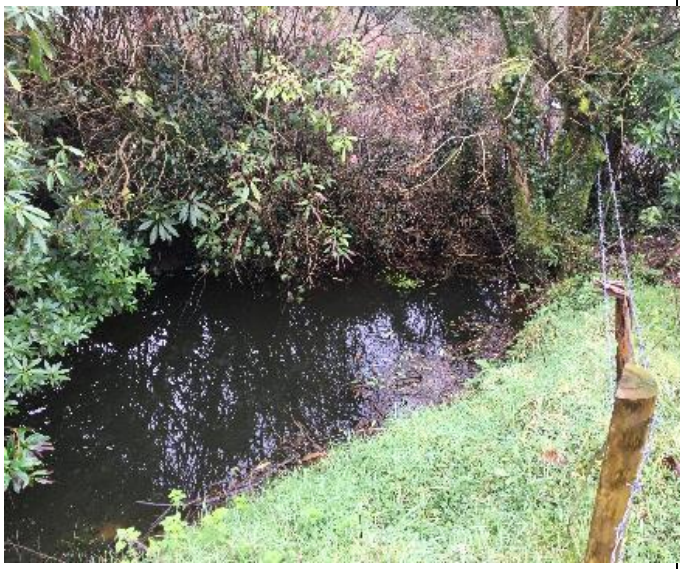
<p>Watercrossing Structure W16</p> <p>Type: Drain</p> <p>Fisheries: Class 4, Poor Fisheries</p> <p>Location/Townland: R503, Knockancullenagh</p> <p>Existing Structure: Plastic Circular Culvert.</p> <p>Works at the Crossing: Cable trenching over structure.</p> <p>Ecology Notes: No Fisheries Potential</p>

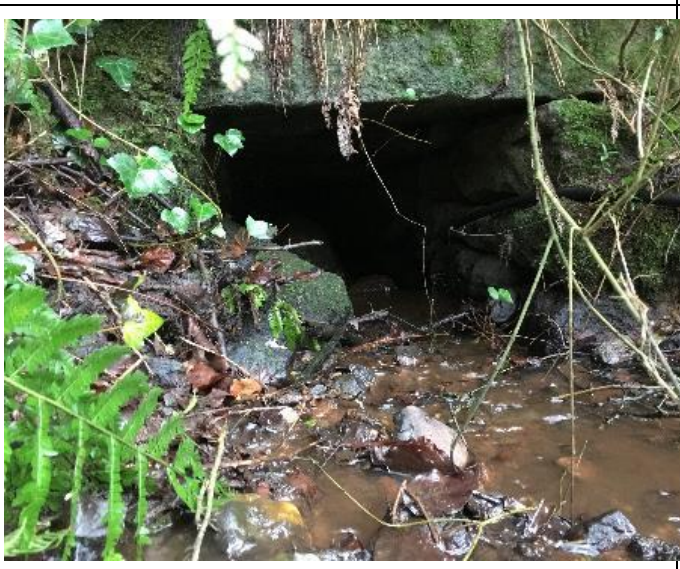
<p>Watercrossing Structure W17</p> <p>Type: Stream, 1st Order</p> <p>Fisheries: Class 3, Sub-optimal Fisheries</p> <p>Location/Townland: R503, Knockancullenagh</p> <p>Existing Structure: Masonry Box Culvert</p> <p>Works at the Crossing: Cable trenching under structure. Culvert may need replacing.</p> <p>Ecology Notes: No Fisheries Potential, steep</p>

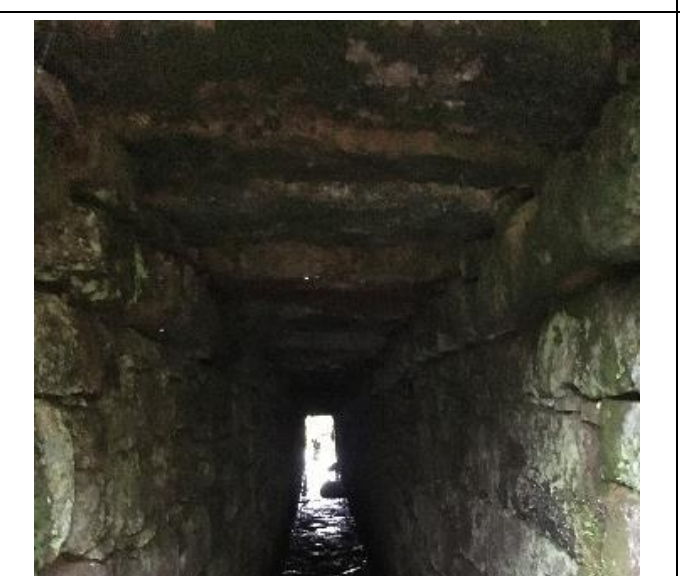
<p>Watercrossing Structure W18</p> <p>Type: Stream, 2nd Order</p> <p>Fisheries: Class1, Optimal Fisheries</p> <p>Location/Townland: R503, Knockancullenagh/Fanit</p> <p>Existing Structure: Masonry Box Culvert</p> <p>Works at the Crossing: Cable trenching over structure.</p> <p>Ecology Notes: steep, boulder cobble pool riffle. Downstream 100% shade, steep gradient</p>

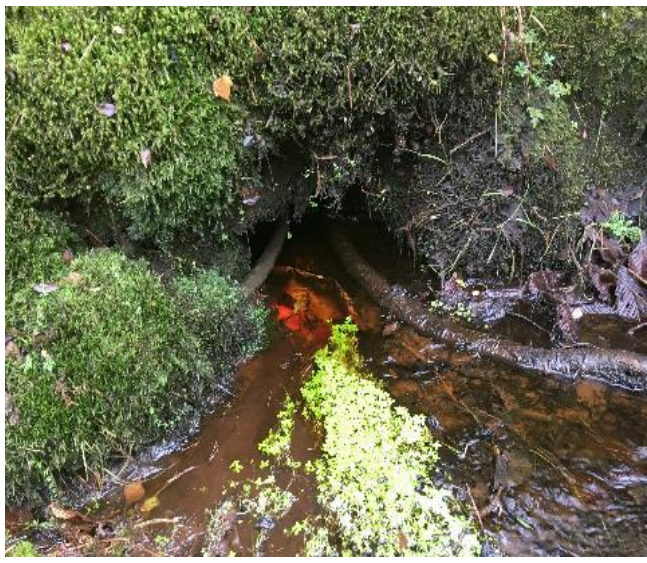
<p>Watercrossing Structure W19</p> <p>Type: Drain</p> <p>Fisheries: Class 4, Poor Fisheries</p> <p>Location/Townland: R503, Fanit</p> <p>Existing Structure: Masonry Box Culvert</p> <p>Works at the Crossing: Cable trenching under structure. Culvert may need replacing.</p> <p>Ecology Notes: No Fisheries Potential</p>

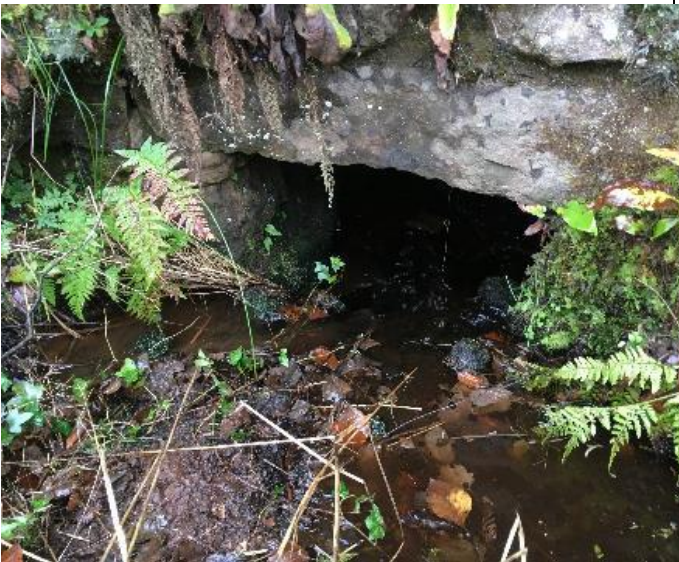
<p>Watercrossing Structure W20</p> <p>Type: Drain</p> <p>Fisheries: Class 4, Poor Fisheries</p> <p>Location/Townland: R503, Fanit</p> <p>Existing Structure: Masonry Box Culvert</p> <p>Works at the Crossing: Cable trenching under structure. Culvert may need replacing.</p> <p>Ecology Notes: No Fisheries Potential 100% shade downstream</p>

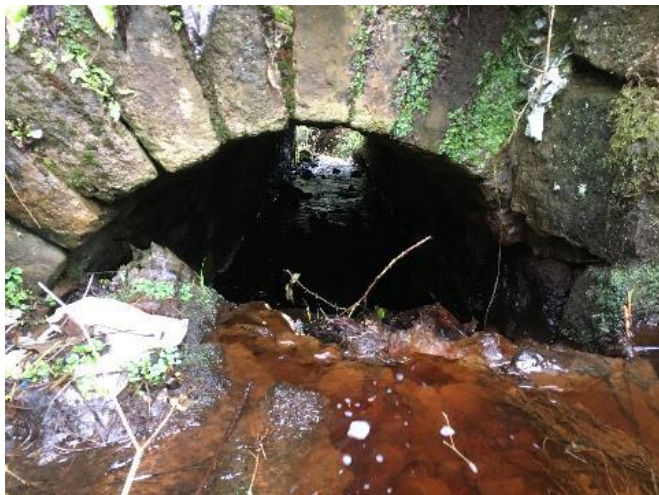
<p>Watercrossing Structure W21</p> <p>Type: Stream, 1st Order</p> <p>Fisheries: Class 3, Sub-optimal Fisheries</p> <p>Location/Townland: R503, Fanit</p> <p>Existing Structure: Masonry Single Arch Bridge</p> <p>Works at the Crossing: Cable trenching over structure.</p> <p>Ecology Notes: No Fisheries Potential 100% shade downstream</p>

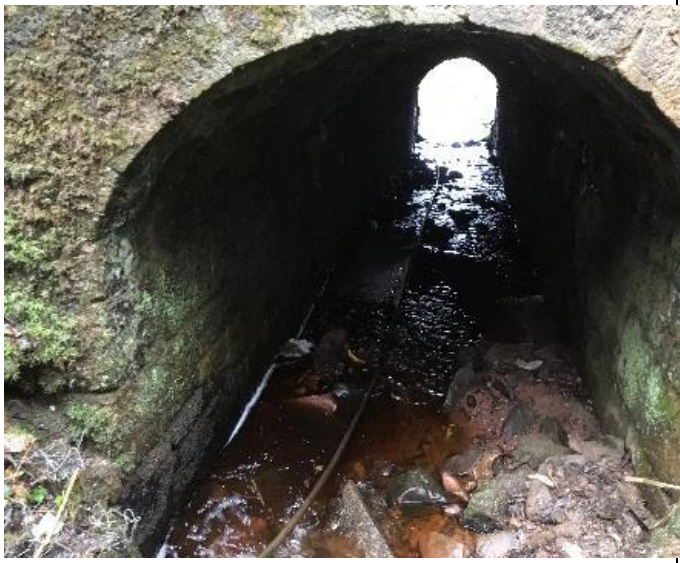
<p>Watercrossing Structure W22</p> <p>Type: Stream, 1st Order</p> <p>Fisheries: Class 3, Sub-optimal Fisheries</p> <p>Location/Townland: R503, Fanit/Lackamore</p> <p>Existing Structure: Masonry Single Arch Bridge</p> <p>Works at the Crossing: Cable trenching over structure.</p> <p>Ecology Notes: steep/cascade</p>

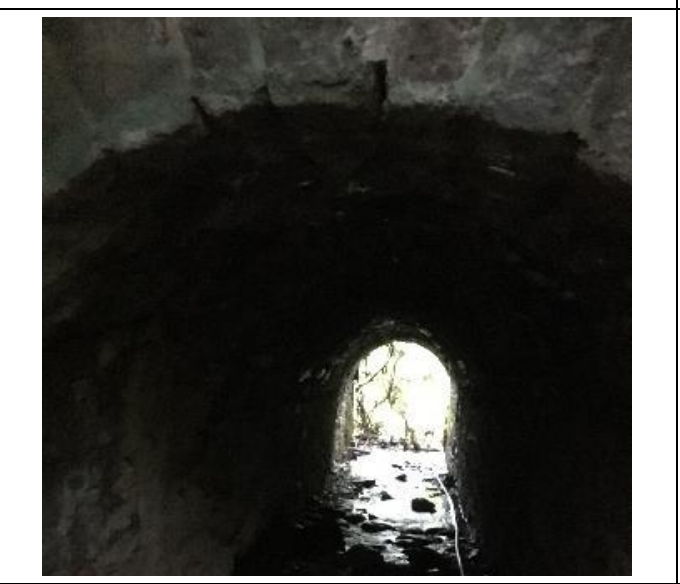
<p>Watercrossing Structure W23</p> <p>Type: Stream</p> <p>Fisheries: Class 3, Sub-optimal Fisheries</p> <p>Location/Townland: R503, Lackamore</p> <p>Existing Structure: Masonry Arch Bridge</p> <p>Works at the Crossing: Cable trenching over structure.</p> <p>Ecology Notes: No Fisheries Potential Upstream:100% shade. Minor steep cascades Downstream: 100% shade</p>

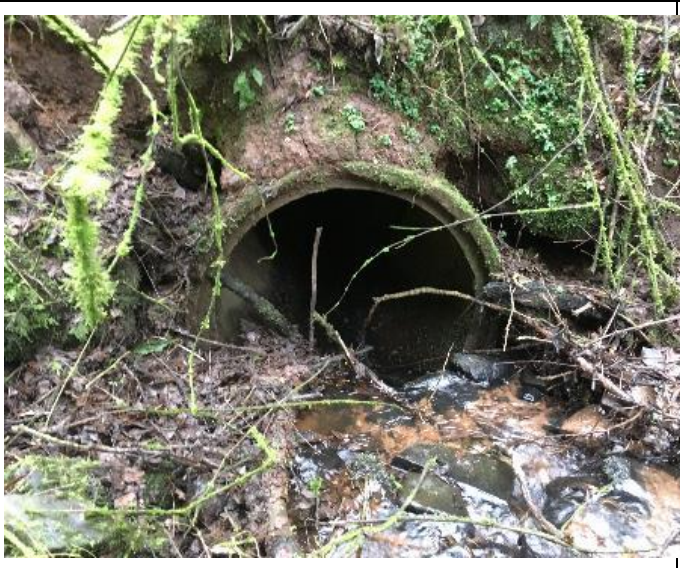
<p>Watercrossing Structure W24</p> <p>Type: Stream, 1st Order</p> <p>Fisheries: Class 3, Sub-optimal Fisheries</p> <p>Location/Townland: R503, Lackamore</p> <p>Existing Structure: Concrete Circular Culvert</p> <p>Works at the Crossing: Cable trenching over structure.</p> <p>Ecology Notes: No Fisheries Potential</p>

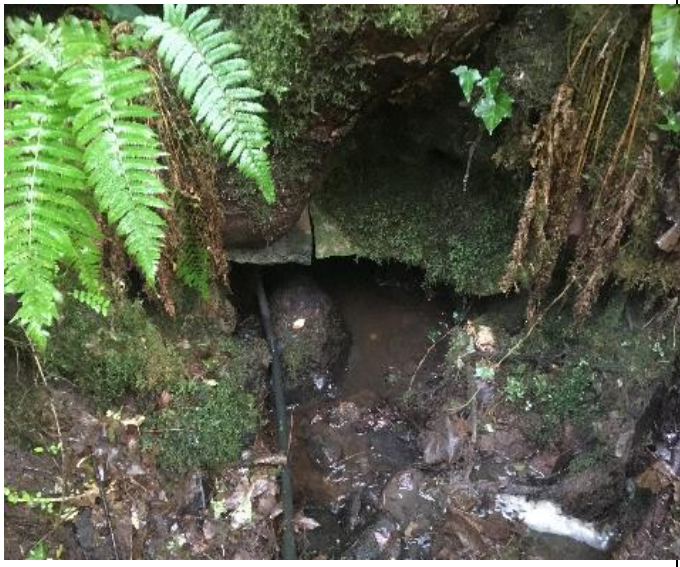
<p>Watercrossing Structure W31</p> <p>Type: Stream, 1st Order</p> <p>Fisheries: Class 3, Sub-optimal Fisheries</p> <p>Location/Townland: R503, Tooreenbrien Upper</p> <p>Existing Structure: Concrete Circular Culvert</p> <p>Works at the Crossing: Crossing under new existing culvert</p> <p>Ecology Notes: No Fisheries Value, Steep Gradient</p>

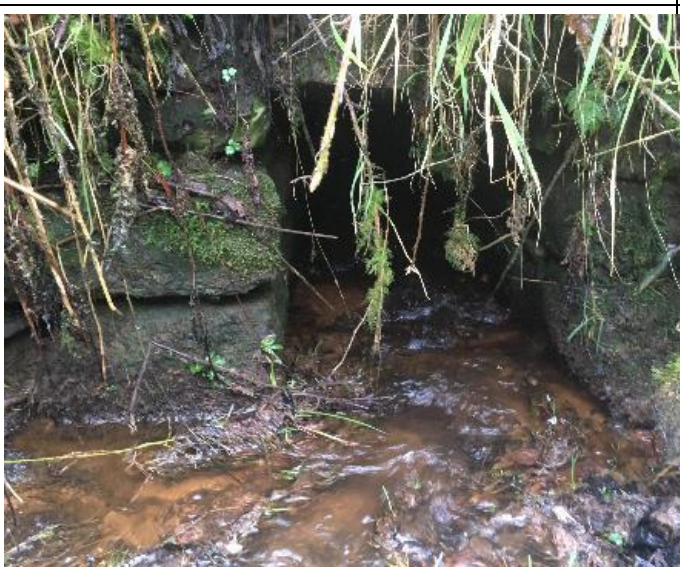
<p>Watercrossing Structure W32</p> <p>Type: Minor Stream</p> <p>Fisheries: Class 3, Sub-optimal Fisheries</p> <p>Location/Townland: R503, Tooreenbrien Upper</p> <p>Existing Structure: Masonry Box Culvert</p> <p>Works at the Crossing: Cable trenching under structure. Culvert may need replacing.</p> <p>Ecology Notes: No Fisheries Value</p>

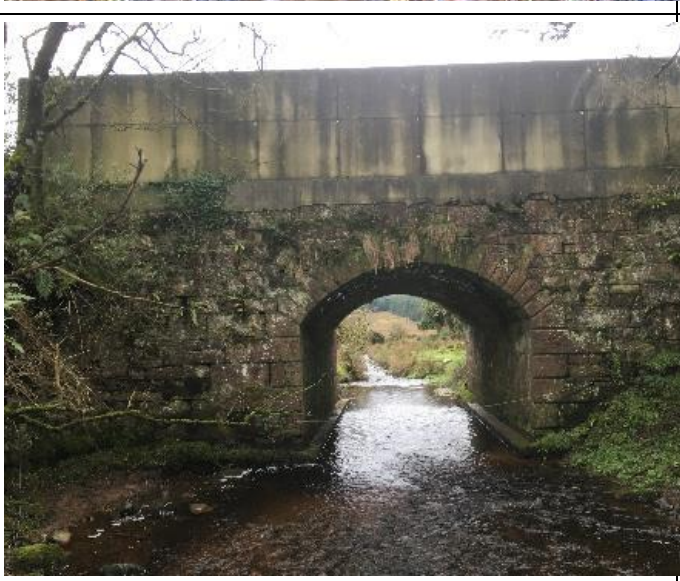
<p>Watercrossing Structure W33</p> <p>Type: Stream</p> <p>Fisheries: Class1, Optimal Fisheries</p> <p>Location/Townland: R503, Tooreenbrien Upper/Tooreenbrien Lower</p> <p>Existing Structure: Masonry Arch Bridge - Single</p> <p>Works at the Crossing: Cable trenching over structure.</p> <p>Ecology Notes: cobble substrate, drained, channelised, riffle/glide</p>

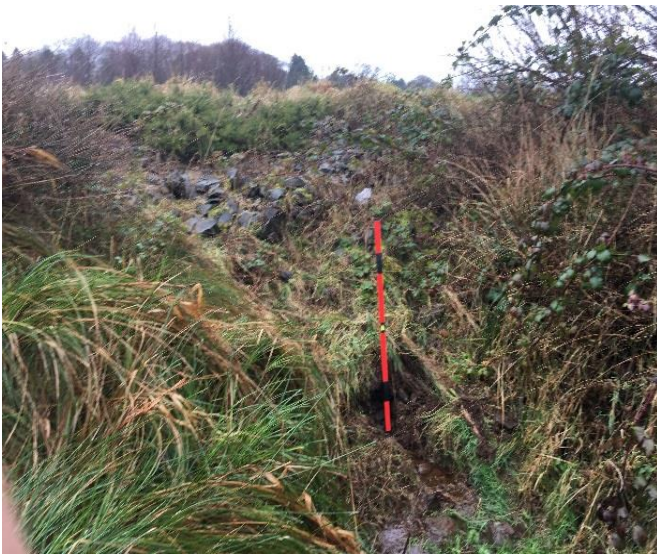
<p>Watercrossing Structure W37</p> <p>Type: Stream, 1st Order</p> <p>Fisheries: Class 3, Sub-optimal Fisheries</p> <p>Location/Townland: R503, Reardnogy Beg</p> <p>Existing Structure: Masonry Arch</p> <p>Works at the Crossing: Crossing over culvert</p> <p>Ecology Notes: No Fisheries Value</p>

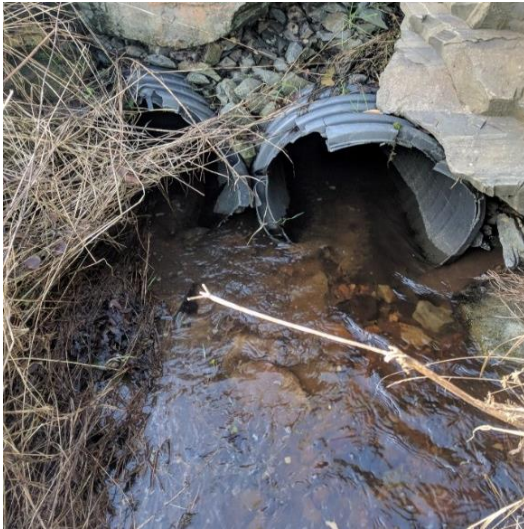
<p>Watercrossing Structure W38</p> <p>Type: Stream, 1st Order</p> <p>Fisheries: Class1, Optimal Fisheries</p> <p>Location/Townland: R503, Reardnogy Beg/Reardnogy More</p> <p>Existing Structure: Plastic Circular Culvert</p> <p>Works at the Crossing: Cable trenching under structure.</p> <p>Ecology Notes: c. 0.7 m wide, c. 140cm deep</p>

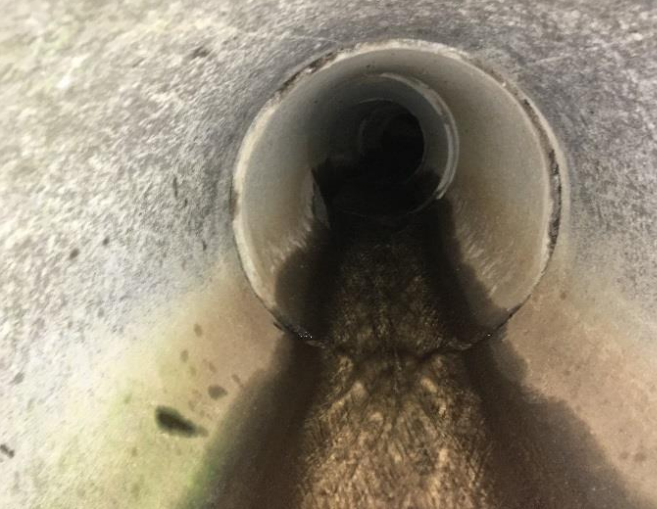
<p>Watercrossing Structure W39</p> <p>Type: Stream, 2nd Order</p> <p>Fisheries: Class1, Optimal Fisheries</p> <p>Location/Townland: R503, Reardnogy More</p> <p>Existing Structure: Plastic Circular Culvert</p> <p>Works at the Crossing: Cable trenching over structure.</p> <p>Ecology Notes: c. 0.6 m wide, c. 100cm deep</p>

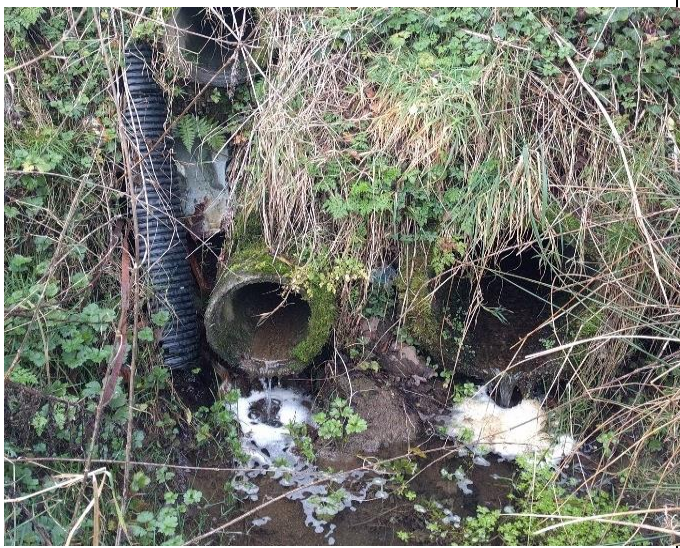
<p>Watercrossing Structure W40</p> <p>Type: Drain</p> <p>Fisheries: Class 4, Poor Fisheries</p> <p>Location/Townland: R503, Rear Cross Village, Reardnogy More/ Shanballyedmond</p> <p>Existing Structure: Concrete Circular Culvert X 3</p> <p>Works at the Crossing: Cable trenching under structures.</p> <p>Ecology Notes: No Fisheries Value</p>

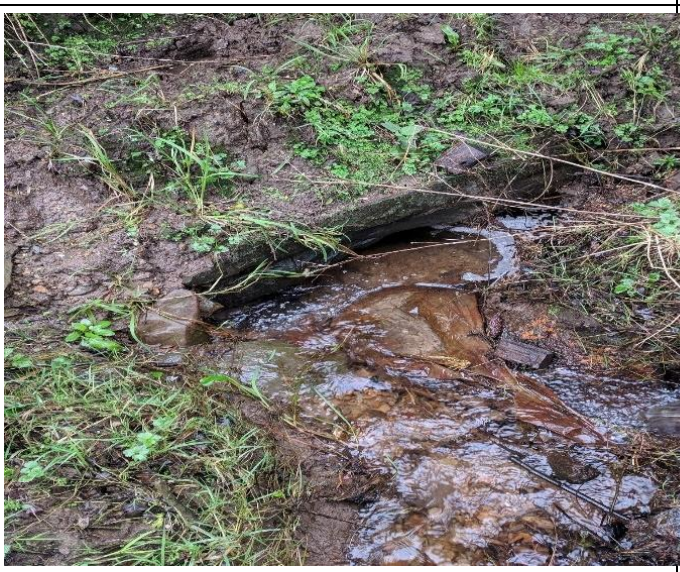
<p>Watercrossing Structure W42</p> <p>Type: Stream, 1st Order</p> <p>Fisheries: Class 3, Sub-optimal Fisheries</p> <p>Location/Townland: R503, Baurnadomeeny</p> <p>Existing Structure: Masonry Box Culvert</p> <p>Works at the Crossing: Cable trenching over structure.</p> <p>Ecology Notes: No Fisheries Potential</p>

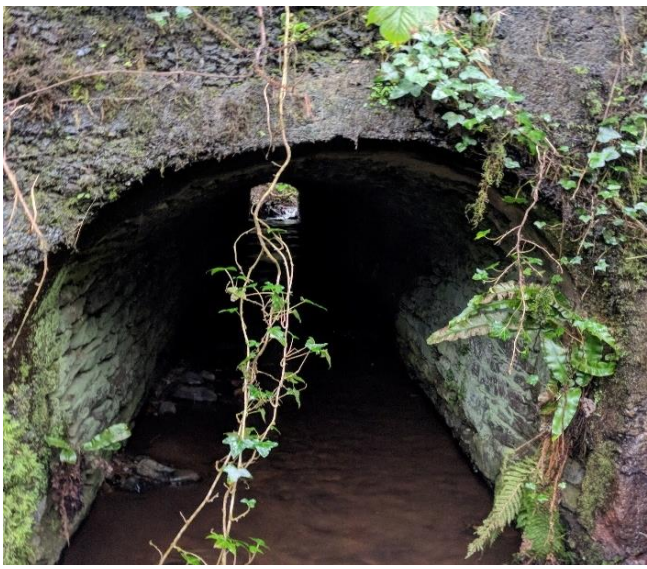
<p>Watercrossing Structure W43</p> <p>Type: Stream, 1st Order</p> <p>Fisheries: Class 3, Sub-optimal Fisheries</p> <p>Location/Townland: R503, Bournadomeeny</p> <p>Existing Structure: Masonry Arch</p> <p>Works at the Crossing: Cable trenching over structure.</p> <p>Ecology Notes: cobble gravel substrate, riffle, steep banks</p>

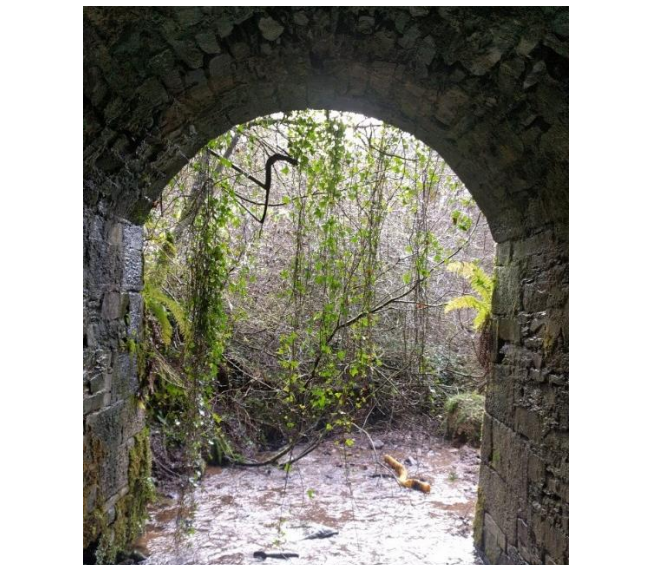
<p>Watercrossing Structure W44</p> <p>Type: Stream, 1st Order</p> <p>Fisheries: Class 3, Sub-optimal Fisheries</p> <p>Location/Townland: R503, Bournadomeeny</p> <p>Existing Structure: Masonry Arch</p> <p>Works at the Crossing: Cable trenching over structure.</p> <p>Ecology Notes: cobble gravel substrate, riffle, steep banks</p>

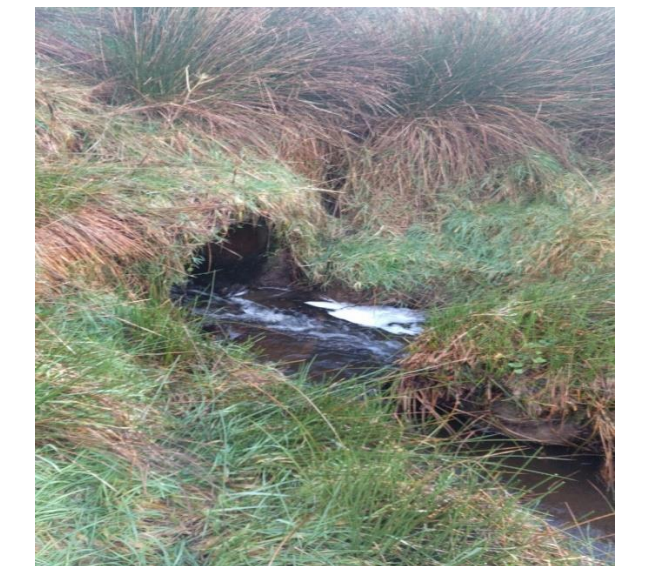
<p>Watercrossing Structure W45</p> <p>Type: Stream, 1st Order</p> <p>Fisheries: Class1, Optimal Fisheries</p> <p>Location/Townland: R503, Bournadomeeny/Coonmore</p> <p>Existing Structure: Concrete Circular Culvert</p> <p>Works at the Crossing: Cable trenching over structure.</p> <p>Ecology Notes: Riffle / glide, cobble substrate, channelised</p>

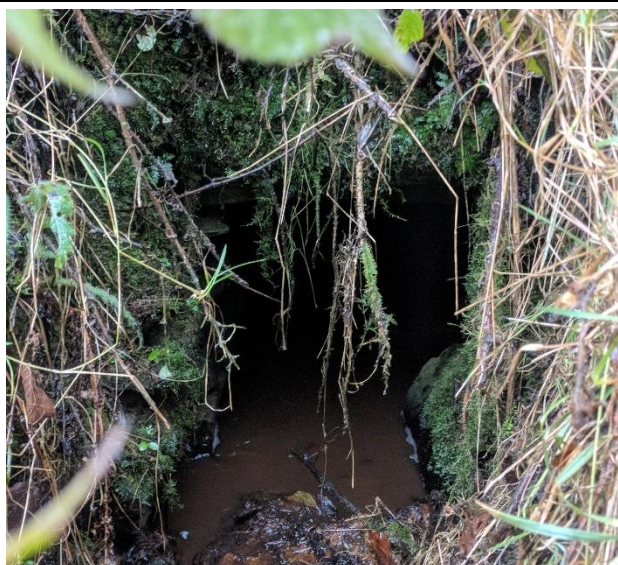
Watercrossing Structure W46

Type: Drain

Fisheries: Class 4, Poor Fisheries

Existing Structure: Masonry Box Culvert

Works at the Crossing: Cable trenching over structure.

Ecology Notes: No Fisheries Value

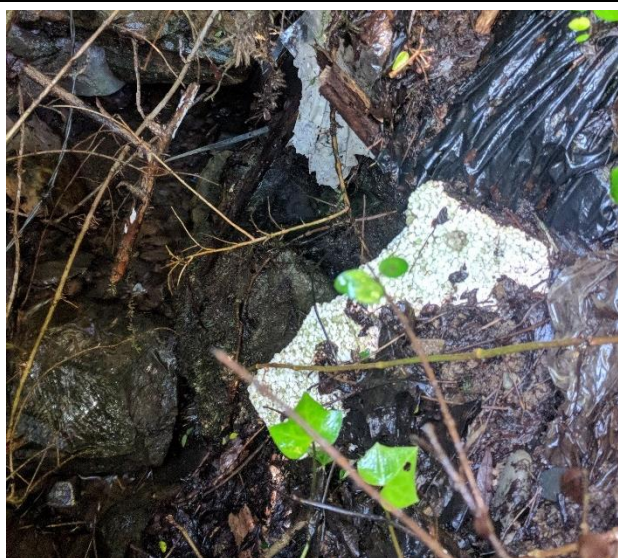
Watercrossing Structure W47

Type: Drain

Fisheries: Class 4, Poor Fisheries

Existing Structure: Masonry Box Culvert

Works at the Crossing: Cable trenching over structure.

Ecology Notes: No Fisheries Value

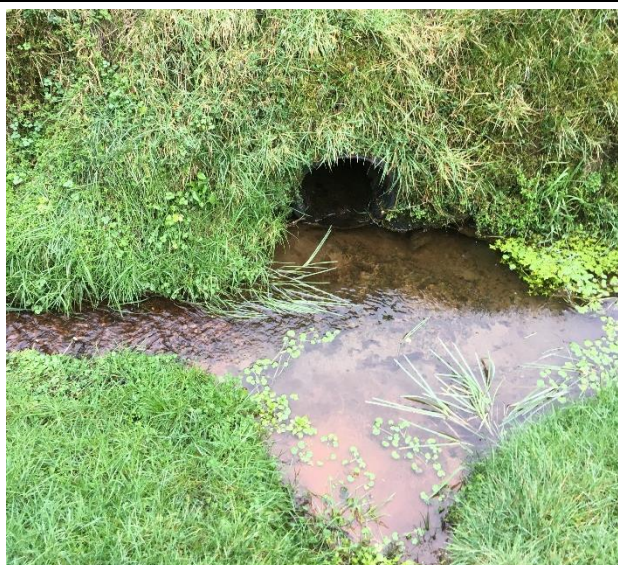
Watercrossing Structure W48

Type: Drain

Fisheries: Class 4, Poor Fisheries

Existing Structure: Plastic Circular Culvert

Works at the Crossing: Cable trenching over structure.

Ecology Notes: No Fisheries Value

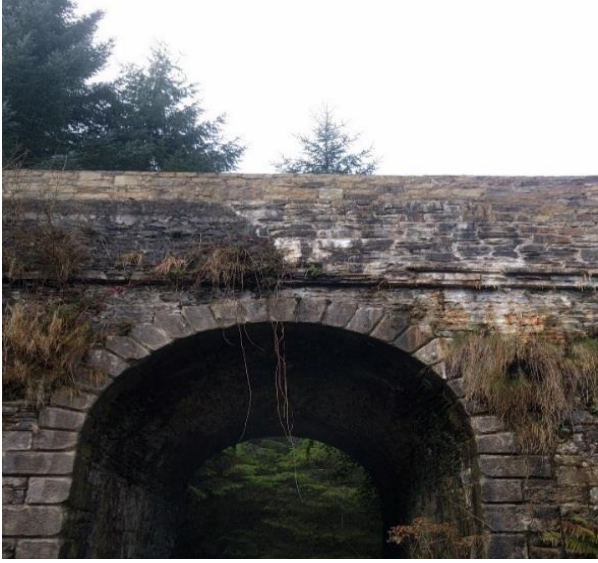
<p>Watercrossing Structure W49</p> <p>Type: River</p> <p>Fisheries: Class1, Optimal Fisheries</p> <p>Location/Townland: R503, Coonmore/Foildarragh</p> <p>Existing Structure: Masonry Arch</p> <p>Works at the Crossing: Cable trenching over structure.</p> <p>Ecology Notes: Cobble/gravel, channelised, riffle</p>

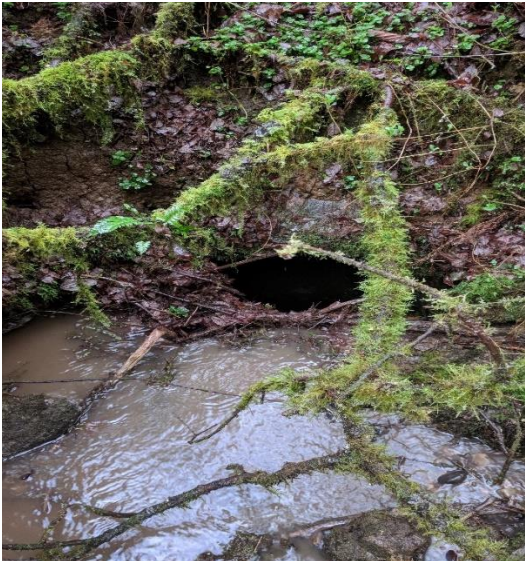
<p>Watercrossing Structure W50</p> <p>Type: Stream, 1st Order</p> <p>Fisheries: Class 3, Sub-optimal Fisheries</p> <p>Location/Townland: R503, Foildarragh</p> <p>Existing Structure: Masonry Box Culvert</p> <p>Works at the Crossing: Cable trenching over structure.</p> <p>Ecology Notes: No Fisheries Value, Very steep gradient, in gorge, 100% cover.</p>

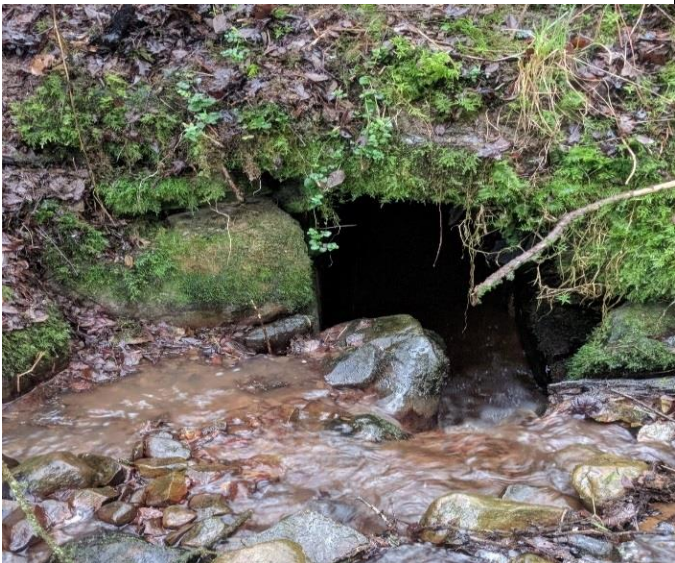
<p>Watercrossing Structure W51</p> <p>Type: Stream, 1st Order</p> <p>Fisheries: Class 3, Sub-optimal Fisheries</p> <p>Location/Townland: R503, Foildarragh</p> <p>Existing Structure: Masonry Box Culvert</p> <p>Works at the Crossing: Cable trenching over structure.</p> <p>Ecology Notes: No Fisheries Value, Very steep gradient, in gorge, 100% cover.</p>

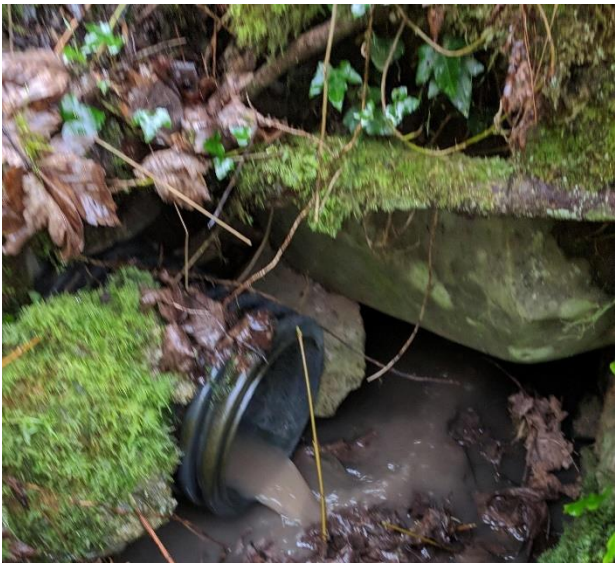
<p>Watercrossing Structure W52</p> <p>Type: Stream, 1st Order</p> <p>Fisheries: Class 3, Sub-optimal Fisheries</p> <p>Location/Townland: R503, Foildarragh</p> <p>Existing Structure: Masonry Box Culvert</p> <p>Works at the Crossing: Cable trenching under structure.</p> <p>Ecology Notes: No Fisheries Value, steep, drained</p>

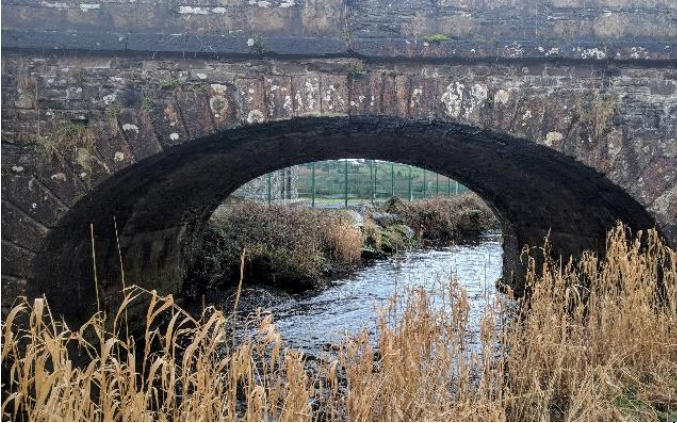
<p>Watercrossing Structure W53</p> <p>Type: River</p> <p>Fisheries: Class1, Optimal Fisheries</p> <p>Location/Townland: Anglesey Bridge, R503, Foildarragh/Kilcommon</p> <p>Existing Structure: Double Masonry Arch</p> <p>Works at the Crossing: Cable trenching over structure, additional works to raise road level & parapet wall height</p> <p>Ecology Notes: U/s: riffle, glide channelized, cobble gravel, sand</p>

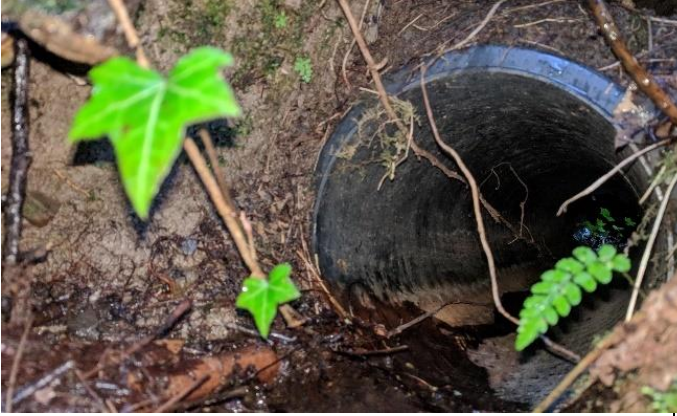
<p>Watercrossing Structure W54</p> <p>Type: Drain</p> <p>Fisheries: Class 4, Poor Fisheries</p> <p>Location/Townland: R503, Kilcommon</p> <p>Existing Structure: Plastic Circular Culvert</p> <p>Works at the Crossing: Cable trenching under structure.</p> <p>Ecology Notes: No Fisheries Value</p>

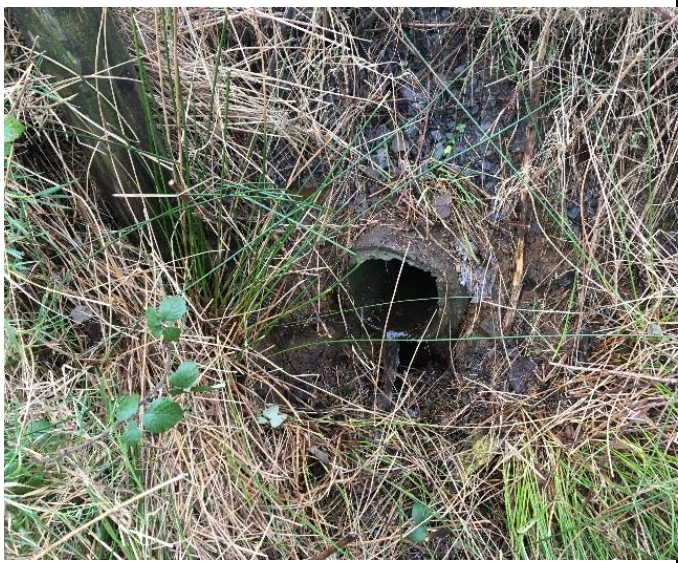
<p>Watercrossing Structure W58</p> <p>Type: Drain</p> <p>Fisheries: Class 4, Poor Fisheries</p> <p>Location/Townland: R503, Loughbrack</p> <p>Existing Structure: Concrete Circular Culvert</p> <p>Works at the Crossing: Cable trenching under structure.</p> <p>Ecology Notes: No Fisheries Value</p>

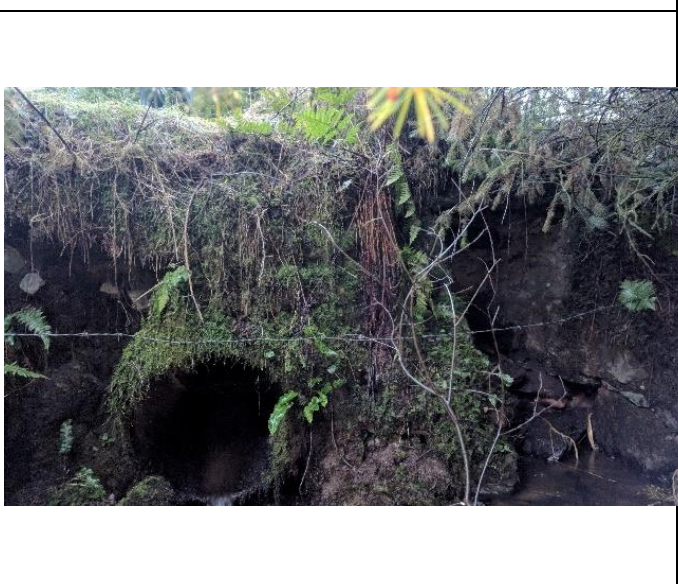
<p>Watercrossing Structure W59</p> <p>Type:</p> <p>Upstream: Drain, Downstream: Stream, 1st Order</p> <p>Fisheries: Class 4, Poor Fisheries</p> <p>Location/Townland: R503, Loughbrack</p> <p>Existing Structure: Concrete Culvert & Masonry Box Culvert</p> <p>Works at the Crossing: Cable trenching under structures.</p> <p>Ecology Notes: No Fisheries Value. Downstream: flow, through forestry</p>

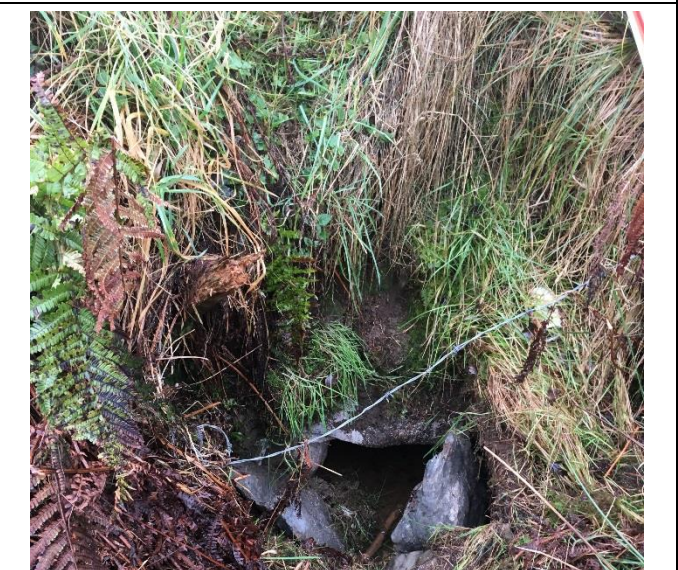
<p>Watercrossing Structure W60</p> <p>Type: Drain</p> <p>Fisheries: Class 4, Poor Fisheries</p> <p>Location/Townland: R503, Loughbrack</p> <p>Existing Structure: Masonry Box Culvert</p> <p>Works at the Crossing: Cable trenching under structure. Culvert may need replacing.</p> <p>Ecology Notes: No Fisheries Value</p>

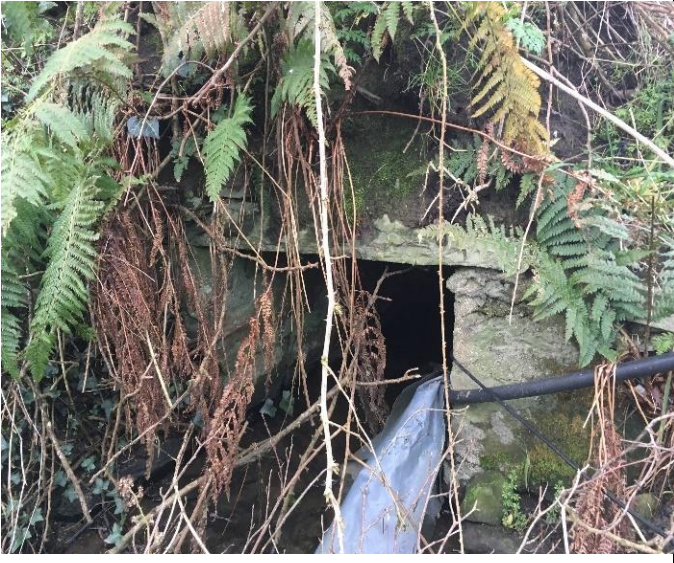
<p>Watercrossing Structure W61</p> <p>Type: Drain</p> <p>Fisheries: Class 4, Poor Fisheries</p> <p>Location/Townland: R503, Knocknabansha/Knockmaroe</p> <p>Existing Structure: Masonry Box Culvert Works at the Crossing: Cable trenching under structure. Culvert may need replacing.</p> <p>Ecology Notes: No Fisheries Value</p>

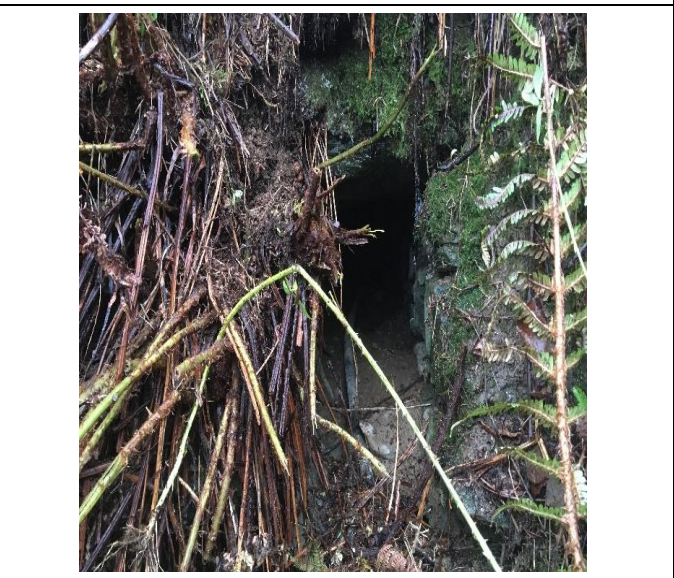
<p>Watercrossing Structure W62</p> <p>Type: Drain</p> <p>Fisheries: Class 4, Poor Fisheries</p> <p>Location/Townland: L2264-50, Knockmaroe</p> <p>Existing Structure: Masonry Box Culvert Works at the Crossing: Cable trenching over structure.</p> <p>Ecology Notes: No Fisheries Value</p>

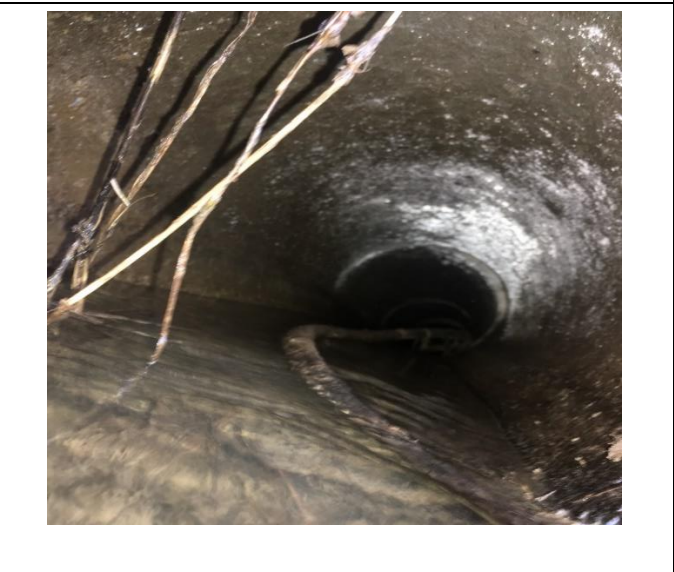
<p>Watercrossing Structure W63</p> <p>Type: Drain</p> <p>Fisheries: Class 4, Poor Fisheries</p> <p>Location/Townland: L2264-50, Knockmaroe/Knockcurraghbola Crownlands</p> <p>Existing Structure: Circular Concrete Culvert Works at the Crossing: Cable trenching under structure.</p> <p>Ecology Notes: No Fisheries Value</p>

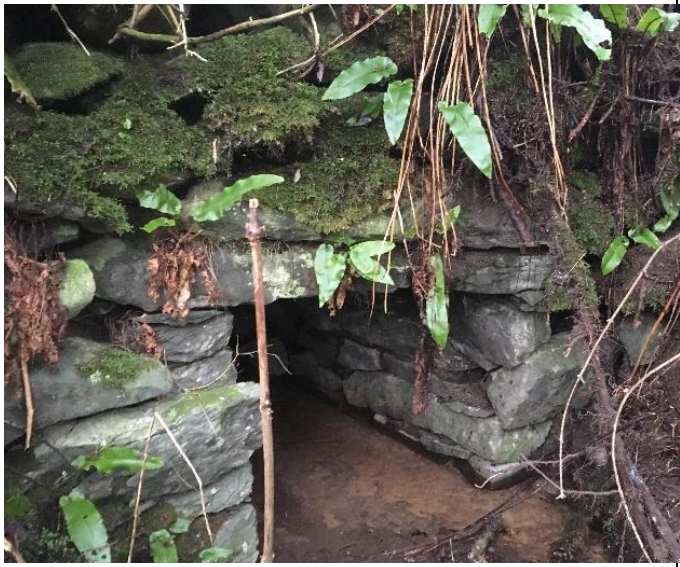
<p>Watercrossing Structure W64</p> <p>Type: Drain</p> <p>Fisheries: Class 4, Poor Fisheries</p> <p>Location/Townland: L2264-50, Knockmaroe</p> <p>Existing Structure: Masonry Box Culvert</p> <p>Works at the Crossing: Cable trenching under structure. Culvert may need replacing.</p> <p>Ecology Notes: No Fisheries Value</p>

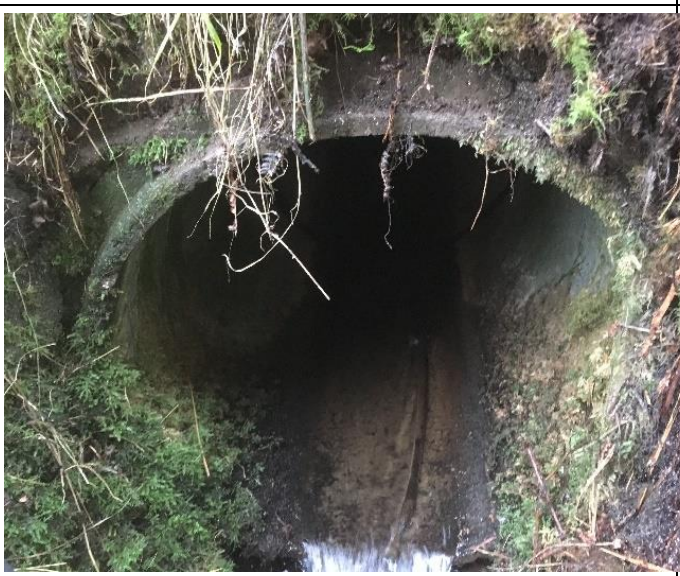
<p>Watercrossing Structure W65</p> <p>Type: Stream</p> <p>Fisheries: Class 2, Optimal Fisheries</p> <p>Location: L6188-0, Knockmaroe</p> <p>Existing Structure: Concrete Circular Culvert</p> <p>Works at Crossing: Cable trenching under structure.</p> <p>Ecology Notes: Steady flow to 20 cm deep with wetted width of c. 1 m. gravel bed.</p>

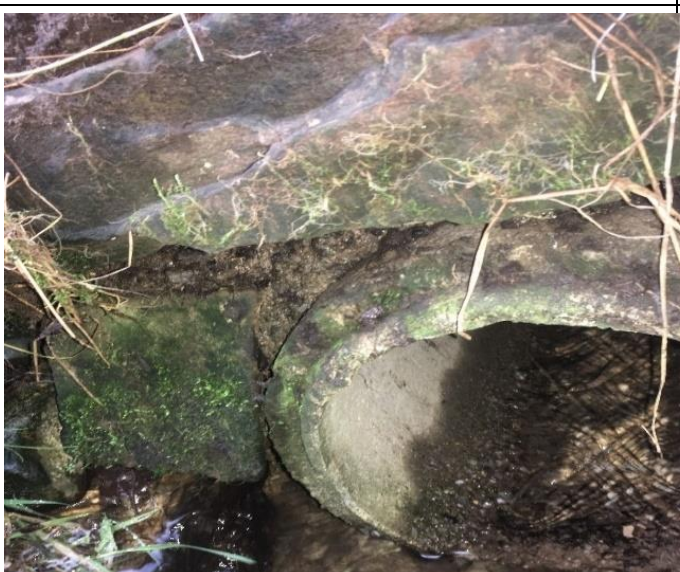
<p>Watercrossing Structure W66</p> <p>Type: Drain</p> <p>Fisheries: Class 4, Poor Fisheries</p> <p>Location/Townland: L6188-0, Knockmaroe</p> <p>Existing Structure: Concrete Circular Culvert</p> <p>Works at the Crossing: Cable trenching under structure.</p> <p>Ecology Notes: No Fisheries Value</p>

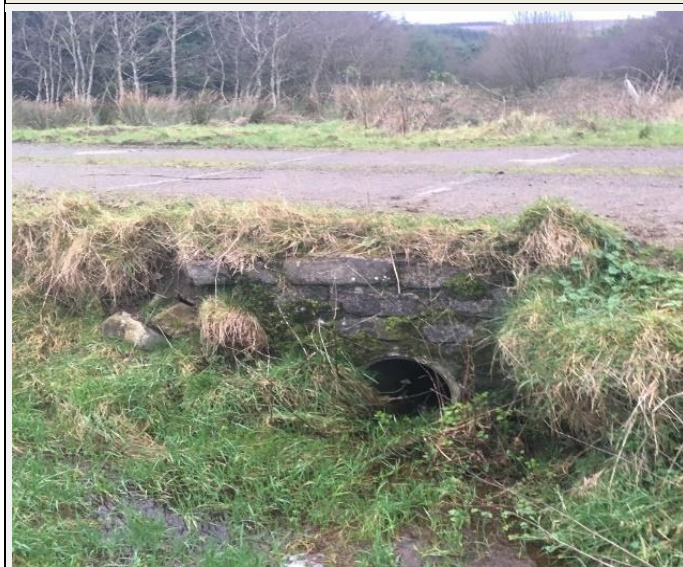
Watercrossing Structure W67

Type: Drain

Fisheries: Class 4, Poor Fisheries

Existing Structure: Concrete Circular Culvert
Works at the Crossing: Cable trenching under
structure.

Ecology Notes: c. 0.5 m wide, 10 cm deep
