Appendix to Appropriate Assessment Report

Appendix A4: Aquatic Habitats & Species Fieldwork & Survey Results

AA4.2 Survey Results - Inventory & Classification of Watercourses at Crossing Locations

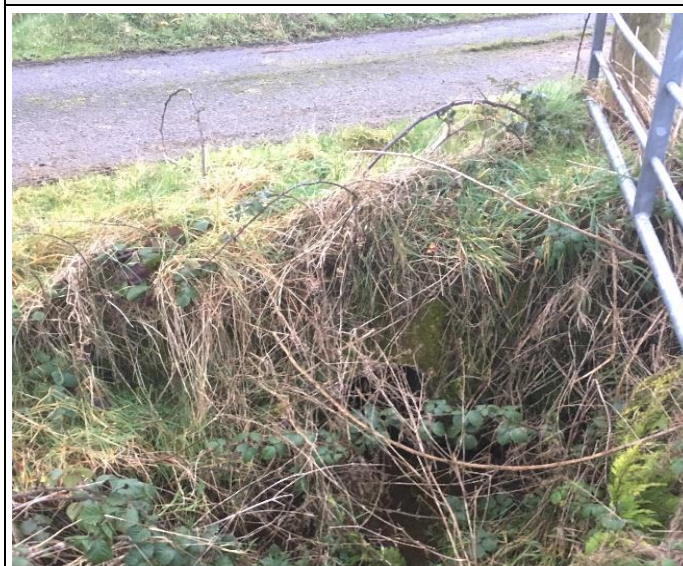
Watercrossing Structure W68

Type: Drain

Fisheries: Class 4, Poor Fisheries

Existing Structure: Concrete Circular Culvert
Works at the Crossing: Cable trenching under
structure.

Ecology Notes: No Fisheries Value, Slow flowing
