# **SAND AND GRAVEL EXTRACTION AT RACEFIELD**

**Environmental Impact Assessment Report  
Volume III: Technical Appendices**

MH18057Rp0001C EIAR Vol III  
Sand and Gravel Extraction at  
Racefield  
F01  
25<sup>th</sup> September 2019

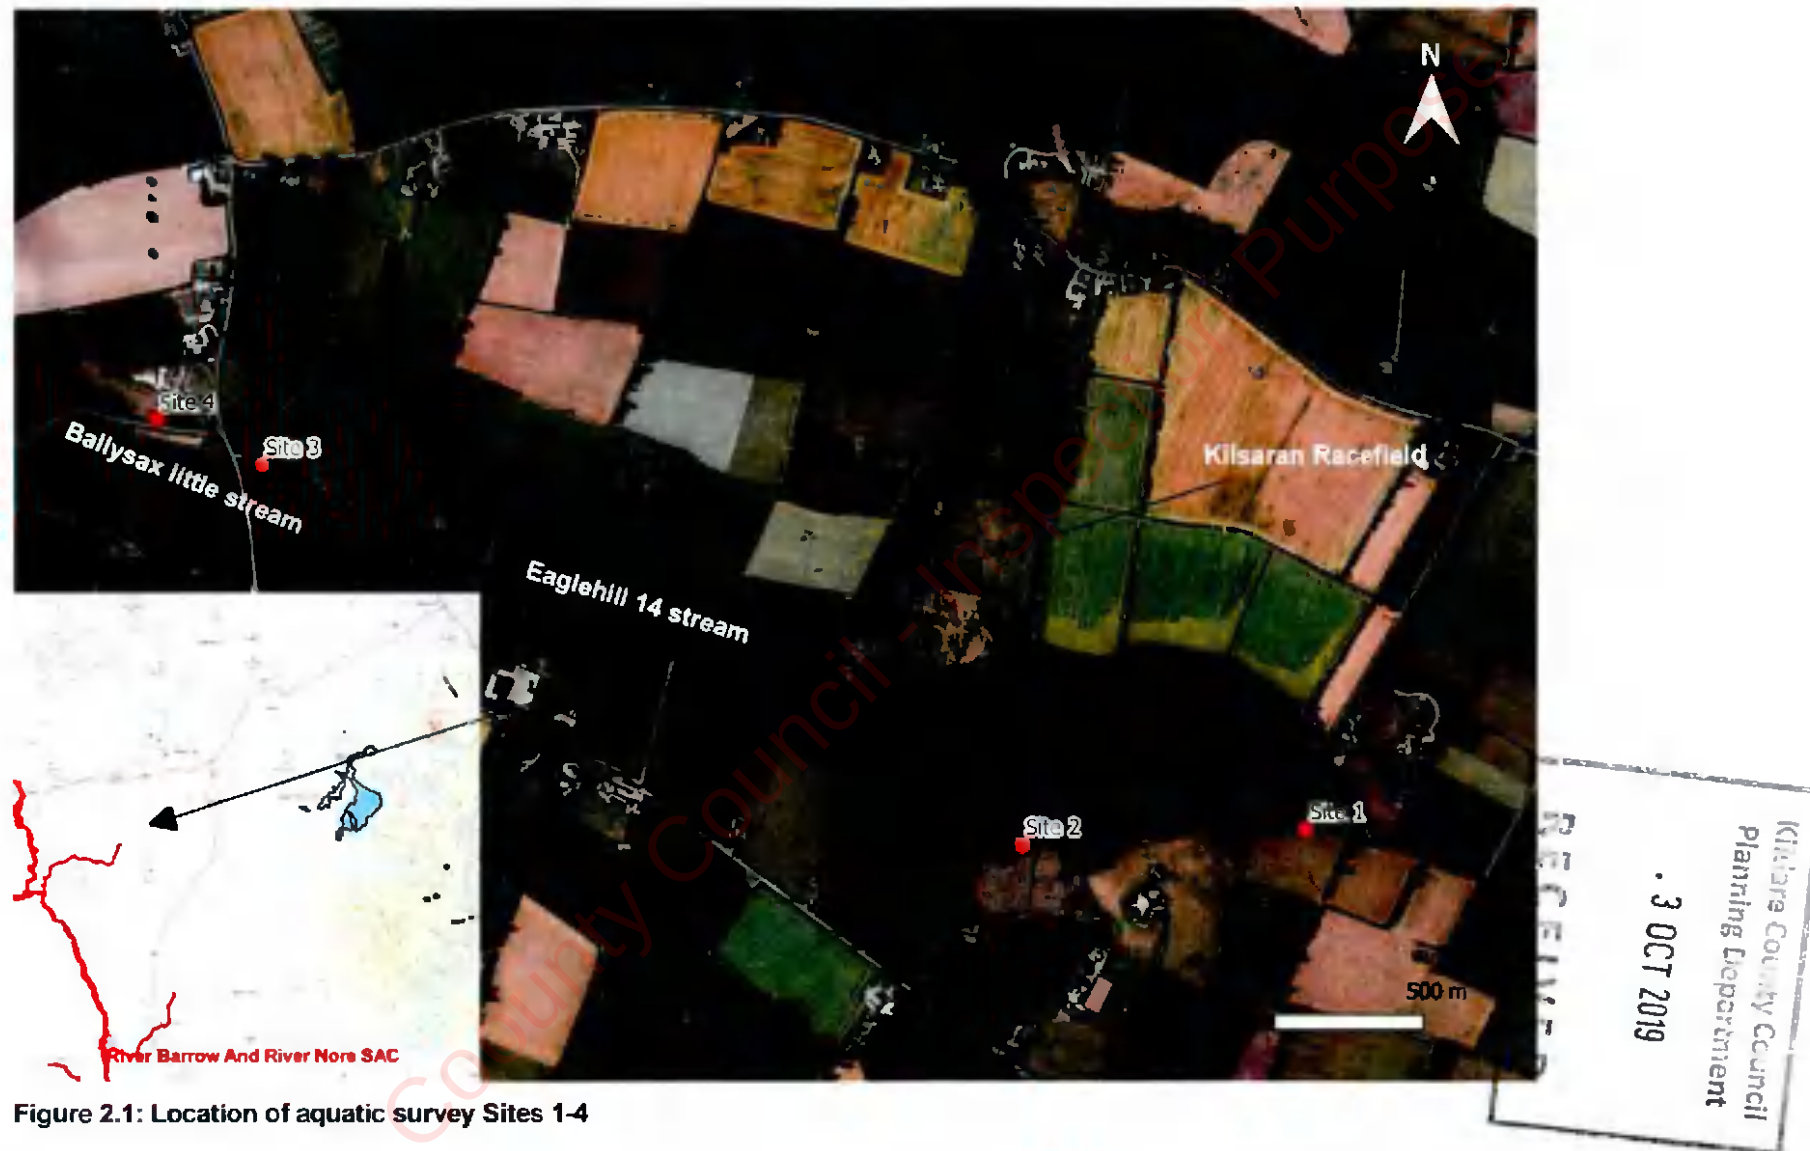
Figure 2.1: Location of aquatic survey Sites 1-4

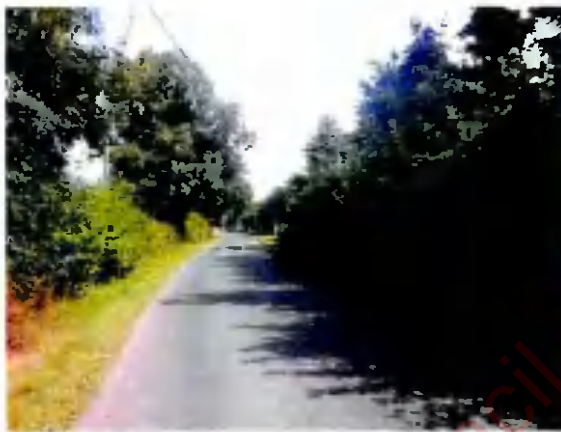
There is insufficient space for two HGVs to pass at certain location along the L8007 between Ballyshannon Cross and the development access. This could lead to material damage collisions as vehicles pass.

Narrow carriageway along site frontage

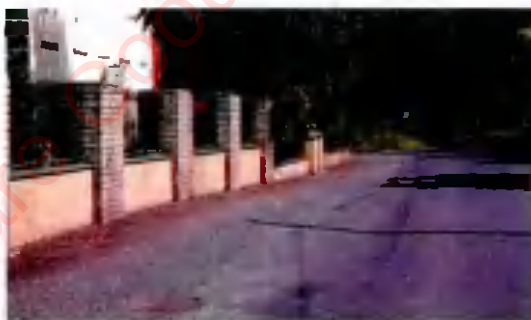
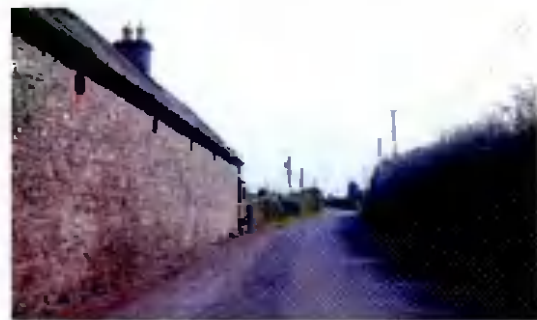
Examples of hard standing areas at private property that are not designed to take HGV loading.

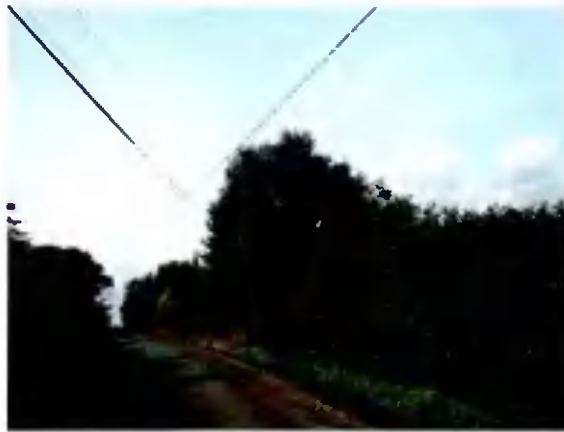
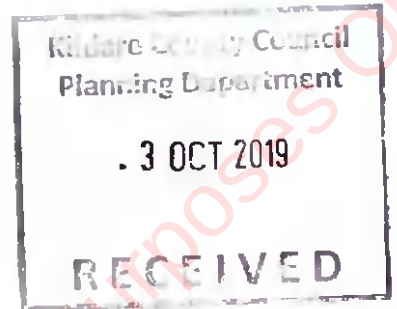
Summer growth of the foliage at road boundary has reduced forward visibility at certain locations along the L8007. This could lead to head-on collisions if drivers are unable to stop if they meet HGVs travelling to/from the quarry.
