McGarrell Reilly Homes

Proposed development of lands in  
Newtownmoyaghy,  
Kilcock, Co. Meath.

**VOLUME III**  
APPENDICES TO ENVIRONMENTAL  
IMPACT ASSESSMENT REPORT

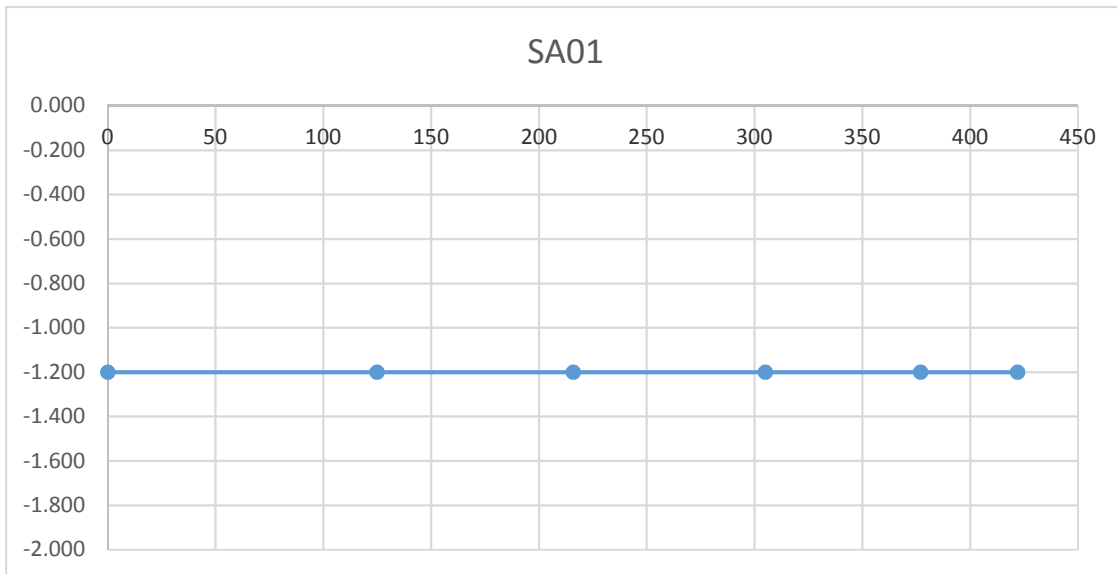
**SA01**

**\*Soakaway failed - Pit backfilled**

Start depth	Depth of Pit	Diff	75% full	25%full
1.20	2.650	1.450	1.5625	2.2875

An Infiltration rate of  $4.353 \times 10^{-4}$  m/s was calculated for the soakaway at the location of SA05. At the locations of SA01, SA02, SA03, SA04, SA06 and SA07 the water level dropped too slowly to allow calculation of 'f' the soil infiltration rate. These locations are therefore not recommended as suitable for soakaway design and construction.

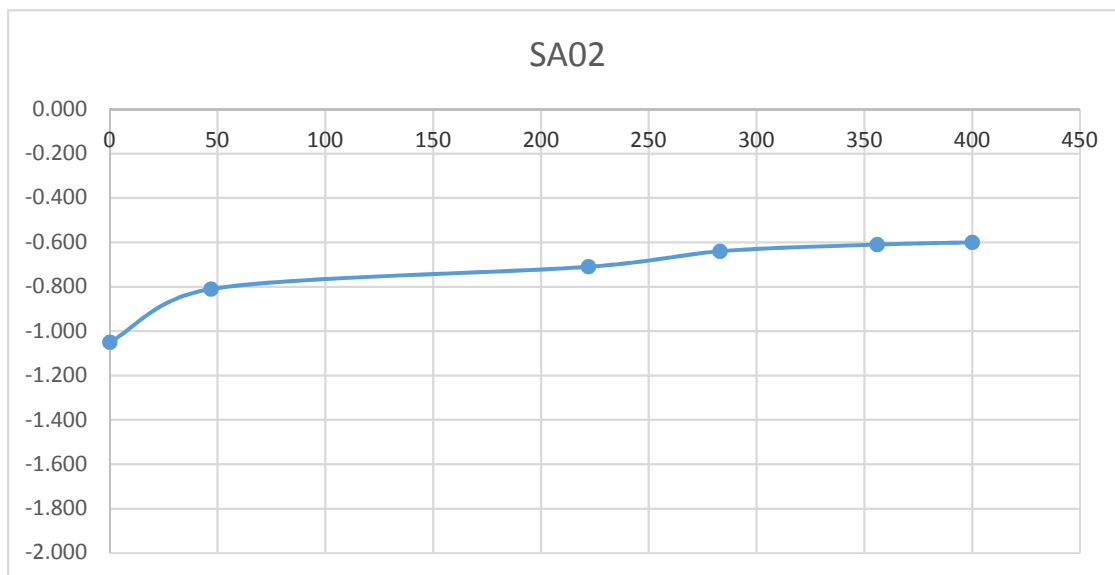
**SA02**

Date	Time	Water level (m bgl)
25/03/2019	0	-1.050
25/03/2019	47	-0.810
25/03/2019	222	-0.710
25/03/2019	283	-0.640
25/03/2019	356	-0.610
25/03/2019	400	-0.600

<b>*Soakaway failed - Pit backfilled</b>				
Start depth	Depth of Pit	Diff	75% full	25%full
1.05	3.000	1.950	1.5375	2.5125

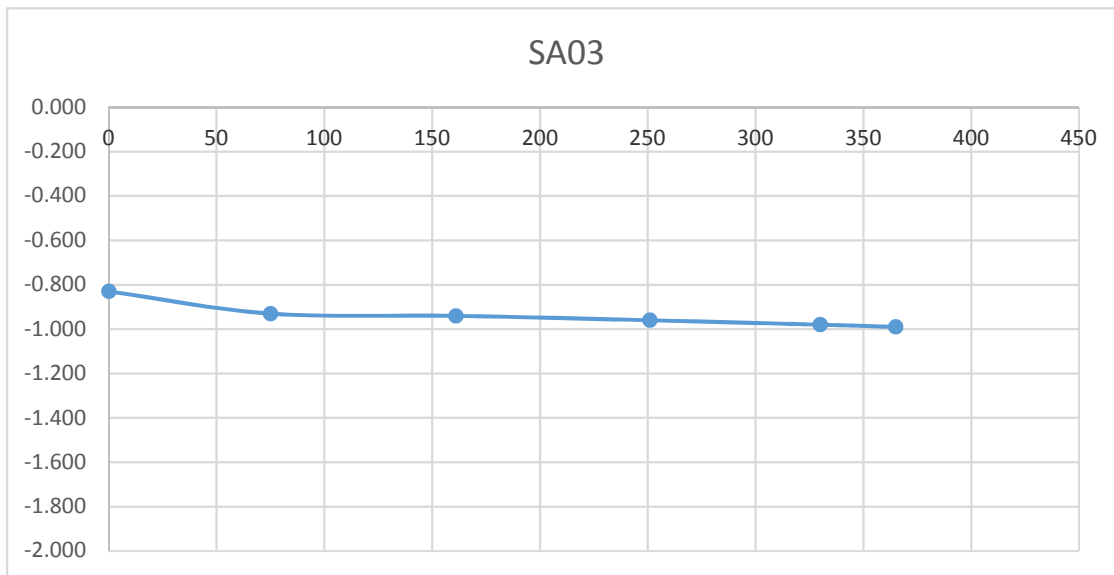
**SA03**

Date	Time	Water level (m bgl)
25/03/2019	0	-0.830
25/03/2019	75	-0.930
25/03/2019	161	-0.940
25/03/2019	251	-0.960
25/03/2019	330	-0.980
25/03/2019	365	-0.990

<b>*Soakaway failed - Pit backfilled</b>				
Start depth	Depth of Pit	Diff	75% full	25%full
<b>0.83</b>	<b>2.250</b>	<b>1.420</b>	<b>1.185</b>	<b>1.895</b>

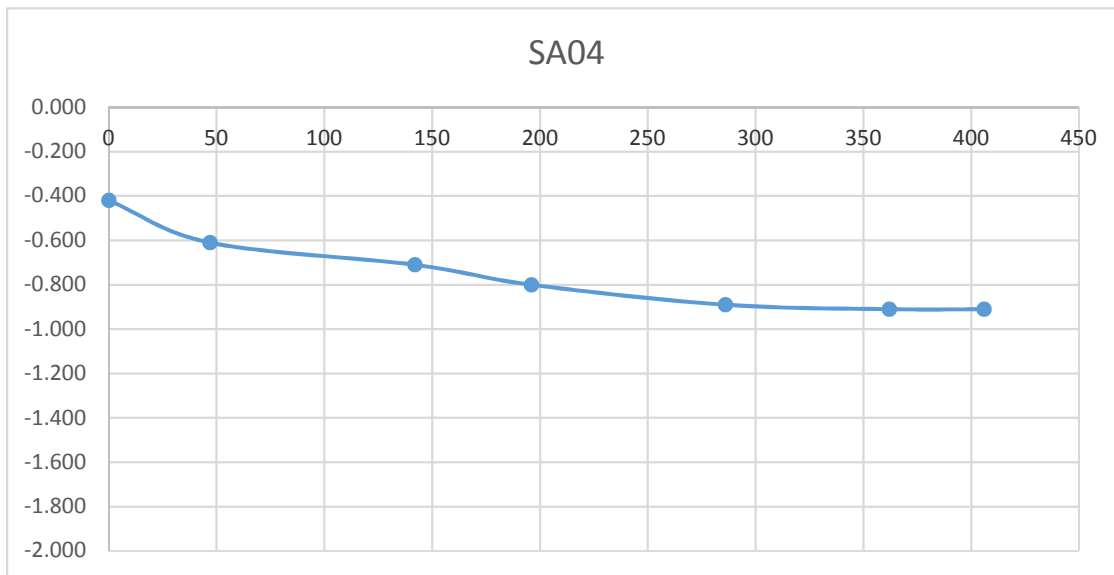
**SA04**

**\*Soakaway failed - Pit backfilled**

Start depth	Depth of Pit	Diff	75% full	25%full
<b>0.42</b>	<b>1.100</b>	<b>0.680</b>	<b>0.59</b>	<b>0.93</b>

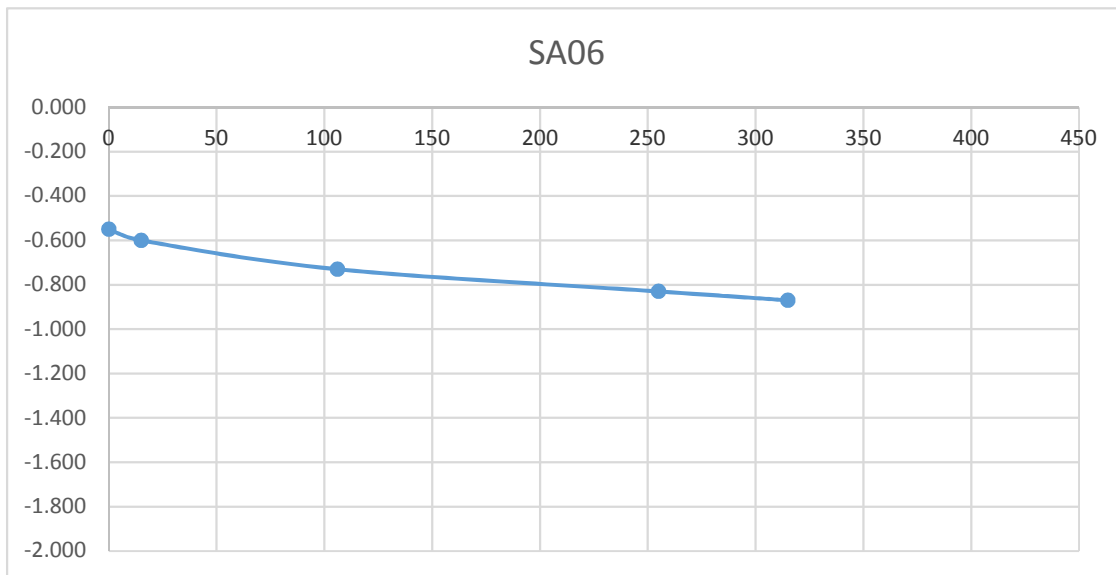
**SA06**

**\*Soakaway failed - Pit backfilled**

Start depth	Depth of Pit	Diff	75% full	25%full
0.55	1.200	0.650	0.7125	1.0375

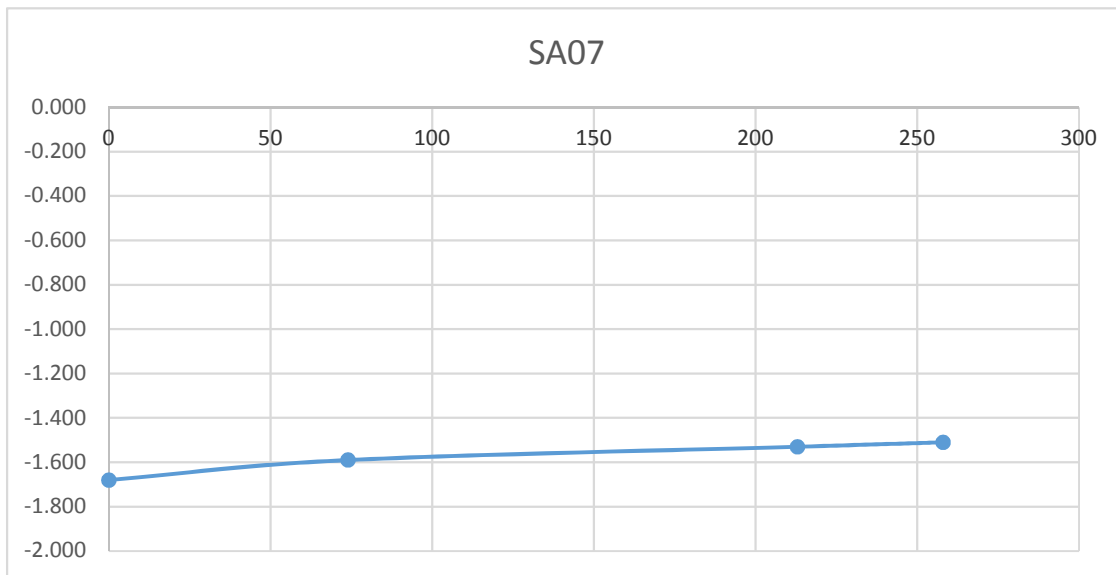
**SA07**

Date	Time	Water level (m bgl)
26/03/2019	0	-1.680
26/03/2019	74	-1.590
26/03/2019	213	-1.530
26/03/2019	258	-1.510

<b>*Soakaway failed - Pit backfilled</b>				
Start depth	Depth of Pit	Diff	75% full	25%full
1.68	2.700	1.020	1.935	2.445

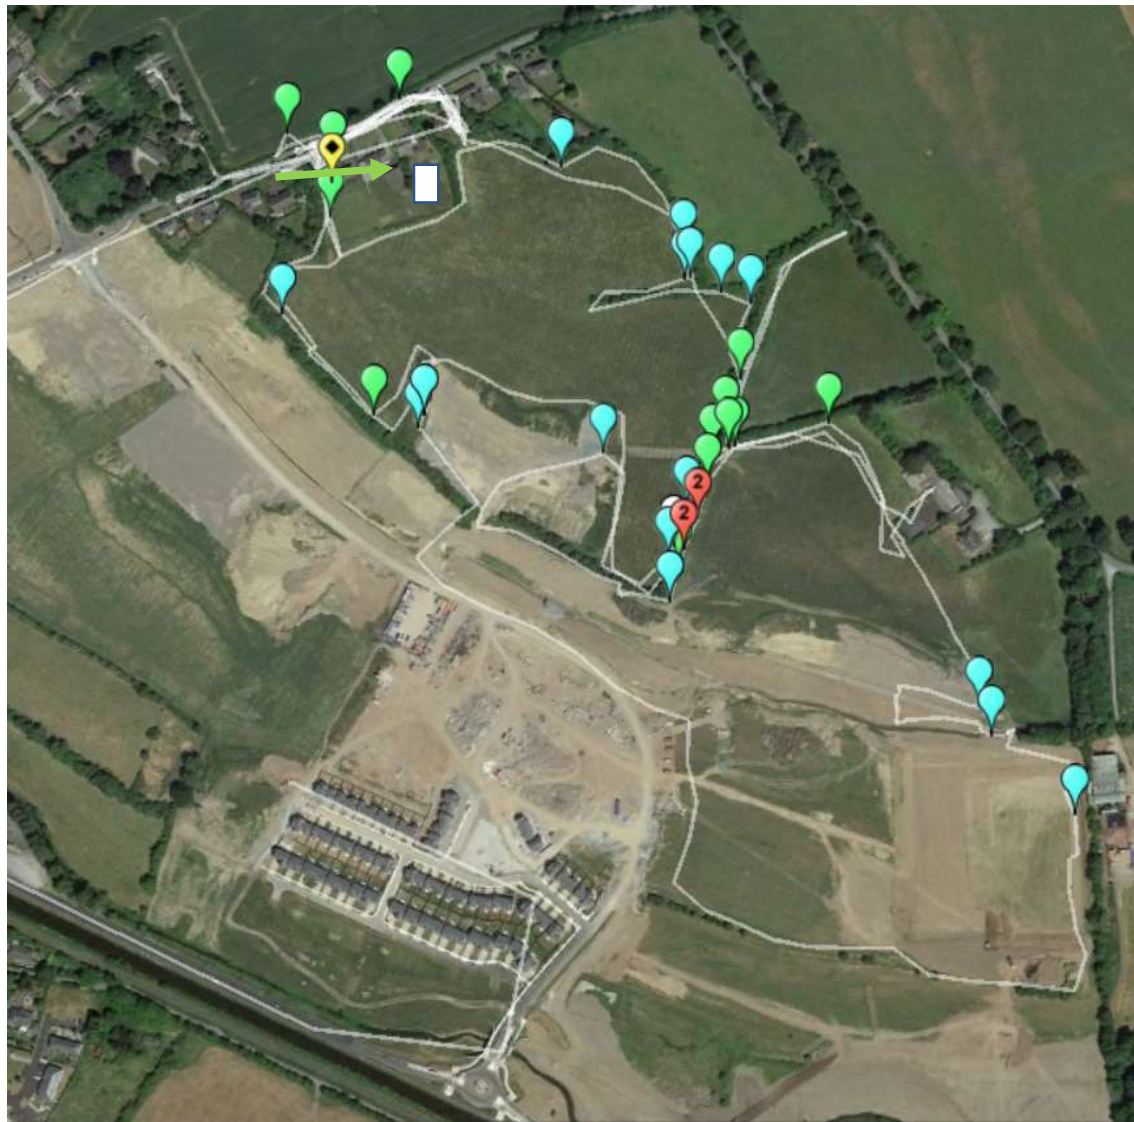
**Figure 1: Bat activity within the proposed Kilcock development area after sunset on 12<sup>th</sup> July 2019**

*White Line*    Transect covered during active survey within and around the site

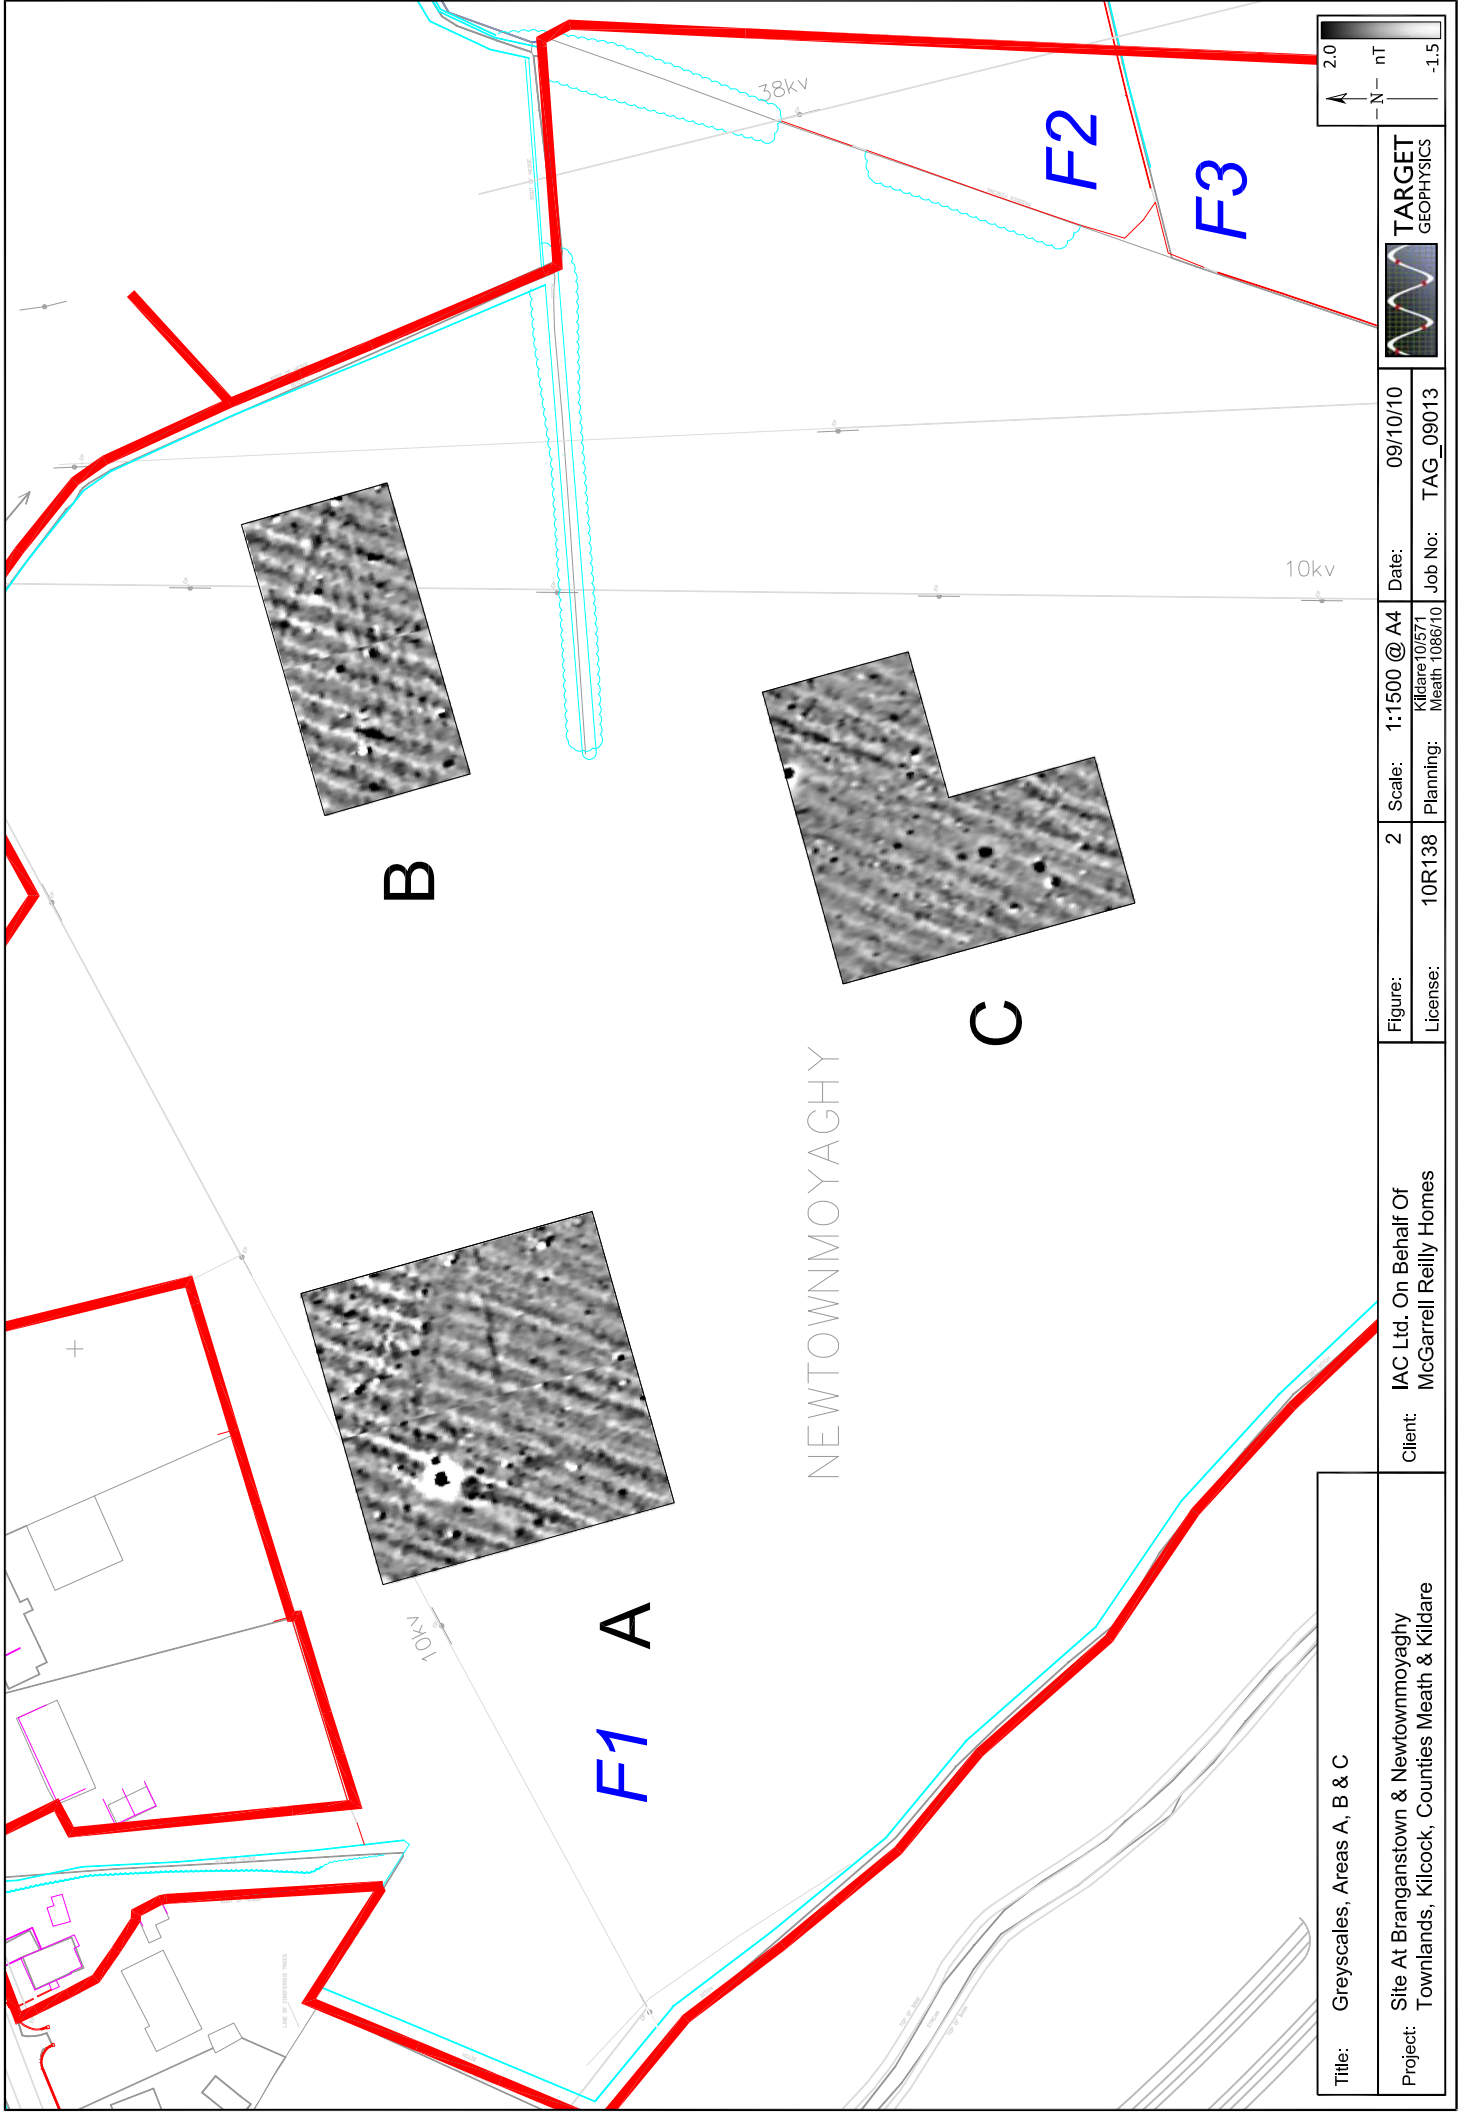
Title: Greyscales, Areas A, B & C
