Stage 1 Road Safety Audit

**Residential Development, Shanganagh Castle,
Cork Little, Co. Dublin**

On behalf of **Dun Laoghaire Rathdown County Council**

December 2019

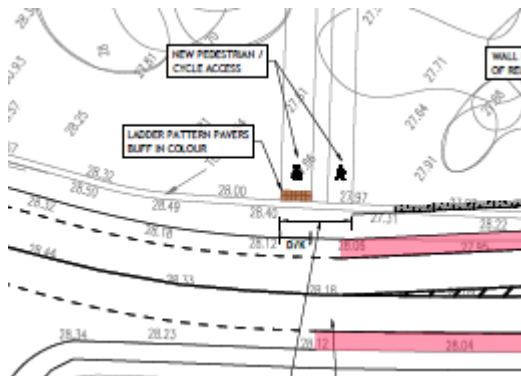
2.2.2 Cyclists use of Footpath.

Problem: Dropped kerbs are provided at some locations where the cyclists seem to be encouraged to cross or make use of the footpath.

Hazard: Cycle / Pedestrian impact may result.

Recommendation: Amend the design so all users have a safe dedicated space within the roads network.

2.2.2	Y	Y	Localised ramp will be provided in conjunction with tactile paving at the separate cycle/pedestrian entrance on the site entrance as there is sufficient space within the site to provide same.

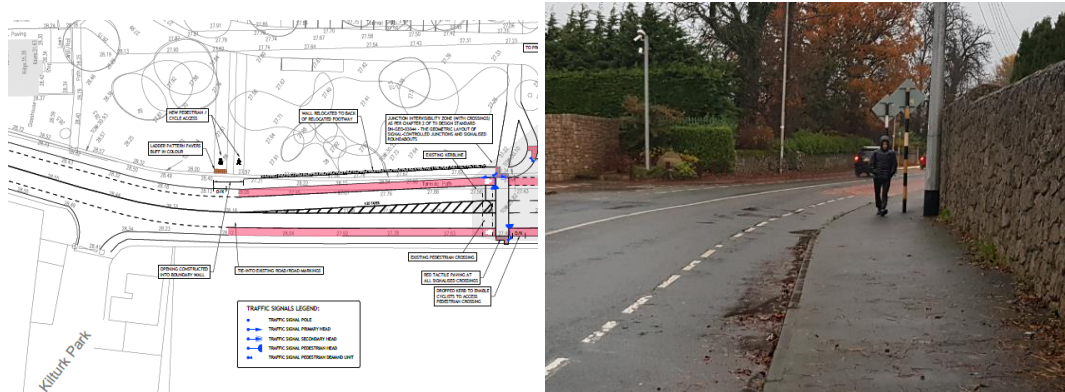
2.3.1 Signalised Junction Location

Problem: The proposed signalised junction is likely to result in queuing of vehicles on the R119. This is of concern where vehicle queues extend back on the southbound approach as there is a bend in the road with limited forward visibility in advance of the junction.

Hazard: Rear end shunts may result.

Recommendation: Relocate the junction further to the south.

Note: Combining this signalised junction with the Allies River Road junction may provide betterment to the existing junction arrangement.

2.3.1	N	N	Sufficient Sight Stopping Distance is provided at the junction for all queue lengths. Refer to 182134/SK32. Additionally, warning signage will be provided of the new signalised junction to warn drivers of the new signalised junction.	Yes

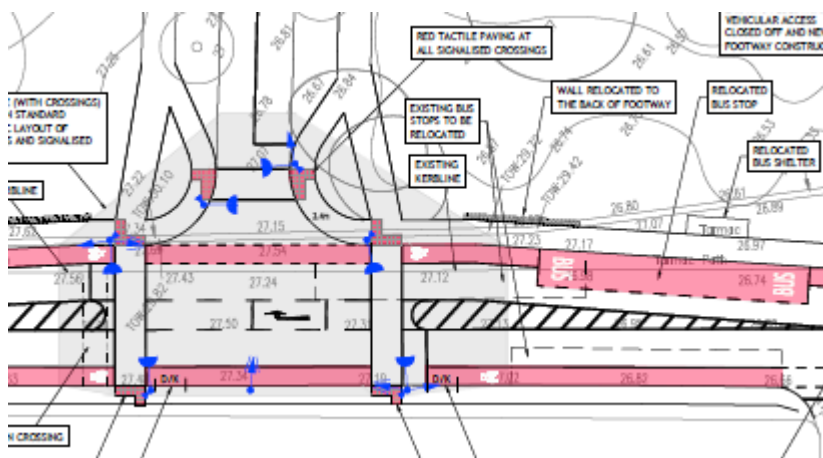
2.3.2 Signalised Junction - Capacity

Problem: The right-turning lane for traffic to access the development from the south is very short. Right turning vehicles may queue back into the through lane.

Hazard: Driver frustration may result in northbound users breaking the red signal in order to clear the junction.

Recommendation: Ensure the right-turning lane is sufficiently long to accommodate the anticipated demand.

2.3.2	N	N	The capacity of the signalised junction has been evaluated for the forecast traffic loading and concluded that queuing for only one car is necessary. There will effectively be sufficient space for two vehicles to queue for the right turn when the space behind the turning bay is included.	Yes

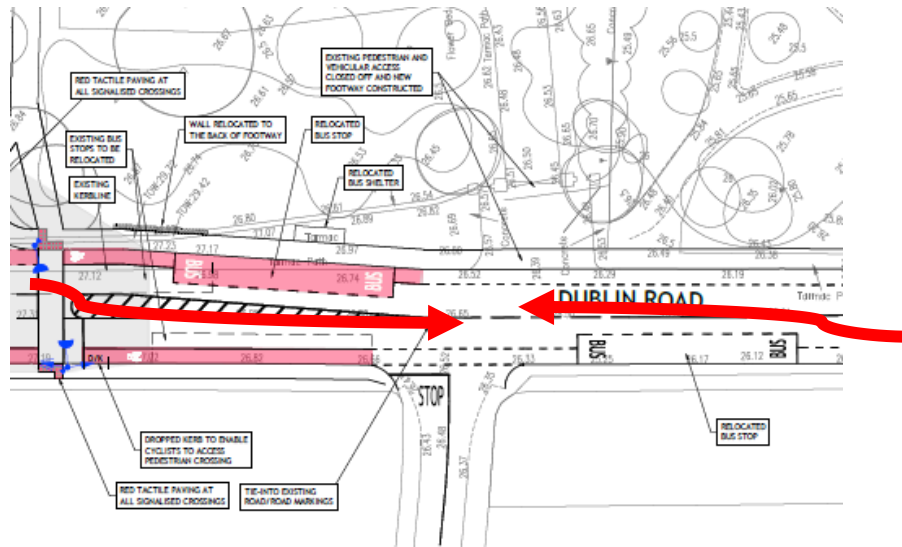
2.3.3 R119 Bus Stops - Stagger

Problem: The relocated bus stops are separated by a short distance whereas the existing bus stop arrangement is directly opposite each other. If both stops are occupied simultaneously following traffic can now attempt to overtake the waiting bus.

Hazard: Opposing overtaking vehicles may meet in the middle of the road. Head-on impact may result.

Recommendation: Relocate the bus stops to ensure the problem above does not result.

2.3.3	Y	N	It is proposed that the bus stop on the southbound lane be omitted. As there is an existing bus stop c. 120m north of this location it could reasonably be concluded that bus users would access that one via the site pedestrian access c. 60m north of the signalised junction. It is worth noting that the Busconnects proposals omits this bus stop.	Yes

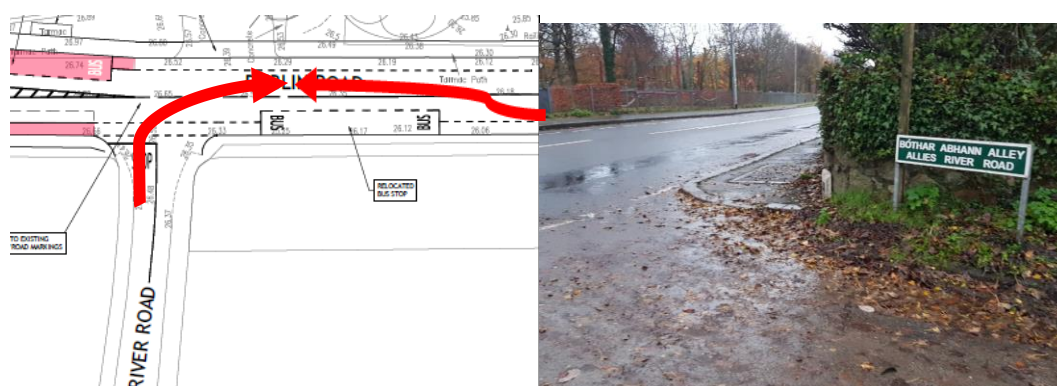
2.3.4 Allies Road Junction – Bus Stop

Problem: There is a bus stop proposed to the south of the existing Allies Road Junction. This junction already has limited junction visibility to the right for exiting vehicles. If the bus stop is occupied users may believe it is safe to exit right out of the junction. Drivers behind the bus may also believe it is safe to overtake the bus.

Hazard: The overtaking vehicle and the vehicle exiting Allies Road may impact to the offside of the bus.

Recommendation: Relocate the bus stop.

2.3.4	Y	N	It is not acceptable to the employer to retain the bus stop in its existing location – immediately north of the Allies River junction. If it was relocated north of the Stop line, it would only be c.90 metres from the next stop north, which is impractical. It is therefore proposed to remove the bus stop. It is worth noting that the Busconnects proposals omits this bus stop.	Y

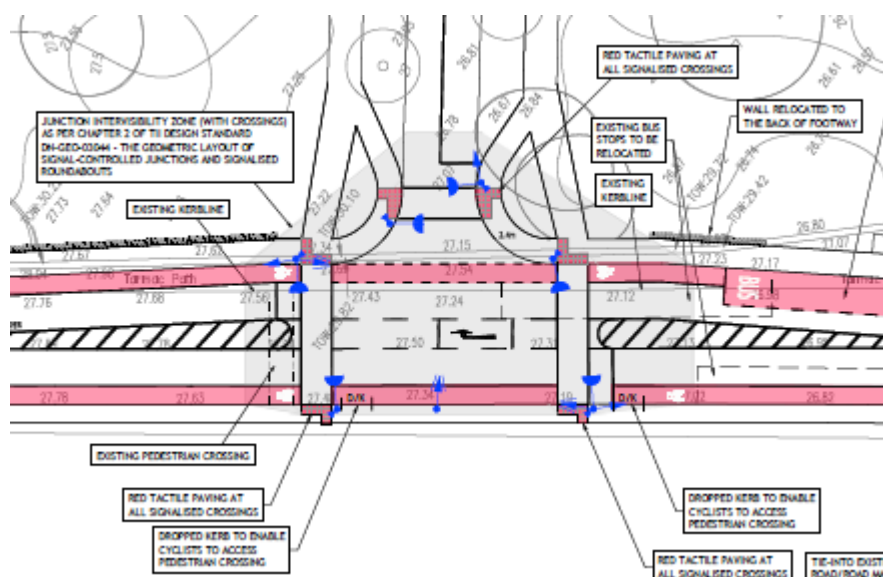
2.3.6 R119 Cyclists – Right Turn

Problem: Cyclists wishing to turn right into the development junction are not catered for. Drivers may believe the cyclists should remain in the provided cycle lane and be surprised by a cyclist departing this lane in order to make use of the right-turning pocket.

Hazard: Impact between cyclists and motorists may result.

Recommendation: Provide suitable facilities to accommodate the cyclists in compliance with the National Cycleway Manual.

2.3.5	Y	N	Refer to 2.3.3	Yes
2.3.6	Y	N	'Cyclist Dismount' markings will be applied to the footpath at the west side of Dublin Road at the signalised crossing.	Yes

* Item 2.3.6
DLRCC Transport does not agree with the 'Cyclists Dismount' solution and has asked for a junction design that includes a 'jug turn', as shown in the National Cycle Manual, or a variation thereof.

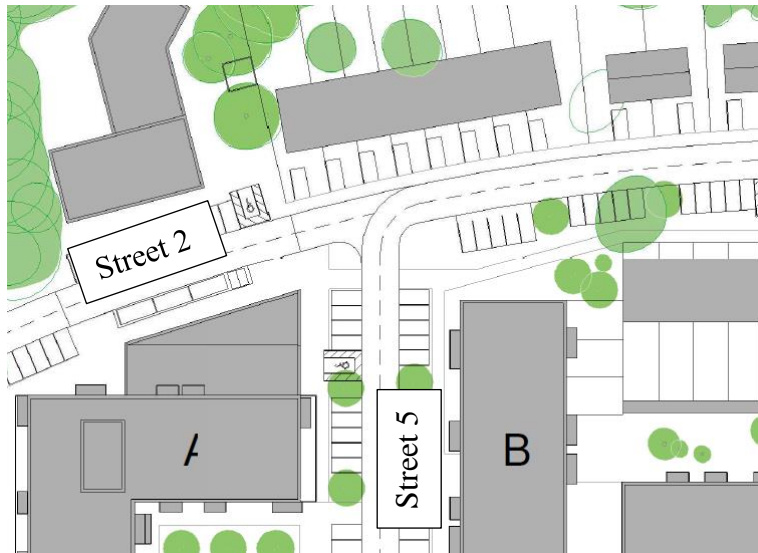
2.3.7 Junction Street 5 with Street 2

Problem: Street 5 seems to continue into Street 2 at the junction. Although Street 2 is a continuous alignment traffic traveling along this street must yield priority to Street 5 traffic.

Hazard: Impact between users of the two streets may occur.

Recommendation: Change the priority at the junction so Street 5 users yield to Street 2.

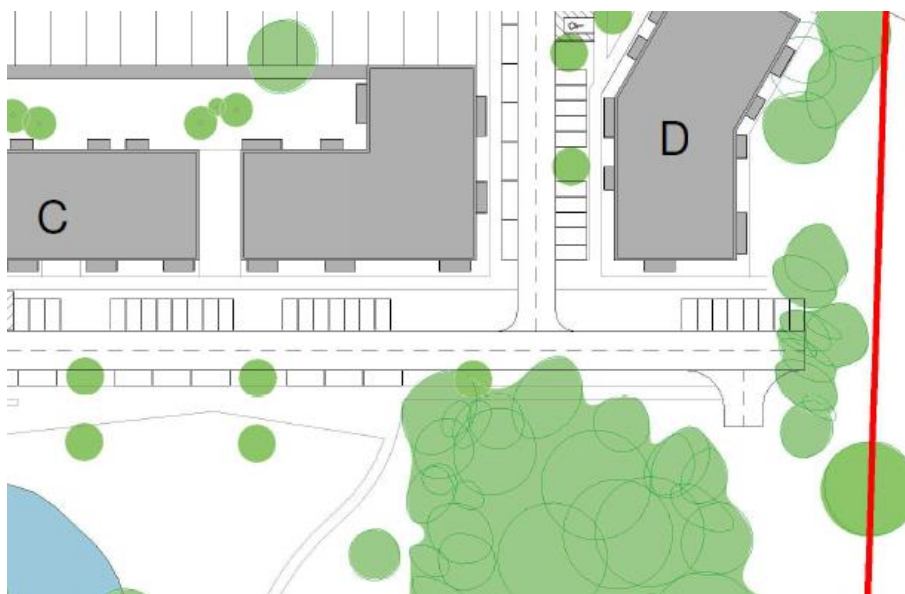
2.3.8 Junction of Street 1 with Street 6

Problem: The predominate traffic movement at this junction is likely to be from Street 6 into Street 1 and vice versa, however traffic from the cul-de-sac end of Street 1 is offered priority at the junction.

Hazard: It is likely users of Street 6 will become complacent over time and fail to yield at the junction. Impact with cul-de-sac traffic may result.

Recommendation: Amend the junction priority and implement a change in materials or road level to ensure the cul-de-sac traffic obey the change in priority.

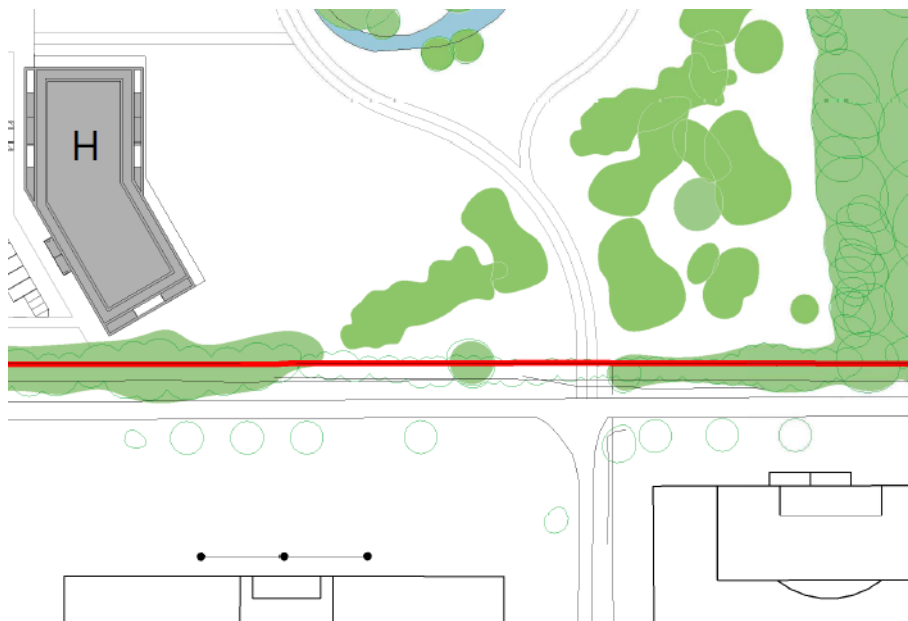
2.3.9 Cycleway Junction at Playing Fields.

Problem: The proposed cycleway junction at the playing fields is in the vicinity of a stream with deep water.

Hazard: Users may lose control when slowing or avoiding other users in the area of the junction. These users may enter the water and risk drowning.

Recommendation: Provide suitable railings to prevent entry to the water.
