APPENDIX 7

BIODIVERSITY

**APPENDIX 7-1. WINTER HABITAT STUDY, TYMON AND BANCROFT PARKS,
ROUGHAN O'DONOVAN, JUNE 2018**

Winter Habitat Study of Bancroft and Tymon Parks

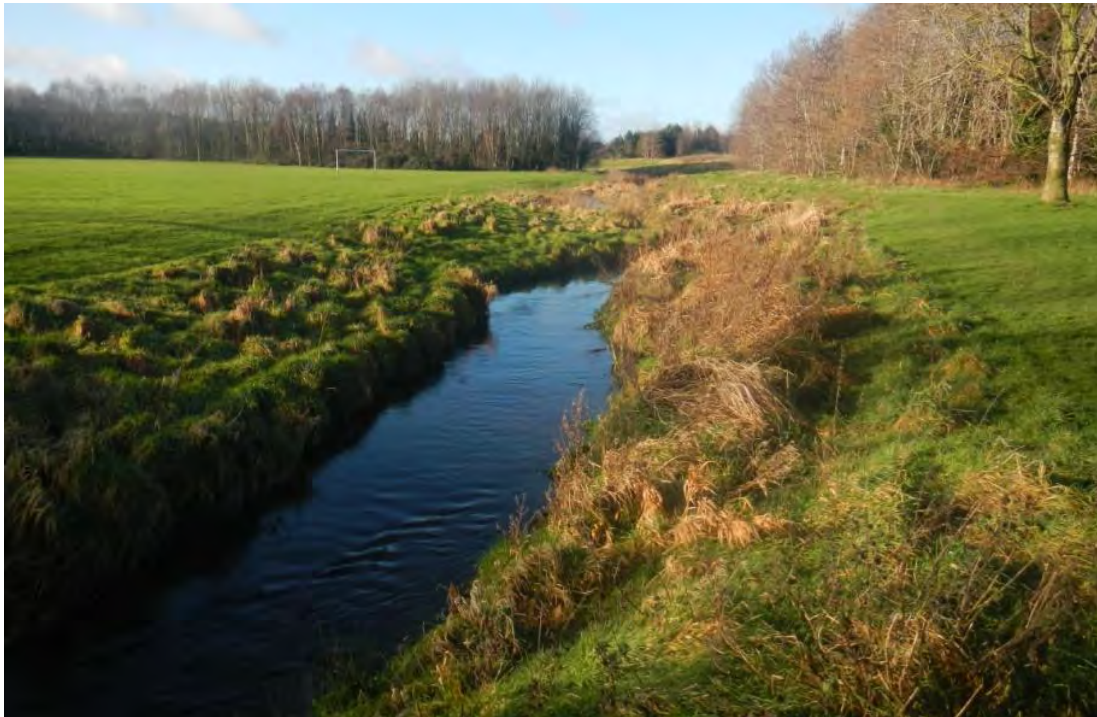
Plate 1. The River Poddle in Tymon Park East.

The River Poddle flows through Bancroft Park and Tymon Park. It is culverted under Castletymon Road and the M50. The channel has been straightened in several places and the banks have been reinforced. The flow is slow and the river is broken up by several ponds in Tymon Park. Lesser Water-parsnip was commonly found growing along the river edges. The River Poddle is frequently bordered by rough grassland, which protects the river from sedimentation and nutrient run-off and has added to the biodiversity value of the river. Litter is a significant problem, especially in Bancroft Park.

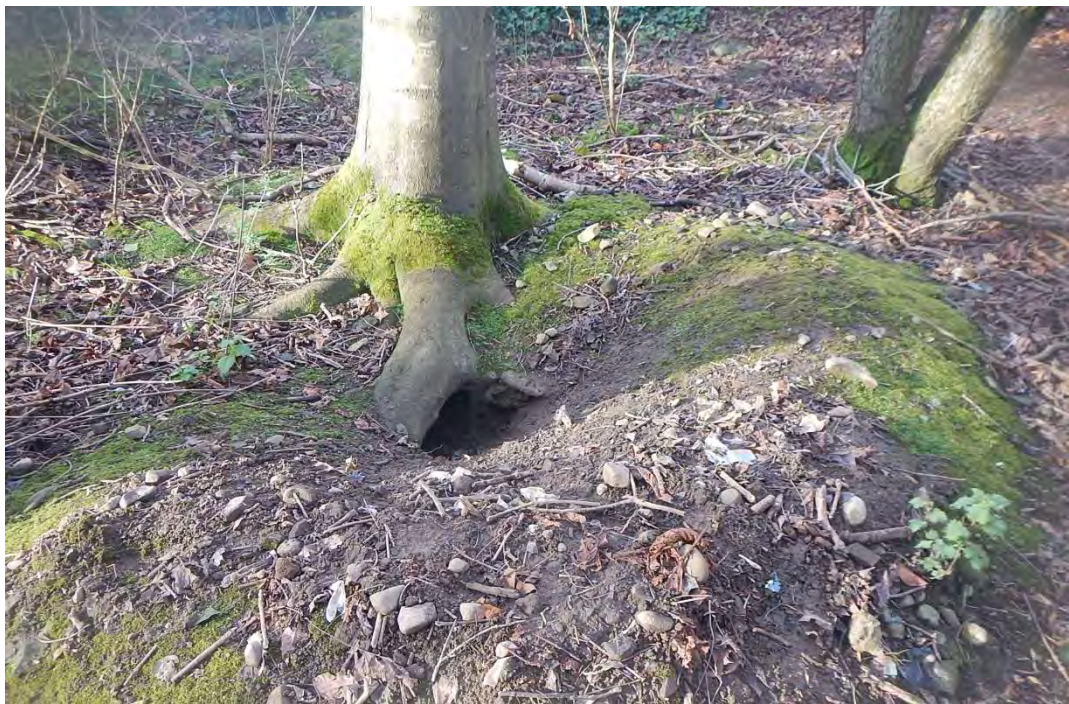
Plate 2. Entrance to Sett 1 showing recent signs of digging.

Two badger setts were recorded in Tymon Park West. The main sett (Sett 1) had 9 entrances in total, with 7 showing signs of recent use. Several of the holes had very large spoil heaps typical of this species. The sett is against the earth bank on the east side of Tymon Lane and may pre-date the foundation of the park.

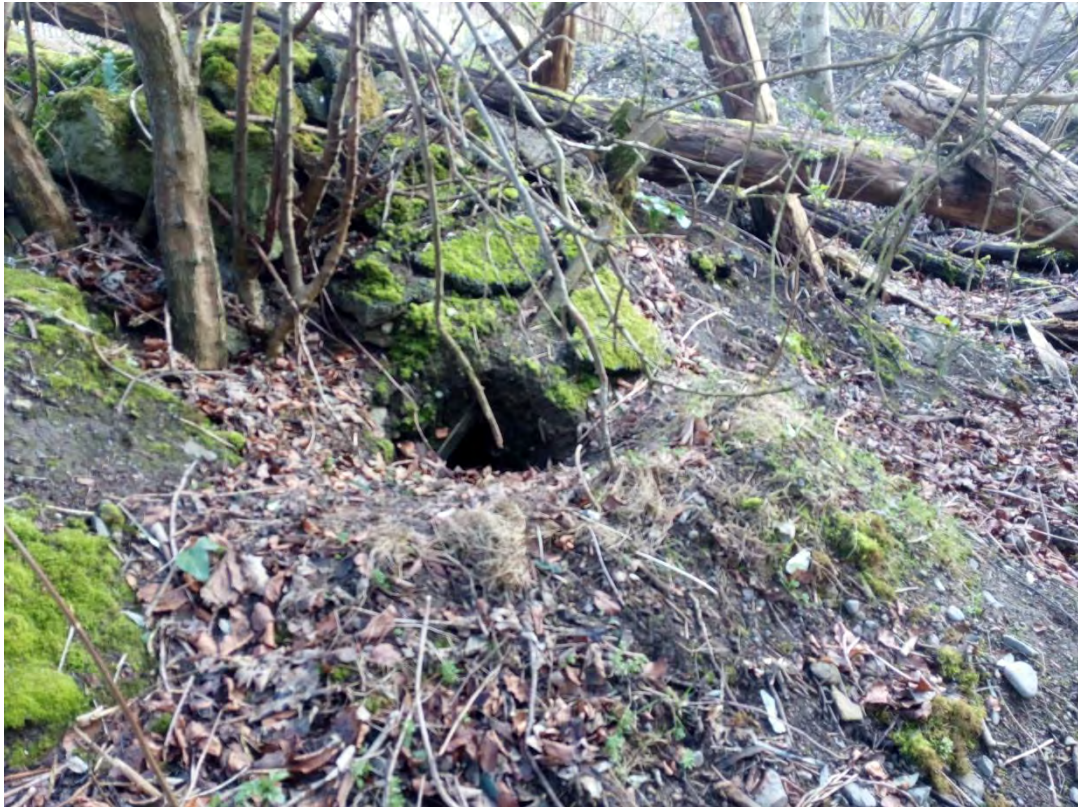
Plate 3. Badger Sett 2 entrance with bedding in spoil.

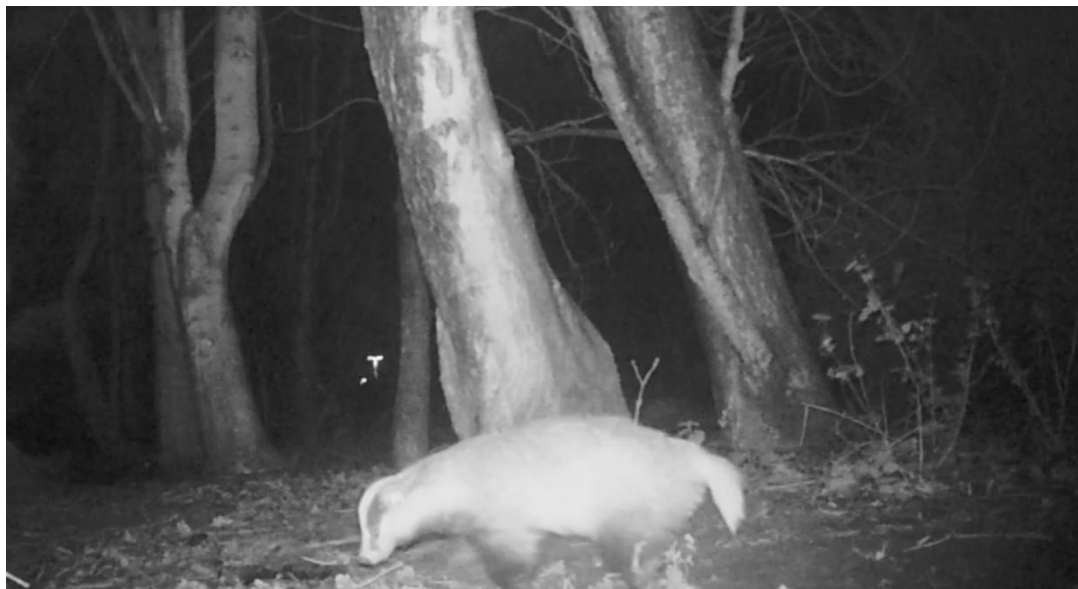
Plate 4. Still image showing a badger close to Sett 1.

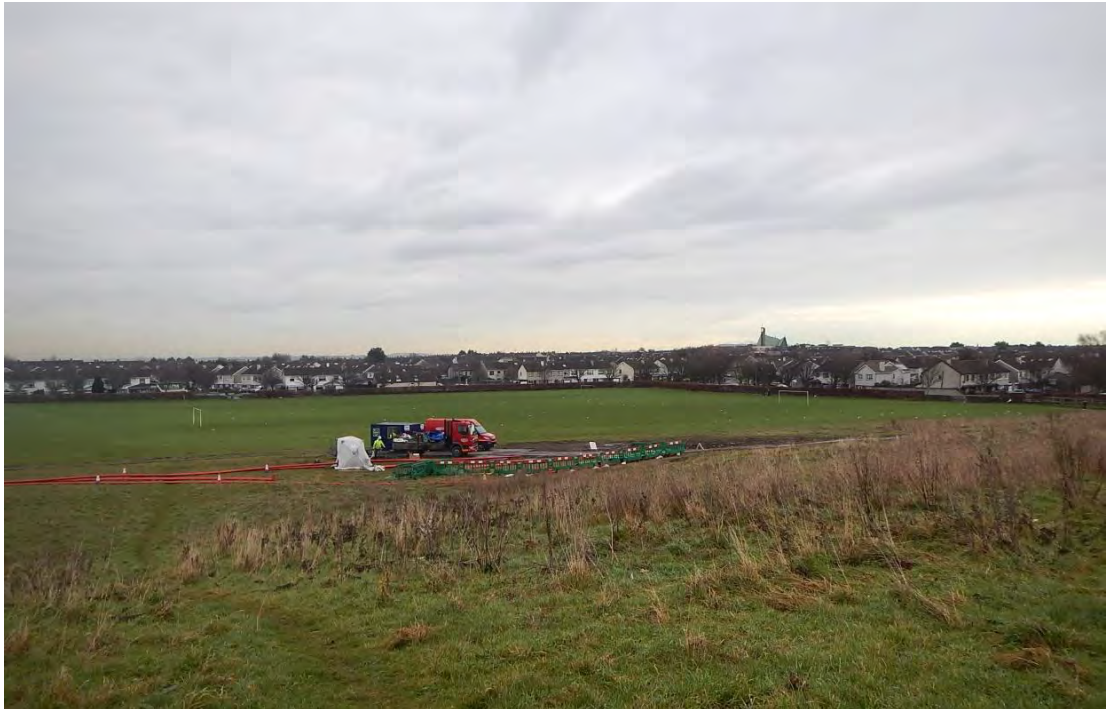
Plate 5. Construction work in a field used historically by brent geese.

Brent Goose, a particular focus of the surveys, was recorded flying over Tymon Park East on the 23rd January. The flock appeared to land in Greenhills Park to the east. Based on anecdotal evidence, Brent Geese have not used Tymon Park in recent years as a result of constant disturbance by dogs. In addition, a dog park was built next to the area that was used by Brent Geese in the fields at the north end of Tymon Park East. Construction activity was noted during the survey period. The areas traditionally used by Brent Geese are presented on the drawings in Appendix A.

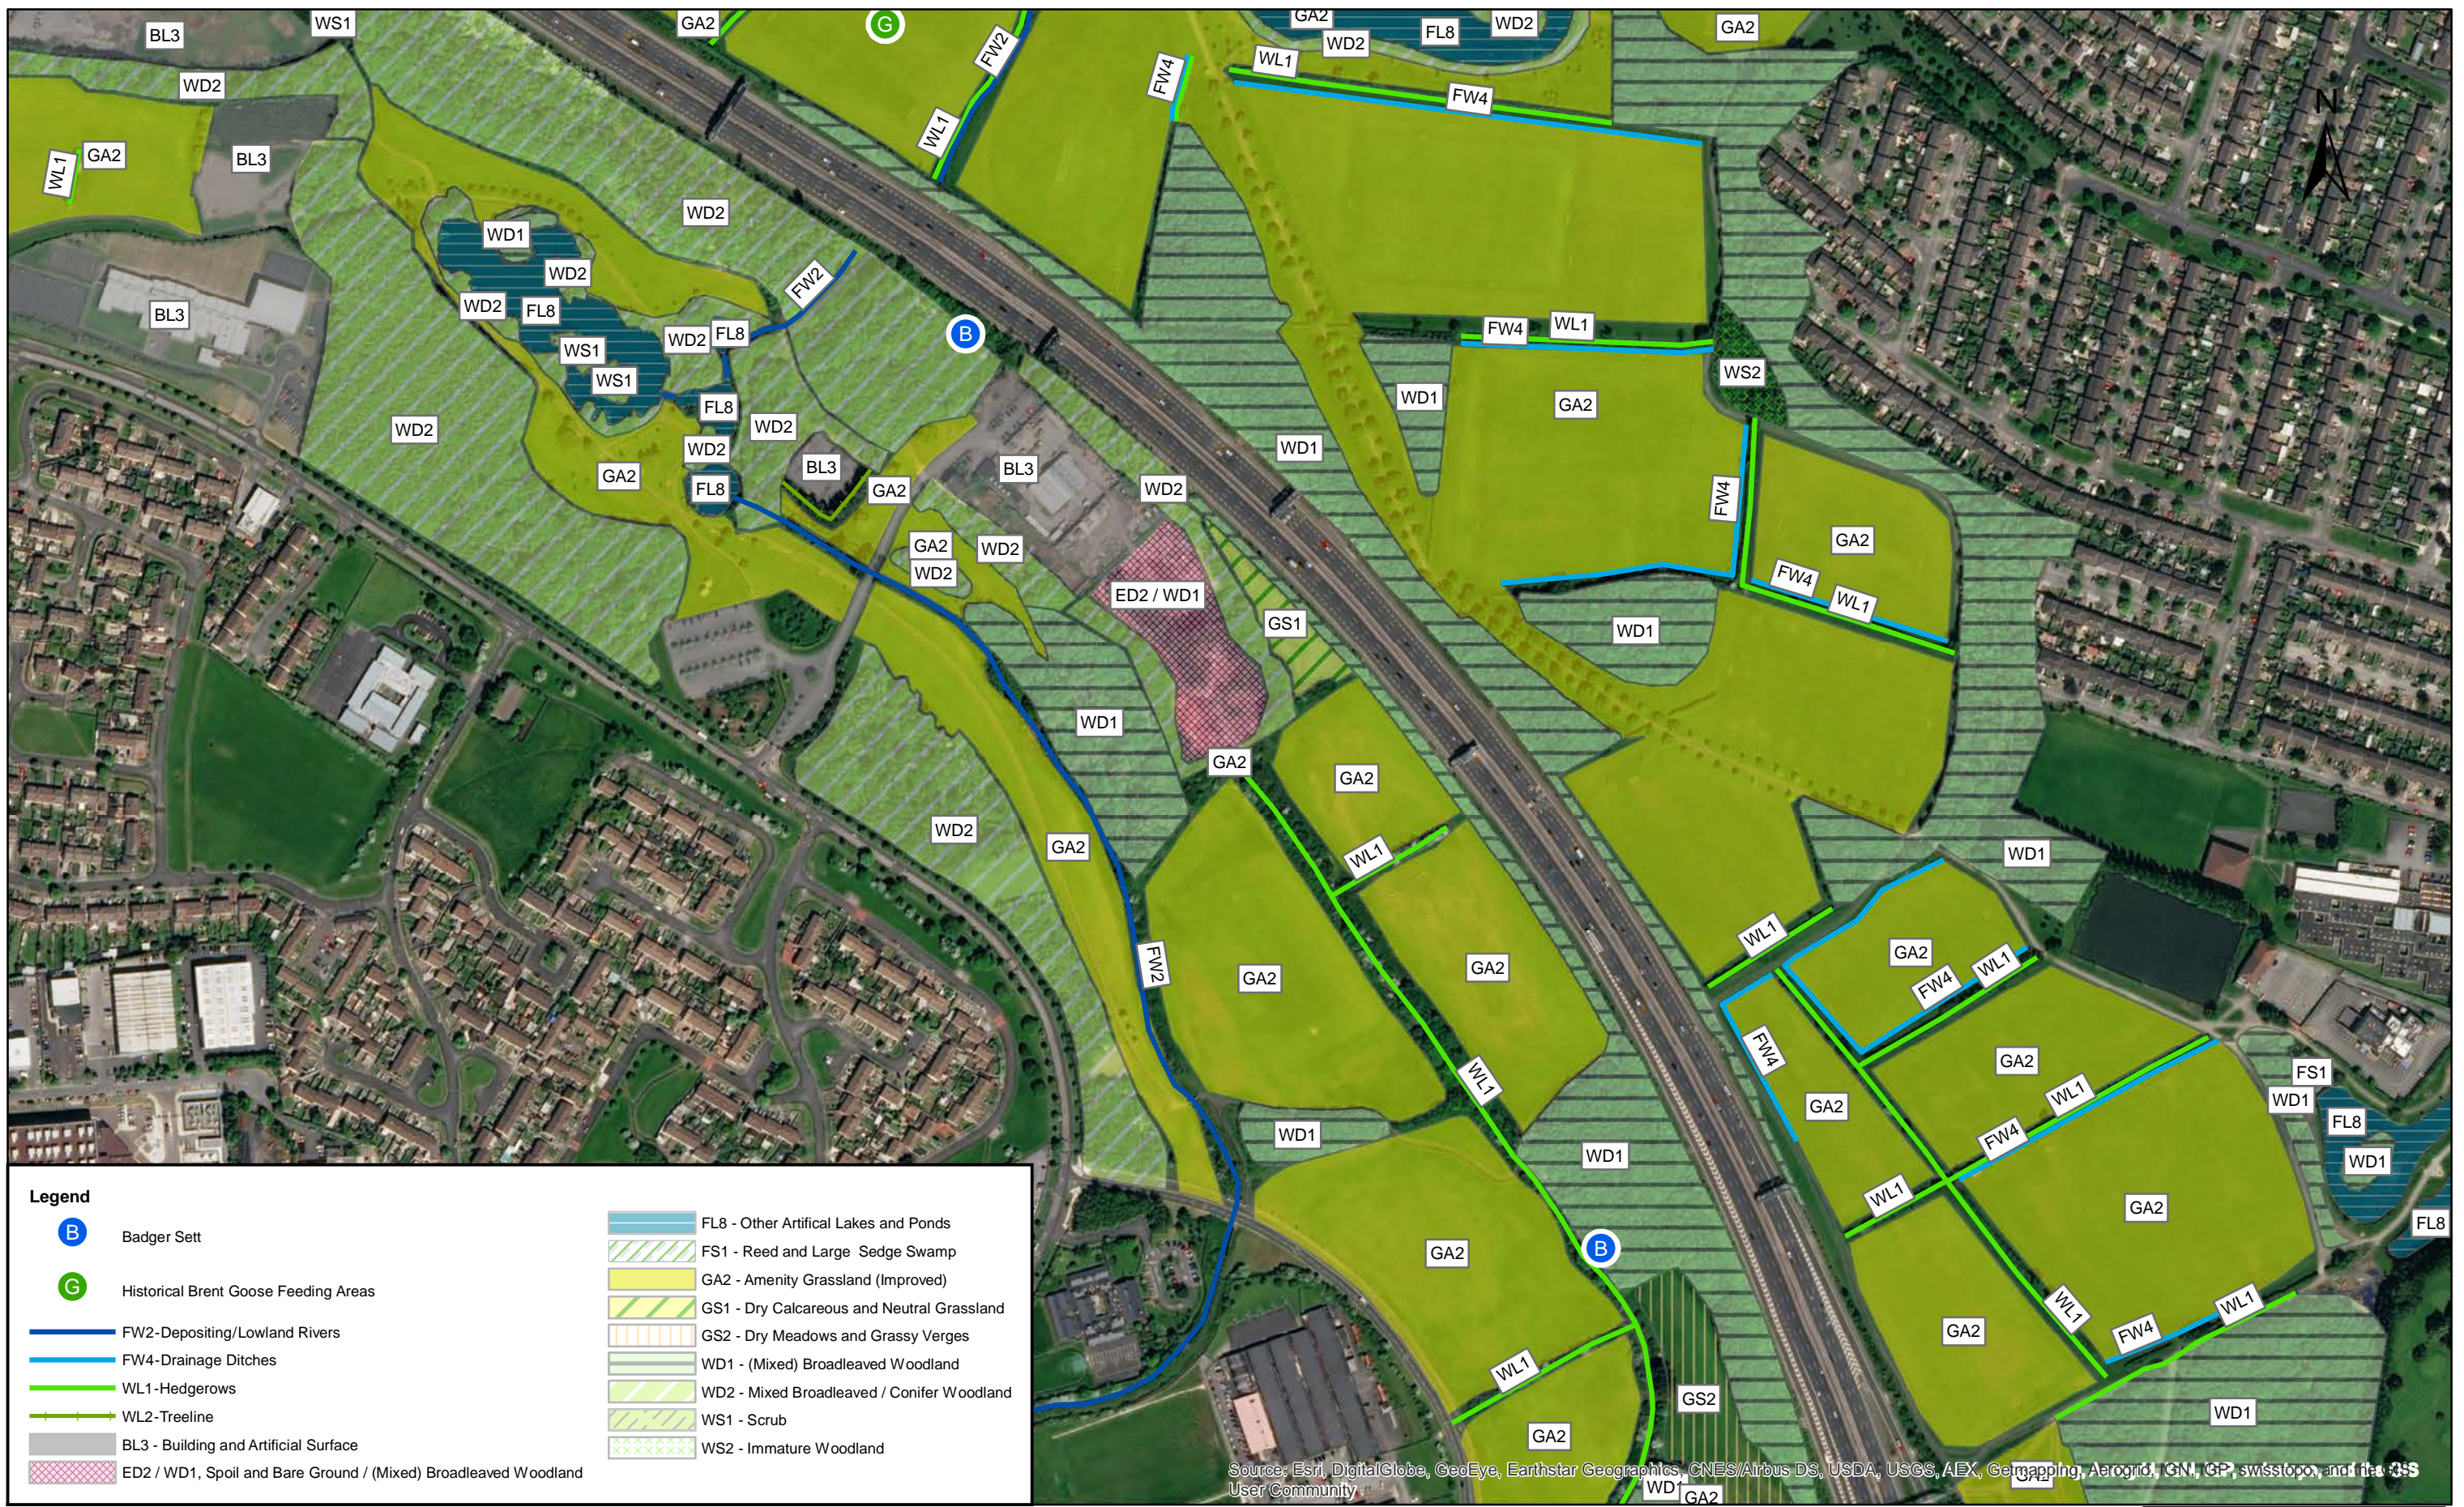
Project Title		TYMON PARK WINTER HABITAT STUDY				
Drawing Title		HABITAT MAPPING SHEET 2 OF 4				
Project	Originator	Volume	Location	Type	Role	Number
TPW	ROD	EBD	SW_AE	DR	EN	00002
Scale (A1)	1:4,000	Date:	June 2018	Job No:	18.104	Rev:

- B Badger Sett
- G Historical Brent Goose Feeding Areas
- FW2-Depositing/Lowland Rivers
- FW4-Drainage Ditches
- WL1-Hedgerows
- WL2-Treeline
- BL3 - Building and Artificial Surface
- ED2 / WD1, Spoil and Bare Ground / (Mixed) Broadleaved Woodland
- FL8 - Other Artificial Lakes and Ponds
- FS1 - Reed and Large Sedge Swamp
- GA2 - Amenity Grassland (Improved)
- GS1 - Dry Calcareous and Neutral Grassland
- GS2 - Dry Meadows and Grassy Verges
- WD1 - (Mixed) Broadleaved Woodland
- WD2 - Mixed Broadleaved / Conifer Woodland
- WS1 - Scrub
- WS2 - Immature Woodland

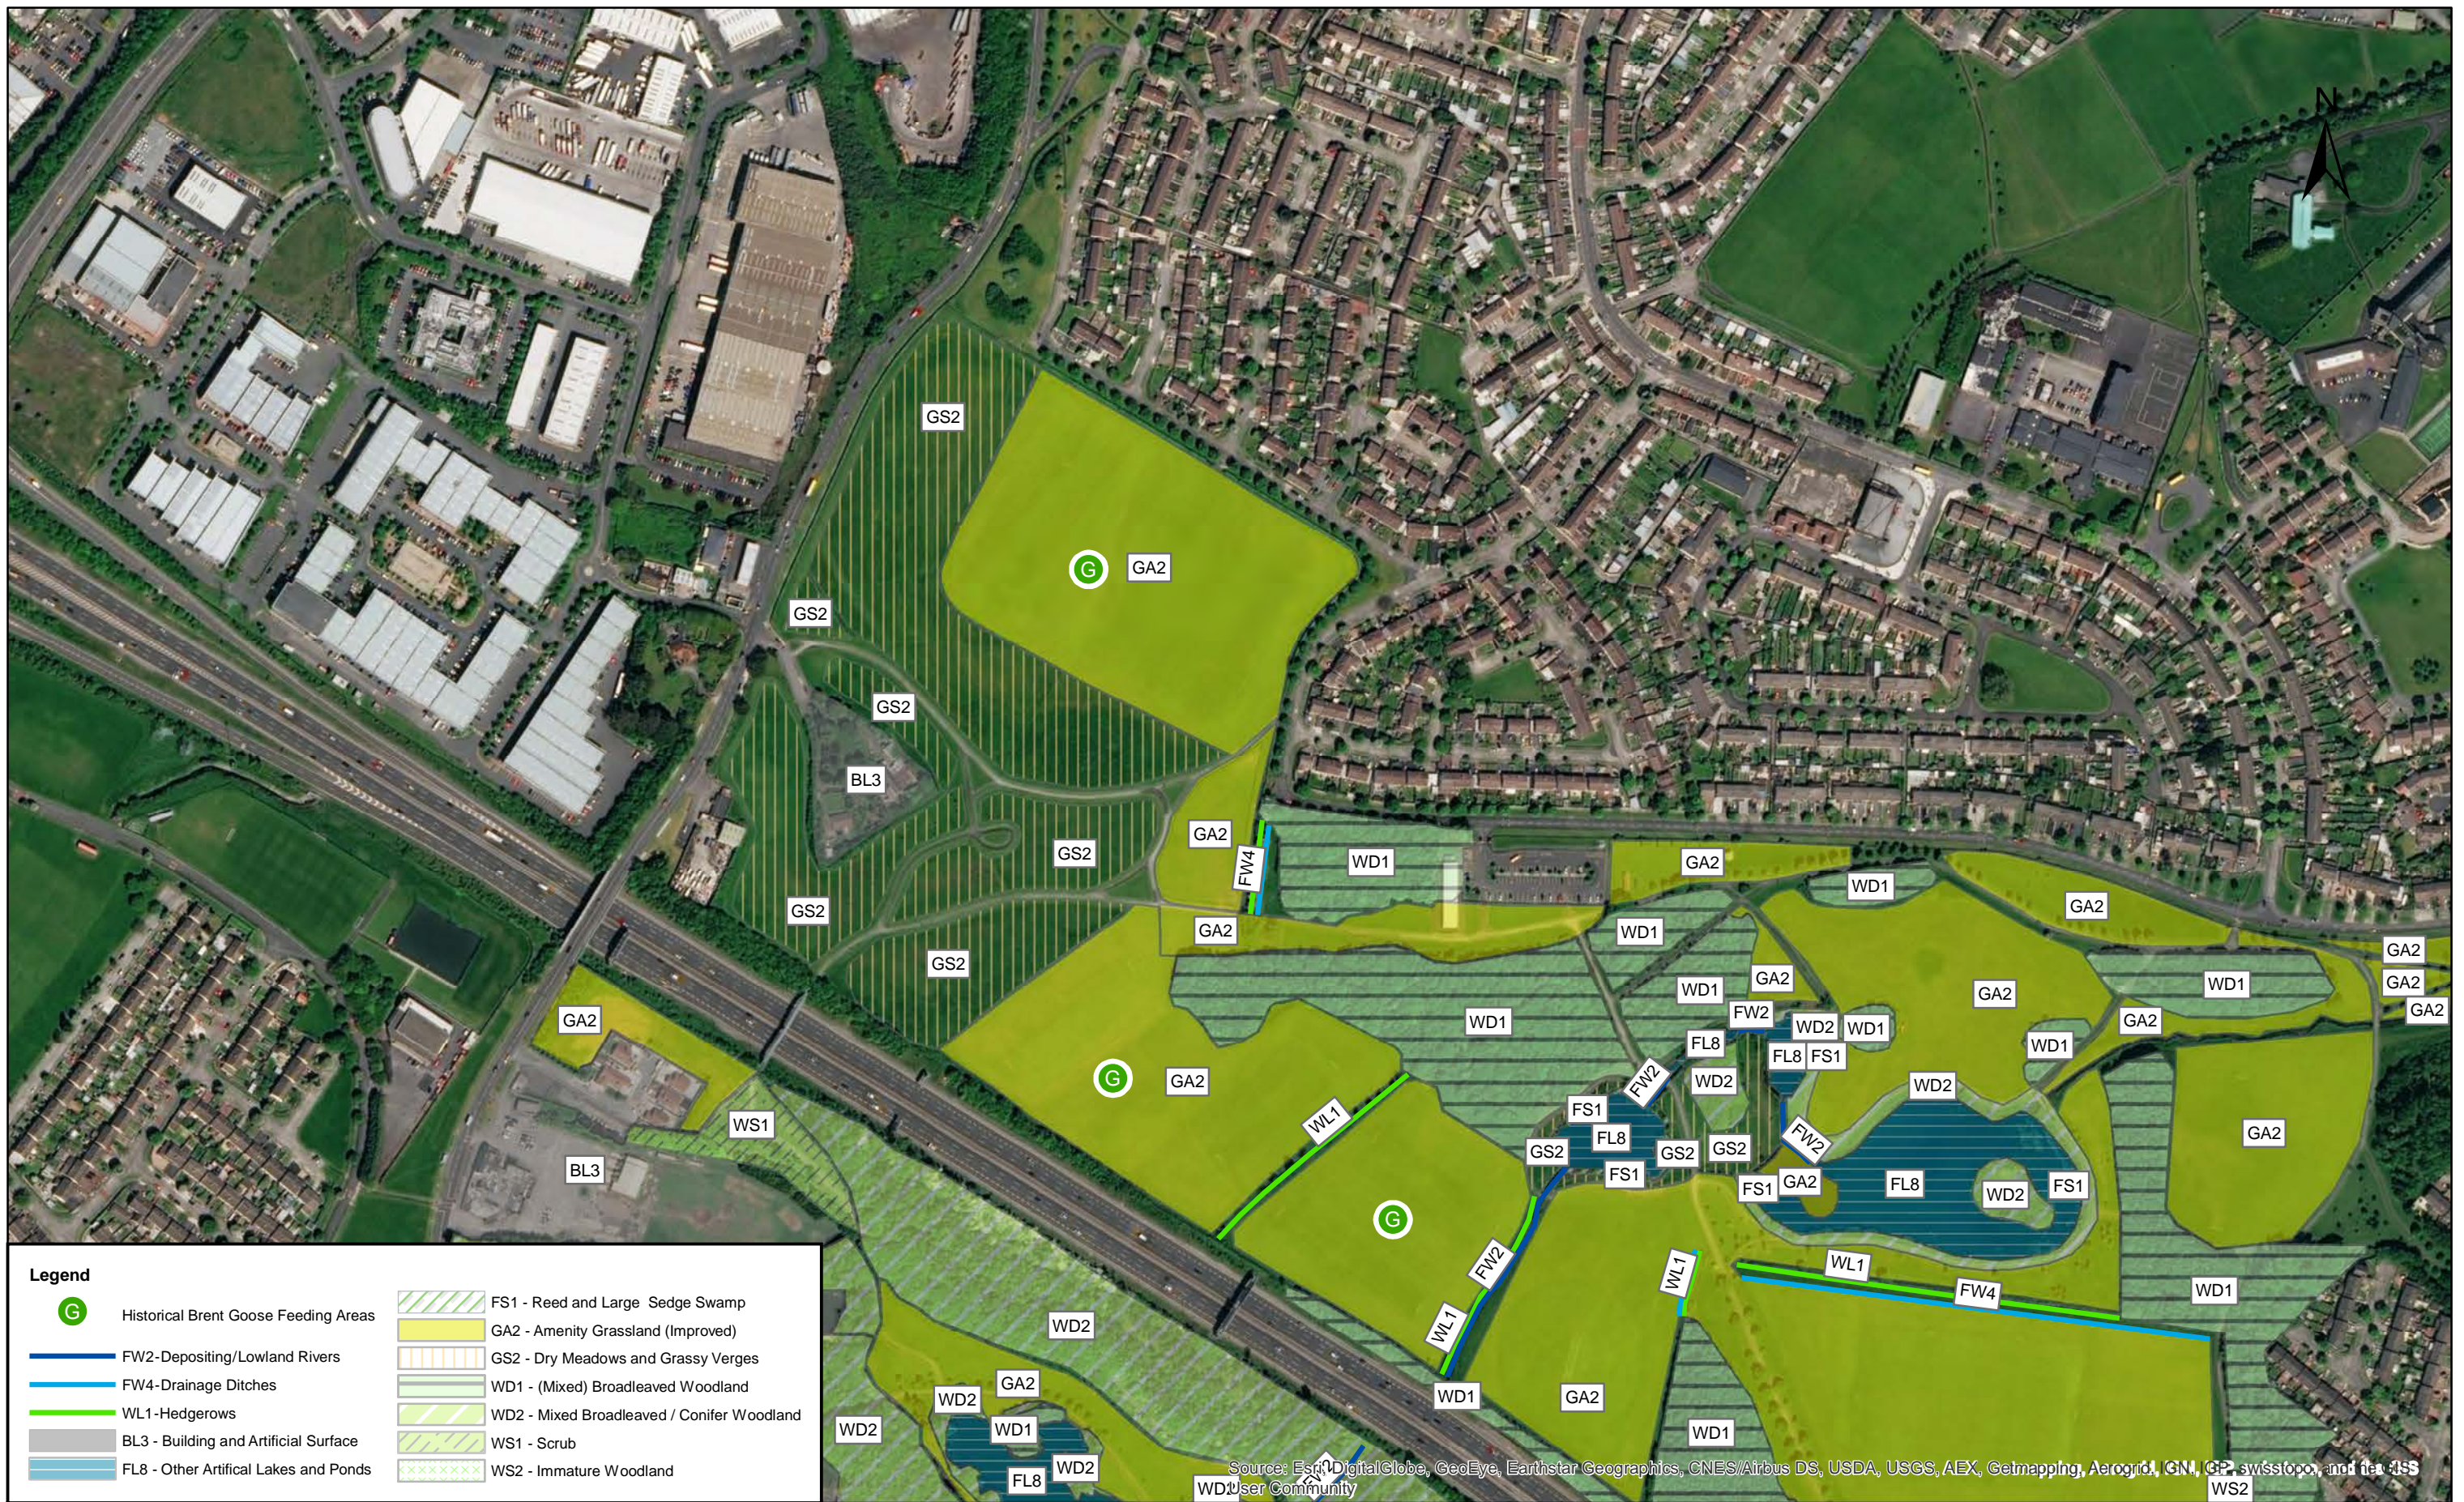
- Legend**
- G Historical Brent Goose Feeding Areas
 - FW2-Depositing/Lowland Rivers
 - FW4-Drainage Ditches
 - WL1-Hedgerows
 - BL3 - Building and Artificial Surface
 - FL8 - Other Artificial Lakes and Ponds
 - FS1 - Reed and Large Sedge Swamp
 - GA2 - Amenity Grassland (Improved)
 - GS2 - Dry Meadows and Grassy Verges
 - WD1 - (Mixed) Broadleaved Woodland
 - WD2 - Mixed Broadleaved / Conifer Woodland
 - WS1 - Scrub
 - WS2 - Immature Woodland

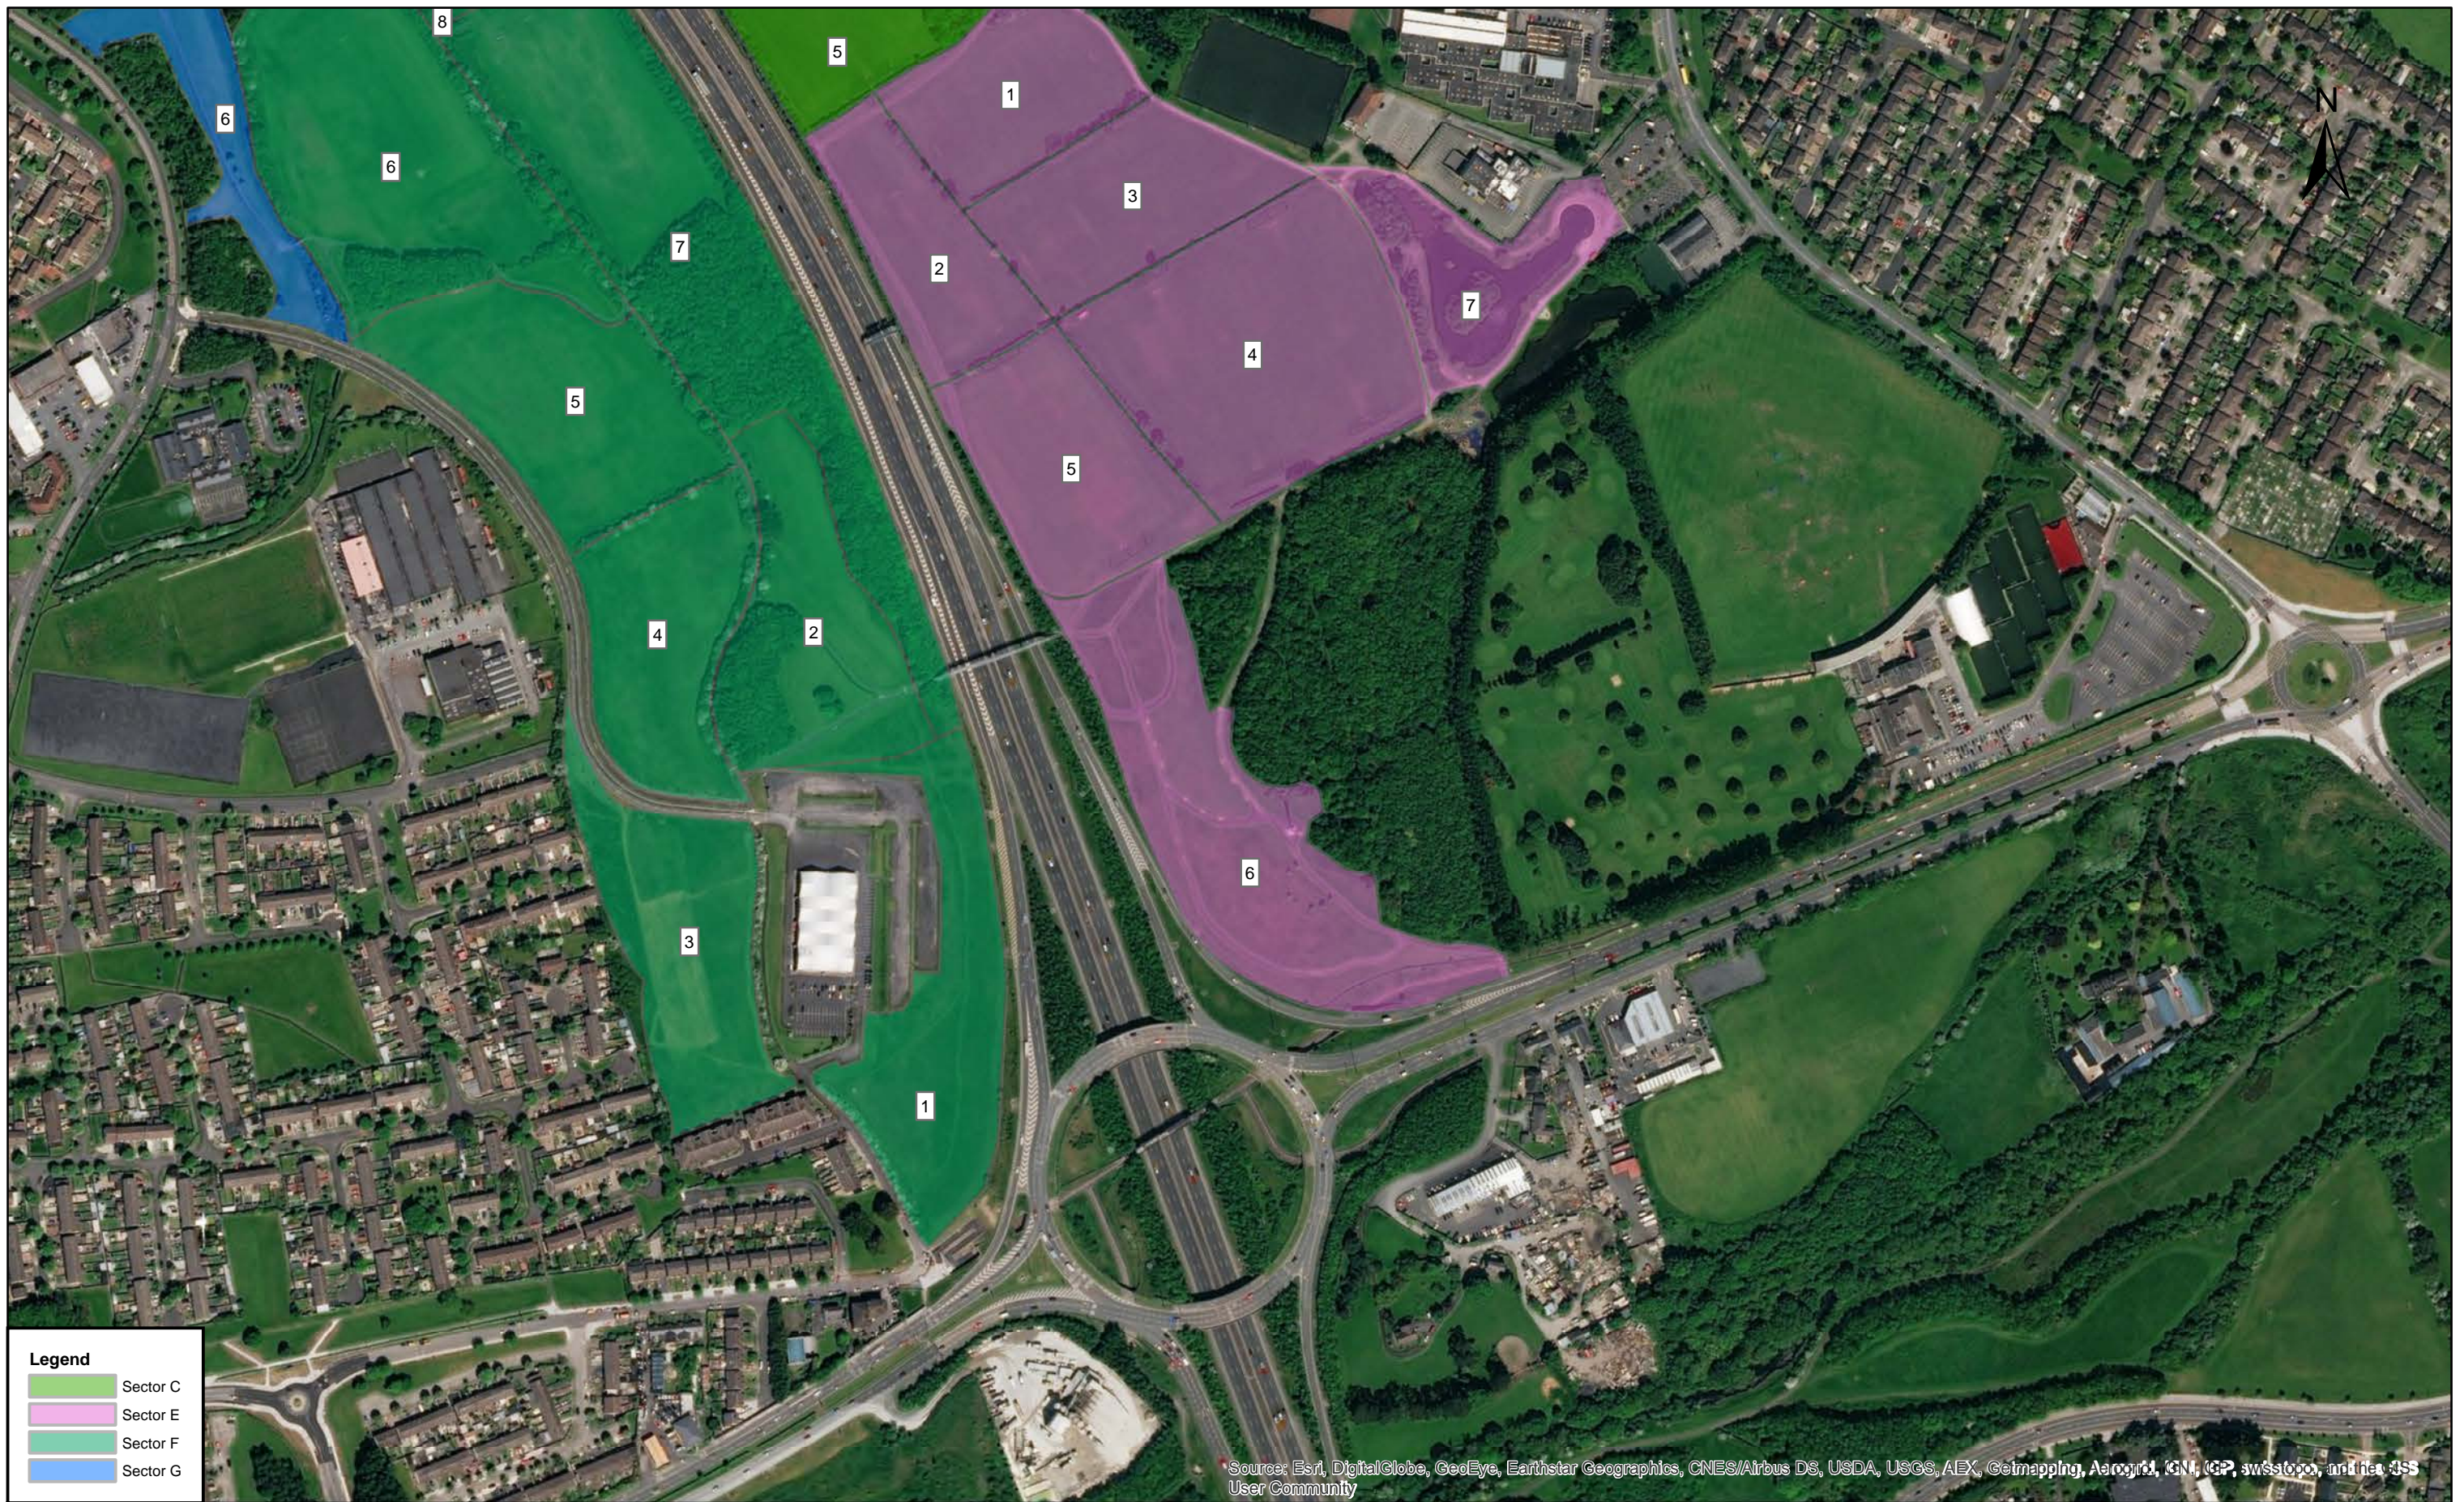
Project Stage	TYMON PARK WINTER HABITAT STUDY						
Drawing Title	BIRD SECTORS SHEET 1 OF 4						
Drawing Number	Project TPW	Originator ROD	Volume EBD	Location SW_AE	Type DR	Role EN	Number 00101
Scale (A1)	1:4,000	Date	June 2018	Job No	18.104	Rev.

- Sector C
- Sector E
- Sector F
- Sector G

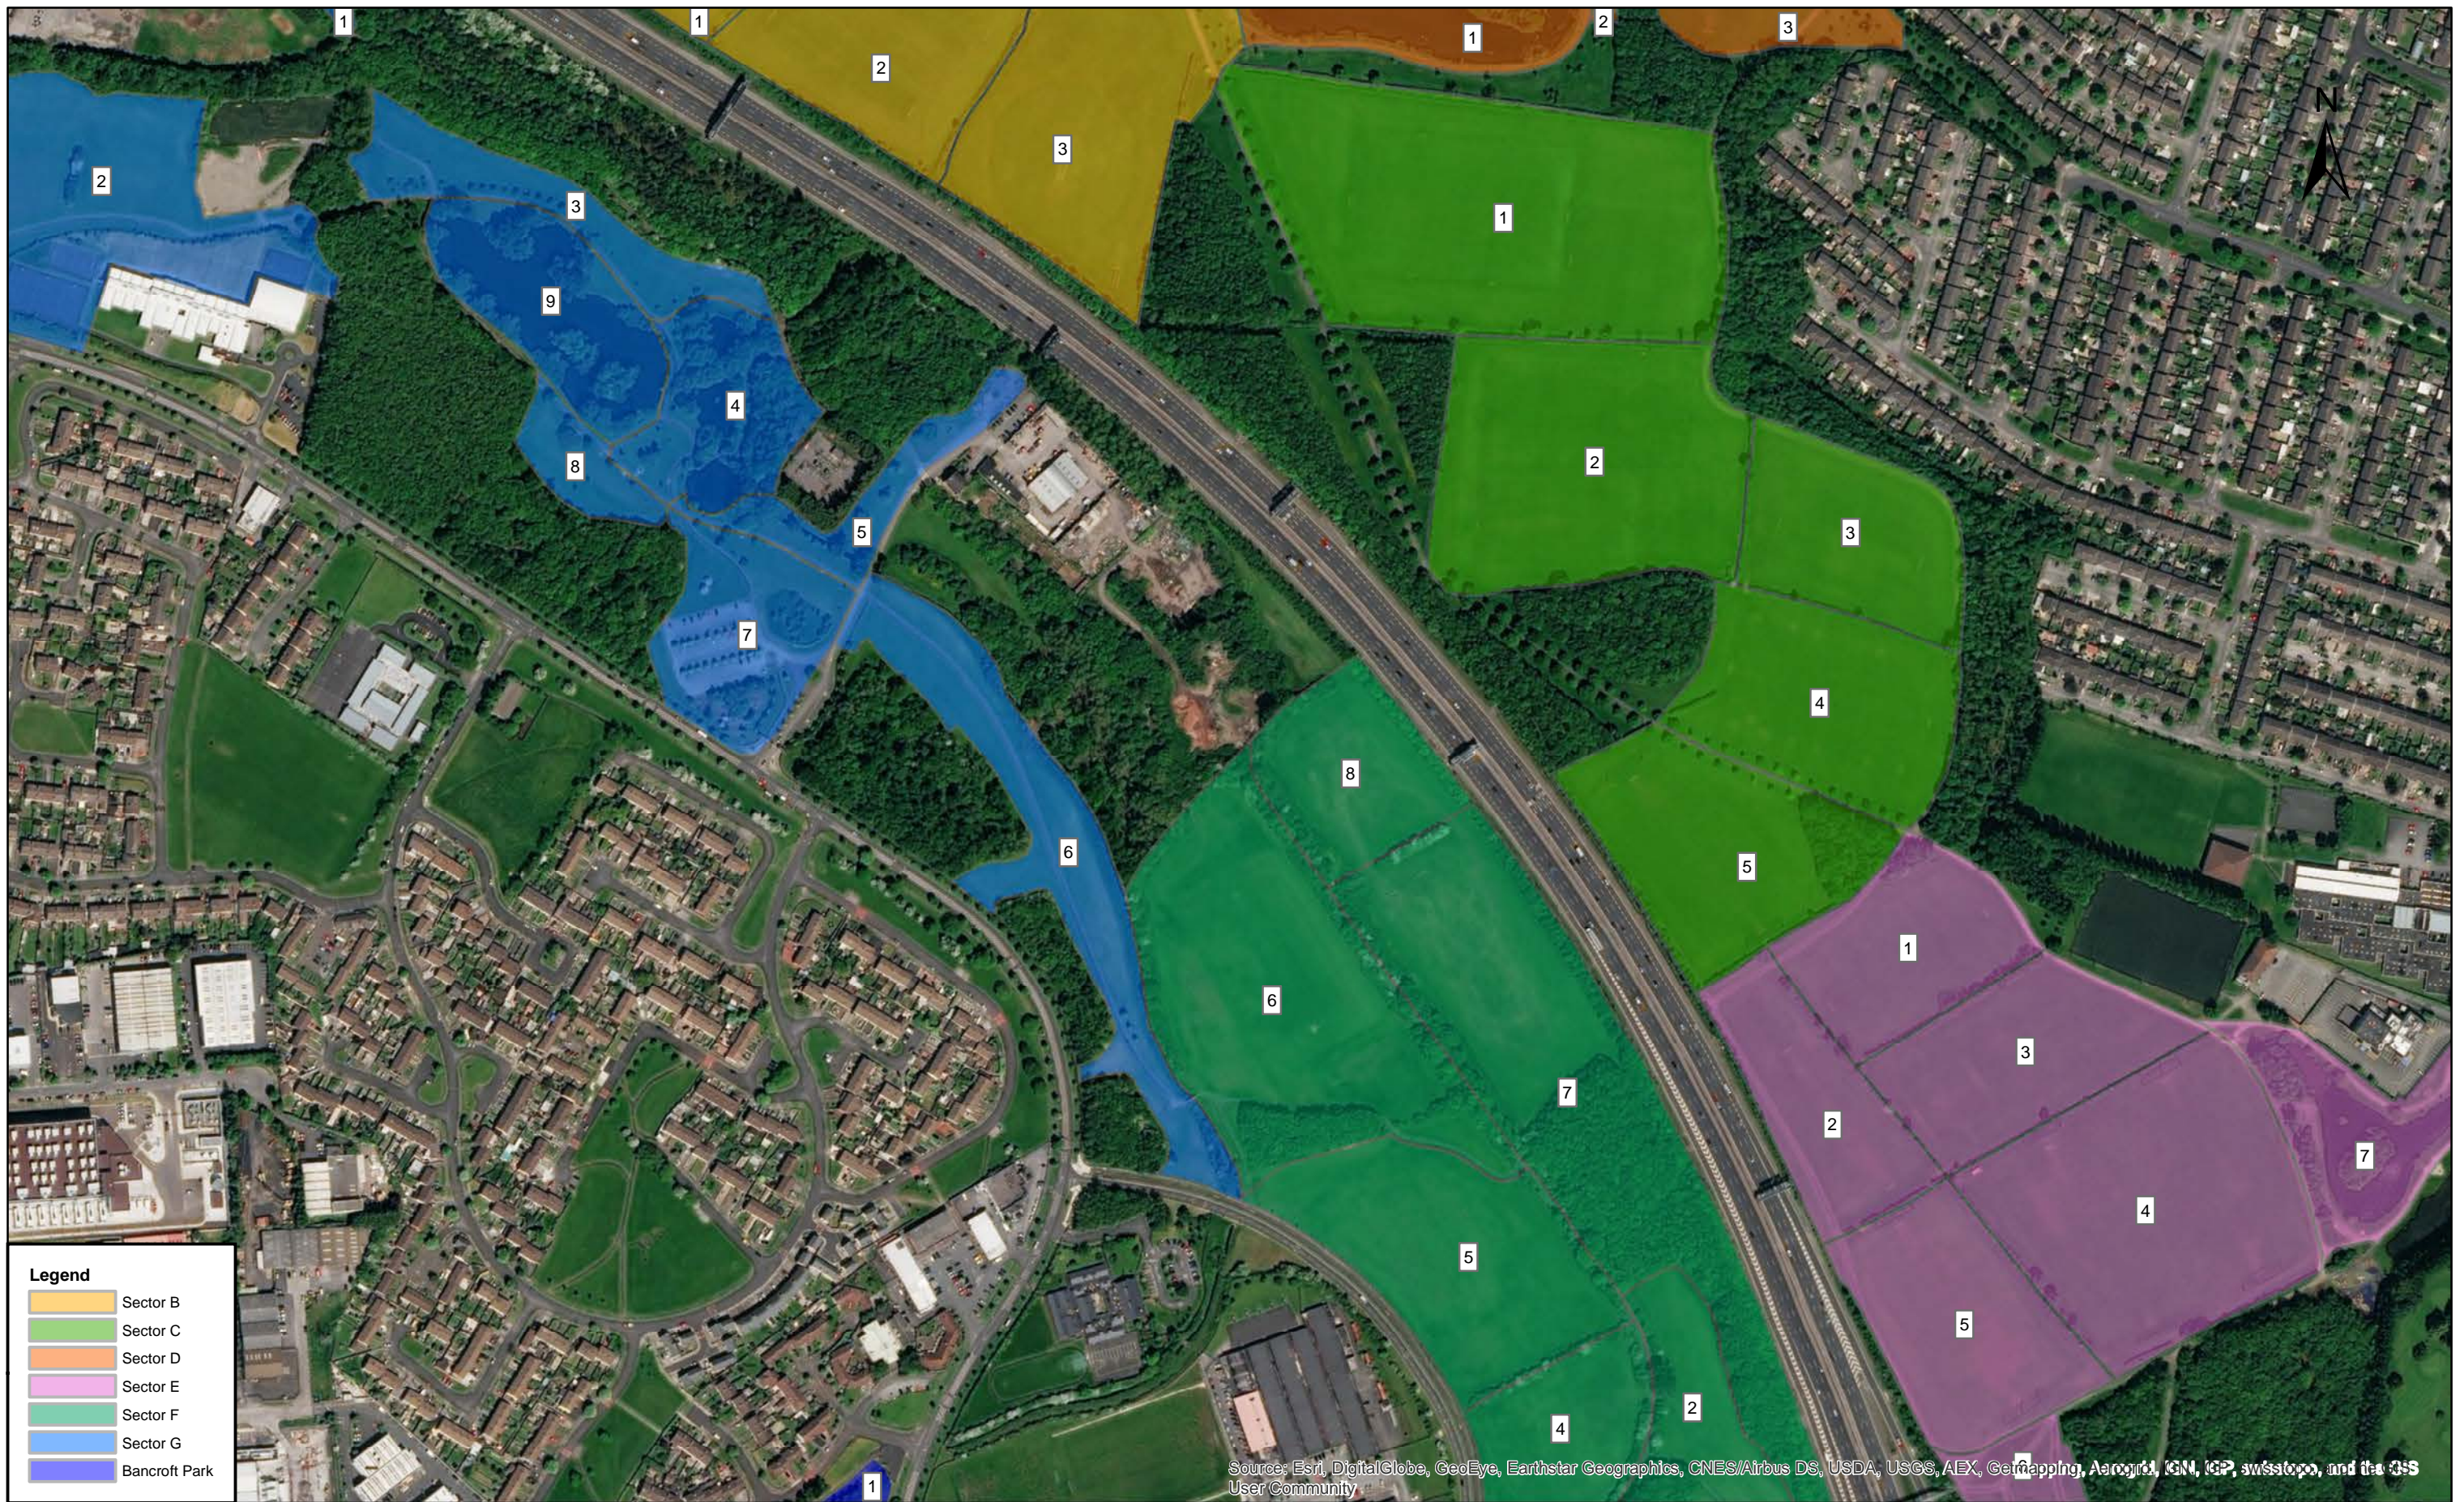
Project Title		TYMON PARK WINTER HABITAT STUDY					
Drawing Title		BIRD SECTORS SHEET 2 OF 4					
Project	Originator	Volume	Location	Type	Role	Number	
TPW	ROD	EBD	SW_AE	DR	EN	00102	
Scale (A1)	1:4,000	Date:	June 2018	Job No:	18.104	Rev:

- Sector B
- Sector C
- Sector D
- Sector E
- Sector F
- Sector G
- Bancroft Park
