APPENDIX 7

BIODIVERSITY

**APPENDIX 7-1. WINTER HABITAT STUDY, TYMON AND BANCROFT PARKS,
ROUGHAN O'DONOVAN, JUNE 2018**

Winter Habitat Study of Bancroft and Tymon Parks

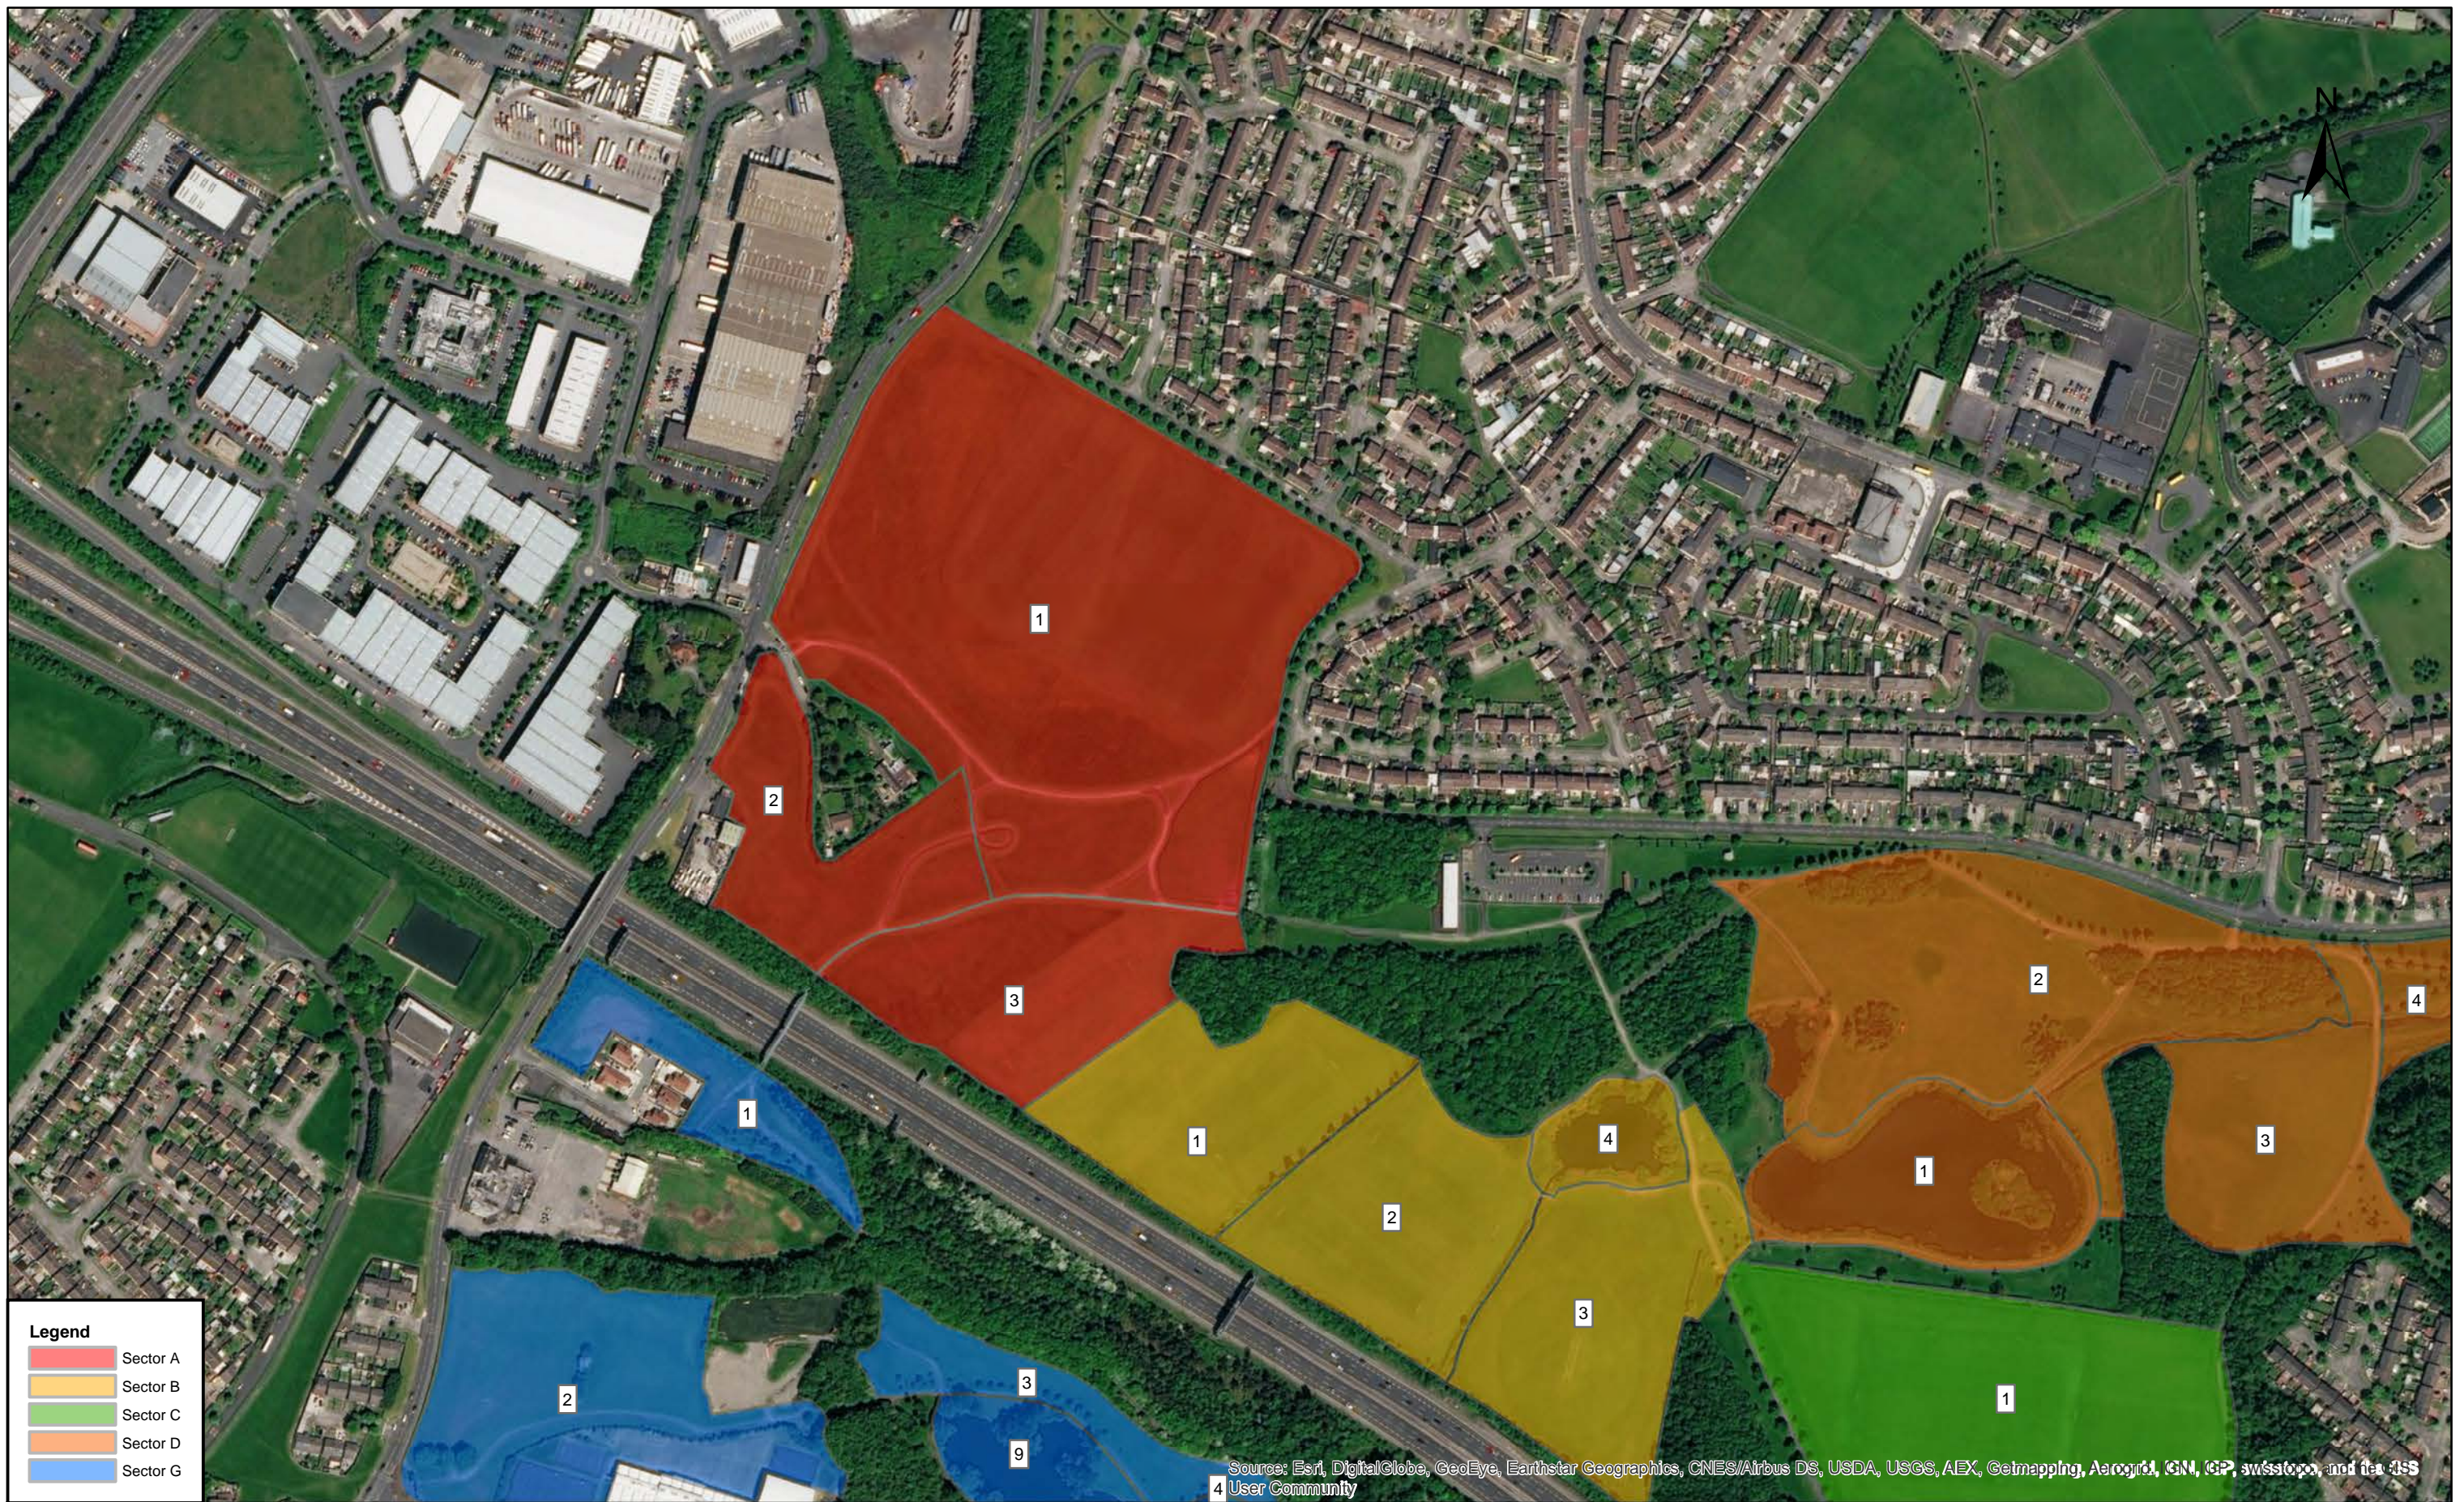
Project Title	TYMON PARK WINTER HABITAT STUDY						
Drawing Title	BIRD SECTORS SHEET 3 OF 4						
Drawing Number	Project	Originator	Volume	Location	Type	Role	Number
TPW	ROD	EBD	SW_AE	DR	EN		00103
Scale (A1)	1:4,000	Date:	June 2018	Job No:	18.104	Rev:

- Sector A
- Sector B
- Sector C
- Sector D
- Sector G

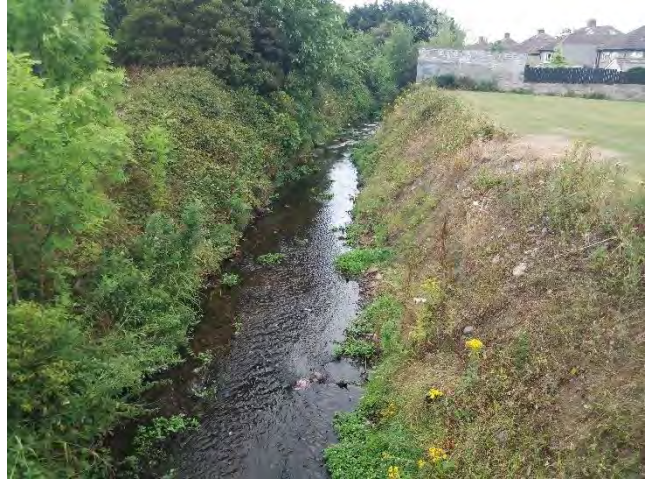
Figure 2. St. Martin's Drive. Banks covered by scrub.

Hedgerows are neglected and escaped. They include the following species: *Sambucus nigra*, *Fraxinus excelsior*, *Buddleja davidii*, *Crataegus monogyna*, *Sorbus aucuparia*, *Rubus fruticosus* agg. It is worth stressing that there are also invasive species of shrub growing here: *Prunus laurocerasus* (Cherry laurel) and *Cornus sericea* (Red osier dogwood). Although these species are not subject to restrictions under Regulations 49 and 50 (EC Birds and Natural Habitats), they are highly invasive and should be prevented from spreading.

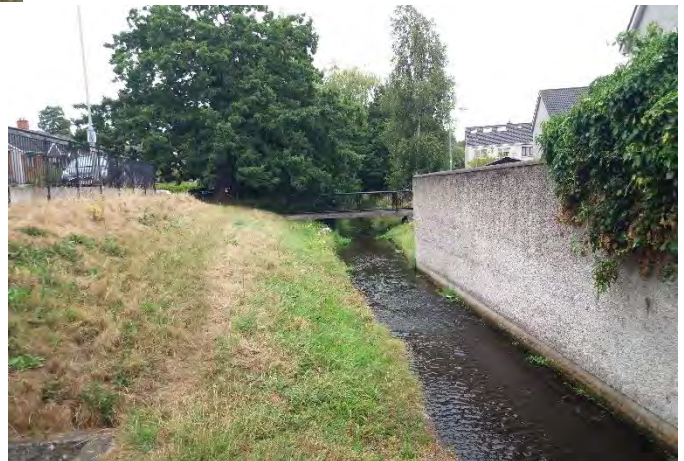
Figure 4. Infrequently mowed grassy verge at the Mount Argus Park.

Sections of the river near the culvert entrance at the Mount Argus park are occasionally mowed and can be classified as **Dry meadows and grassy verges (GS2)**.

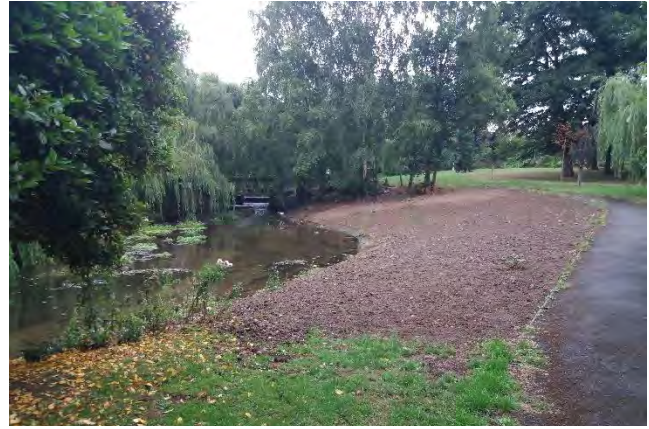
Figure 5. Bare ground at Mount Argus Park.

There were signs of recent works near the wider section of the river at the Mount Argus park. There is a patch of exposed soil. Similar conditions occur along the River Poddle, where the banks eroded. This habitat can be classified as Spoil and bare ground (ED2). It is a temporary habitat and detrimental to the River habitat as bare banks are unstable. This habitat is of low ecological importance.

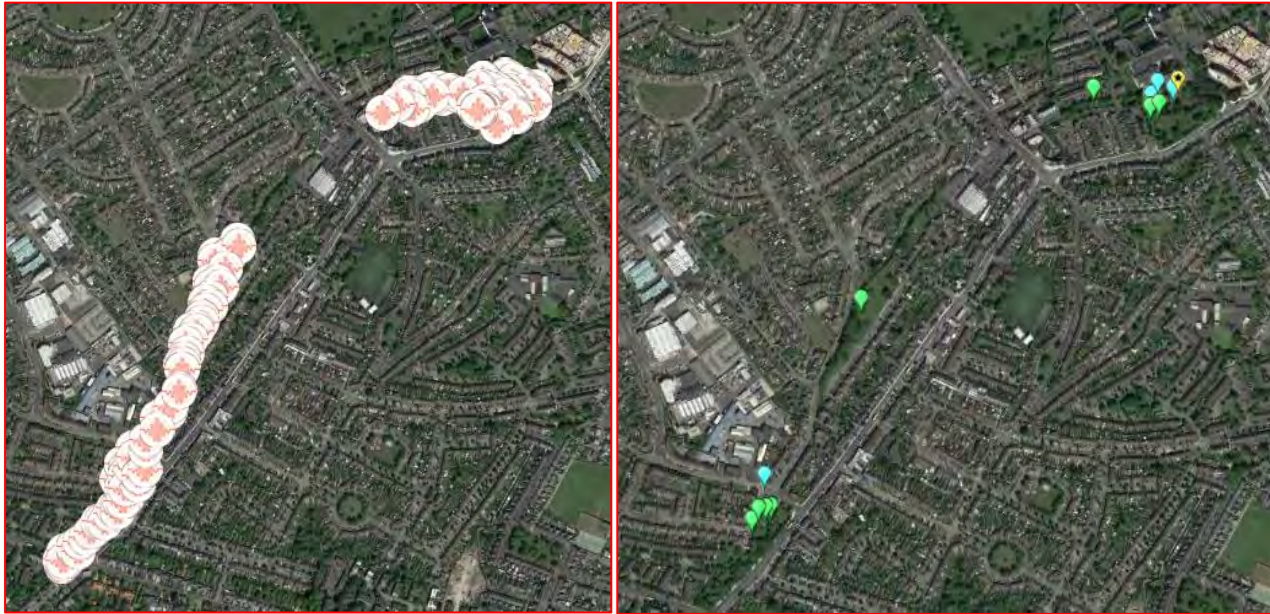
Bat survey area covered along the Puddle

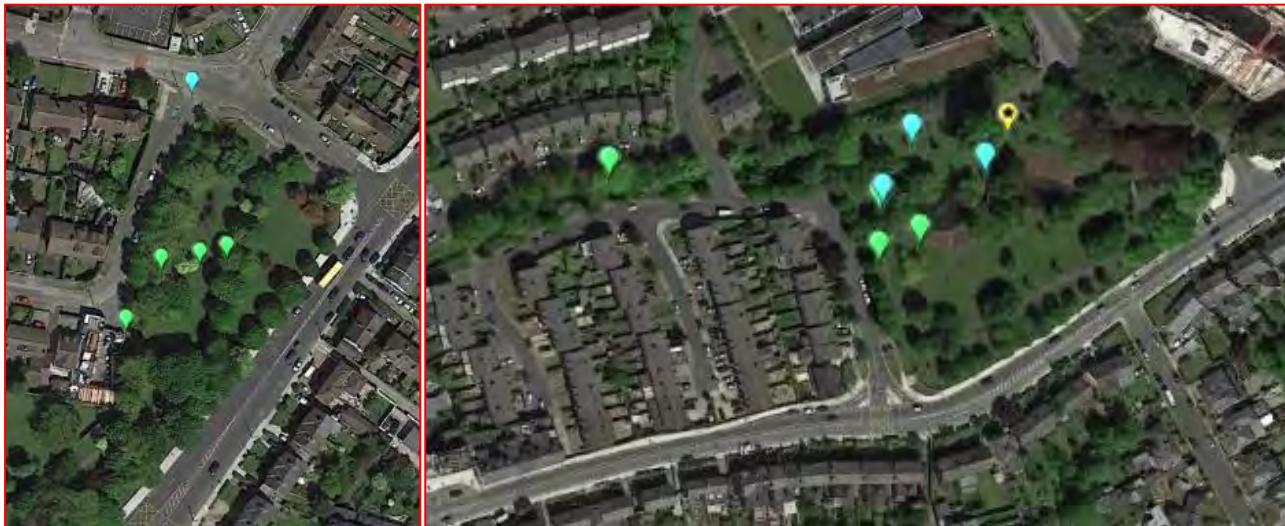
Bat records within the survey area (including below)

Green paddle Common pipistrelle
Blue paddle Soprano pipistrelle Yellow paddle Leisler's bat

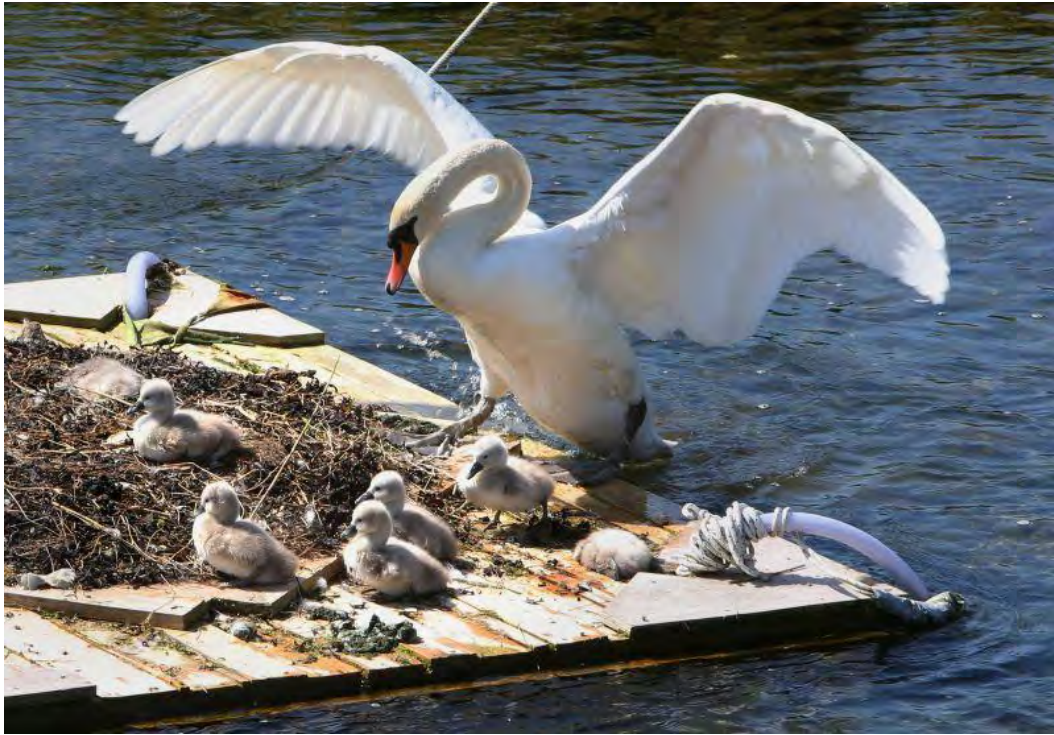
Swan and cygnets on the raft at Oranmore. Photo by Joe O'Shaughnessy via Connacht Tribune.

If the raft floated more than half an inch above the waterline, the cygnets wouldn’t be able to get back on it if they were in the water, he says.

But if it was too low, the waves would come in and wash the nest off. “So it was a very delicate balancing act but it worked perfectly.”
