Archaeological Testing at Cleanrath Wind Farm, Co. Cork

Archaeological Excavation Licence No. 18E0646

July 2020

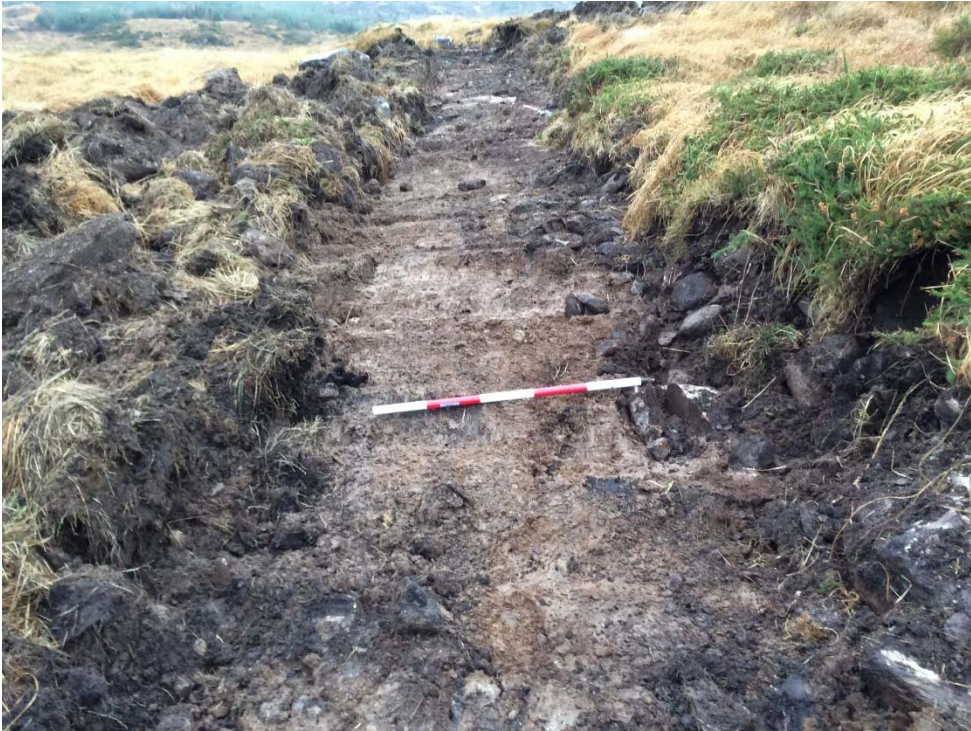
Trench 1 was excavated across T7 turbine base in a roughly E/W direction. It measured 29m in length, 1.8m in width and 0.4m in depth. The stratigraphy consisted of 0.4m (max.) of grass-covered peaty soil which overlay bedrock and a beige-brown stoney natural. Bedrock rose to the surface at the west end of the trench and frequent loose stones and boulders were encountered throughout the trench. No archaeological finds, features or deposits were uncovered.

Plate 1: Trench 1, looking west.

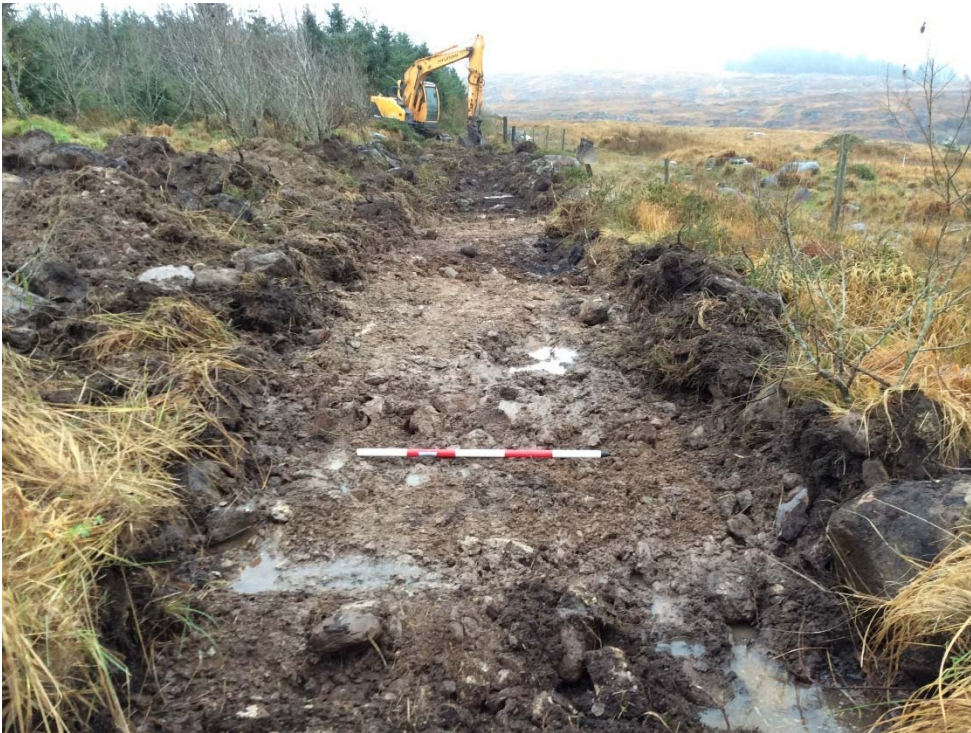
Trench 2 was excavated along the hardstand for T7 in a NW-SE direction. It measured c. 30m in length, 1.8m in width and 0.3m in depth. The stratigraphy consisted of 0.3m of grass-covered peat overlying a grey-brown stoney natural with frequent loose rocks and boulders. No archaeological features or deposits were uncovered.

Plate 2: Trench 2, looking SE.

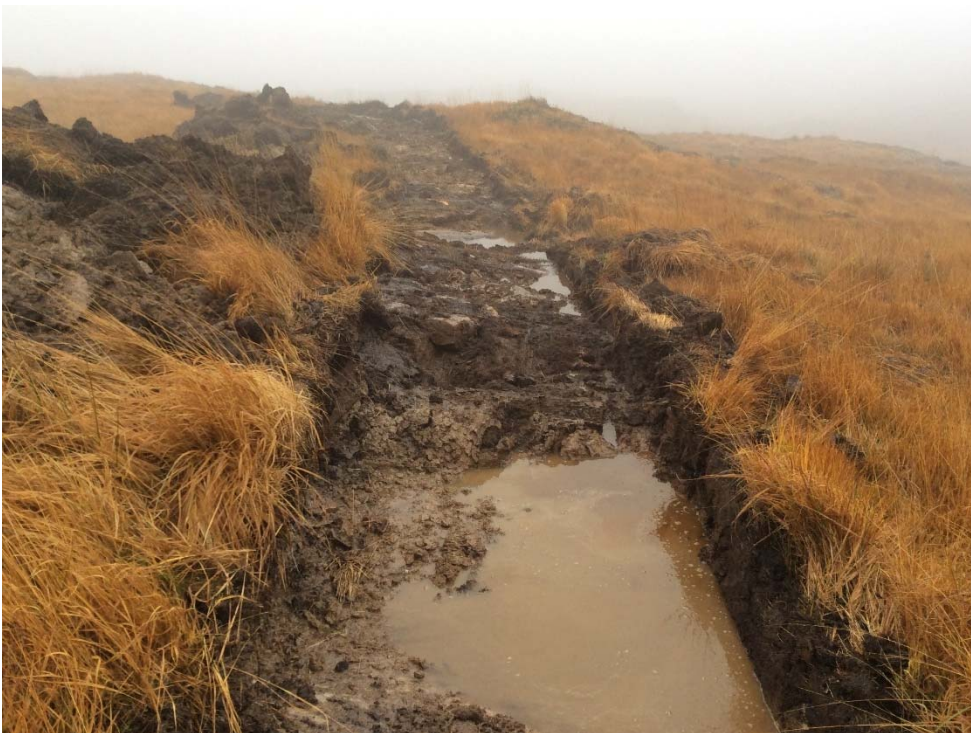
Trench 3 was excavated on the proposed road between T7 and T9 in open mountainous terrain. Frequent rock outcrops were located in this area and the trench was excavated between these ridges. It measured c. 25m in length (NW/SE), 1.8m in width and 0.4m in depth. In general the stratigraphy consisted of 0.3m-0.4m of grass-covered peat overlying bedrock and a beige stoney natural. No archaeological finds or features were uncovered.

Plate 3: Trench 3, looking SE.

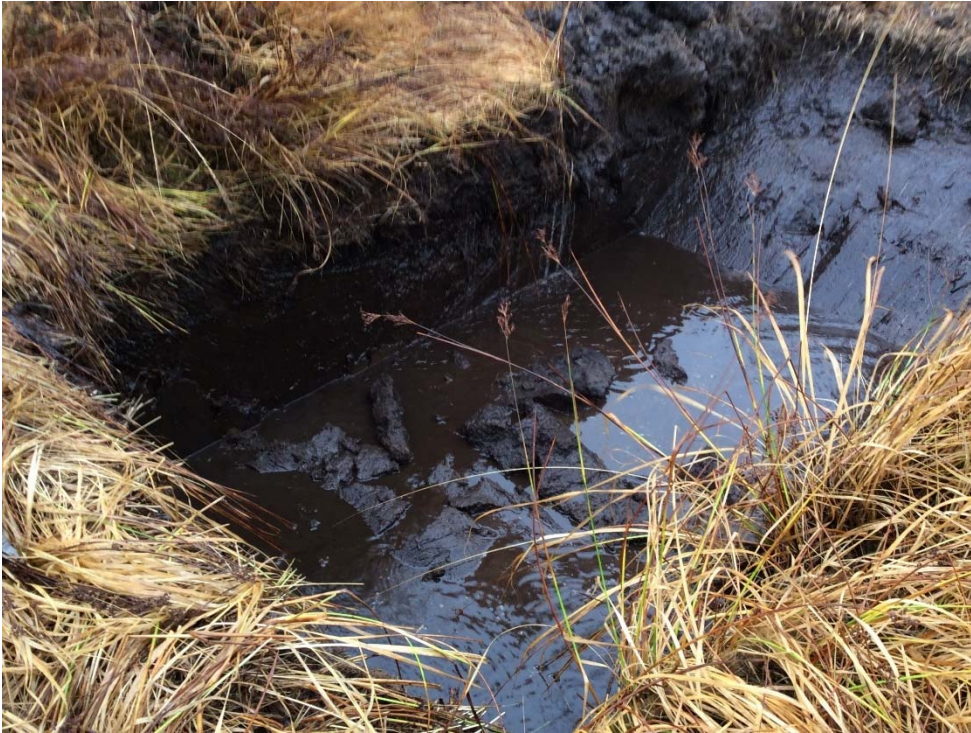
Trench 4 was excavated on the turbine base for T9 in an area of relatively level grass-covered peat. It was orientated roughly N/S and measured 20m in length, 1.8m in width and 0.4m-0.6m in depth. Excavation began at the south end of the trench where waterlogged peat in excess of 1.5m in thickness was encountered. Water ingress and peat depth rendered this end of the trench unsafe to excavate. Further to the north the peat was shallower and measured 0.5m-0.6m thick before rising up further to the north where it measured 0.4m-0.6m thick. It overlay a beige-pink stoney natural and no archaeological finds, features or deposits were uncovered. Water ingress occurred throughout the length of the trench.

Plate 4: Waterlogged deep peat at south end of Trench 4.

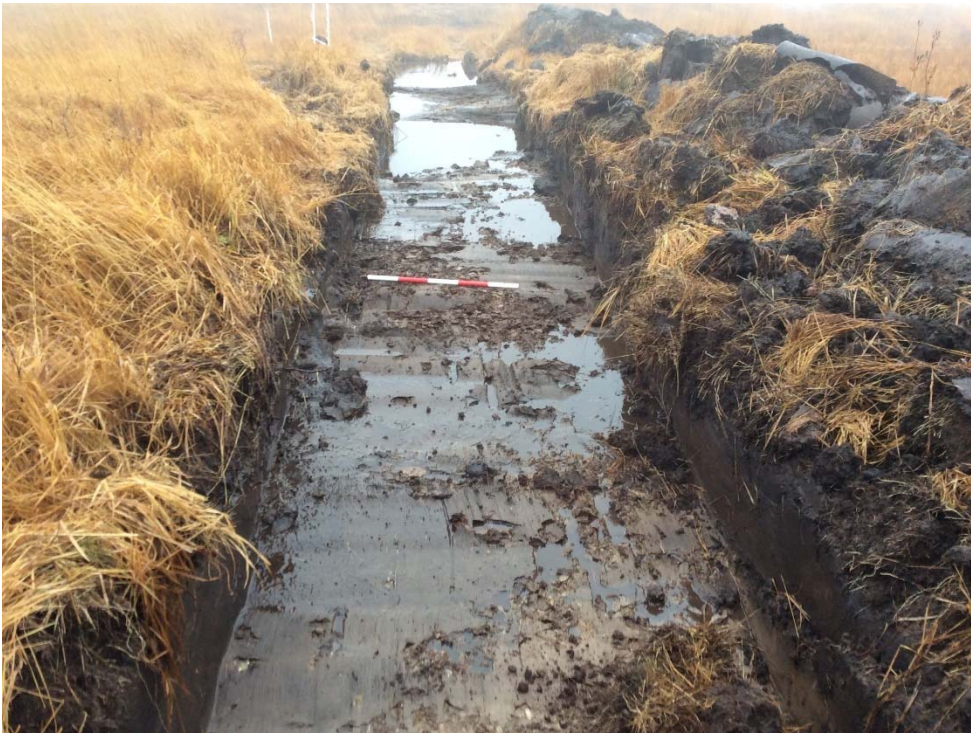
Plate 5: Trench 4, looking south.

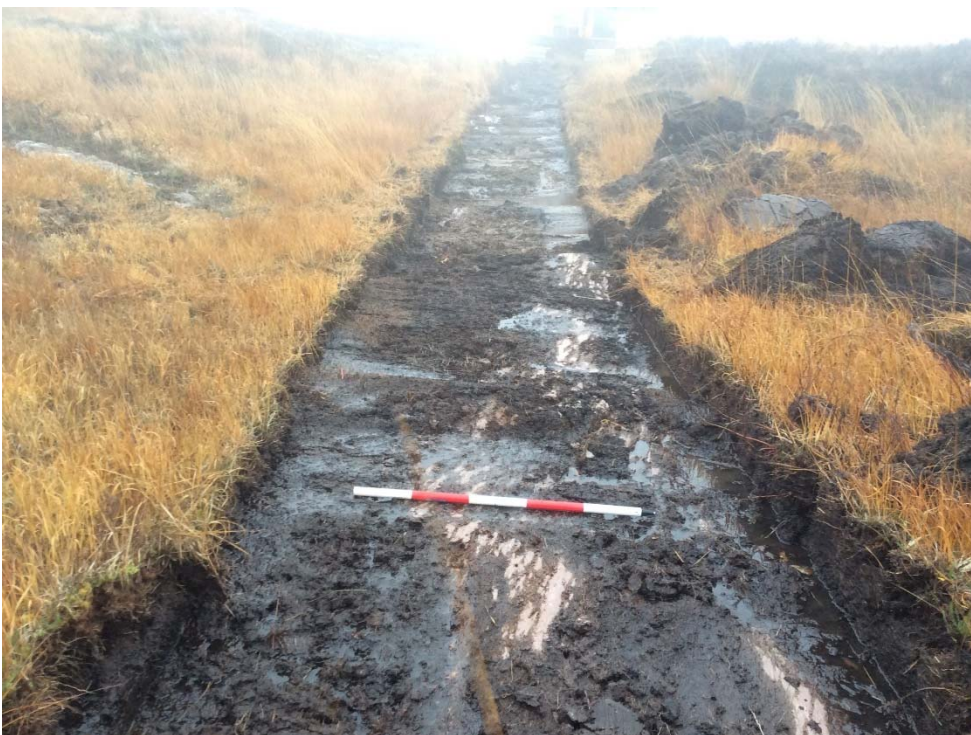
Trench 5 was excavated along the hardstand for T9 to the east of trench 4. It measured 42m in length (NE/SW), 1.8m in width and 0.3m in depth. The stratigraphy consisted of 0.2m-0.3m of grass-covered waterlogged peat overlying bedrock and a stoney grey natural. No archaeological finds or features were uncovered.

Plate 6: Trench 5, looking NE.

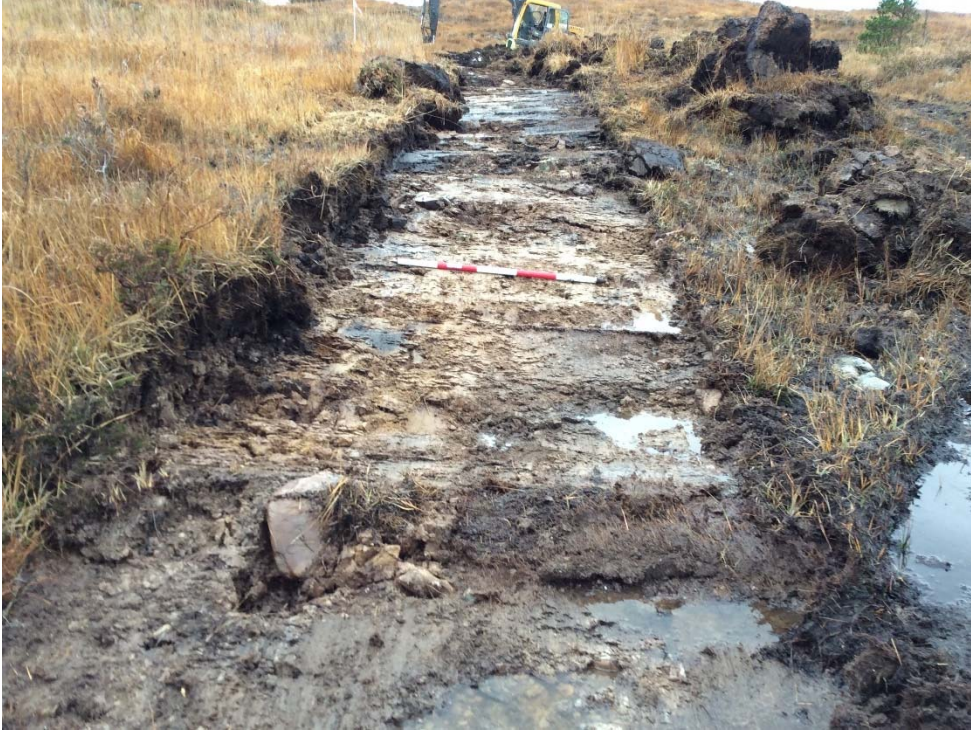
Trench 6 was excavated at turbine base T3 at the north-east side of the permitted development site. It was orientated roughly north-south adjacent to a bedrock ridge/outcrop. It measured 29m in length, 1.8m in width and 0.3m in depth. The stratigraphy generally consisted of shallow peaty soil (0.25m) overlying both rock and a beige stoney natural. No archaeological finds or features were uncovered.

Plate 7: Trench 6, looking south.

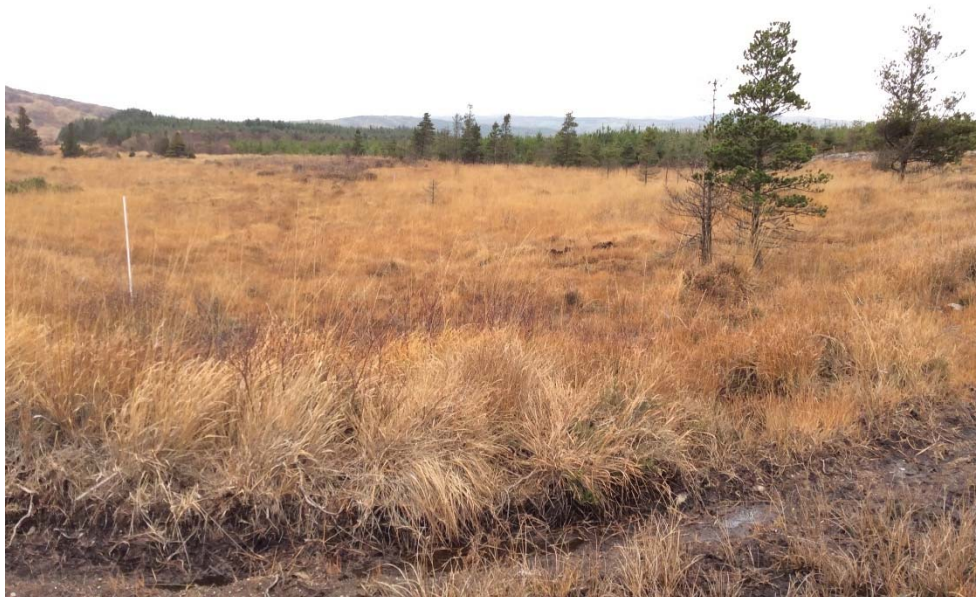
Trench 7 was excavated on the hardstand for T3, west of trench 6. This area comprised grass-covered peat with occasional coniferous trees. Excavation began at the west end of the trench where peat measuring 1.8m in depth was encountered and overlay a stoney grey-beige natural. Excavation continued in an easterly direction for c. 15m before excavation was stopped due to collapse of the trench sides. Excavation recommenced further to the east where the peat was shallower. Here it measured 0.8m in thickness and overlay both rock and a beige-grey natural. The peat continued to become shallower as trenching progressed to the east where it measured 0.3m-0.4m in thickness. No archaeological finds or features were uncovered. The trench measured c. 40m in length, 1.5m in width and 0.3m-1.8m in depth.

Plate 8: Area of hardstand for T3 prior to excavation of test trench 7, looking west.

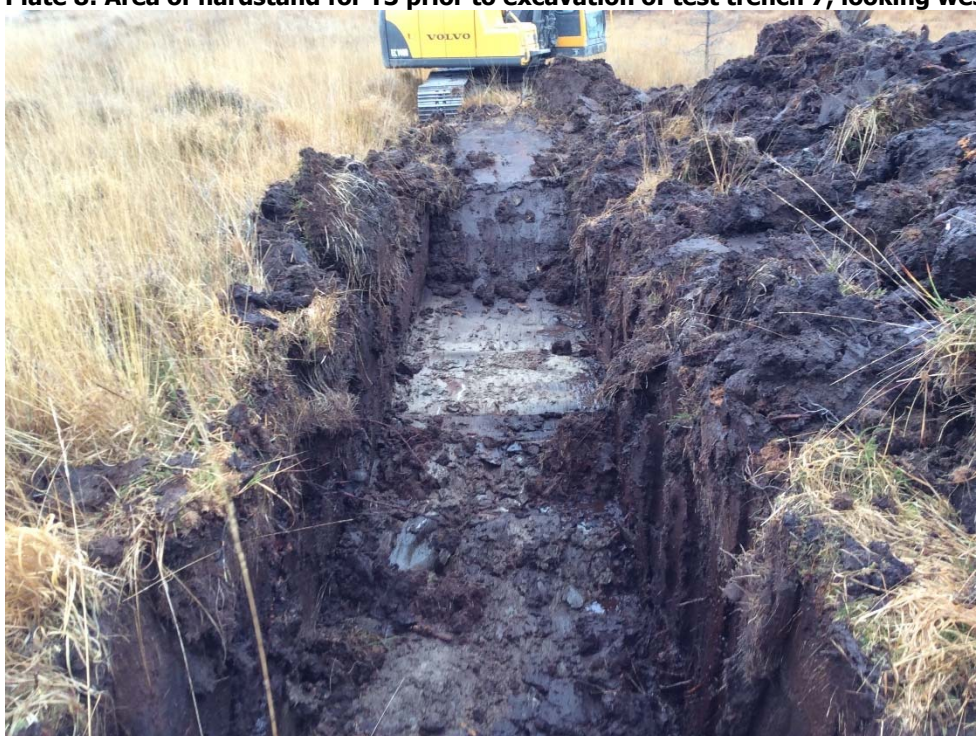
Plate 9: Western end of Trench 7, looking east.

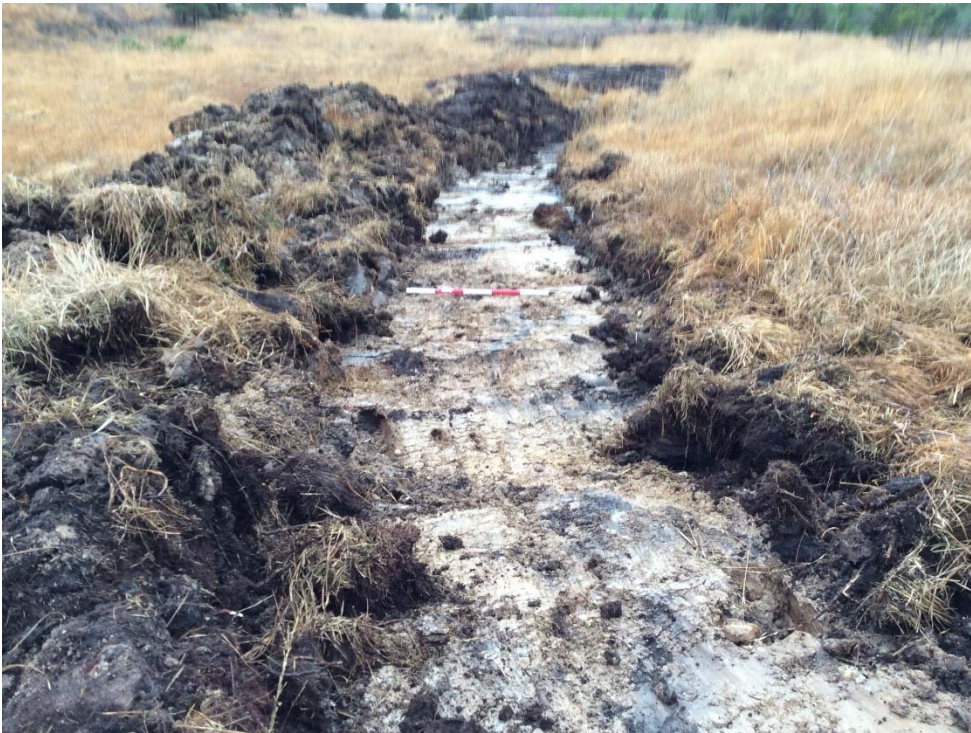
Plate 10: Eastern end of Trench 7, looking west.

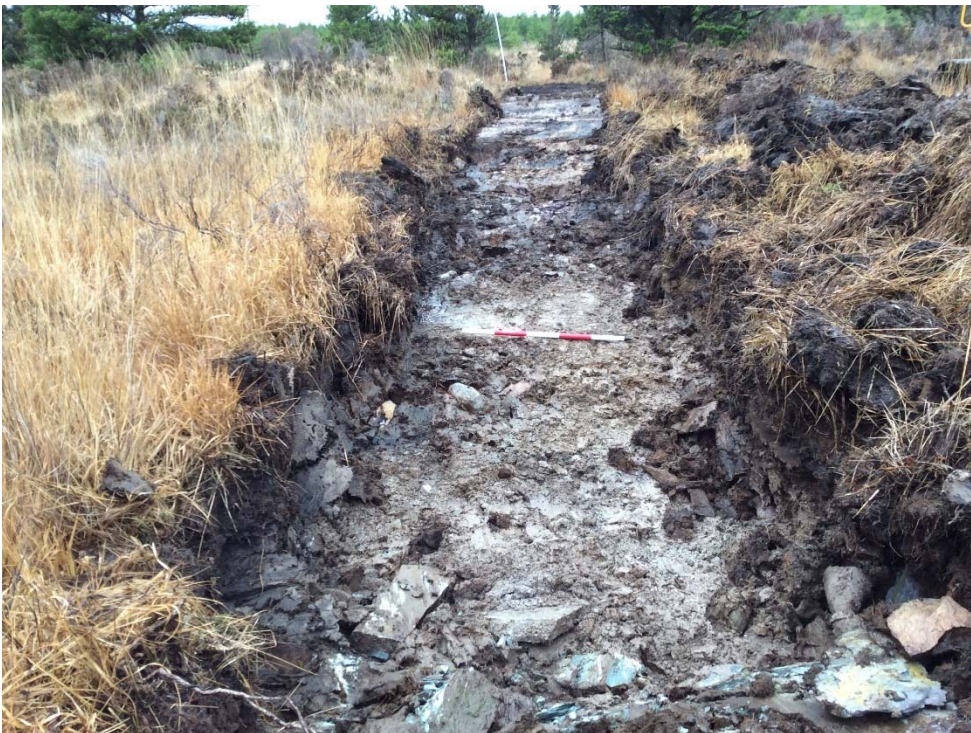
Trench 8 was located on the proposed road to T3 and was excavated in two halves due to the presence of an intervening boundary. It was orientated roughly north-south and measured 32m in length, 1.5m in width and 0.4m-1m in depth. The stratigraphy in the southern half of the trench was shallow consisting of c. 0.4m of grass-covered peat overlying a stoney beige clay. Further to the north the peat became deeper with frequent tree roots. No archaeological finds, features or deposits were uncovered.

Plate 11: Southern end of Trench 8, looking north.

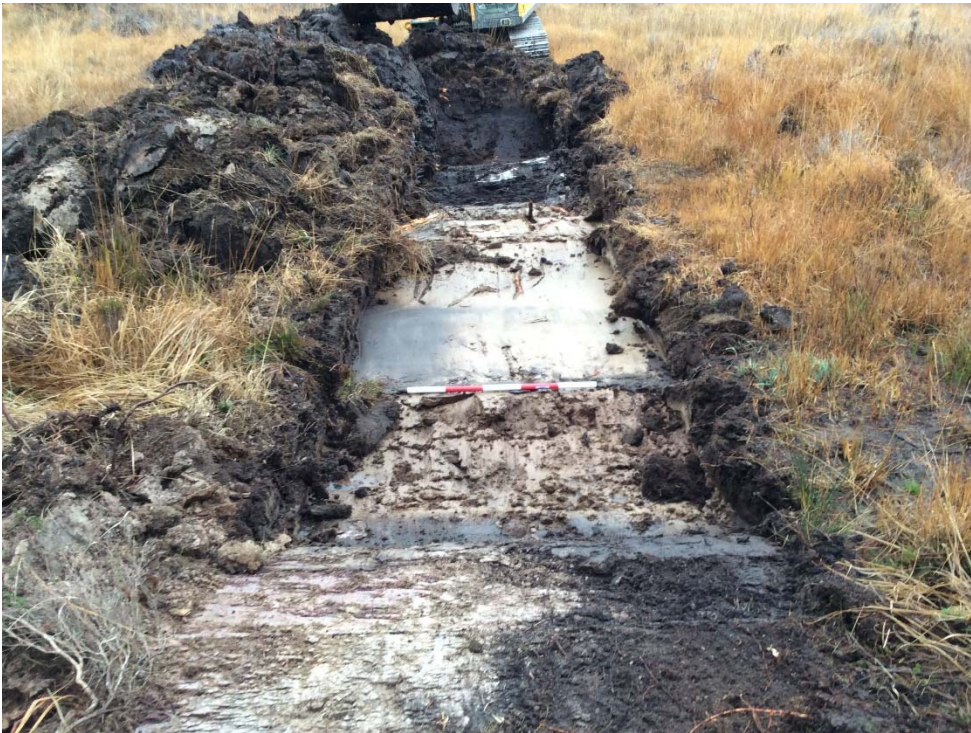
Plate 12: Northern half of Trench 8, looking north.

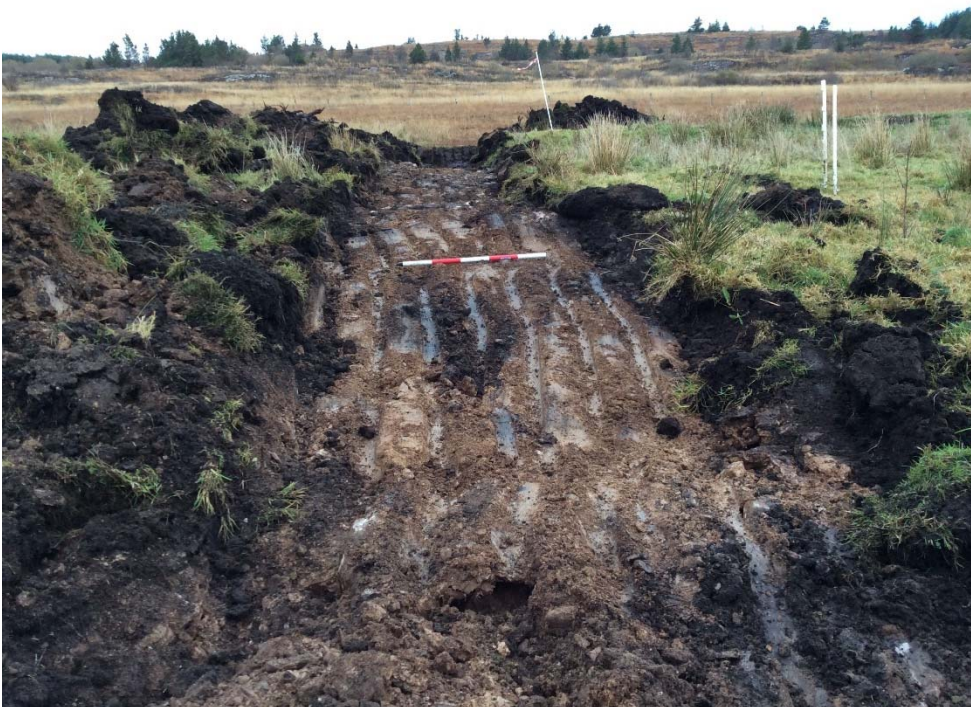
Trench 9 was located at the turbine base for T4 and was situated in rough pasture. It was orientated roughly north-south and measured 25m in length, 1.5m in width and 0.2m-0.8m in depth. The stratigraphy generally consisted of peaty soil overlying a stoney beige natural. At the south end of the trench soil cover was shallow and measured only 0.2m in thickness. Further to the north the peat measured 0.8m in thickness and contained frequent tree roots. No archaeological finds or features were uncovered.

Plate 13: Trench 9, looking north.

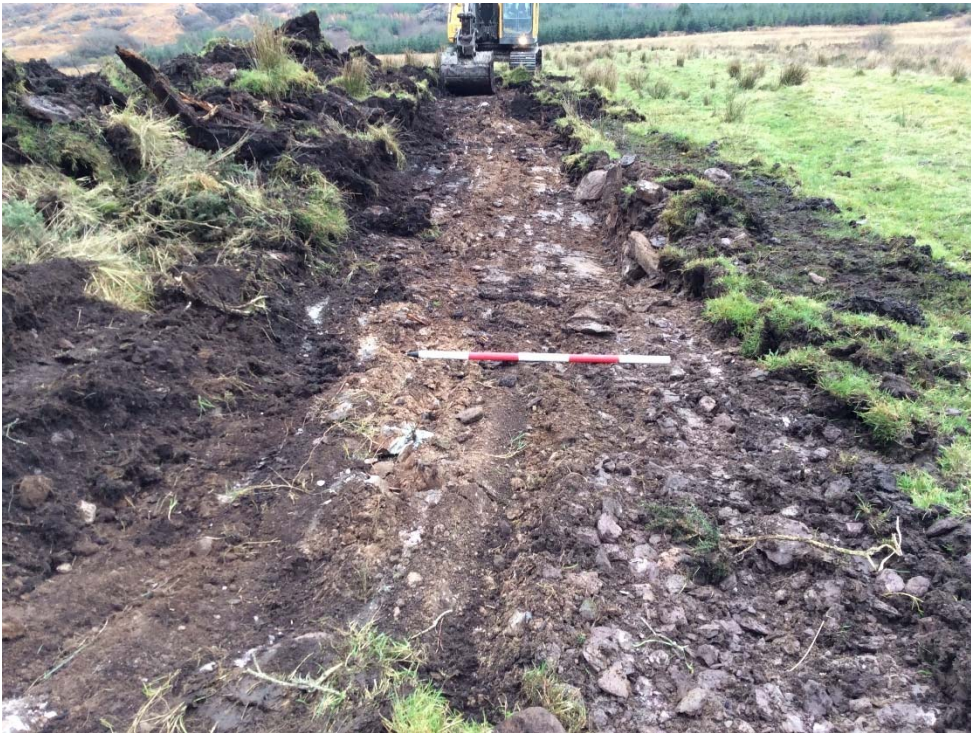
Trench 10 was excavated along the hardstand for T4 and was orientated in an ENE-WSW direction. It measured 47m in length, 1.5m in width and 0.2m-0.4m in depth. The stratigraphy generally consisted of peaty sod-covered soil overlying a stoney beige natural. No archaeological finds or features were uncovered.

Plate 14: Eastern end of trench 10, looking west.

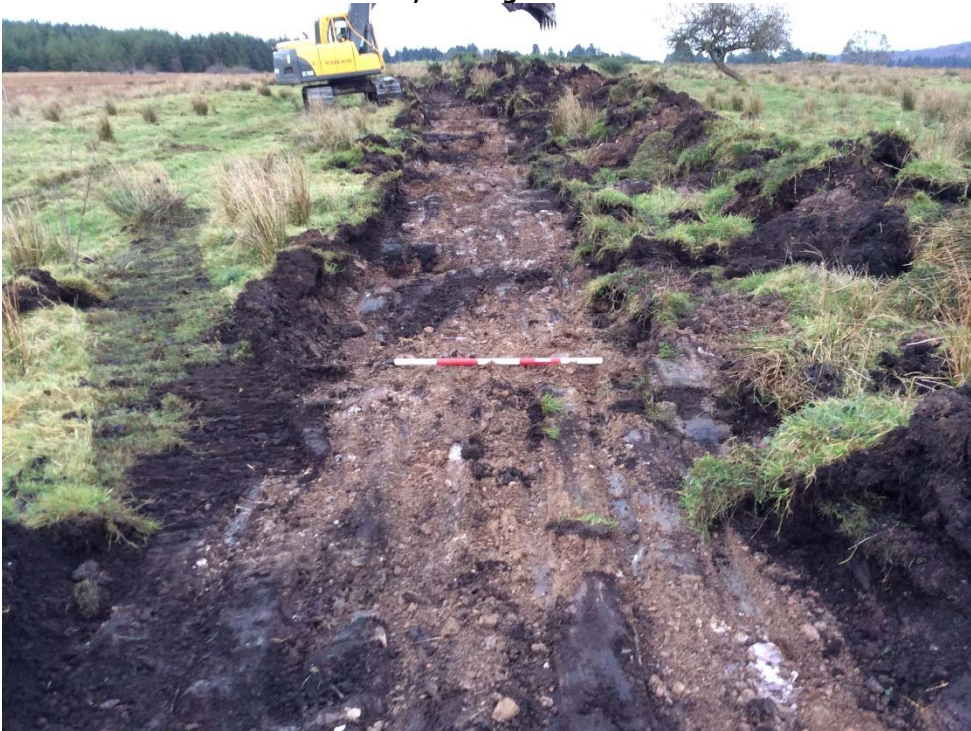
Plate 15: Trench 10, looking east.

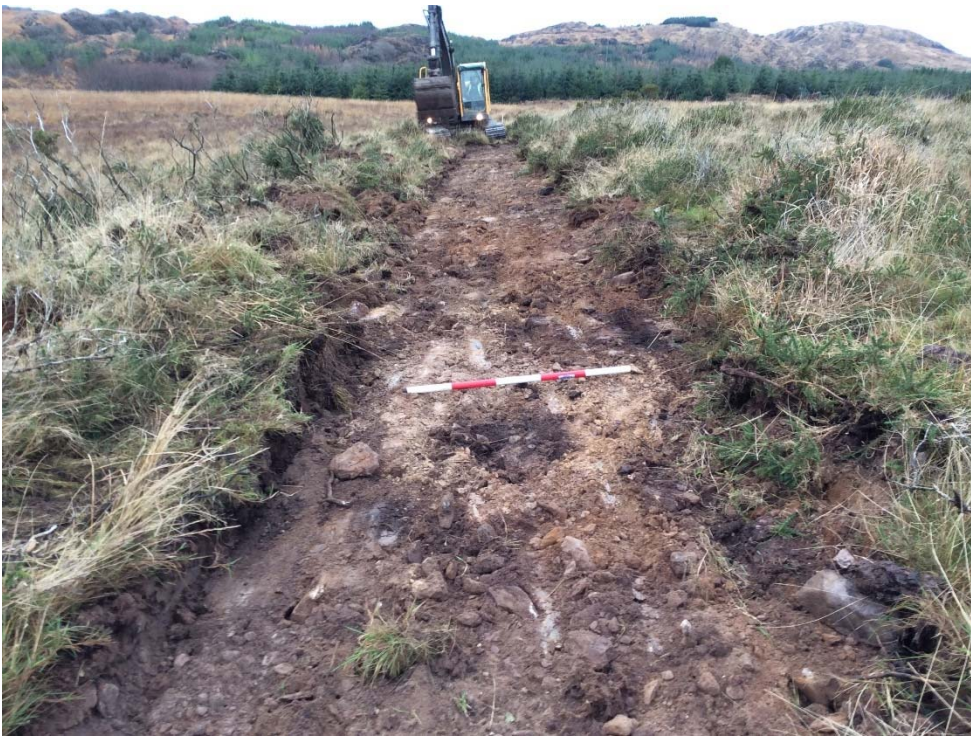
Trench 11 was excavated on the proposed road to T4, west of the hardstand. The stratigraphy was very shallow here comprising 0.15m of sod and topsoil overlying a beige-orange natural which was stoney in

places. It measured 33m in length ENE/WSW, 1.5m in width and 0.2m in depth. No archaeological finds or features were uncovered.

Plate 16: Trench 11, looking west.

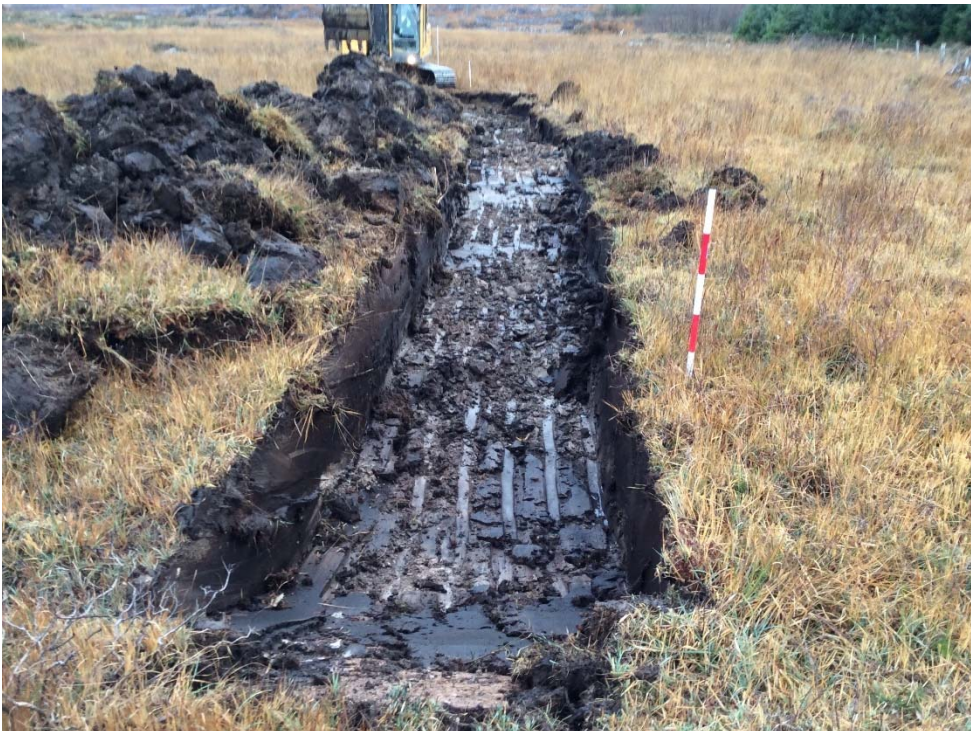
Trench 12 was excavated on the proposed road to T4 in grass-covered peat. The peat was c. 1m deep at the north end of the trench adjacent to a bedrock ridge and became shallower towards the south where it measured 0.4m-0.5m thick. It overlay a beige stoney natural and no archaeological finds or features were uncovered. The trench measured 28m in length (N/S), 1.5m in width and 0.4m-1m in depth.

Plate 17: Trench 12, looking south.
