Watercourse Survey Report

Cleanrath Windfarm

Project Title: **Cleanrath Wind Farm**

Document Title: **Aquatic Macroinvertebrate Sampling Report**

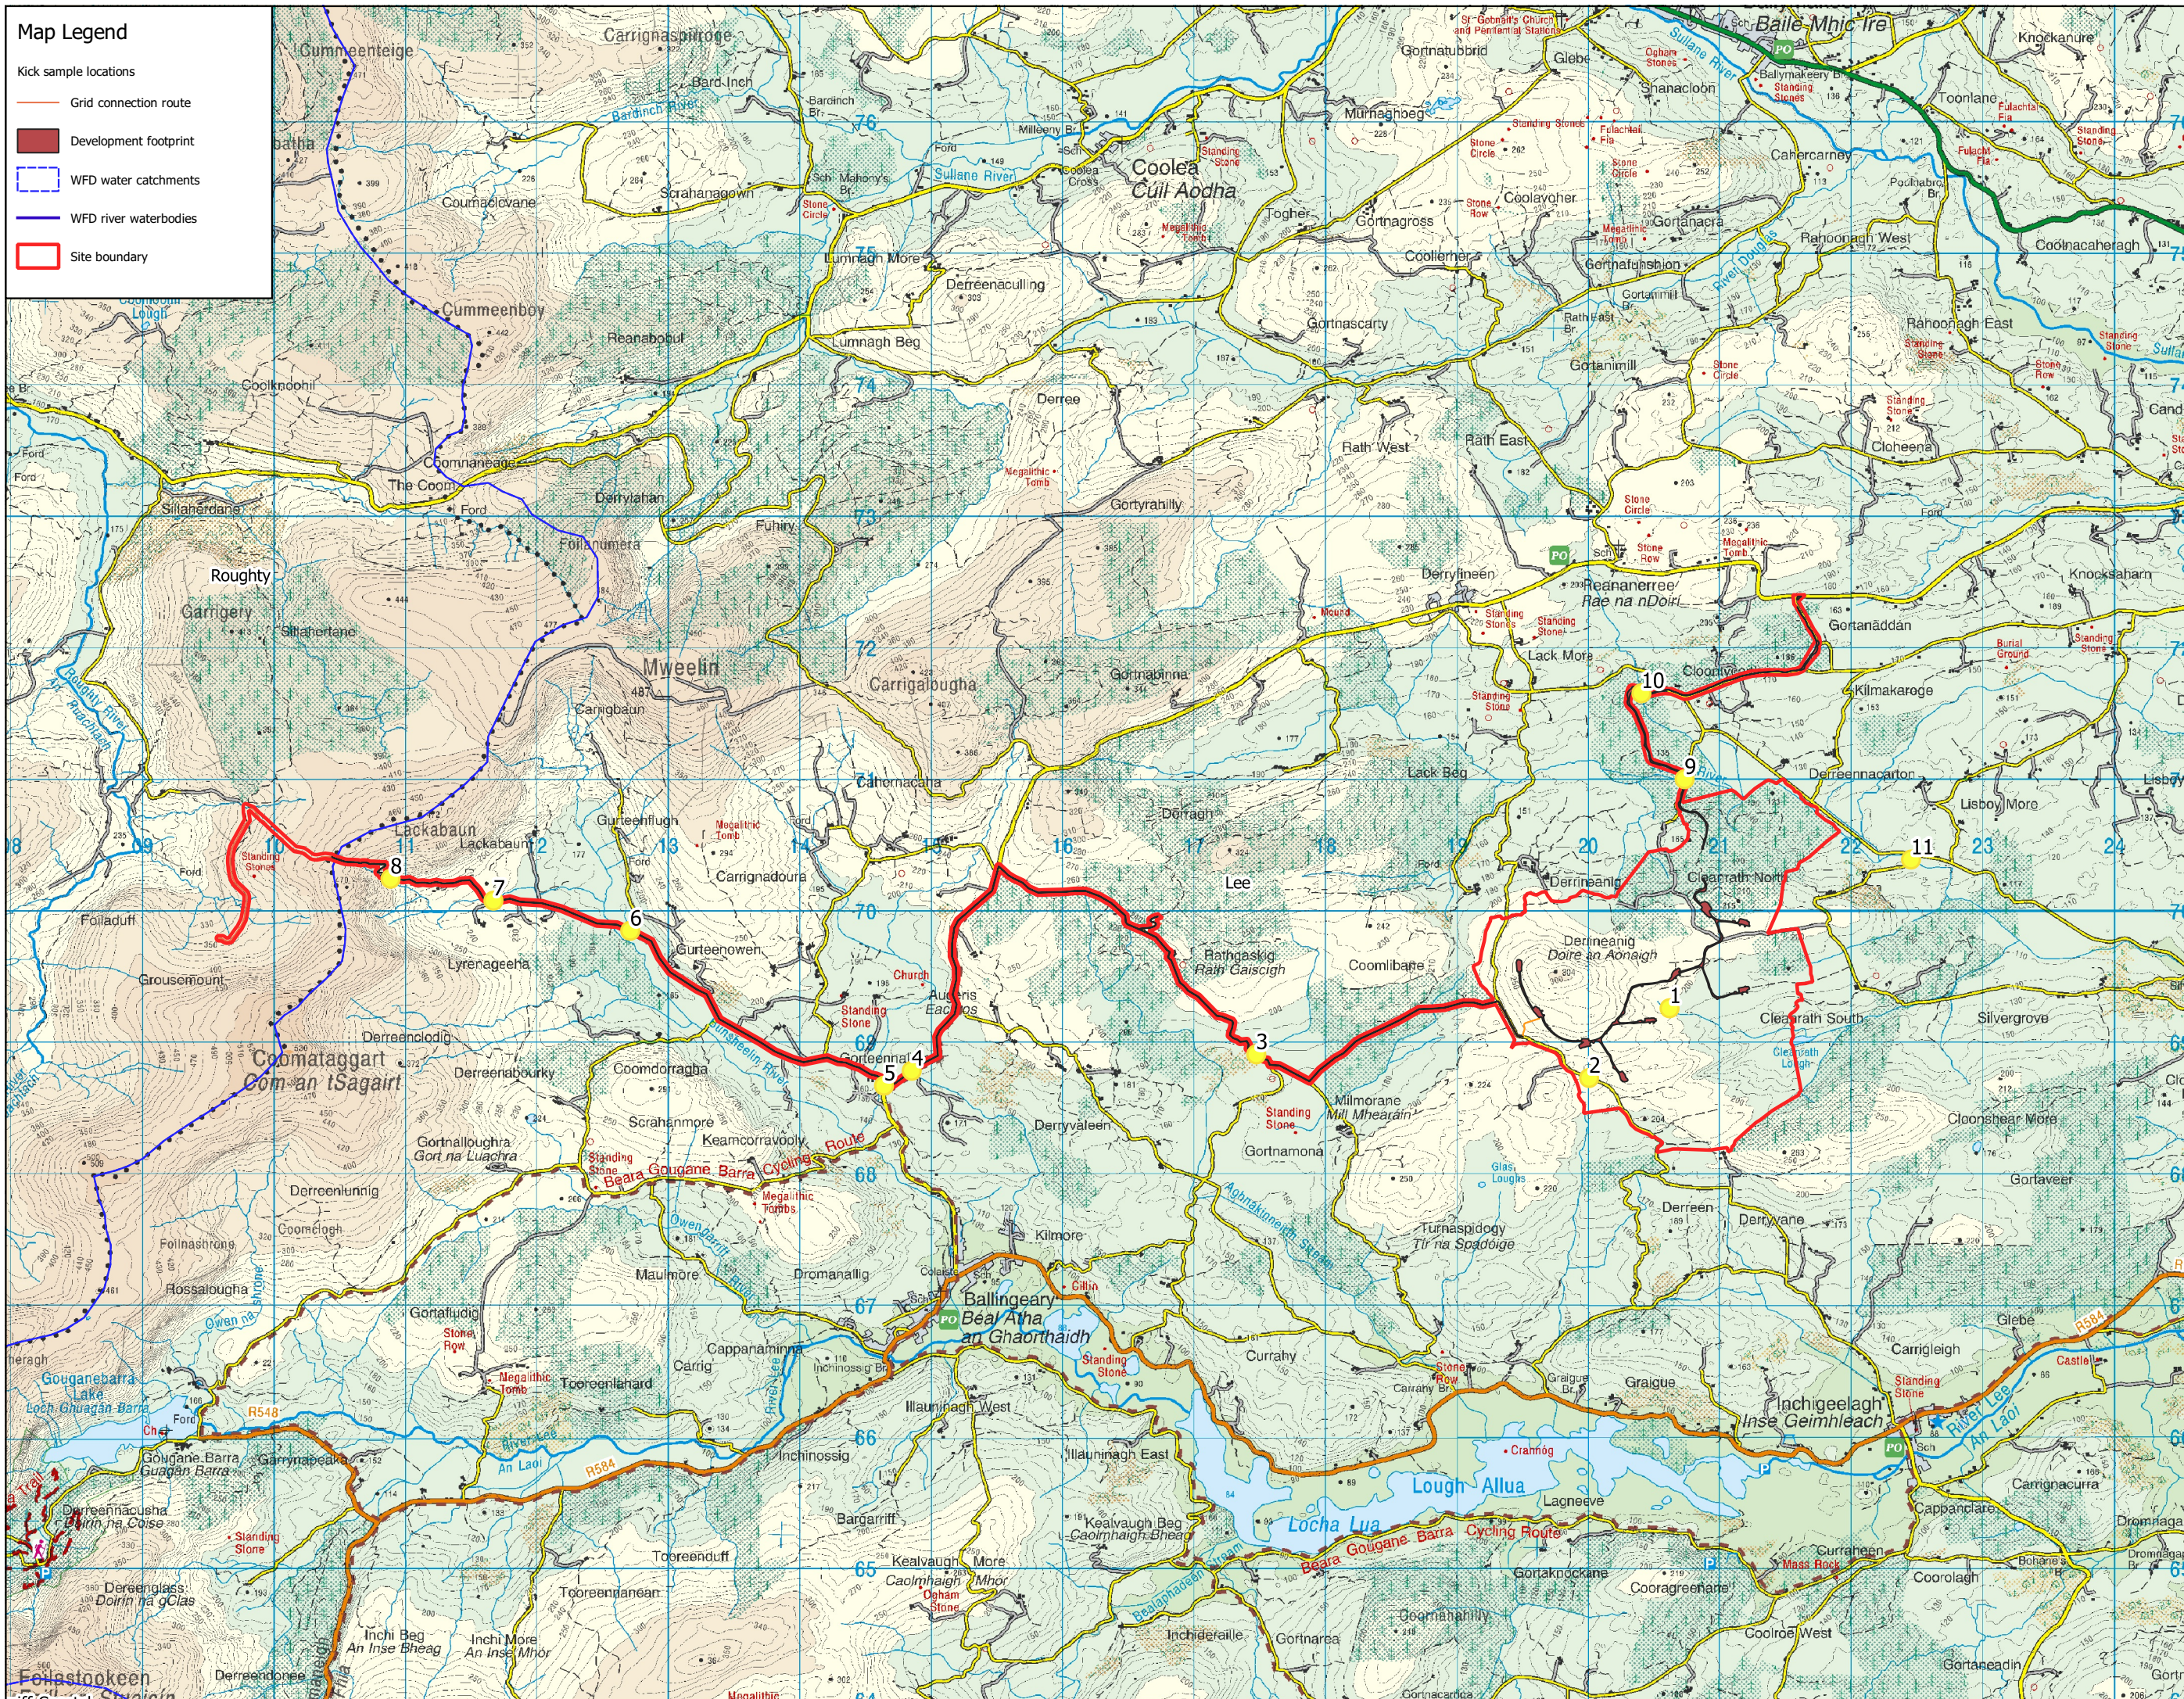
191223a	Figure 1.
Scale 1:44976	Date 18.05.202

Drawing Title
Kick sample locations

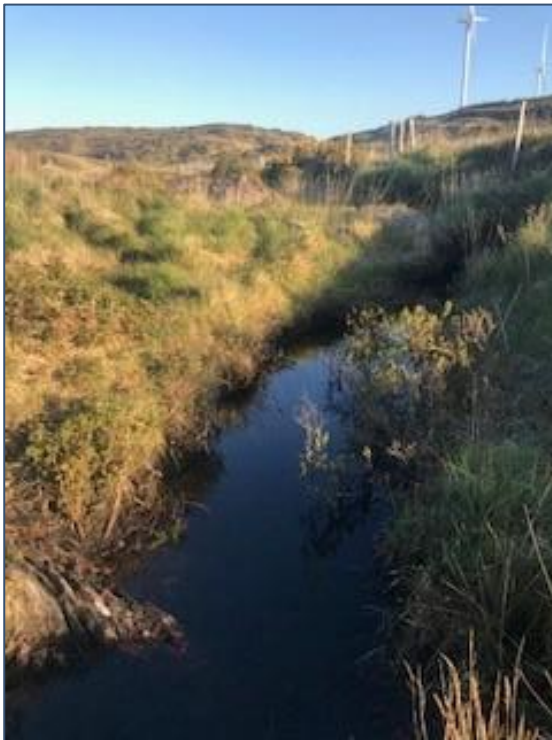
Plate 2.1. Sample Station 2.

Sample Station 2 was located in a narrow bog stream that is located to the south of an existing public road. There was no defined channel to the north of the road and no direct surface water connectivity with the wind farm site (the stream arises out of a wetland to the north. There were no riffles in the stream and it had a substrate comprising primarily of peat and bedrock. It was approximately 1.5m in width. This stream is shown in Plate 2.1. It flows to the south of the wind farm site and enters Lough Allua after approximately 2.5km.

The instream macrophytes included bog pondweed (*Potamogeton polygonifolius*) and stoneworts (*Chara Sp.*). There was some growth of algae within the stream. Emergent vegetation included a number of small sedges (*Carex Spp.*). The bankside vegetation was dominated by typical bog species including bog myrtle, milkwort (*Polygala serpyfolia*), cross leaved heath (*Erica tetralix*) and butterwort.

The stream did not provide suitable habitat for freshwater pearl mussel and did not provide significant fisheries habitat as it was very narrow, steep and shallow with a substrate of bedrock and peat. The Q rating assigned to the channel was Q3. It was assigned this value as the density and diversity of invertebrates was low and no Group A species were present. Group B species were recorded and Group C species were common. This rating is likely due to the lack of riffle habitat and nature of the substrate, which was not ideal for undertaking a Q value assessment rather than any pollution within the channel. There was no luxuriant growth of algae, sewage fungus or any other slimes and the stream appeared clean – but peaty. No signs of any impacts resulting from the construction and operation of the windfarm were recorded.

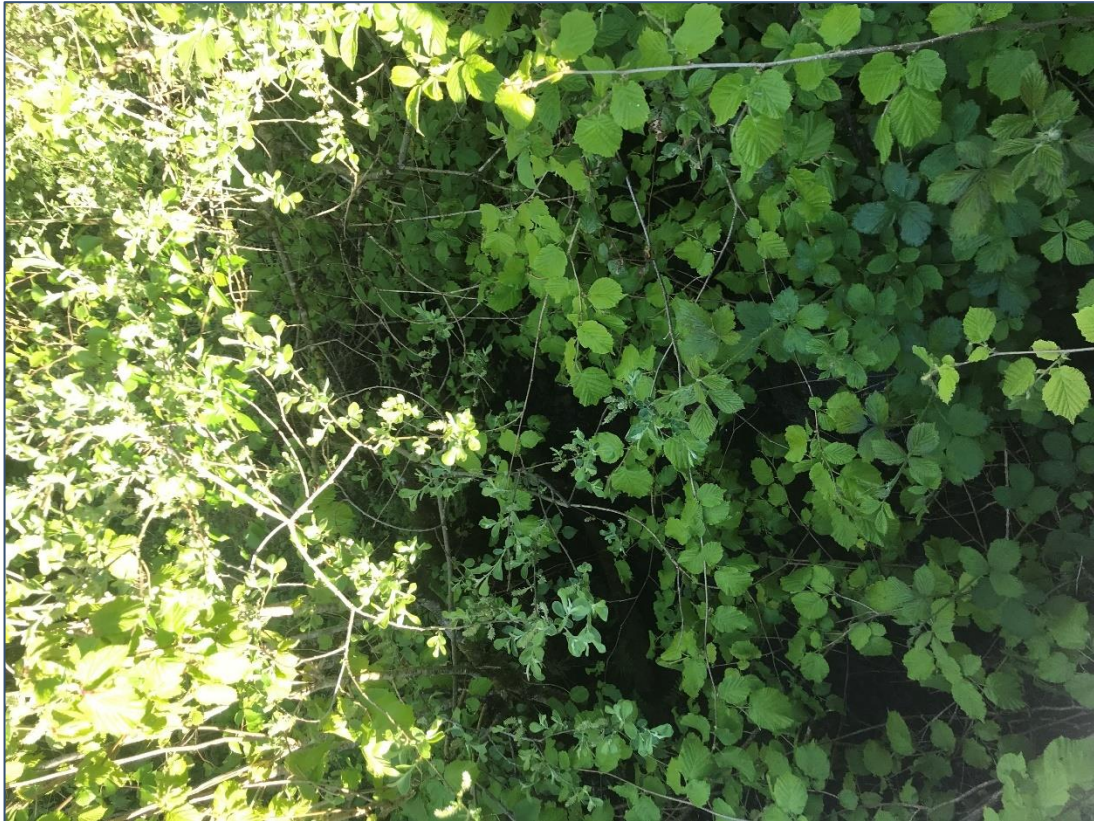
Plate 2.2. Sample Station 3.

Sample Station 3 was located along the grid connection route in the Townland of Rathgaskig. This watercourse is a tributary of the Aghnakinneigh Stream and is approximately 3.5 metres wide at the sample point. It was very shallow at the time of the survey. It had a substrate of gravels and cobbles but no riffles in the area surrounding the grid connection route. The sample was taken downstream of the grid connection (which was located in the road bed where it crossed the bridge on the public road).

There were no signs of pollution or any instream or bankside works having taken place. This stream is shown in Plate 2.2.

No instream or emergent vegetation was recorded. The stream was very shaded and the bankside vegetation was dominated by dense bramble (*Rubus fruticosus agg.*), hazel (*Corylus avellana*), Herb Robert (*Geranium robertianum*), birch (*Betula pubescens*), holly (*Ilex aquifolium*) and grey willow (*Salix cinerea*). Filamentous algae, whilst present, was very sparse.

The Q rating assigned to the channel was Q4. It was assigned this value as 2 Group A taxa were recorded along with a Group B Taxon in fair numbers. Group C were well represented but not excessive. The sample was not undertaken in a riffle and thus not in ideal habitat for a biological sample. In addition, it was heavily shaded at the sample location. No suitable habitat for freshwater pearl mussel was recorded at this location as the watercourse was too shallow and steep. The gravel substrate provides some potential habitat for salmonid fish. No signs of any impacts resulting from the construction of the grid connection were recorded.

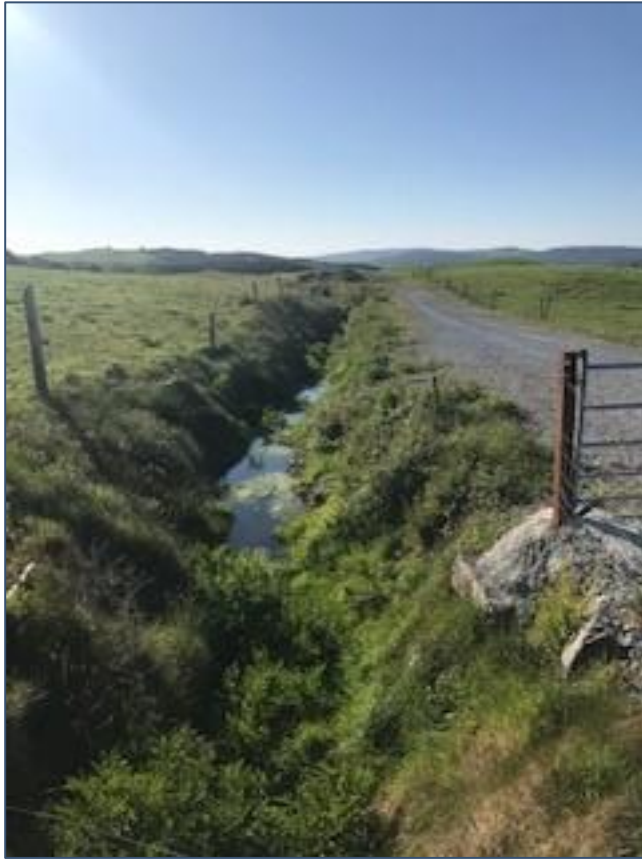
Plate 2.3. Sample Station 4.

Sample Station 4 was located alongside an agricultural track that had been recently surfaced with limestone chips and was surrounded by fields of improved agricultural grassland. The grid connection route passed along and within the bed of an adjacent public road with no instream works required. The sample was taken downstream of the grid connection. The drain was a managed drainage channel with a substrate of boulders and cobbles and a moderated degree of siltation. It was approximately one metre wide at the sample point. This drain converges with the River Lee at Ballinageary after approximately 3km. This drain is shown in Plate 2.3.

The instream macrophytes included duckweed (*Lemna minor*) emergent vegetation including hemlock water dropwort (*Oenanthe crocata*) and floating sweet grass (*Glyceria fluitans*). The bankside vegetation was dominated by grassy vegetation and bramble and foxglove (*Digitalis purpurea*).

The Q rating assigned to the channel was Q3. It was assigned this value as Group A were absent, group B were represented in fair numbers and Group C were also numerous. There was also moderate growth of filamentous algae present. This result is typical of a drain that is surrounded by improved agricultural lands. The stream does not provide any suitable habitat for freshwater pearl mussel or any significant habitat for salmonid fish at the sample point. The cable was laid in the public road (not in the private agricultural track that is adjacent to the stream) No signs of any impacts resulting from the construction of the grid connection were recorded.

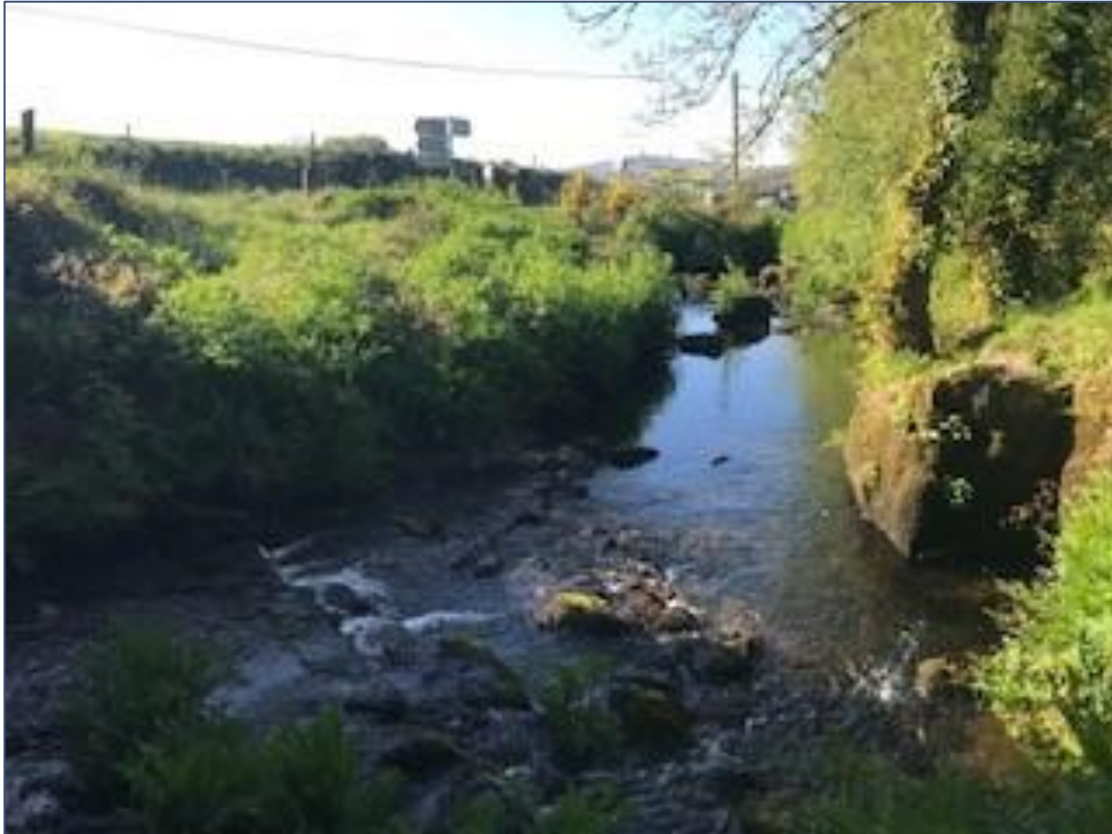
Plate 2.4. Sample Station 5.

Sample Station 5 was located on a tributary of the Bunsheelin River that flows into the River Lee approximately 2km downstream at Ballinageary. It was approximately 6m wide at the survey point, with an average depth of 0.3m at the time of the survey. The substrate was dominated by bedrock, boulders and cobbles and there was little siltation. The grid connection cable was strapped to the side of the bridge in this location and there was no requirement for instream works. This sample station is shown in Plate 2.4.

The instream macrophytes included the aquatic moss *Fontinalis antipyretica* along with other bryophytes. Emergent vegetation included hemlock water dropwort. The bankside vegetation was included grassy vegetation and woodrush (*Luzula sylvatica*), hemlock water dropwort and bramble. Ash (*Fraxinus excelsior*), Birch and sycamore (*Acer campestre*) were present surrounding the banks.

The Q rating assigned to the channel was Q4. It was assigned this value as Group A and B taxa were recorded in fair numbers with Group C numerous. The sample was undertaken in a riffle and was a suitable location to undertake an accurate biological water sample. The river offered potential habitat for freshwater pearl mussel (despite the presence of bedrock) though none were recorded at the sample site. The river also provided good quality fisheries habitat, with riffles, glides and pools present and a stony substrate. No signs of any impacts resulting from the construction of the grid connection were recorded.

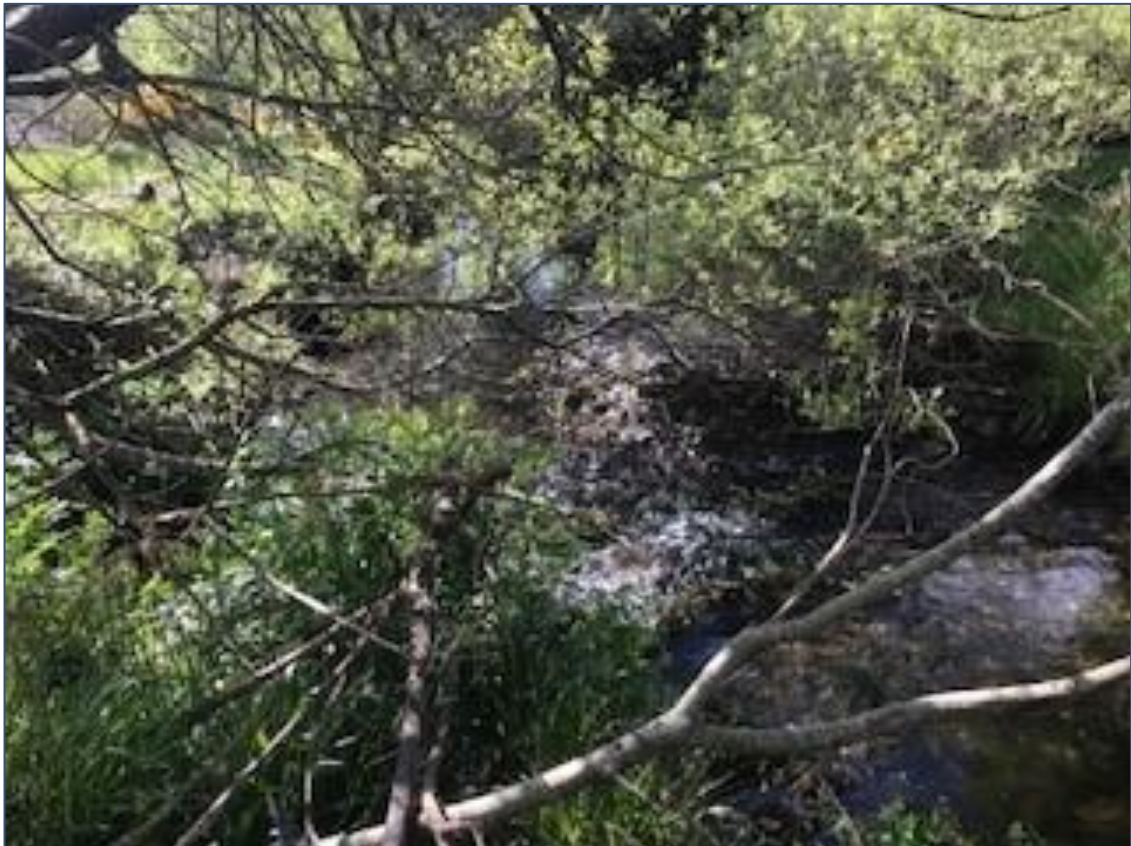
Plate 2.5. Sample Station 6.

Sample Station 6 was located at the confluence of two streams that are downstream of the grid connection route and form part of the Bunsheelin River that flows into the River Lee at Ballinageary, approximately four kilometres downstream. This river is approximately three metres wide at the sample point with a substrate of cobbles and gravels with no appreciable siltation. The sample point is surrounded by pasture lands along with a recently constructed house and garden. The grid connection was located in the existing road and there were no signs of pollution at either crossing point or downstream at the sample site. This sample site is shown in Plate 2.5.

The instream macrophytes included the aquatic moss *Fontinalis antipyretica* along with other bryophytes. Emergent vegetation included hemlock water dropwort. The bankside vegetation was dominated by woodrush, willow, gorse and holly scrub. The river provided suitable habitat for freshwater pearl mussel, though none were recorded at the sample site. The stream is possibly a little steep and unstable for the species. The substrate of gravels and cobbles provides good Salmonid fish habitat.

The Q rating assigned to the channel was Q4. It was assigned this value as Group A were recorded in fair numbers with Group B recorded and Group C recorded in fair numbers. There was no filamentous algae or sewage fungus and no signs of other pollution. No signs of any impacts resulting from the construction of the grid connection were recorded.

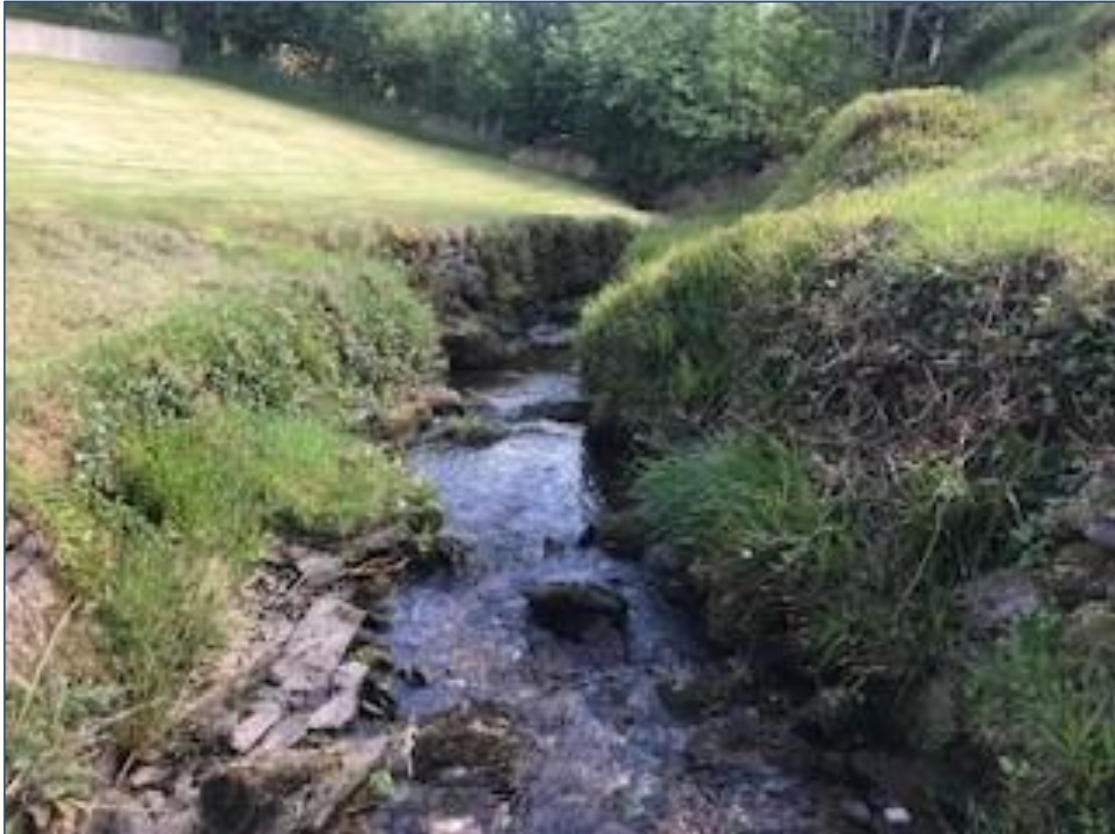
Plate 2.6. Sample Station 7.

Sample Station 7 was located at the edge of a private garden downstream of the grid connection route. It is a tributary of the Bunsheelin River and is approximately one kilometre upstream of sample station 6. The stream was approximately 2.5 metres wide and 0.1m deep at the time of survey and had a substrate of cobbles and gravels. The grid connection was located in the road upstream and no signs of disturbance or instream works were recorded. This sample station is shown in Plate 2.6.

The instream macrophytes included the aquatic moss *Fontinalis antipyretica* along with other bryophytes. No emergent vegetation was recorded. The bankside vegetation was dominated by grassy vegetation associated with the lawn of a private house. It included species such as sorrel (*Rumex acetosa*), dandelion (*Taraxicum officinale agg.*), field speedwell (*Veronica serpyfolia*) and ribwort (*Plantago lanceolata*). The channel was steep, shallow and likely to be subject to large fluctuations in water levels. In this regard it is unsuitable for freshwater pearl mussel at this location. It does provide some potential habitat for salmonid species but is very small and shallow.

The Q rating assigned to the channel was Q4. It was assigned this value as Group A were recorded in fair numbers with Group B recorded and Group C recorded in fair numbers. There was no filamentous algae or sewage fungus and no signs of other pollution. No signs of any impacts resulting from the construction of the grid connection were recorded.

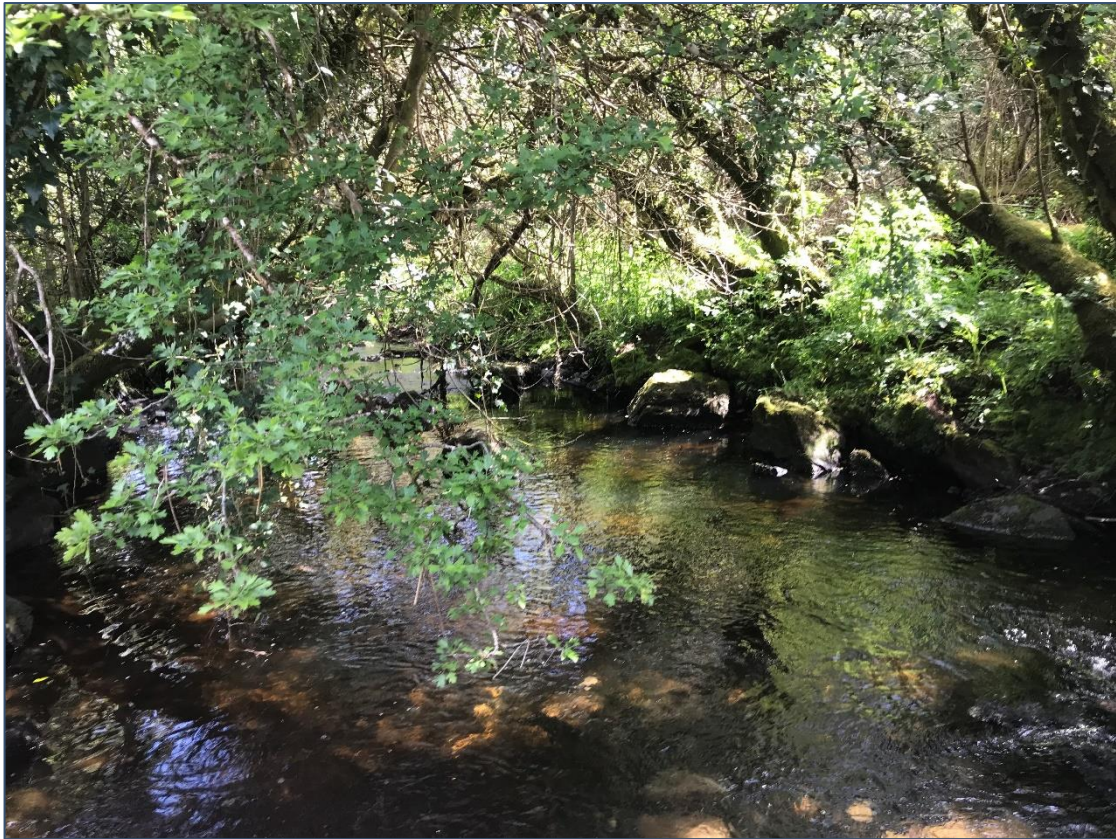
Plate 2.7. Sample Station 9.

Sample Station 9 was located at a location where the access road to the wind farm crosses the Toon River. The river here is approximately 5 metres wide with a mixed substrate of boulders, cobbles, gravels and fine gravels. The river provides good quality salmonid habitat. It also provides suitable habitat for freshwater pearl mussel, though none were recorded at the sample location. Evidence of road enhancement works were noted on the bridge and on the surrounding road infrastructure but no signs of any effects on the river channel were identified. This sample station is shown in Plate 2.7.

The instream macrophytes included the aquatic moss *Fontinalis antipyretica* along with other bryophytes. Water crowfoot was recorded upstream of the bridge, where the channel conforms to the EU Habitats Directive Annex I habitat ‘water courses of plain to montane levels with the *Ranunculum fluitantis* and *Callitriche-Batrachion* vegetation (3260)’. Emergent vegetation included hemlock water dropwort. The bankside vegetation was included bramble, ferns and figwort (*Scrophularia* sp.) with shading from tree species including hawthorn (*Crataegus monogyna*), grey willow and ash.

The Q rating assigned to the channel was Q4. It was assigned this value as Group A were recorded in fair numbers with Group B recorded and Group C recorded in fair numbers. There was no filamentous algae or sewage fungus and no signs of other pollution. No signs of any impacts on the river resulting from the construction of the wind farm were recorded.

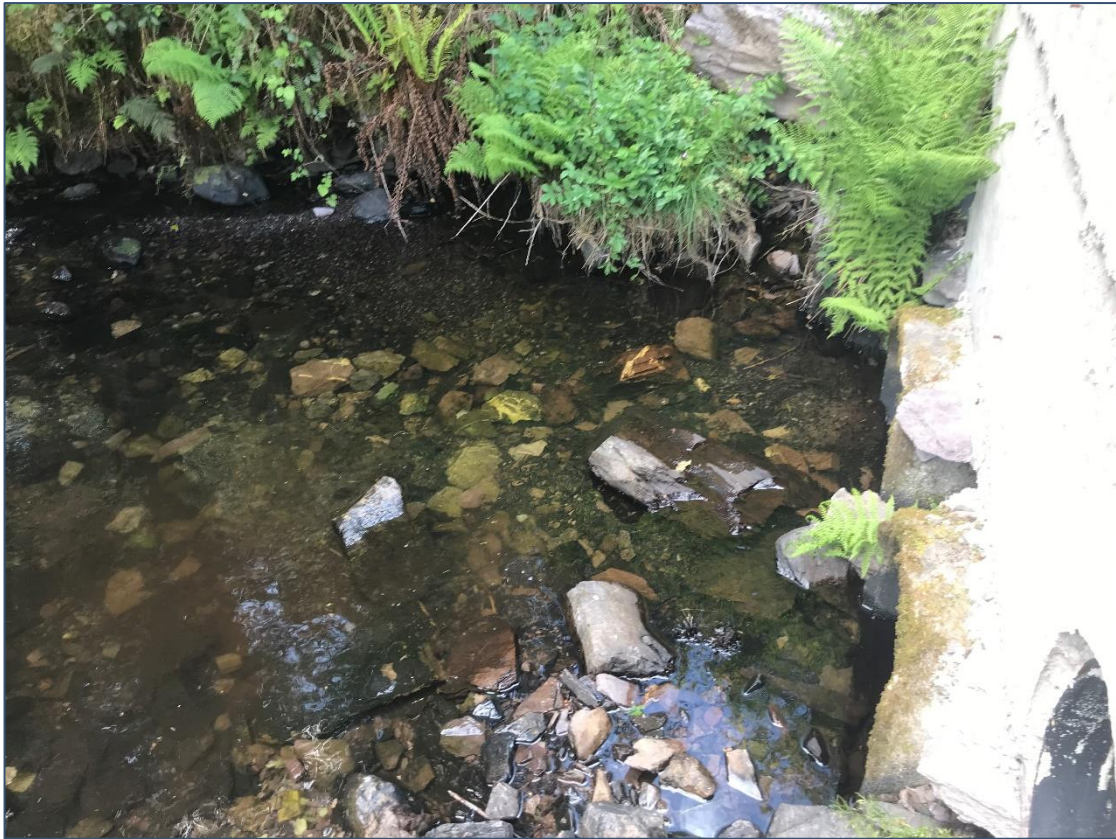
Plate 2.8. Sample Station 10.

Sample Station 10 was located at a location where the access road to the wind farm crosses a tributary of the Toon River. The river here is approximately 4.5 metres wide with a mixed substrate of boulders, cobbles, gravels and silts. The river provides good quality salmonid habitat. It also provides suitable habitat for freshwater pearl mussel, though none were recorded at the sample location. Evidence of road enhancement works were noted on the bridge and on the surrounding road infrastructure. This included extensive works on the culvert. However, no signs of any instream works or effects on the river channel were identified. This sample station is shown in Plate 2.8.

No submerged or emergent macrophytes were recorded. The bankside vegetation included meadowsweet, bramble, nettle (*Urtica dioica*) and wavy bittercress (*Cardamine flexuosa*).

The Q rating assigned to the channel was Q4. It was assigned this value as Group A were recorded in fair numbers with Group B recorded and Group C recorded in fair numbers. There was no filamentous algae or sewage fungus and no signs of other pollution. No signs of any impacts on the river resulting from the construction of the wind farm were recorded.

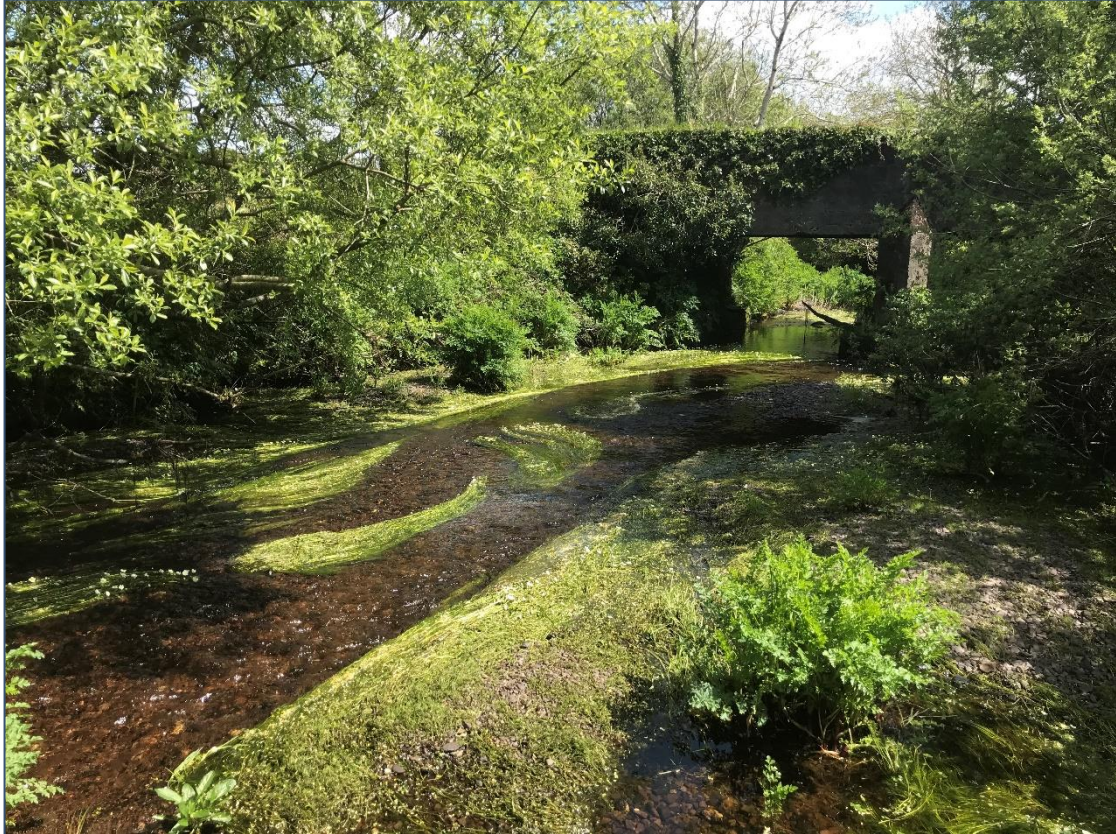
Plate 2.9. Sample Station 11.

Sample Station 10 was located on the Toon River approximately 1.8 kilometres downstream of sampling station 9. The river here is approximately 10 metres wide with a gravel substrate. The river provides good quality salmonid habitat. It also provides suitable habitat for freshwater pearl mussel, though none were recorded at the sample location. No signs of any effects of the windfarm on this river channel were identified. This sample station is shown in Plate 2.9.

Submerged macrophytes included water crowfoot (*Ranunculus sp.*) and the channel conforms to the EU Habitats Directive Annex I habitat ‘water courses of plain to montane levels with the *Ranunculion fluitantis* and *Callitriche-Batrachion* vegetation (3260)’ at this location. Emergent vegetation included hemlock water dropwort, marsh ragwort (*Senecio aquaticus*) and figwort. The bank side vegetation included hemlock water dropwort, bramble, gorse and broom (*Sarothamnus scoparius*) scrub with willows on the banks.

The Q rating assigned to the channel was Q4. It was assigned this value as Group A were recorded in fair numbers with Group B recorded and Group C recorded in fair numbers. There was no filamentous algae or sewage fungus and no signs of other pollution. No signs of any impacts on the river resulting from the construction of the wind farm were recorded.
