**REPORT ON  
ASSESSMENT OF PEAT STABILITY  
FOR  
CLEANRATH WIND FARM, CO. CORK**

**Prepared for:  
McCarthy Keville O'Sullivan**

**December 2015**

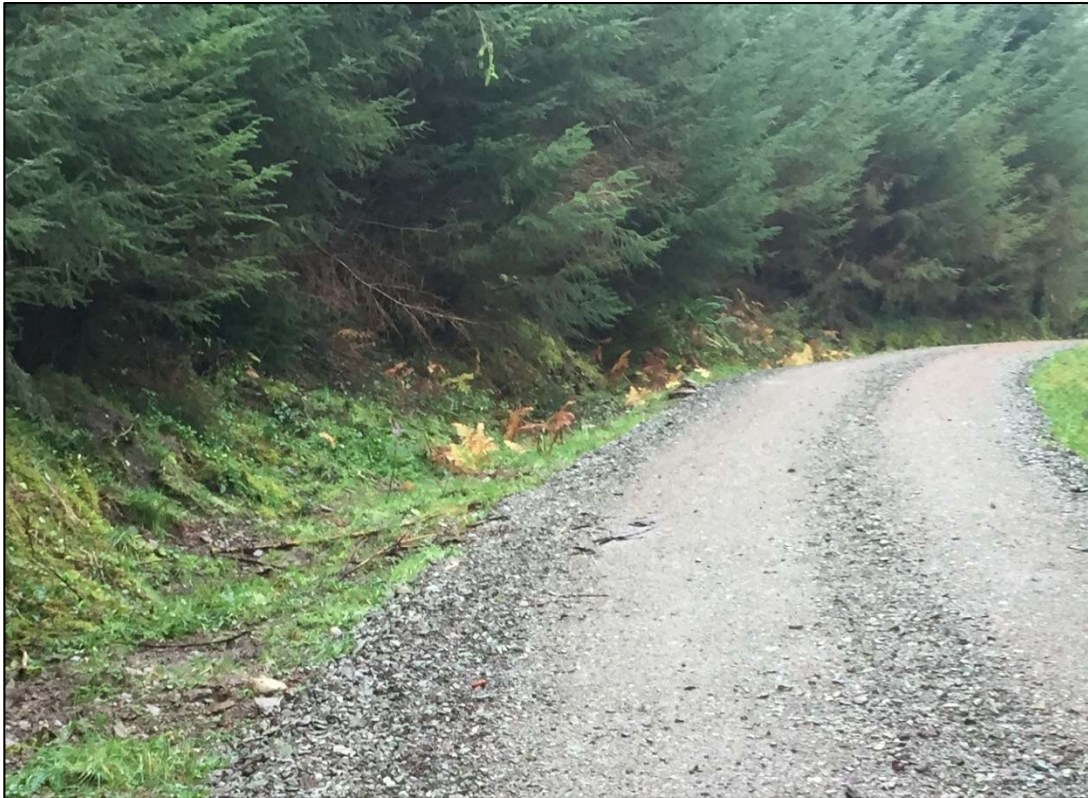
Photo 3 Example of an existing access road on site

- (6) The access roads for the wind farm comprise upgrading of existing access roads and construction of new proposed access roads. The existing access roads appear to have been constructed using an excavate and replace construction technique (Photo 3). The upgrading works and construction of new proposed access roads will be carried out using both excavate and replace and floated construction techniques.

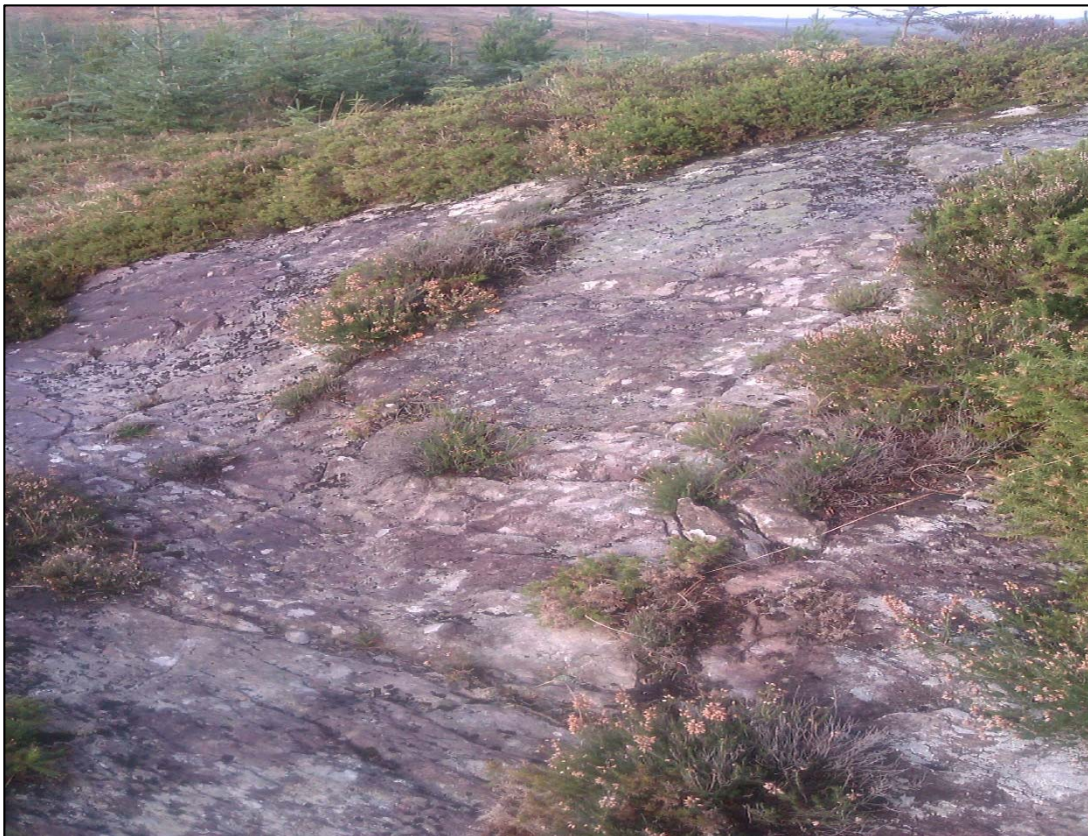
Photo 4 Example of ground conditions on site

Based on the site walkover and the minimal exposures present at the site the superficial deposits were typically described as peaty topsoil/ brown firm fibrous Peat overlying sandy gravelly Clay with cobbles and boulders and/or overlying weathered bedrock (Photos 4 & 5).

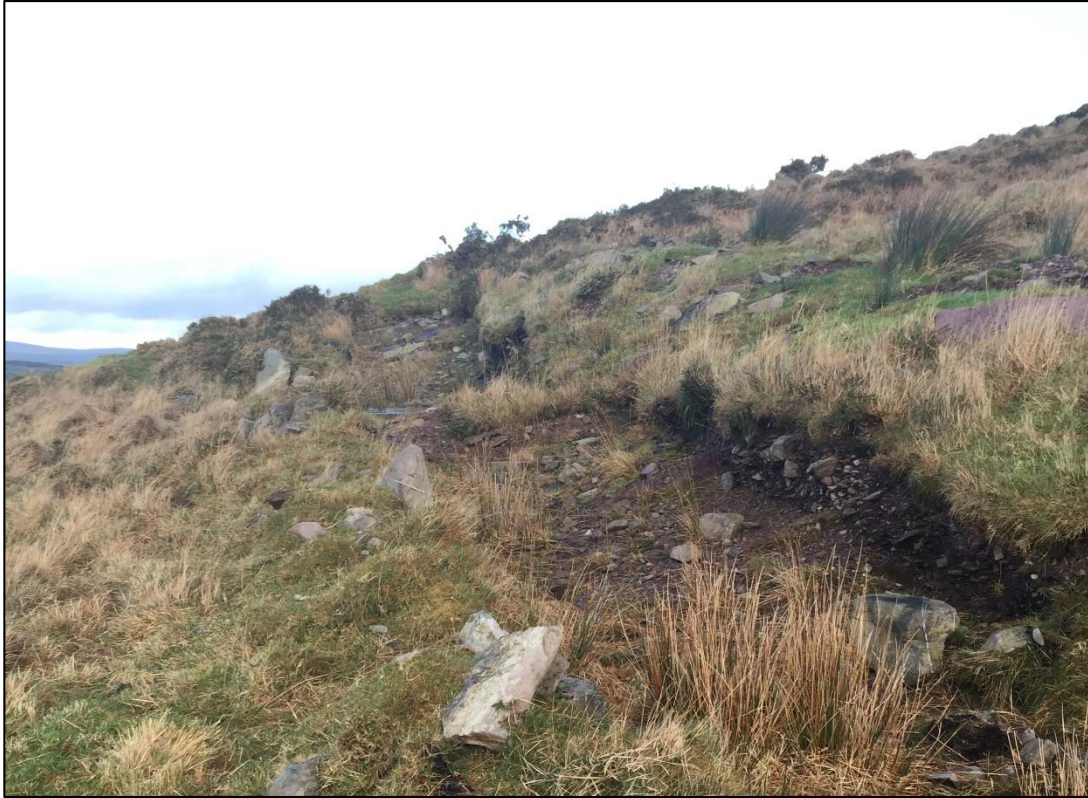
Photo 5 Example of ground conditions on site
