Derrybrien Wind Farm Project

Remedial Environmental Impact Assessment Report Chapter 11 - Hydrology and Hydrogeology

Document No.: QS-000280-01-R460-001-000

Date: July 2020

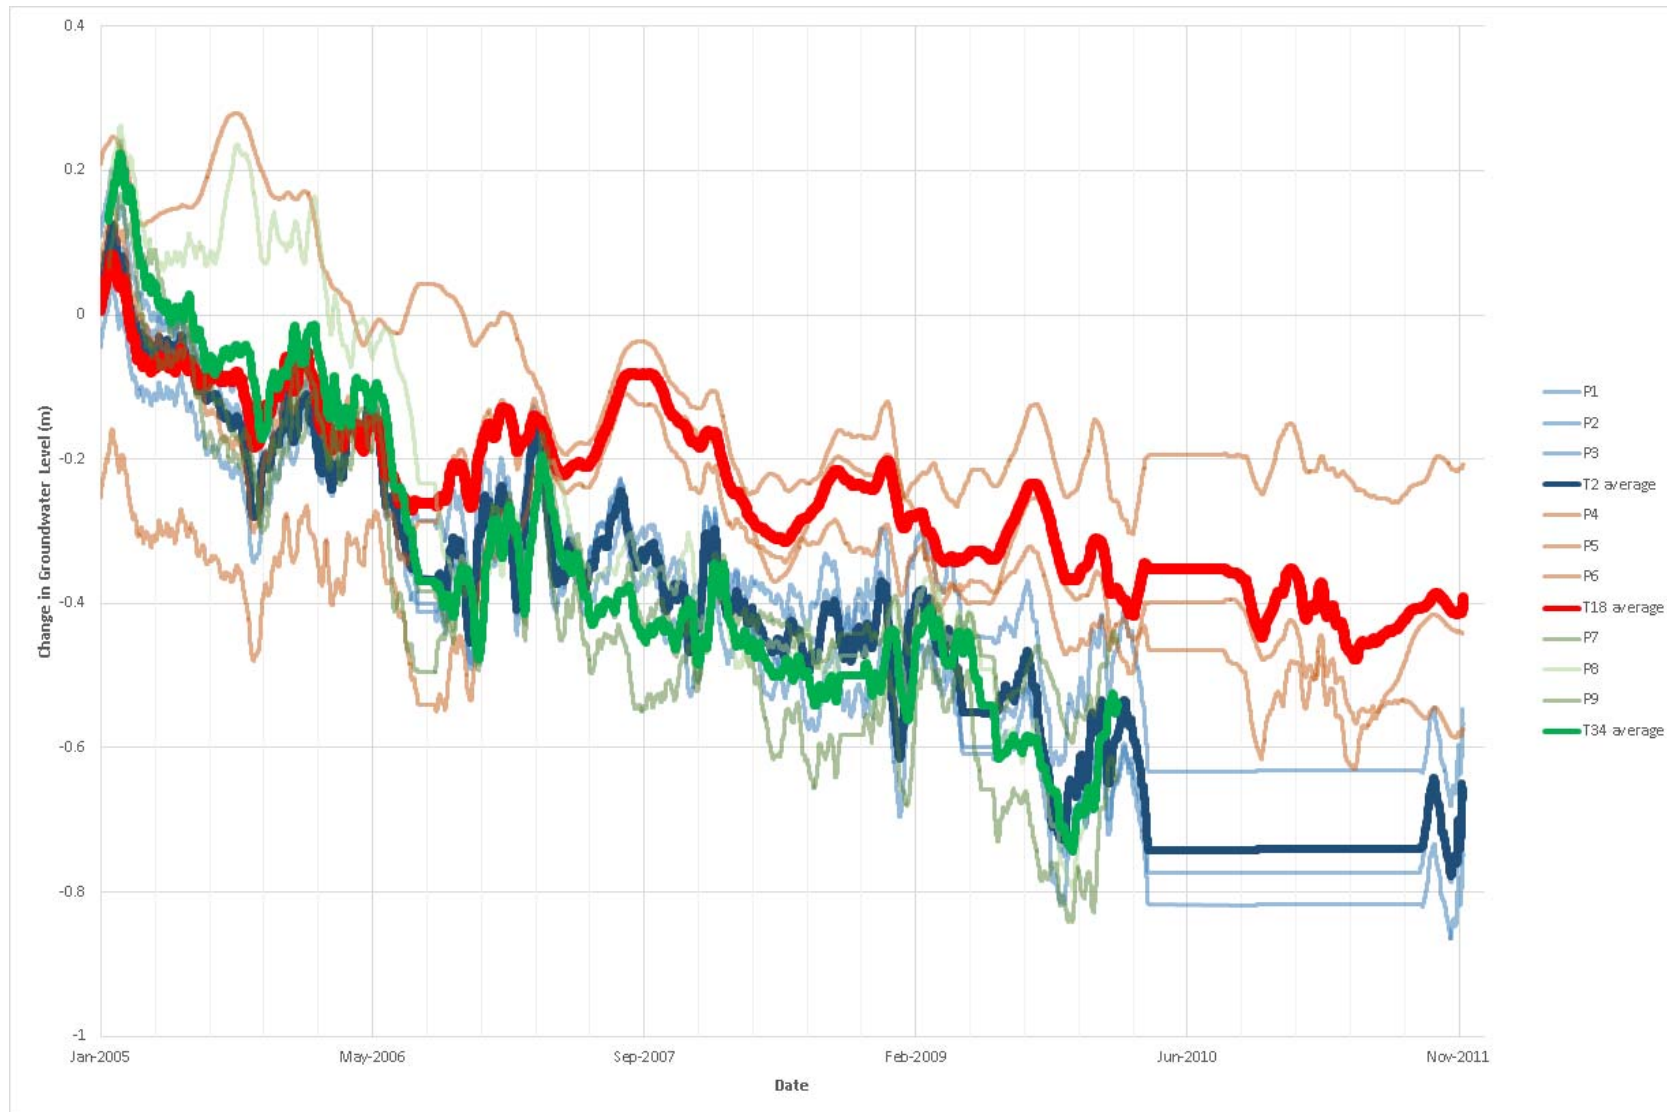
Figure 11.3 Changes in groundwater level relative to baseline 2005-2011

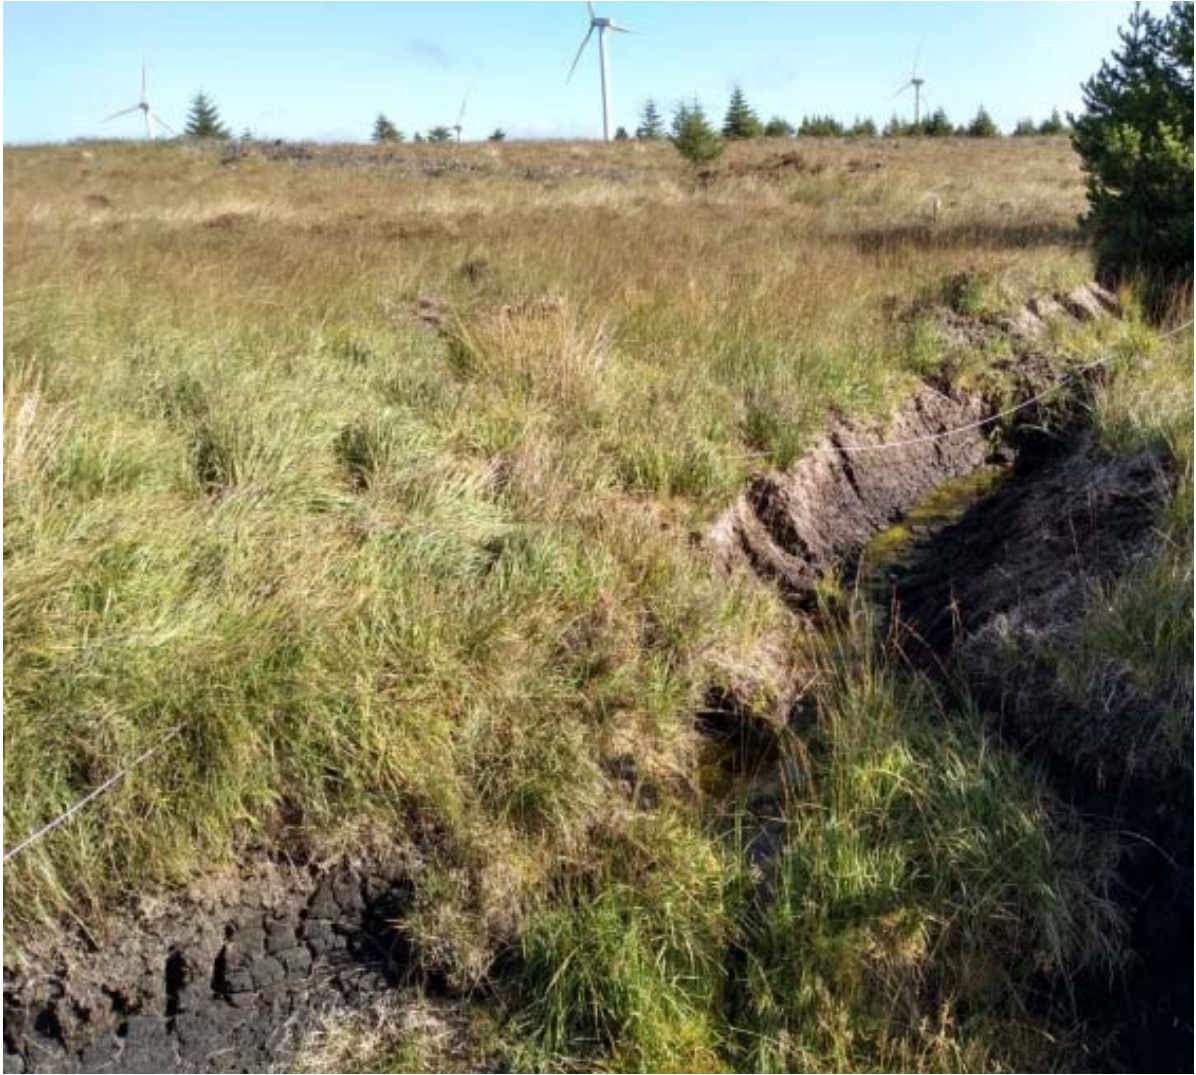
Plate 11.1 Typical site land at Derrybrien Wind Farm

which both represent a drained bog situation, i.e. where active blanket bog has been degraded. The wind farm site had been extensively drained in the past, prior to any wind farm construction, by a series of parallel open ditches to facilitate commercial forestry and turf cutting under turbary rights. Turf cutting has and continues to take place on the eastern part of the site. Farming is also undertaken in the lower lying areas. The principal economic activity in the immediate area is forestry and farming, the latter being dominated by grazing of cattle. The ditches and drains in the worked bog and forestry discharge to the natural drainage and watercourses in the area (Plate 11.1 and Plate 11.2).

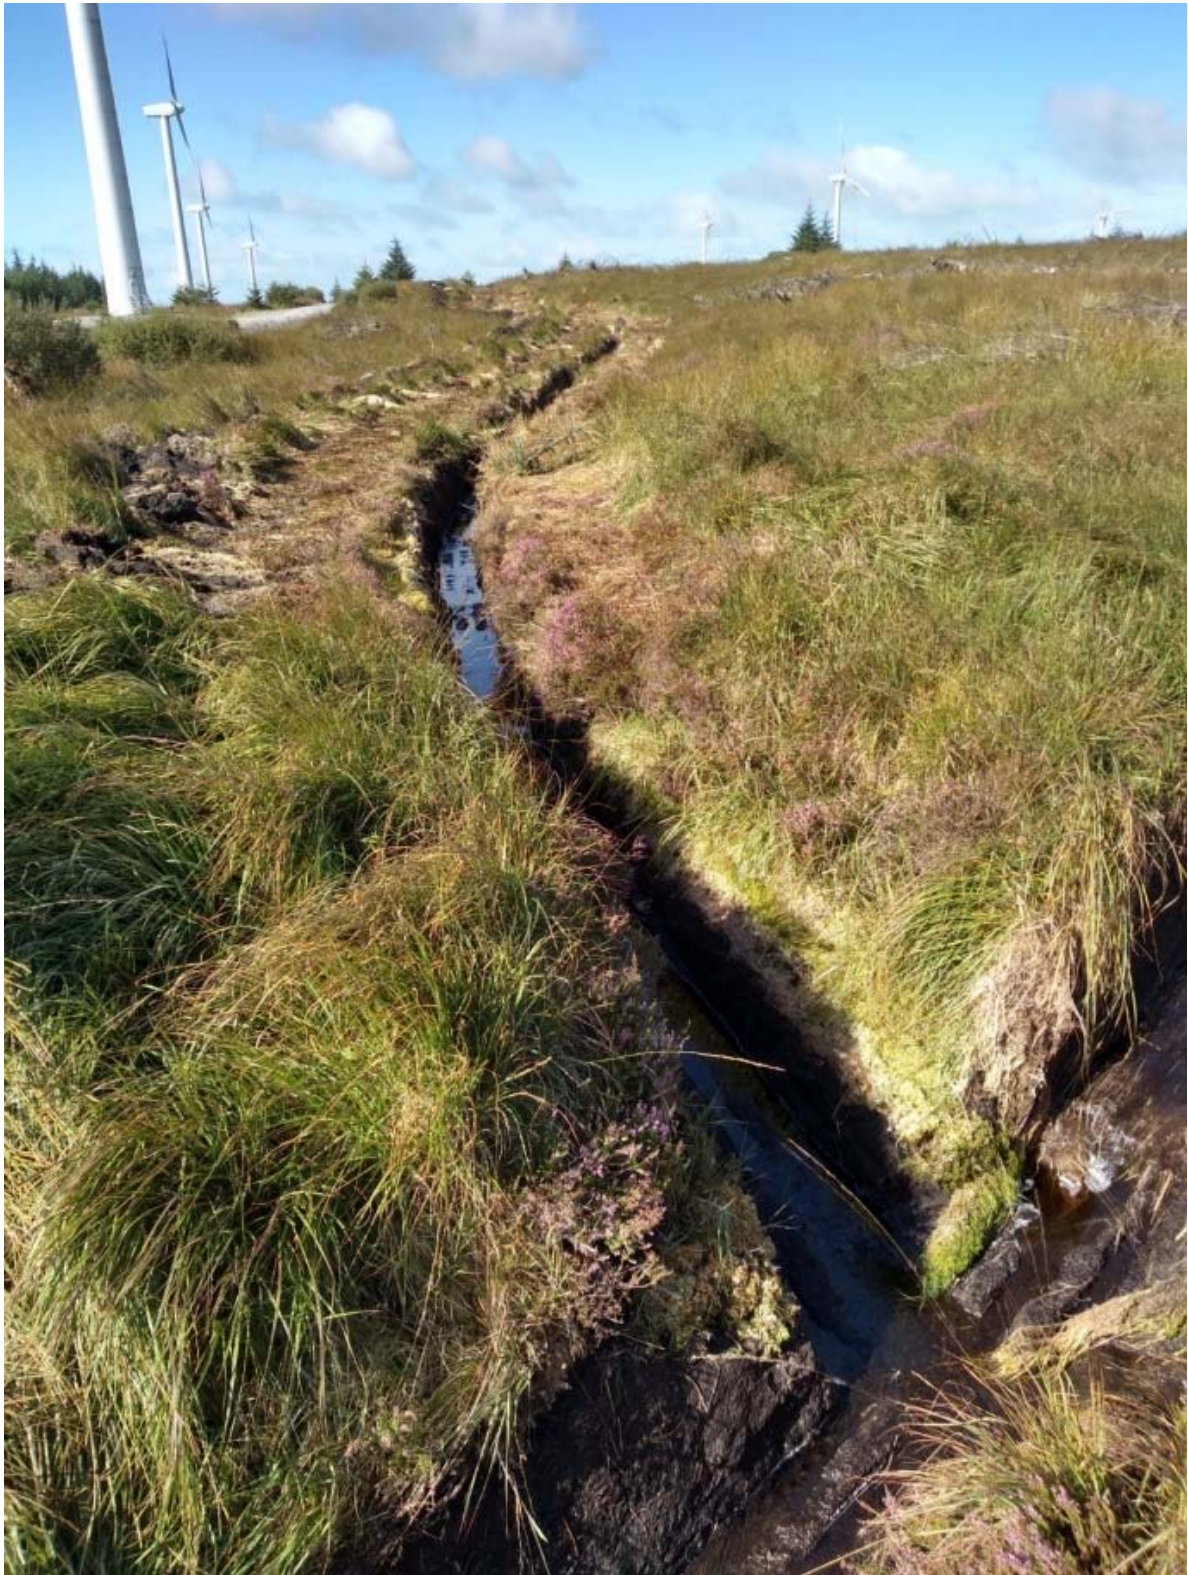
Plate 11.2 Drainage channel at Derrybrien

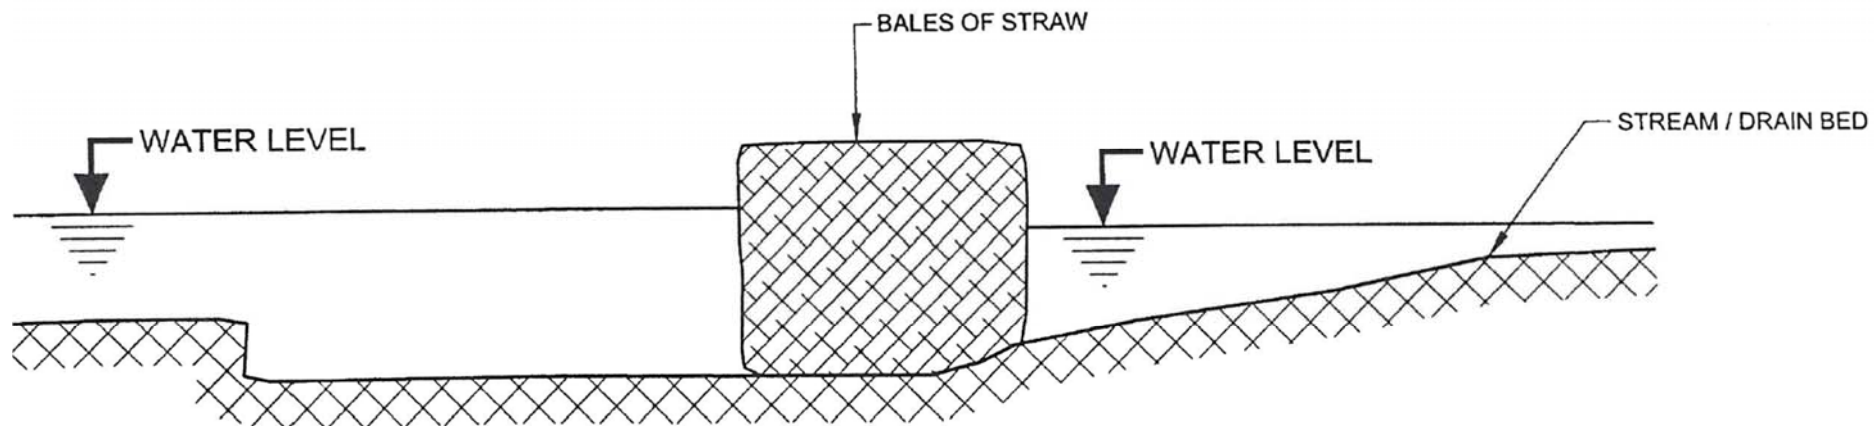
Figure 11.10 Detail of straw bale filters used throughout wind farm

At each turbine base during construction, in cases where water ponded in the excavation, this was removed using 4-inch or 6-inch mobile pumps and pumped to a nearby existing drain, often over ground on existing vegetation. Any silt resulting from this pumped water was captured by both existing vegetative matter and constructed straw bales which connected into the local existing drainage. When the turbine bases were completed, a buried drain was installed around the turbine bases, the outlets of which were connected into the surface drainage network.

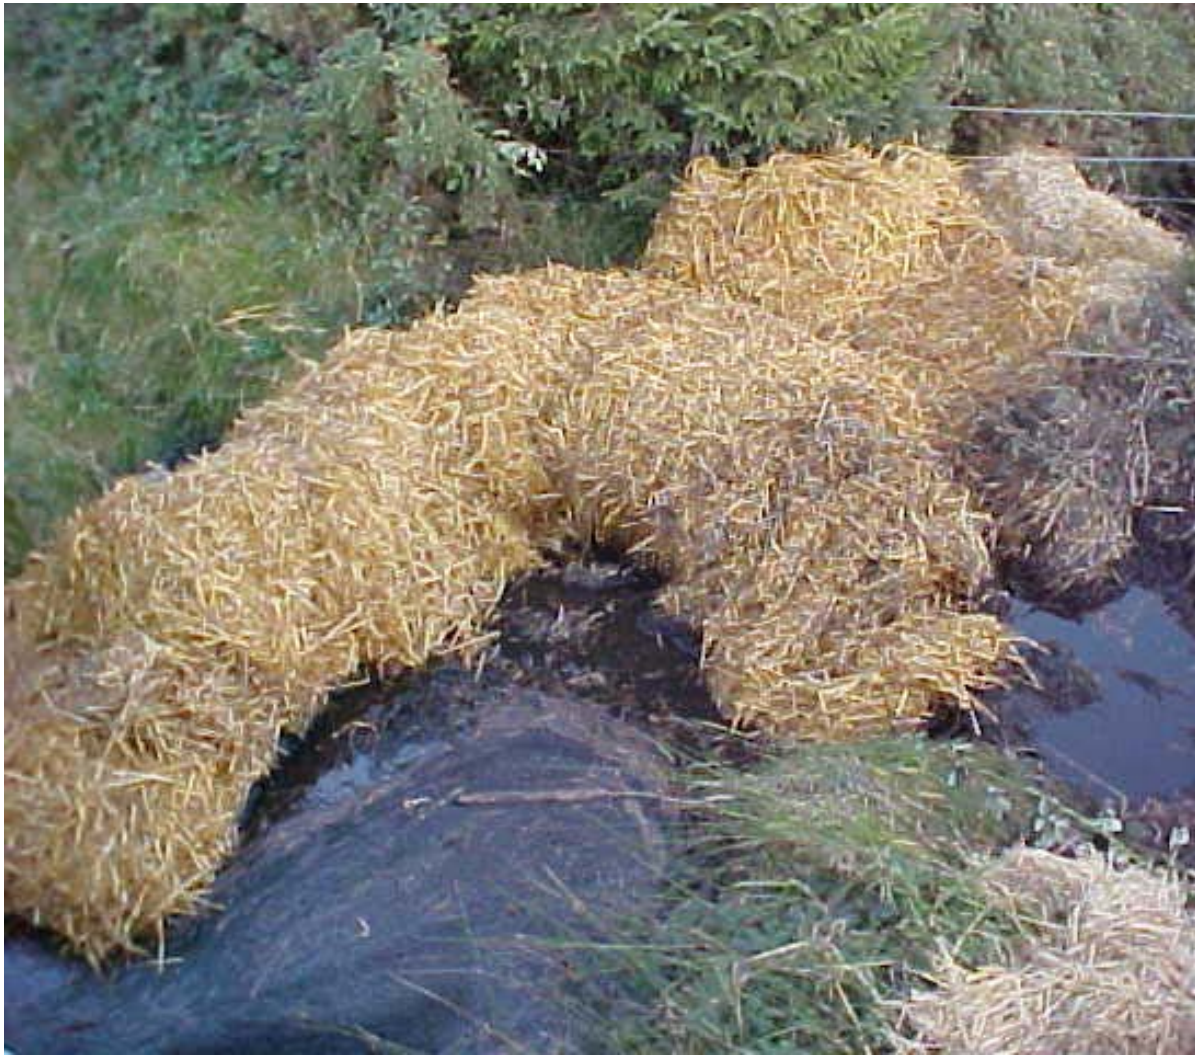
Plate 11.3 Straw bale filter on wind farm site

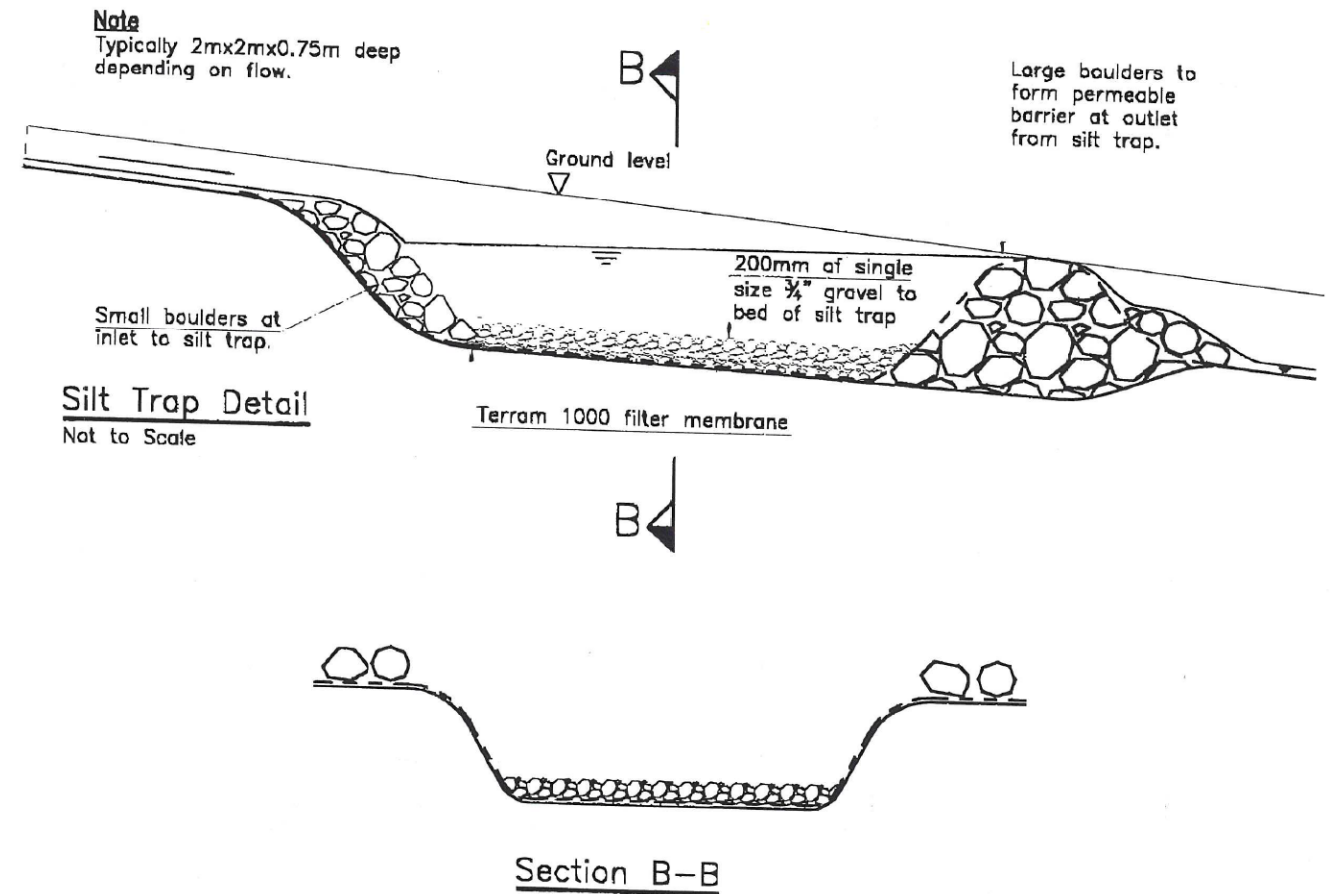
Figure 11.12 Construction Detail of silt traps installed at exits from wind farm site

Pre-existing drainage on the wind farm site was maintained and any of this drainage affected by access tracks or turbine base construction was directed into a suitable known watercourse and through a silt trap prior to the water leaving the site. Where works were being carried out in areas of deep peat or poor ground conditions the drains were piped through and backfilled to reduce the risk of sediment loss. Additional measures practised on site to mitigate against the occurrence of silty water included:

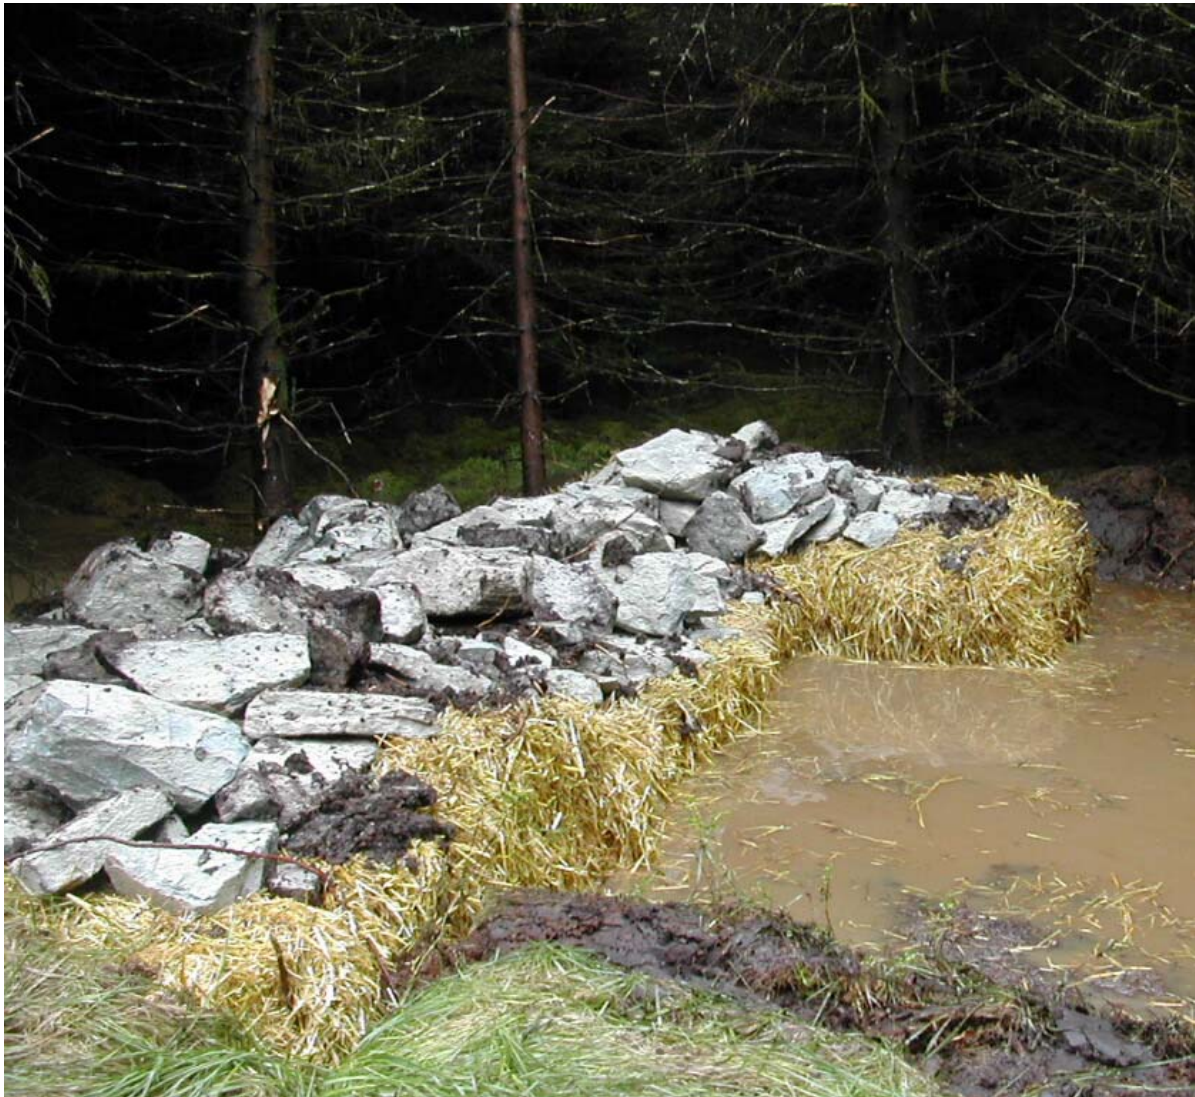
Plate 11.4 Silt trap installed at exits from wind farm site

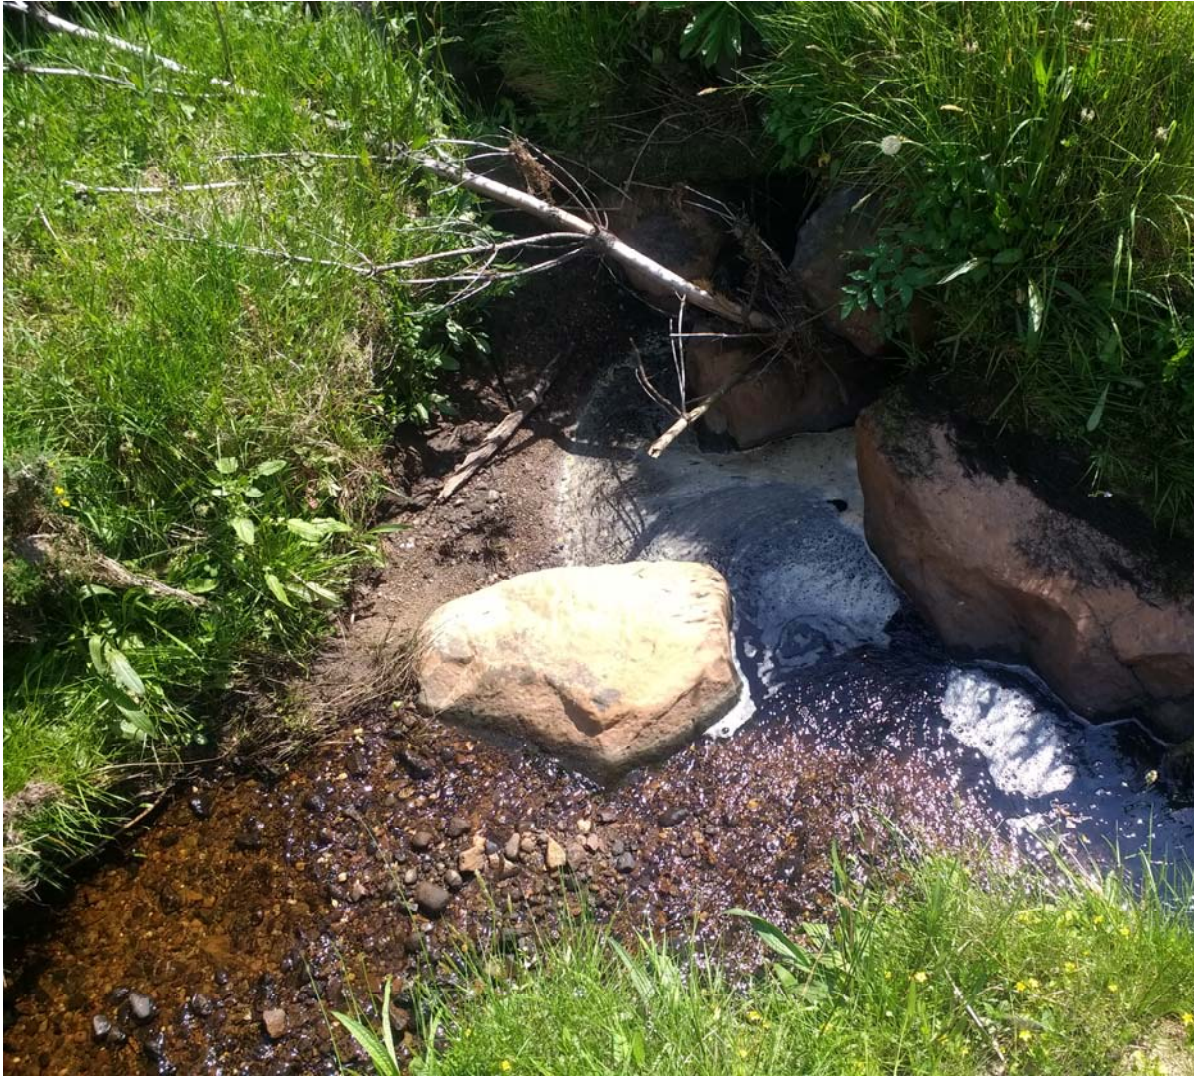
Plate 11.5 Sediment build-up at upstream end of Barrage 4 in 2018

From a hydrological perspective, the deliberately porous nature of the barrage structures allowed water to flow through without any excessive build-up of water on the upstream side of each structure. In a number of cases drainage pipes enabled the flow of water through the structure. The barrages were each constructed to prevent further propagation of the peat slide and to prevent possible further release of debris into the watercourse downstream. As a consequence of this silt, peat and other debris did build up on the upstream side of a number of barrages (Plate 11.5). If this material was not removed the impact of the barrages from a hydrological perspective is classed as **Moderate** due to the knock-on effect of the barrages. Upon completion of the construction stage, the four temporary containment barrages were removed while Barrages 1 to 4 were left in place, as shown in Figure 11.13 (Note: the access tracks at T68 and between T23 and T70 also act as rockfill containment barrages but are not considered in isolation due to their position at the top of the subcatchment as part of the overall on-site wind farm drainage system).

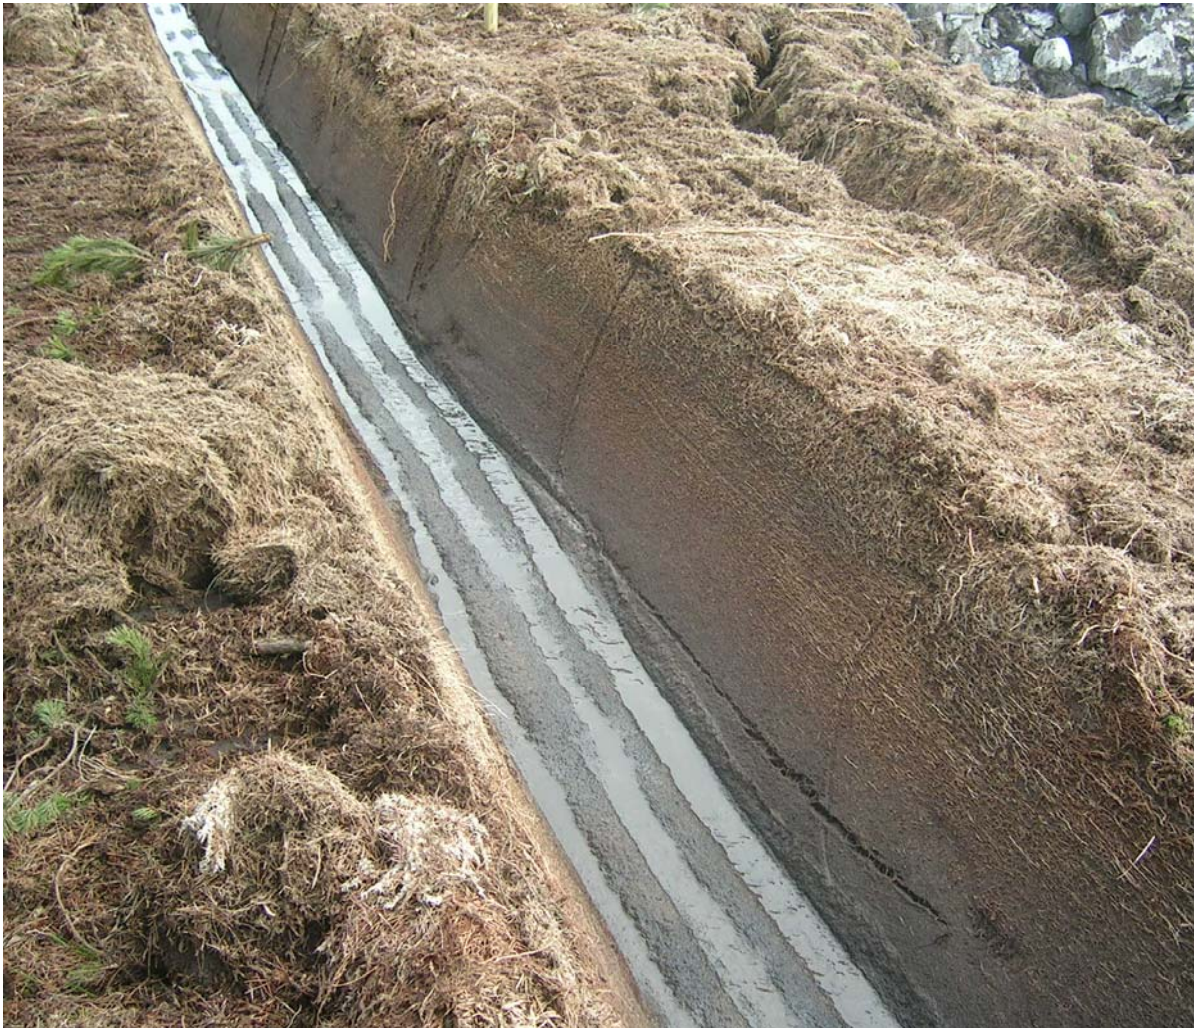
Plate 11.6 Typical drain installed during wind farm construction

However, depending on local topography, some concentration of flows and preferential pathways are unavoidable unless suitable drainage is put in place. The 4.5 m wide roads were comprised of 0.6 – 1.0 m of crushed rock granular fill with 1-2 layers of geogrid reinforcement and a basal reinforcing layer of small trees and branches placed directly on the vegetated surface of the peat.

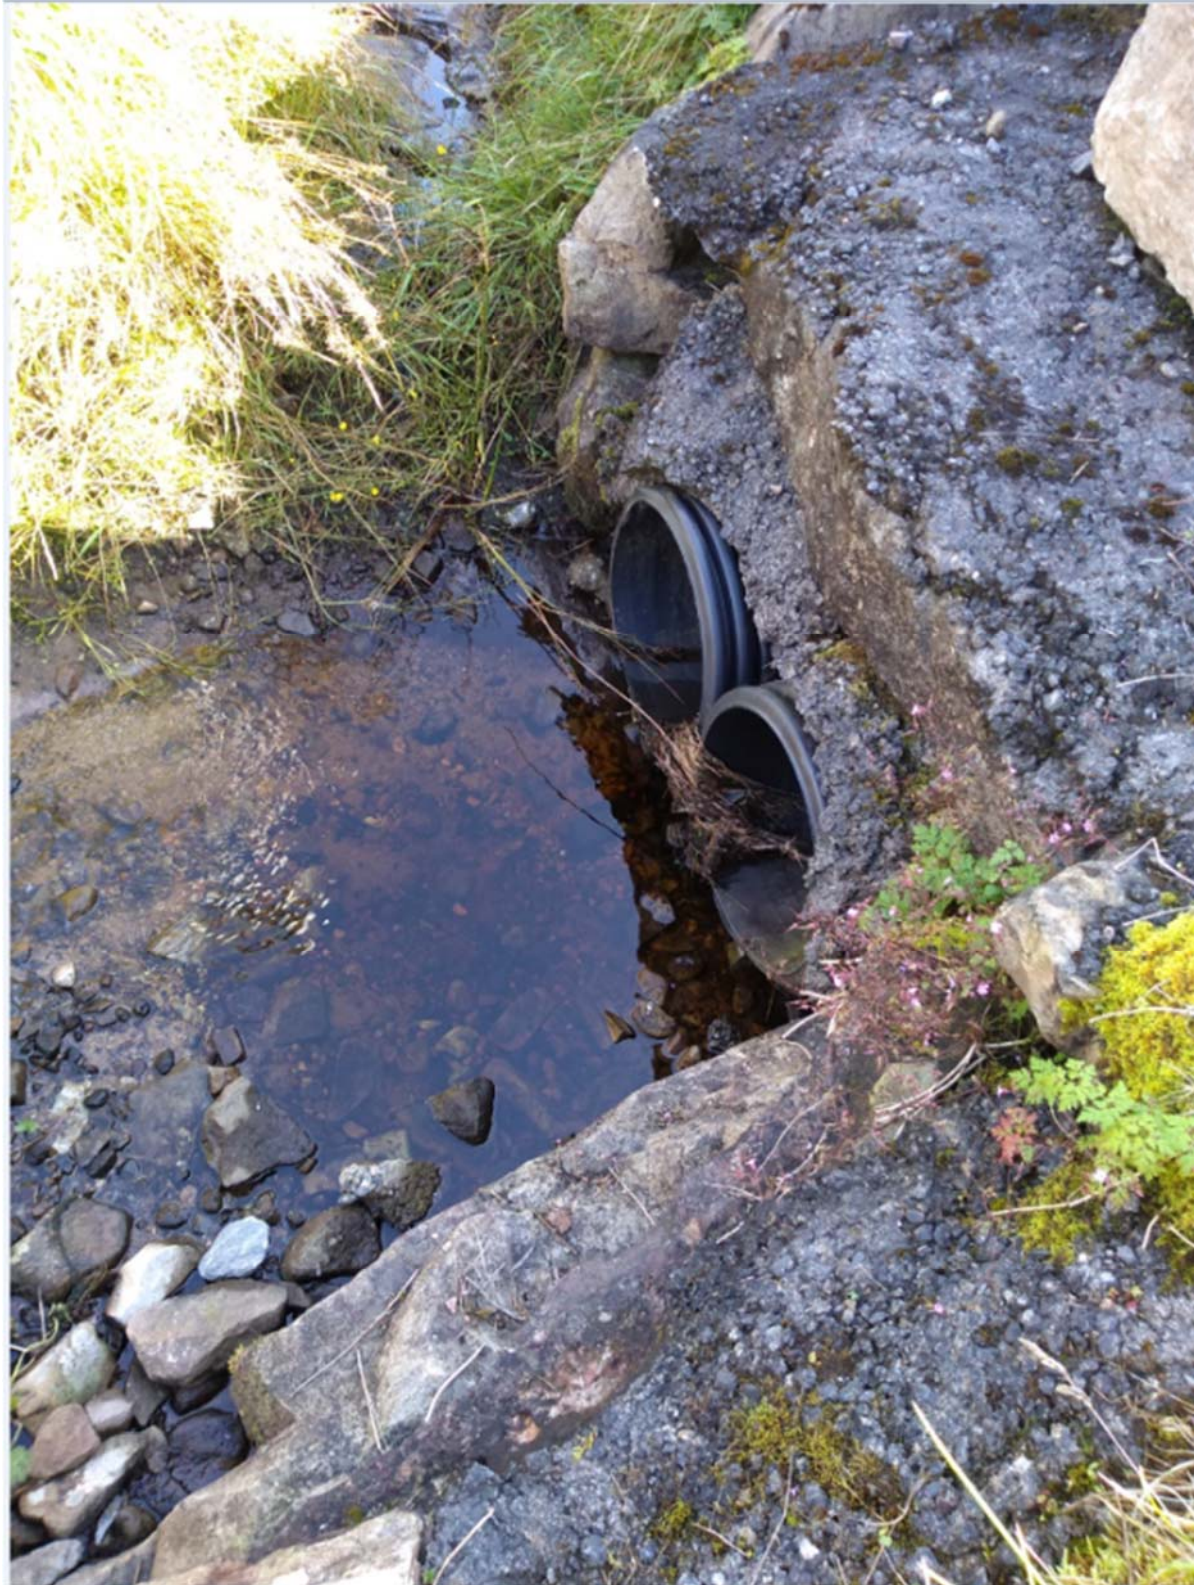
Plate 11.7 Twin 600 mm pipes at crossing near T35

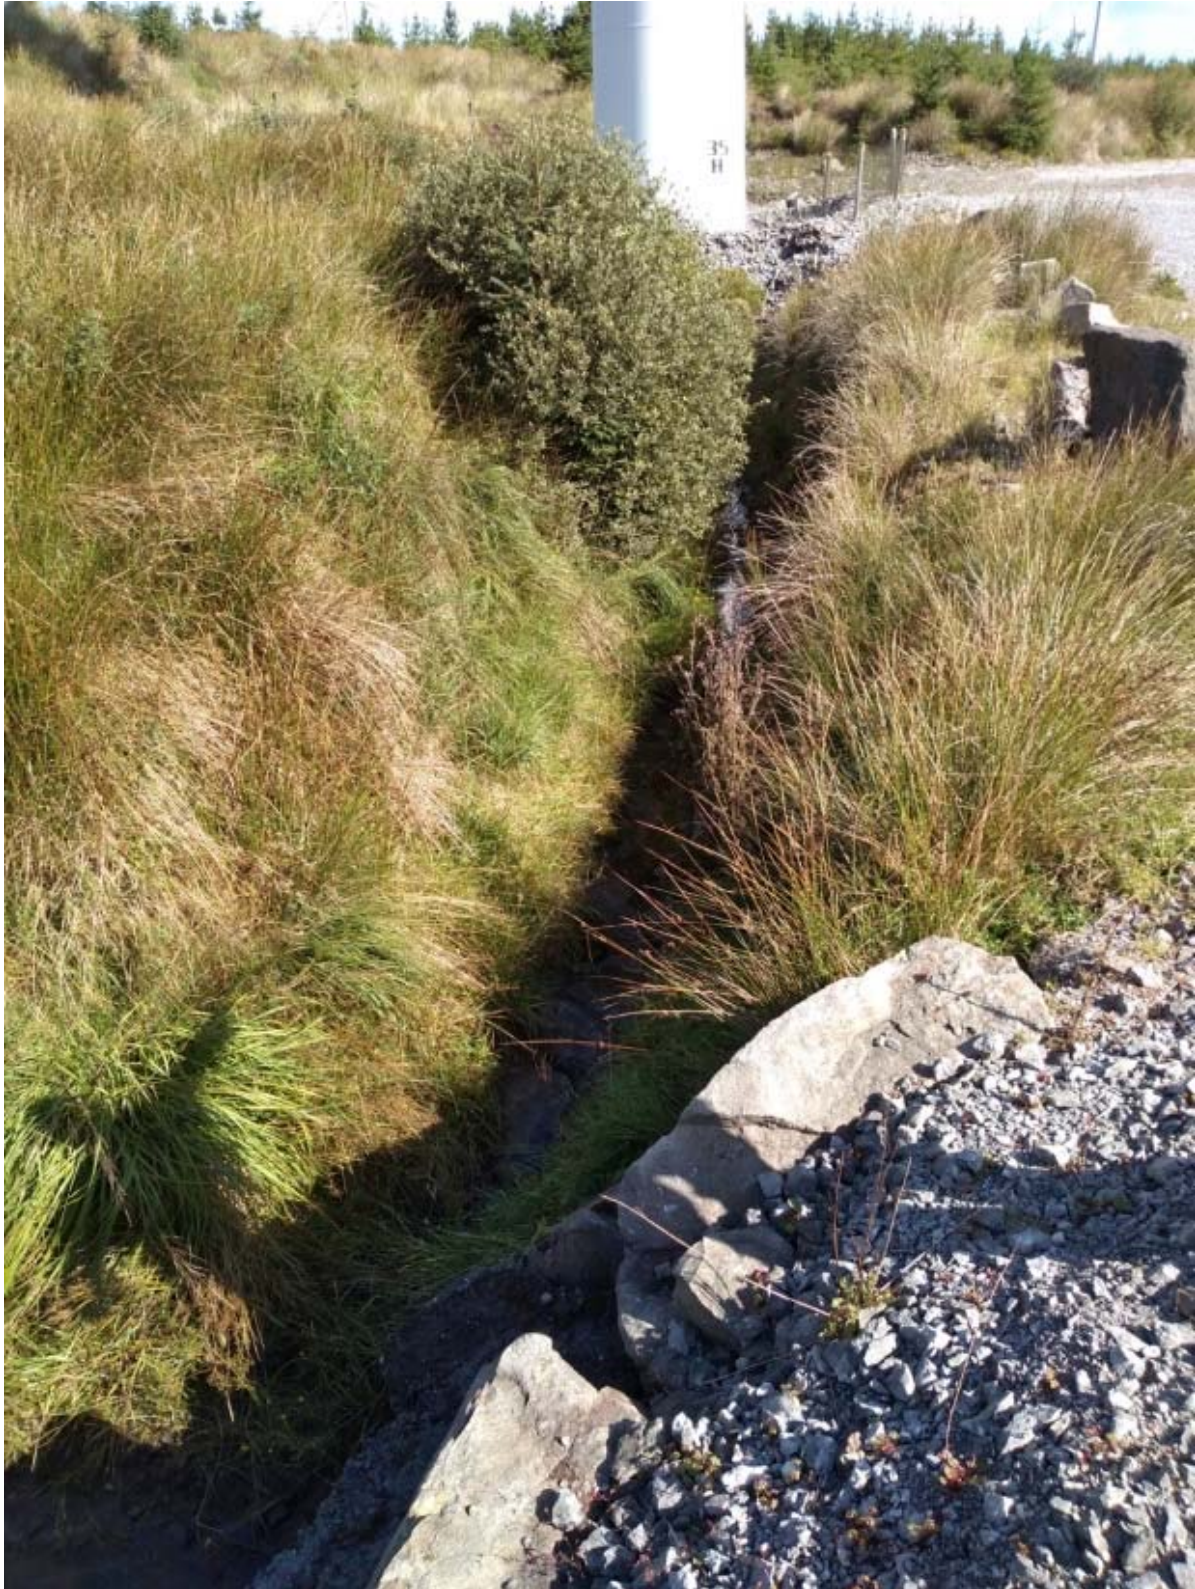
Plate 11.8 Location of T35 in relation to crossing point

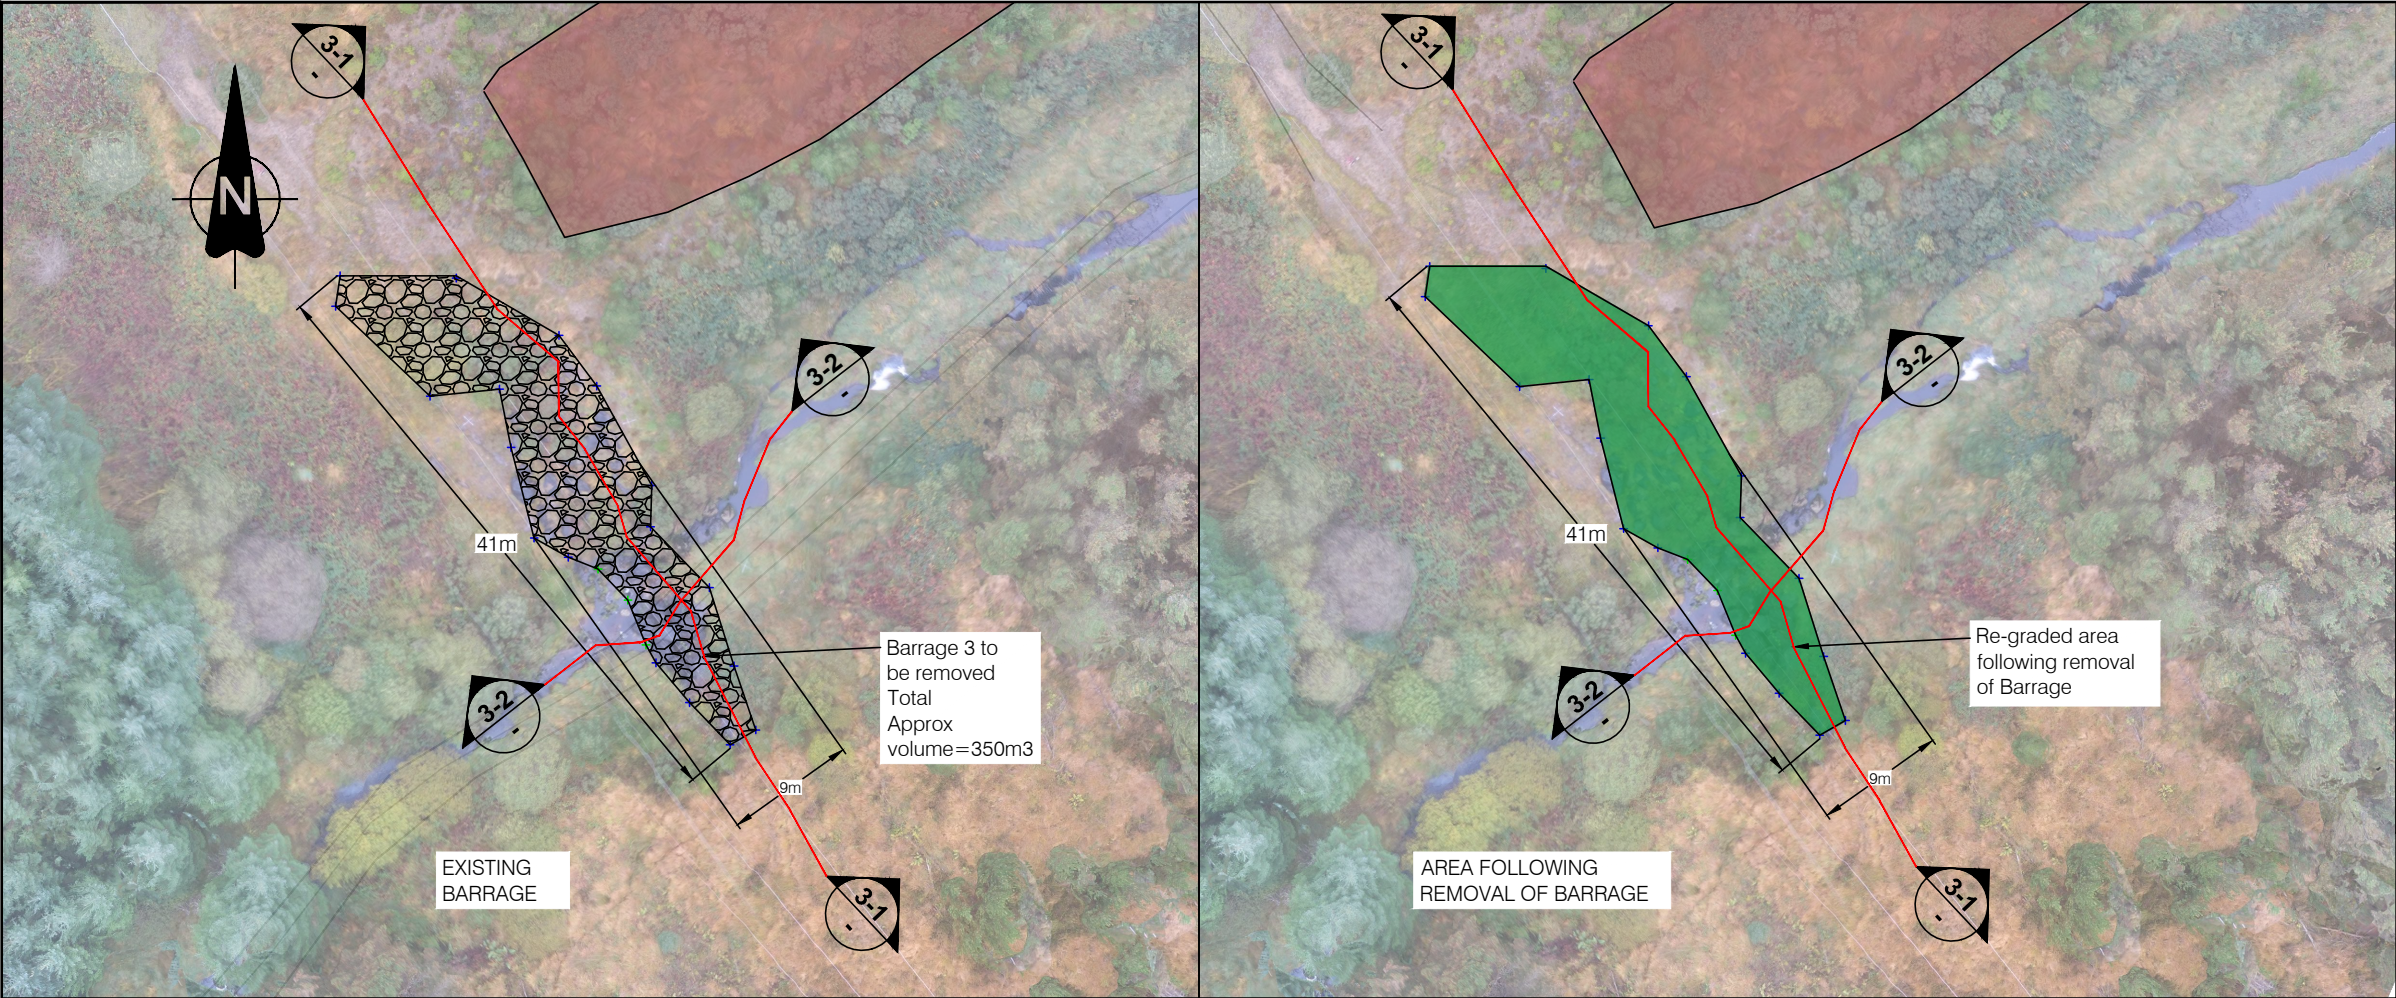
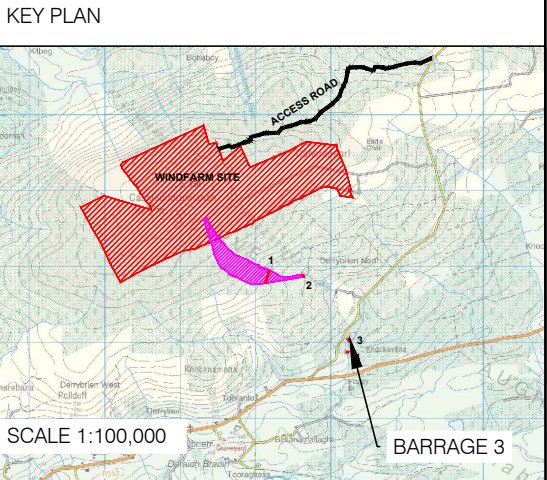
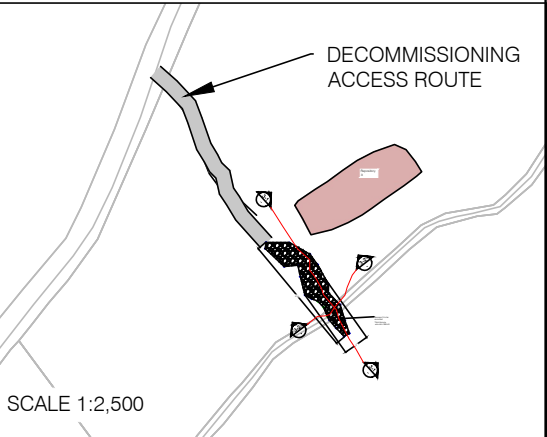
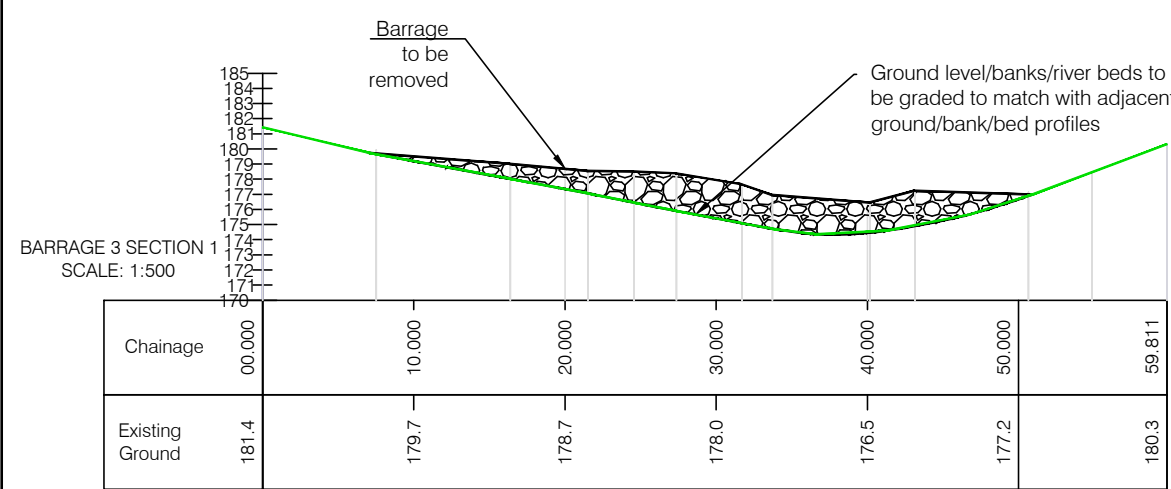
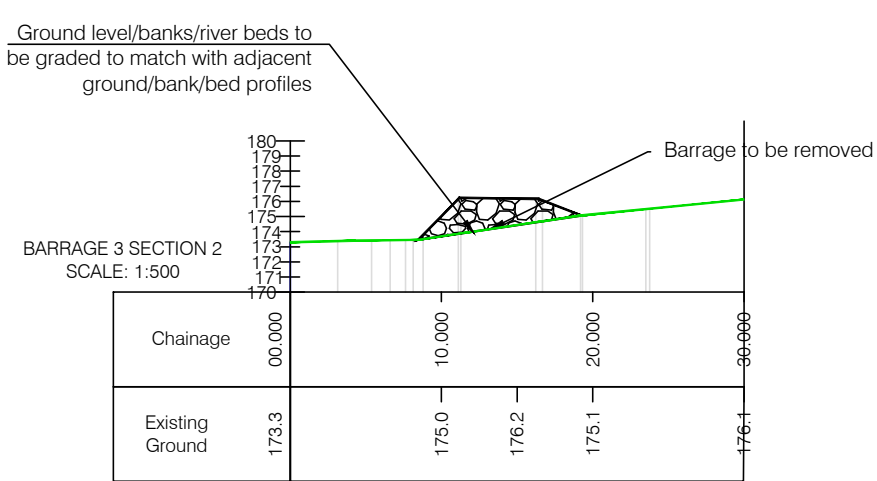
Drawing title	Figure 11-17 Barrage 3 Removal
Production unit	Civil & Environmental Engineering

DECOMMISSIONING ACCESS ROUTE-BARRAGE 3

Decommissioning Plan For Barrage:

- Reference chapter 11 for details of removal works plan

The works at each barrage are expected to last no more than one week. Each watercourse shall be blocked upstream of the works area using sand bags and a timber weir and the remaining water shall be over-pumped. The pump will be bunded and located away from the watercourse and have a silt bag on its outlet. A tight mesh will be fitted on the suction hose before pumping commences. Water will be discharged to vegetation, preferably on the downstream side of the barrage. Where an existing watercourse profile / channel passes through the location of the barrage it is desirable that the natural profile of the watercourse and neighbouring banks are preserved by matching the reclaimed channel section as closely as possible with the upstream and downstream channel sections. However, the barrage locations have a high gradient such that flows following rainfall will be high velocity and may cause significant erosion of the banks. For this reason, care will be taken to ensure the restored banks are gradually sloped back from the channel to the neighbouring banks to mitigate the risk of erosion and collapse of the banks. All elements of the barrage structures will be removed to Borrow Pit / Quarry 3.

Upon completion of these decommissioning works, the weir and sand bags will be removed slowly to prevent a surge in the river. Silt fences will be installed on the stream-side of the banks and the other side spread with grass-seed to encourage re-vegetation. Provided these mitigation measures are put in place during decommissioning the impact on the hydrological regime will be reduced from Slight to **Not Significant**.
