Derrybrien Wind Farm Project

Remedial Environmental Impact Assessment Report Chapter 11 - Hydrology and Hydrogeology

Document No.: QS-000280-01-R460-001-000

Date: July 2020

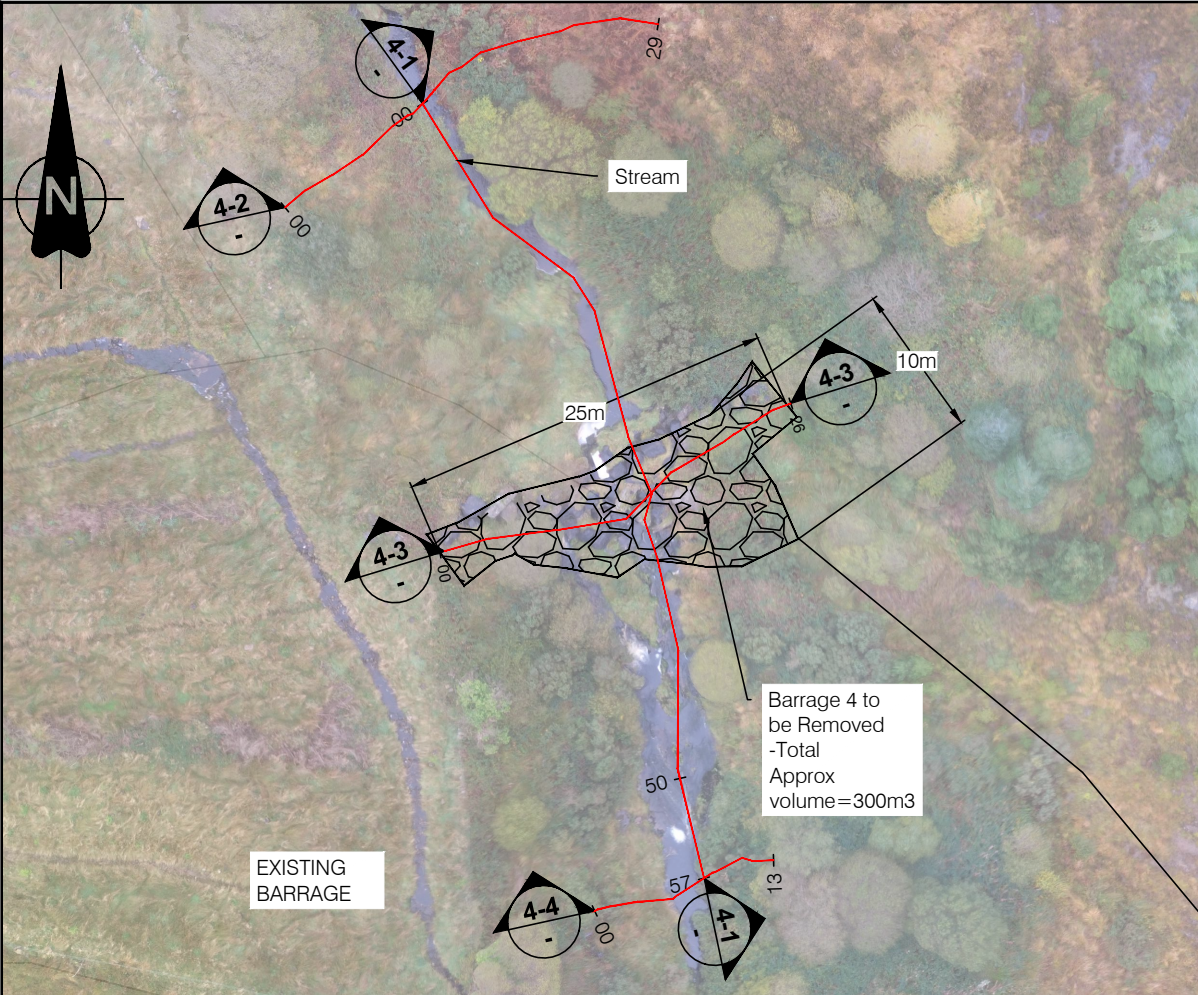
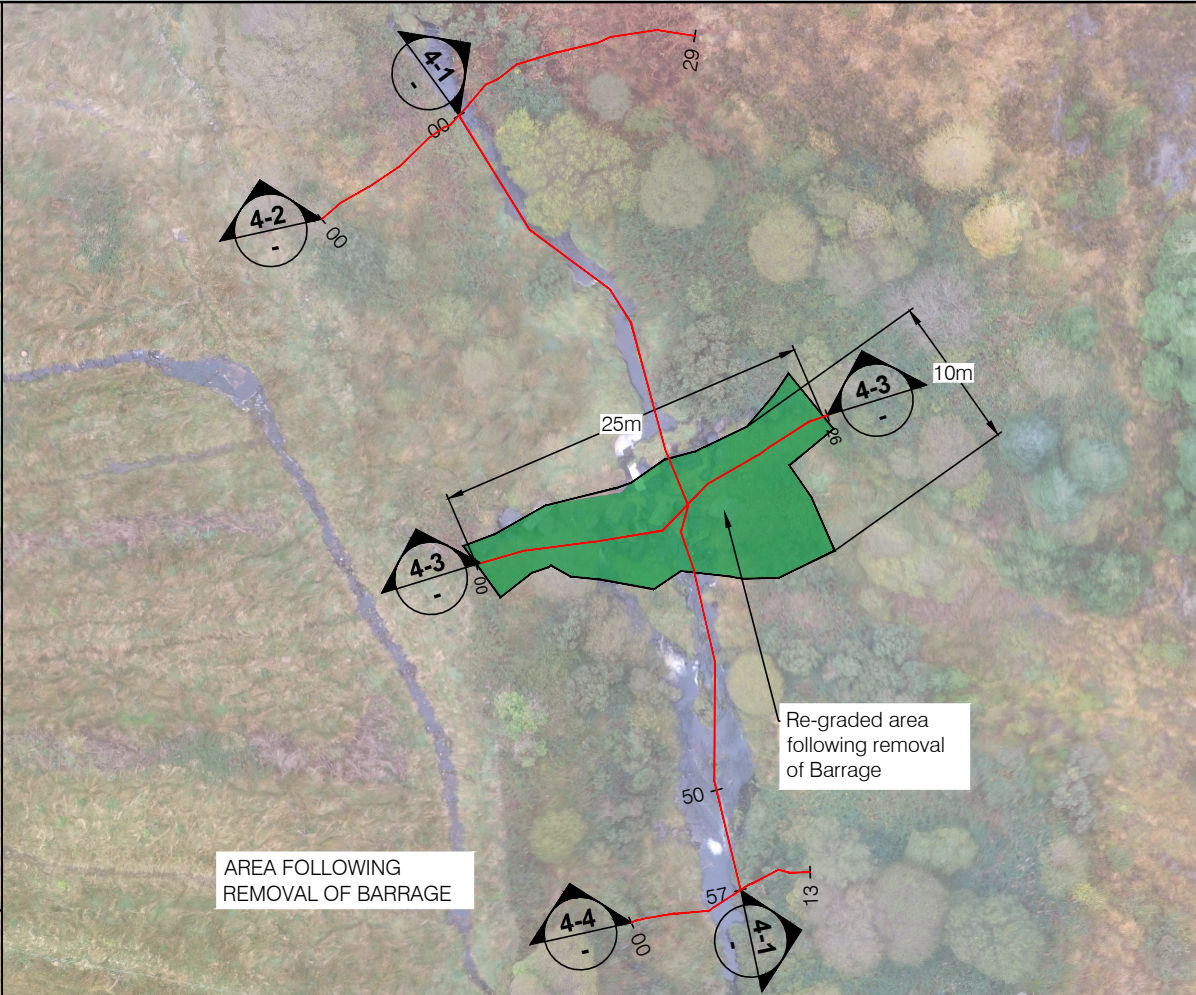
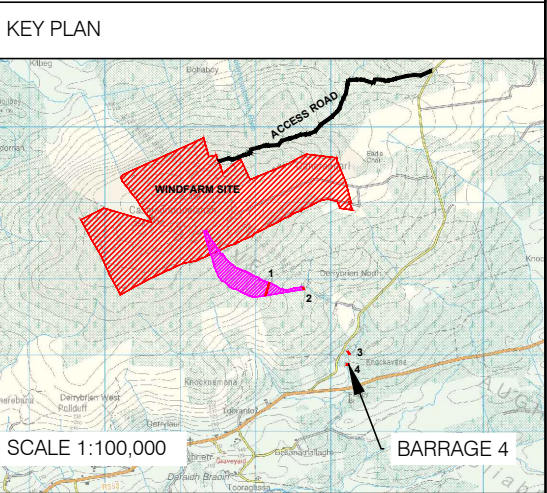
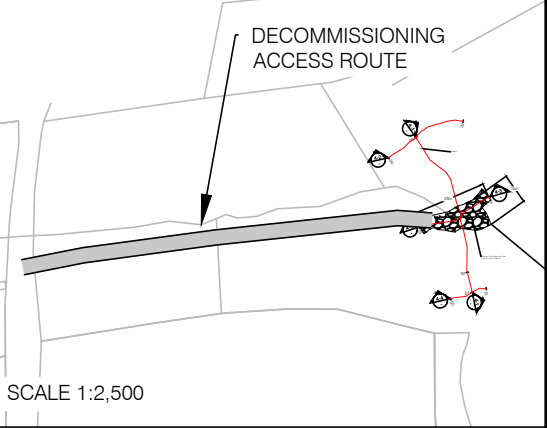
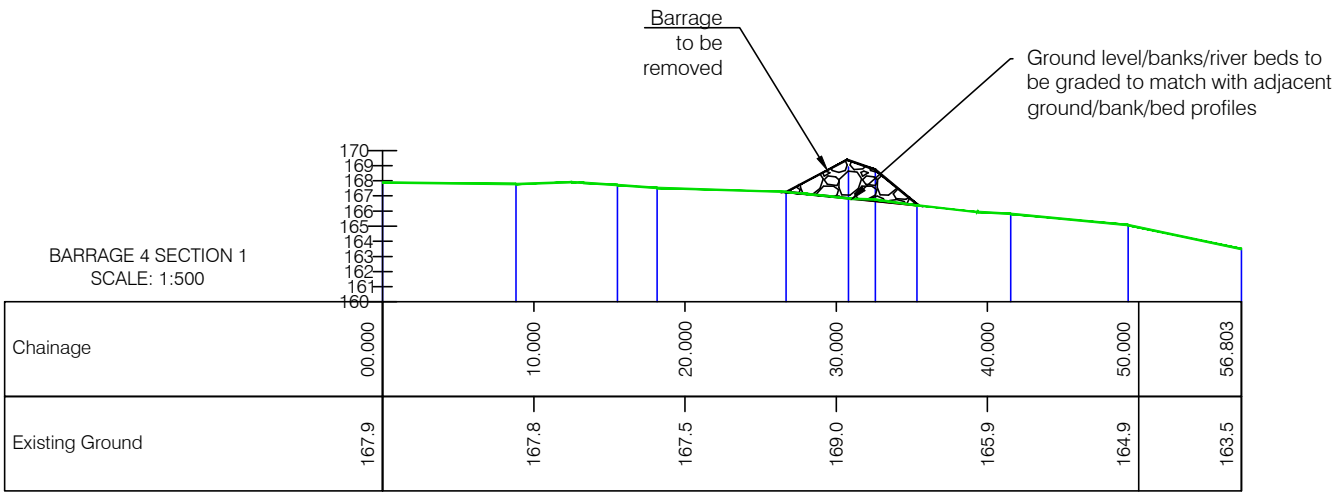
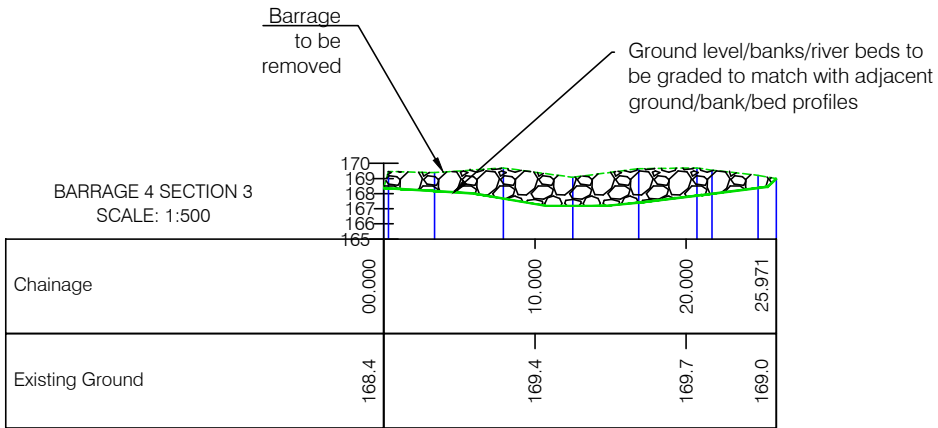
DECOMMISSIONING ACCESS ROUTE-BARRAGE 4

- Decommissioning Plan For Barrage:
1. Reference chapter 11 for details of removal works plan

The works at each barrage are expected to last no more than one week. Each watercourse shall be blocked upstream of the works area using sand bags and a timber weir and the remaining water shall be over-pumped. The pump will be bunded and located away from the watercourse and have a silt bag on its outlet. A tight mesh will be fitted on the suction hose before pumping commences. Water will be discharged to vegetation, preferably on the downstream side of the barrage. Where an existing watercourse profile / channel passes through the location of the barrage it is desirable that the natural profile of the watercourse and neighbouring banks are preserved by matching the reclaimed channel section as closely as possible with the upstream and downstream channel sections. However, the barrage locations have a high gradient such that flows following rainfall will be high velocity and may cause significant erosion of the banks. For this reason, care will be taken to ensure the restored banks are gradually sloped back from the channel to the neighbouring banks to mitigate the risk of erosion and collapse of the banks. All elements of the barrage structures will be removed to Borrow Pit / Quarry 3.

Upon completion of these decommissioning works, the weir and sand bags will be removed slowly to prevent a surge in the river. Silt fences will be installed on the stream-side of the banks and the other side spread with grass-seed to encourage re-vegetation. Provided these mitigation measures are put in place during decommissioning the impact on the hydrological regime will be reduced from Slight to **Not Significant**.
