Gort Windfarms Ltd.

Remedial Environmental Impact Assessment Report Chapter 14-Roads, Traffic & Transport

Document No.: QS-000280-01-R460-001-000

Date: July 2020

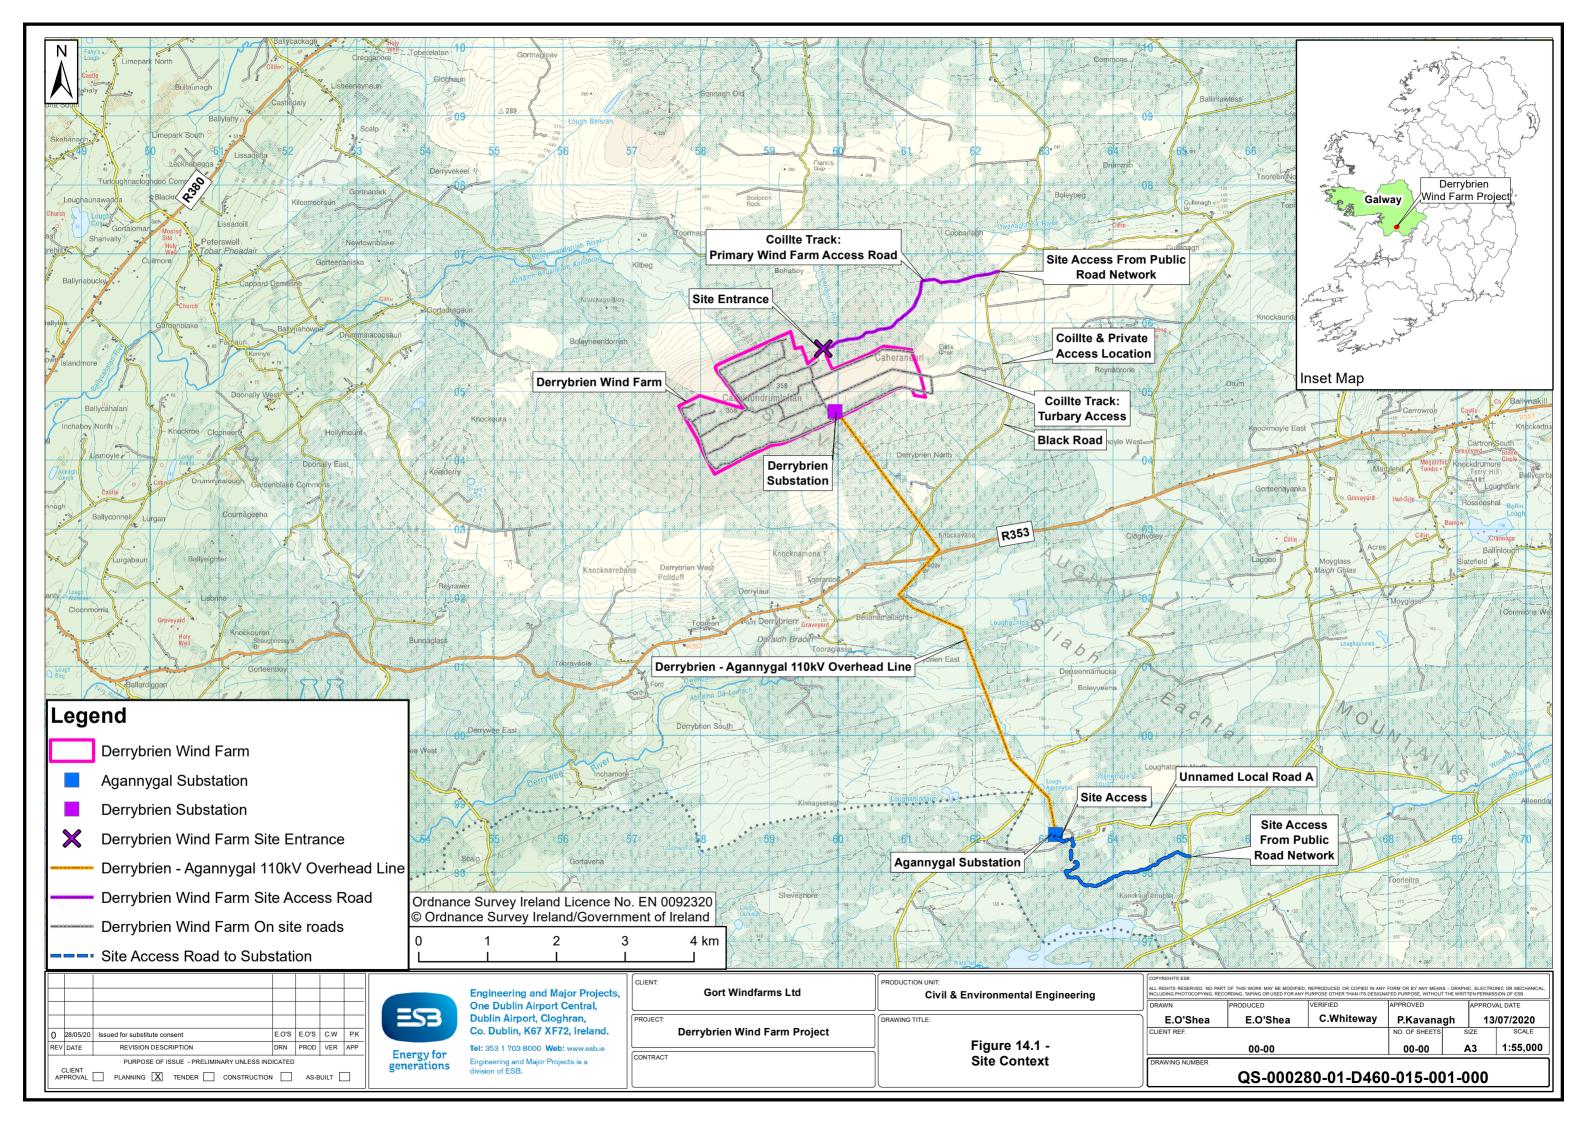
Figure 14-1 below illustrates the location of the wind farm generally, including the immediately surrounding transport network and key features of the Project which relate to traffic and transport.

The following sections identify some of the key features of the receiving environment surrounding the project in its baseline condition; describing the receiving environment both at that baseline and at present day. Figure 14-1 illustrates the locations of the receiving environment features which are described below.

Agannygal Substation is located to the north of Unnamed Local Road A, as illustrated by Figure 14-1. While access to the substation is from this road only a short section of the road is used by vehicles associated with the project with an existing Coillte track providing the majority of the access route to the substation, as outlined by Section 14.2.10. The local road generally runs in an east west direction connecting to other local roads; in County Clare at its western end and in County Galway at its eastern end.

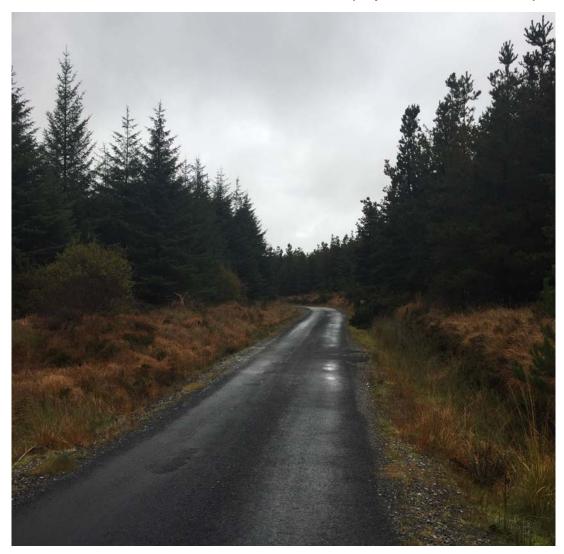
Plate 1: Coillte Track to Wind Farm; Northbound (Captured November 2019)

In its baseline condition the Coillte forest track comprised an un-surfaced track typically of 2.9 m width comprising a make-up of crushed limestone and crushed rock material. The image provided by Plate 1 illustrates the track after upgrades which were undertaken as part of the Project. No image could be sourced for the track prior to the upgrades.

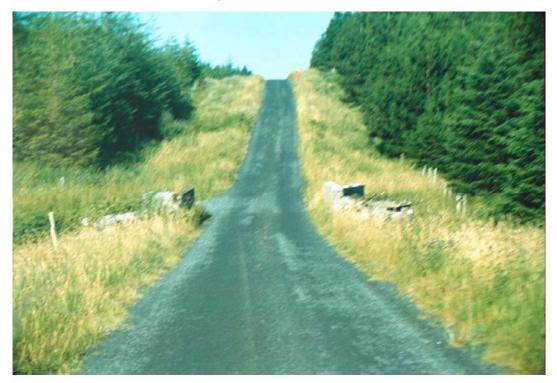
Plate 4: Black Road circa. August 2003

In its baseline condition Black Road comprised a narrow, surfaced road, with verges and access gates along its length used for two-way vehicle passing. It was, and remains, a two-way unmarked road. No posted speed limit was observed during the site visit. Plate 4 is an image of Black Road circa. August 2003 and Plate 5 illustrates Black Road in November 2019.

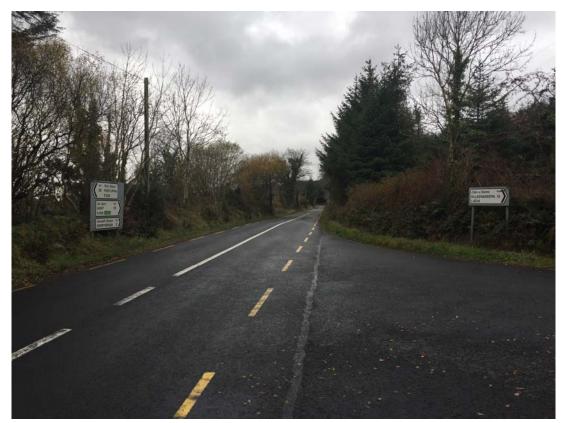
Plate 6: R353; Westbound (Captured November 2019)

In its baseline condition the R353 comprised a two-lane two-way surfaced road with line markings. No posted speed limit was observed during site visits. Plate 6 illustrates the R353 at its intersection with Black Road.

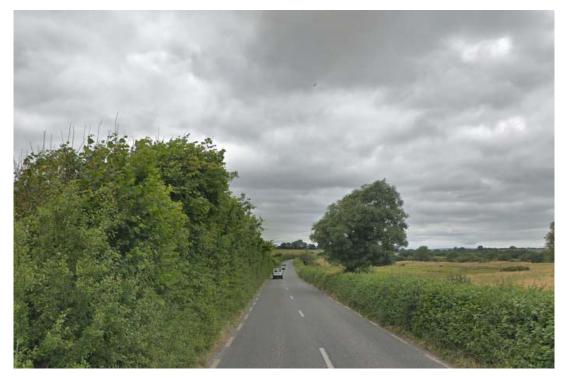
Plate 7: R476; Northbound (Image from Google Maps Sourced February 2020)

In its baseline condition the R476 comprised a one-lane two-way surfaced road with line markings in a rural environment. Plate 7 illustrates the R476 in the northbound direction, south of Corofin.

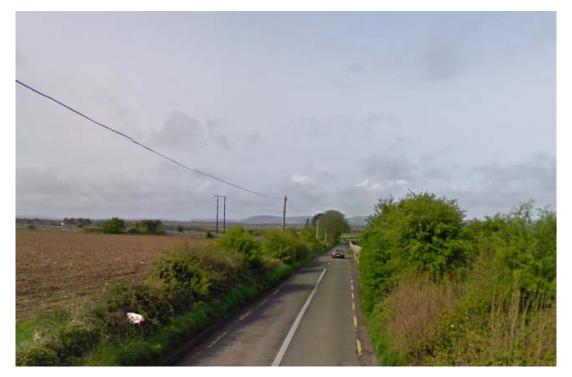
Plate 8: R460; Westbound (Image from Google Maps Sourced February 2020)

In its baseline condition the R460 comprised a one-lane two-way surfaced road with line markings in a rural environment. Plate 8 illustrates the R460 in the westbound direction, west of Gort.

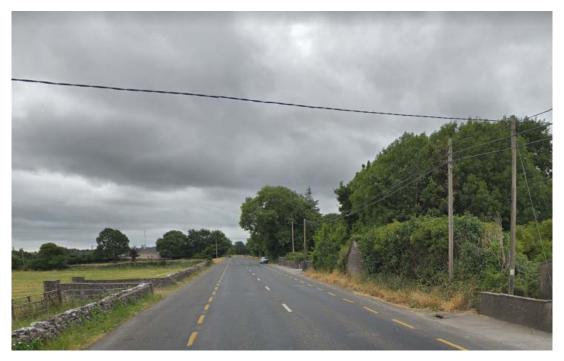
Plate 9: N18 (now R458); Southbound (Image from Google Maps Sourced November 2019)

The N18 (now R458) is located to the west of the wind farm and generally runs in a south west to north east direction between Gort (southern end) and Loughrea (northern end). In its baseline condition the N18 comprised a two-lane two-way surfaced road with line markings. The image provided by Plate 9 illustrates the R458 as it is at present day.

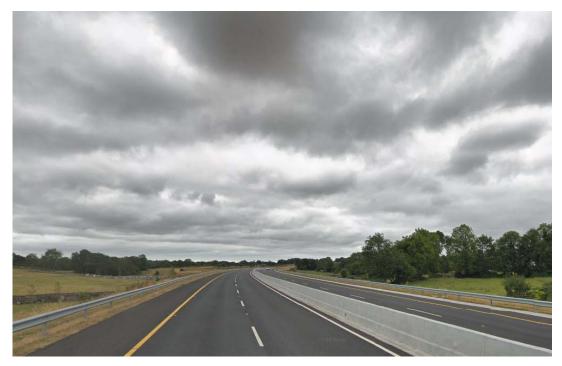
Plate 10: M18; Southbound (Image from Google Earth Sourced November 2019)

The M18 comprises a four-lane two-way motorway. It has a speed limit of 120 km / hr. The image provided by Plate 10 illustrates the M18 in present day.

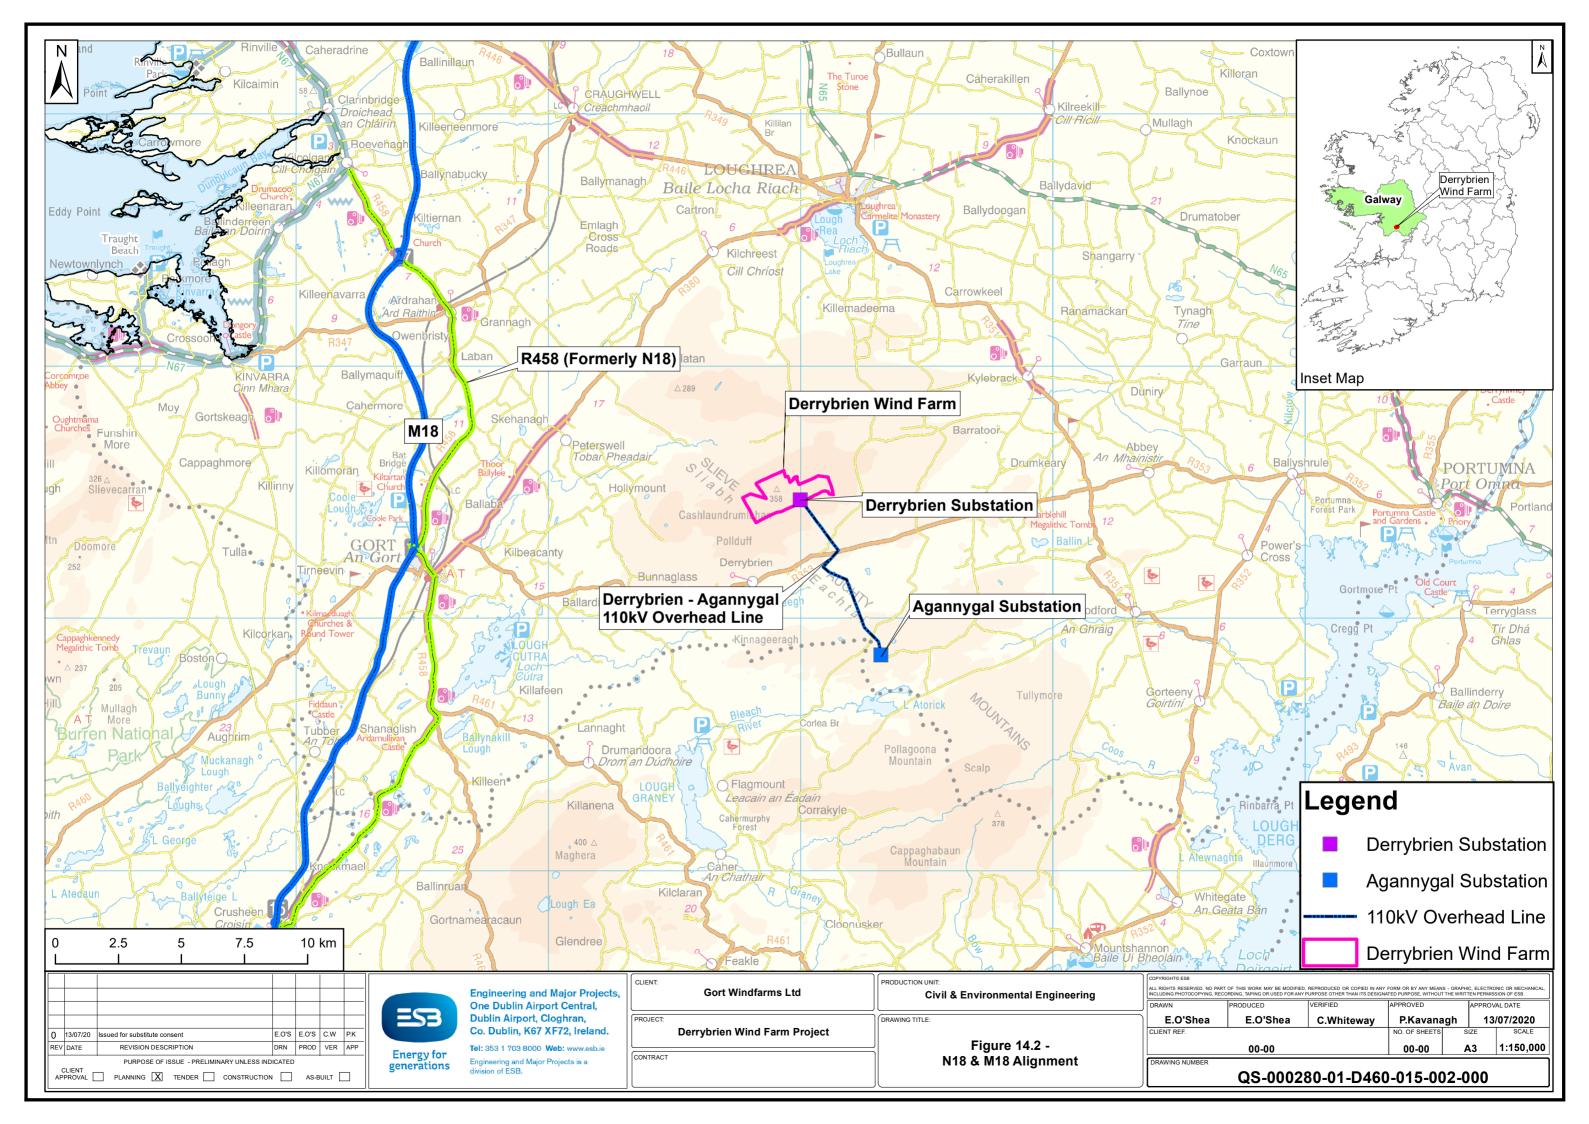
Provided for clarity Figure 14-2 below highlights the N18 alignment (baseline condition) in addition to the M18 alignment (present day).

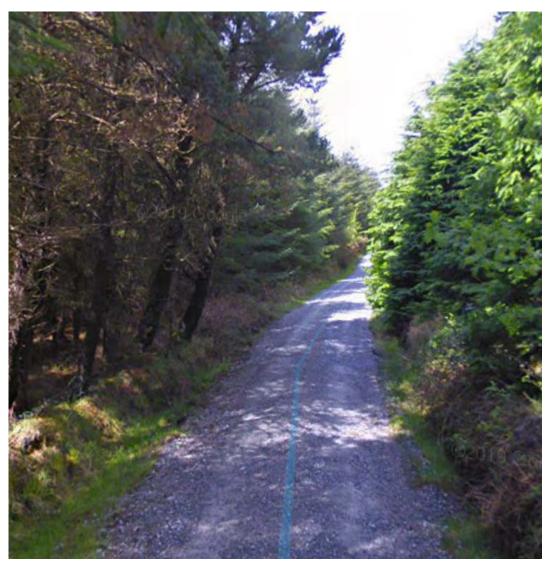
Plate 11: Unnamed Local Road A (Image from Google Maps Sourced November 2019)

The road is a narrow, two-way, unsealed, unmarked road as illustrated by Plate 11. No posted speed limit was observed during the site visit.

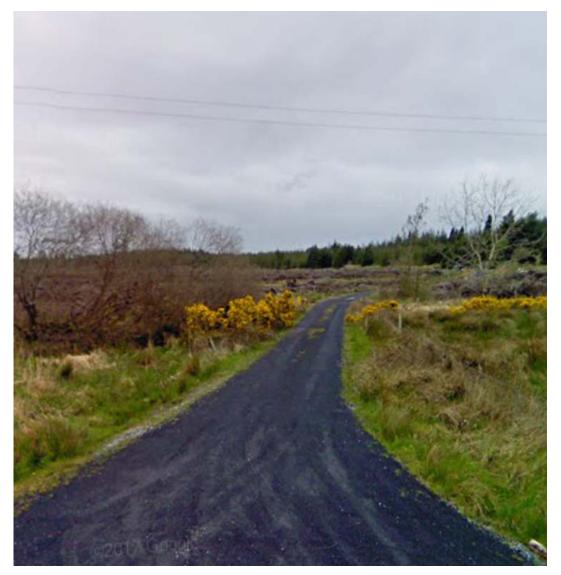
Plate 12: Coillte Track to Substation (Image from Google Maps Sourced November 2019)

The track comprises a narrow, two-way, unsealed, unmarked road as illustrated by Plate 12.

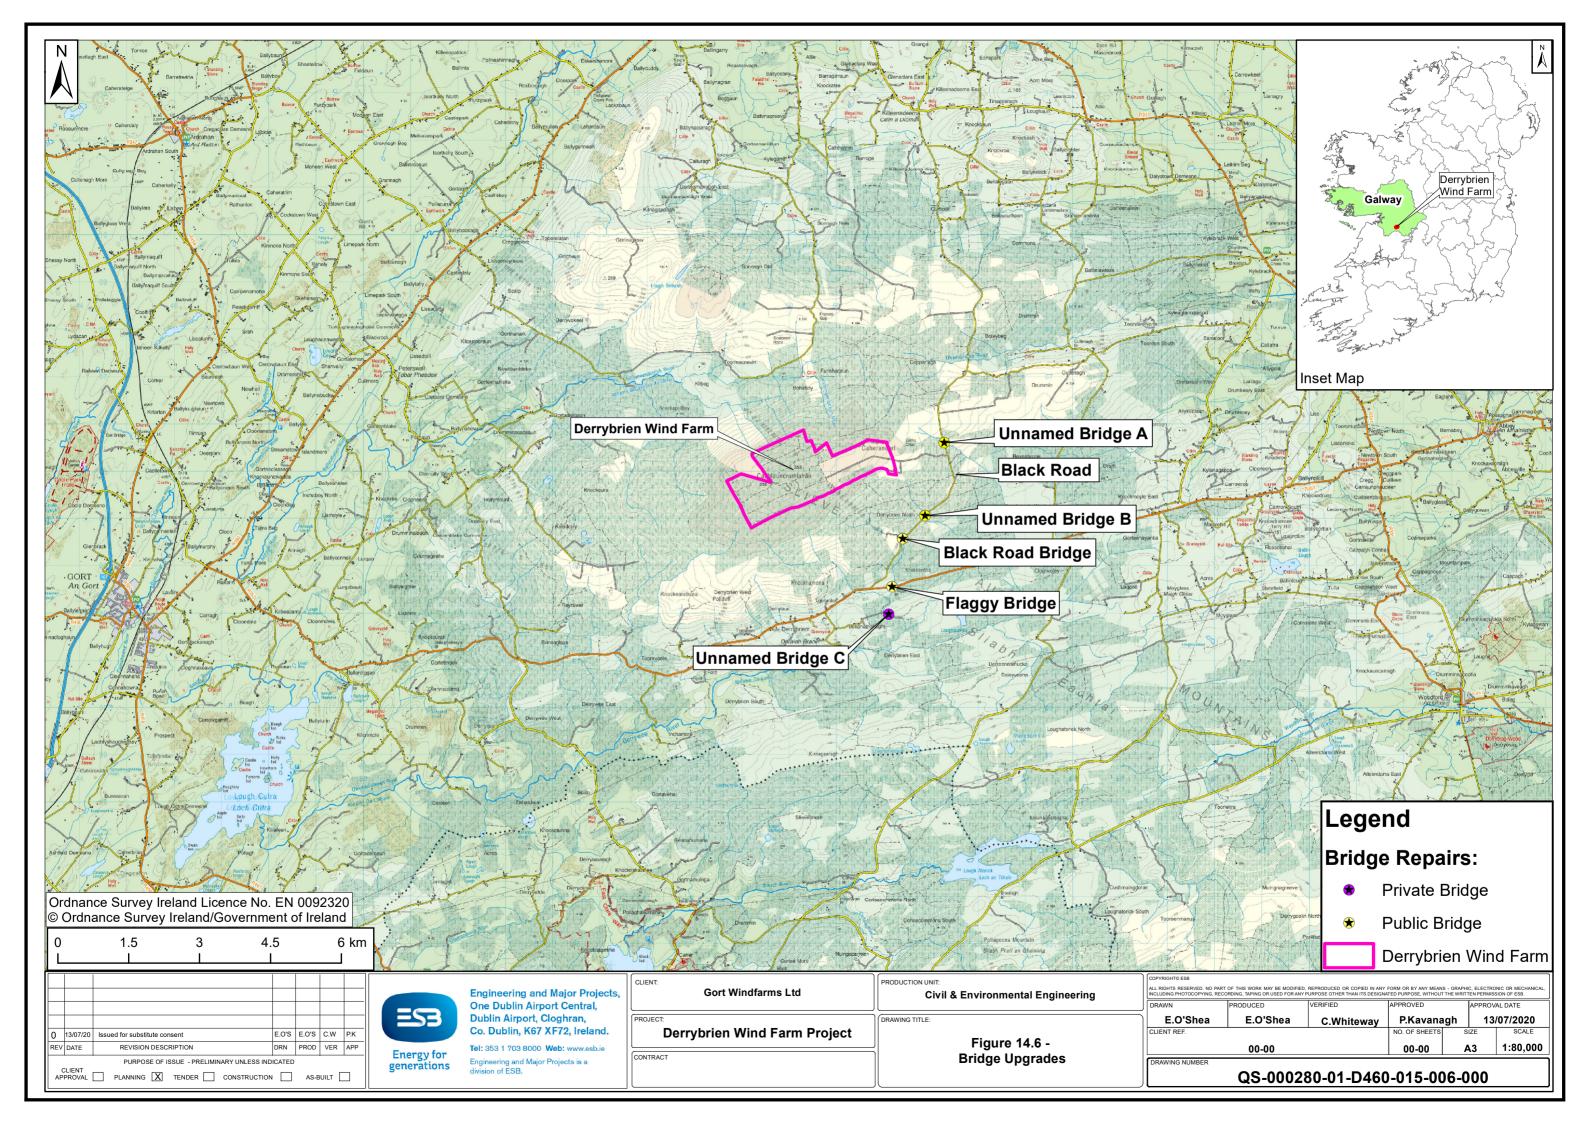
In order to facilitate the project, works were undertaken to the following three bridges on Black Road involving strengthening of the bridges and surfacing works for an effective width of 4 m and the replacement of the bridge parapets:

The location of the bridge upgrade works is illustrated by Figure 14-6.

Repair works were also undertaken at Unnamed Bridge C (561069.97, 702004.2172 ITM, also identified on Figure 14-6) including repairs to bridge parapets and deck slab. During these works' impacts were limited to those experienced by the private landowner and deemed to be temporary significant at individual level, but with no impact to the general public.

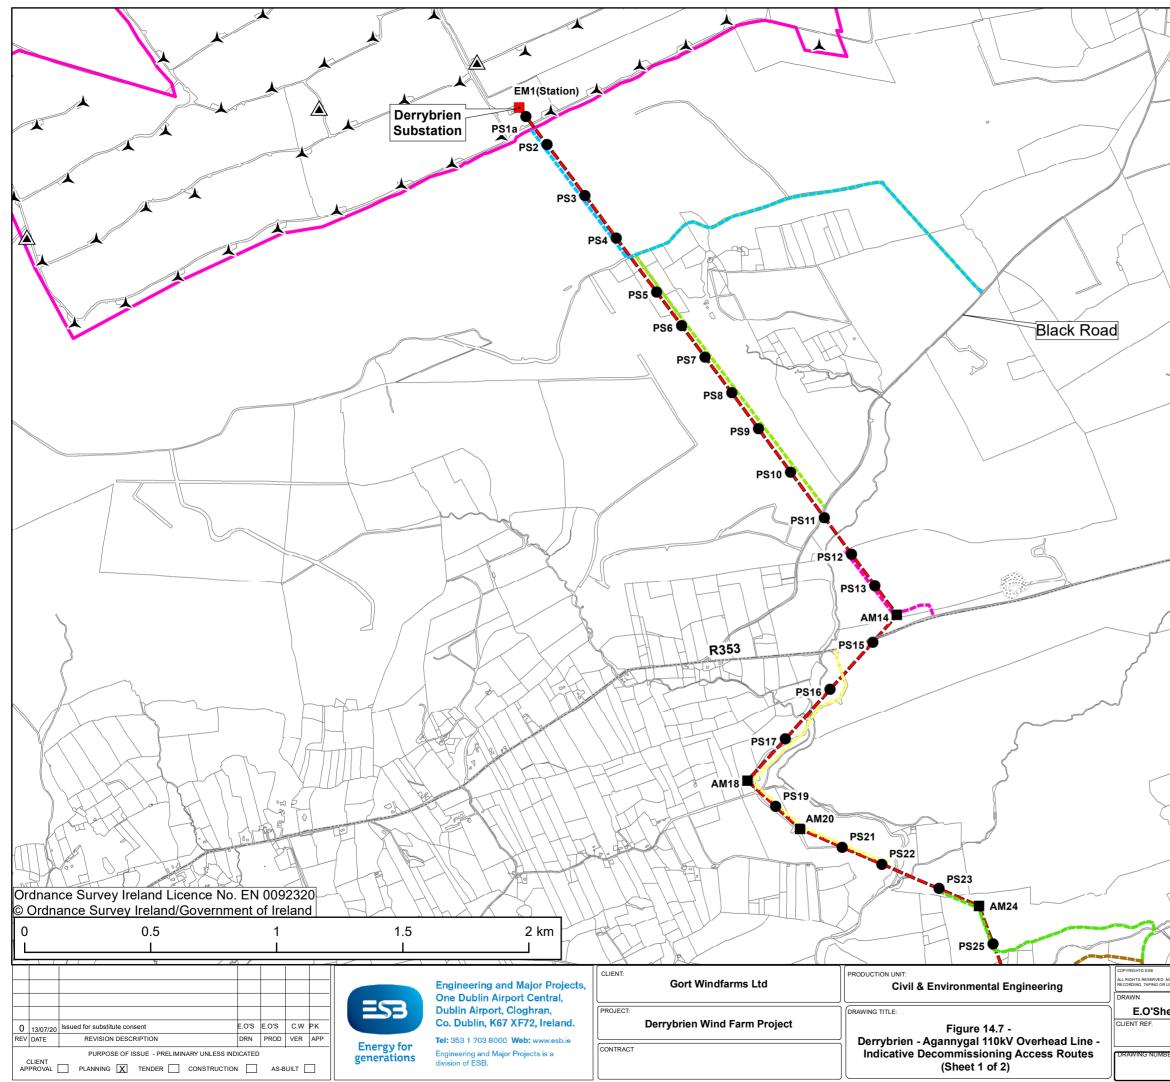
Difficulties were encountered in finding information on the access locations used from the public road network for the construction of these works. Figure 14-7 and Figure 14-8 illustrate the access locations identified for the decommissioning of the OHL and it is assumed, for the purposes of this assessment, that those same locations were used during construction.

N
		H		
		st As Built s As built		
	Derrybr Mast type: Poleset Angle End		il 110 kV Ov	erhead Line
	Indicati	Access Rout we access route we access route we access route we access route we access route we access route	 EM1 to PS PS5 to PS PS12 to A PS15 to PS PS15 to PS 	11 M14 S22 S25
	copied in any form or by any ose, without the written per IFIED C.Whiteway	MEANS - GRAPHIC, ELECTROM MISSION OF ESB. APPROVED P.Kavanag	APPROV	LUDING PHOTOCOPYING, AL DATE 3/07/2020
00-00 QS-000280		NO. OF SHEETS 1/2	size A3	scale 1:15,000
	J. 5400	010-00

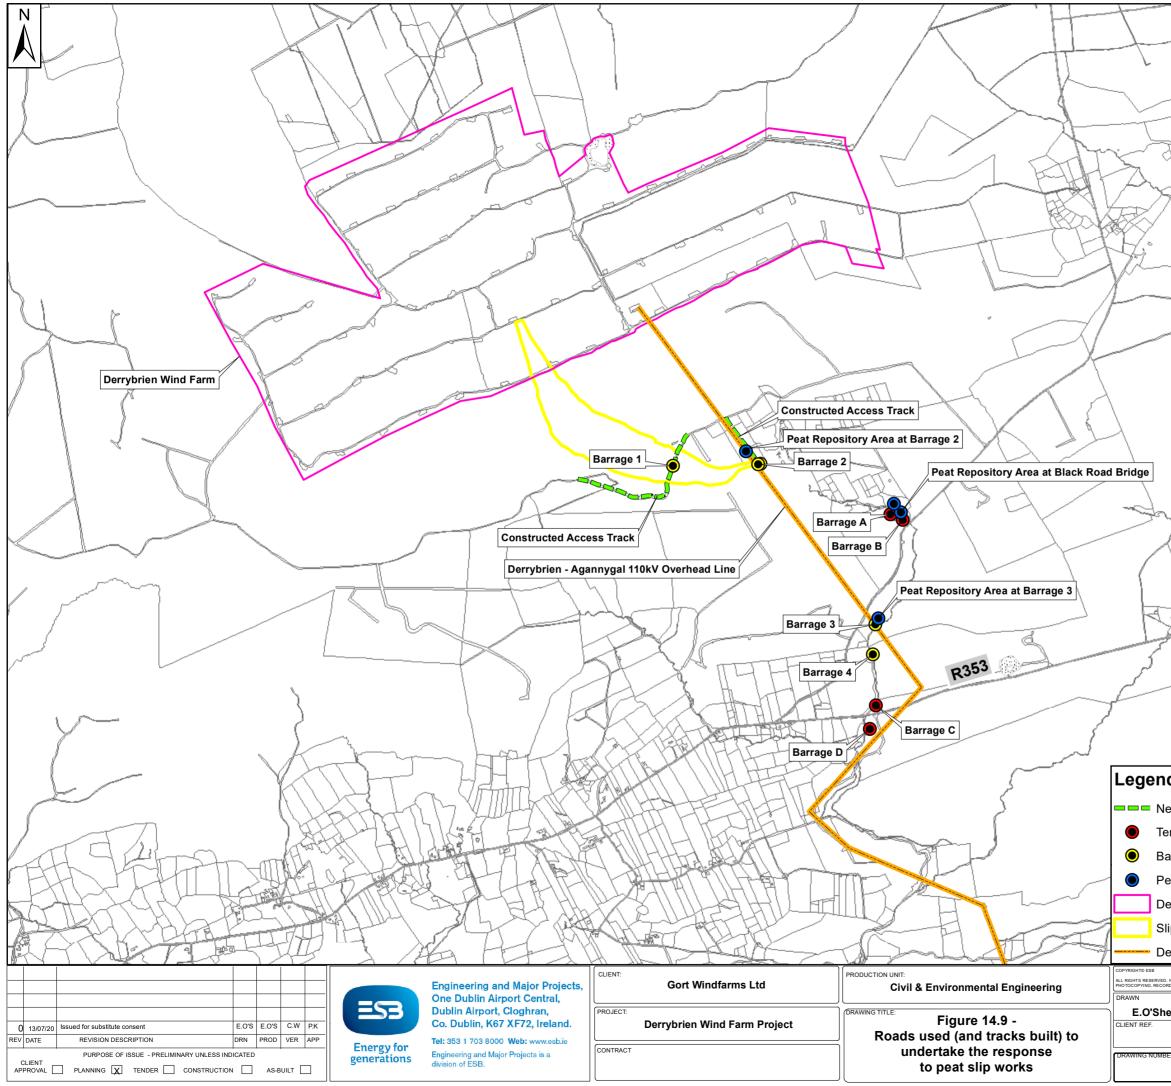
QS-000280-01-D460-015-009-000

Figure 14-9 illustrates details / features referred to by the impact assessment as documented by this section.

-			
			H L H
d ew Access Track Constructed mporary Barrages (no longer in place) (approximate locations) arrages eat Repository errybrien Wind Farm Site ip Area errybrien - Agannygal 110kV Overhead Line			
NO PART OF THIS WORK MAY BE MODIFIED, REPRODUCED OR COPIE DING, TAPING OR USED FOR ANY PURPOSE OTHER THAN ITS DESIGNA PRODUCED VERIFIED	D IN ANY FORM OR BY ANY MEANS - GRAPH TED PURPOSE, WITHOUT THE WRITTEN PER	HIC, ELECT MISSION O	RONIC OR MECHANICAL, INCLUDING ESB.
ea E.O'Shea C.White			30/07/2020 IZE SCALE
00-00	00-00		A3 1:20,000

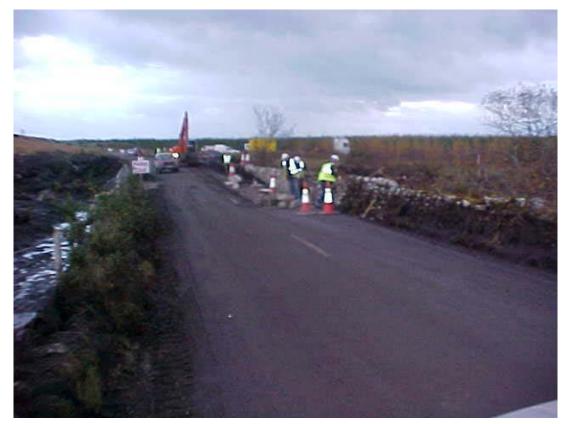
Plate 13: R353 Repair Works post Peat Slide

As a result of the peat slide over-topping was experienced at both Black Road Bridge on the Black Road (561367.49, 703601.55 ITM) and Flaggy Bridge on the R353 (561137.3483, 702585.7451 ITM). This over-topping resulted in damage to bridge parapets and temporarily prevented vehicle movements on both roads at the impacted locations.

Clearance works were undertaken in order to remove peat and to replace damaged parapets and walls at these locations. Both as a result of the peat-slide itself and the clean-up works, both roads were closed for durations of approximately 1-2 weeks. Diversions and road closures were managed by GCC during this period. However, if required, local access was facilitated with some delays experienced by users of local routes. **Temporary, negative, significant** impacts were experienced during these events.

Plate 13 illustrates these works at Flaggy Bridge.
