## Derrybrien Wind Farm Project

## Remedial Environmental Impact Assessment Report Chapter 8 - Aquatic Ecology & Fisheries

Document No.: QS-000280-01-R460-001-000

Date: August 2020

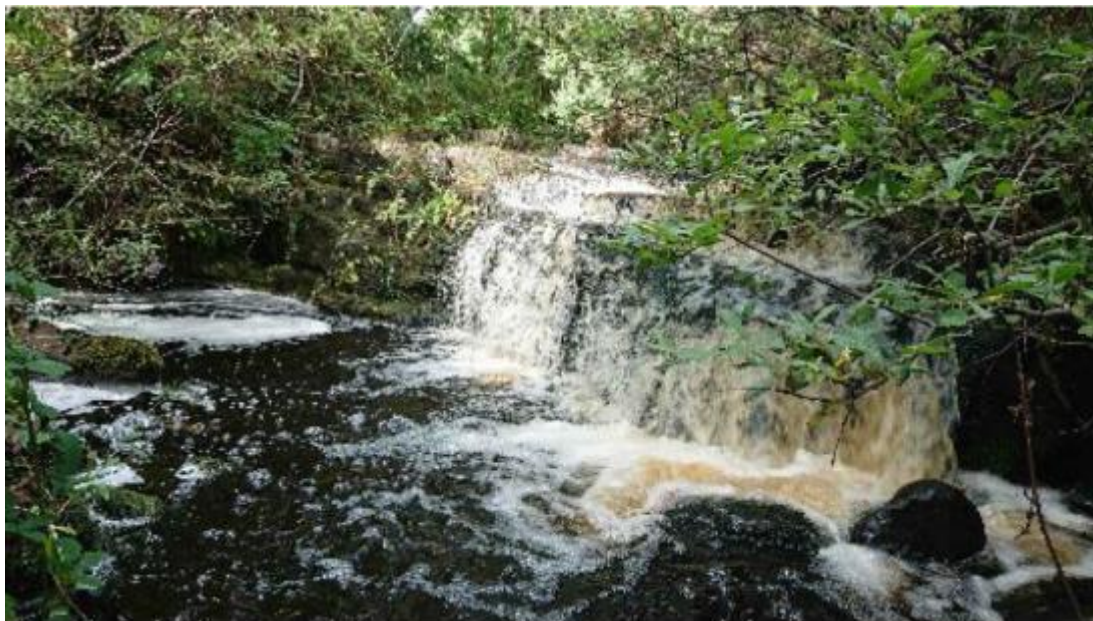
**Plate 8.3 Waterfall ~300m downstream from Flaggy Bridge (Site O5, SC7b) – August 2018**

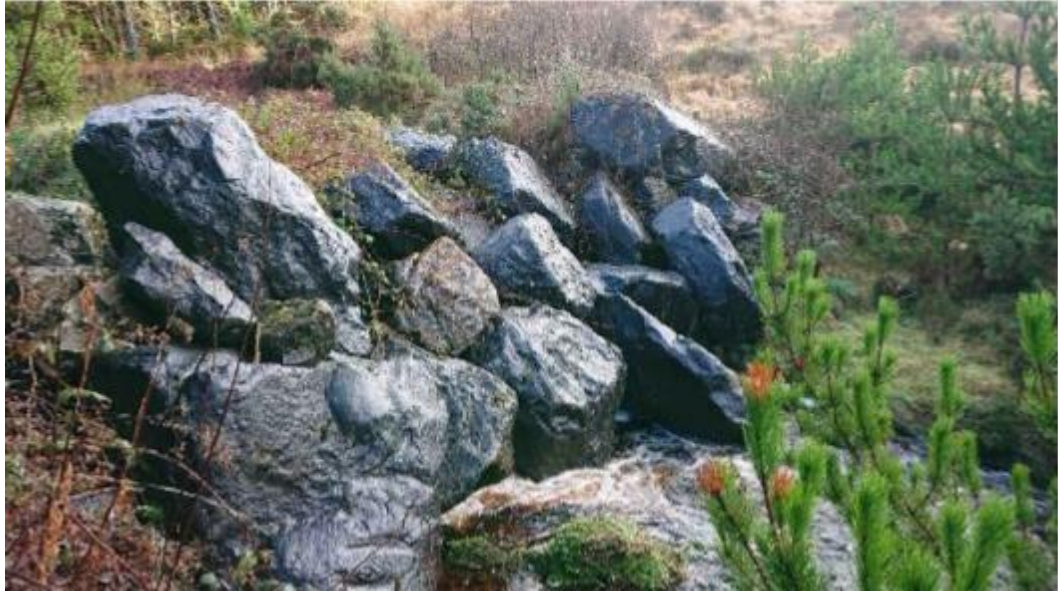
**Plate 8.4 Barrage 3, d/s Site O4 – SC7b (January 2020)**

Bridge (near the present Site O4) and Flaggy Bridge (near Site O5) Inis Environmental Services (2008) found no fish. Whereas in the same survey, at sites 350m and 450m downstream of Flaggy Bridge (i.e. 250-350m u/s of Site O6 in this study) 3 trout were present 350m d/s Flaggy Bridge and 2 trout, 22 stone loach and 1 eel were recorded at the site a further 100m d/s. All trout were either 1+ or 2+, no 0+ fish were recorded. Trout density varied from 0.027-0.05/m<sup>2</sup>. The absence of fish at O4 and O5 despite at least some suitable salmonid nursery habitat at both sites may be due in part to the presence of a waterfall situated just under 300m downstream from Flaggy Bridge (Site O5) (Plate 8.3) and Barrages 3 and 4 just downstream of Black Road Bridge (Site O4) (Plate 8.4).

The proposal therefore is to remove any material currently being held back by the barrages and batter back the edges of the channel to the extent that once the boulder face of the barrage is removed that the stream, even in a spate, would not give rise to new channel erosion or would only remove a minimum of residual loose material. Even the initial removal of compacted material from behind the barrage using a backhoe digger could give rise to substantial loss of suspended solids which in turn could negatively impact macroinvertebrates and fish downstream. If this is undertaken without mitigation, the downstream impact can be described as **slight or moderate, negative, temporary**, affecting the ecological status of the SC7(b) channel at Site O5, possibly dropping from Q4-5 or Q4 to Q3-4. There could also be a **slight negative and temporary** impact on spawning in the lower part of the subcatchment around Site O6A, depending on the amount of solids generated by the works, resulting in a slight reduction in trout fry recruitment at the site. Both these impacts would be localised within the SC7(b)/(d) subcatchment.

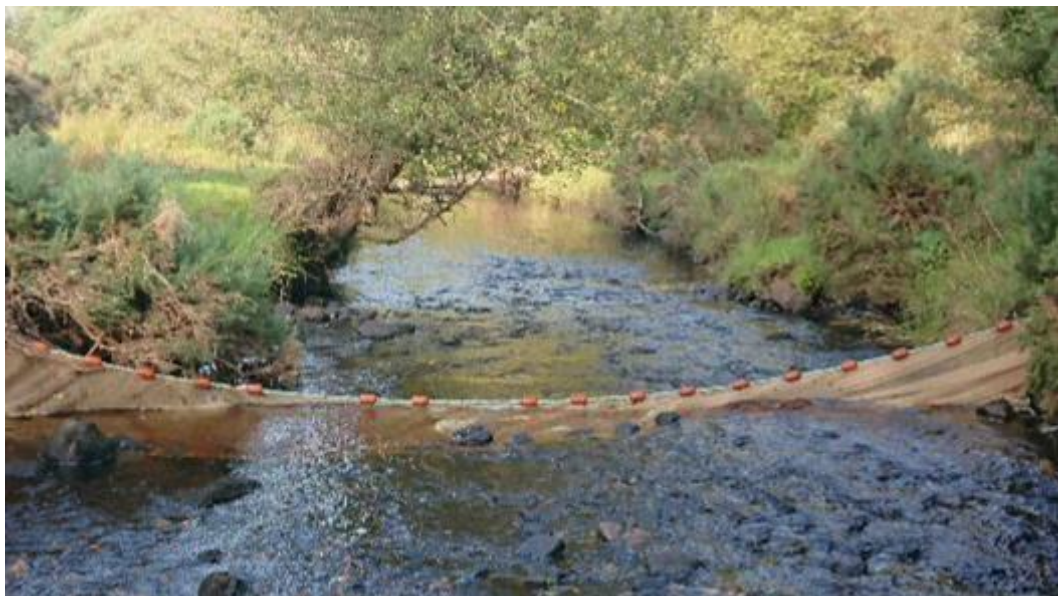
**Plate 8.5 Site O7C, main channel of the Owendalulleagh immediately downstream of forestry road fording point showing stop net at u/s end of survey reach (September 2019)**

In order to access angle mast 24 and poleset 25, construction machinery had to cross a shallow fording point on the main channel of the Owendalulleagh at Site O7C (Figure 8.1, ITM: 562447, 701486, Plate 8.5). At those locations where the structures were close to the stream (Code 29D21) there was a risk that suspended solids would have reached the channels due to run-off from damaged ground being tracked by vehicles or from solids-contaminated water that was pumped out of foundations for the structures. In the case of the masts there was the added risk of cement run-off as the foundations for the legs had to be concreted. In the latter case large concrete pipes turned vertically were used as forms for the concrete foundations, so these would have confined any poured cement and thereby very considerably reduced the chances of any significant amounts reaching surface water. Tracking over the small stream at mast 30 would certainly have generated some increase in suspended solids in the stream, although the overburden at that point is very sandy, and the amounts mobilised may well have been quite small.

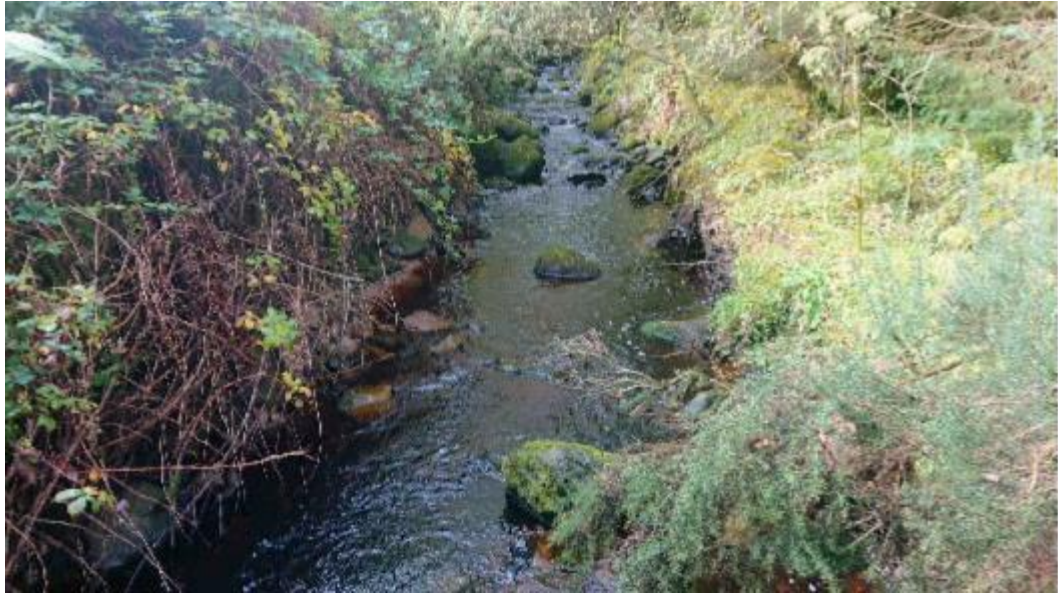
**Plate 8.6 Site O5A (SC7c) showing large boulders in channel. (September 2019)**

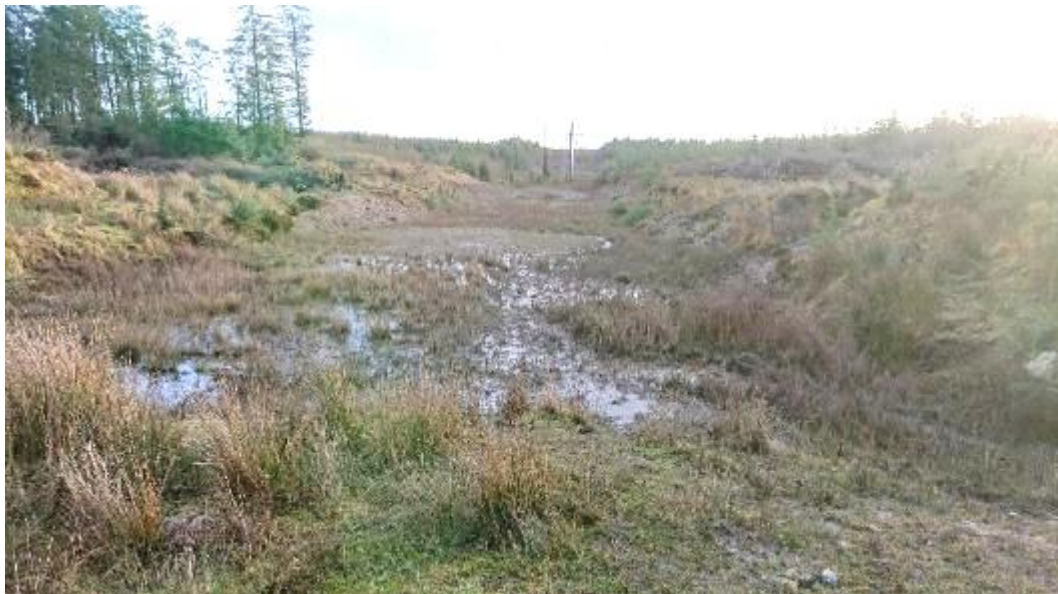
**Plate 8.8 OHL corridor showing ground lowered beneath Moneypoint-Oldstreet 400kV OHL. View south from Poleset 28A.**

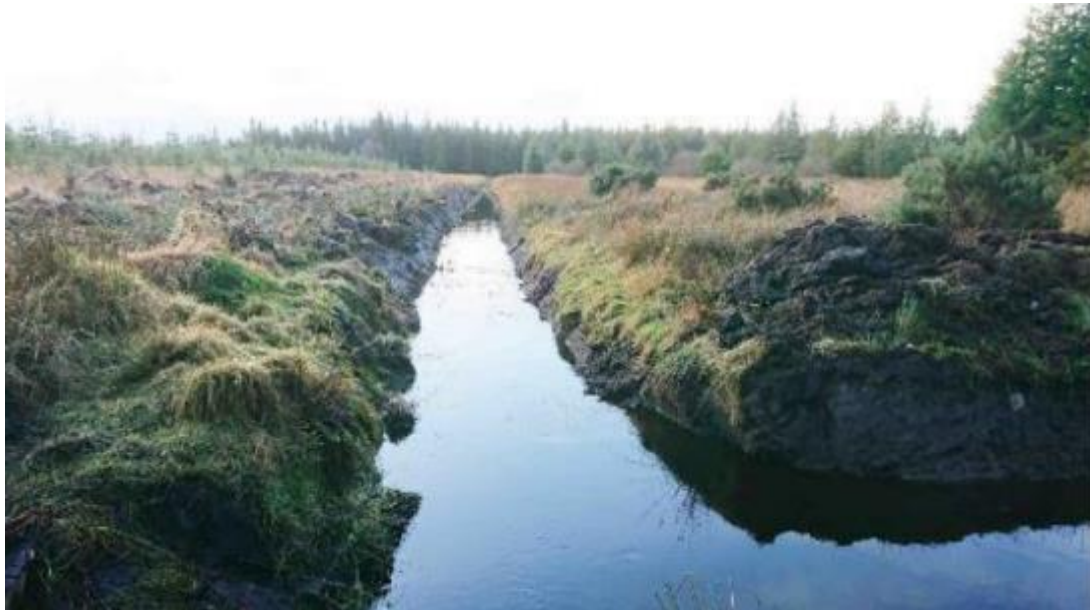
**Plate 8.9 Long depositing stretch on stream draining to Lough Atorick from Agannygal Substation. (View to the south west from ITM 563565 697855).**

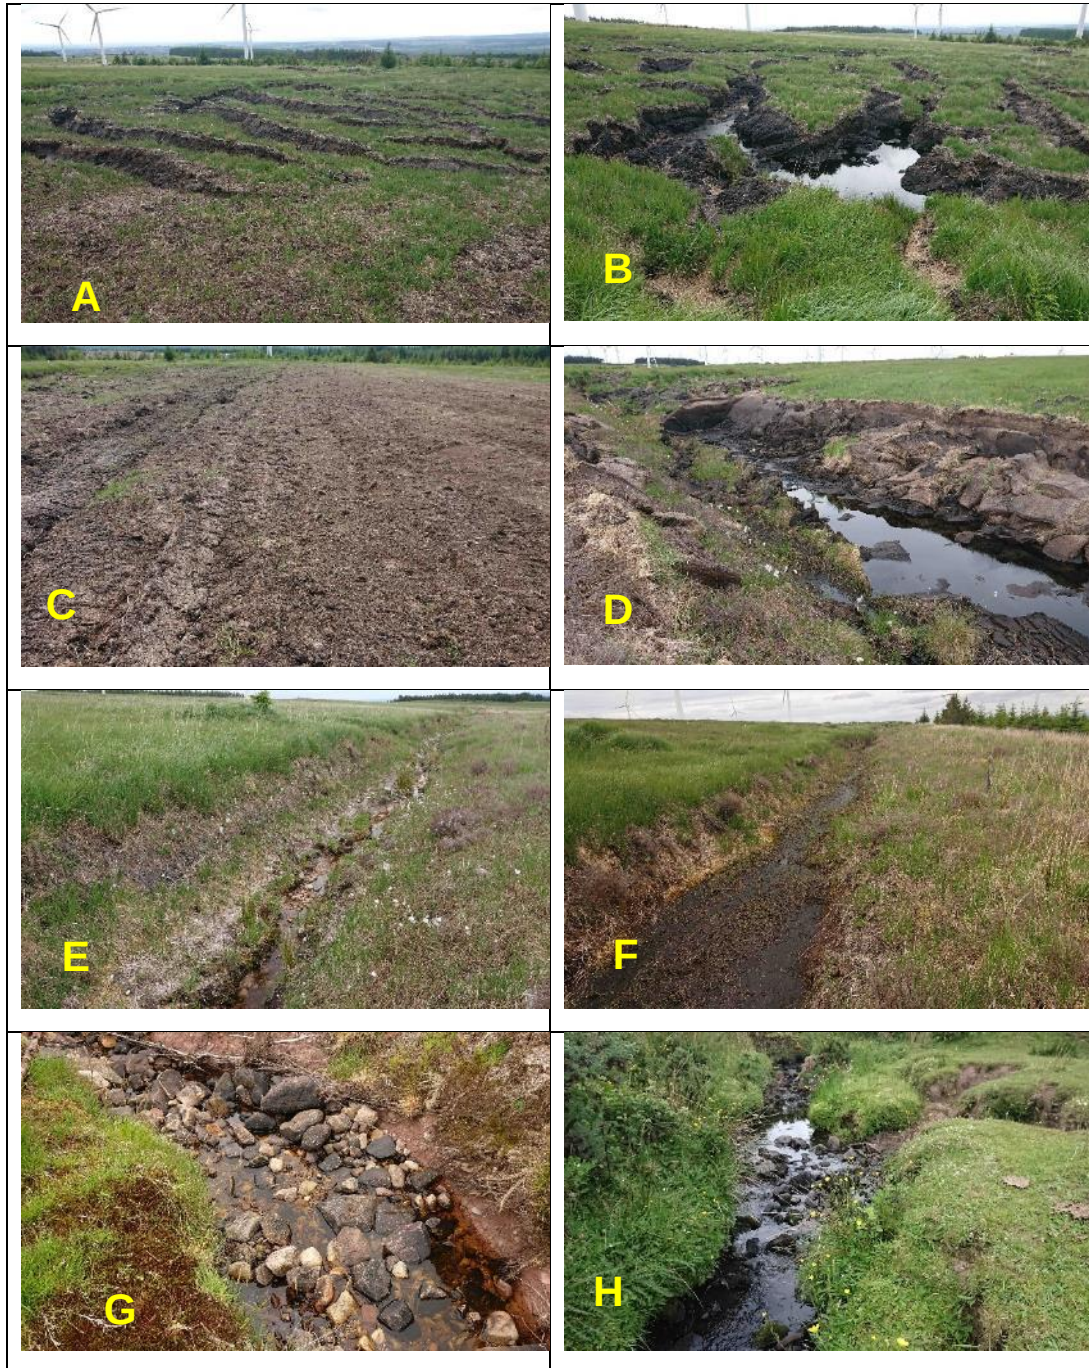
**Plate 8.10 (A-H) Peat Disturbance in Turbary Plot in Wind Farm Site**

A = disturbance showing peat tears, B = shows close-up of peat tear with water, C = badly eroded surface of turbary plot upslope of peat disturbance, D = shows peat excavation rectangle at base of turbary plot adjoining and east of disturbance area plot, E = eastern section of east-west drain shoring eroding base, F = east-west drain western section showing deposited peat in base, G = substrate at Q-rating survey site (O3B) and H = photo of stream at O3C Q-rating survey area.

failure. However, the surface vegetative cover has all but disappeared, eroded by constant machinery movements associated with spreading the extruded sods to dry flat or in small piles (Plate 8.10(C)). This surface may be subject to peat silt loss during intense rainfall. Machinery pressure and the absence of a vegetative cover on this part of the plot may have contributed to its destabilisation. Adjoining turbary plots are separated by drains running parallel to their long axes and the one on the eastern side of the affected site adjoining the failed section appears to have been widened and peat excavated out of it.
