Gort Windfarms Ltd.

Remedial Environmental Impact Assessment Report Chapter 9- Landscape and Visual

Document No.: QS-000280-01-R460-001-000

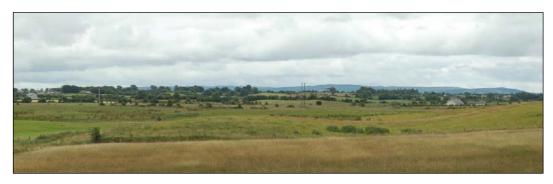
Plate 9-1 Viewed from the north the Slieve Aughty Mountains have a low, rounded profile

Derrybrien Wind Farm is in the northern part of the Slieve Aughty range east of the peak of Cushlaundrumlahan. This is a linear mountain, aligned approximately SW-NE, with a relatively flat, rounded top and gently sloping sides. It is a monolithic landform feature, with no outlying ridges or peaks. Due to its limited height and undramatic landform, as an upland feature it is unremarkable in appearance.

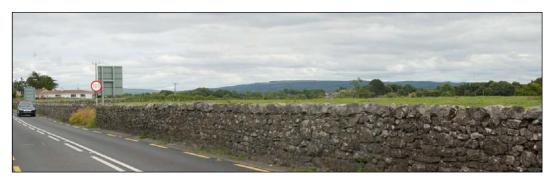
Plate 9-2 The view towards the Slieve Aughty Mountains from the west

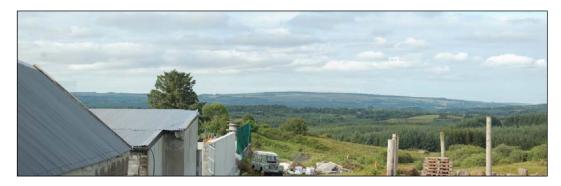
Plate 9-3 A view towards Derrybrien from the south across the upland landscape

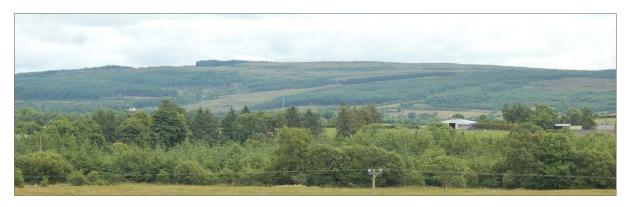
Plate 9-4 Extensive coniferous plantations in the Slieve Aughtys were a feature of the landscape prior to the wind farm project development

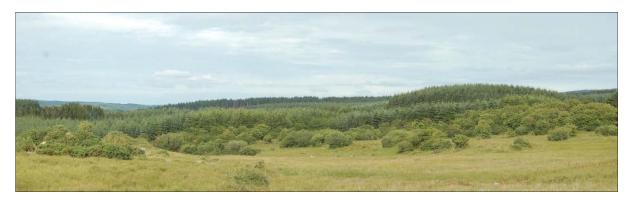
Plate 9-5 Extensive areas of forestry are interspersed with areas of peat bog and transitional woodland scrub, forming a typical marginal mountain mosaic landscape

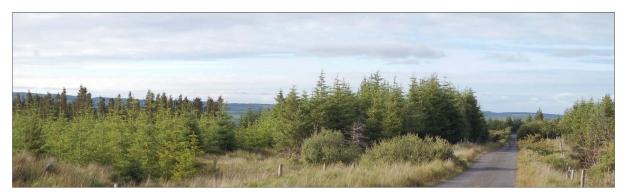
Plate 9-6: Within the uplands the forest would have generated a high degree of visual enclosure as is evident today, though some felling and replanting would have occurred since 1998

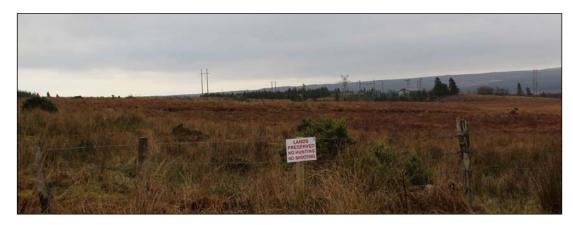
Plate 9-7 Open bogland and coniferous forestry was present in the landscape around the Agannygal substation. Today the forestry is partly felled, increasing visibility.

This area is also sparsely settled, and would have been prior to the development of the Project. The location of the substation at Agannygal (seen in Plate 7 below) was previously a dense block of coniferous forestry with a large area of open bog or moorland to the east. While some felling of the forestry was carried out during construction of the substation, the land to the west remains open moorland, Additional felling of the forestry around the substation is evident from aerial imagery from 2017 and 2020.

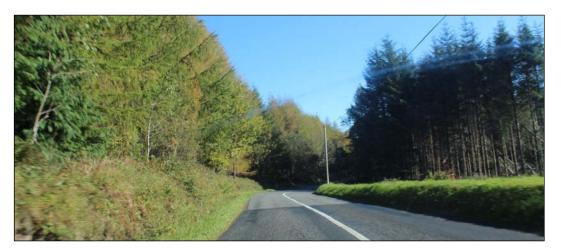
Plate 9-8 Dense coniferous forestry along R353 west of Derrybrien

To the west of Derrybrien the R353 descends from the uplands to the plains following a winding path through a landscape with near blanket forest coverage as shown in Plate 8 above. The road is outside of the wind farm's ZTV for most of its length to the west of Derrybrien. However, travelling east towards Derrybrien, for a short stretch between Bunnaglass and Tooravoola, the wind farm can be glimpsed. It appears that the landcover in this area and views remain similar to the pre-development scenario, albeit the roadside trees would have been less mature.

The landscape and visual effects of the peat slide which occurred in 2003 are not now evident in the landscape or from the public roads. Vegetation has grown considerably over the intervening period, as shown in Plates 8 and 10 in Section 9.3.

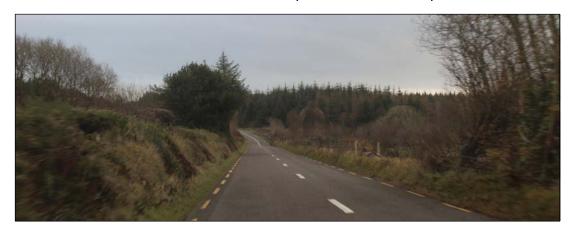
Plate 9-9 The R353 east of Derrybrien

To the east of Derrybrien the R353 follows a straight path across a part-forest, part-peatland covered upland plain. There are some open views to the open bogland and coniferous plantations to the south and some areas enclosed by forestry.

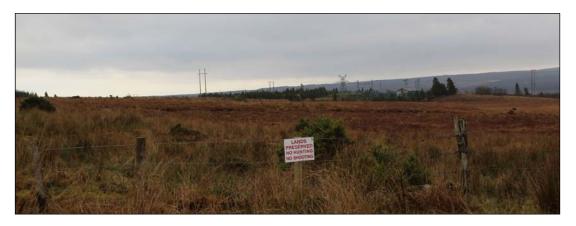
Plate 9-11 Agannygal substation (visible from the local road to the west) is located in an area which was forested

The Agannygal substation is visible across an area of bog, from a short section of the local road, in the townland of Loughatorick North as shown below in Plate 9-11. Views from the south are also available. Overall, the views of the substation are localised.

The substation is set within an area of bogland interspersed with coniferous forestry landcover. Today, an area of peatland is located to the west of the substation, while the forestry in the immediate vicinity of the substation has been partly felled since 1998, on inspection of the 2017 GeoHive aerial view, and 2020 Google maps aerial view. The substation is likely to have been more screened from view before the felling took place.

The Agannygal substation is visible over a very limited area. It is clearly visible from the local road to the west, where a view over an area of bogland allows clear views of the substation. Other sections of this road, and part of the approach road to the west, are heavily screened with vegetation. The visual effect is considered of Slight, adverse visual effect in the vicinity of the substation. As noted in Section 9.3, the substation was constructed in a block of coniferous forestry, and felling has subsequently been carried out. Visual effects are likely to have been less at the time of construction. A photograph is included in the Baseline (Plate 9) in Section 9.3

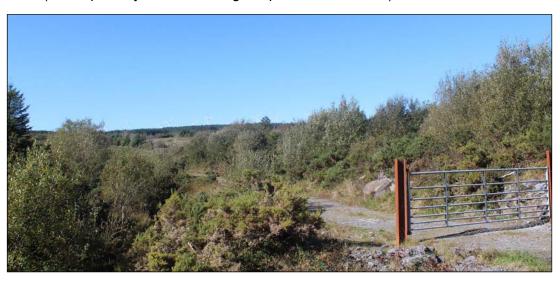
Plate 9-12 View from Black Road towards the turbines and location of the peat slide

The nearest public road to the wind farm site is known locally as 'the Black Road'. This is a single lane, relatively remote local road aligned roughly north-south, crossing the ridge of Cashlaundrumlahan and connecting Derrybrien and the R353 to Loughrea to the north. The Black Road passes some 1km to the east of the wind farm. (It was partially blocked during the peat slide in 2003.)

The visual effects of the peat slide appear to have been localised, as it was visible from the Black Road and also a section of the R353, where the peat was observed flowing across the Black Road and at Flaggy Bridge on the R353.
