Derrybrien Wind Farm Project

Remedial Environmental Impact Assessment Report Chapter 15- Cultural Heritage Appendices

Document No.: QS-000280-01-R460-001-000

Appendix 15-3 Archaeological report on 2004-5 phase of construction

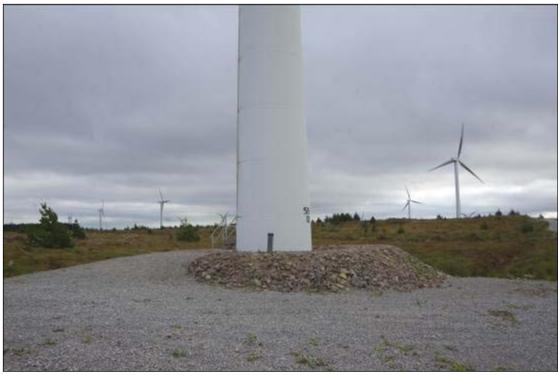
Plate 15- 8 View of typical turbine base

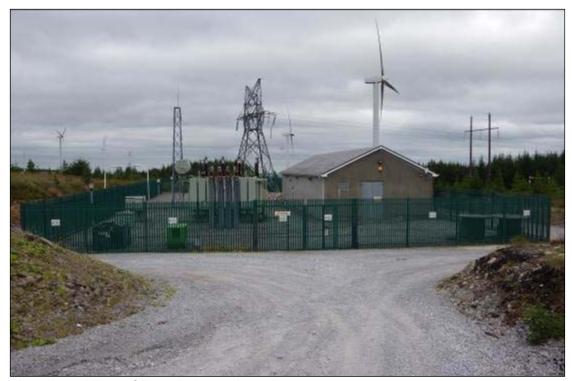
Plate 15- 9 View of Derrybrien substation

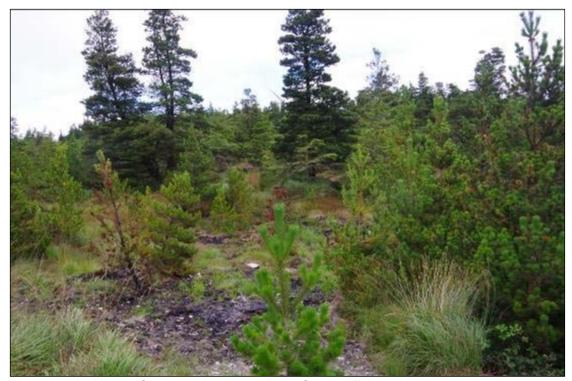
Plate 15- 13 View of regrowth at location of peat slide

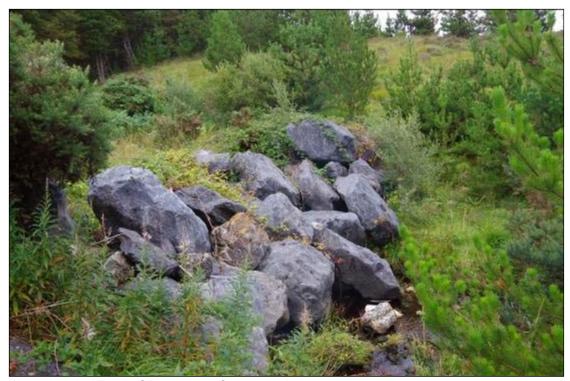
Plate 15- 15 View of Barrage 3 from north

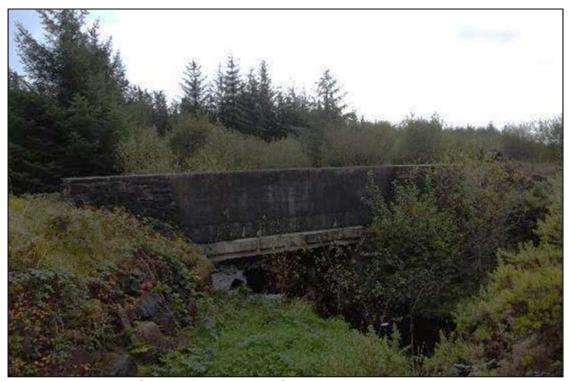
Plate 15- 17 View of Black Road bridge from north

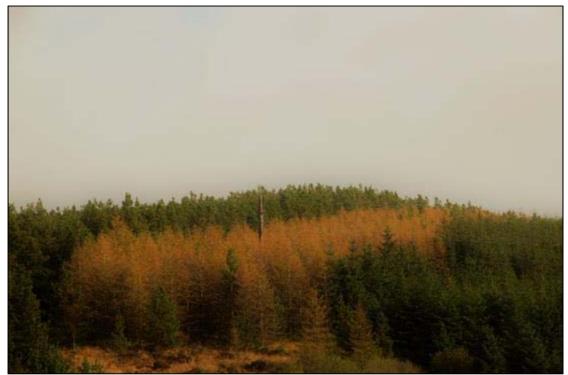
Plate 15- 19 View of overhead line within forestry to south of R353 road

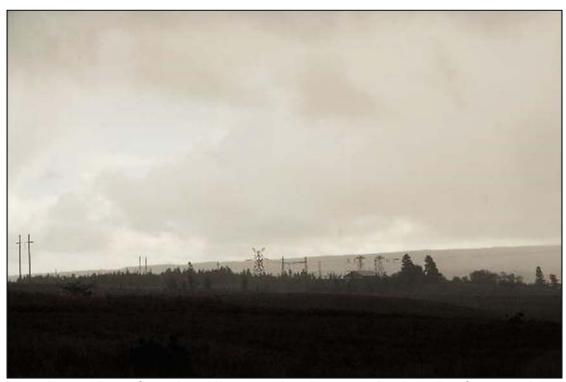
Plate 15- 20 View of overhead line entering Agannygal substation from northh

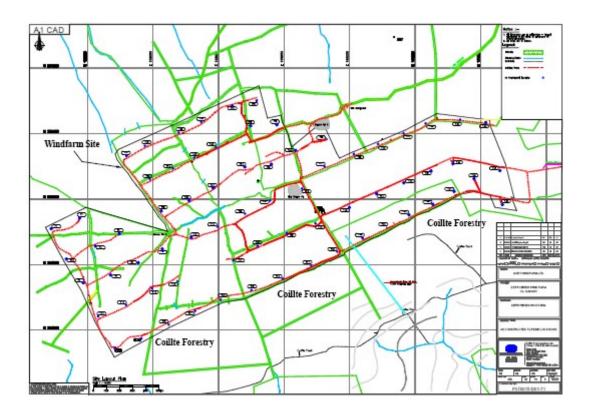
Figure 3. Turbine base and cable trench locations

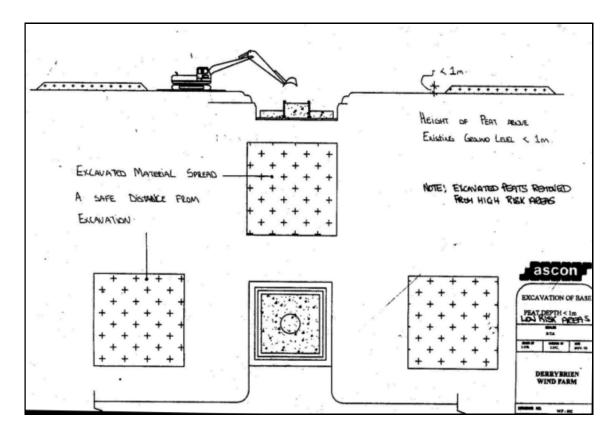
Where peat depths were lower than 1m, a site specific method of construction was devised. This methodology had four stages;

- Excavate and side cast or remove material to the required formation level.
- Bench sides of excavation to have safe batters prior to any operatives entering the excavation.
- If de-watering of the excavation was required. All excess run off shall be directed into suitable watercourses.
- Silt traps should be put in place at all agreed outfalls from the site prior to pumping operations commencing.

Figure 9. Excavation methodology for bases of less than 1m depth

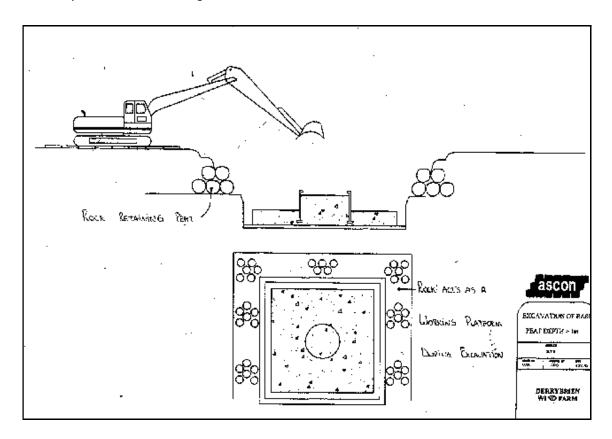
In areas where peat depth was greater than 1m in depth a separate methodology was employed. This involved;

- The placement of rock on the sides of the excavation that are perpendicular to the slope. Rock should be placed on the sides of the trench, which were parallel to the down slope during excavation. This would ensure that the rock does not exert any additional side forces on the face of the peat parallel to the down slope and the rocks shall act to retain the peat during excavation.
- All excavated material would be removed unless the area adjacent to the excavation was deemed suitable for side casting prior to the commencement of operations.
- Bench sides of excavation to be safely battered prior to the entry of any operatives into the excavation.
- If de-watering of the excavation was required. All excess run off shall be directed into suitable watercourses.

Silt traps should be put in place at all agreed outfalls from the site prior to pumping operations commencing.

Figure 10. Excavation methodology for bases of greater than 1m depth

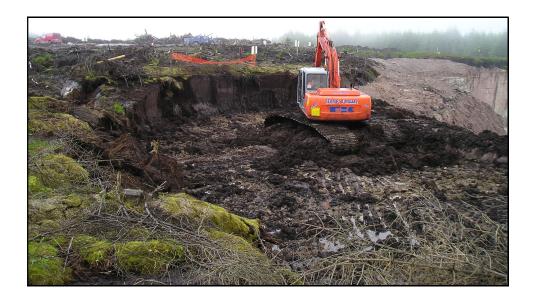
The construction methodology for the turbine base and crane stand involved the removal of all overlying soft peat and clays from the site. This was undertaken by means of mechanical excavator. All excavated material was carried by lorry from the turbine site to a stockpile storage area. The removal of excavated material by this means ensured that all weighty material was removed from a potential vulnerable site to a more stable secure site.

Plate 1. Mechanical excavator removing peat

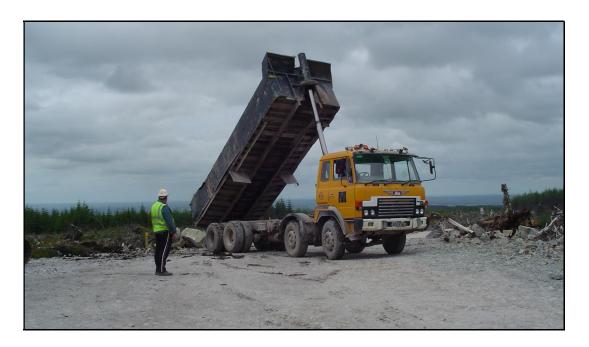
As peat was being removed from the site, replacement stone was being transported to the site. This stone was the material on which the crane would be based and it was also needed to ensure ground stability in the area. The stone was carried to the site by lorries and deposited in all excavated areas with the exception of the designated turbine base area, where a clear area was required to build the base.

Plate 2. Lorry depositing rock after peat removal

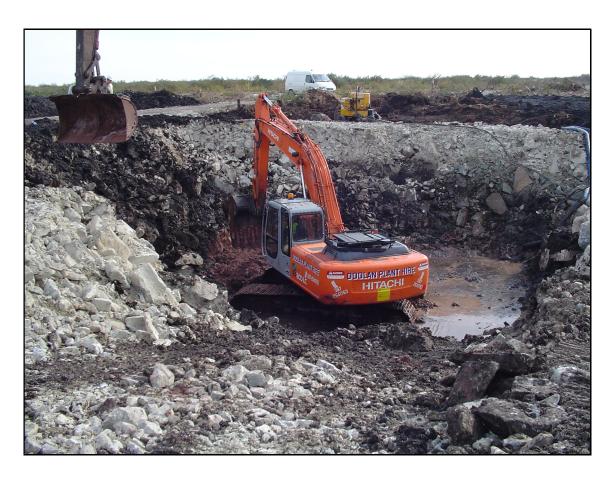
Plate 3. Stone crane base and excavated turbine base

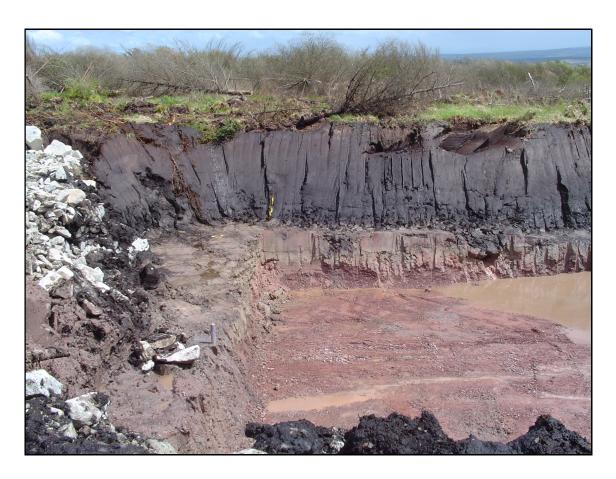
Although the stratigraphic matrix of the development site varied considerably in depth, it did not vary in composition, form and texture. Throughout the site the stratigraphy consisted of peat overlying a layer of compact pinkish red stoney silty clay. This clay overlay bedrock. As previously noted, the depth of these stratigraphic horizons varied throughout the site. In the higher reaches of the hilltops the peat cover tended to be lower as too was the pink silty clay. In the lower lying areas, peat deposits measured up to 3-4m in depth with the pink silty clay measuring up to 2m.

Plate 4. Section view of site stratigraphy

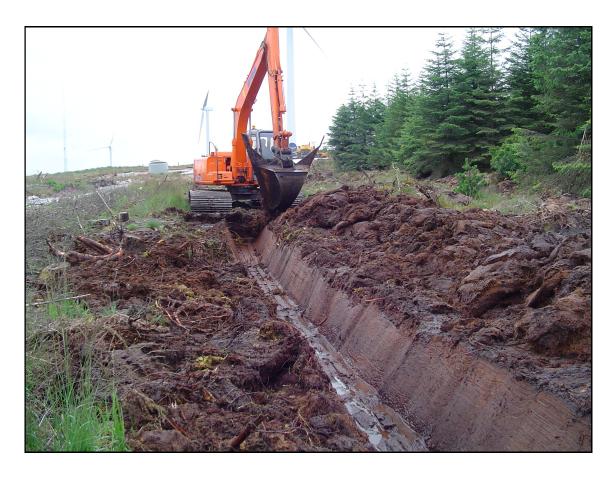
The excavation of this trench was by means of mechanical excavator, whereby the machine would travel across the peatland excavating the trench into which the cable would then be buried. Once the trench was completed and the cable laid, the trench was then covered using the reverse technique to that of the trench excavation.

Plate 5. Cable trenching in progress

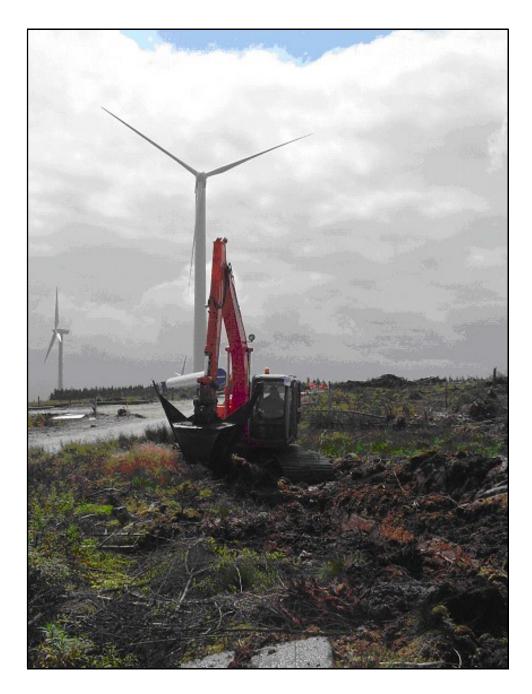
Plate 6. Cable trenching towards a nearby wind turbine

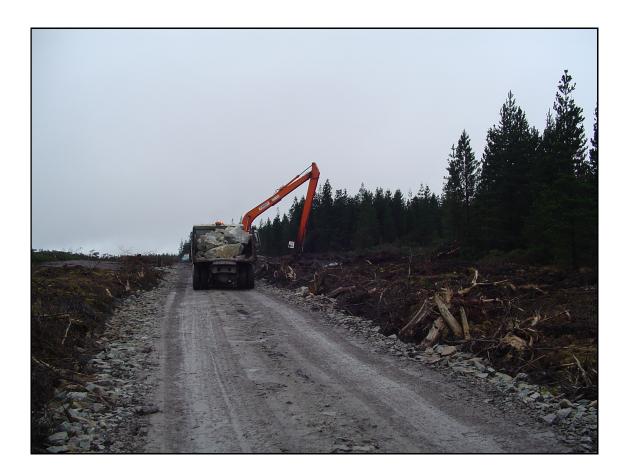
Plate 7. Turbine base excavation in progress

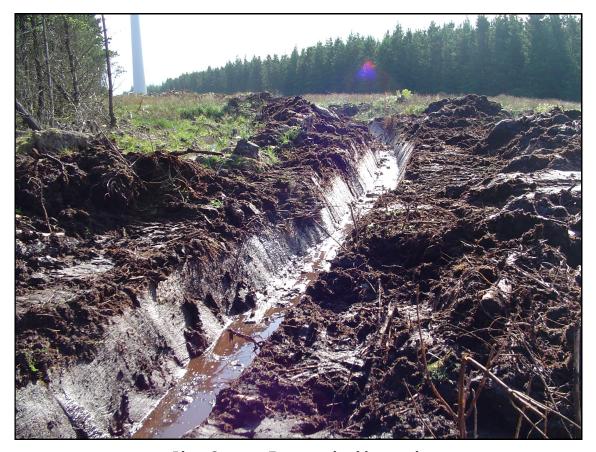
Throughout the development area, the depth of the cable trench excavations never exceeded 1m. As such, it was only the upper levels of the peat layer that was impacted. No archaeological material was noted in any of the cable trenches.

Plate 8. Excavated cable trench
