# **Environmental Impact Assessment Report**

## **Volume 2 of 3 – Main Report** *For*

### **FURTHER DEVELOPMENT OF UMMERA GRAVEL PIT MACROOM, COUNTY CORK**

**September 2020**

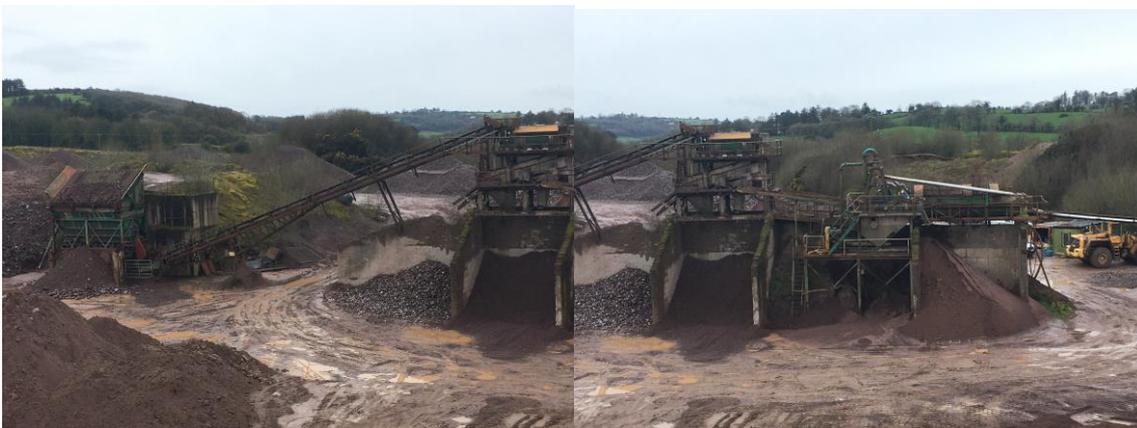
**Plate 2-1: View of Washing Plant from the East**

- A stationary washing plant powered by an electrical motor – see Plate 2-1
- A Volvo front-end loader used for loading raw material into the washing plant and loading trucks.
- A water pump powered by electrical motor located adjacent to the Clashavoon Stream. The pump has a capacity of 74m<sup>3</sup>/hr at a head of 15m – the height between the intake and the wash plant. This pump is used to top up the water recirculation system.
- A second pump powered by electrical motor located in the western pond, adjacent to the site office, to recirculate wash water. It has capacity of 135m<sup>3</sup>/hr.
- Track-mounted excavators are hired-in when needed to clean out the settlement ponds, segregate materials at the working face and strip topsoil. Dumpers are also hired-in when needed for this work.

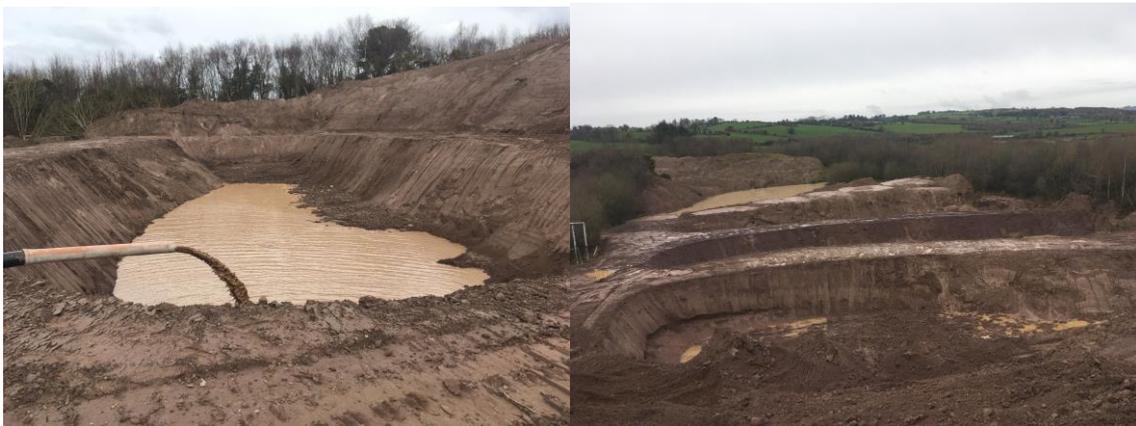
**Plate 2-2: Settlement Ponds (Eastern Pond Filling; View from East)**

The settlement ponds in the wash water recirculation system are approximately 3m deep with surface areas (from east to west) of 980m<sup>2</sup>, 1,200m<sup>2</sup>, 1,000m<sup>2</sup> and 1,750m<sup>2</sup> (total area = 4,930m<sup>2</sup>; total volume = 14,790m<sup>3</sup>). The pump capacity is 135m<sup>3</sup>/hr, so in a working day, approximately 800m<sup>3</sup> of water is used for washing. The retention time in the ponds is therefore approximately 18.5 days (which increases to 21 days when weekends are factored), which is sufficient to settle silt and clay particles. The travel path through the ponds is approximately 250m. This capacity will decrease as silt builds up over time. Ponds are cleaned approximately once per year. Plate 2-2 shows the settlement ponds.

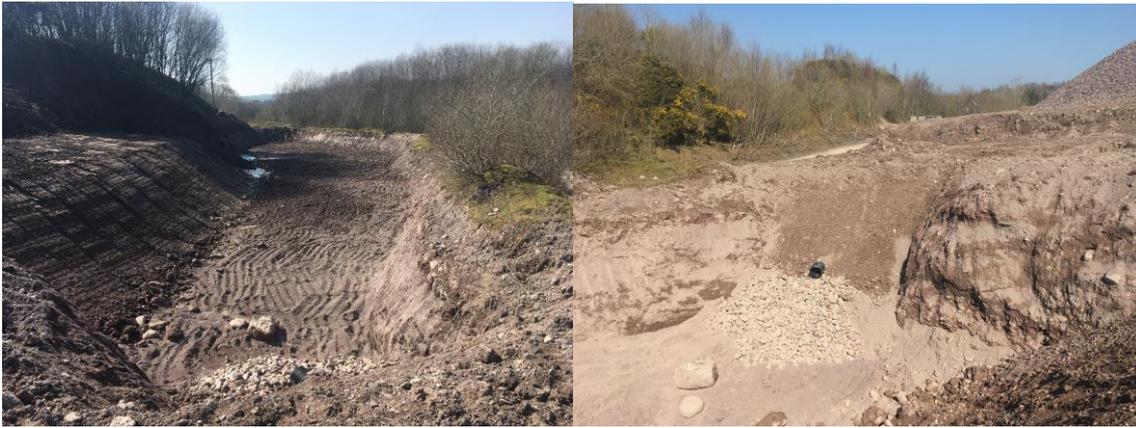
**Plate 2-3: Overflow Settlement Pond (Looking SW; Inlet Structure)**

The overflow pond adjacent to the access road is 60m long and approximately 14m wide, with a surface area of approximately 580m<sup>2</sup>. The pond is 1m deep (to the invert of the discharge pipe), giving a capacity of approximately 580m<sup>3</sup>. Plate 2-3 shows the overflow settlement pond.

To date, no discharge from the overflow pond has been observed.

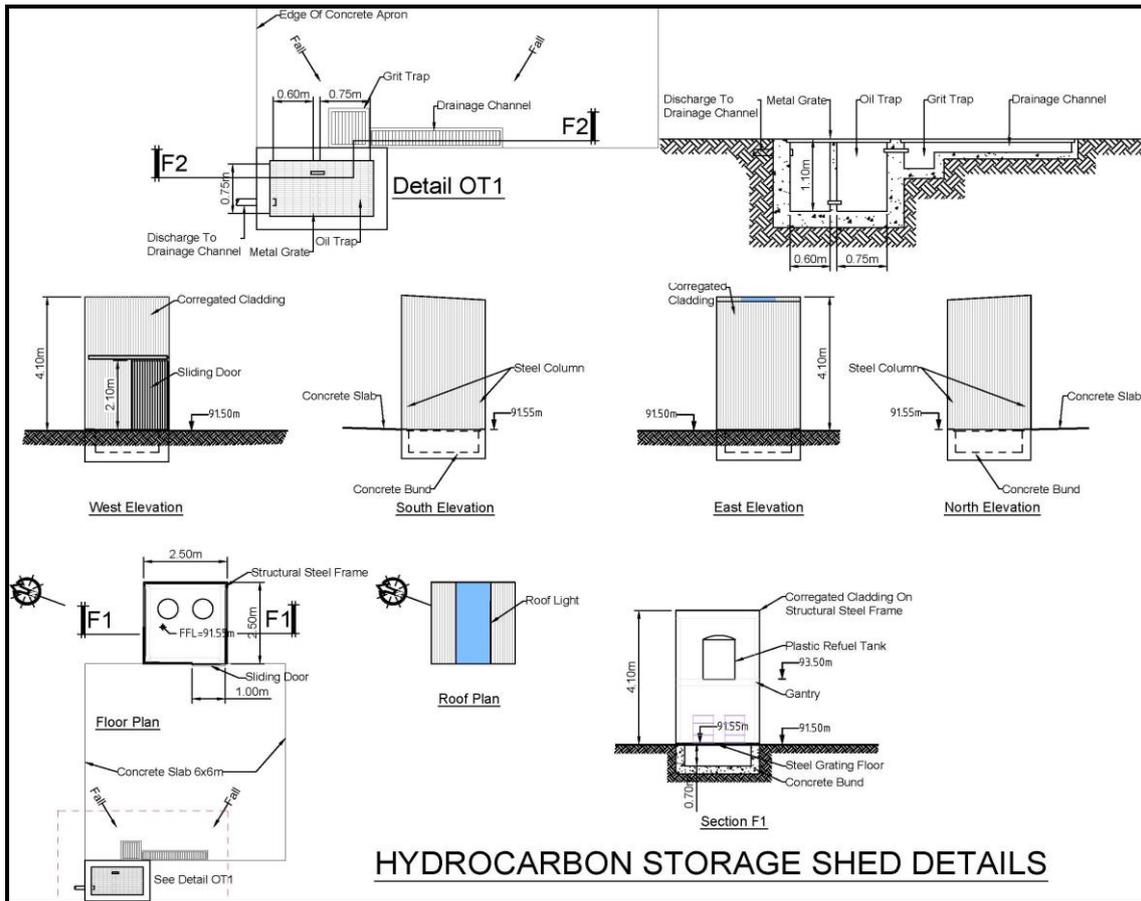
Plate 2-4: Proposed Fuel Storage Shed & Refuelling Pad

A concrete refuelled pad consisting of a reinforced 6m x 6m bermed concrete slab with falls to a grit trap and oil trap. A fuel storage shed will be located adjacent in which diesel will be stored as well as oils. Plate 2-4 shows the proposed infrastructure. It is also proposed to pave the access road into the pit (from the public road to the site office).

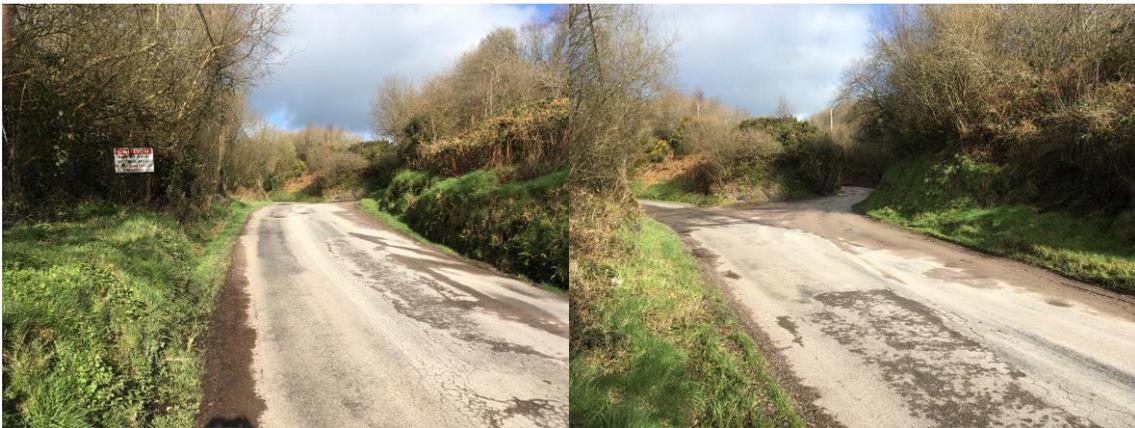
Plate 4-1: View of Pit Entrance from Local Road L-3423 – Looking North

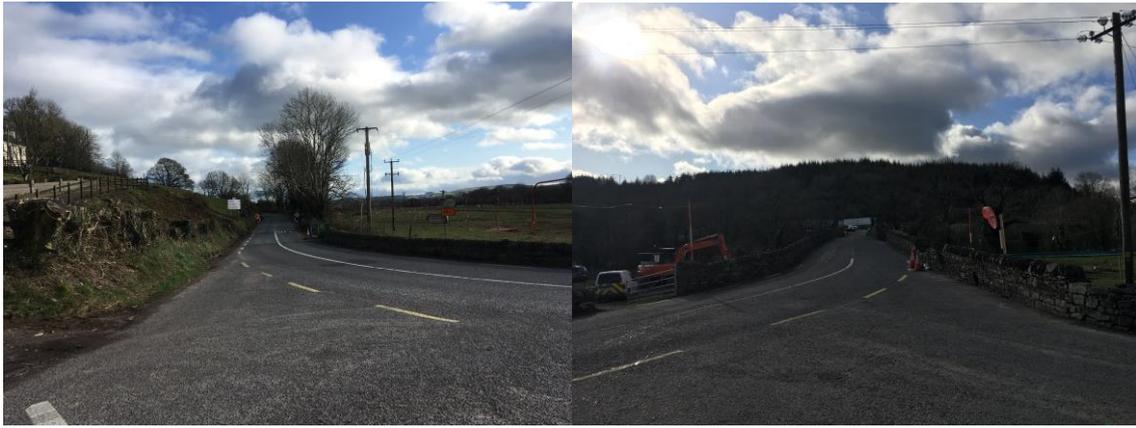
The L-3423 / R618 junction is the first major junction encountered by HGV traffic exiting the gravel pit. The junction is at the outside of a 90° curve in the R618, so sightlines are good at this junction; visibility to the left (east) is approximately 160m and visibility to the right (south) is approximately 150m. Plate 4-2 shows the views at this junction for traffic entering the R618. DCWL HGVs travel to the N22, travel east to the R587 and head south through Kilmichael and into Dunmanway and from there to Bredagh Cross, Drimoleague.

Plate 4-2: View of L-3423 / R618 Junction from Local Road

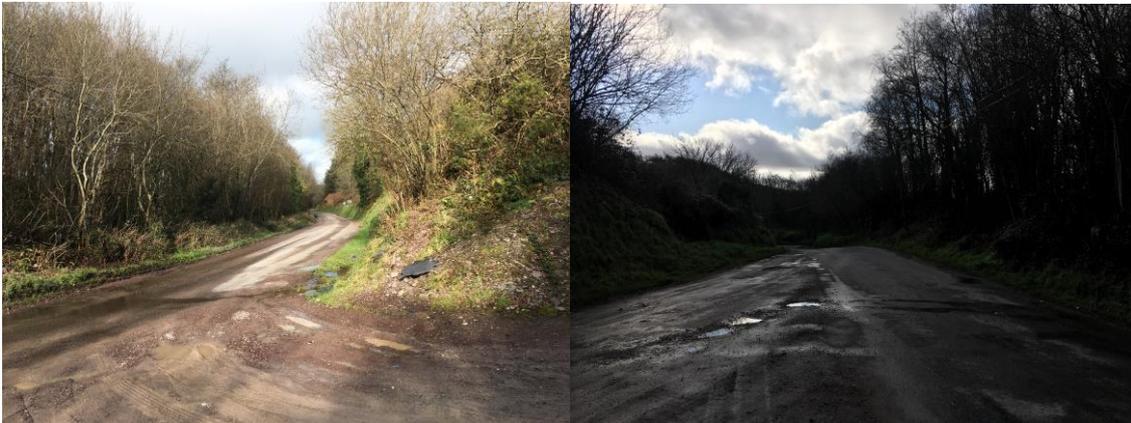
Plate 4-4: Views from Site Entrance Looking North and South

The gate is set back 18m from the road edge allowing a HGV pull off the road safely if the gate is closed.

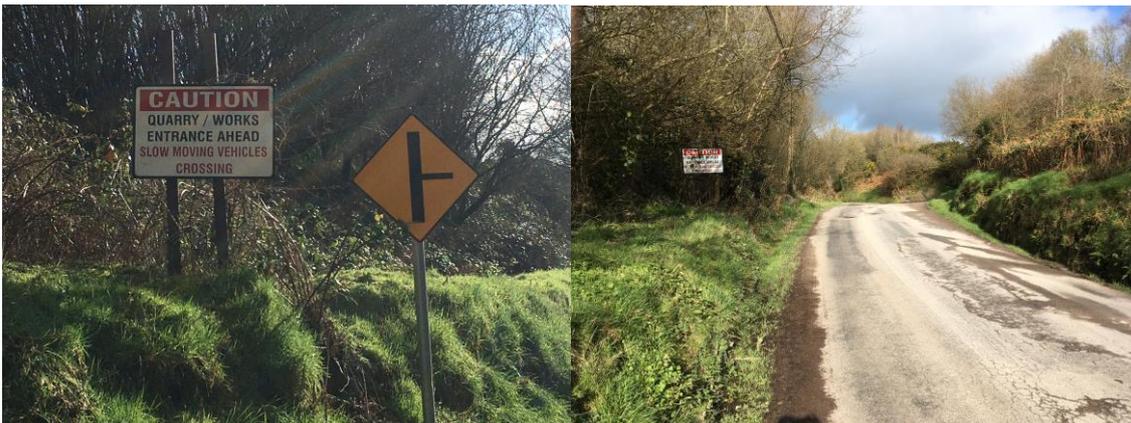
Plate 4-5: Warning Signage on Approach to Entrance – from North & South

Warning signage was erected at the approaches to the entrance since DWCL commenced using it in the 1990's – see Plate 4-5.

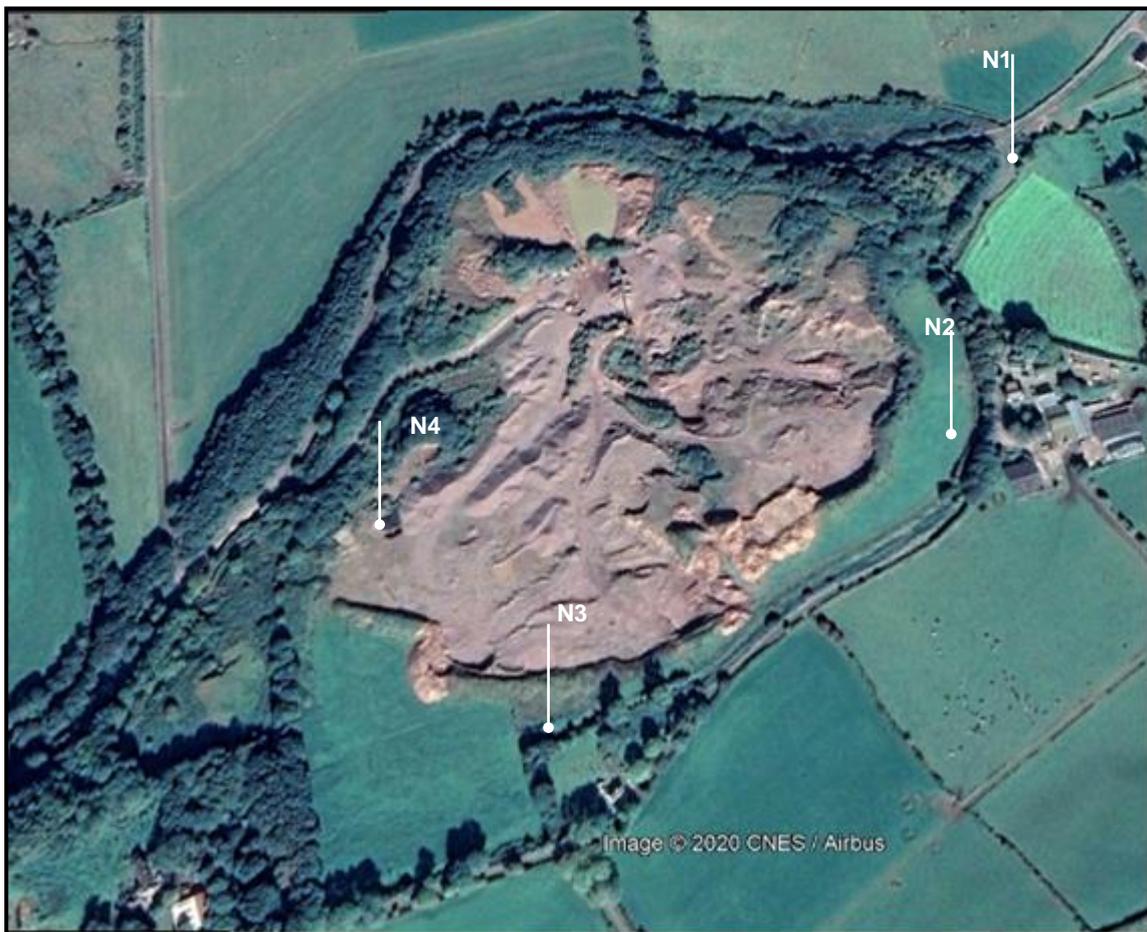
**Figure 5-2: Noise Monitoring Stations**

During both surveys, monitoring was undertaken at four locations representing the nearest receptors (Figure 5-2, Plates 5-1 to 5-4, Table 5-1). Survey details, equipment specifications and weather conditions are listed in Appendices 5-1 and 5-2. Time history profiles are presented in Appendix 5-3, and noise data in Appendix 5-4. Data are summarised in Table 5-2.

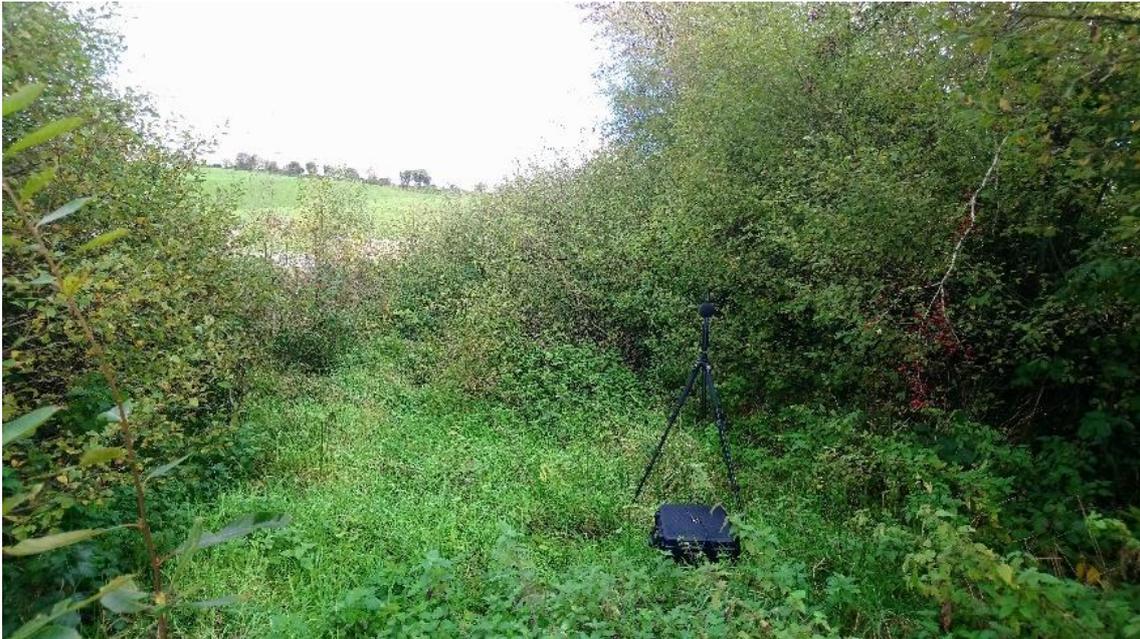
**Plate 5-1: N1, looking NE towards public road**

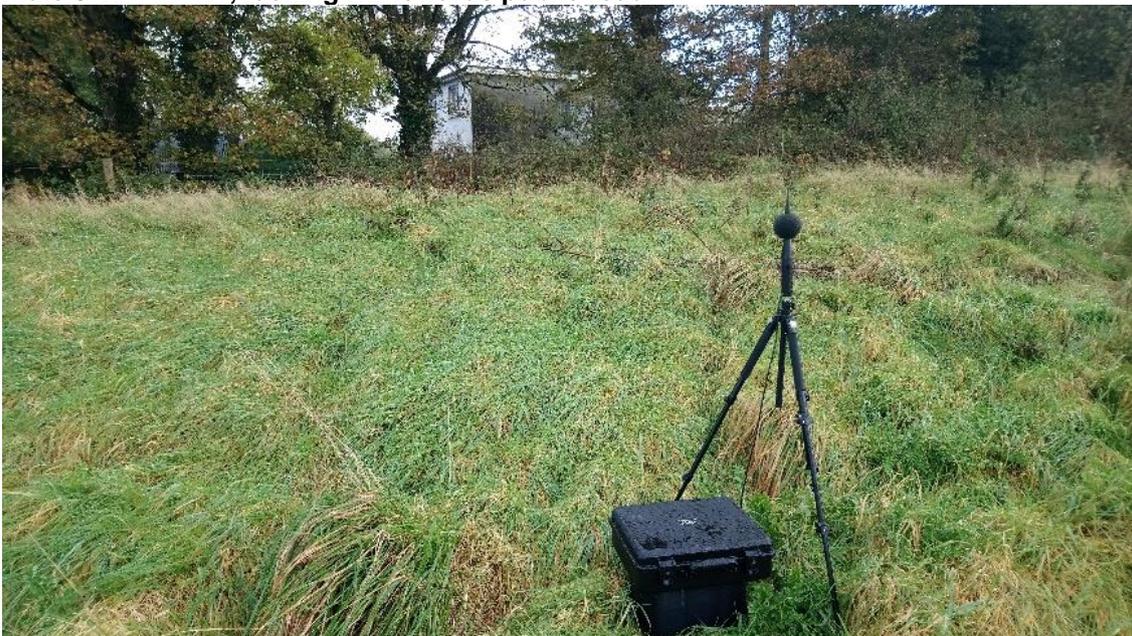
**Plate 5-2: N2, looking E towards farmhouse**

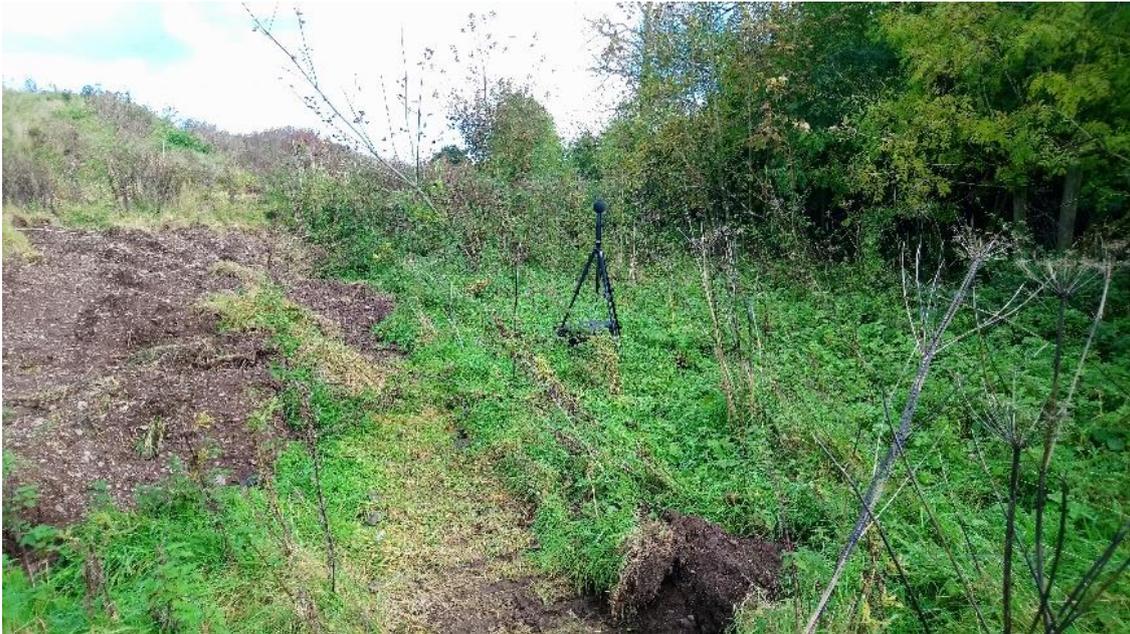
**Plate 5-3: N3, looking NE**

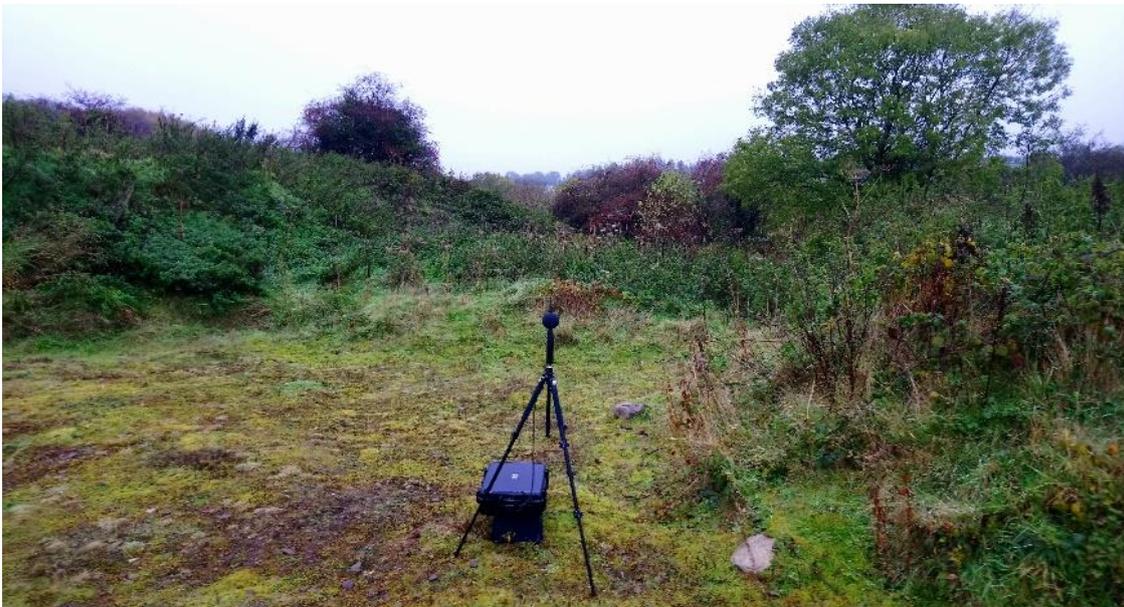
**Plate 5-4: N4, Looking W towards Dwellings in Distance**

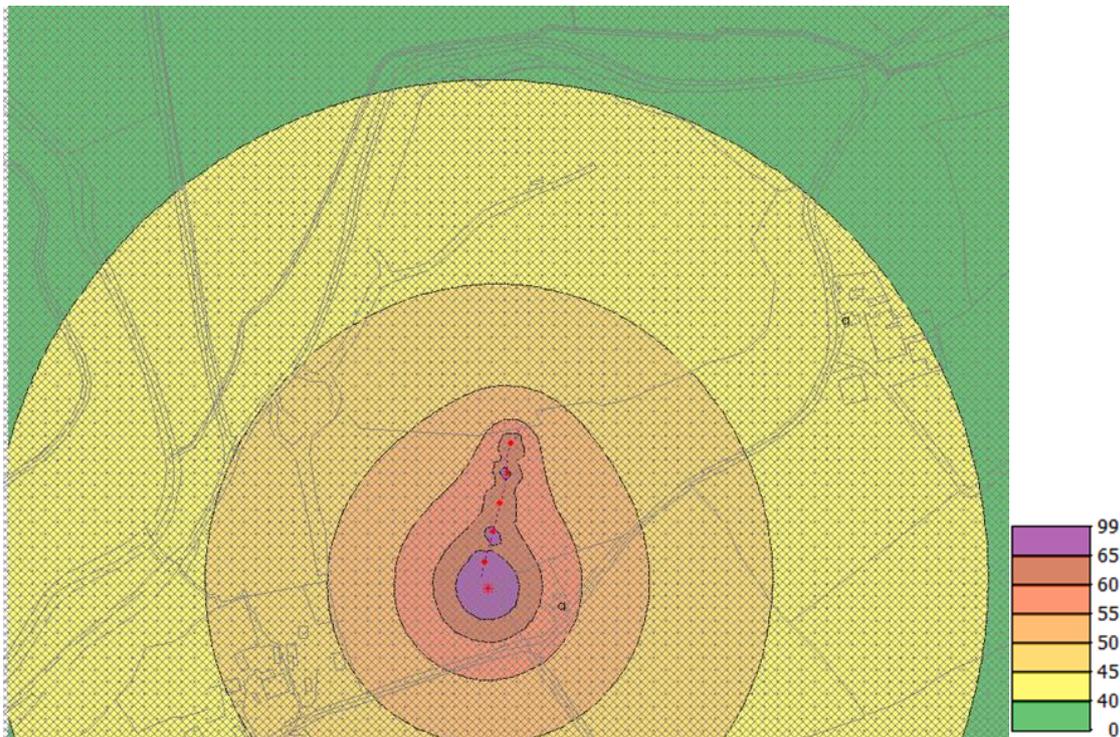
**Figure 5-3: Model Output – Berm Construction near Cottage (H2) to South**

The model output is shown in Figures 5-4 and 5-5. L<sub>Aeq 1 h</sub> levels predicted at the dwellings (close to their respective facades) during local berm construction will be 57dB at the cottage to the south, and 58dB at the farmhouse to the southwest. These levels will remain below the 65dB criterion identified in Section 5-2 with respect to the berm construction phase. It is reiterated that this activity is expected to last 1-2 weeks and will occur once in these zones during the lifetime of the project. At the end of the project, soil stored in the berms is likely to be redistributed across the worked areas as part of the final reinstatement works. Noise emissions during this period are likely to be similar to the berm construction works, and thus noise levels at the nearest receptors will again remain below the 65dB criterion.

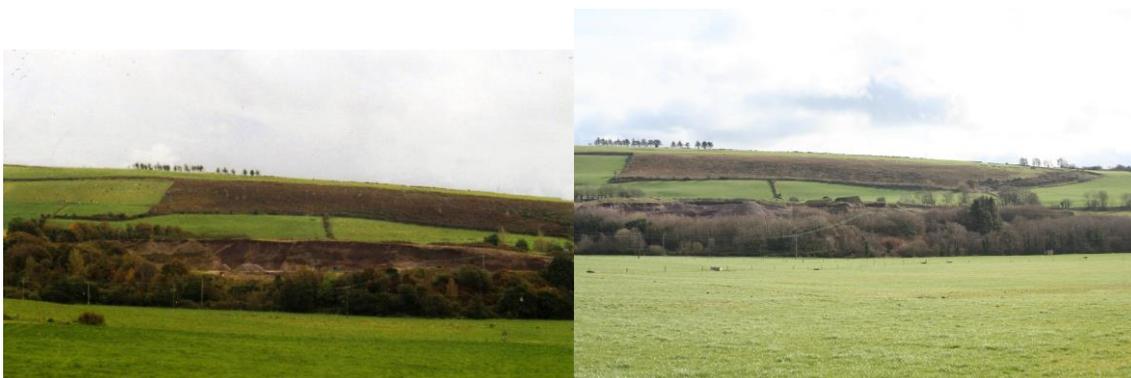
**Plate 6-1: View of Gravel Pit from West – a) 2005 and b) 2020**

Residents of the nearest house (H1) noted nuisance dust deposition at their property in the late 1990's / early 2000's. They also noted that dust nuisance has not been an issue in recent years. The operations at the pit have not changed in any significant way, so it is not clear why this is the case; the sprinkler system was installed in the late 1990's following complaints. It may be that as trees matured along the western boundary of the gravel pit, they protected the site from the prevailing wind direction. Plate 6-1 shows the gravel pit in 2005 (Summer) and 2020 (Winter) viewed from the west. Although taken in Winter with no foliage on the trees, it is evident that they provide greater shelter from the wind.

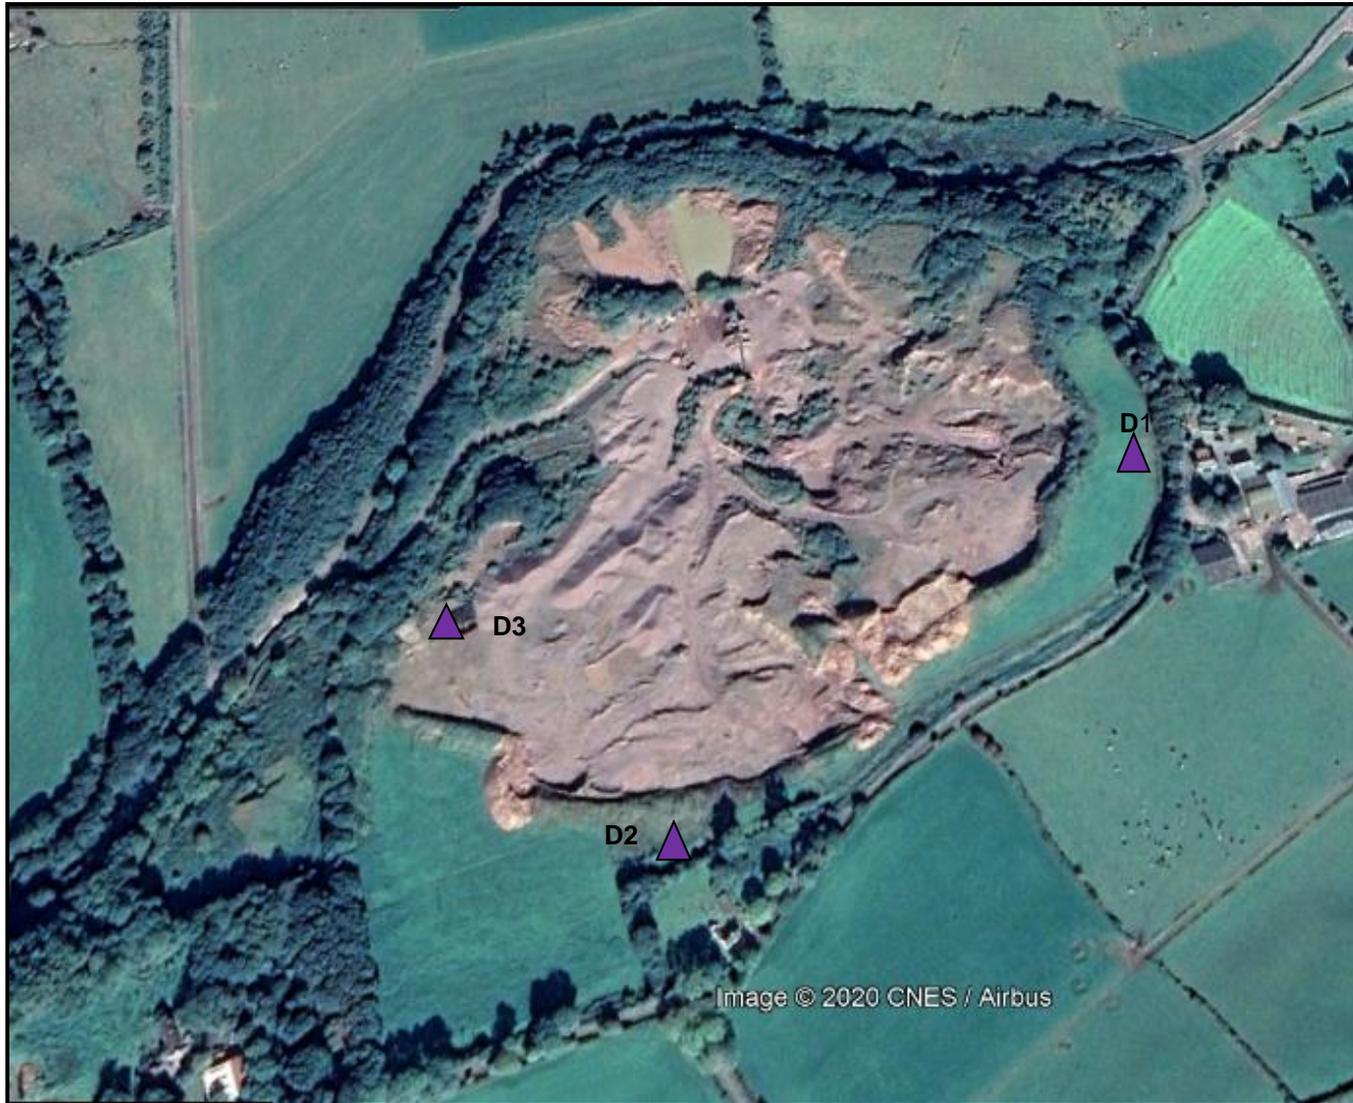
**Figure 6-1: Dust Monitoring Location Map**

Generally, the levels of dust in the countryside are low (<20 mg/m<sup>2</sup>/day). From the walkover survey of the site, there is no indication of dust deposition along the boundary vegetation. Dust monitoring has been conducted at the gravel pit at three monitoring locations – D1, D2 and D3 - using Bergerhoff dust gauges as per the German VDI 2119 Standard Method '*Measurement of Dustfall*'. D1 is located at the eastern side of the pit near house H1; D2 is located at the southern end of the site near house H2 and D3 is located near the site entrance. These are shown on Figure 6-1, with results summarised in Table 6-3.

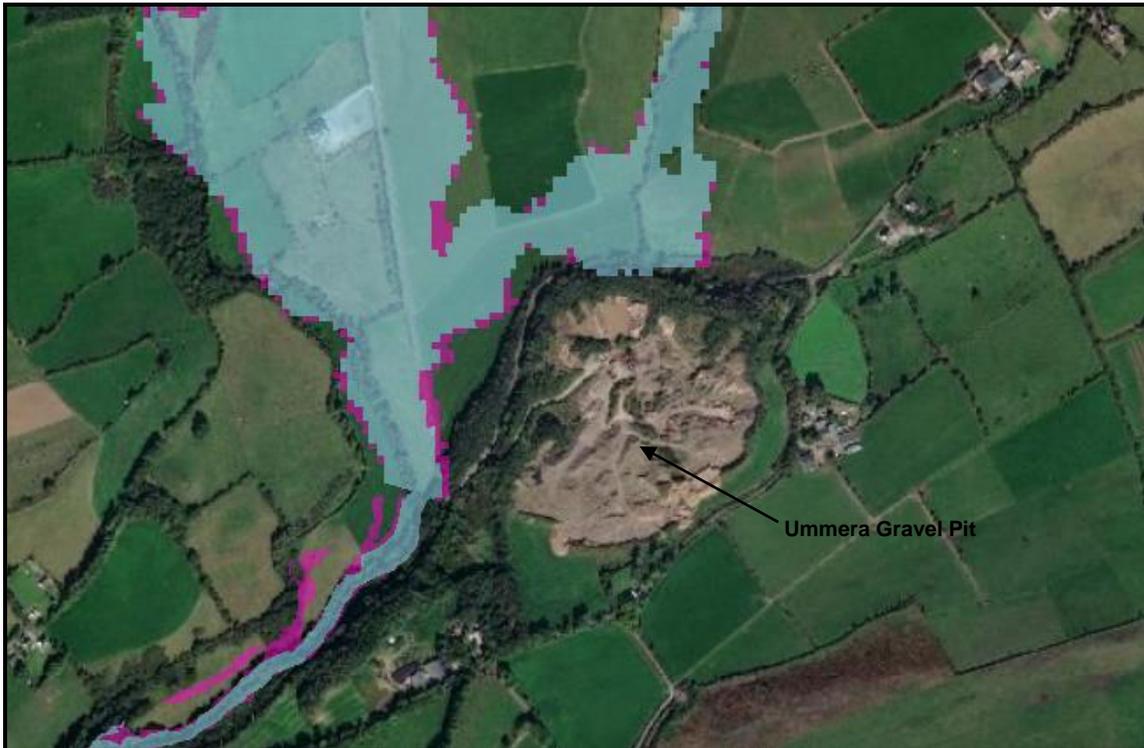
**Plate 7-1: Flooding Extent for Clashavoon Stream & Laney River**

The site does not flood. It is not located within the flood zones as shown in the Macroon LAP (2017). Some parts of the L-3423 and L7478 are shown as being susceptible to flooding, but this does not impact on the gravel pit. Flooding extent is shown on Plate 7-1.

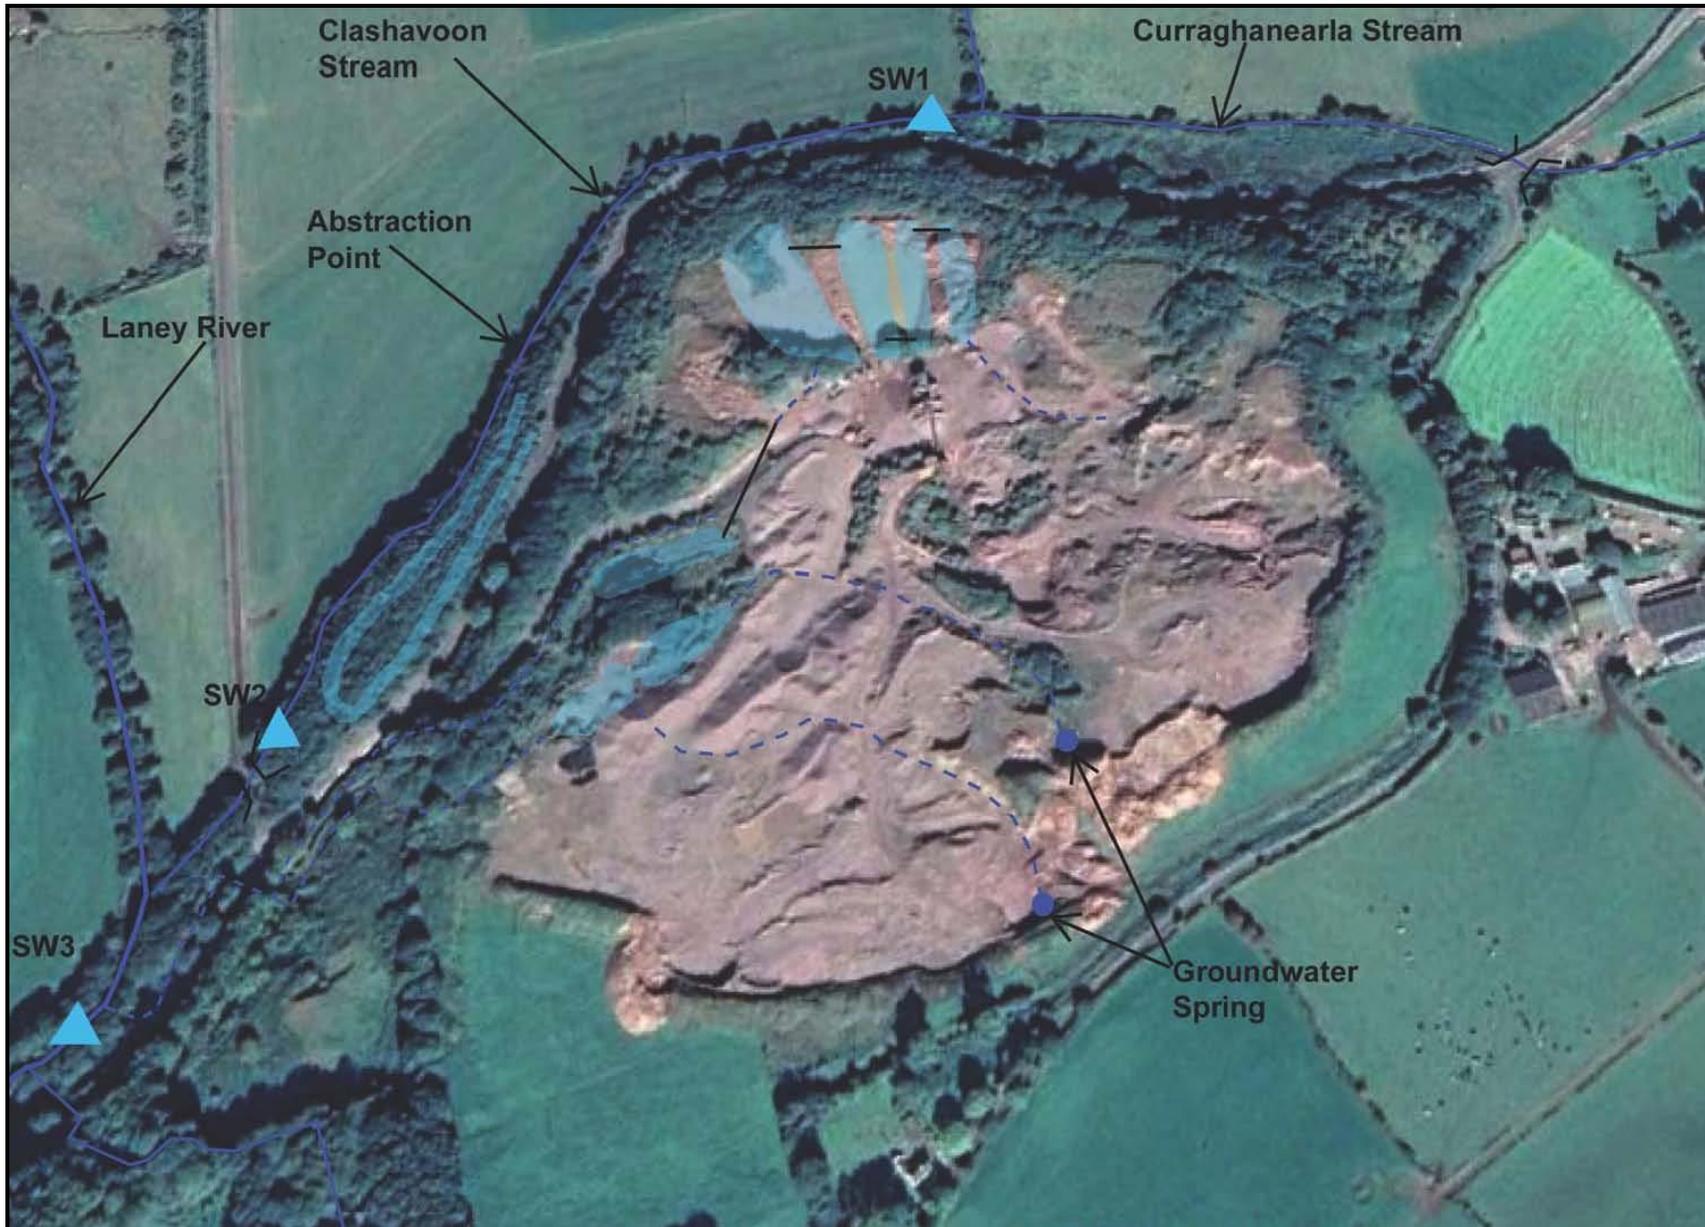
**Figure 7-2: Local Surface Water Drainage**

Surface water management has been improved in recent years to minimise the risk of polluting the Clashavoon Stream. Runoff water from the gravel pit is treated in the on-site settlement ponds prior to recirculation or discharge from site. Additional improvements are proposed to further reduce the risk to the receiving waters. Surface water management will be kept under review during the further development of the gravel pit and improvements made when necessary. Runoff rates and volumes will return to near greenfield conditions with the restoration of the site to agricultural land use.

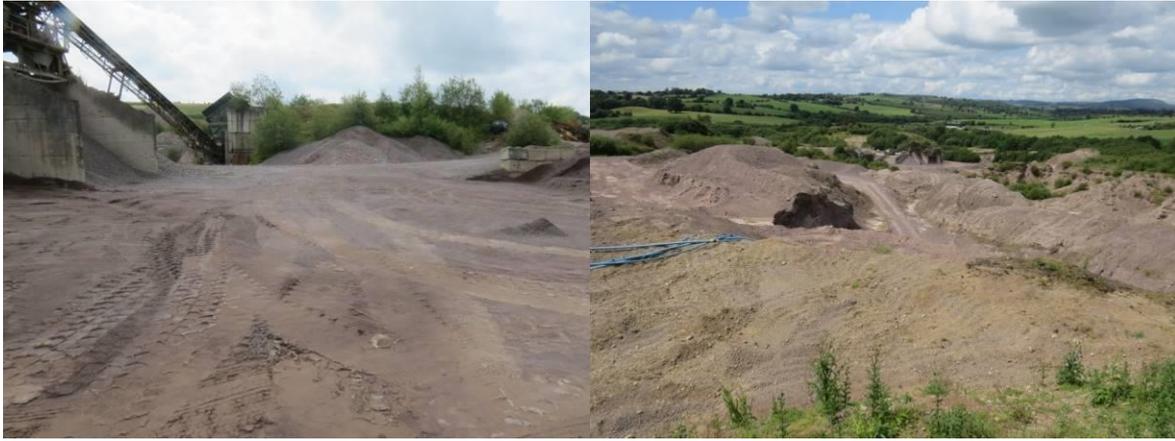
**Plate 10-1: Active Quarry Habitat**

This habitat was recorded within the gravel pit around the areas of active gravel extraction, recently deposited heaps of sorted aggregate and spoil along with active tracks and set down areas (see Plate 10-1). ED4 was found to be the most extensive semi-natural habitat on site. The active quarry habitat also contained a large washing / screening plant and loading bays. No vegetation was recorded in this habitat due to the high rates of disturbance. This habitat is of **negligible ecological significance**. However, active Sand martin (*Riparia riparia*) nest burrow clusters were located at 2 no. locations within the active southern faces on the southern side of the gravel pit; with nests also noted east of the washing plant on an inactive face.

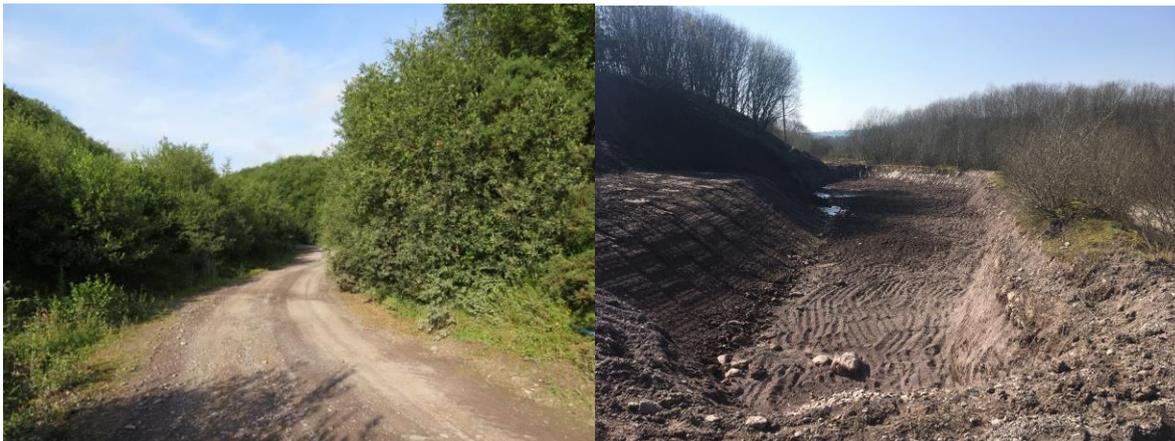
**Plate 10-2: Bare Ground Habitat**

This habitat was recorded within the western section of the Site in the form of an access road to the gravel pit from the public road and unvegetated spoil heaps – see Plate 10-2. The roadway was c. 4 m wide and was made of gravel. The habitat was not vegetated due to the regular traffic from the site.

Recently a small section of Scrub (WS1) land was excavated to install the new emergency overflow pond at the site, forming an open exposed trench along the sites access road (See Plate 10-2). Given water will only enter this pond when the current settlement ponds reach maximum capacity and much of the water entering this pond will be filtered through the gravely soil substrate it thought this habitat will largely remain dry and therefore ED2 in the short-term. While in the medium to long-term sections of standing water (FL8) may well form, with recolonising bare ground (ED3) and transitional scrub forming along the pond banks and dryer sections. Furthermore, during these improvement works at the site an additional pond has been added to the existing settlement pond complex located in the north of the site. While this pond was filled with water from the washing process the adjoining areas of the pond are now bare ground (ED2) habitat which will in the medium to long-term form recolonising bare ground.

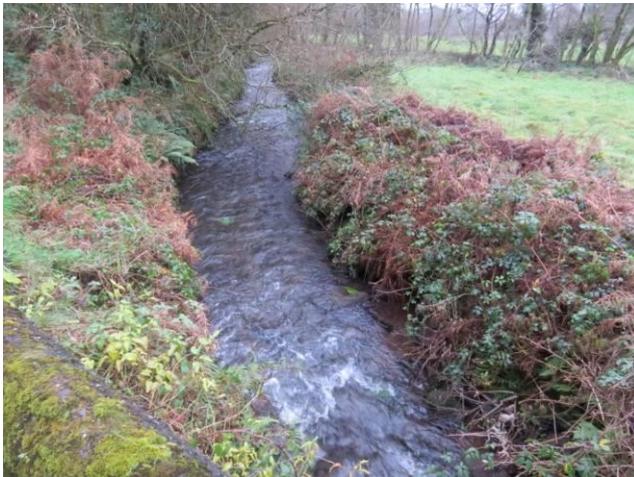
**Plate 10-6: Depositing Lowland River (FW2)**

The Clashavoon Stream (Plate 10-6) forms part of the western margin of the S37L application boundary. The stream was found to have a wetted width of c. 4 m and had a pool-riffle-glide morphology. The riverbed consisted of 20 percent boulder, 30 percent cobbles, 40 percent gravels and 10 percent fine sediment. During the site visit, the water level and flow rates were relatively high for the channel. The riparian vegetation was willow dominated dry woodland. This habitat is of **County importance** due to its potential to host otter (listed on Annex II of the Habitat Directive) as well as other species such as salmonids – i.e. brown trout.

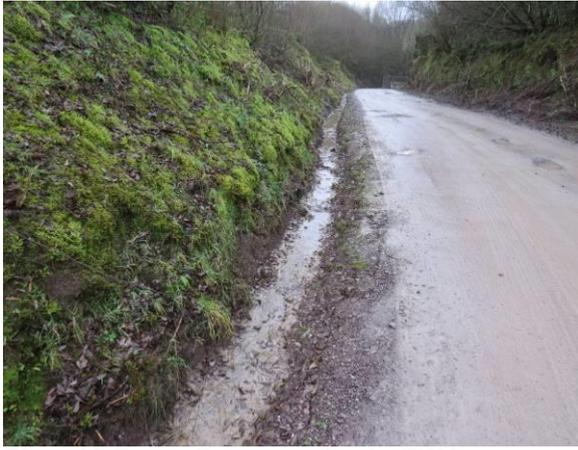
**Plate 10-7: Drainage Ditch (FW4)**

During the December 2019 survey a small drain (Plate 10-7) was recorded along the edge of the public road southwest of the gravel pit entrance and along the main entrance track to the gravel pit.

The entrance track and roadside drain was c. 3 cm wide and 5-10 cm deep and carried surface water from the gravel pit and public road to the southwest along the road before crossing under the road via culvert into a deeper drain (c. 2 m deep, c. 1 m wetted width) with more slow moving/standing water on the western side of the road which eventually flowed to the River Laney. This drain has limited potential for aquatic species or habitat and likely dries; it was not flowing during the July 2019 survey. This a man-made drain which supports little to no ecological receptors and is of **negligible ecological significance**.

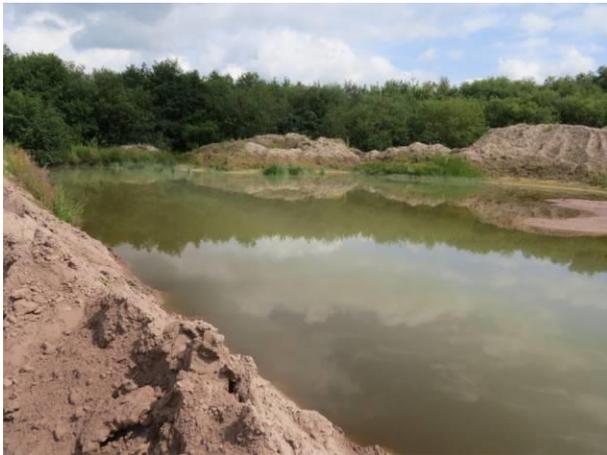
**Plate 10-8: Western Settlement Pond (July 2019)**

This habitat was recorded within the northern and western section of the gravel pit during the July and December 2019 surveys. A large pond used to settle out fine sediment is located close to the northern boundary of the site. During the July site visit, the water was judged to be c. 1 to 2m at the deepest section of the pond and sediment laden. No floating vegetation was observed on the pond.

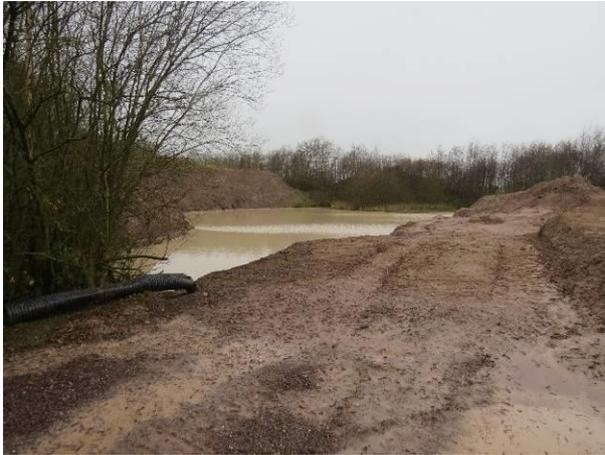
**Plate 10-9: Western Settlement Pond (December 2019)**

Given that these ponds have ongoing maintenance requirements with water being continuously recirculation, the water levels fluctuate and with high levels of silt present, the potential for colonisation of plants and species within the ponds is limited.

While the settlement ponds did not support notable aquatic vegetation, standing waterbodies are generally scarce in the agricultural landscape of Cork. When lightly used or restored, such habitats can provide important forging habitat for bats; as well as habitat for invertebrates, amphibians and birds. Such habitat is therefore of **local importance (lower value)**. However, in their current state they are of **negligible value** (see Plate 10-9).

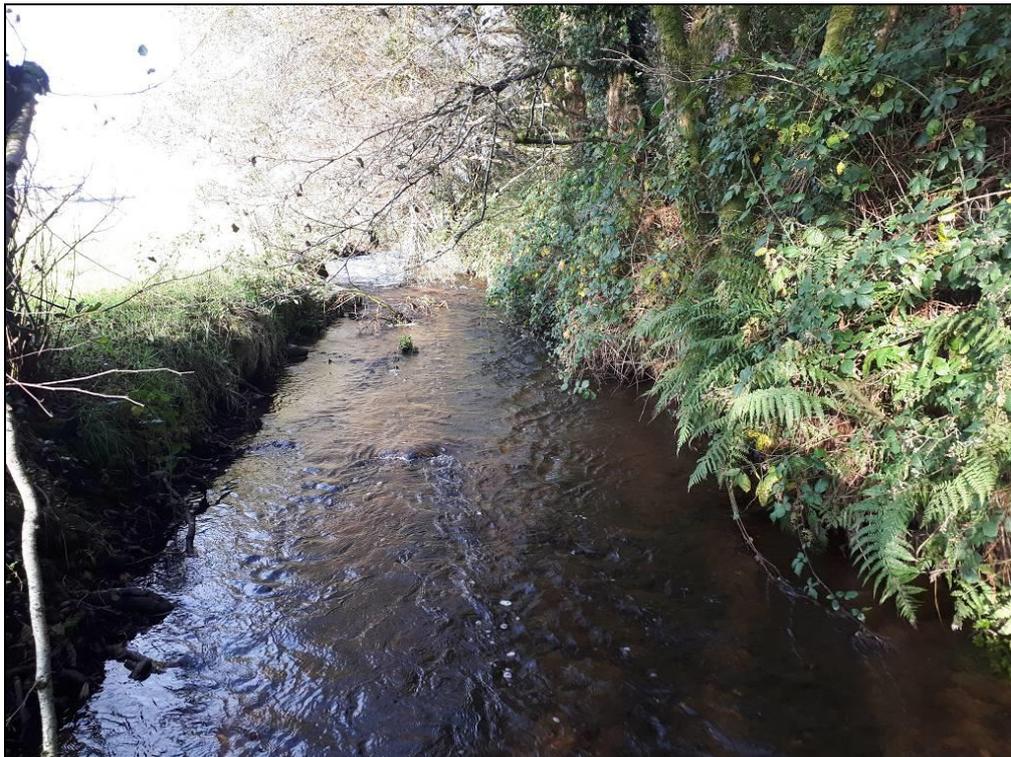
**Plate 10-28: Site 1: Sampling Site Downstream of Abstraction Point**

The contents of the kick sample contained a significant amount of fine detritus material. It is possible that this material is as a result of decaying algal growths during the summer months.

**Table 10-13: Site 1 Macroinvertebrate Taxa List**

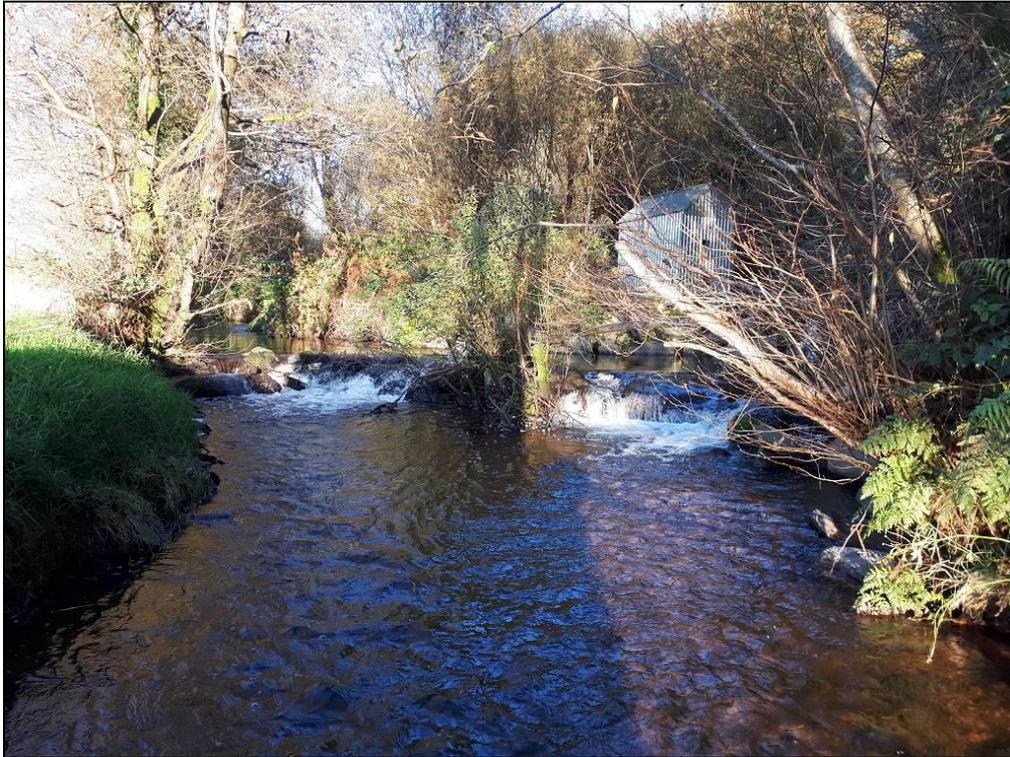
**Plate 10-29: Man-made Weir on Clashavoon Stream**

The abstraction point and pumphouse are located on the left (eastern) bank of the Clashavoon Stream. A man-made weir is located immediately downstream of the abstraction point that comprises a number of large boulders. A pool is present along the left bank where the abstraction of surface water occurs. The weir results in a backwater in the Clashavoon Stream for a short stretch upstream of the weir. At the time of sampling, the water of the Clashavoon Stream was clear.

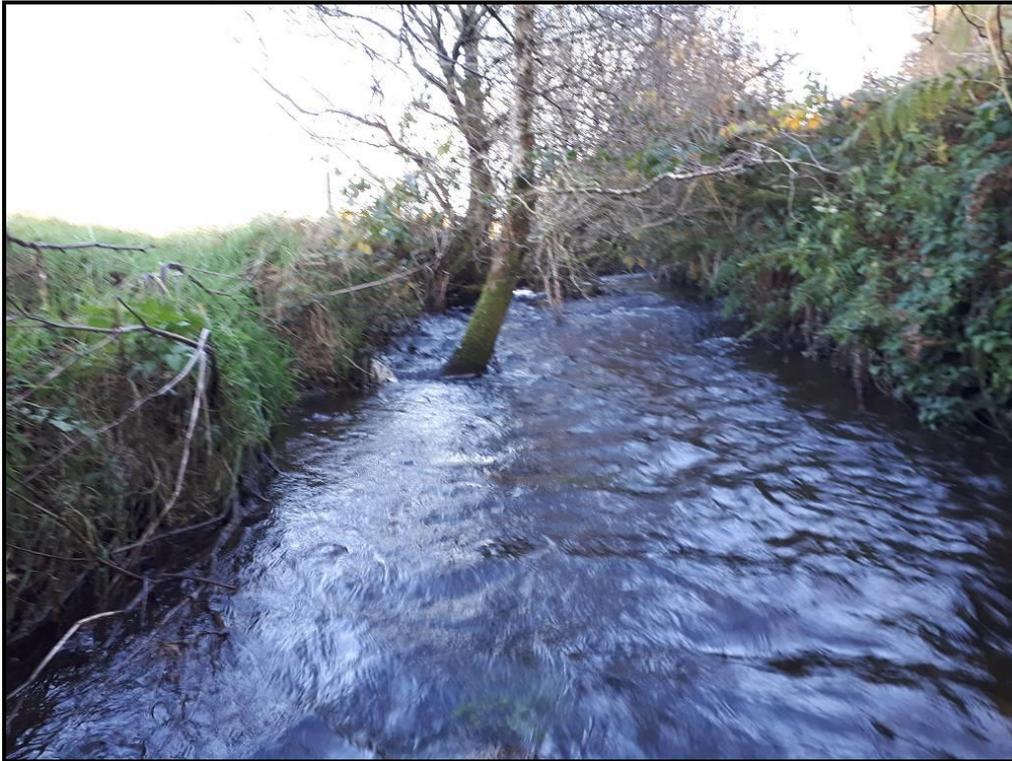
**Plate 10.31 Site 2 Sampling Site**

The contents of the kick sample contained a notable amount of fine detritus material, however less than that encountered in the sample at Site 1. It is possible that this material is as a result of decaying algal growths during the summer months.

**Table 10-14: Site 2 Macroinvertebrate Taxa List**
