# **Environmental Impact Assessment Report**

## **Volume 2 of 3 – Main Report** *For*

### **FURTHER DEVELOPMENT OF UMMERA GRAVEL PIT MACROOM, COUNTY CORK**

**September 2020**

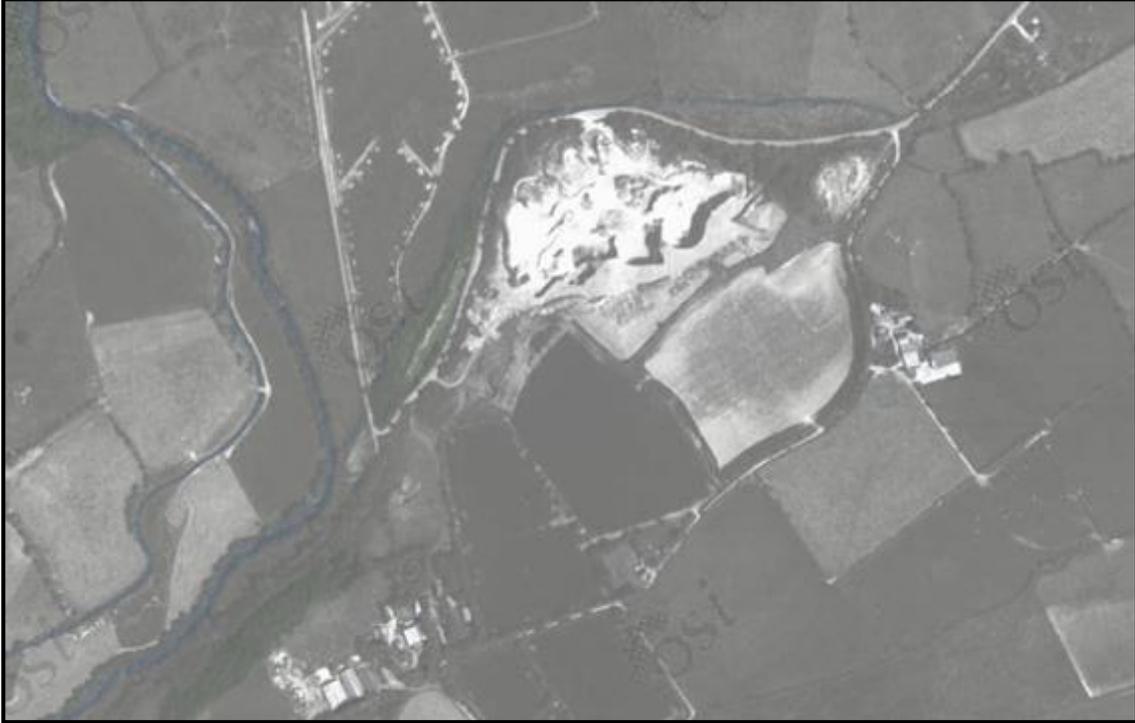
**Plate 11-1: 1995 OSi Aerial Photograph**

The removal of agricultural land has been ongoing since gravel extraction commenced at Ummera. The pit has advanced to the south from the northwest corner since the 1940's. The progress is well documented since 1995 when OSi aerals became available. Aerial photography for 1995, 2000, 2005 and 2018 are provided in Plates 11-1 to 11-4, which demonstrate the progression of gravel extraction. It is apparent from the 1995 and 2000 aerial photographs that internal hedgerows were removed by the farmer (previous owner) during this period.

The 1995 aerial photograph is black & white, so detail is difficult to ascertain. The following is noted:

The area of extraction currently extends to approximately 8ha, increasing steadily since extraction commenced at Ummera, partially demonstrated in Plates 11-1 to 11-4. In the past 30 years, it is estimated that approximately 500,000m<sup>3</sup> of sand and gravel has been removed from the Ummera pit. This is only an estimate as records of loads is not available. An estimated volume of 375,000m<sup>3</sup> (i.e. 750,000 tonnes) will be removed during the further development of the gravel pit over a 15-year period – i.e. approximately 50,000 tonnes/yr.

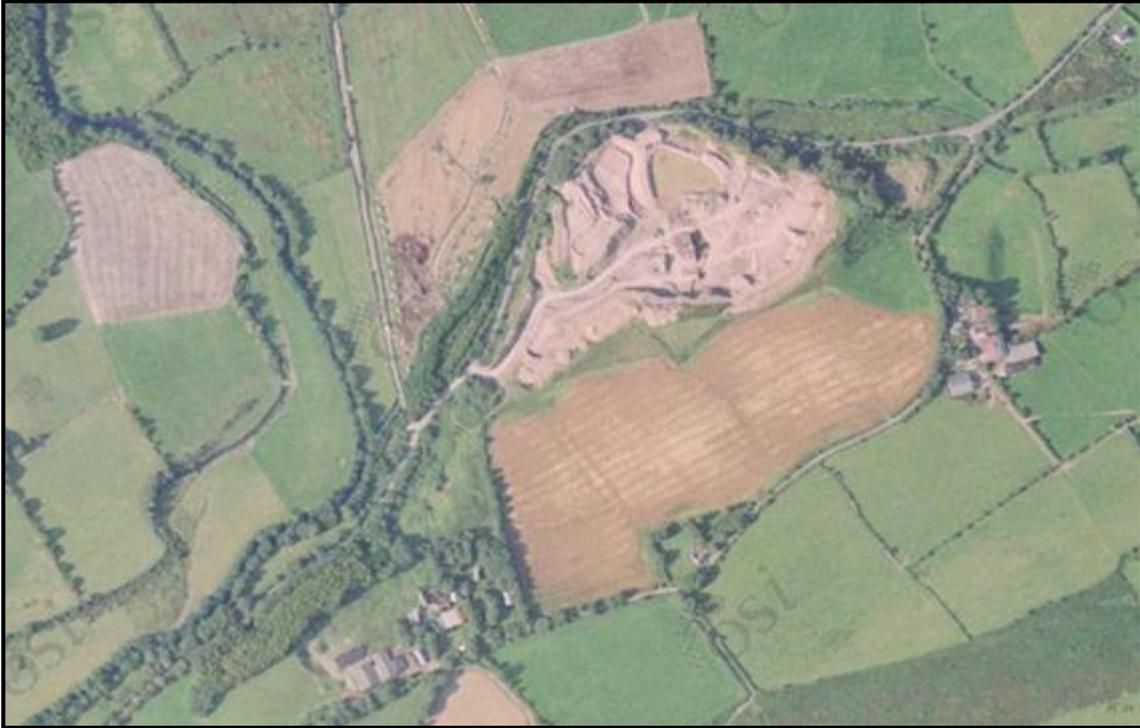
**Plate 11-2: 2000 OSi Aerial Photograph**

The following is noted from the 2000 aerial photograph:

- The gravel pit occupies much the same area as that seen in the 1995 aerial photograph; extraction has moved 20 to 30m to the south.
- The hedgerows in the agricultural fields to the south and southeast have been removed.
- The gravel pit is accessed from the southwest corner, with the entrance at the northwest corner closed off. The berms constructed at the former entrance are not yet vegetated.
- The washing plant has been moved into the gravel pit – to its current location. It would therefore have been less visible from the public road. A settlement pond has been constructed within the gravel pit.
- Vegetation is developing over the silt deposited at the northeast corner of the landholding.
- The trees along the northern road boundary have been maintained and provide good screening. There is a berm along the western boundary with shrubs developing.

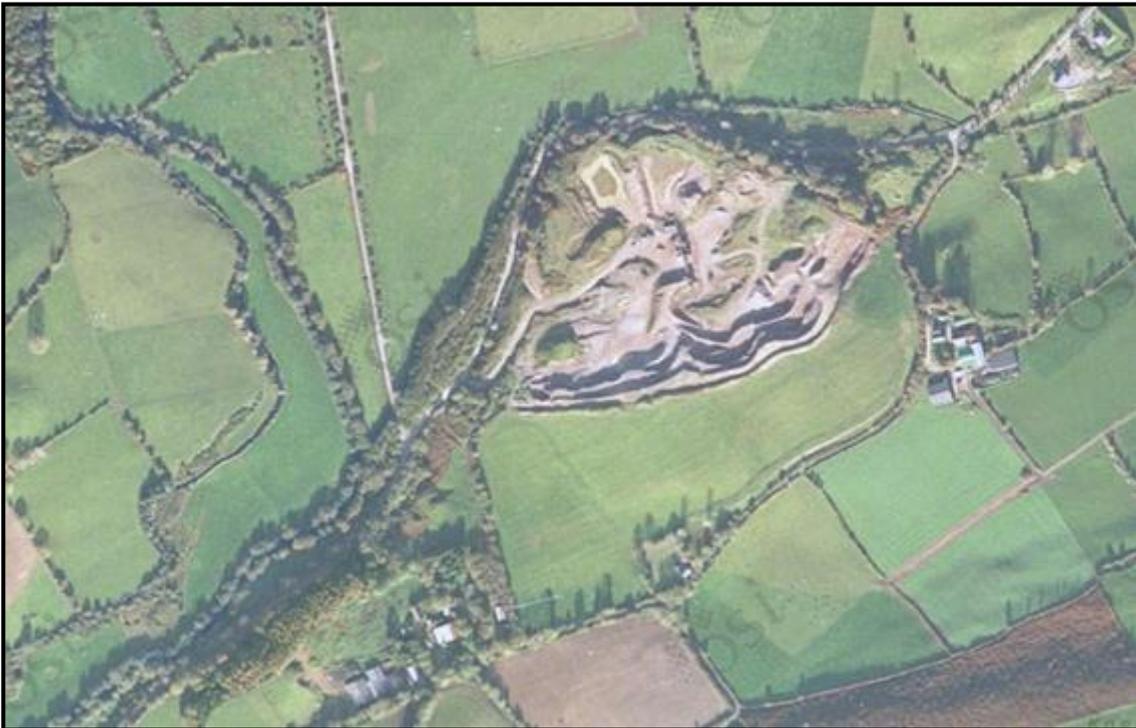
Plate 11-3: 2005 OSi Aerial Photograph

Aerials for 2005 and 2018 show a progression of extraction to the south.

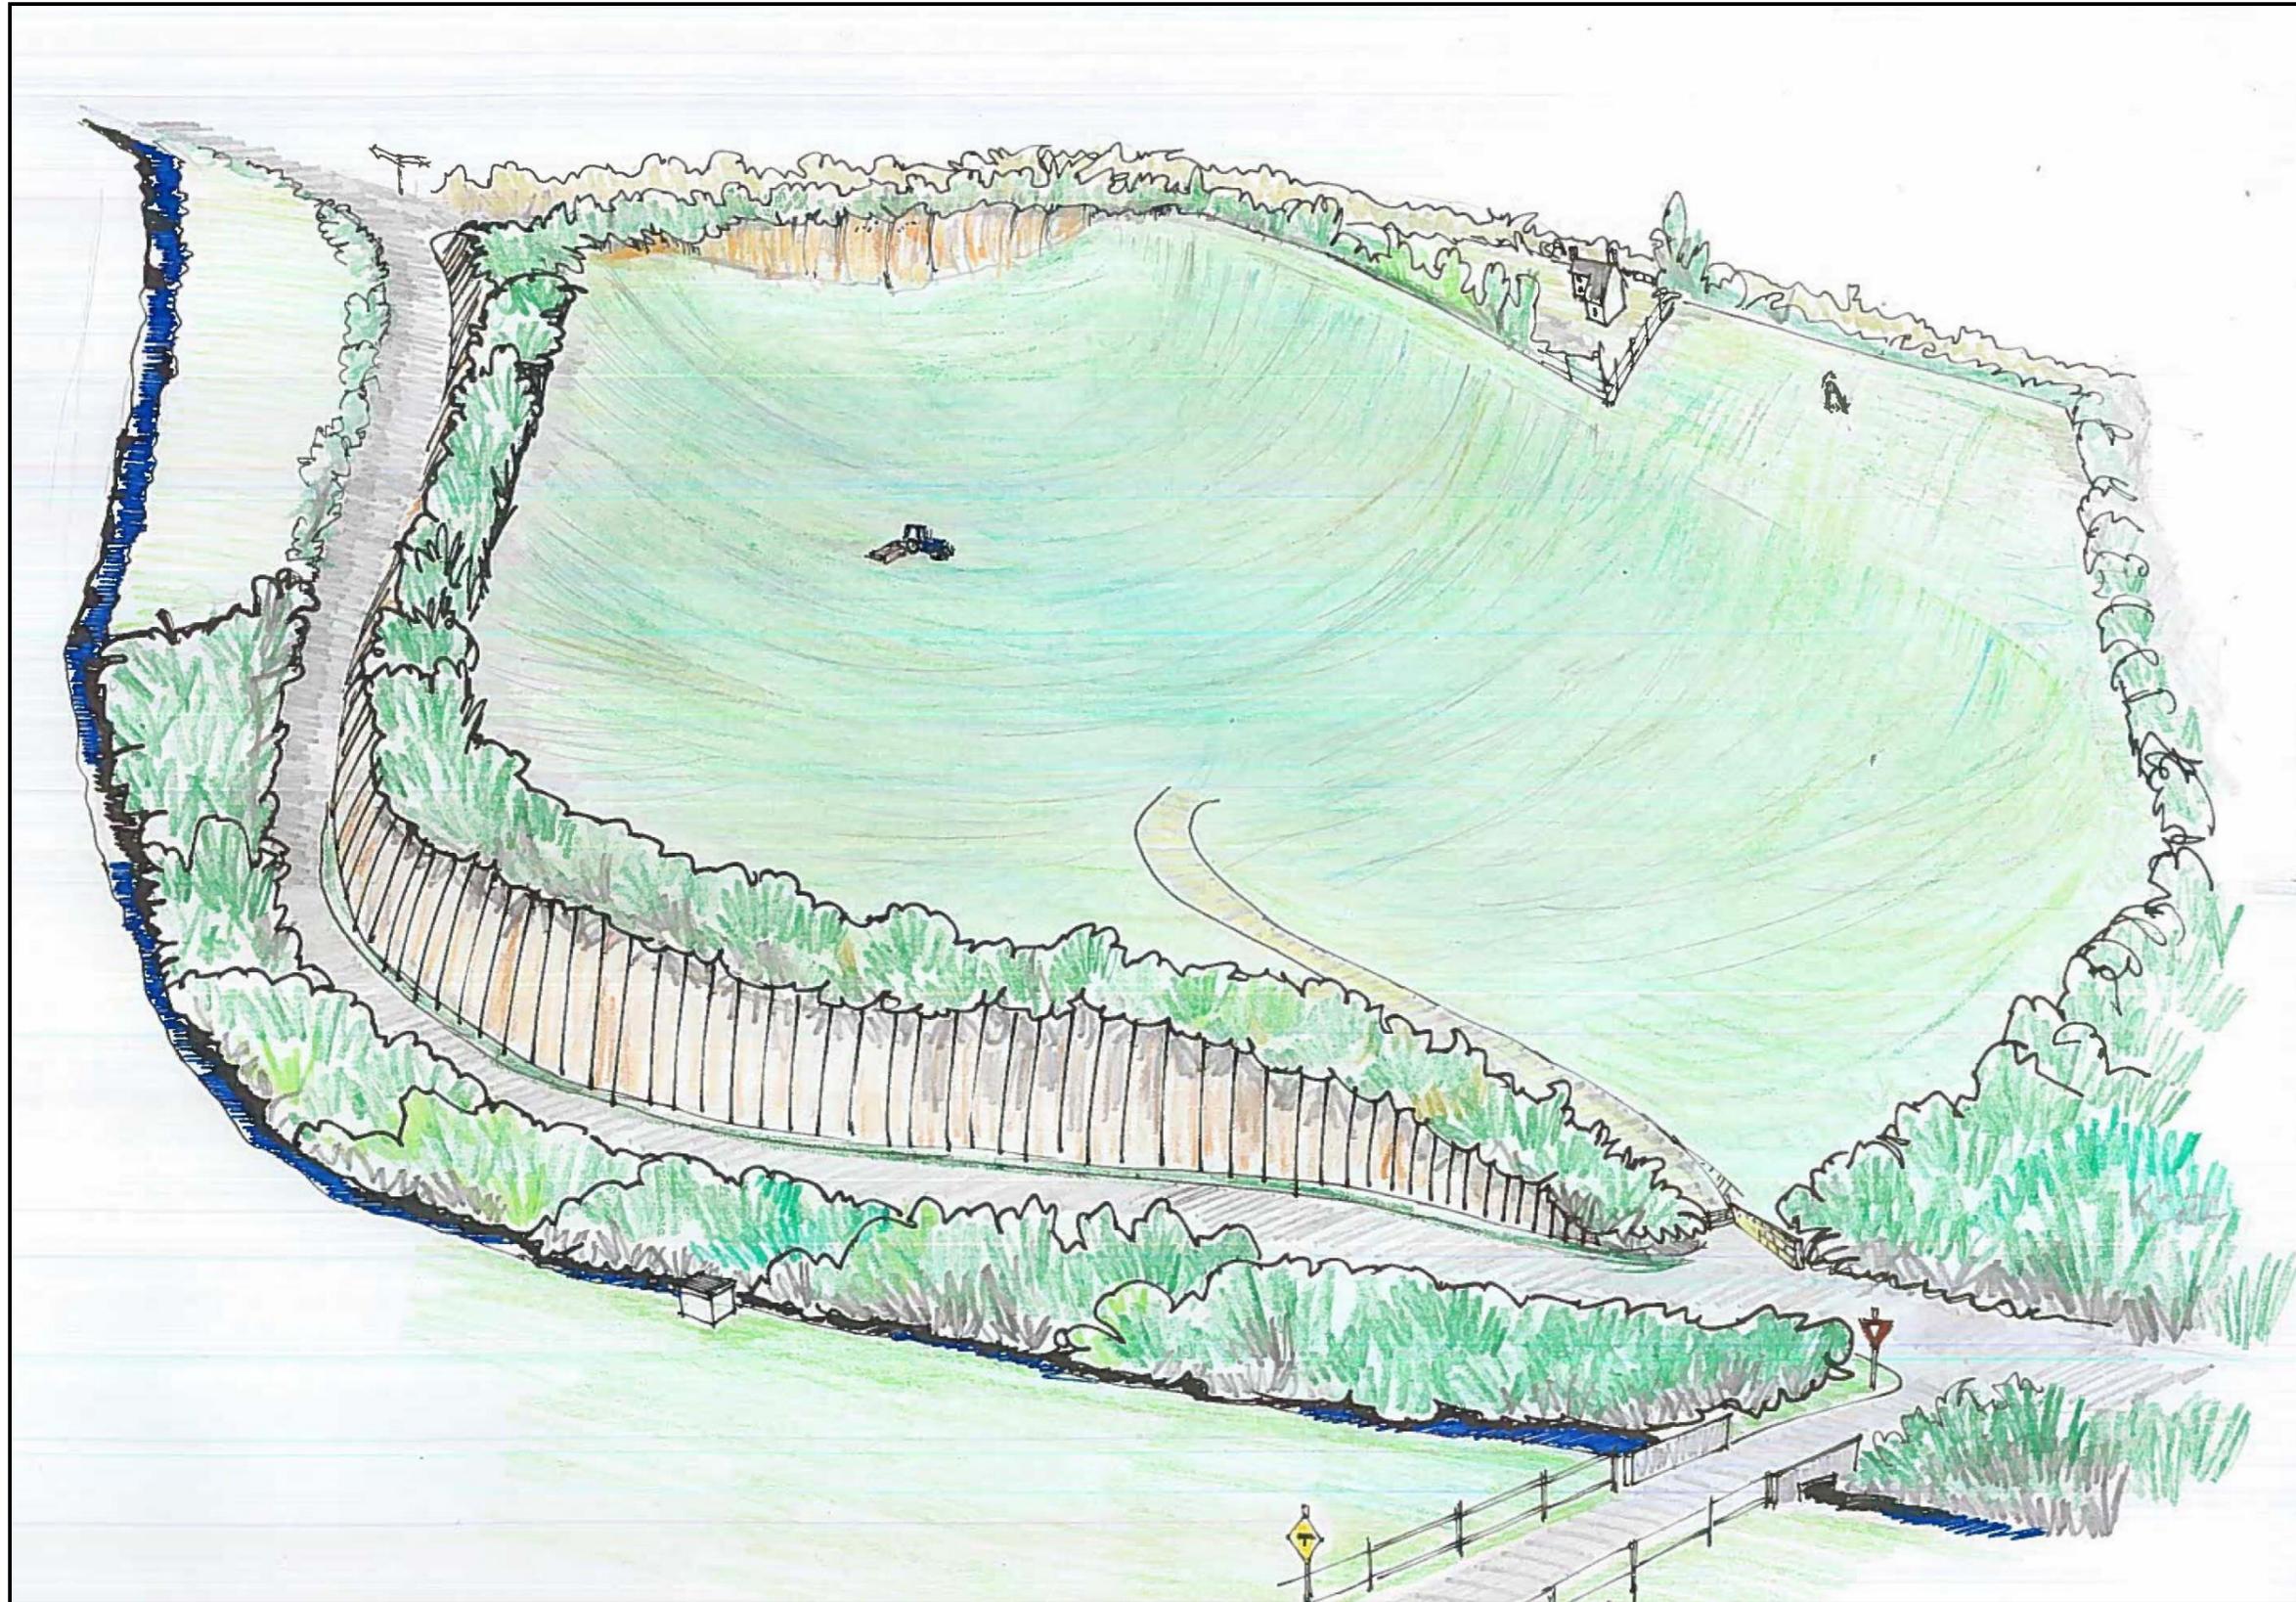
Figure 11-7: Artist Impression – Restored Gravel Pit

It is proposed to return the Ummera gravel pit to agricultural use after extraction is completed. While it would have been preferable to commence phased restoration of the pit, the nature of the deposits has made this difficult to date; the gravel deposit is not homogeneous. Going forward, phased restoration will need to be implemented to better manage the silt cleaned from the settlement ponds and reduce the area of land with exposed soils. The restoration plan for the gravel pit is provided in Figure 11-6.
