## **APPENDIX 7.1      SITE INVESTIGATION REPORT**

**S.I. Ltd Contract No: 5699**

**Residential Developments**  
**Dunshaughlin, Co. Meath**  
**Site Investigation Report**

Issue Date:	10/03/2020
Status	Final
Revision	1

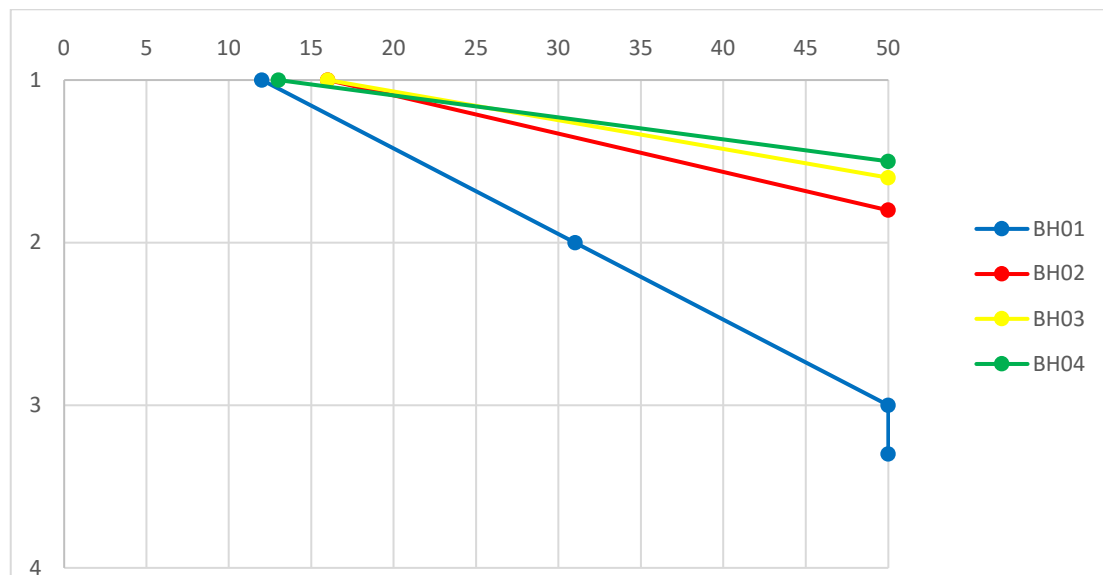
The SPT N-values are consistent with values of 12 to 16 recorded at 1.00mbgl. BH01 increased to 31 at 2.00mbgl whilst the remaining boreholes terminated above this depth. The graph below shows the SPT N-value vs depth.

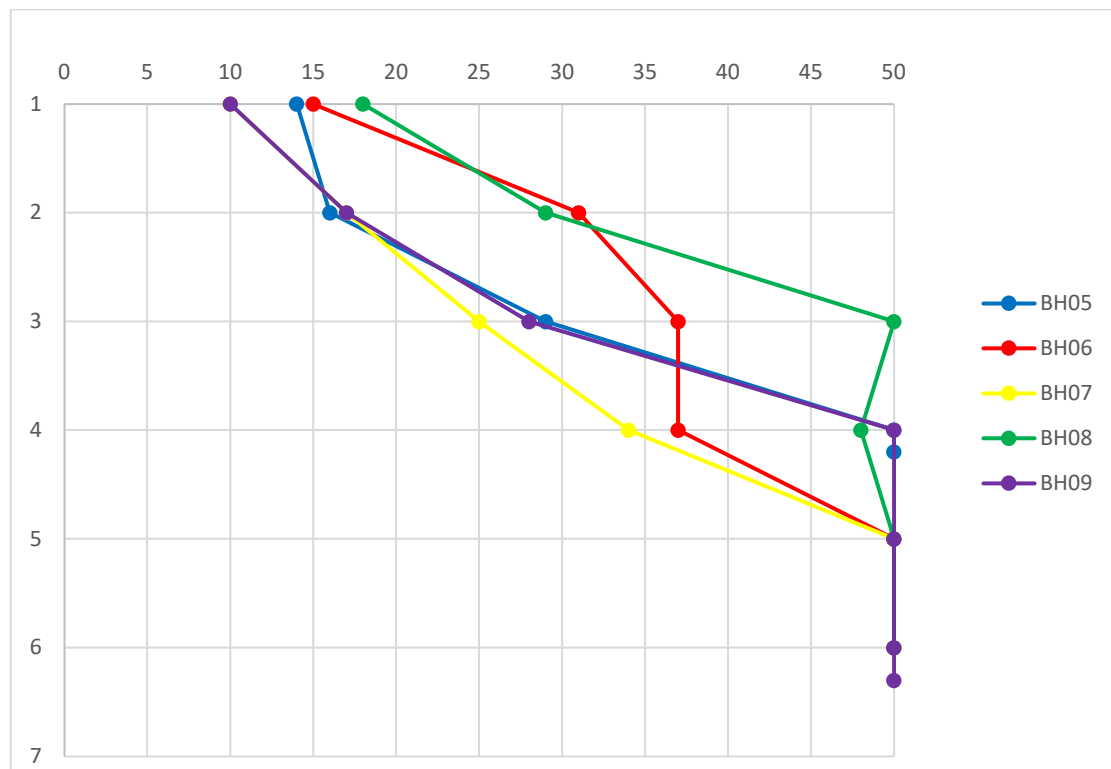
The SPT N-values are consistent with values of 10 to 18 recorded at 1.00mbgl. BH05, BH07 and BH09 increased to 16 and 17 at 2.00mbgl whereas BH06 and BH08 increased to 31 and 29 respectively. The graph below shows the SPT N-value vs depth.

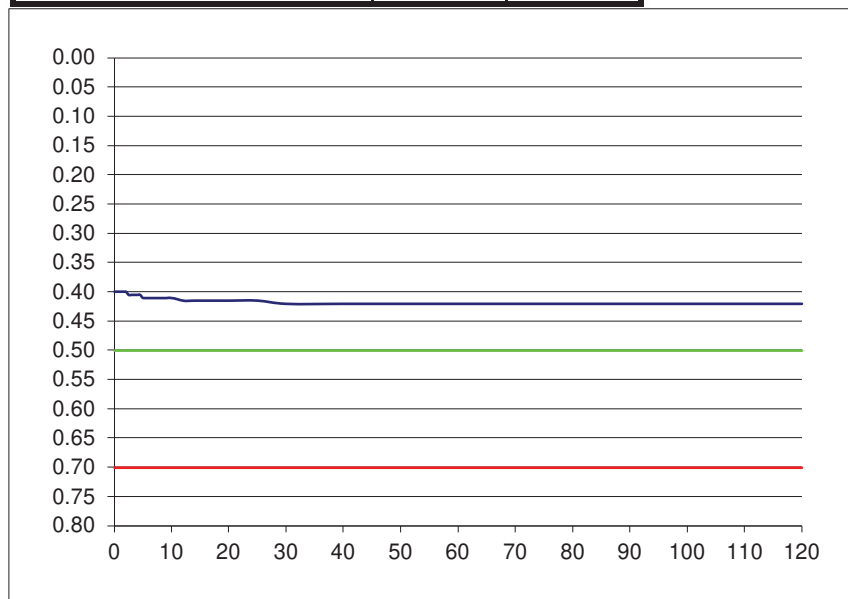
Elapsed Time (mins)	Fall of Water (m)	<b>Pit Dimensions (m)</b>		
0	0.40	Length (m)	1.90	m
0.5	0.40	Width (m)	0.60	m
1	0.40	Depth	0.80	m
1.5	0.40	<b>Water</b>		
2	0.40	Start Depth of Water	0.40	m
2.5	0.41	Depth of Water	0.40	m
3	0.41	75% Full	0.50	m
3.5	0.41	25% Full	0.70	m
4	0.41	75%-25%	0.20	m
4.5	0.41	Volume of water (75%-25%)	<b>0.23</b>	m <sup>3</sup>
5	0.41	Area of Drainage	<b>4.00</b>	m <sup>2</sup>
6	0.41	Area of Drainage (75%-25%)	<b>2.14</b>	m <sup>2</sup>
7	0.41	Time		
8	0.41	75% Full	N/A	min
9	0.41	25% Full	N/A	min
10	0.41	Time 75% to 25%	N/A	min
12	0.42	Time 75% to 25% (sec)	N/A	sec

14	0.42
16	0.42
18	0.42
20	0.42
25	0.42
30	0.42
40	0.42
50	0.42
60	0.42
75	0.42
90	0.42
120	0.42

**f = Fail or**

All of the infiltration tests recorded no infiltration and therefore, failed the specification. The BRE Digest stipulates that the pit should half empty within 24hrs, and extrapolation indicates this condition would not be satisfied. The test was terminated at the end of the first (of a possible three) fill/empty cycle since further testing would give even slower fall rates due to increased soil saturation. The unsuitability of the soils for soakaways is further suggested by the soil descriptions of the materials in this area of the site where the soakaway was completed, i.e. well compacted clay/silt soils.

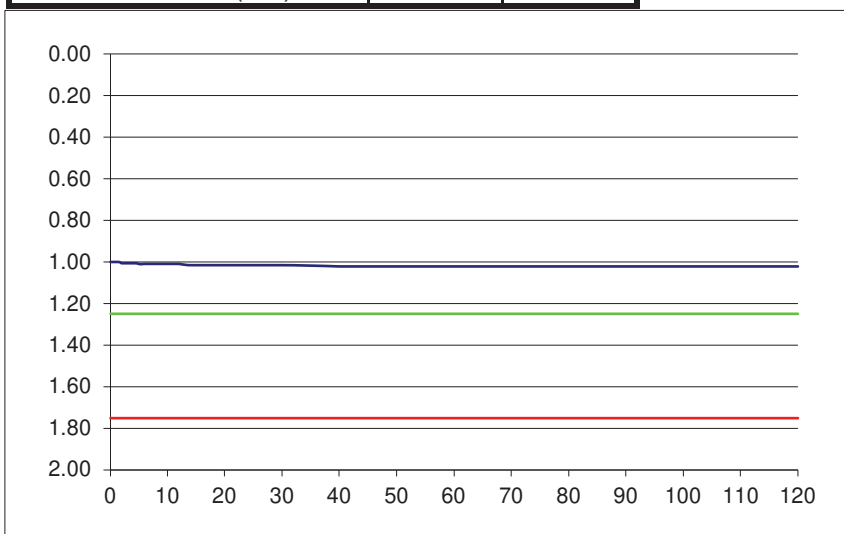
Elapsed Time (mins)	Fall of Water (m)
0	1.00
0.5	1.00
1	1.00
1.5	1.00
2	1.01
2.5	1.01
3	1.01
3.5	1.01
4	1.01
4.5	1.01
5	1.01
6	1.01
7	1.01
8	1.01
9	1.01
10	1.01
12	1.01
14	1.02
16	1.02
18	1.02
20	1.02
25	1.02
30	1.02
40	1.02
50	1.02
60	1.02
75	1.02
90	1.02
120	1.02

Pit Dimensions (m)	
Length (m)	1.80 m
Width (m)	0.60 m
Depth	2.00 m
Water	
Start Depth of Water	1.00 m
Depth of Water	1.00 m
75% Full	1.25 m
25% Full	1.75 m
75%-25%	0.50 m
Volume of water (75%-25%)	<b>0.54</b> m <sup>3</sup>
Area of Drainage	<b>9.60</b> m <sup>2</sup>
Area of Drainage (75%-25%)	<b>3.48</b> m <sup>2</sup>
Time	
75% Full	N/A min
25% Full	N/A min
Time 75% to 25%	<b>N/A</b> min
Time 75% to 25% (sec)	<b>N/A</b> sec

**f =** Fail or  
m/min

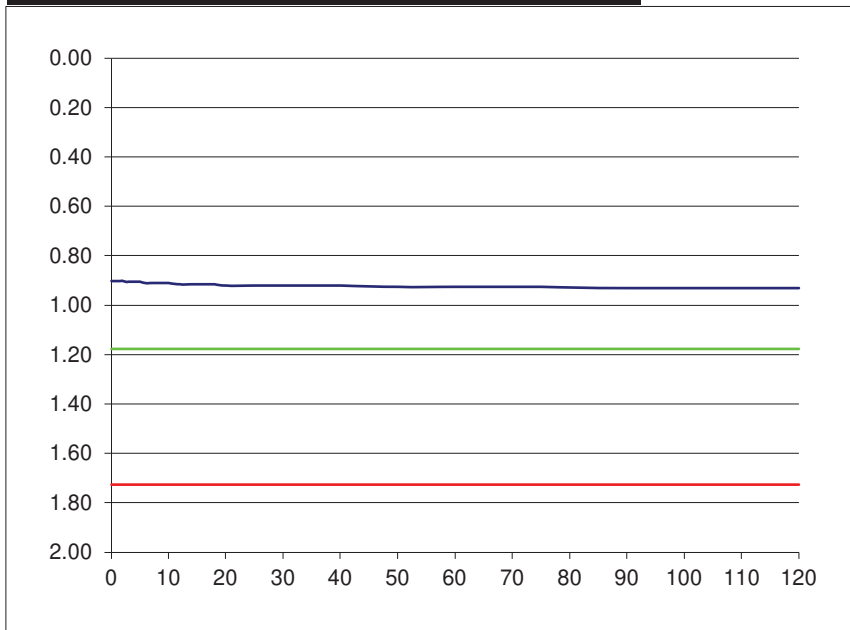
<b>Ground Conditions</b>		
From	To	
0.00	0.30	TOPSOIL.
0.30	0.60	Soft becoming firm slightly sandy gravelly silty CLAY with high cobble
0.60	2.00	Firm becoming stiff slightly sandy gravelly silty CLAY with high cobble

Elapsed Time (mins)	Fall of Water (m)
0	0.90
0.5	0.90
1	0.90
1.5	0.90
2	0.90
2.5	0.91
3	0.91
3.5	0.91
4	0.91
4.5	0.91
5	0.91
6	0.91
7	0.91
8	0.91
9	0.91
10	0.91
12	0.92
14	0.92
16	0.92
18	0.92
20	0.92
25	0.92
30	0.92
40	0.92
50	0.93
60	0.93
75	0.93
90	0.93
120	0.93

<b>Pit Dimensions (m)</b>	
Length (m)	1.60 m
Width (m)	0.60 m
Depth	2.00 m
<b>Water</b>	
Start Depth of Water	0.90 m
Depth of Water	1.10 m
75% Full	1.18 m
25% Full	1.73 m
75%-25%	0.55 m
Volume of water (75%-25%)	<b>0.53</b> m <sup>3</sup>
Area of Drainage	<b>8.80</b> m <sup>2</sup>
Area of Drainage (75%-25%)	<b>3.38</b> m <sup>2</sup>
<b>Time</b>	
75% Full	N/A min
25% Full	N/A min
Time 75% to 25%	<b>N/A</b> min
Time 75% to 25% (sec)	<b>N/A</b> sec

**f = Fail or Fail**  
**m/min m/s**

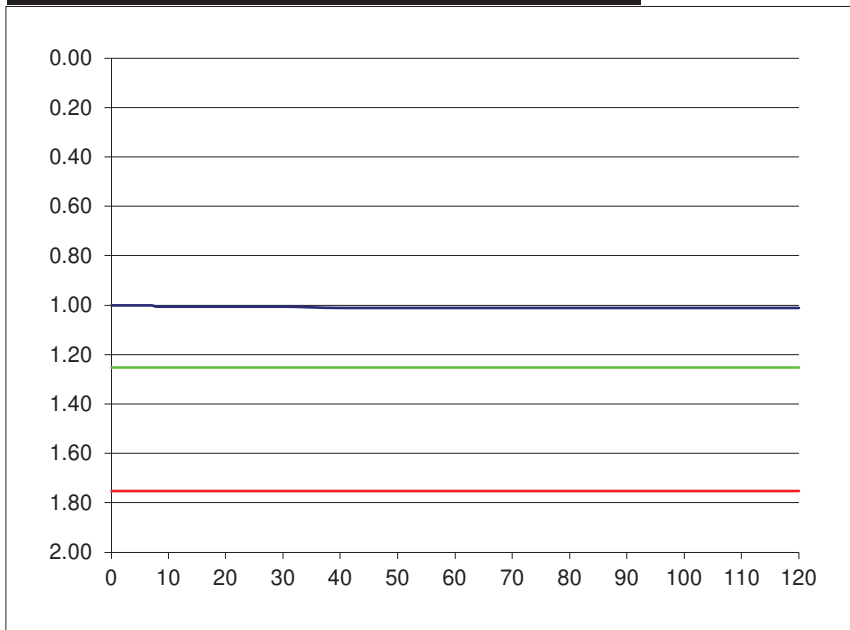
<b>Ground Conditions</b>		
From	To	
0.00	0.30	TOPSOIL.
0.40	0.60	Dark brown PEAT.
0.60	2.00	Firm grey slightly sandy gravelly silty CLAY with high cobble content.

Elapsed Time (mins)	Fall of Water (m)
0	1.00
0.5	1.00
1	1.00
1.5	1.00
2	1.00
2.5	1.00
3	1.00
3.5	1.00
4	1.00
4.5	1.00
5	1.00
6	1.00
7	1.00
8	1.01
9	1.01
10	1.01
12	1.01
14	1.01
16	1.01
18	1.01
20	1.01
25	1.01
30	1.01
40	1.01
50	1.01
60	1.01
75	1.01
90	1.01
120	1.01

<b>Pit Dimensions (m)</b>	
Length (m)	1.60 m
Width (m)	0.60 m
Depth	2.00 m
<b>Water</b>	
Start Depth of Water	1.00 m
Depth of Water	1.00 m
75% Full	1.25 m
25% Full	1.75 m
75%-25%	0.50 m
Volume of water (75%-25%)	<b>0.48</b> m <sup>3</sup>
Area of Drainage	<b>8.80</b> m <sup>2</sup>
Area of Drainage (75%-25%)	<b>3.16</b> m <sup>2</sup>
<b>Time</b>	
75% Full	N/A min
25% Full	N/A min
Time 75% to 25%	<b>N/A</b> min
Time 75% to 25% (sec)	<b>N/A</b> sec

**f = Fail or Fail**  
**m/min**
**m/s**

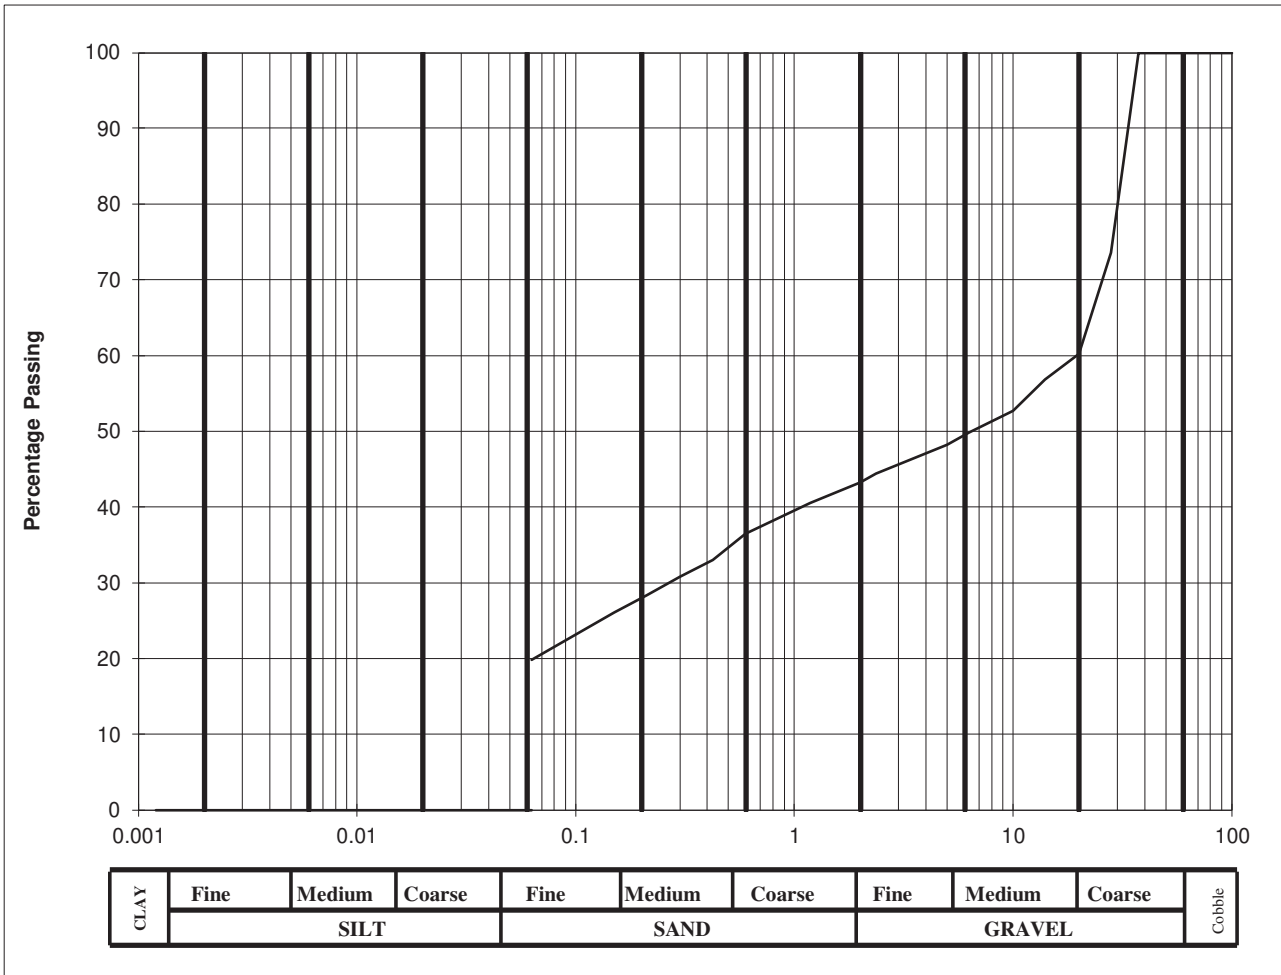
BS Sieve size, mm	Percent passing	Hydrometer analysis	
		Diameter, mm	% passing
100	100	0.0630	
90	100	0.0200	
75	100	0.0060	
63	100	0.0020	
50	100		
37.5	100		
28	73.6		
20	60.2		
14	56.8		
10	52.7		
6.3	49.8		
5.0	48.2		
2.36	44.4		
2.00	43.2		
1.18	40.5		
0.600	36.5		
0.425	33		
0.300	30.8		
0.212	28.4		
0.150	26.1		
0.063	20

Cobbles, %	0
Gravel, %	57
Sand, %	23
Clay / Silt, %	20

The laboratory tests of the soil tested confirm that CLAY soils with low plasticity index of 14% recorded. The particle size distribution curve shows poorly sorted straight-line curves with 20% fines content in the soil from this site.

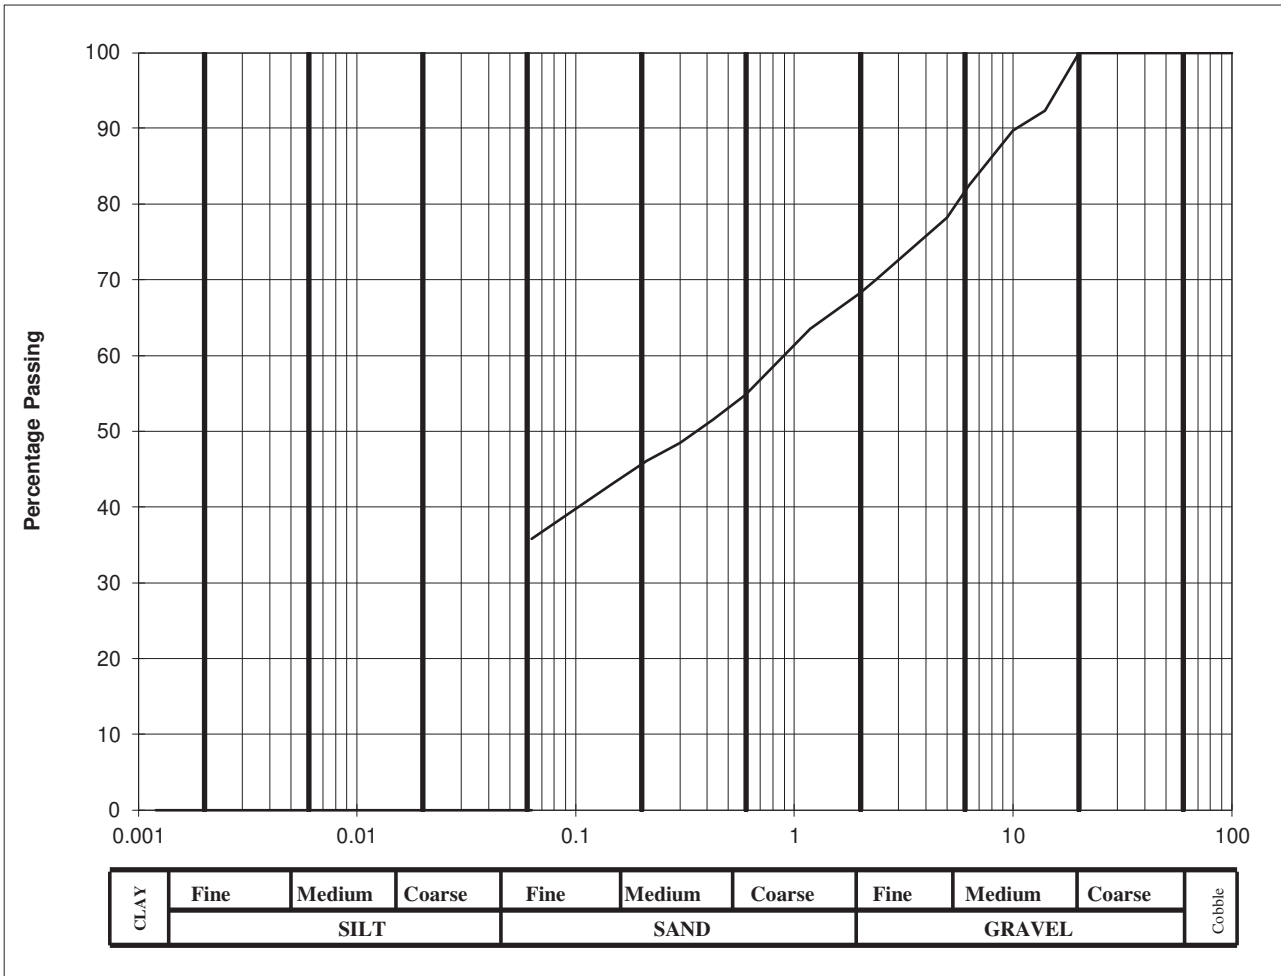
BS Sieve size, mm	Percent passing	Hydrometer analysis	
		Diameter, mm	% passing
100	100	0.0630	
90	100	0.0200	
75	100	0.0060	
63	100	0.0020	
50	100		
37.5	100		
28	100		
20	100		
14	92.3		
10	89.7		
6.3	82.4		
5.0	78.2		
2.36	70		
2.00	68.2		
1.18	63.5		
0.600	54.8		
0.425	51.5		
0.300	48.5		
0.212	46.1		
0.150	43.2		
0.063	36

Cobbles, %	0
Gravel, %	32
Sand, %	32
Clay / Silt, %	36

The laboratory tests of the soil tested confirm that CLAY soils with low plasticity index of 9% recorded. The particle size distribution curve shows poorly sorted straight-line curves with 36% fines content in the soil from this site.

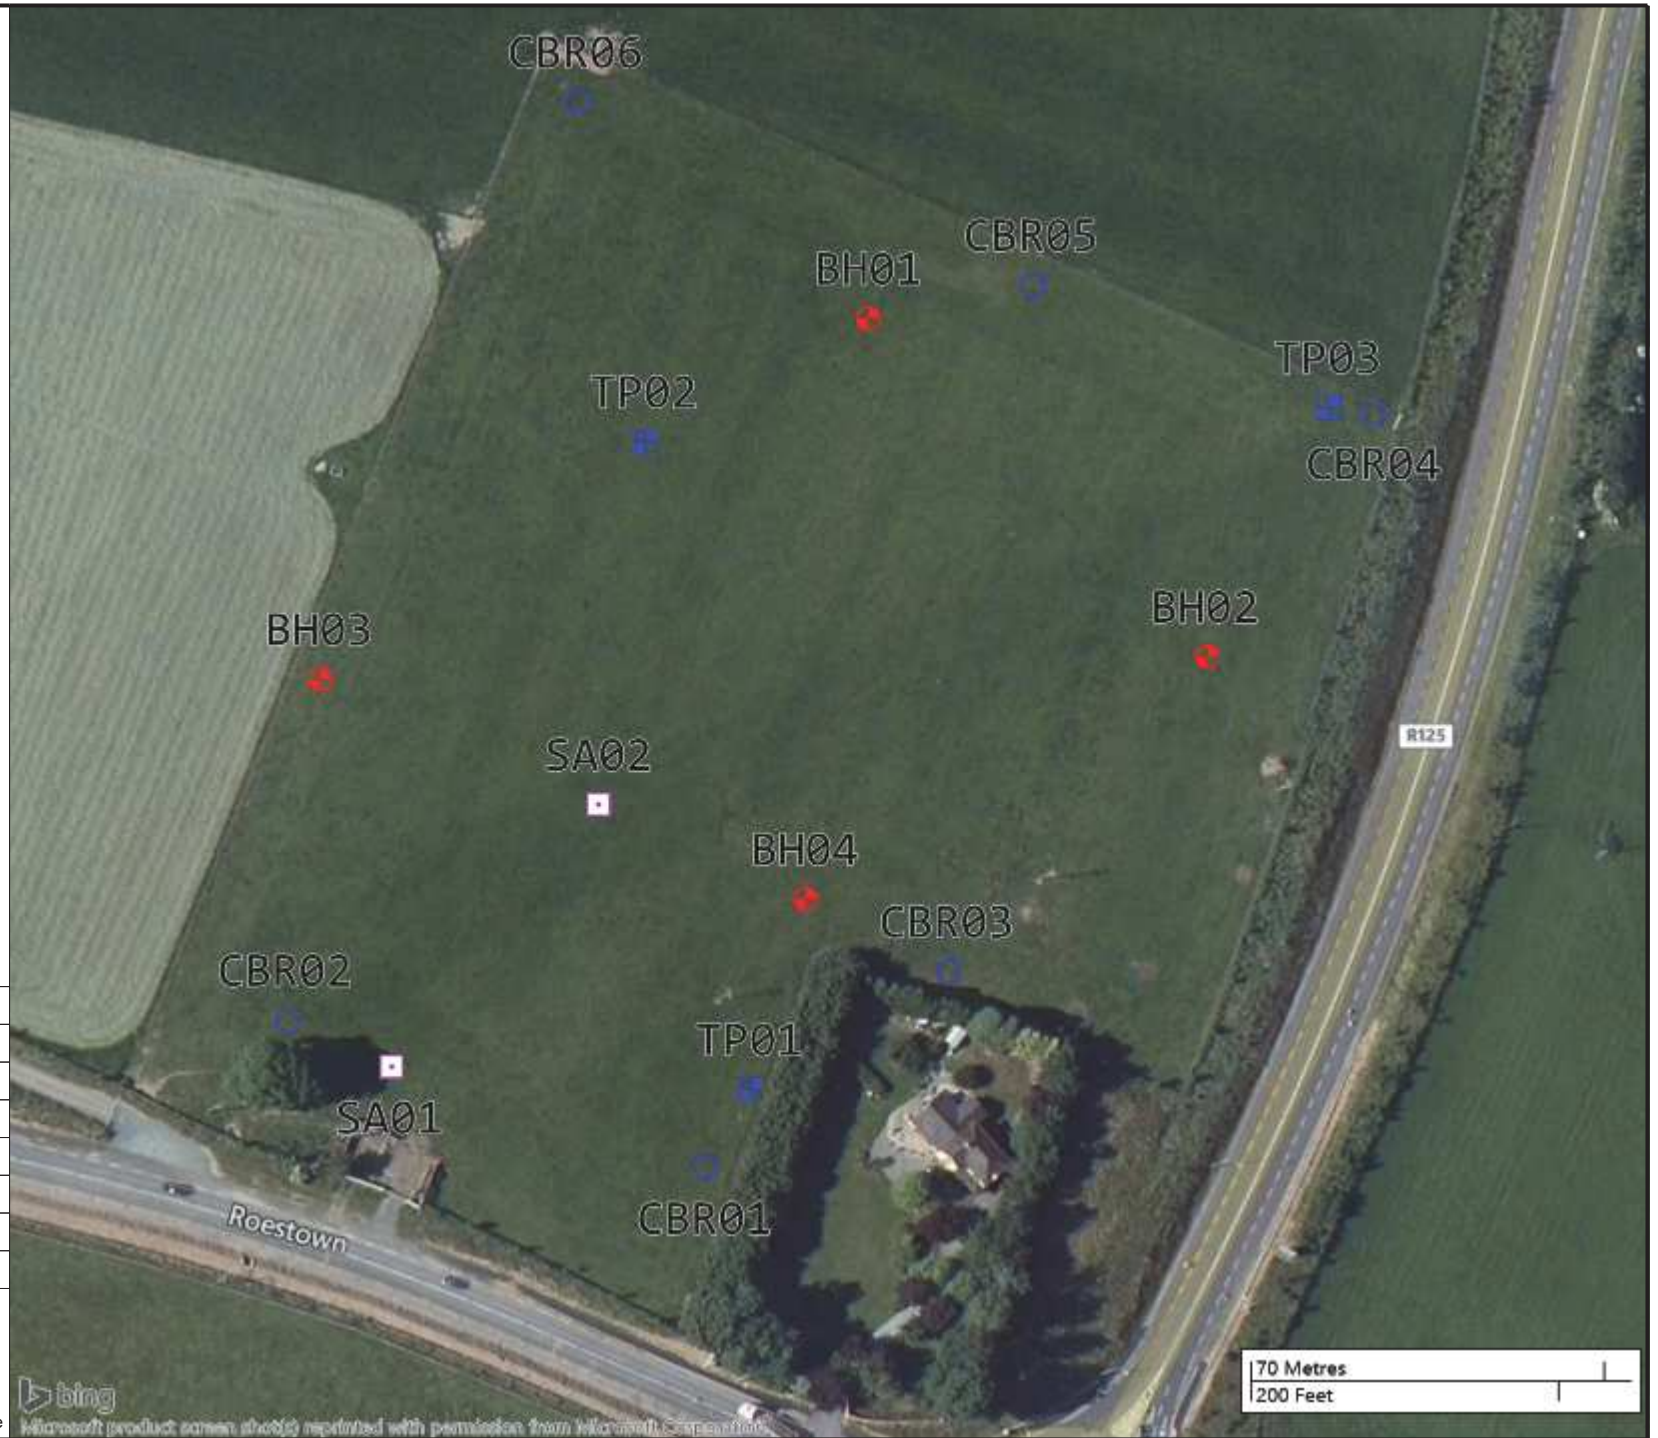
Contract No:	5699
Contract Name:	Residential Development
Location:	Dunshaughlin, Co. Meath
Client:	Castlethorn Construction
Engineer:	Waterman Moylan
Title:	Site Plan
Scale:	1:1500
Drawn By:	SL

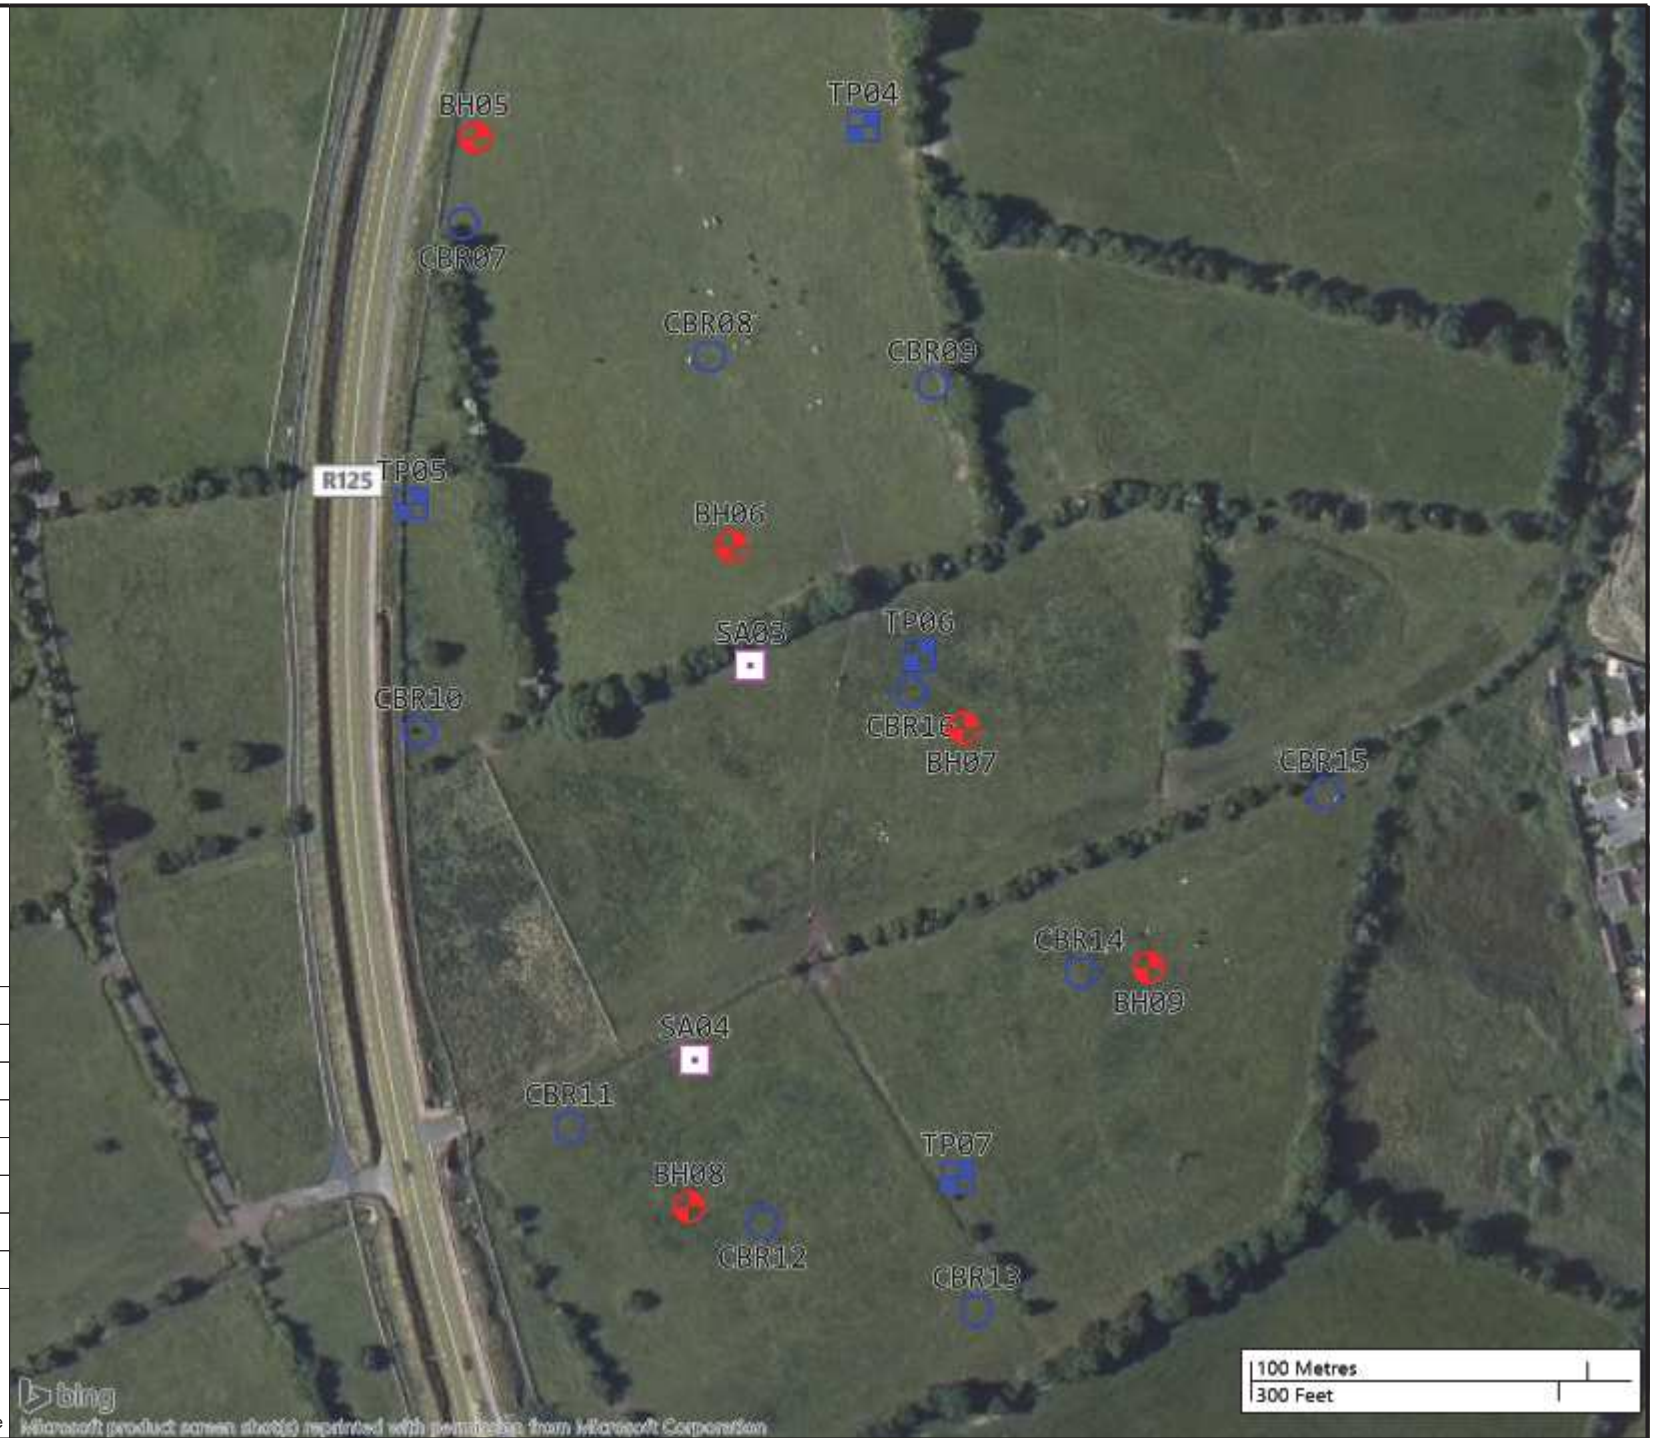
Contract No:	5699
Contract Name:	Residential Development
Location:	Dunshaughlin, Co. Meath
Client:	Castlethorn Construction
Engineer:	Waterman Moylan
Title:	Site Plan
Scale:	1:2250
Drawn By:	SL
