Ground Investigation Factual Report

Carrownagowan Wind Farm **Ground Investigation Factual Report**

The purpose of this report is to present the ground investigation information obtained at the site of the proposed Carrownagowan Wind Farm, Co. Clare

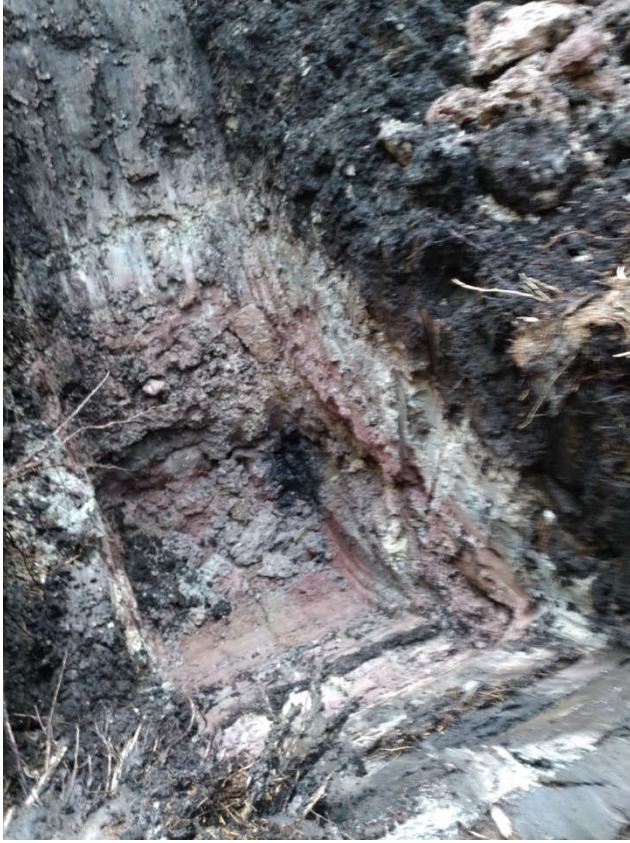
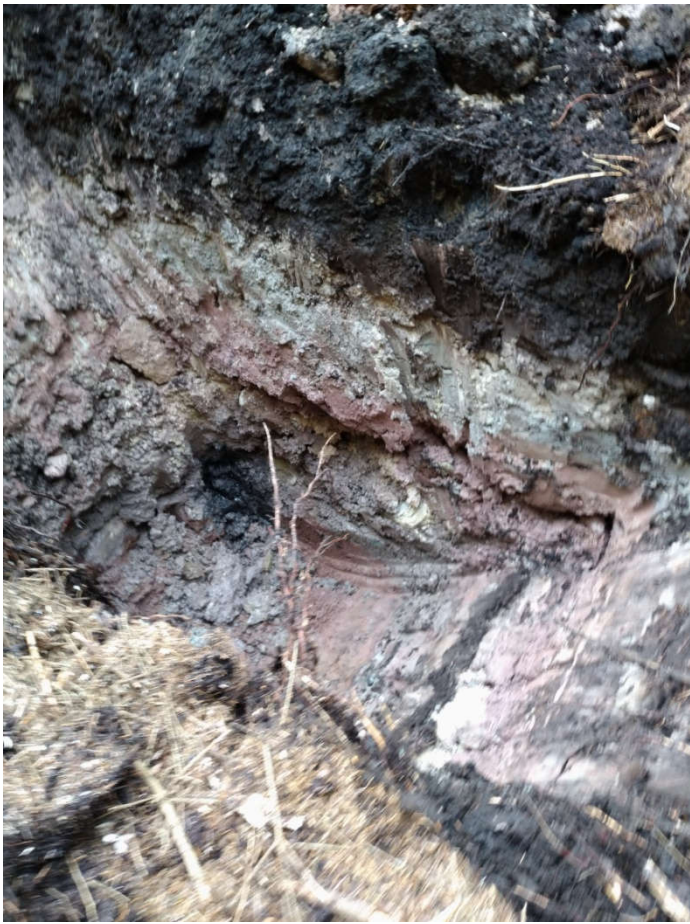
CLAY: Firm to stiff, grey/purple gravelly CLAY with frequent cobbles and boulders. Gravel is angular to sub-angular	
2			
2.5			
3			
3.5			
4			
4.5

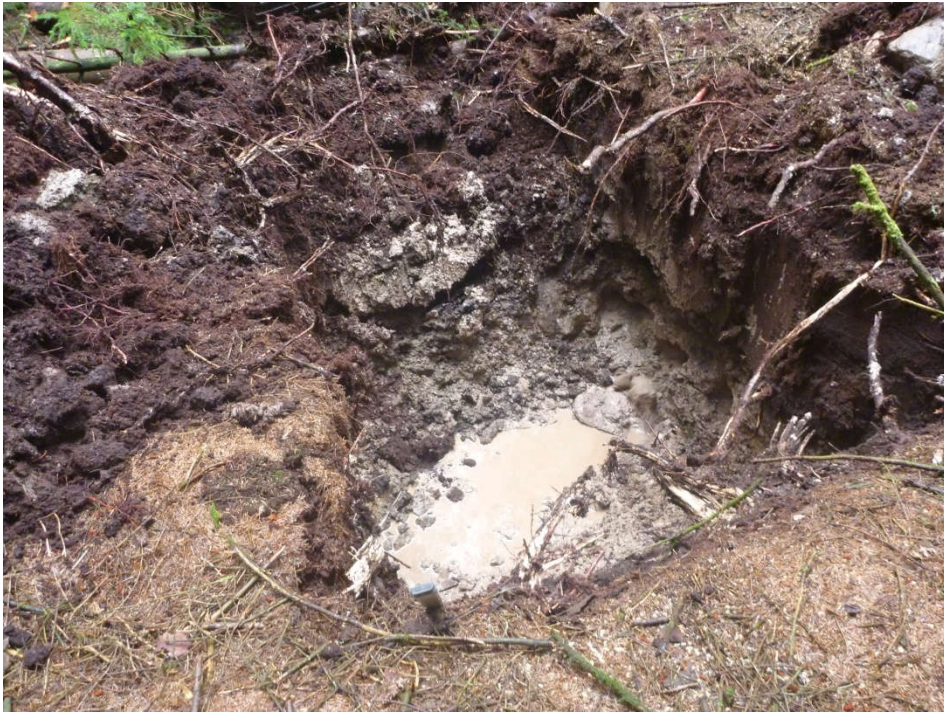
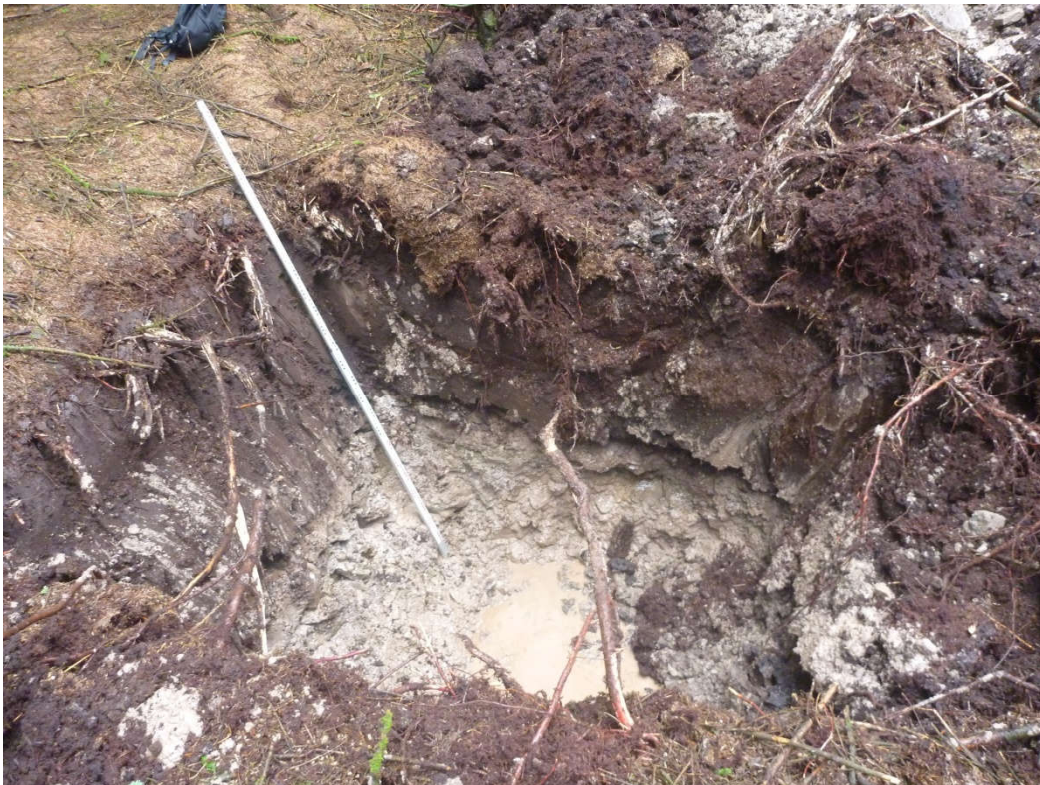
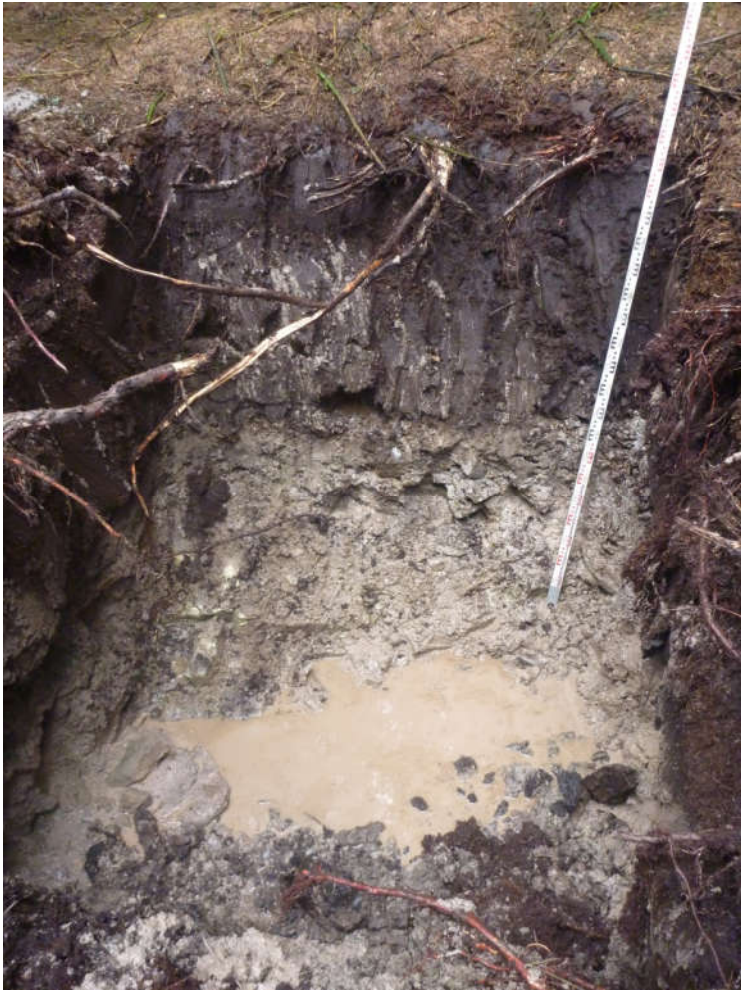
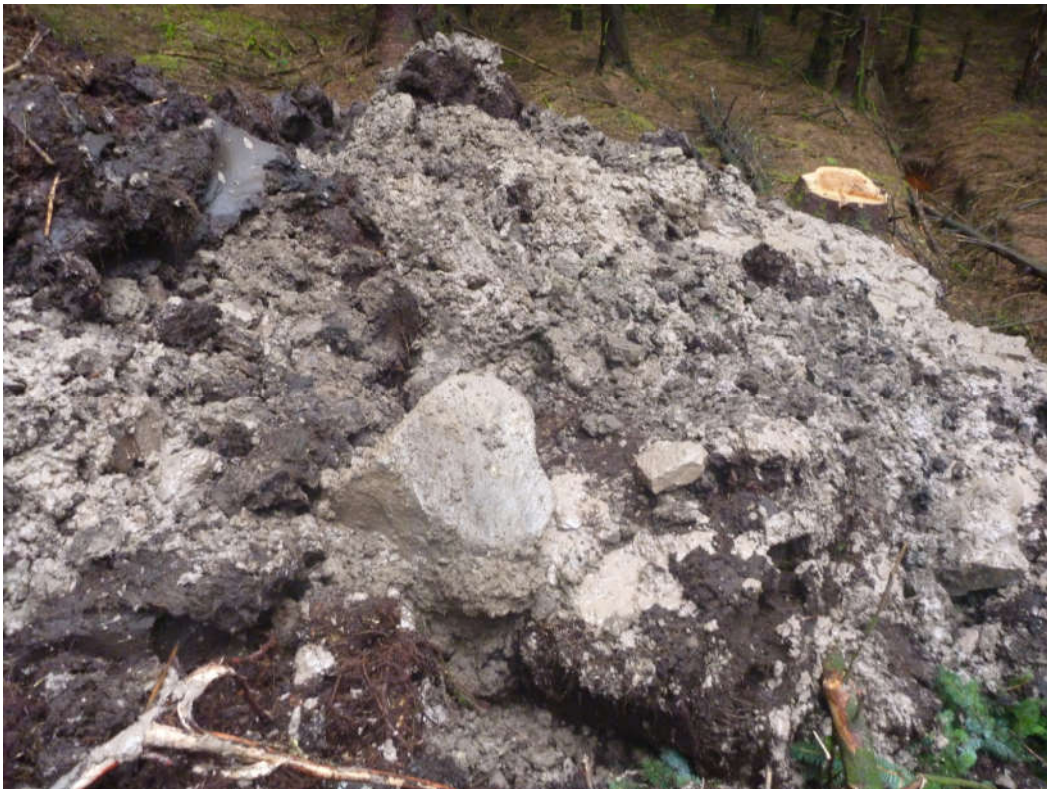
PEAT Soft to firm grey/brown silty very sandy gravelly CLAY with cobbles and boulders. Gravel, cobbles and boulders are angular to sub-angular (material very runny when wet)	Hole stable Groundwater boiling at base of trial pit
2.5 3 3.5 4 4.5		Possible Bedrock Terminated on suspected bedrock

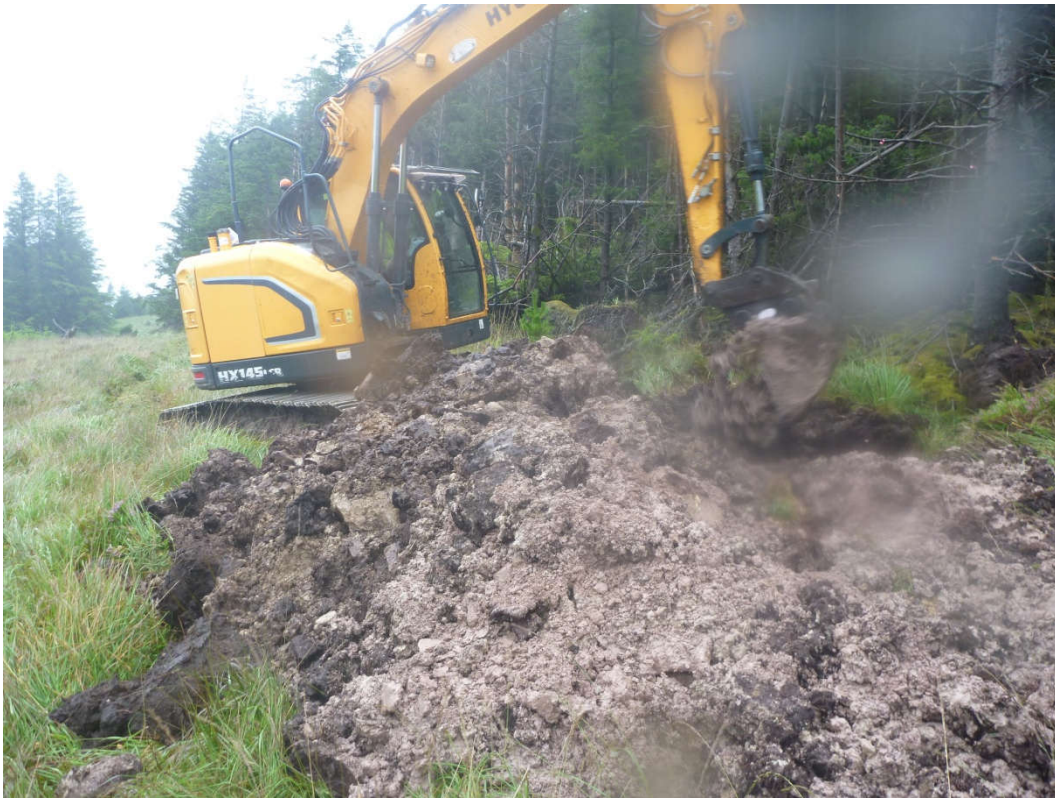
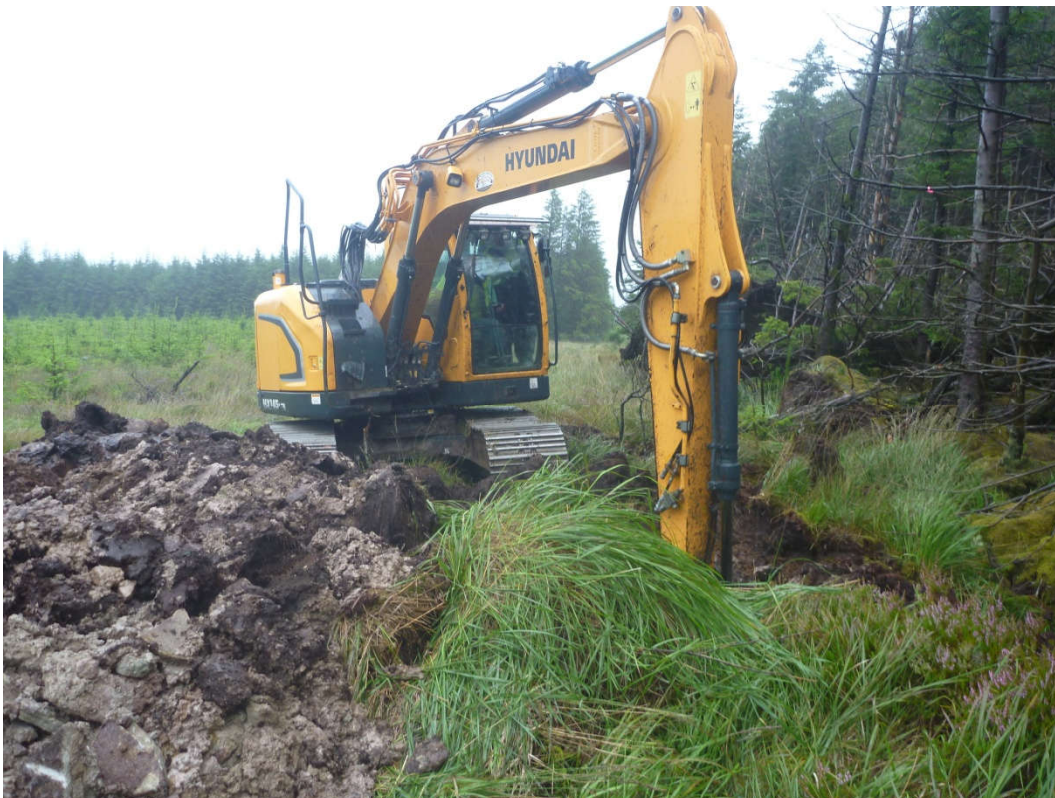
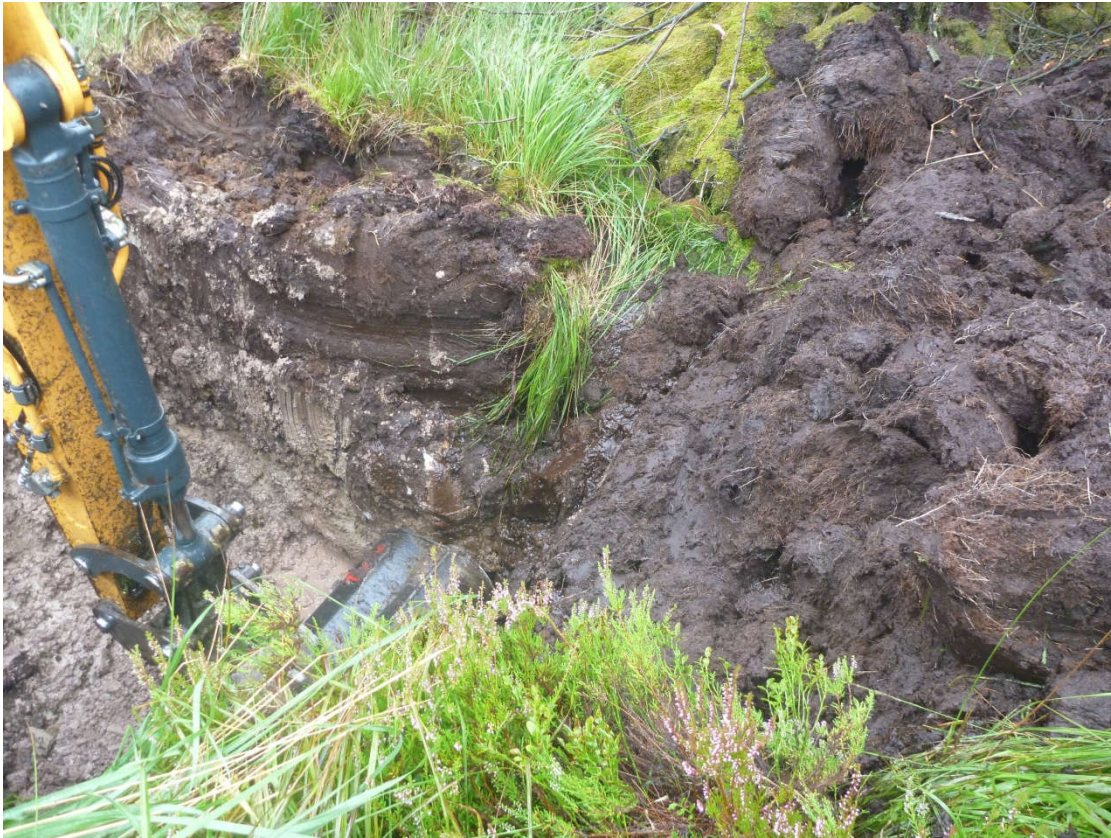
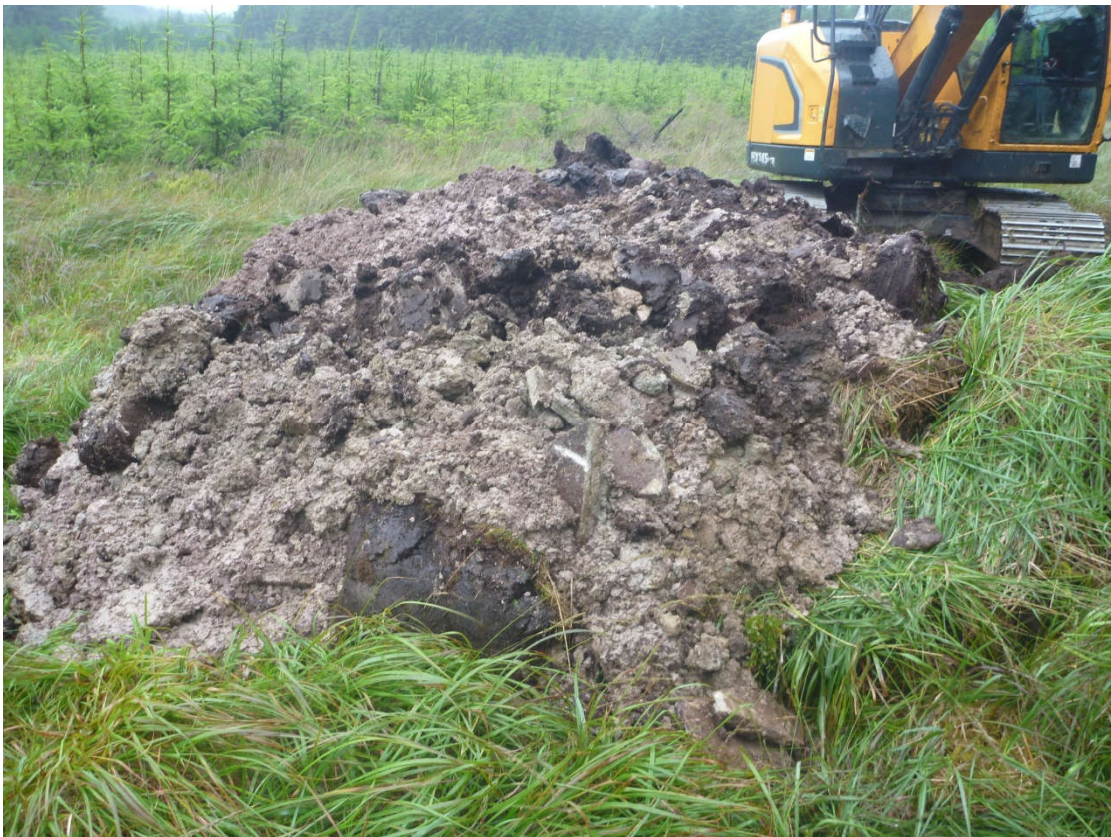
PEAT	Poor stability due to land drain No Groundwater Encountered. Rapid water ingress from drain caused instability.
2

Purple/Brown very silty very sandy gravelly CLAY with cobbles and boulders. Cobbles and boulders are angular. Material very runny when wet	
2.5		Terminated as land drain flowing rapidly into trial hole causing instability	
3			
3.5			
4			
4.5

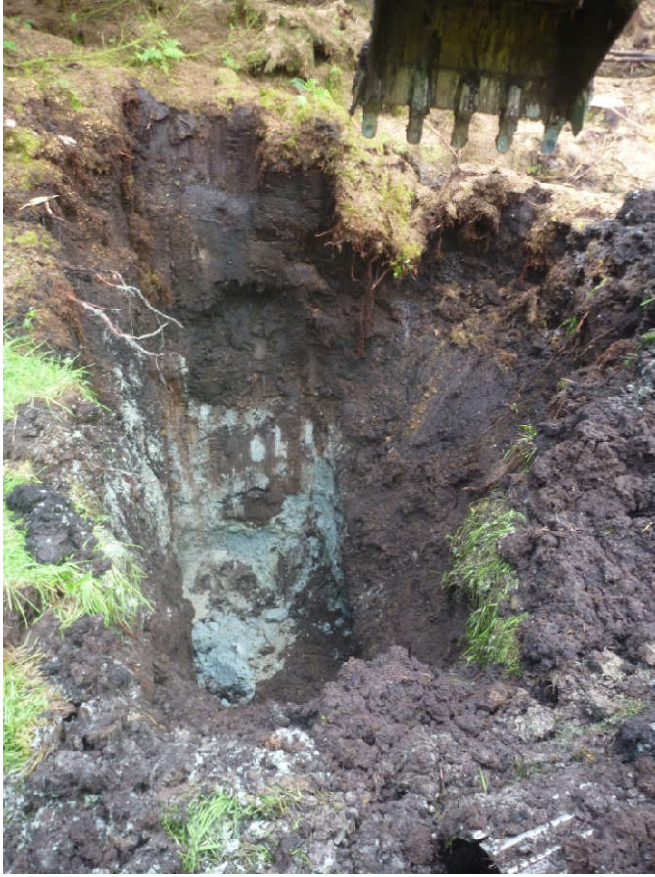
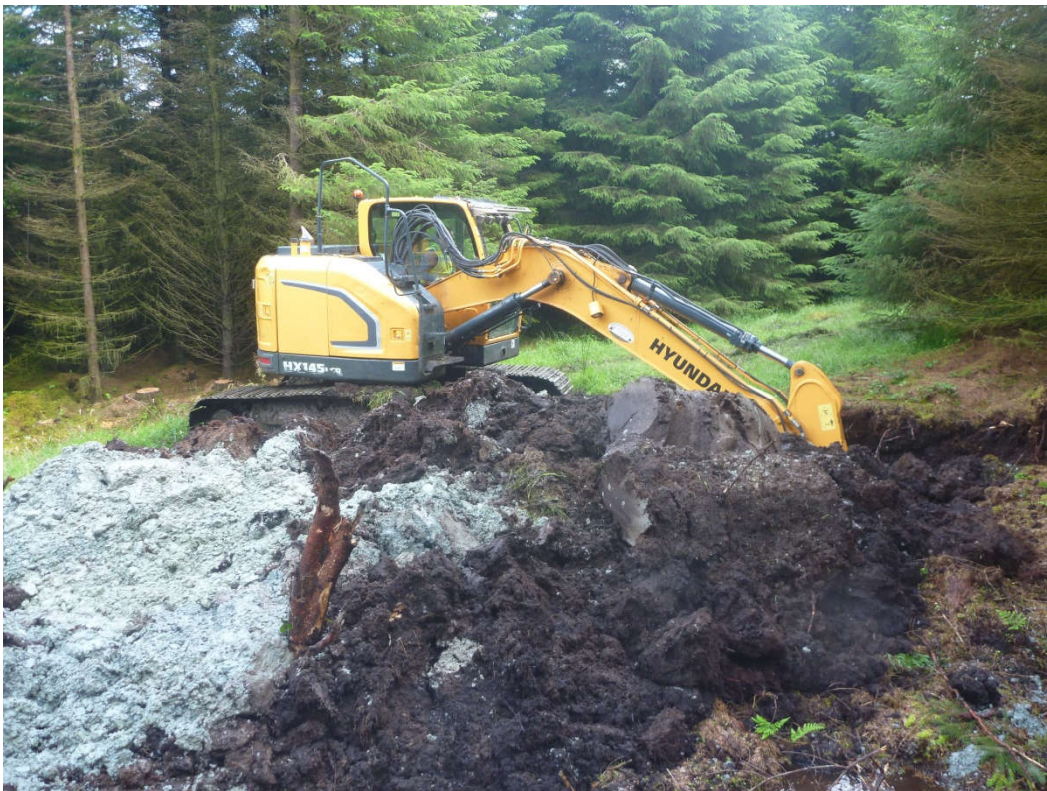
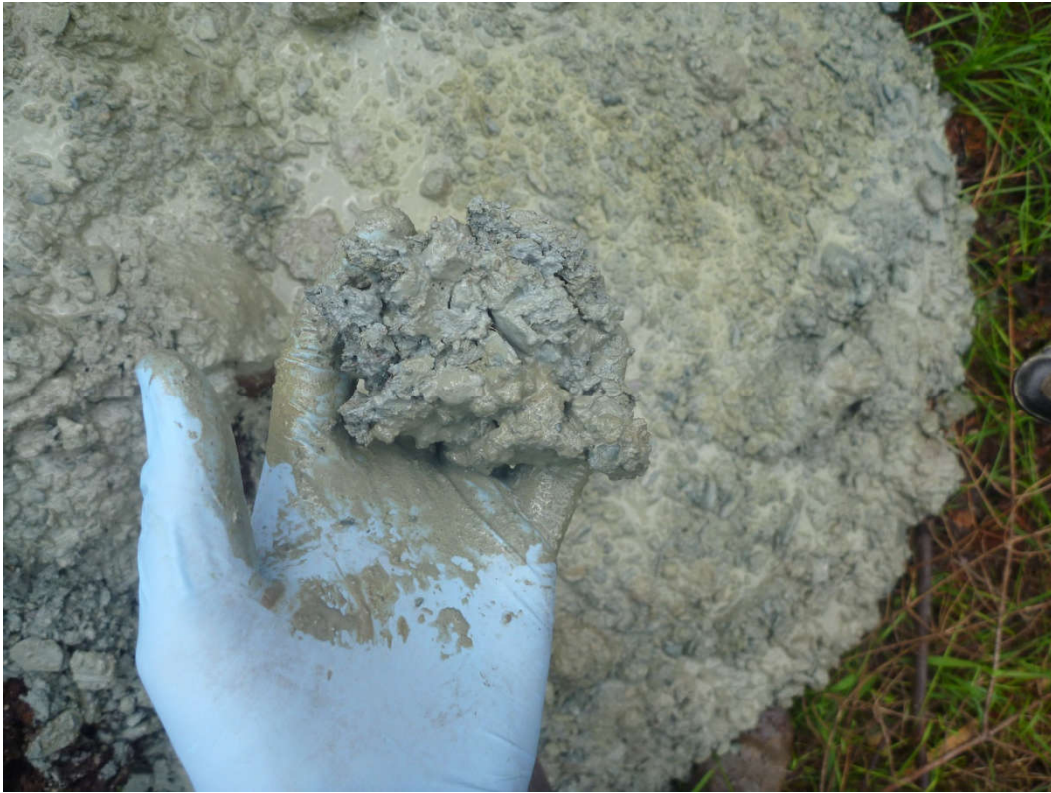
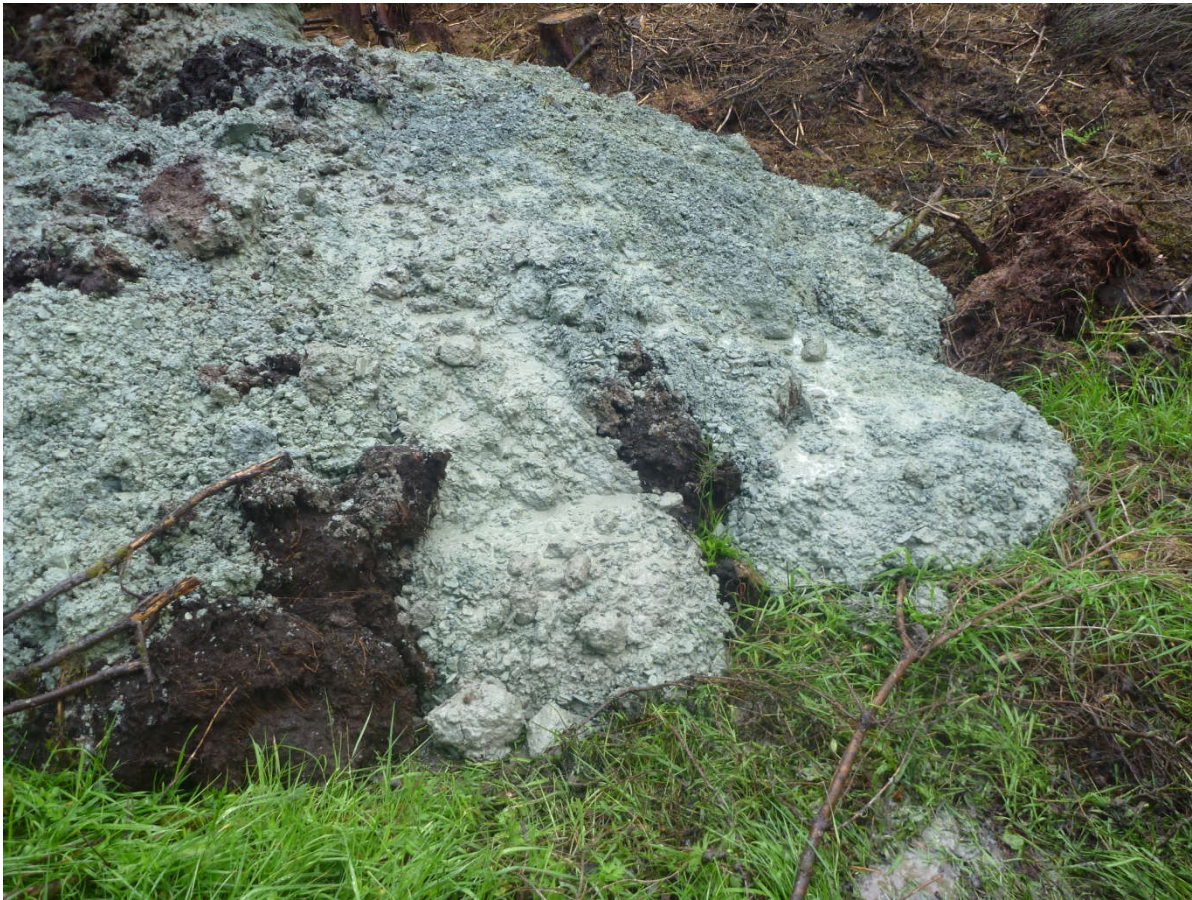
Depth (m)	Graphic Log	Material Description	Additional Observations
0.5		PEAT	Very poor stability. Depths approximate as hole collapsed before measurements taken.
1			
1.5			
2			
2.5			Groundwater flowed in quickly at peat interface. This caused instability of hole
3		Blue/grey very silty, very sandy GRAVEL with pockets of clay. Recovered as very runny material.	
3.5			
4		Terminated at maximum reach of excavator	
4.5

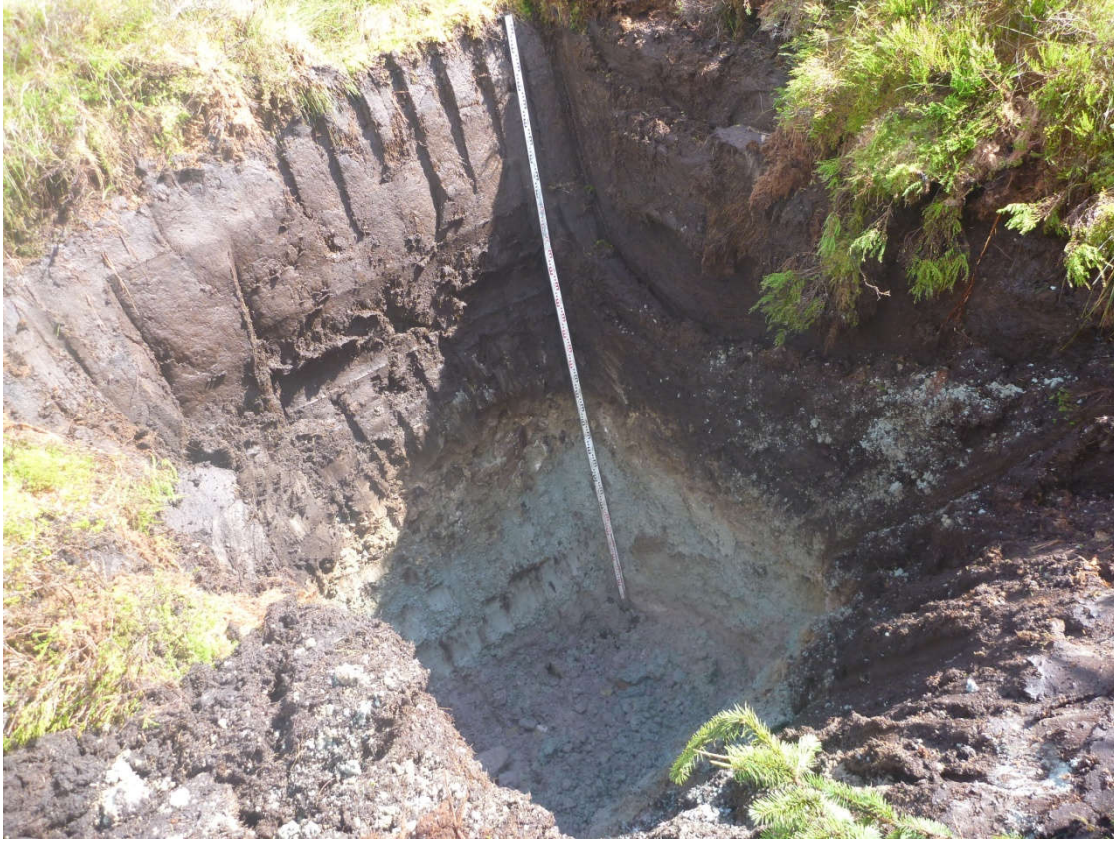
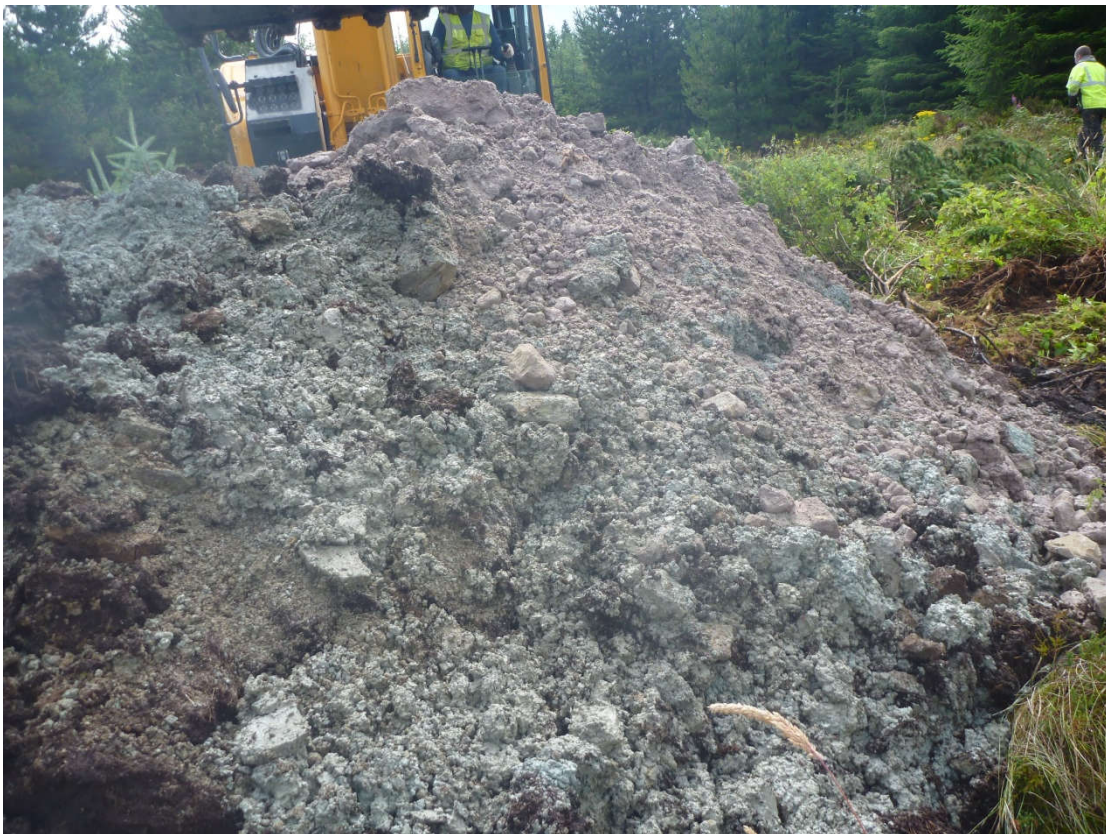
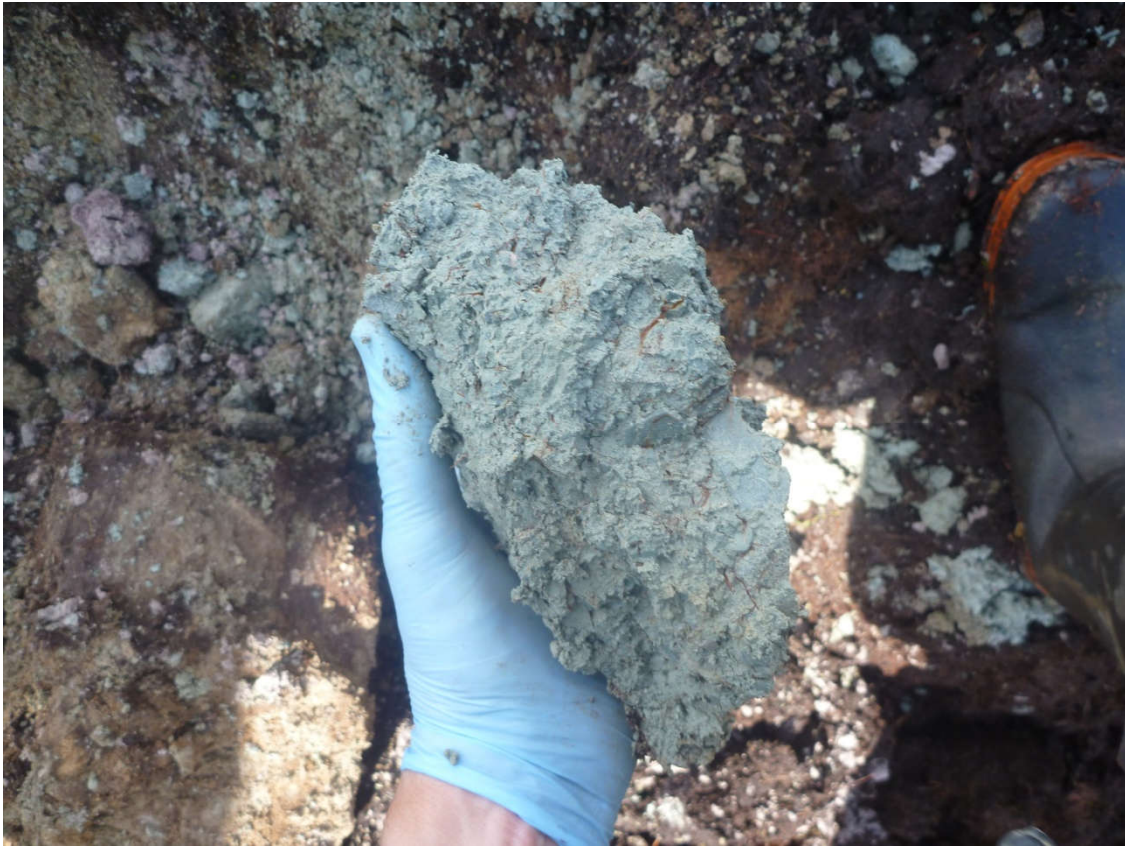
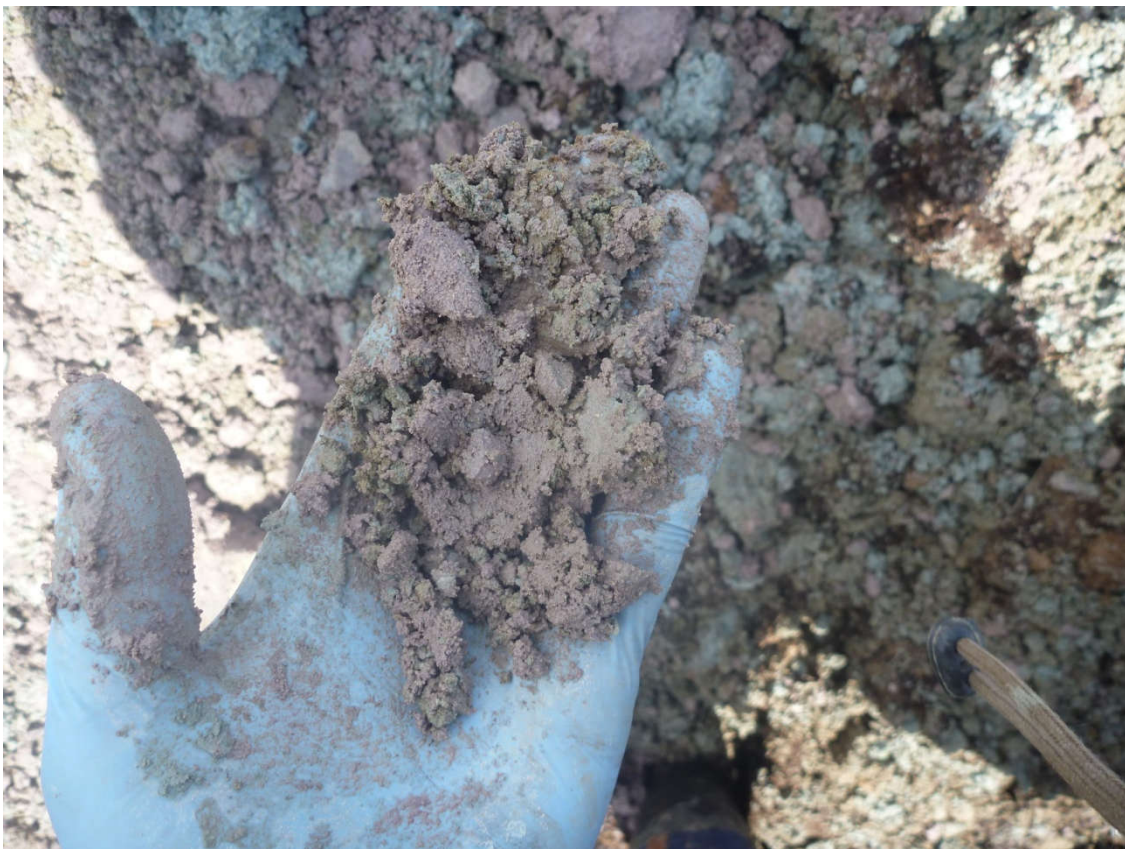
PEAT	Hole stable No Groundwater Encountered
2.5

Soft blue/grey silty sandy CLAY	
3.5

Purple very sandy, very gravelly SILT/CLAY with cobbles and boulders. Likely to be very runny when wet.	
4.0		Terminated due to maximum reach of excavator	
4.5

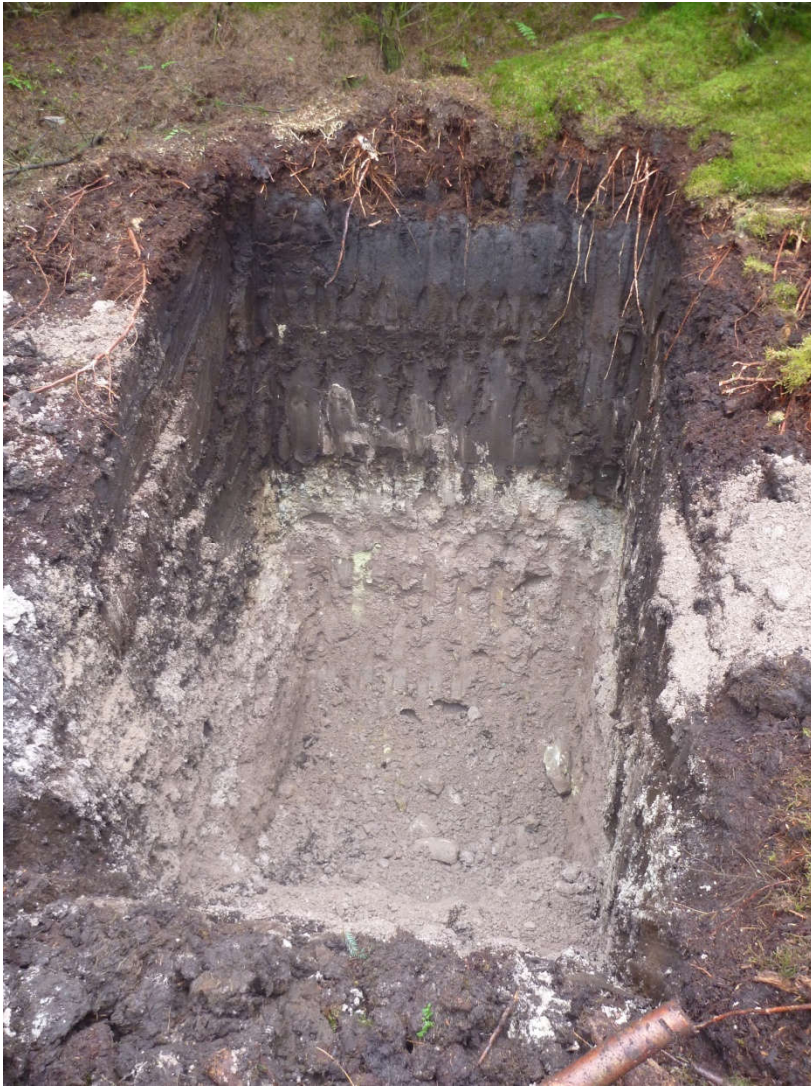
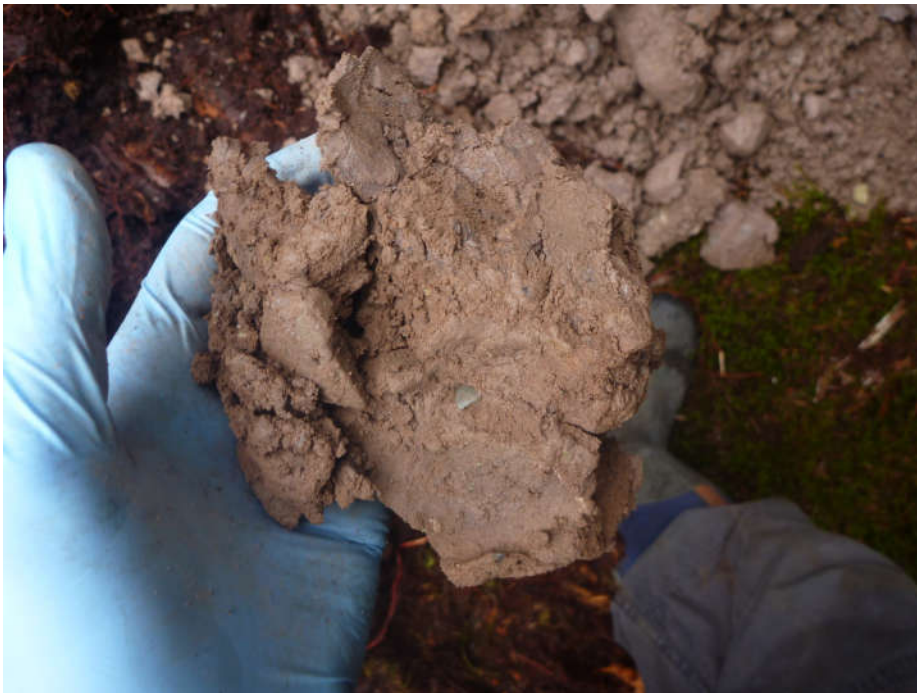
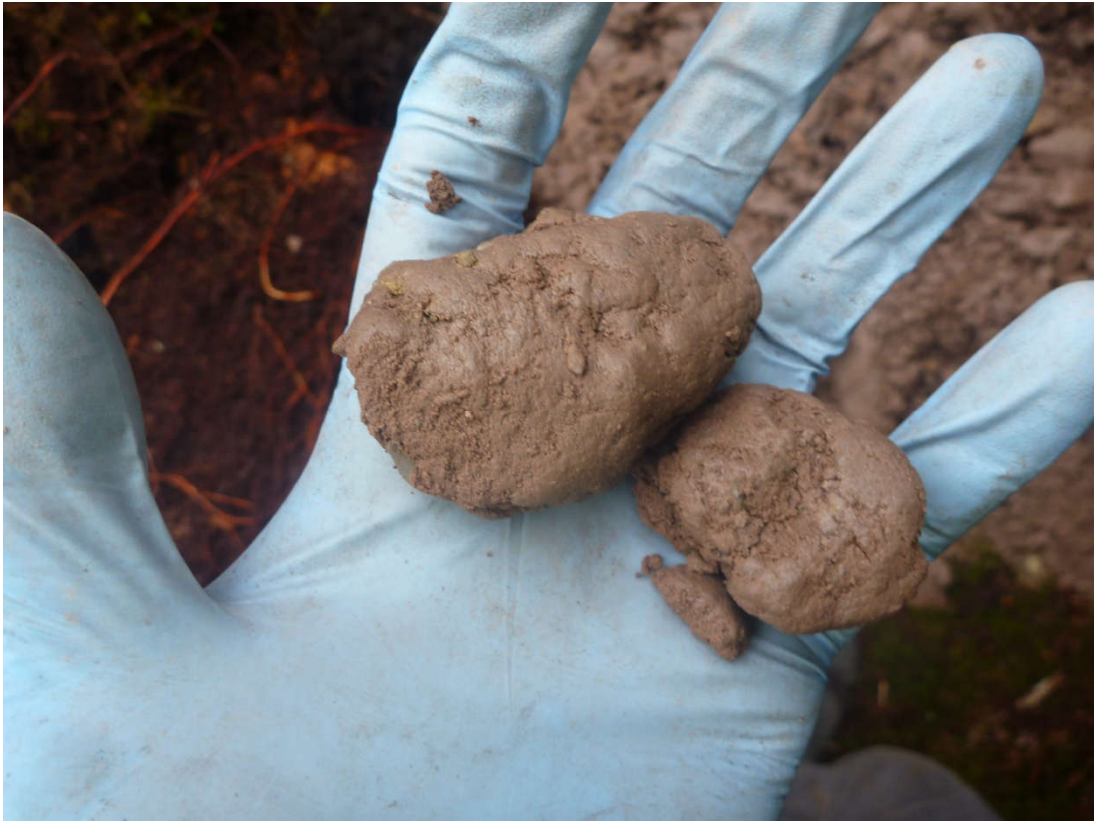
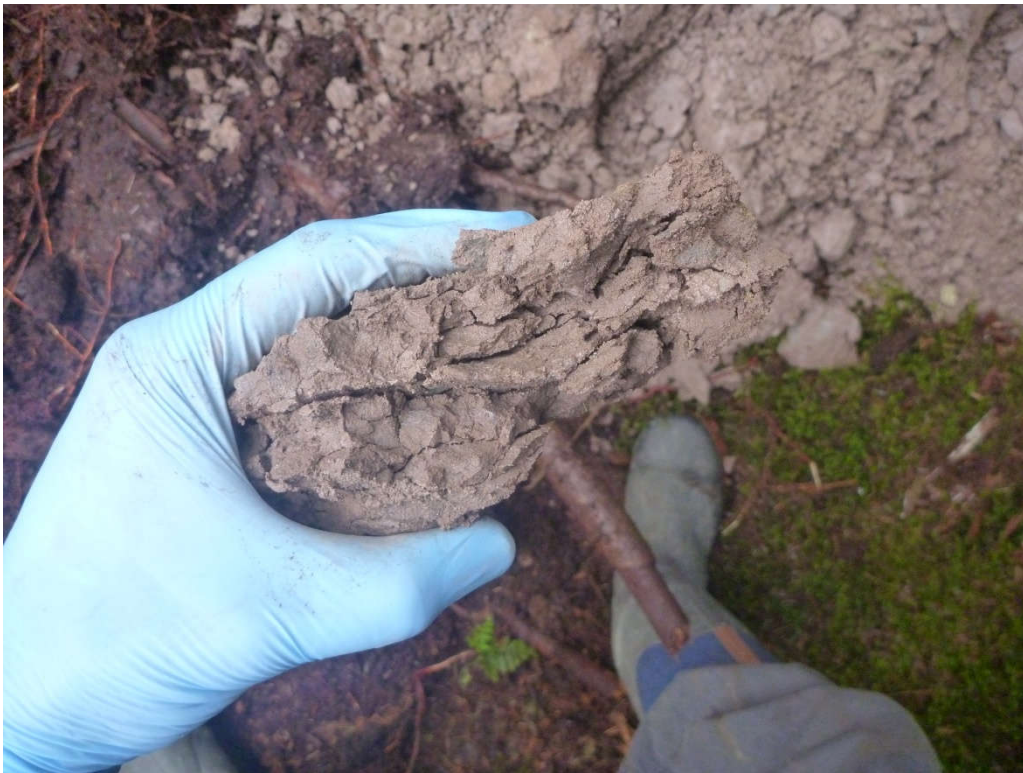
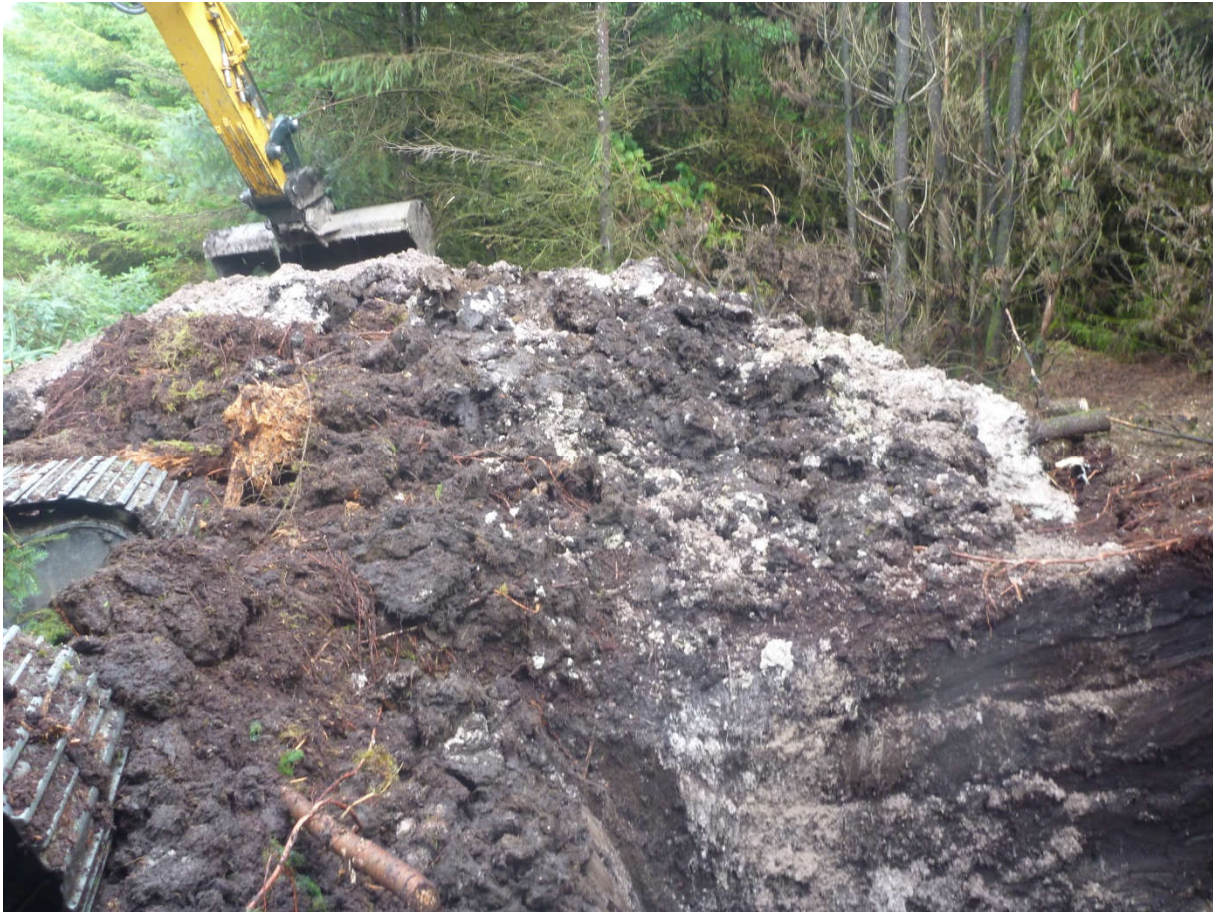
PEAT	Hole stable Slow seepage at base of Peat
2

Firm purple/grey very silty, very sandy, very gravelly CLAY with cobbles and boulders. Material appears laminated. Material very runny when wet.	
4		Terminated on possible rock
