Ground Investigation Factual Report

Carrownagowan Wind Farm **Ground Investigation Factual Report**

The purpose of this report is to present the ground investigation information obtained at the site of the proposed Carrownagowan Wind Farm, Co. Clare

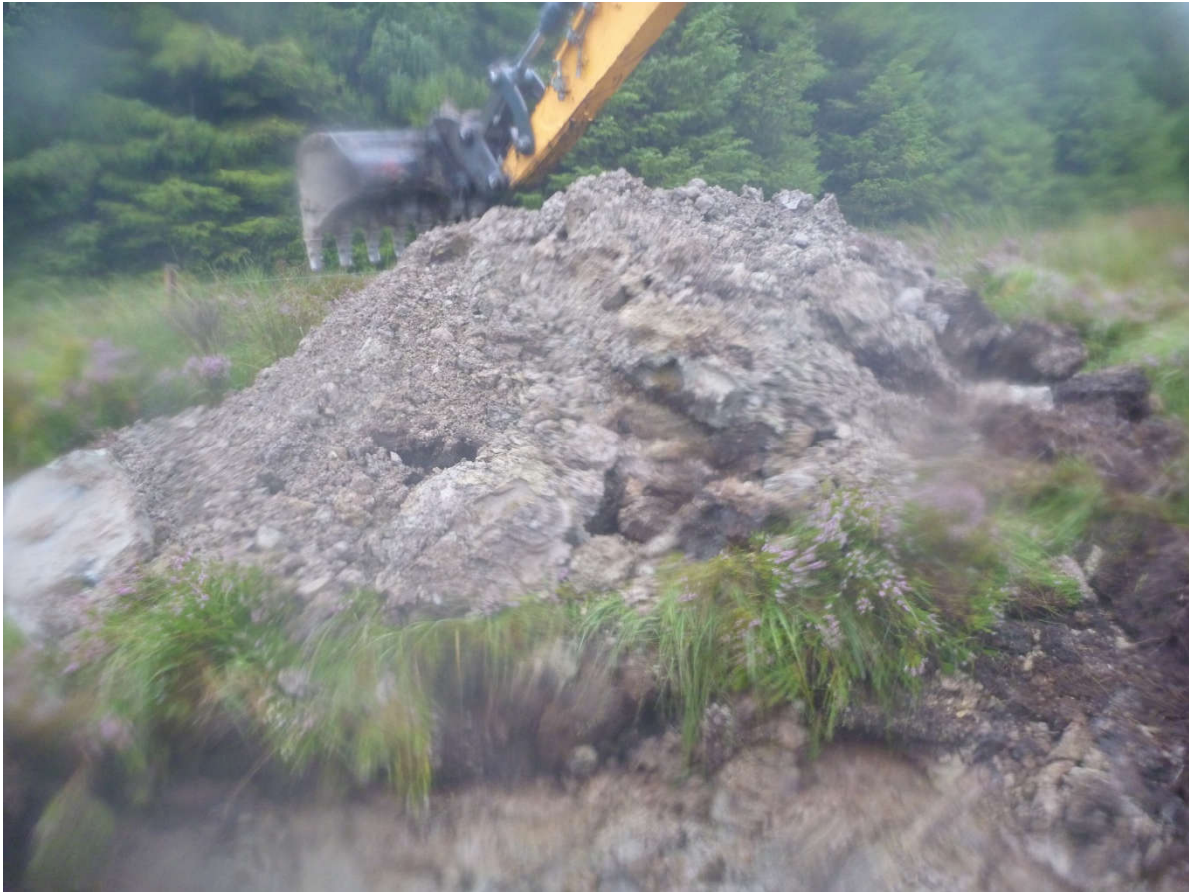
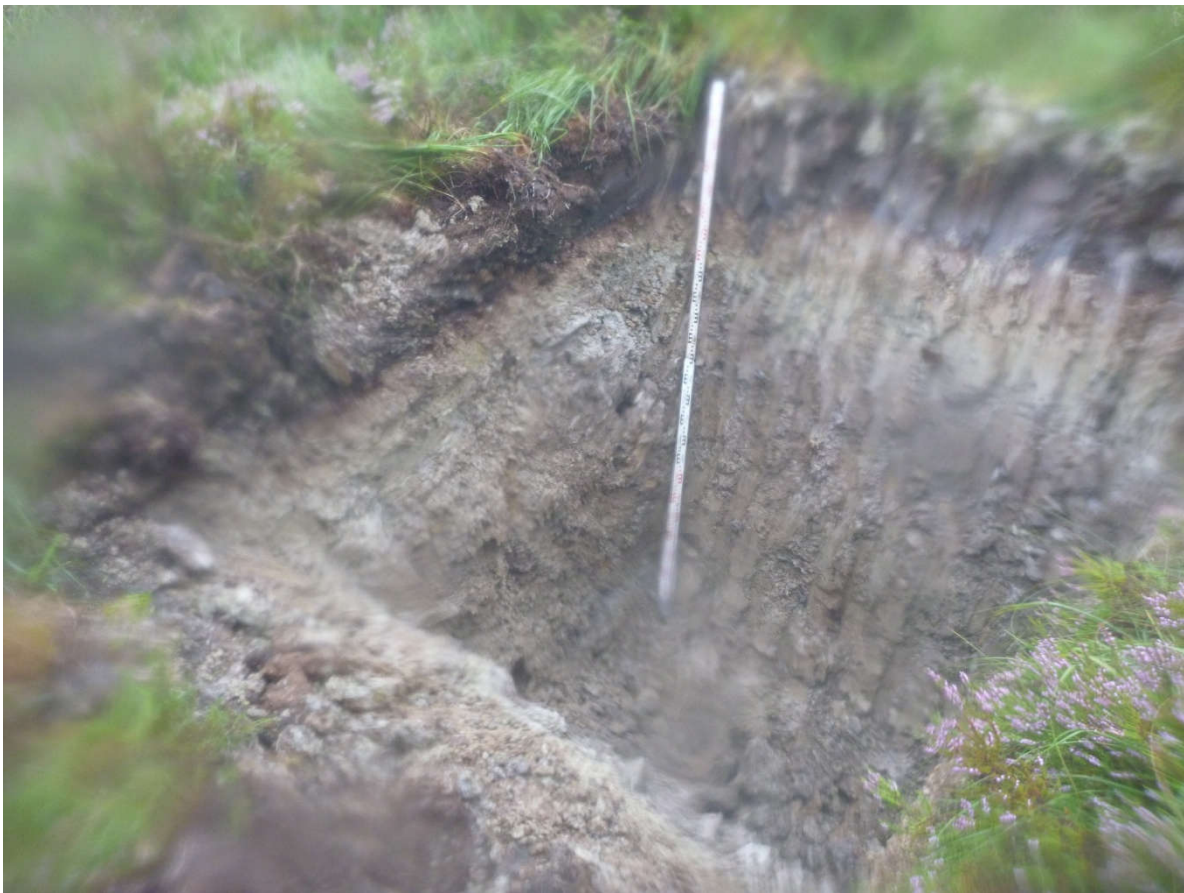
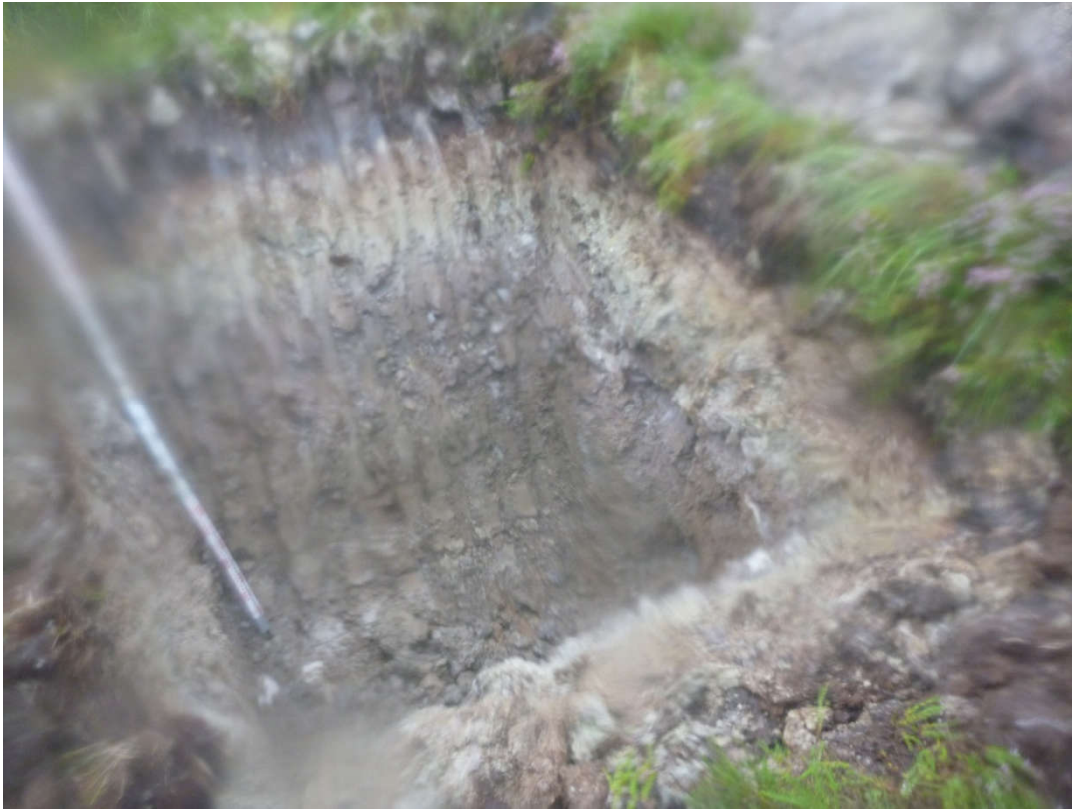
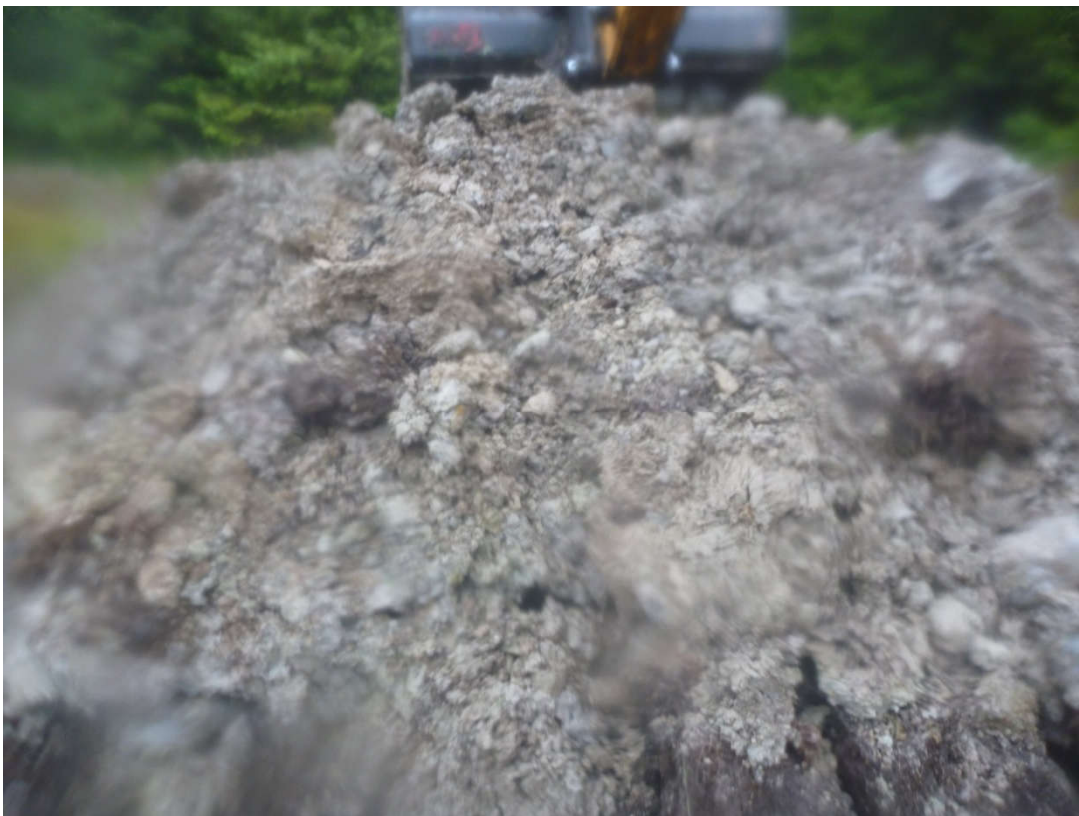
PEAT	Hole stable No Groundwater Encountered. Some overland flow into trial pit.
0.5

Grey soft gravelly CLAY	
1

Purpley firm very silty, very sandy, gravelly CLAY with cobbles and boulders.	
1.5			
2			
2.5			
3		Terminated at engineers request	
3.5			
4			
4.5

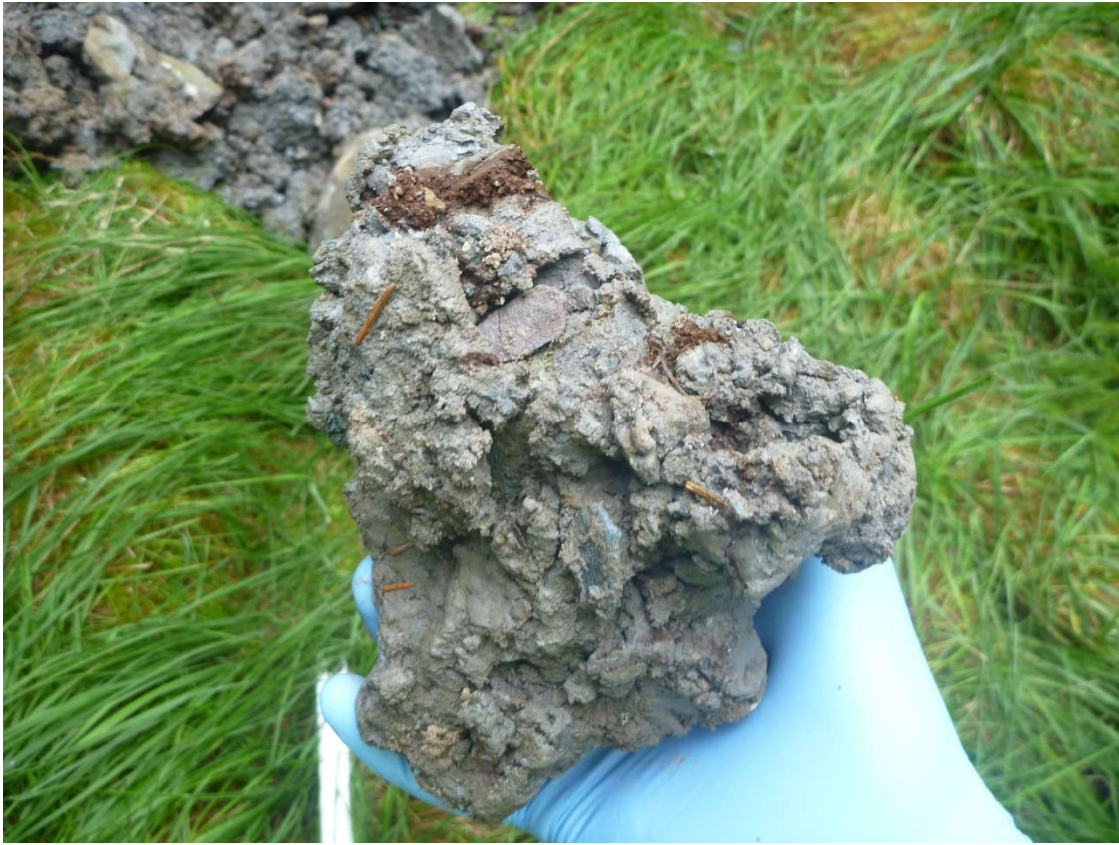
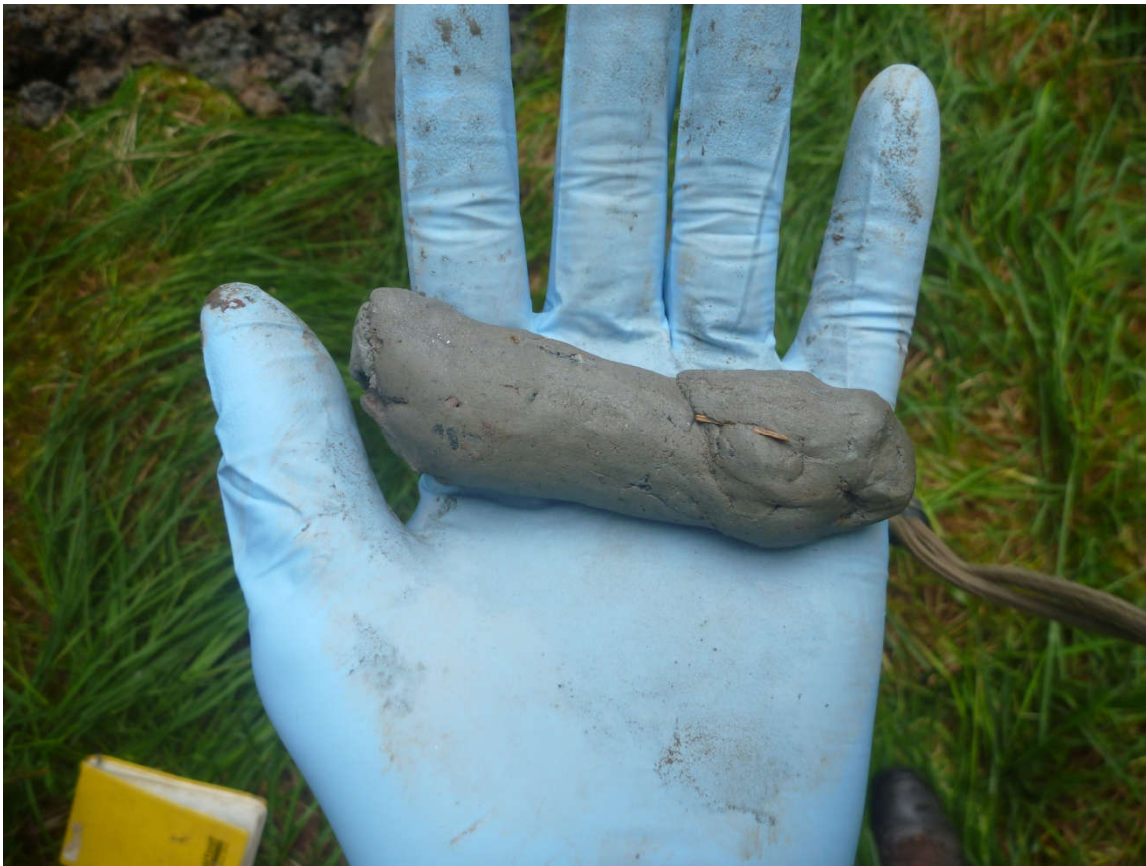
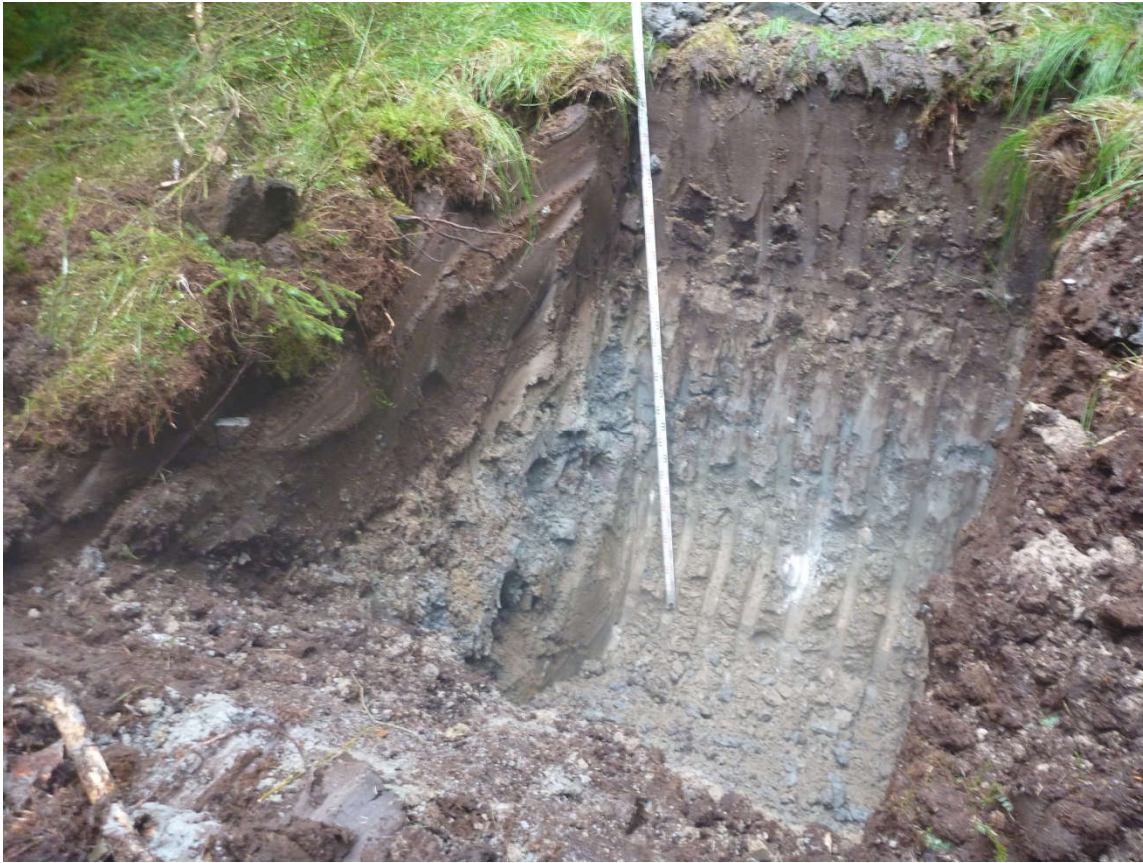
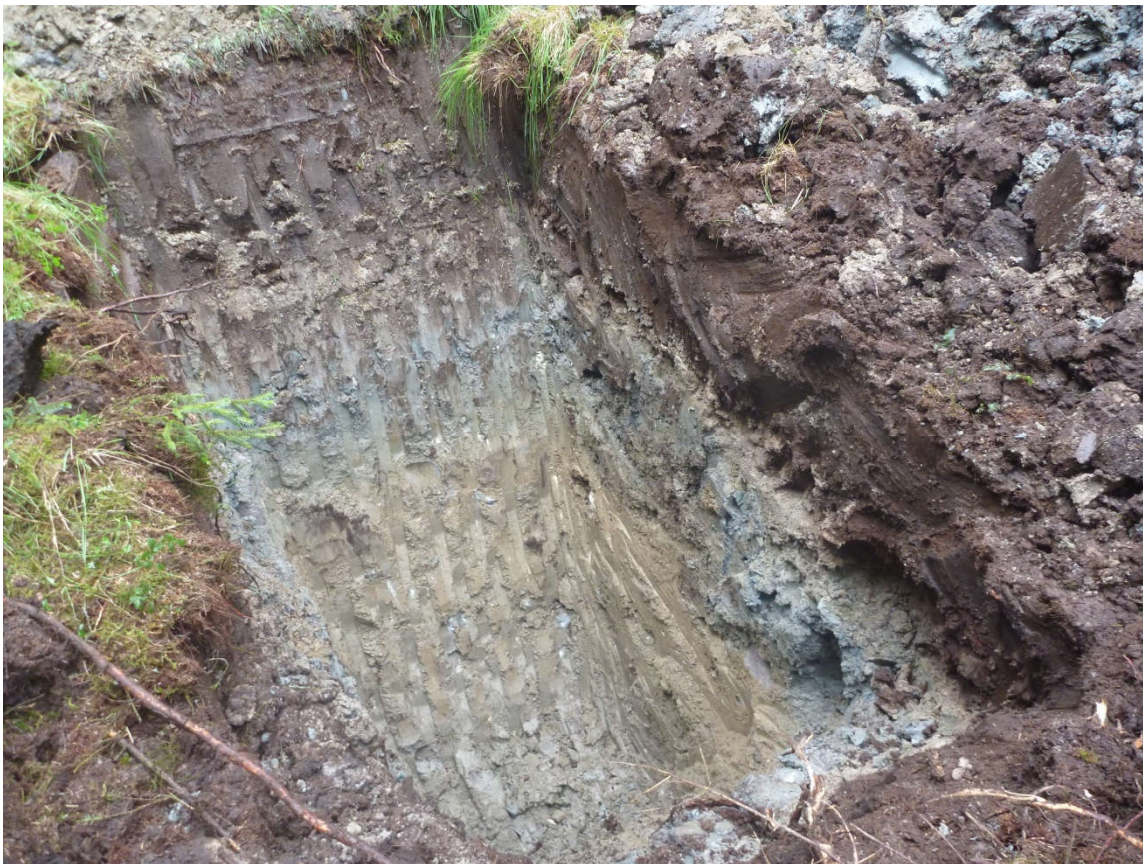
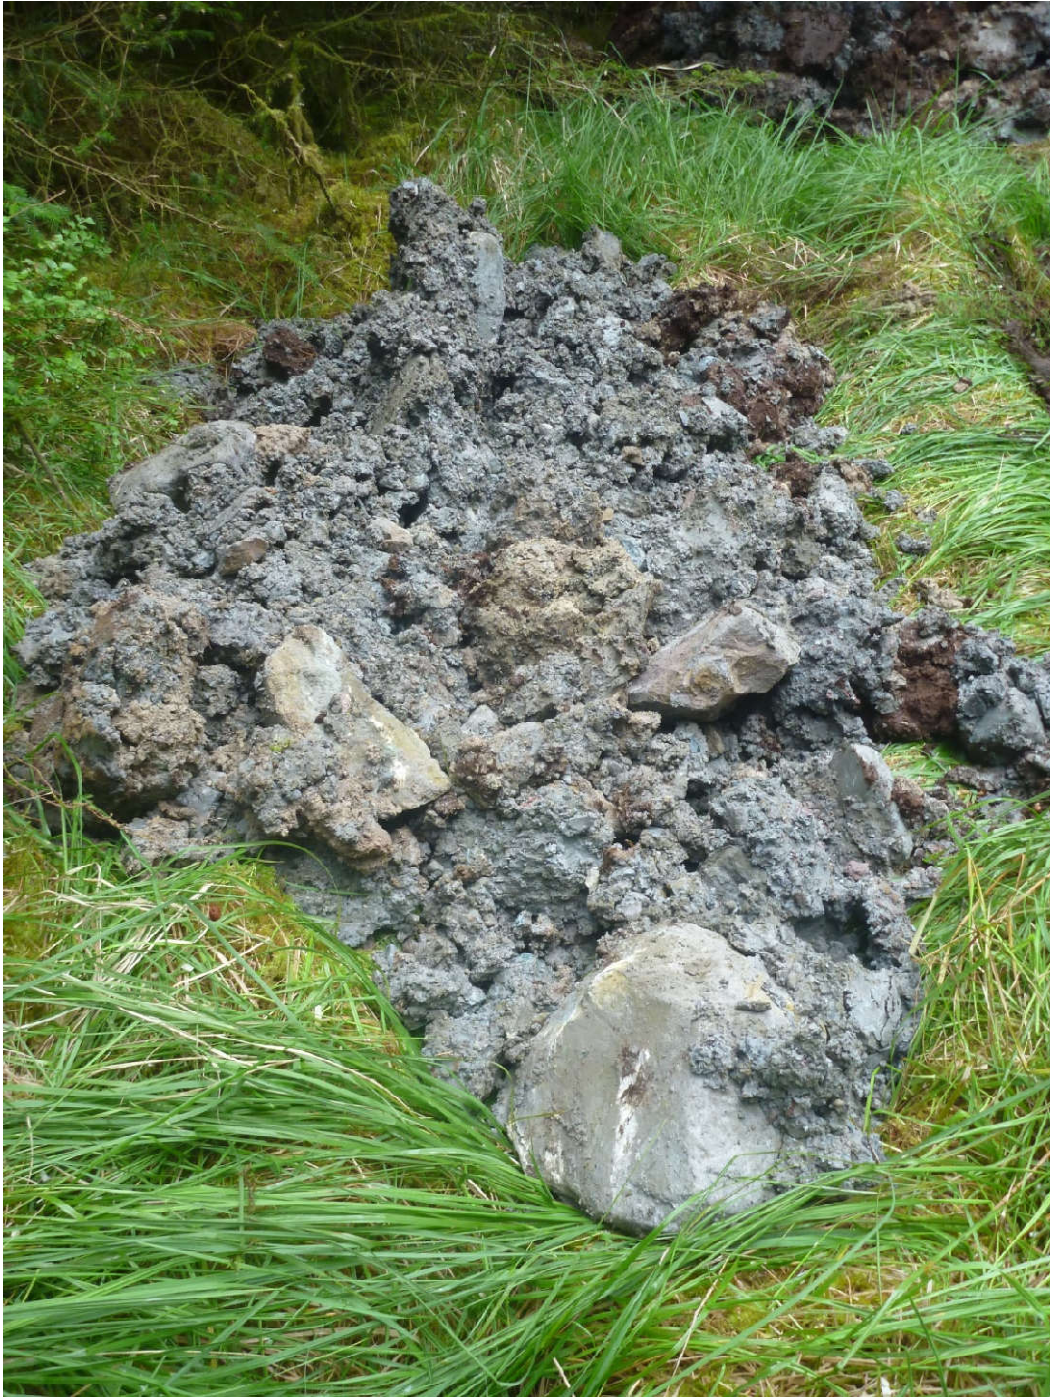
PEAT	<div style="border: 1px solid black; padding: 2px;">Hole stable</div> <div style="border: 1px solid black; padding: 2px;">No Groundwater Encountered</div>
1.5

CLAY: Firm to stiff grey/blue sandy gravelly CLAY with boulders and cobbles. Boulders and cobbles are sub-angular. Material is remouldable on rolling	
2.0

CLAY: Stiff to very stiff brown/grey sandy gravelly CLAY with some large boulders. Material remouldable on rolling and appears to be laminated.	
3.0

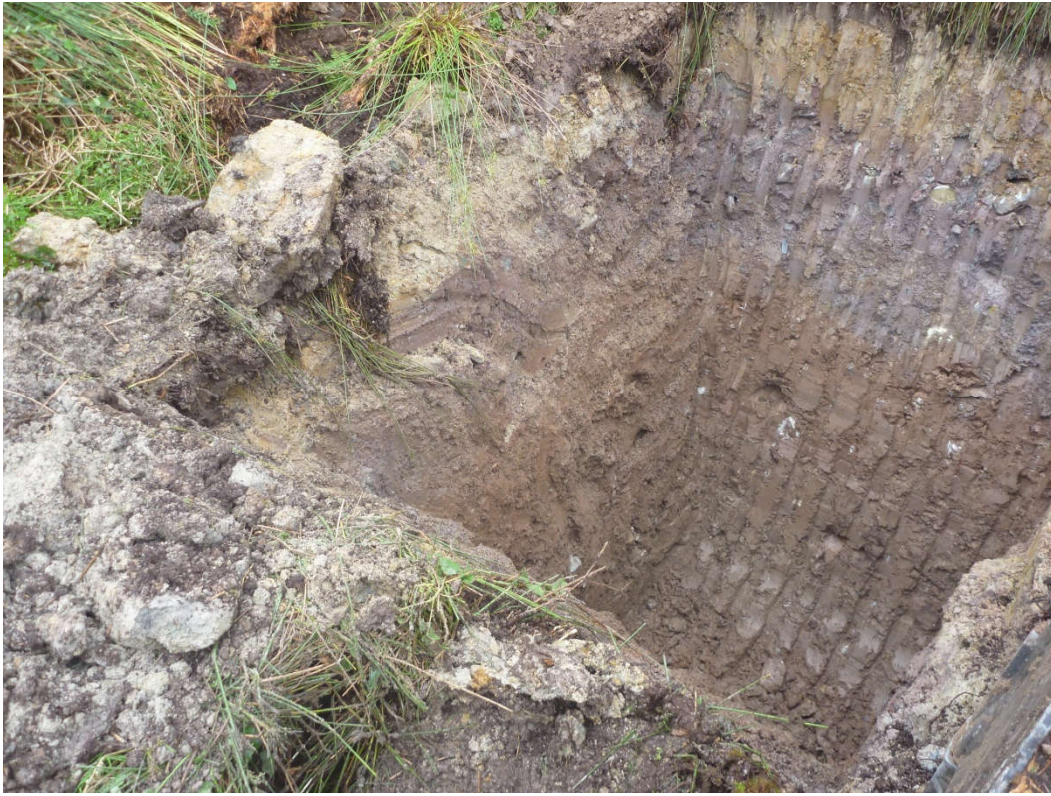
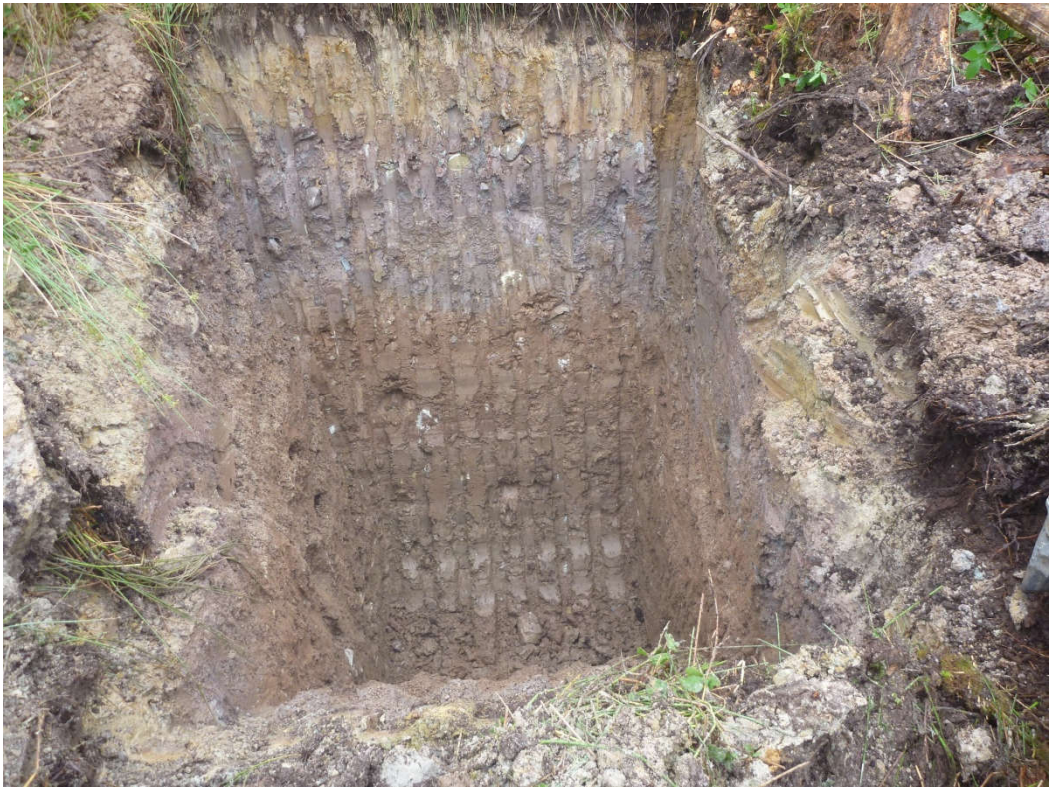
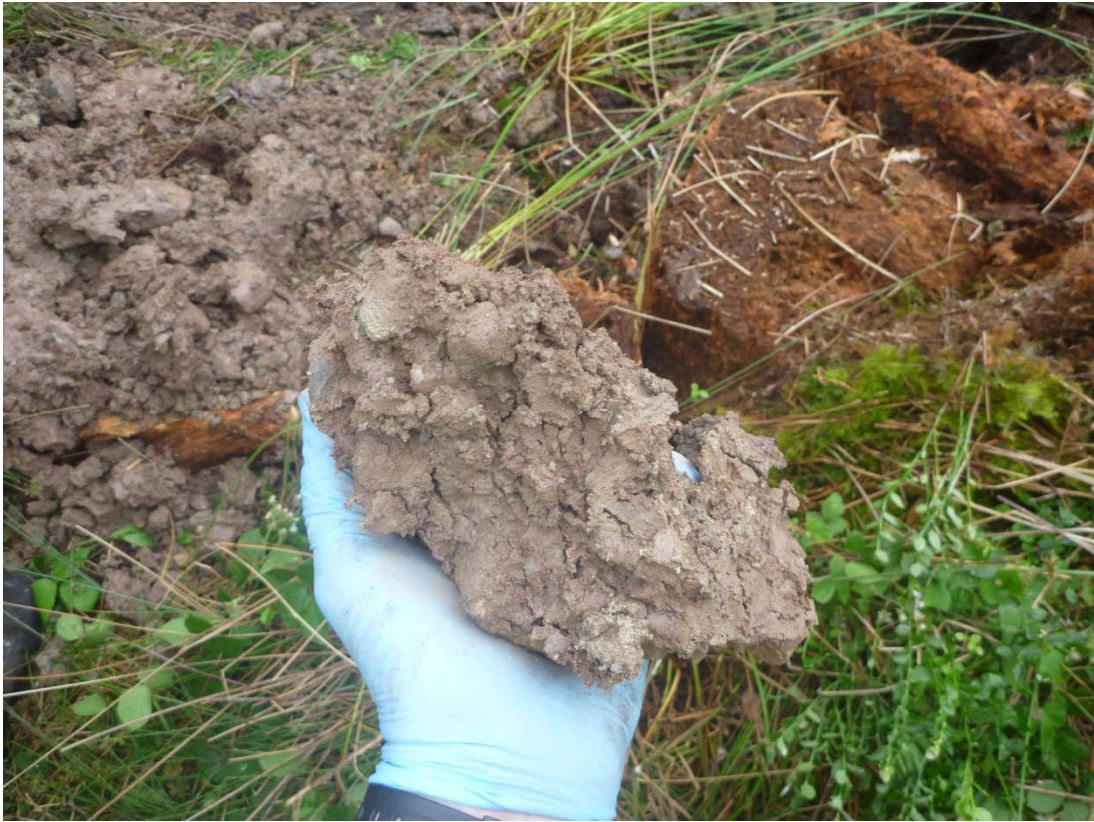
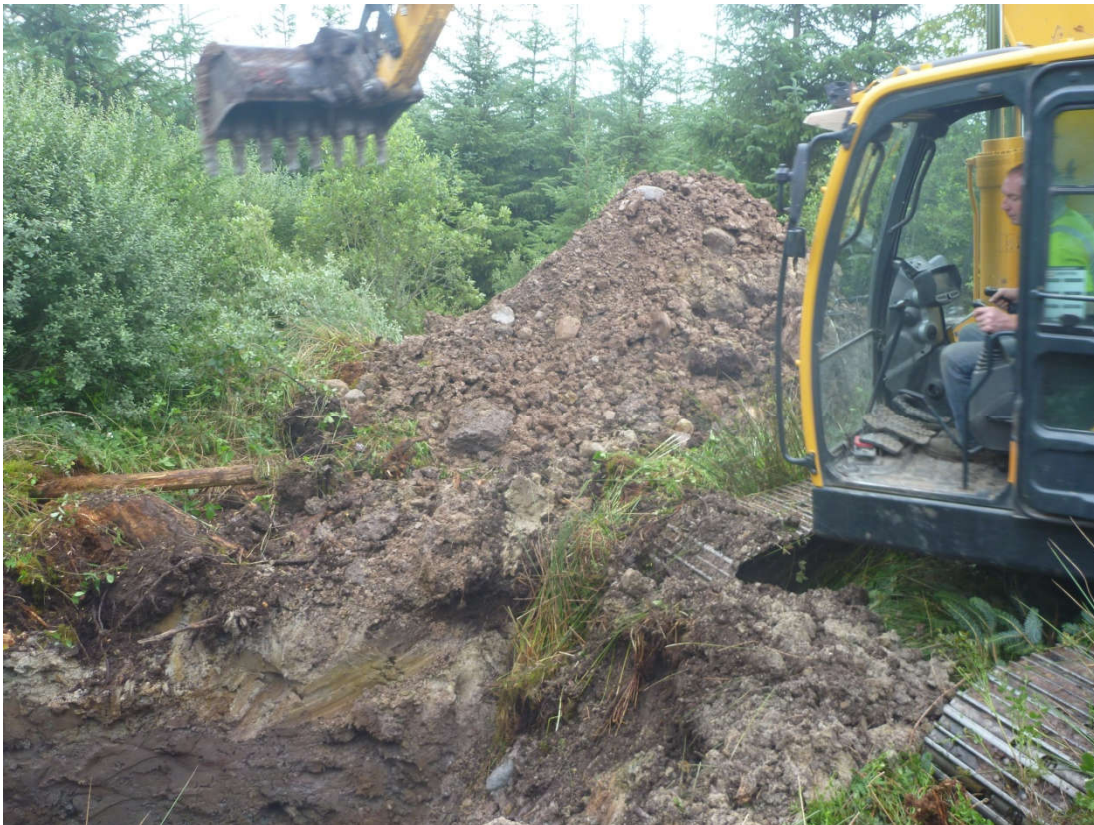
PEAT	Hole stable No Groundwater Encountered
0.5

CLAY: Grey/Brown (Subsoil)	
1

CLAY: Firm to stiff, grey/brown gravelly CLAY with frequent cobbles and boulders. Gravel is angular to sub-angular	
1.5

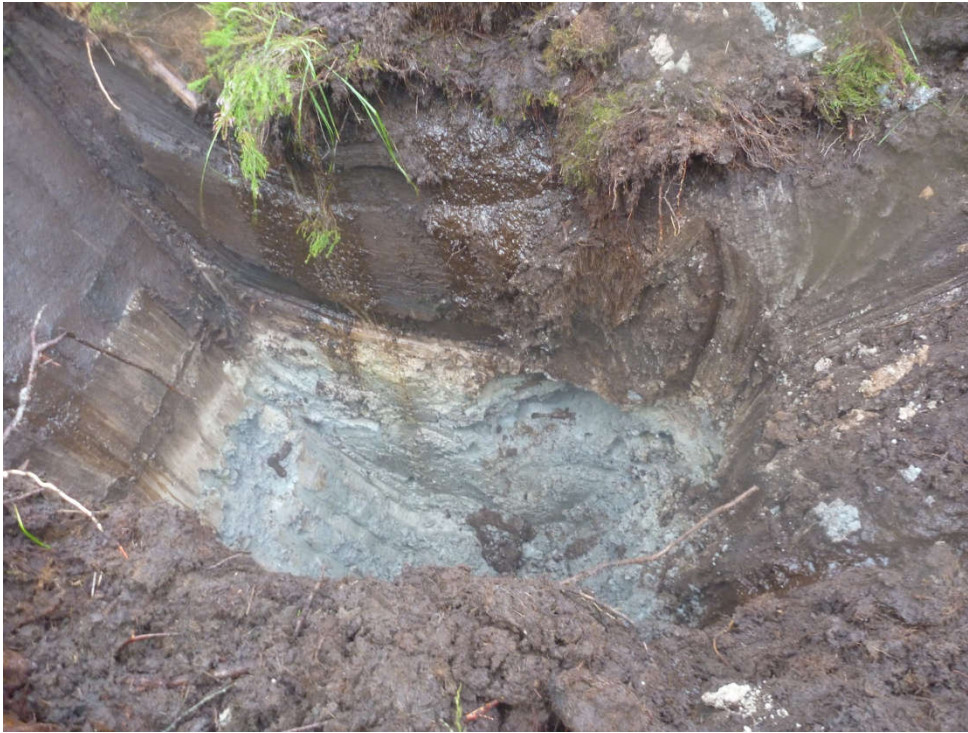
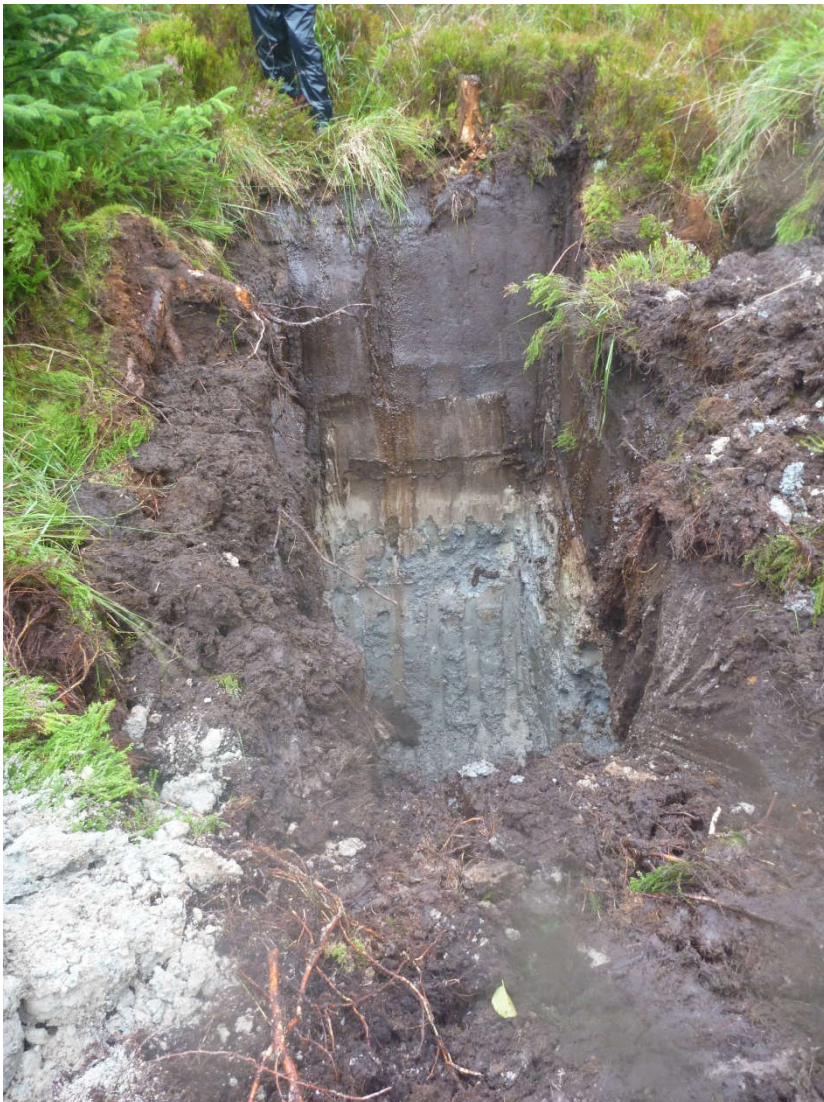
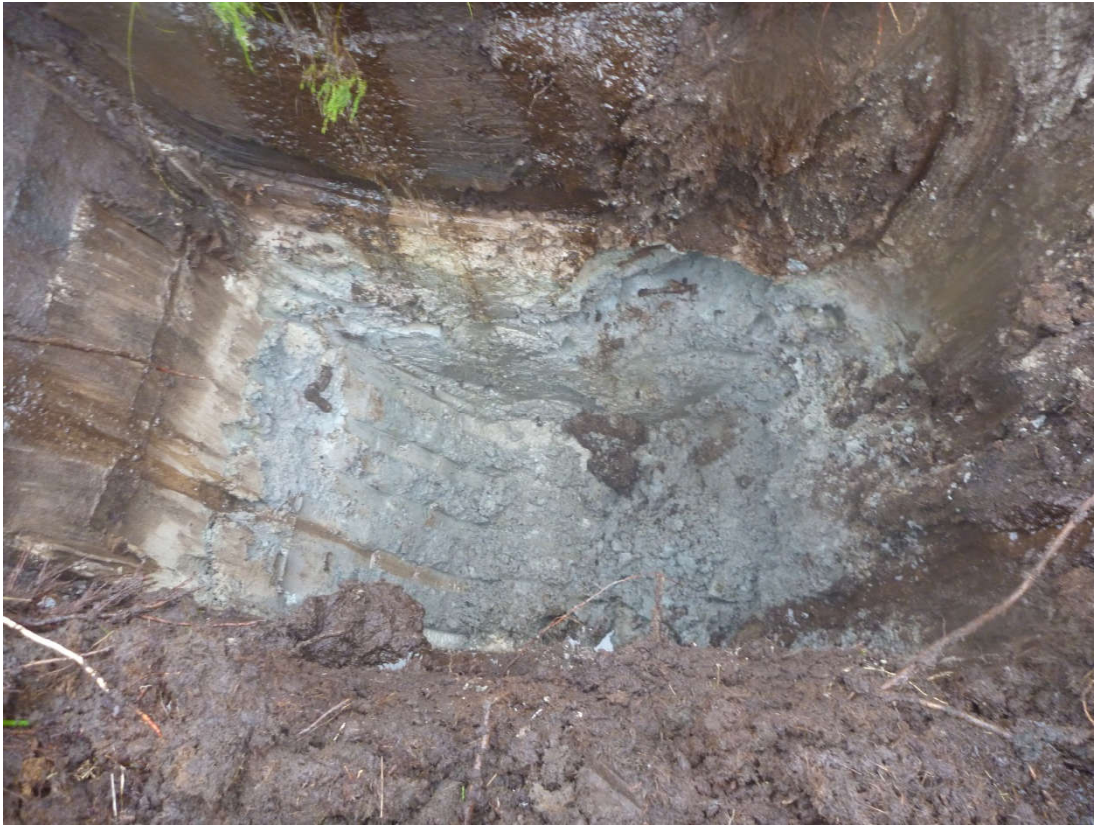
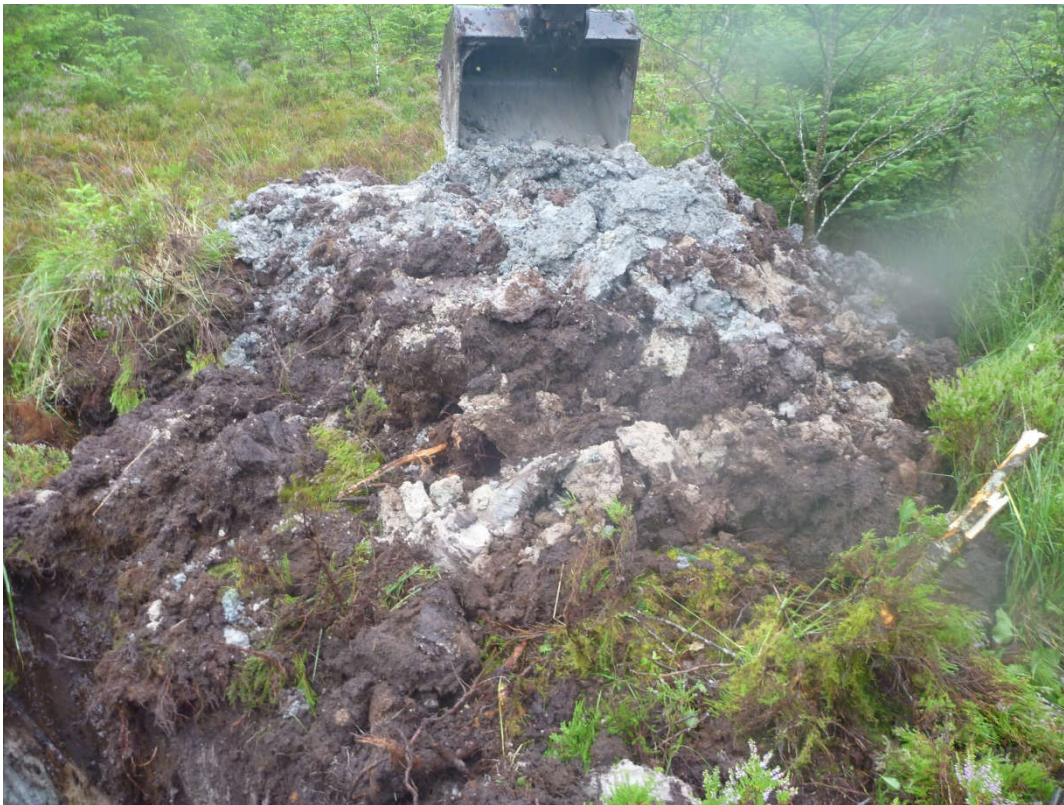
PROJECT NUMBER 19107 PROJECT NAME CARROWNAGOWAN WF CLIENT COILLTE		COORDINATES 561736 677202 COORD SYS ITM LOGGED BY P. CURRAN DATE 21.08.2019	
COMMENTS			
Depth (m)	Graphic Log	Material Description	Additional Observations
0.5		PEAT	Hole stable No Groundwater Encountered. Flow from surface into trial hole.
2		Firm blue/grey sandy gravelly CLAY. Some large angular boulders.	
3.5		Terminated at engineers request	
4			
4.5

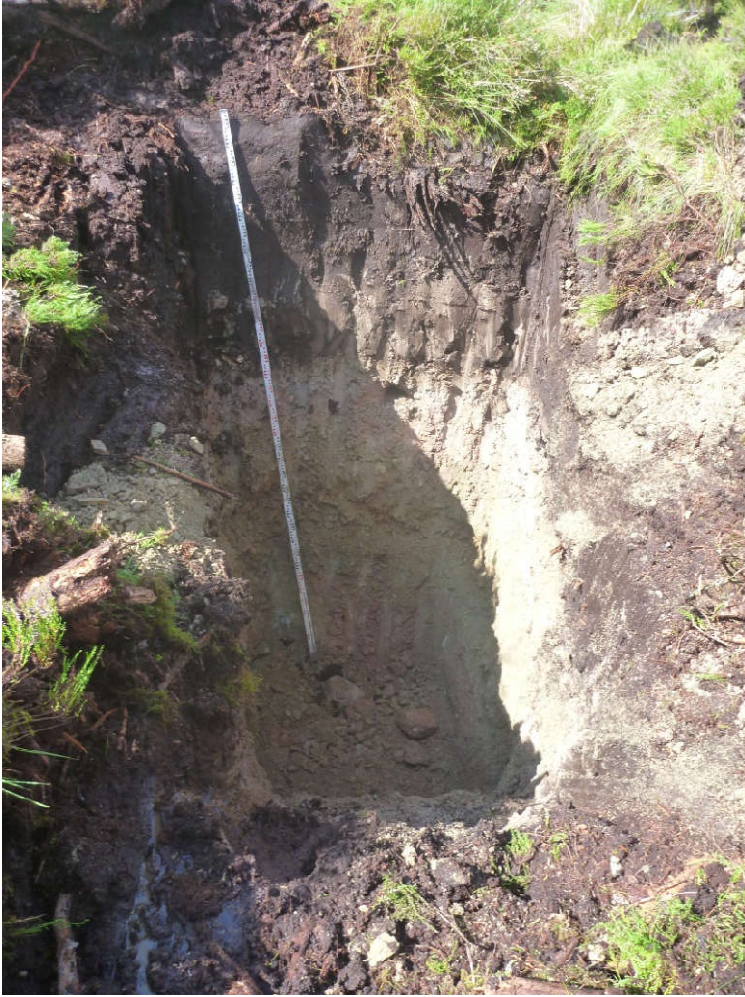
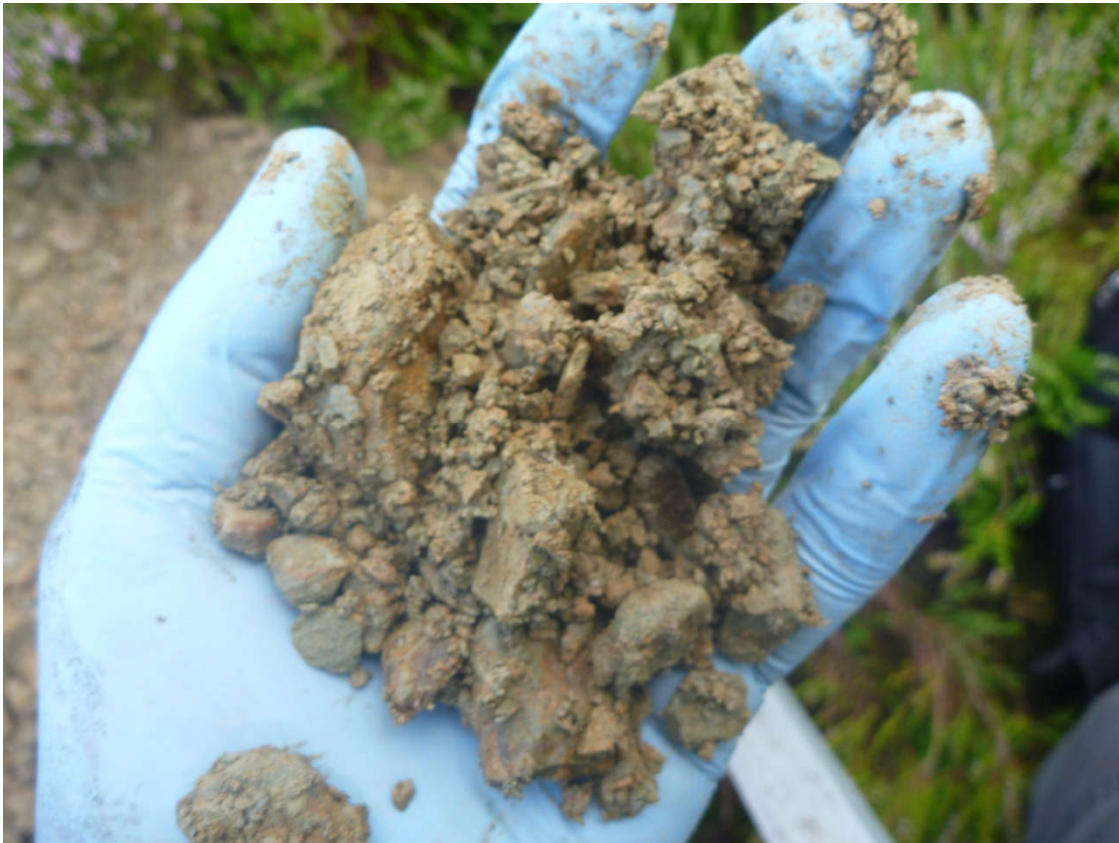
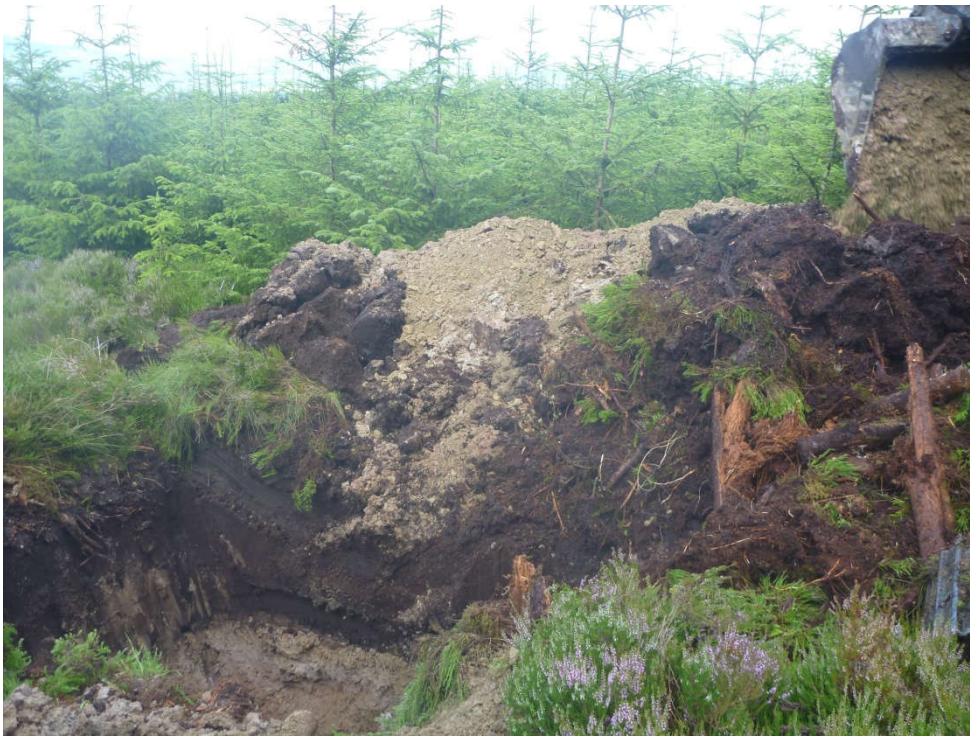
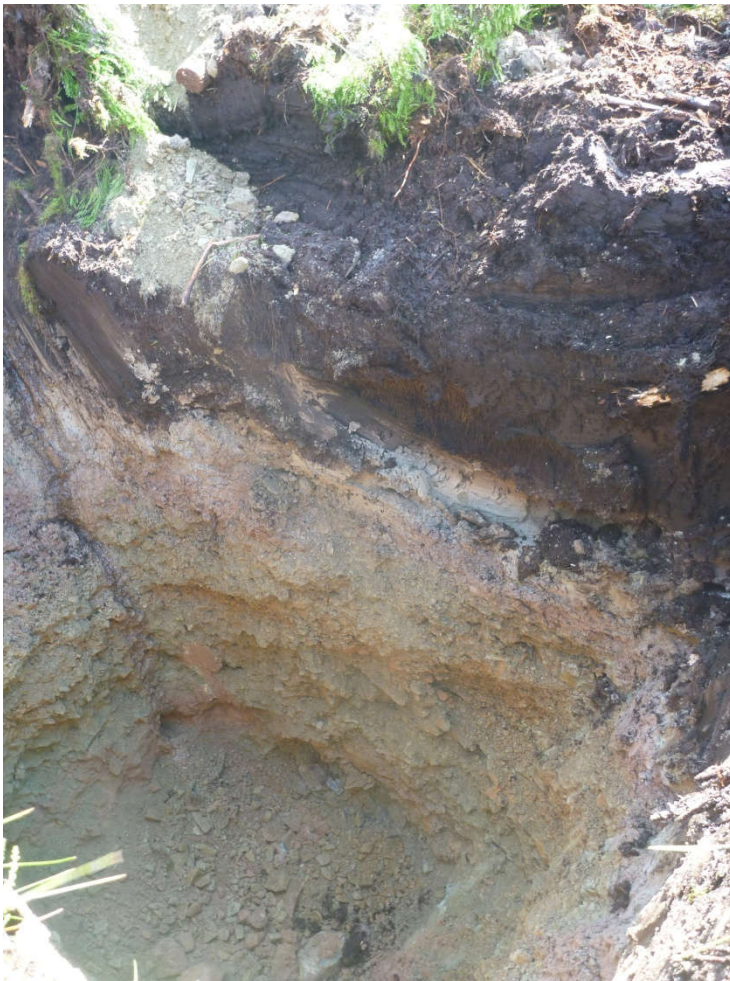
PEAT Possible Bedrock Soft grey sandy CLAY Brown/purple clayey GRAVEL. Gravel is angular (Possibly weathered shale)	Hole stable No Groundwater Encountered
		Terminated on possible bedrock

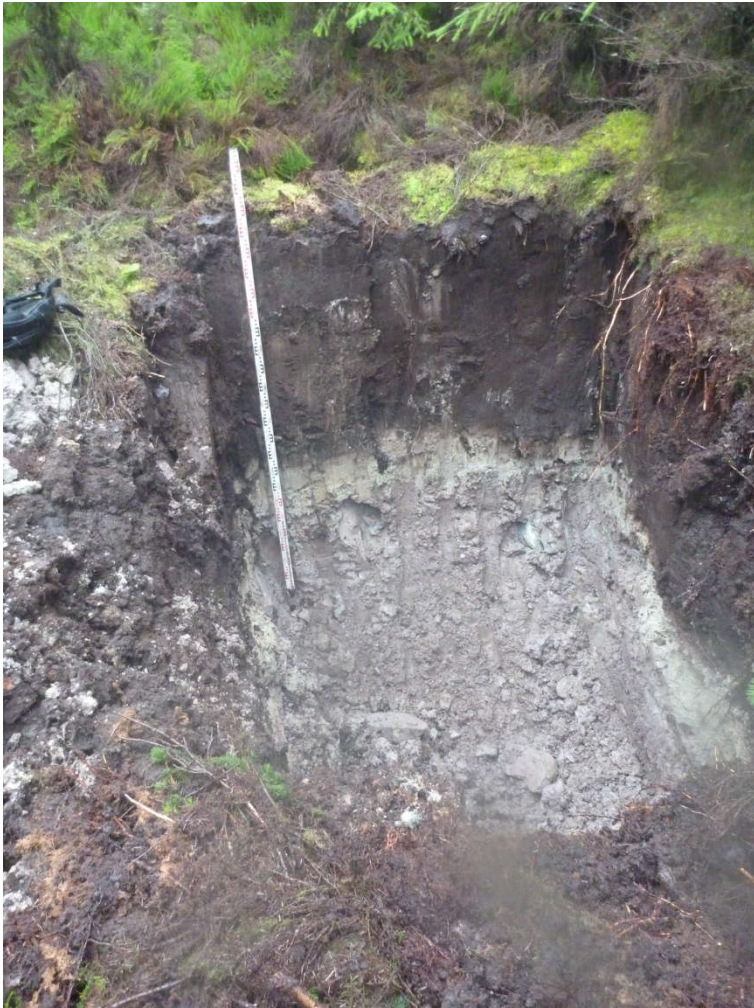
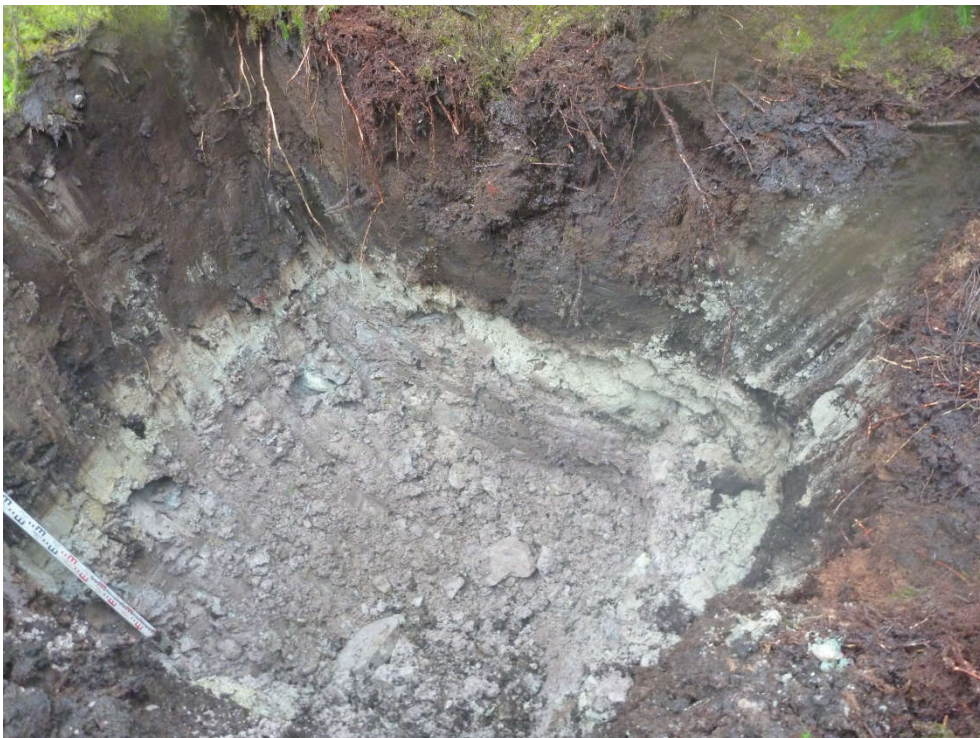
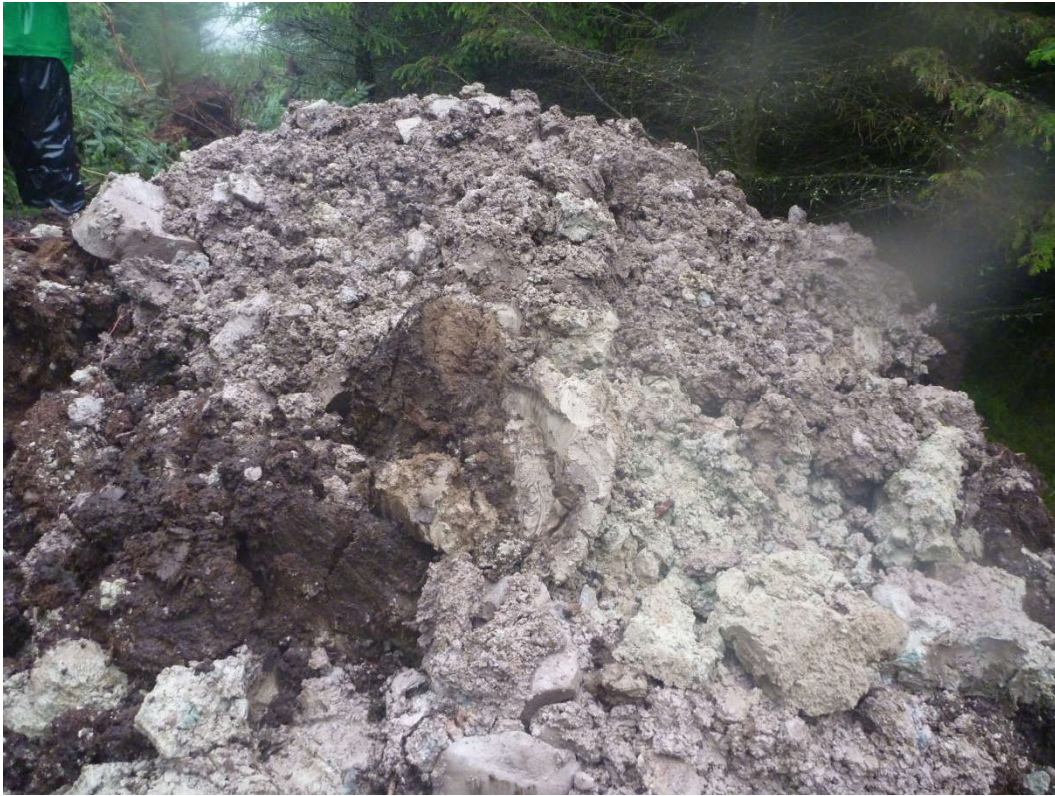
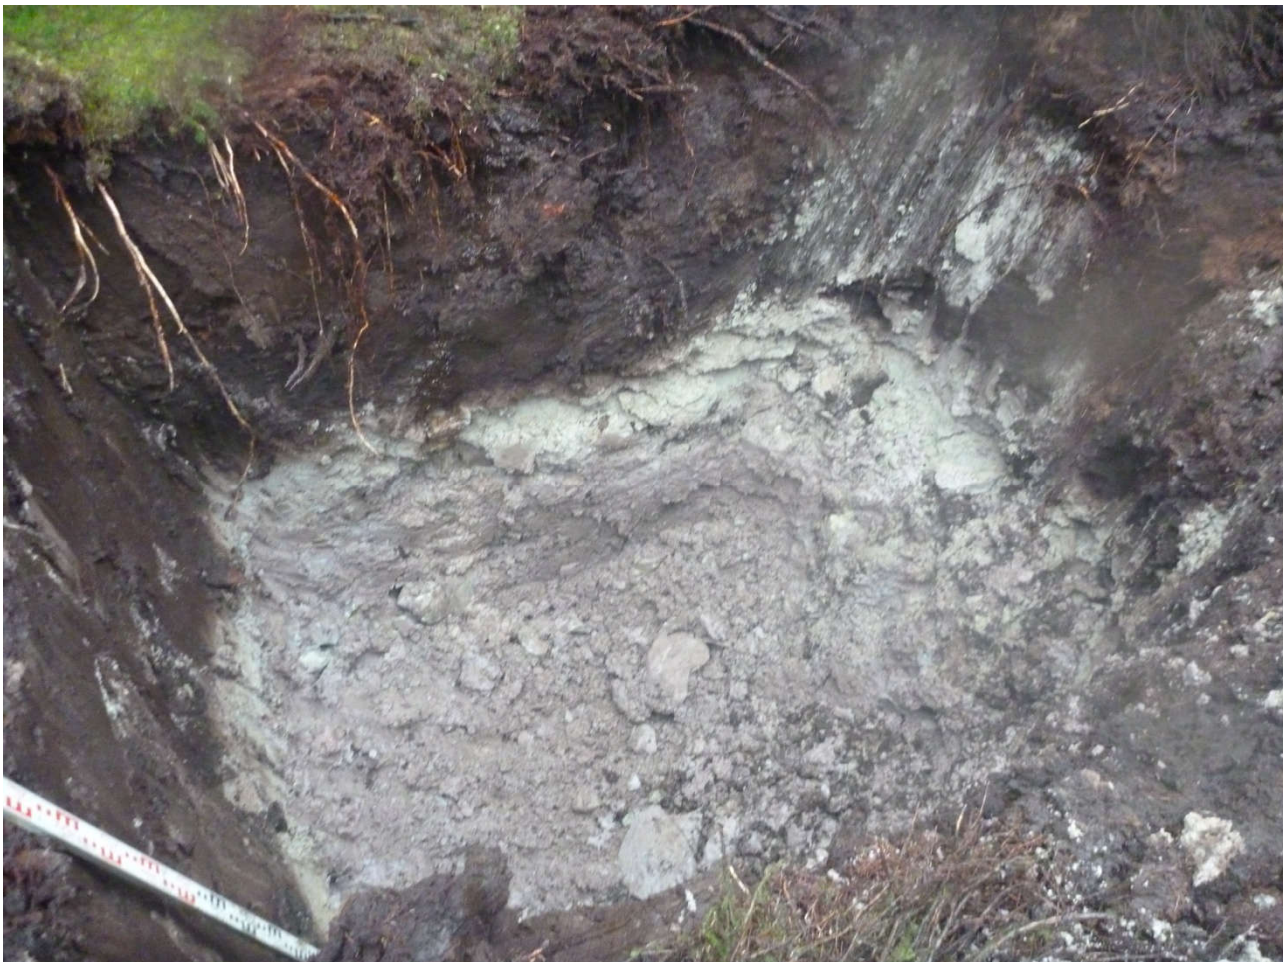
PEAT	Hole stable No Groundwater Encountered
1.5

Grey firm gravelly CLAY	
2.0

Purpley brown firm very silty, very sandy, gravelly CLAY with cobbles and boulders.	
2.5		Terminated at engineers request	
3.0			
3.5			
4.0			
4.5
