Ground Investigation Factual Report

Carrownagowan Wind Farm **Ground Investigation Factual Report**

The purpose of this report is to present the ground investigation information obtained at the site of the proposed Carrownagowan Wind Farm, Co. Clare

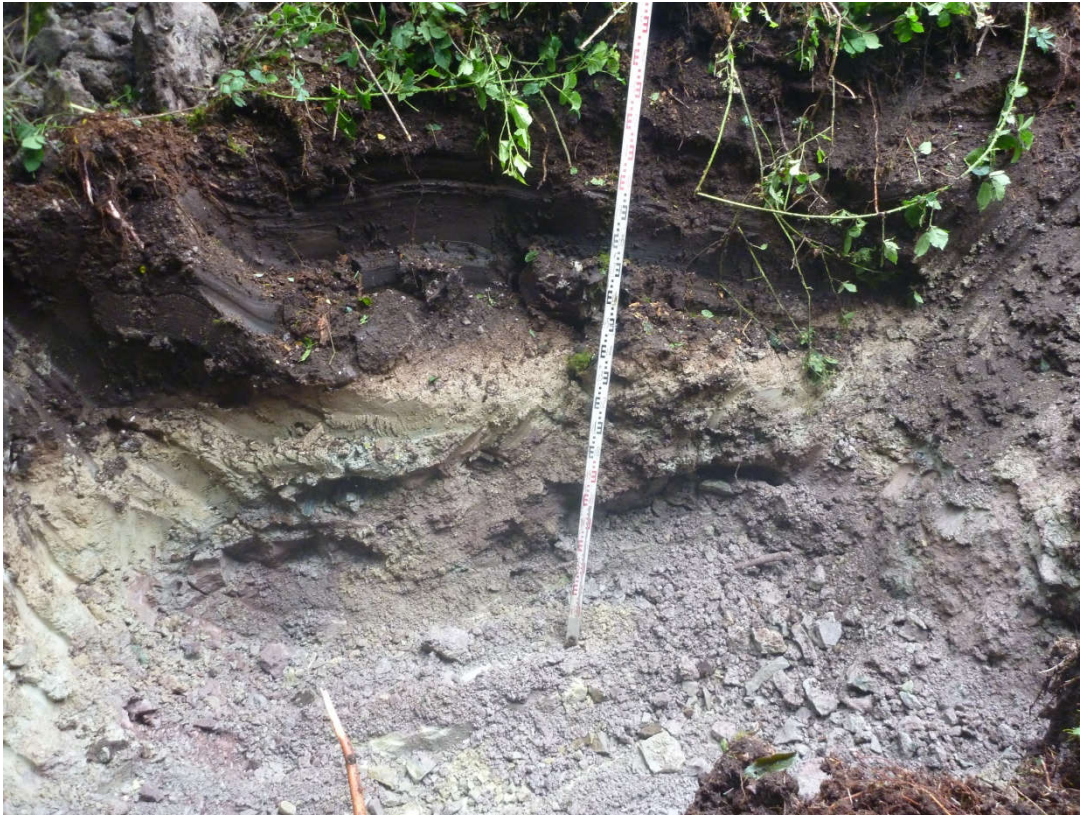
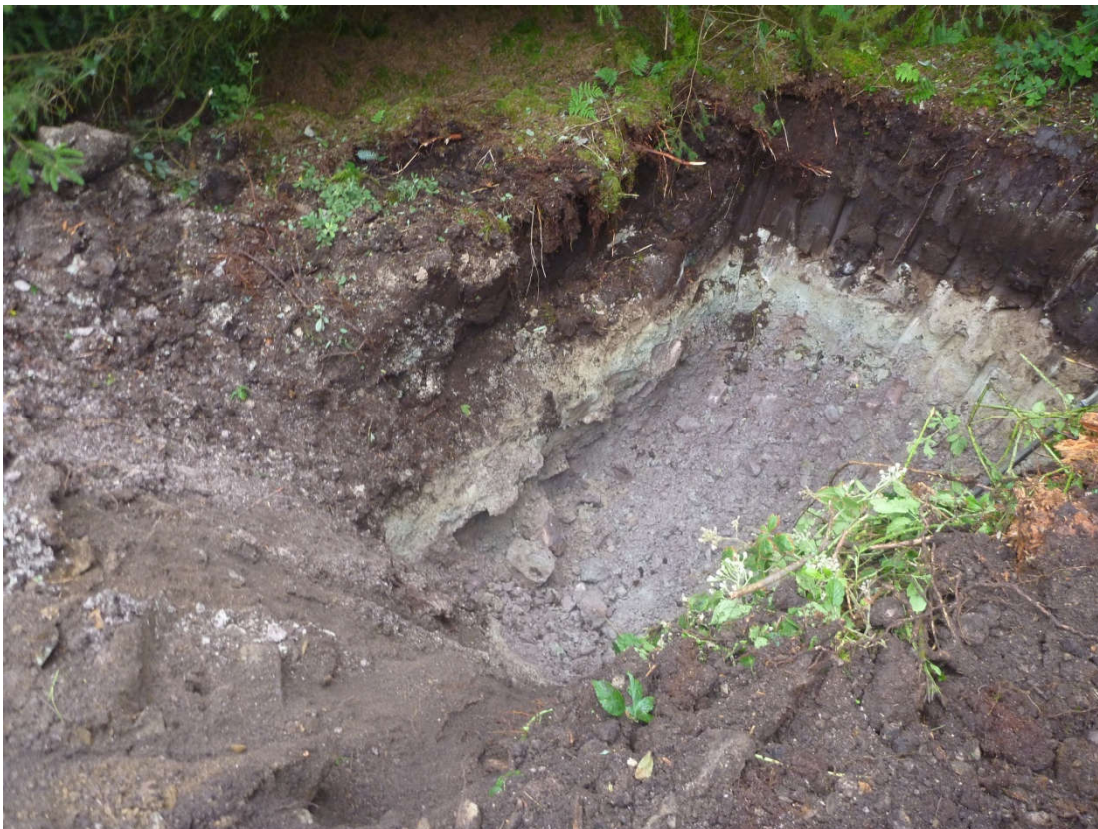
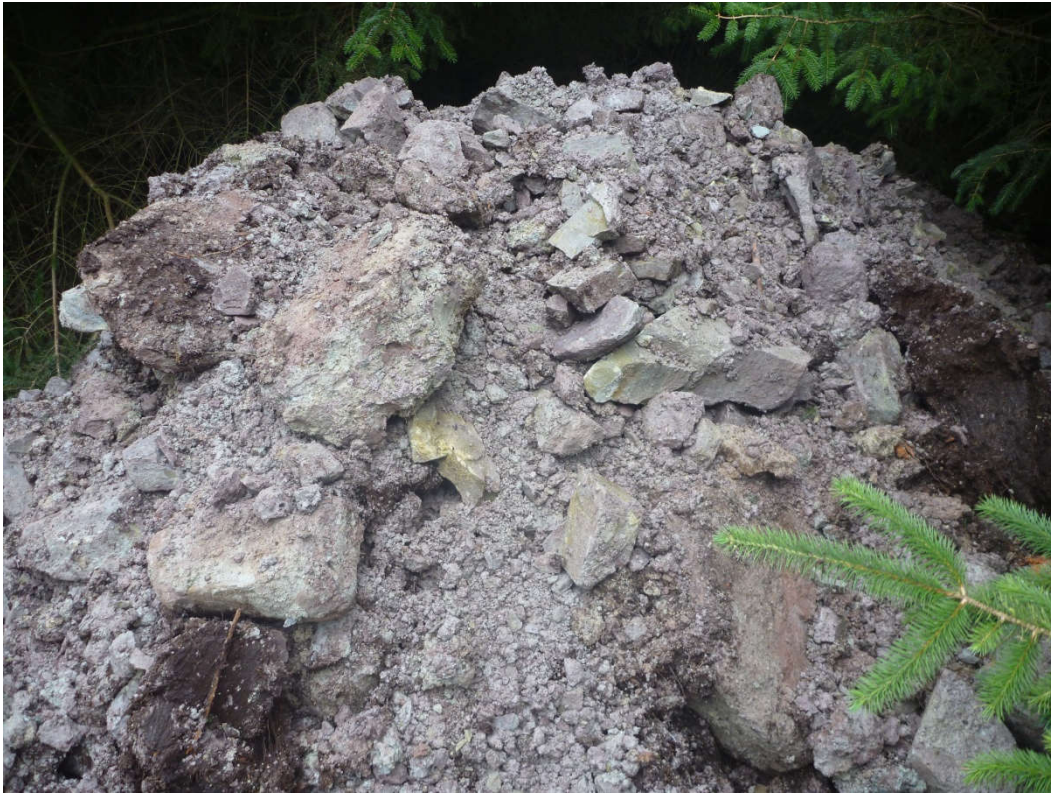
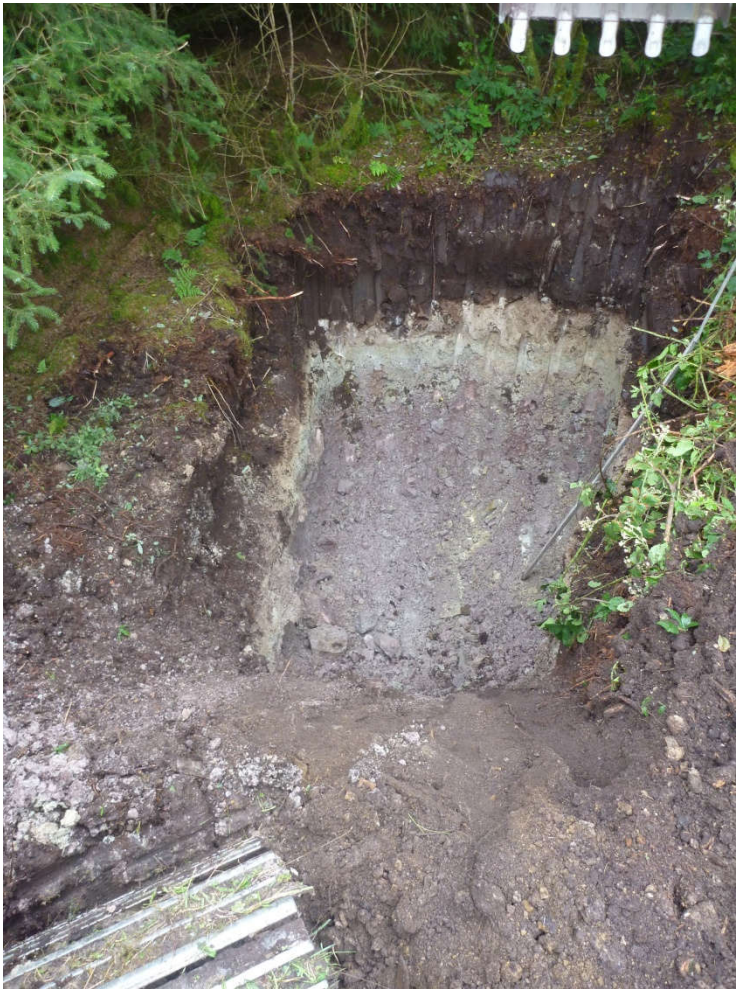
PEAT	<div style="border: 1px solid black; padding: 2px; margin-bottom: 2px;">Hole stable</div> <div style="border: 1px solid black; padding: 2px;">No Groundwater Encountered</div>
1.5

CLAY: Grey/Blue Soft CLAY	
2

CLAY: Firm purple sandy gravelly CLAY with abundant cobbles and boulders. Cobbles and boulders are angular.	
2.5

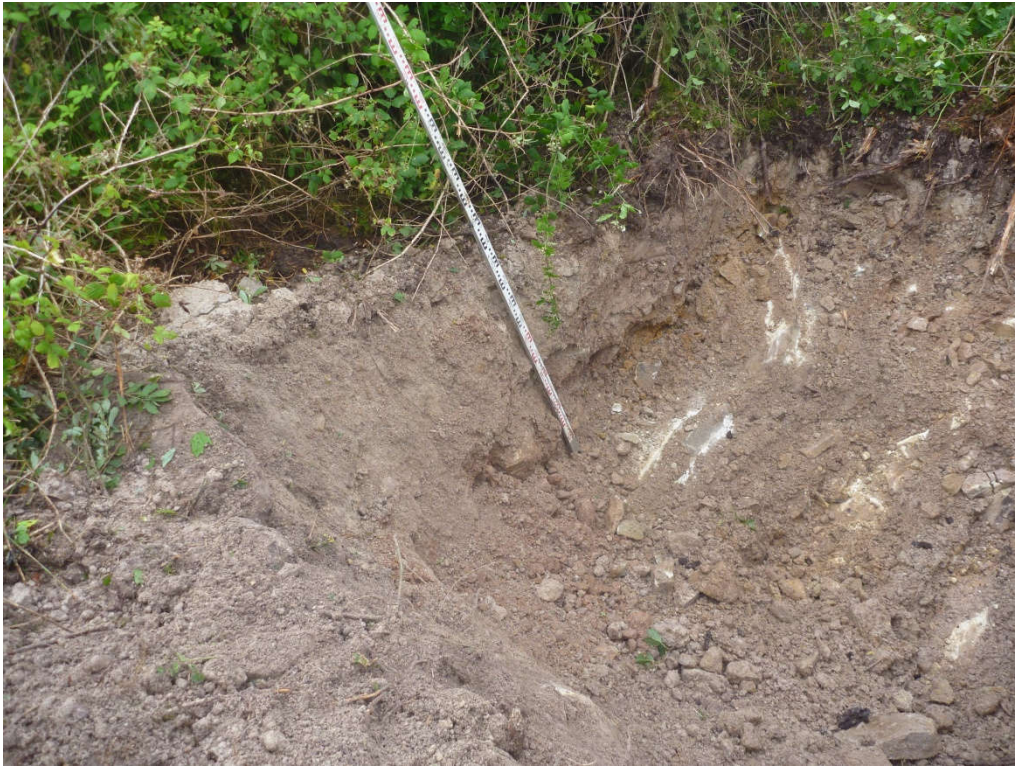
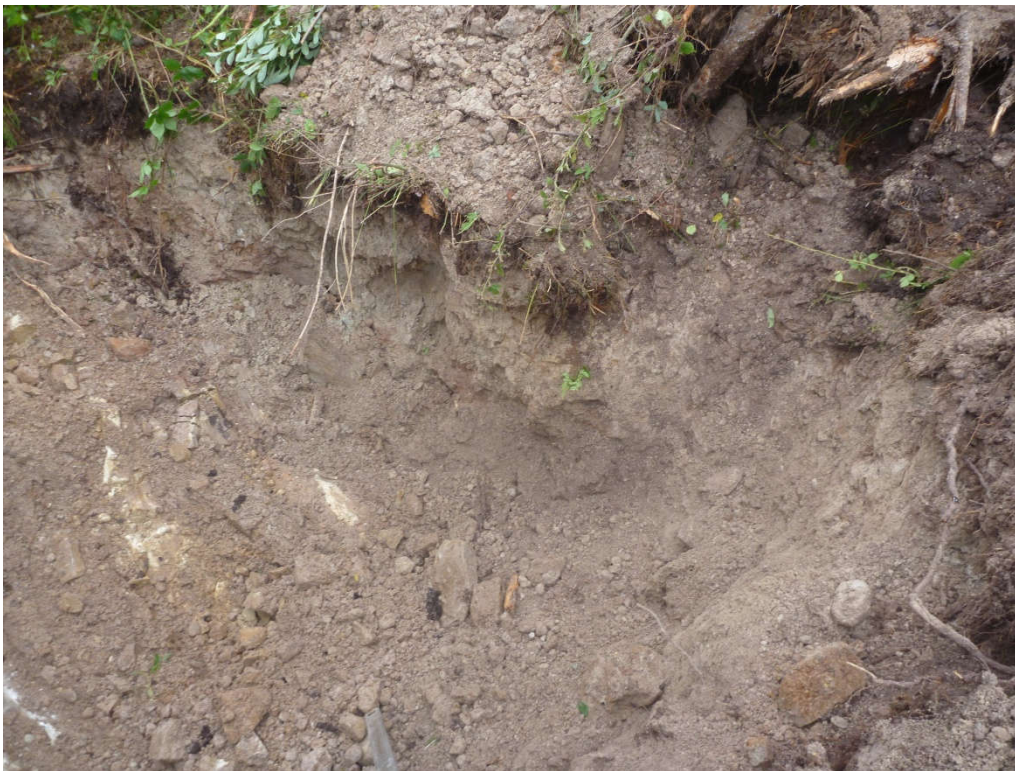
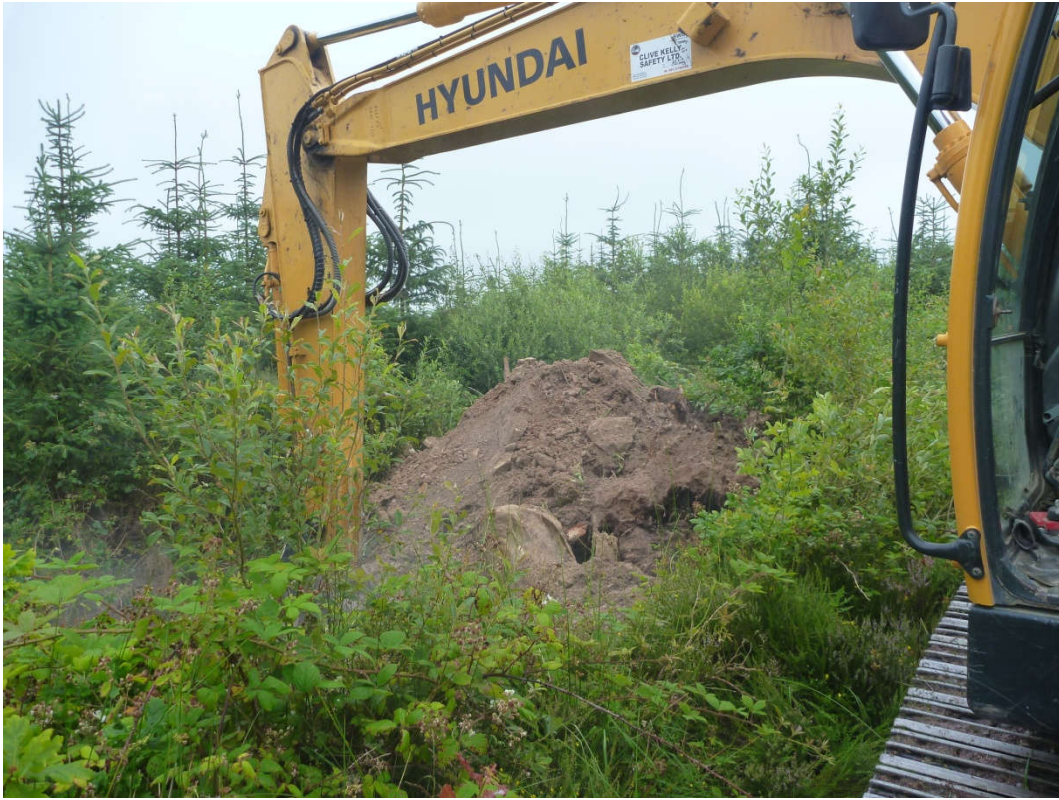
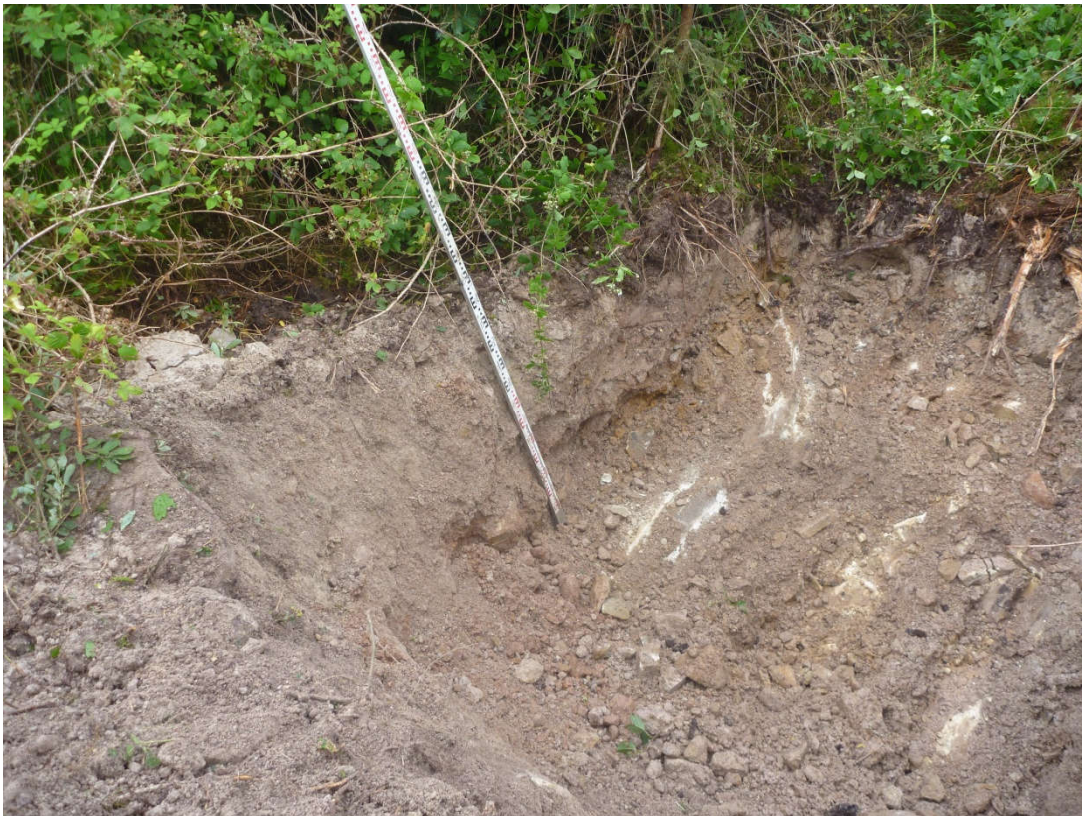
PEAT	Hole stable
0.5

CLAY: Gravelly sandy CLAY	No Groundwater Encountered
1

GRAVEL: Grey very clayey GRAVEL with abundant cobbles and boulders. Cobbles and boulders are angular to sub-angular	
		Possible Bedrock	
1.5		Terminated on possible bedrock	
2			
2.5			
3			
3.5			
4			
4.5

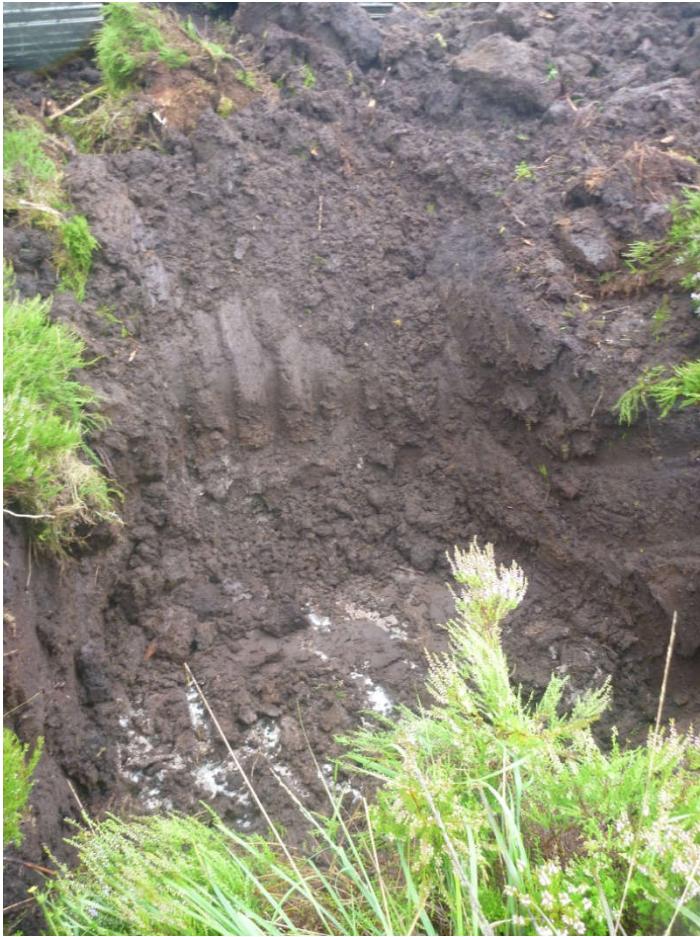
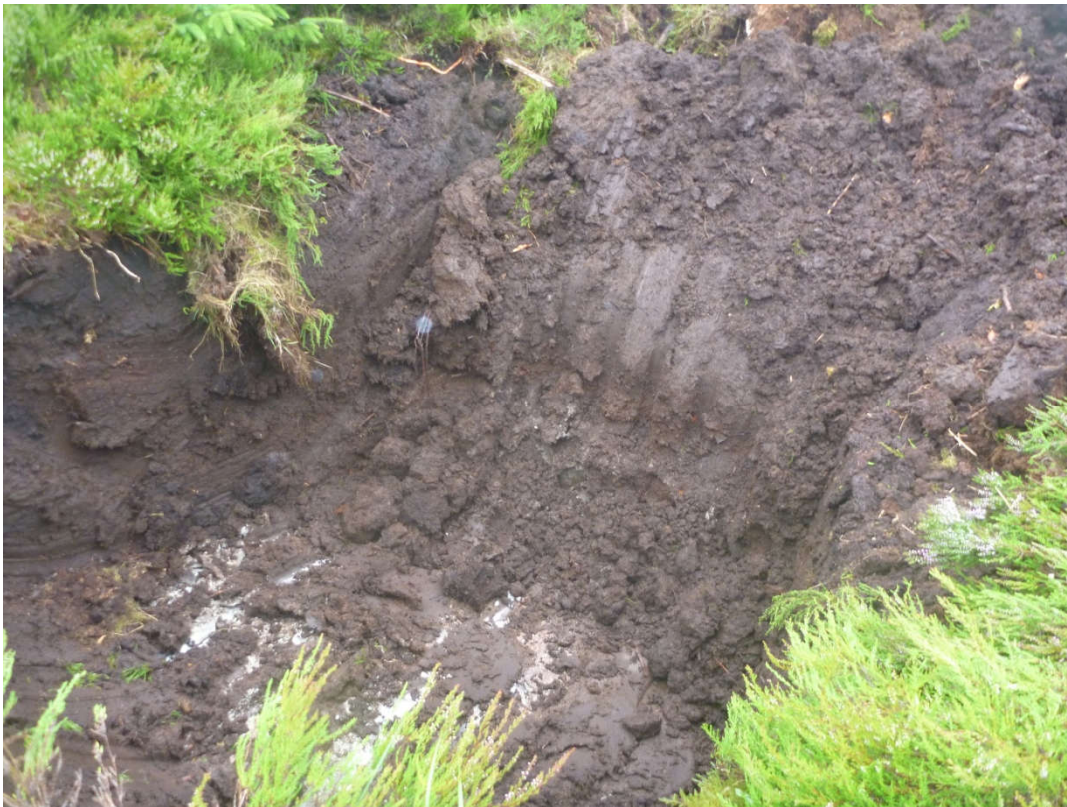
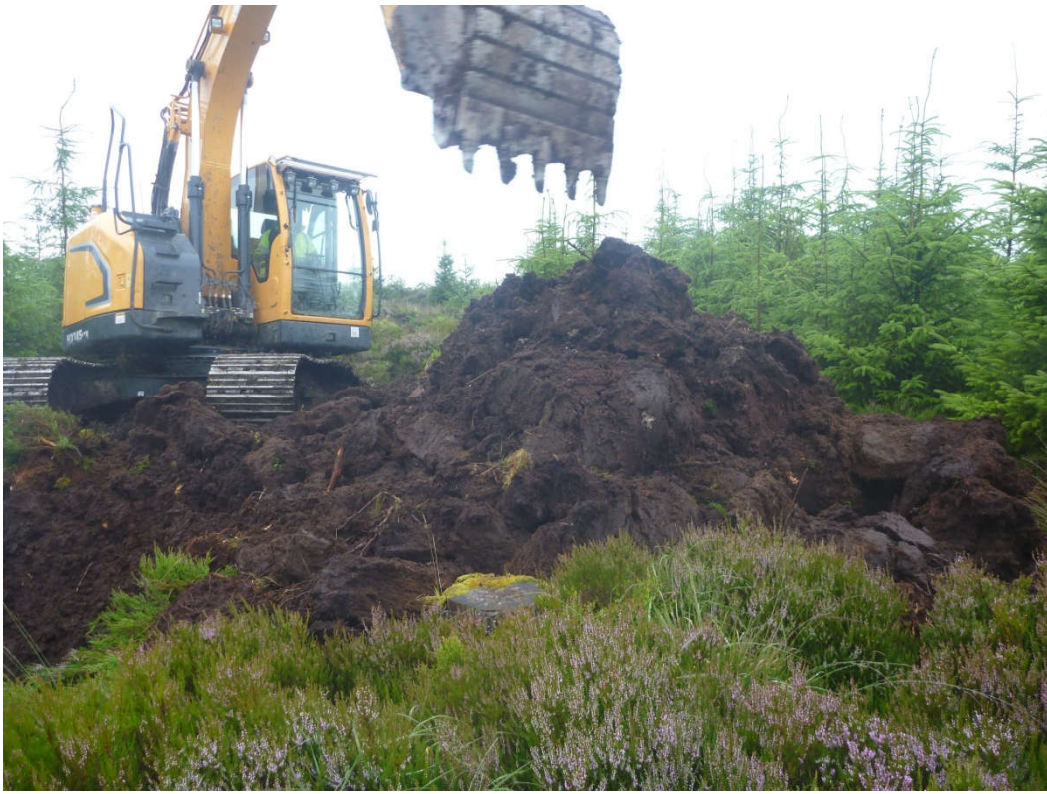
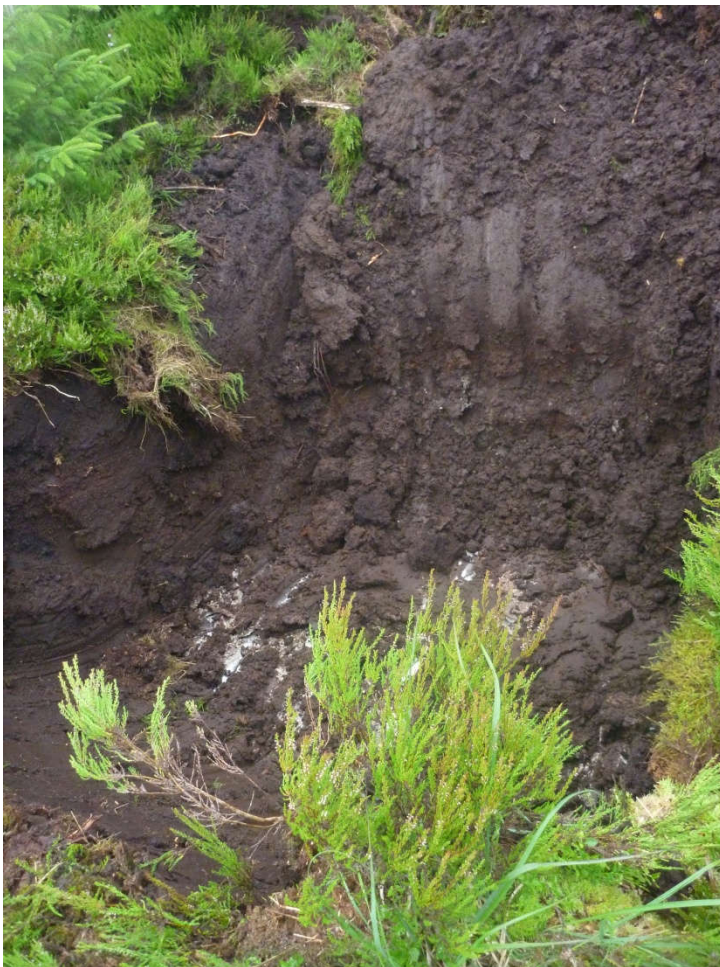
PEAT	Hole stable. No Groundwater Encountered
1.5

Possible bedrock	
2.0		Terminated on possible bedrock	
2.5			
3.0			
3.5			
4.0			
4.5

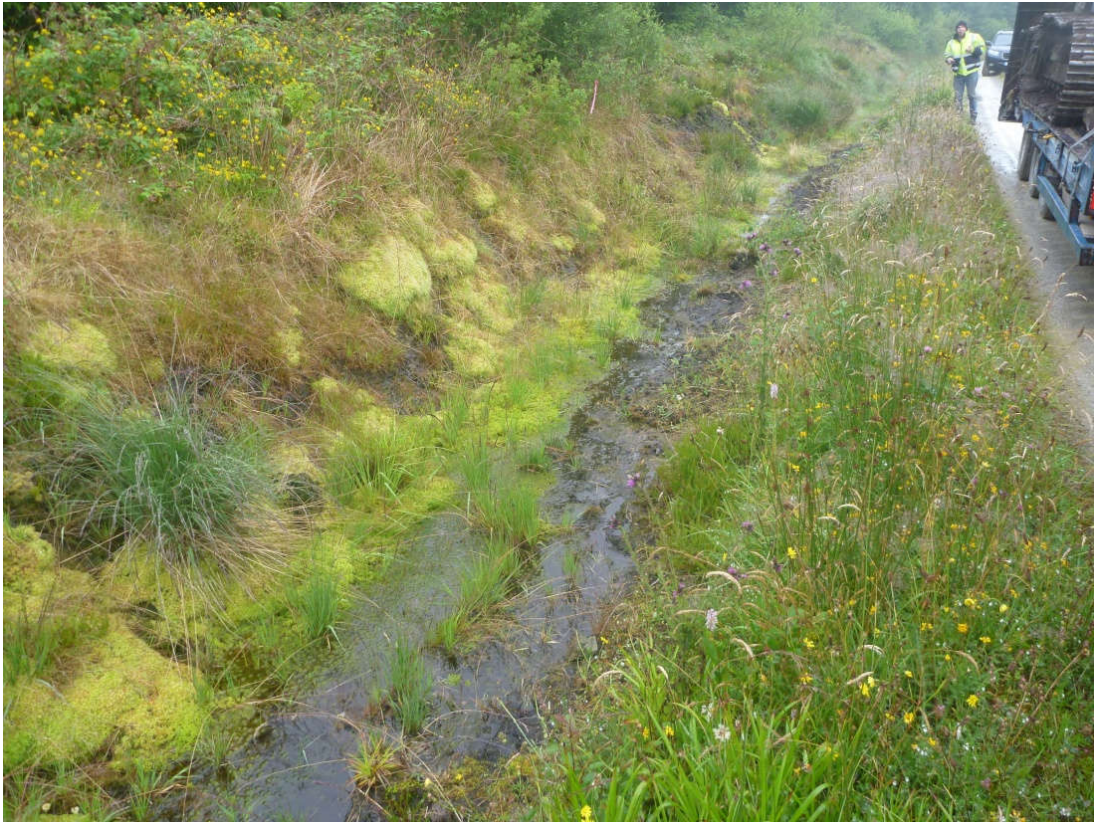
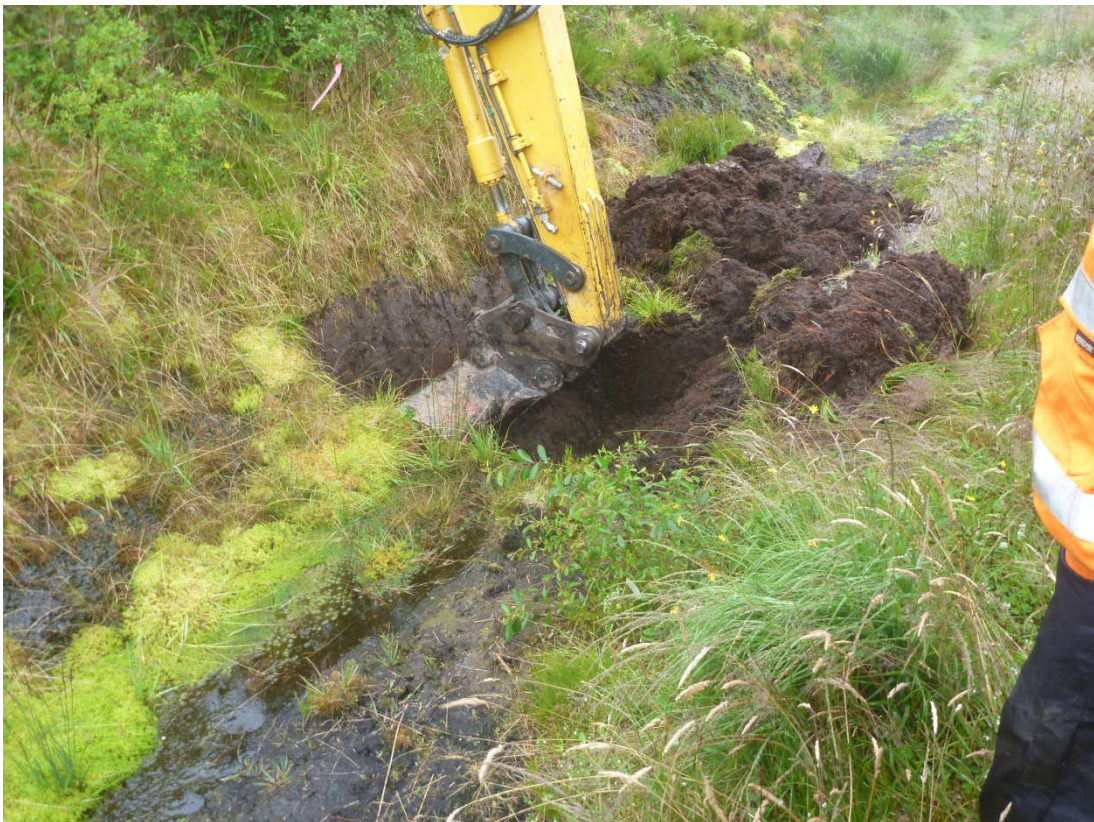
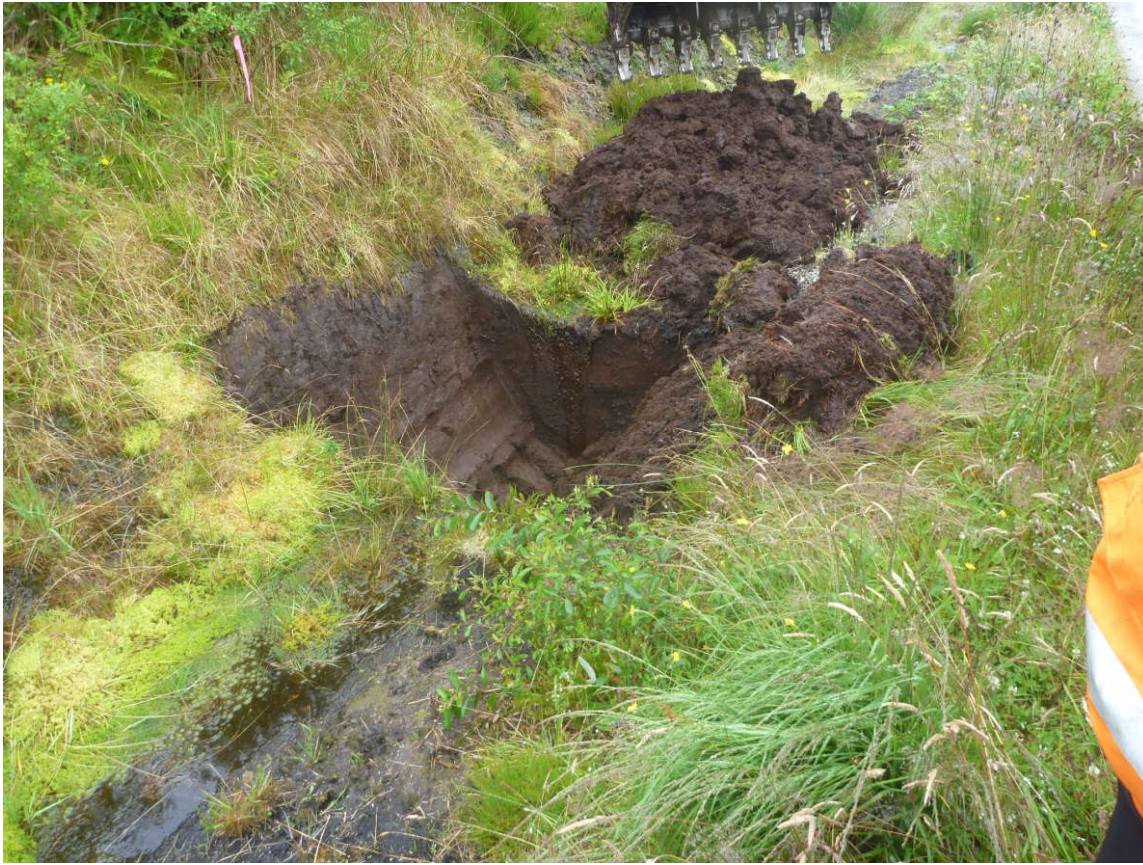
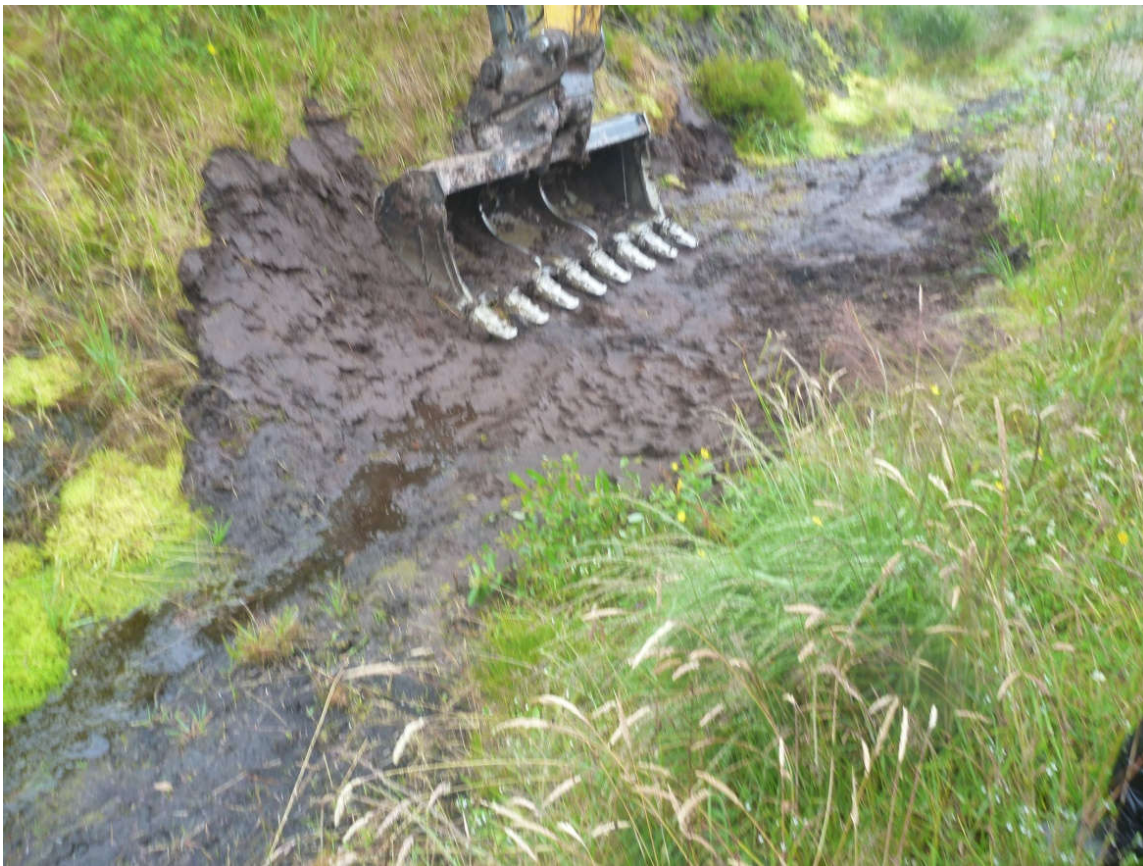
PEAT Terminated as peat became unstable.	Poor stability in Peat Surface water flowing into hole from drain Excavated at edge of existing access track as trees too heavy to get through Approximately 2m depth of peat in cuttings at edge of roadway. Likely 3m+ peat in area.

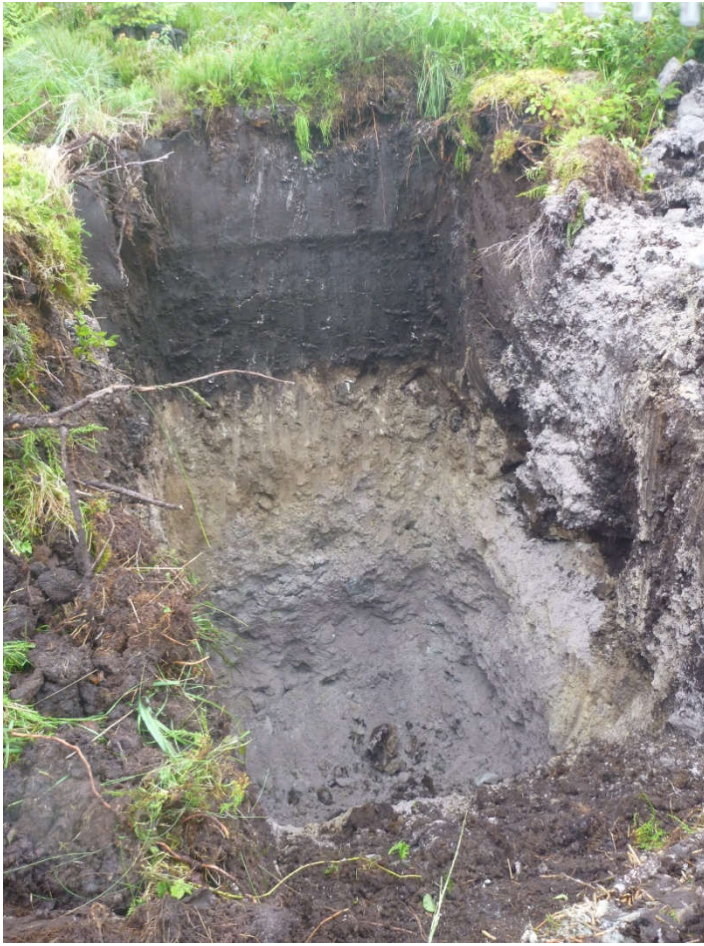
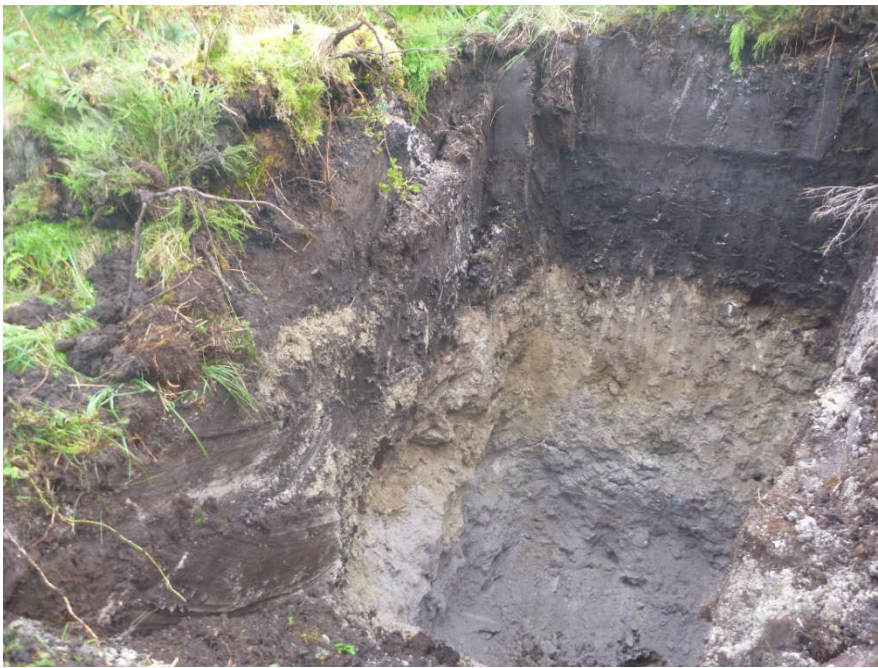
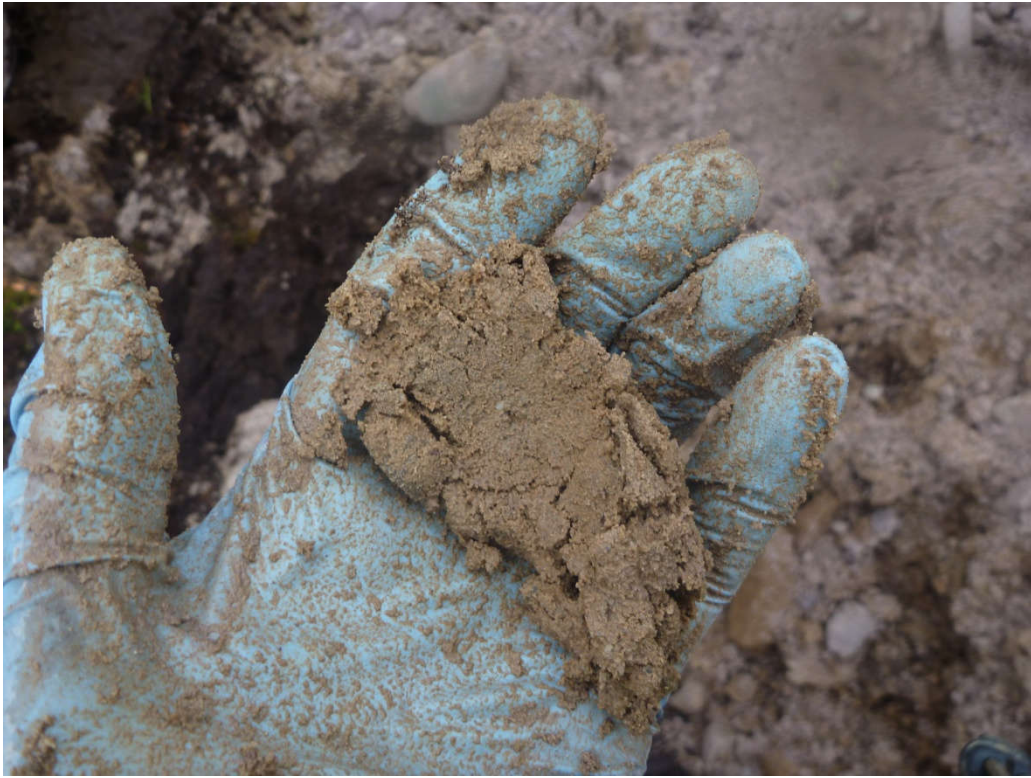
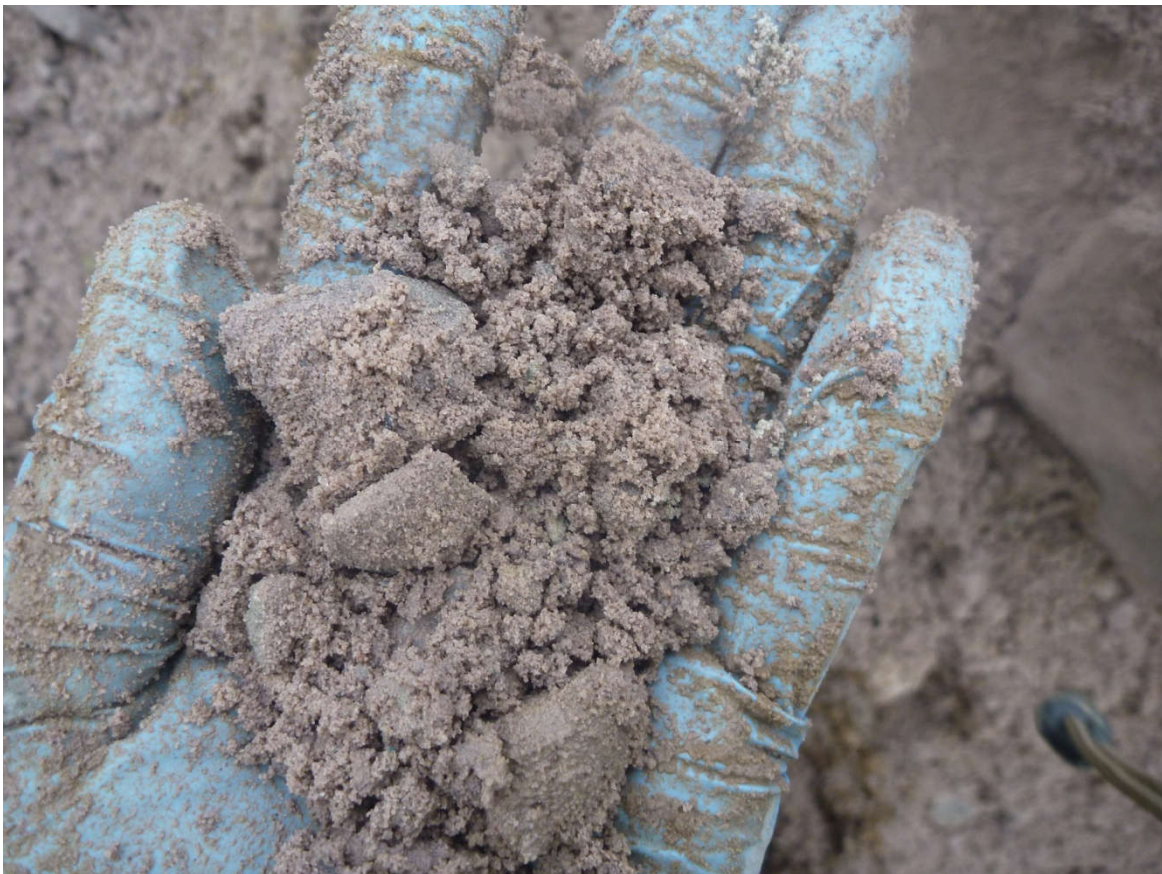
PEAT	Hole moderately stable. Likely to be running sands when wet No Groundwater Encountered
2 2.5

SAND: Brown silty SAND. Sand is fine	
3 3.5 4

SAND: Grey/purple silty SAND with cobbles and boulders. Cobbles and boulders are sub-angular. Not likely to be stable when wet, likely to run.	
4.5		Terminated at maximum reach of excavator
