Appendix 6-6

Ecological Surveys – Turbine Delivery Route

Ecological Surveys along Turbine Delivery Route Proposed Carrownagowan Wind Farm

ISSUE FORM	
Project number	19107
Document number	6031
Document revision	Rev A
Document title	Turbine Delivery Route Ecological Surveys
Document status	Final
Document prepared by	CoN - MWP (May 2020)
Document checked by	GH - MWP (12-05-2020)

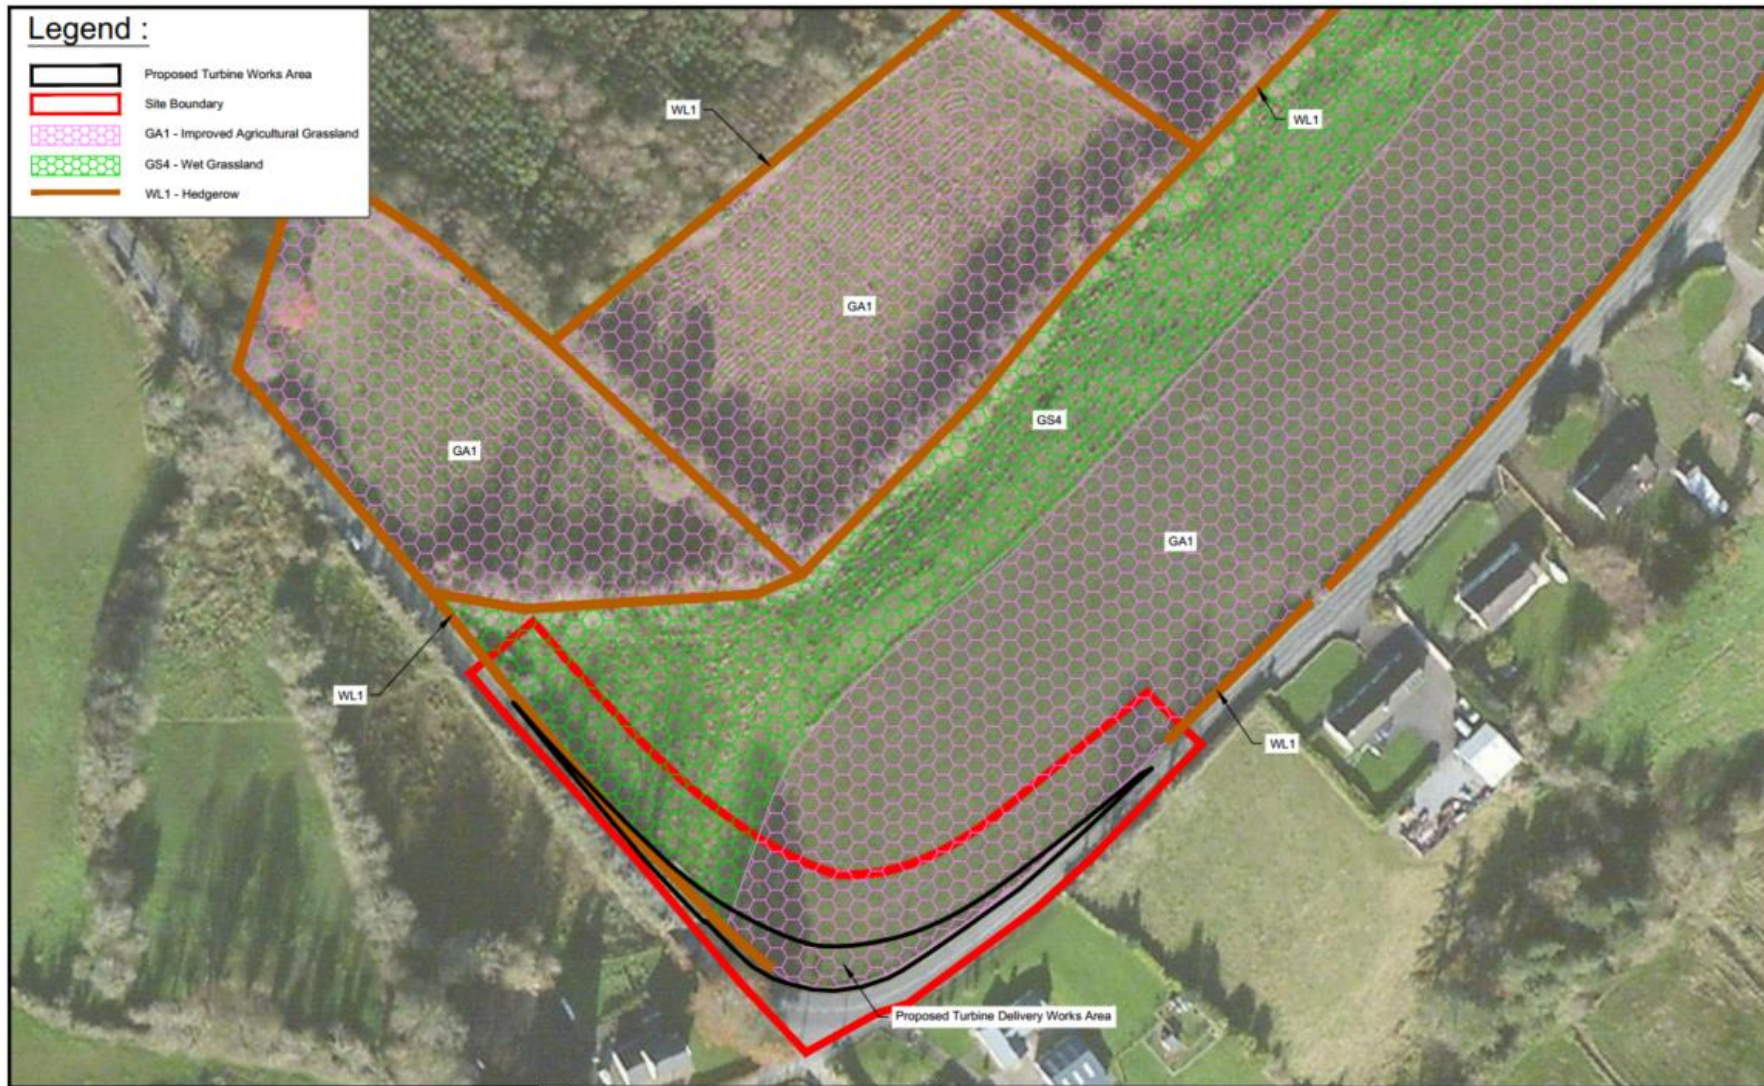
Figure 2: Site 1 Habitat Map

Site No. 1 is located at a 90° bend on the R352 regional road at Coolready. The delivery of the turbine blades will require road widening into third party land on the north-northwest side of the junction.

The dominant habitat type is improved agricultural grassland (GA1). The lower lying field area was heavy on foot, and is best described as wet grassland (GS4), reverting from improvement. Hedgerows (WL1) bound the grassland habitats. Whitethorn, blackthorn, bramble, horsetail, and ivy are the main species occurring in the hedgerows. Hedgerow and treelines (WL2) form the field boundaries extending away from the site. A drainage ditch (FW4), drains to the north-northwest, on the field side of the western hedgerow. During time of survey, the drain had little to no flow, and was well vegetated. The local road networks, and the dwellings, and farm houses in the area are best described as buildings and artificial surfaces (BL3). The habitat map can be viewed in Figure 2 below.

No Invasive Species were observed during time of survey (listed under the Third Schedule of the European Communities (Birds and Natural Habitats) Regulations 2011 (S.I. 477 of 2015)).

The desk study identified a number of documented badger records for the area extending away from the site. During time of survey the hedgerows were recently cut back. No mammal tracks or resting places, for species such as badger were observed. The habitats present within the footprint of the works, are not optimal for roosting bats, but can be used by foraging bat species. This habitat type is common in the area.

The site is situated within the Owenogarney sub catchment area (WFD_SC_010), ultimately forming the Shannon Estuary North (WFD Catchment Id: 27). No river or stream drains through the site. Meelagh Lough is situated approximately 520m to the north of the site. The field drainage network in the area generally drains to the northwest.
