Peat Stability Report

Malachy Walsh and Partners

Carrownagowan Wind Farm

Peat Stability Risk Assessment

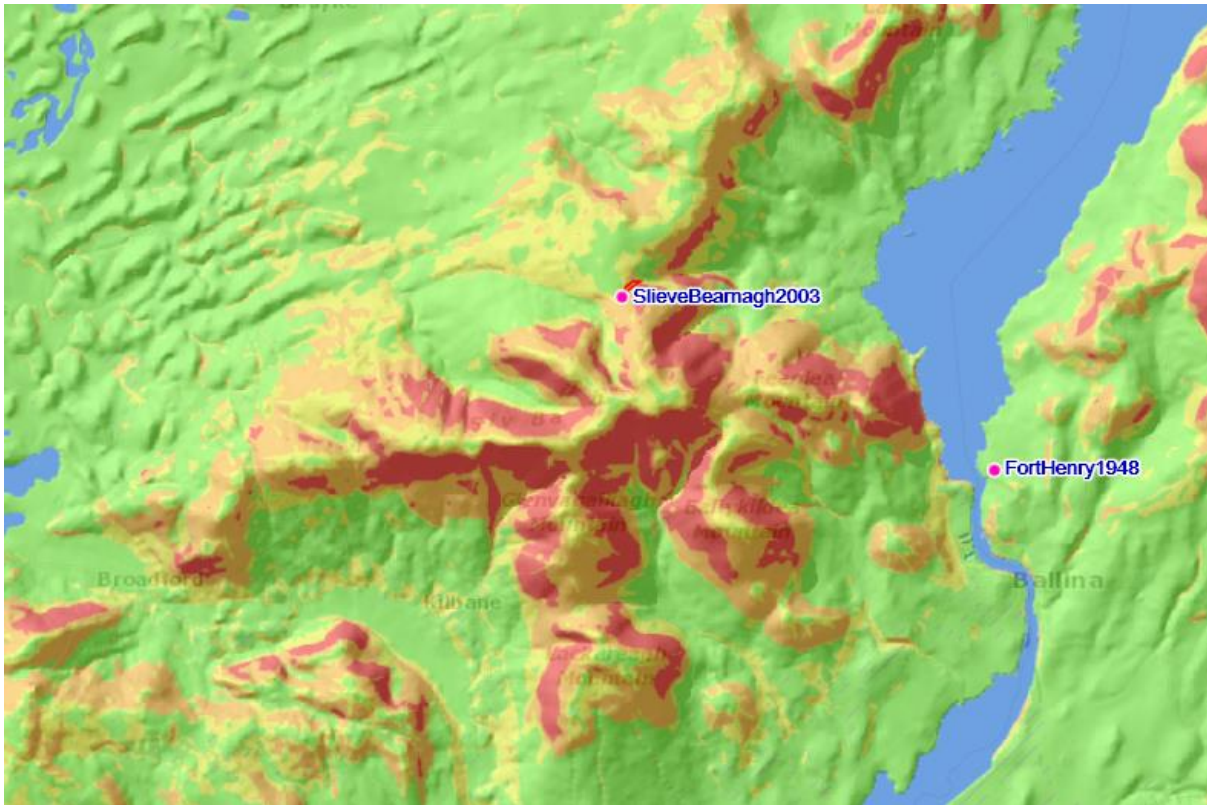
Figure 1-6 – GSI Recorded Landslide Events for Gleensk Section

The GSI dataset lists no landslide events in the study area and 2no. in the wider locality. The relevant recorded landslide events are illustrated below Figure 1-6

The Fort Henry 1948 landslide was a failure of an earth embankment constructed between 1926 and 1928 and has no further significance in terms of this report as a peat landslide risk assessment.

The Slieve Bearnagh slide of 2003 was a peat slide which occurred during a period of road construction associated with forestry.

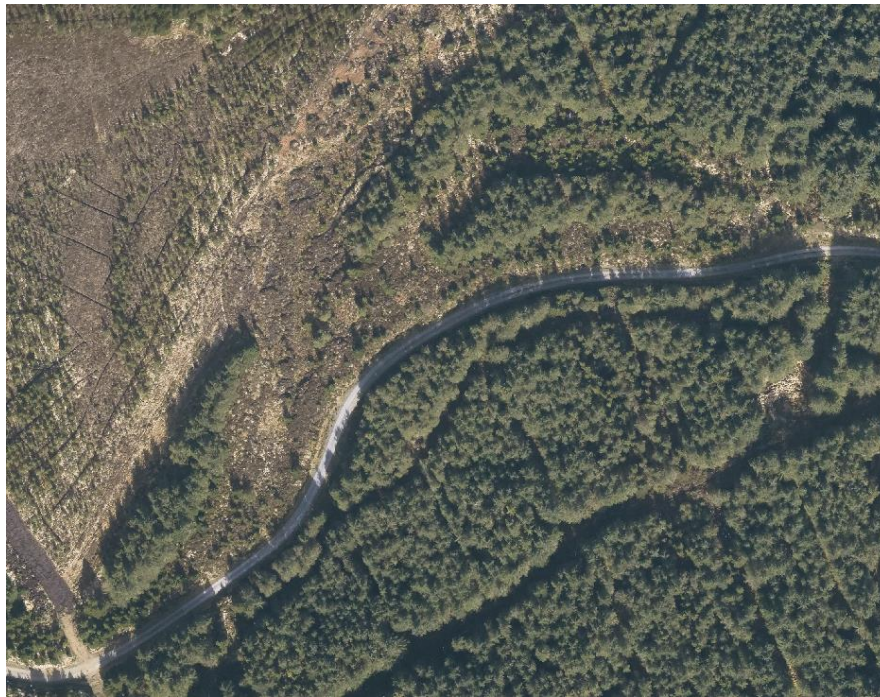
Figure 1-7 Existing Slieve Bearnagh Slide

MWP visited and investigated the slide area in 2018. Peat depths were generally in excess of 2m with a maximum depth of 3.7m encountered. Shear strengths ranged from 8kPa to 16kPa. The slide area coincided with a break in slope going from gently sloping 3.5deg to sloping at 7.5deg. From the site visit and analysis of data gathered MWP concluded that the slide was most likely triggered by excessive surcharge caused by side cast material along the road edge. The slide ran out along an existing firebreak cutting and was arrested with a berm approx 350m from the slide head. The GSI list the impact of the landslide as having 'No apparent impact'.

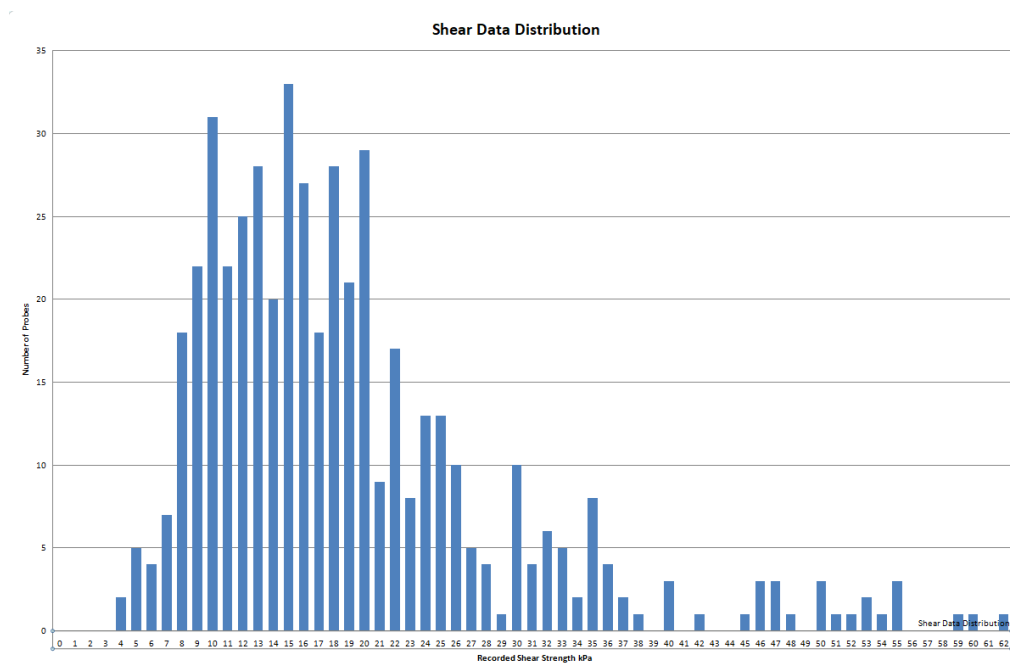
Figure 3-3 Shear data

Shear values were collected at 489 probe locations using a hand shear vane with results which range from 4kPa to 62kPa across the site.

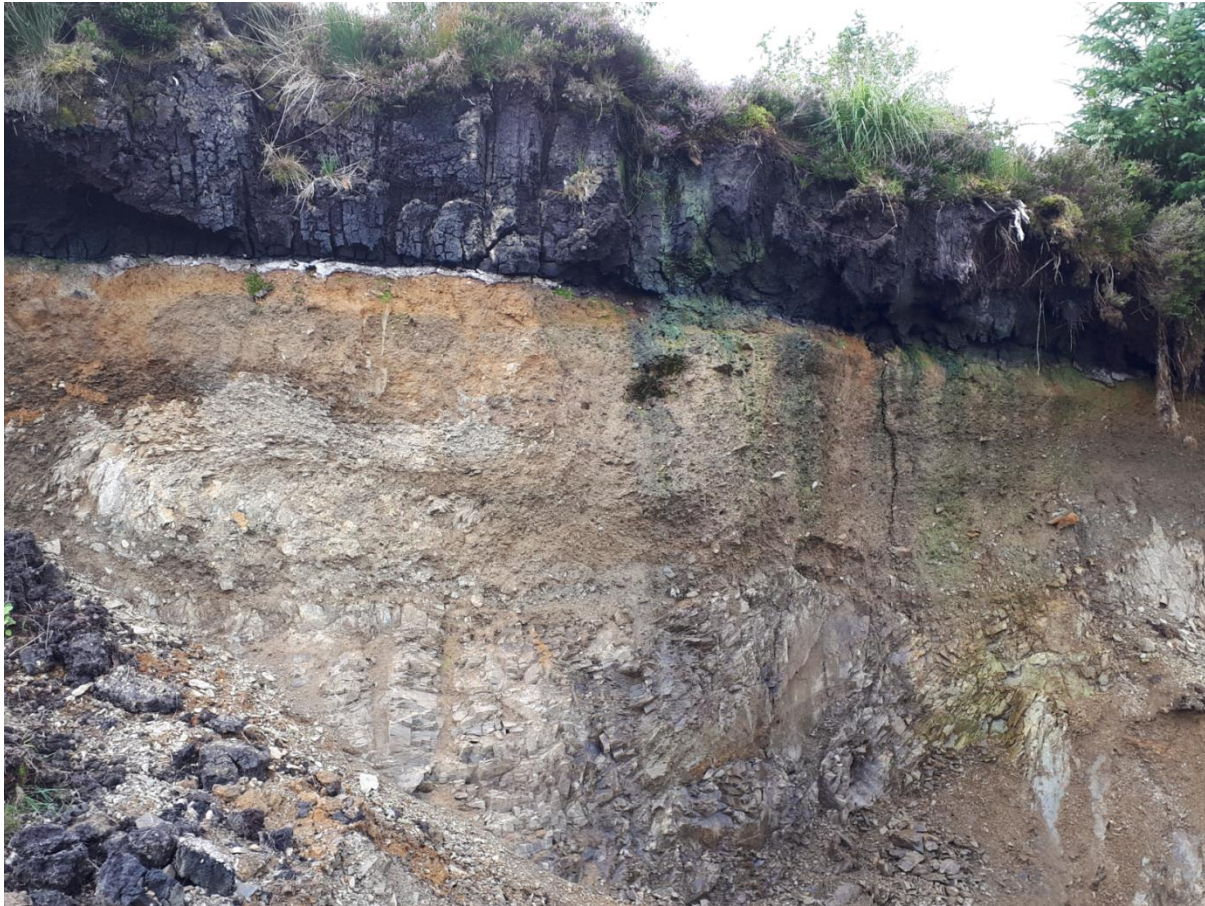
Figure 4-1 Typical soil profile

From the peat probing data and trial holes a mixture of rock, granular soils with some cohesive soils were encountered. The rock head observed in road cuttings and existing borrow pits as illustrated below in Figure 4-1 is rough and undulating.

This represents a low to moderate risk rating for most areas in this assessment.

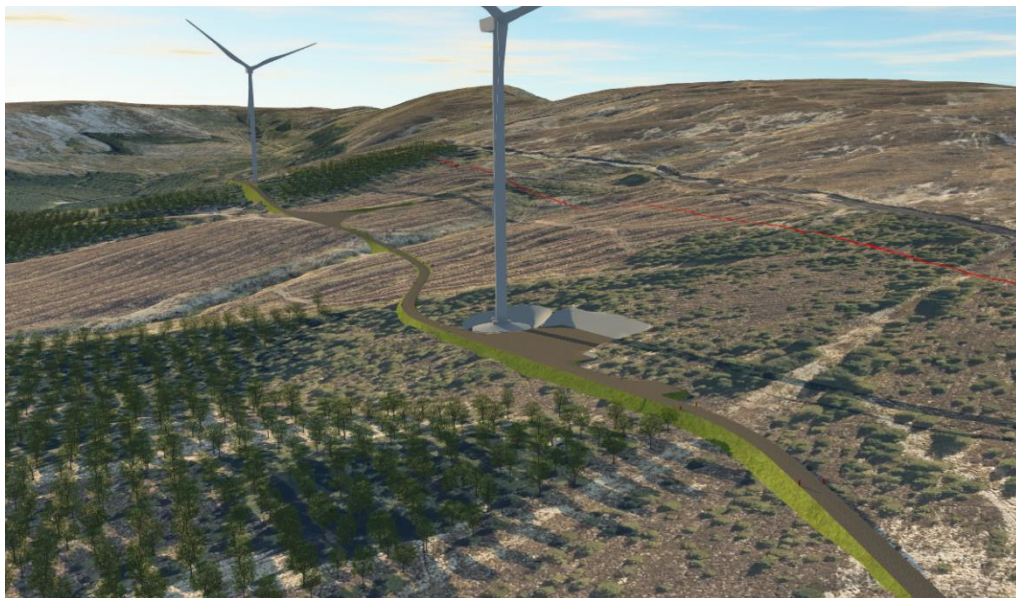
Figure 4-9 Turbine T3 Location from 3D model

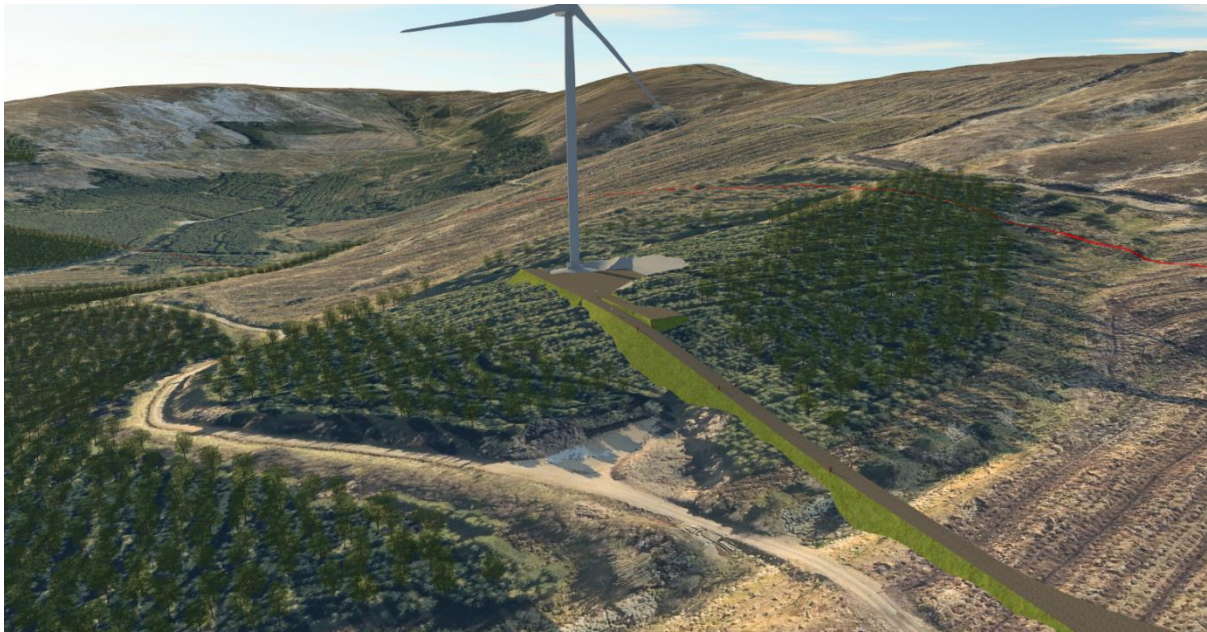
Figure 4-10 Turbine T4 from 3D model

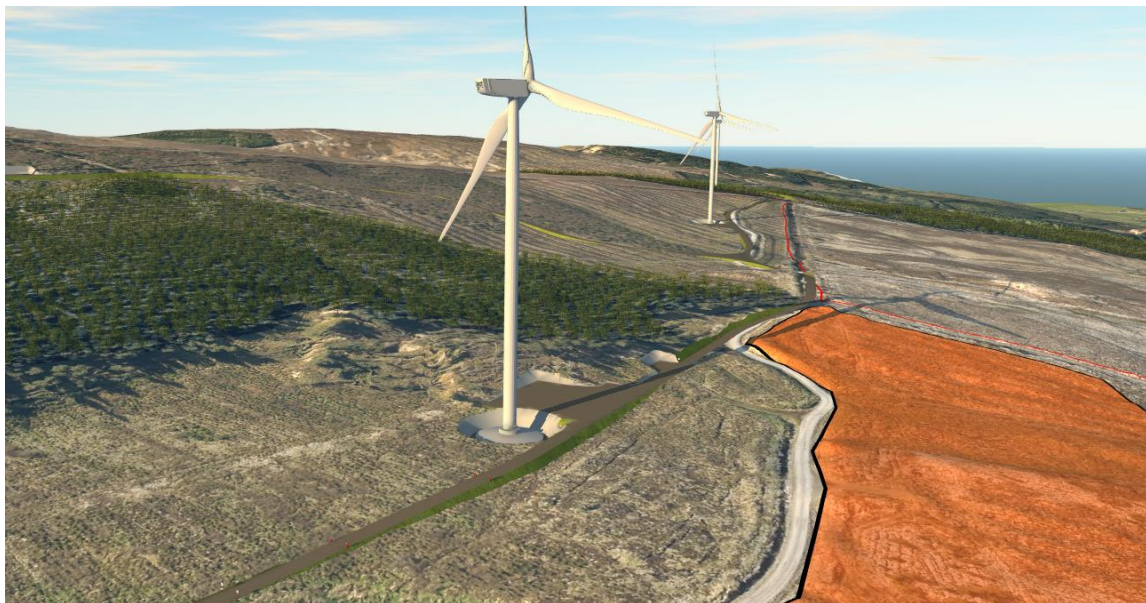
Figure 4-11 T5 Location from 3D Model with BP1 shaded in orange

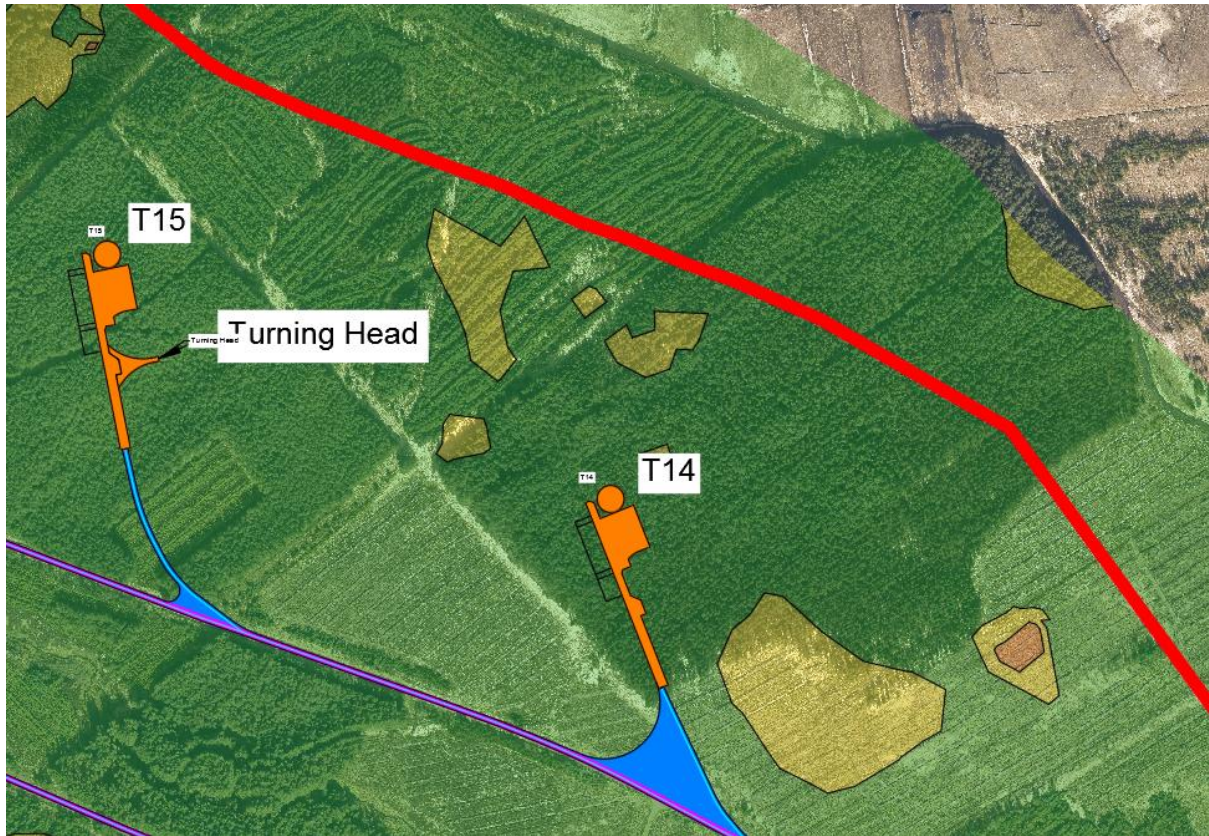
Figure 4-12 T14 FoS calculation output

As illustrated below in Figure 4-12 T14 is located in an area with a FoS greater than 4.
