AGP18019_03

REPORT
ON THE
GEOPHYSICAL INVESTIGATION
FOR THE
GREENLINK INTERCONNECTOR,
Co. WEXFORD
FOR
GREENLINK INTERCONNECTOR LTD.

APEX Geophysics Limited was requested by ARUP on behalf of Greenlink Interconnector Ltd. to carry out a geophysical survey for the proposed Greenlink Interconnector on the Hook Head Peninsula in Co Wexford.

The Greenlink Interconnector is a proposed 500 MW HVDC electricity interconnector linking the power grid in Ireland with Great Britain. The geophysical survey was requested as part of the ground investigation to survey the ground conditions at the area of landfall for the connector cable, the cable route towards the Great Island transmission substation in Wexford and the proposed convertor substation. The cable is currently planned to lie approximately 850mm below ground level along the road sections and 1050mm along off-road sections.

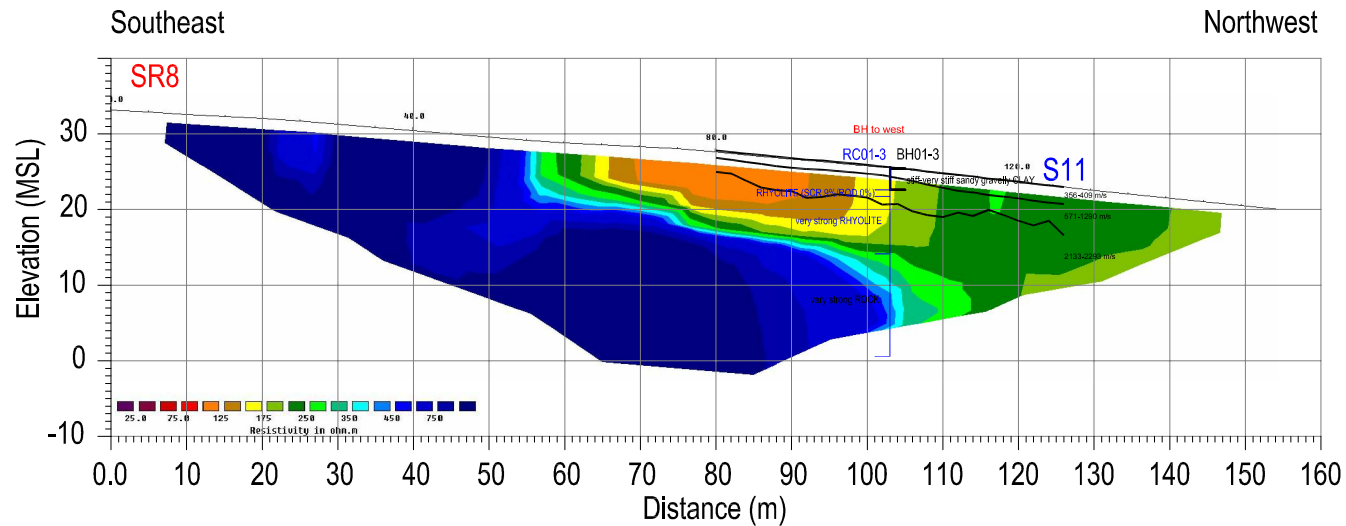
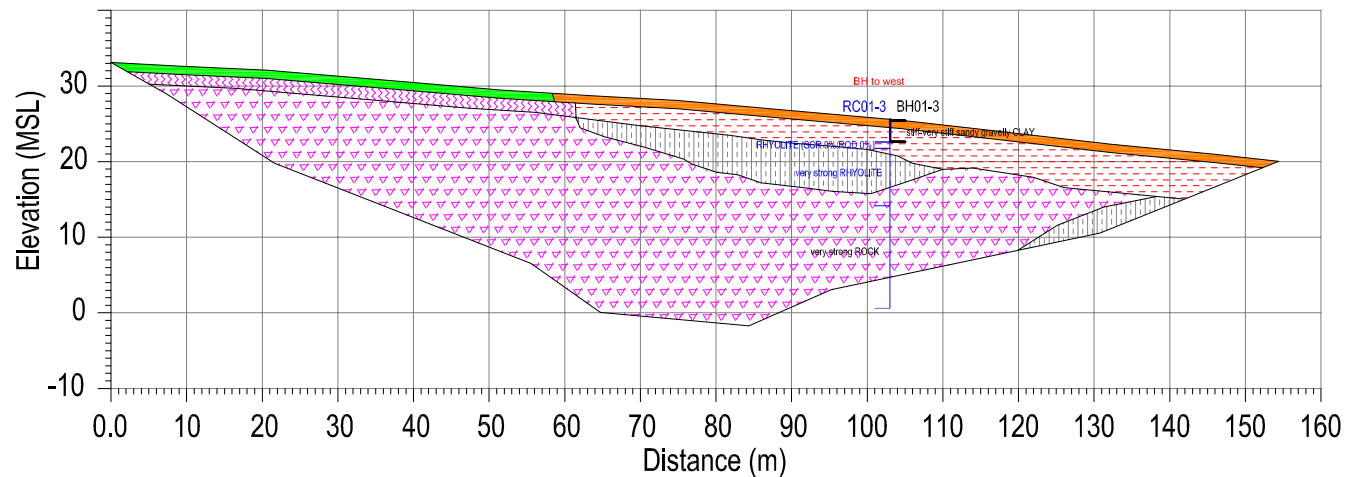
PROJECT:	GREENLINK INTERCONNECTOR GEOPHYSICAL SURVEY		
CLIENT:	GREENLINK		
DRAWING NO:	AGP18019_S3_SR6 & SR7		
SCALE:	AS INDICATED @ A3		
DATE:	26-04-2018		
Version:	Date:	Drawn By:	Checked:
01	15-01-2019	YOC	TM
02	26-04-2019	YOC

South of the track, SR6 is adjacent to the main Converter Station Site where outcrop is known to occur. The geophysical data has been interpreted as indicating an average of 3m of very soft to firm soils over slightly weathered to fresh slate and rhyolitic bedrock in agreement with RC/BH03-3. (Rhyolite resistivities are slightly lower than observed at Site 2 and the Converter Station site to the west).

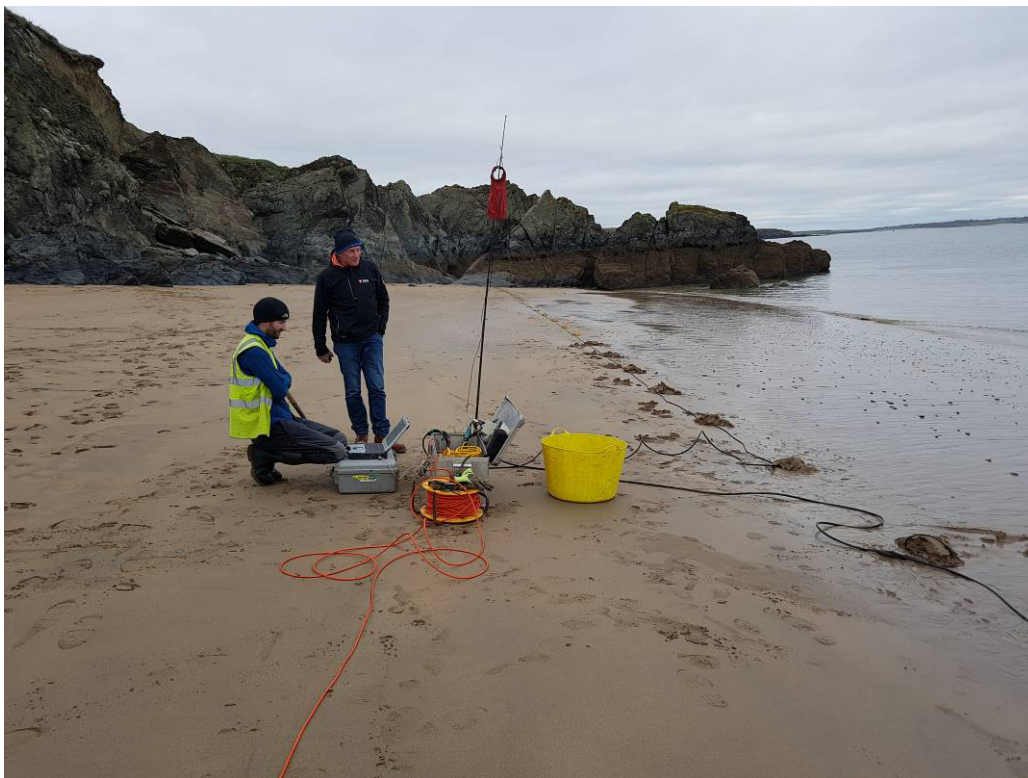
Plate 7 – Seismic recording set-up on Profile 4

To build up a refraction section, seismic shots were taken at many positions along the geophone spread and set distances beyond each end. In general, shots were taken every eight geophone locations and up to 100 m beyond the end of the cable spread.

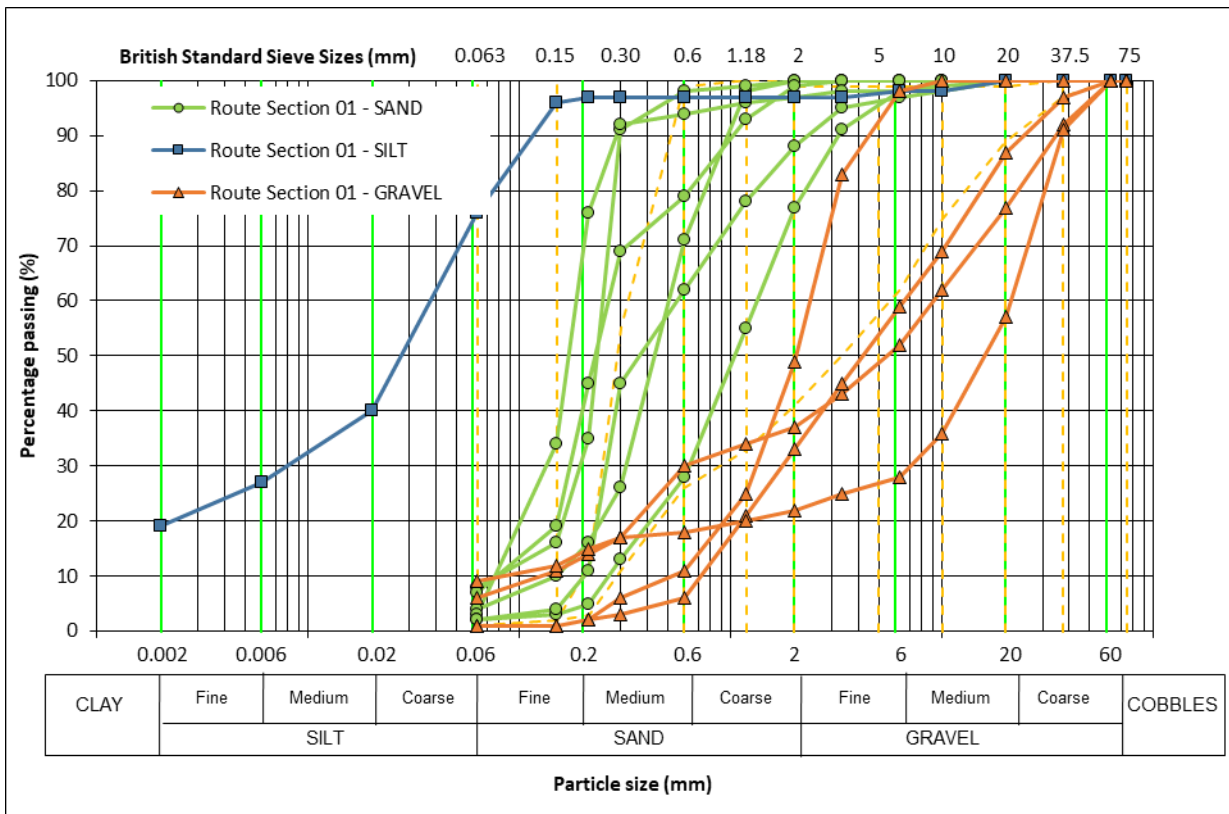
Figure 7 PSD plots for tested material in route section 01, UK.

PSD plots for the varying material types, granular or cohesive, are shown below.

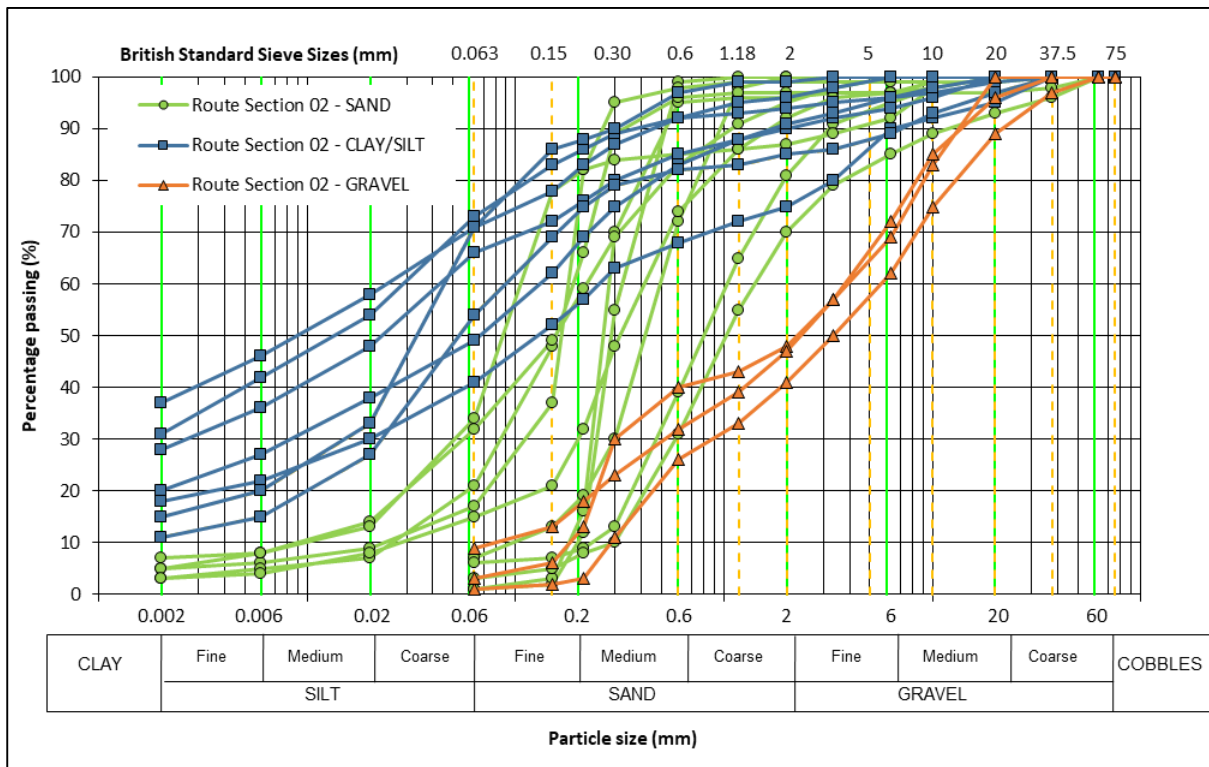
Figure 14. PSD plots for tested material in route section 02, UK.

PSD plots are shown below for the varying material types.

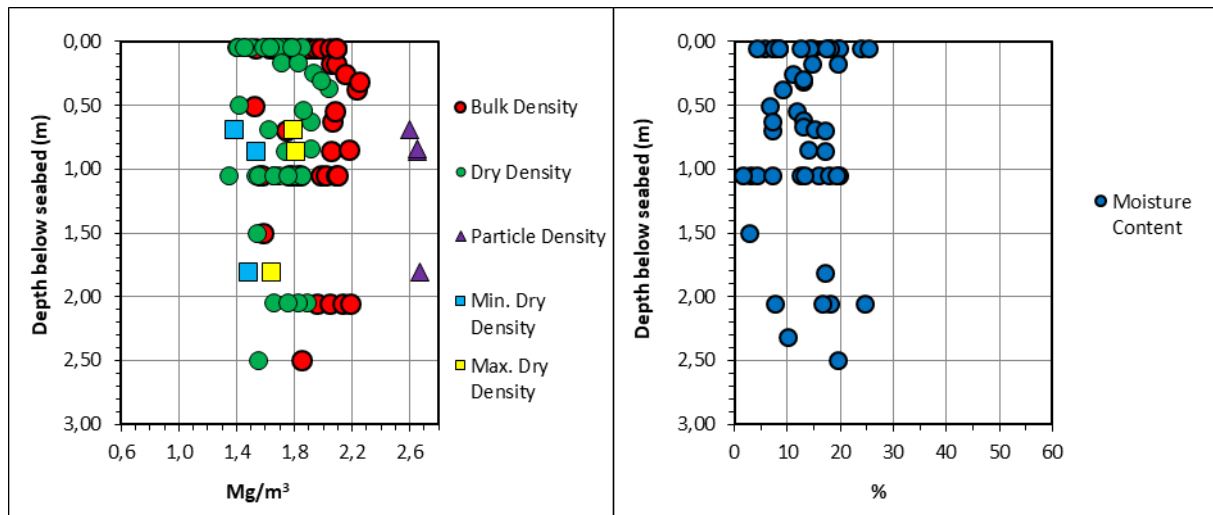
Figure 15 Summary of laboratory test data for route section 02, UK.

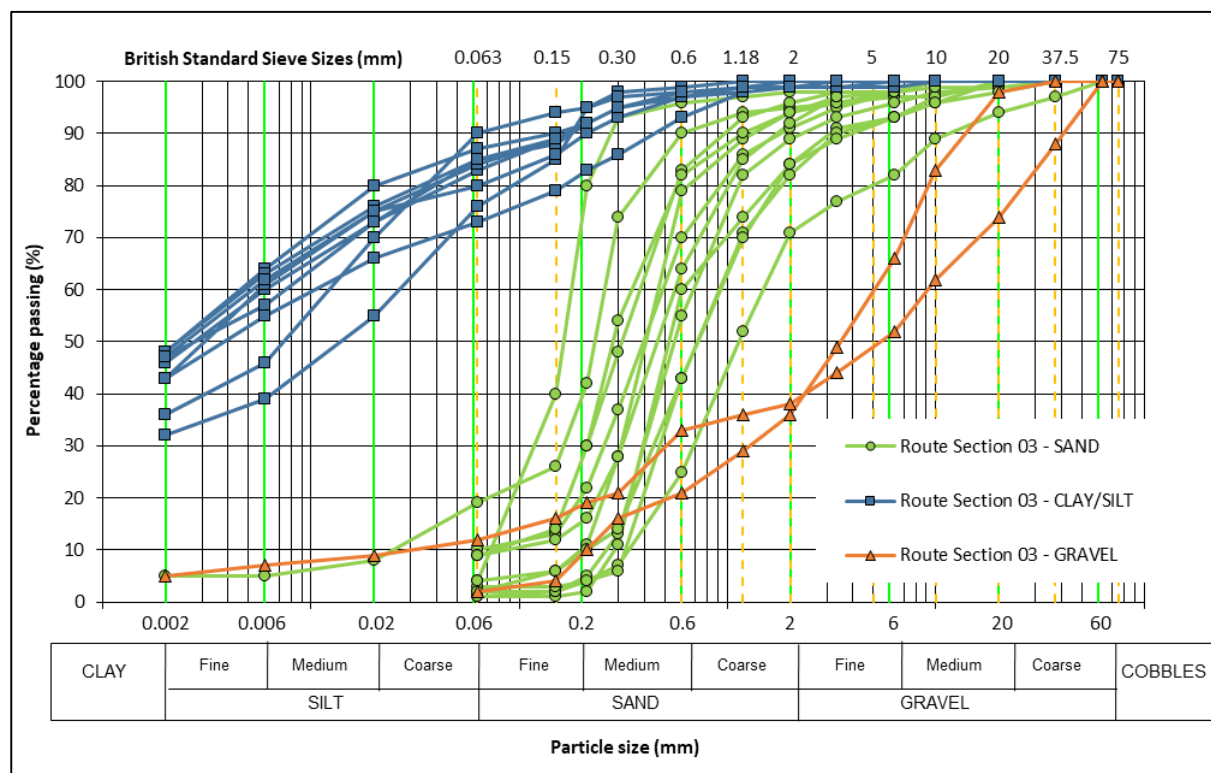
Figure 23. PSD plots for tested material in route section 03, UK.

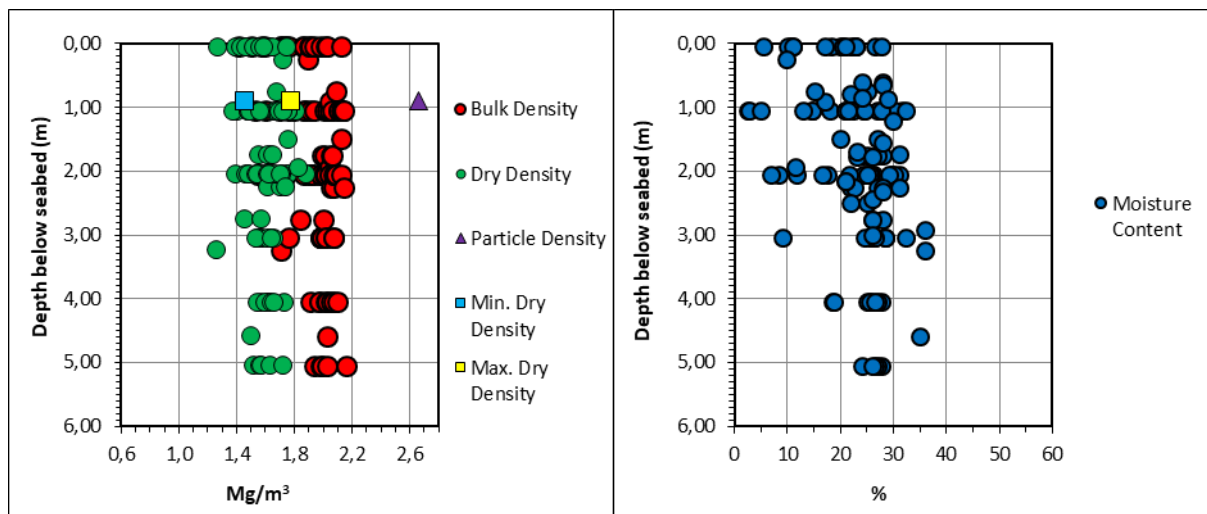
Figure 24 Summary of laboratory test data for route section 03, UK.

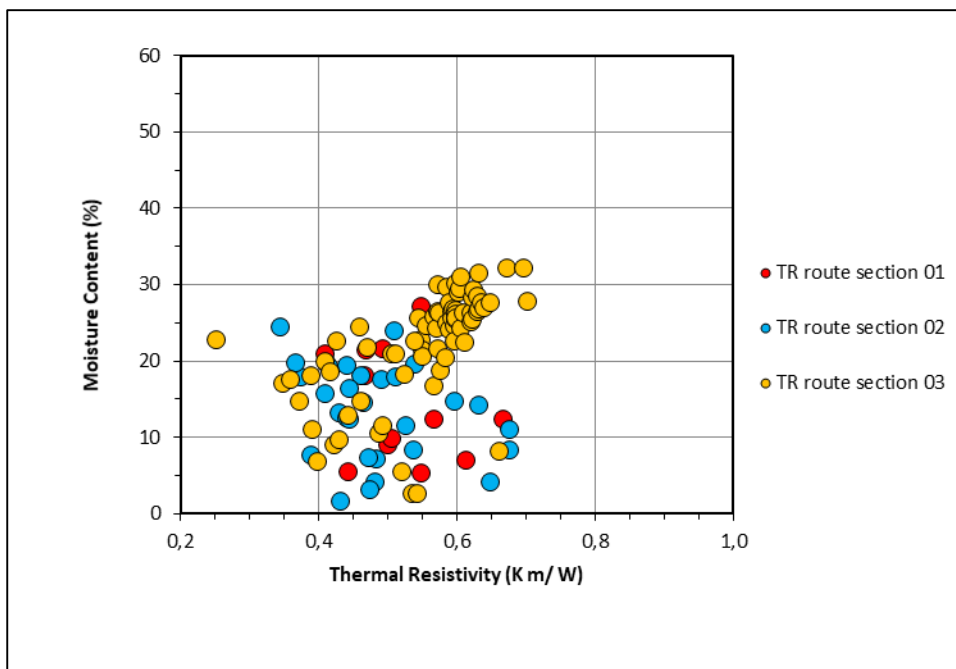
Figure 27 Thermal resistivity data for the entire UK section.

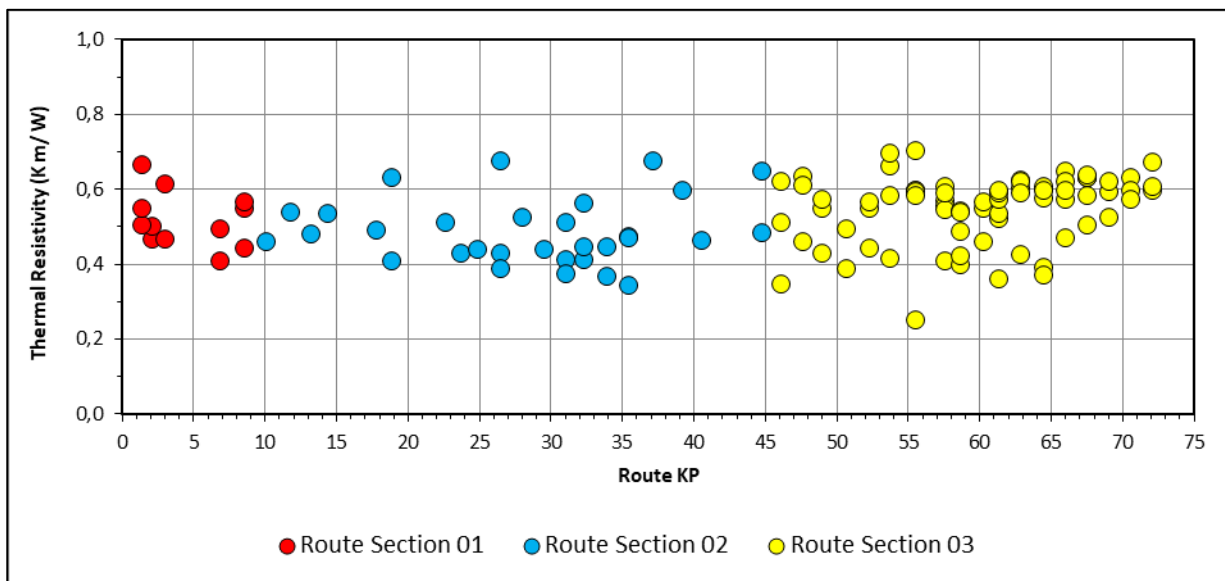
Figure 28. Plot of thermal data against route KP for the entire UK section.

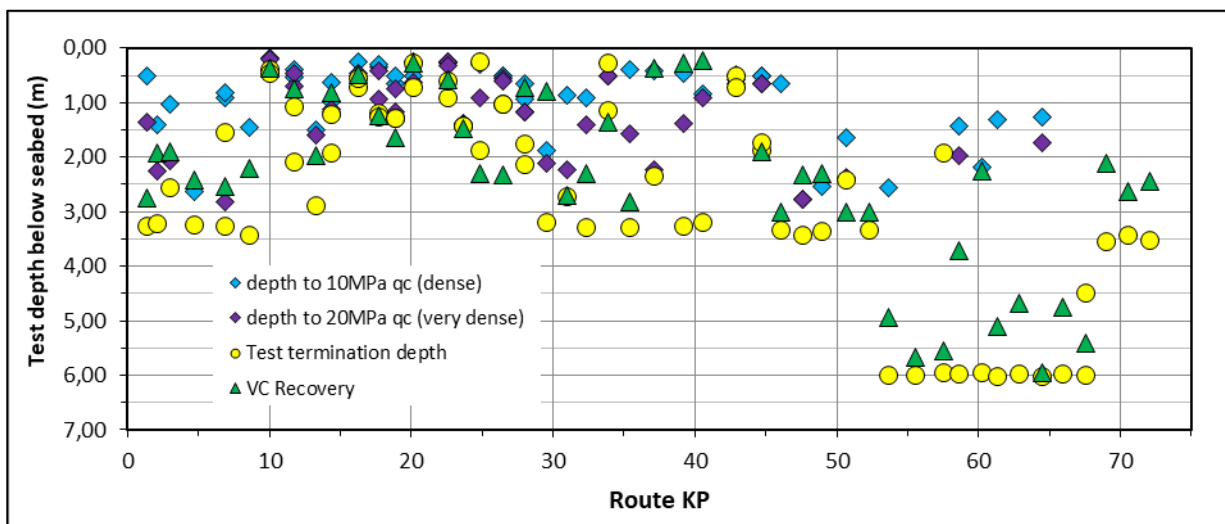
Figure 29. Summary of CPT depths and VC recovery for the entire UK section.

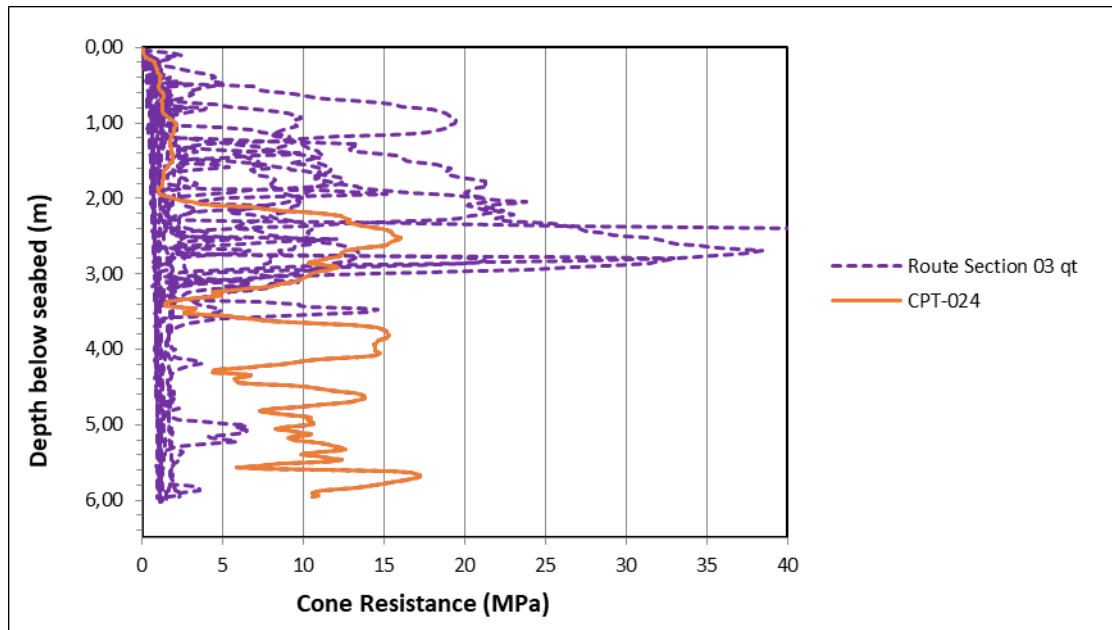
Figure 30. Plot of measured CPT cone resistance for route section 03, UK.

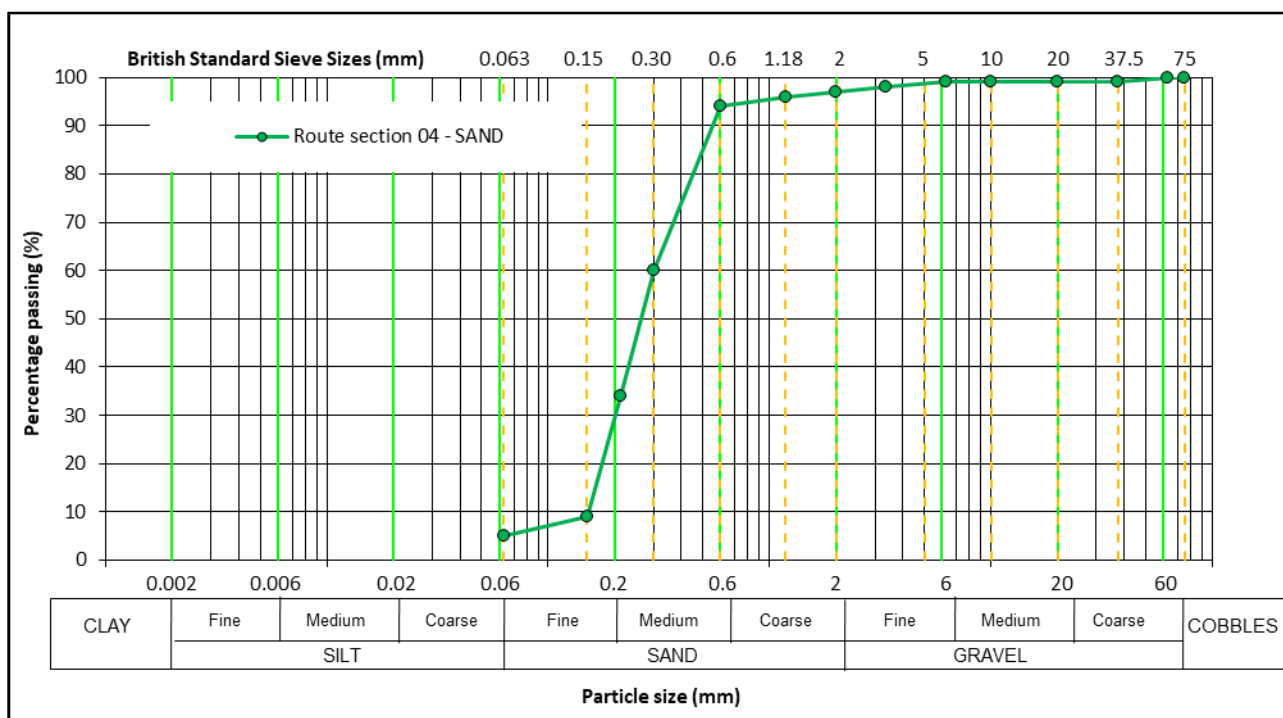
Figure 33. PSD plot for tested material in route section 04, IRE.

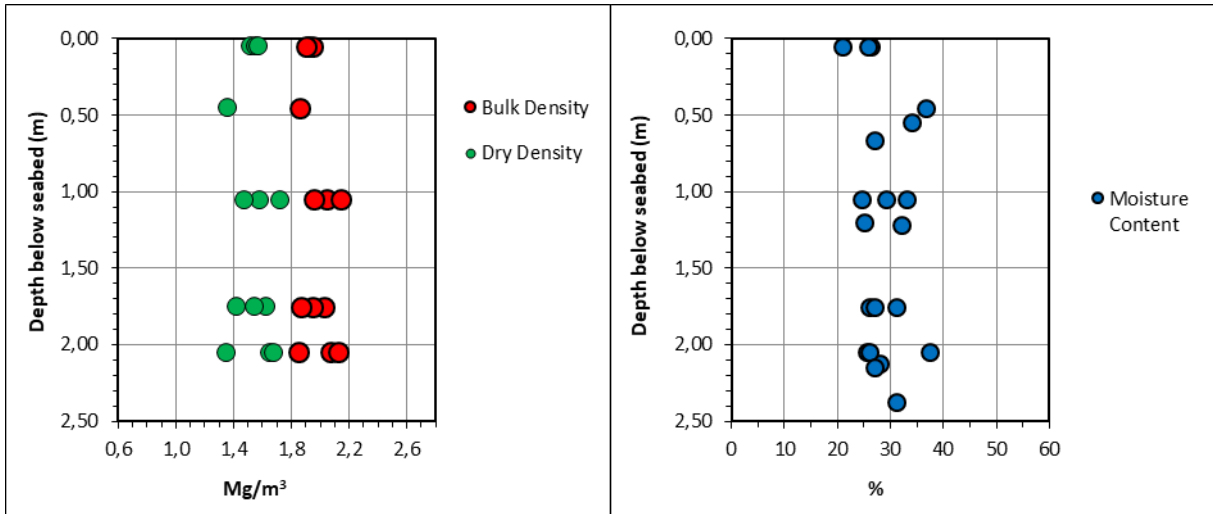
Figure 34. Summary of laboratory test data for route section 04, IRE.

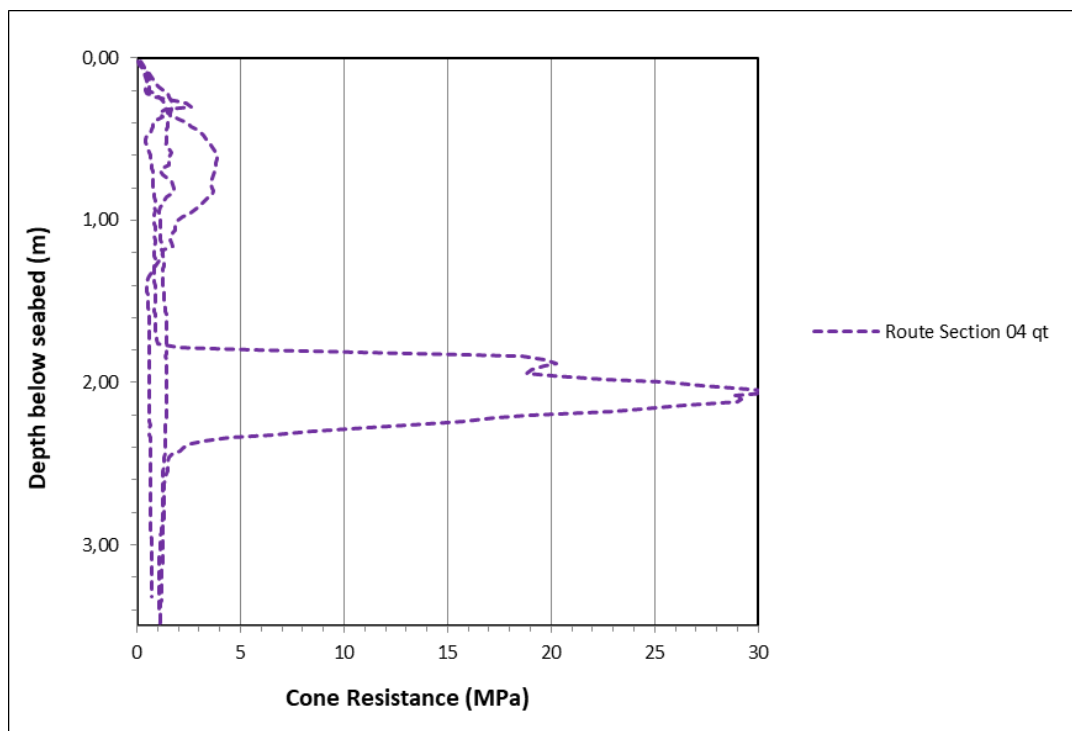
Figure 39. Plot of measured CPT cone resistance for route section 04, IRE.

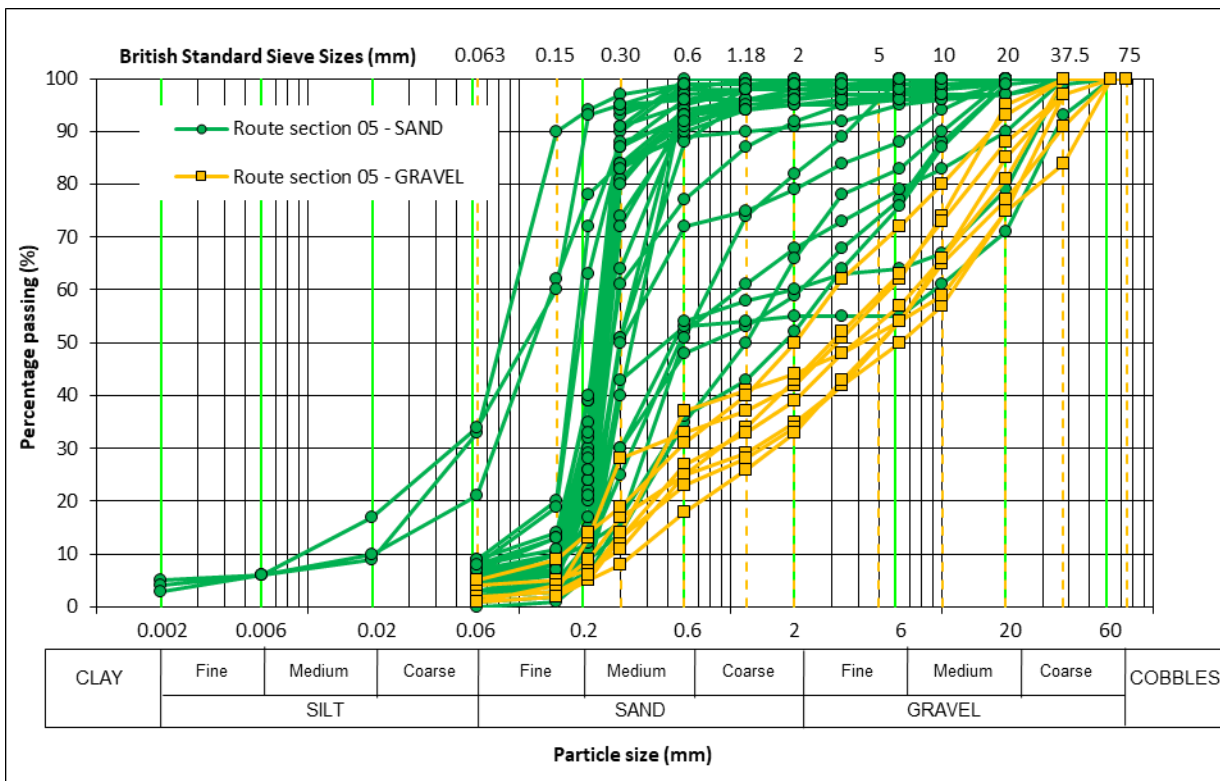
Figure 42. PSD plot for tested material in route section 05, IRE.

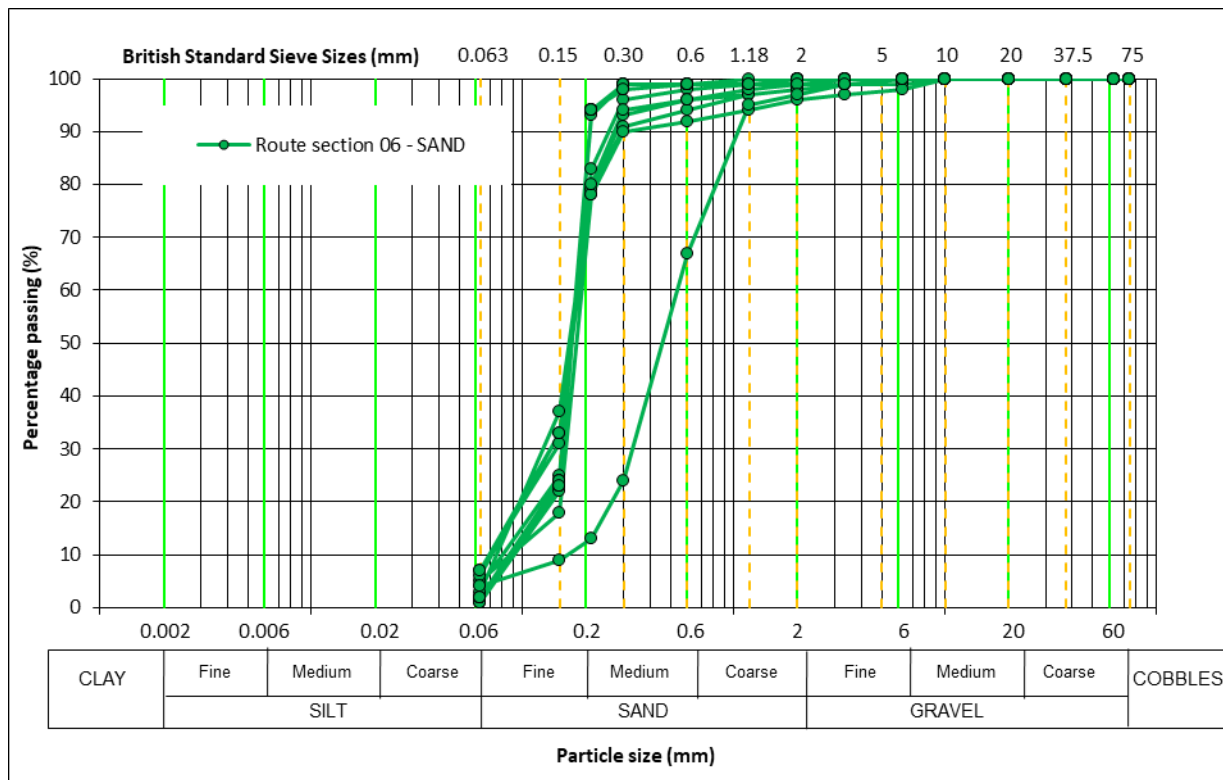
Figure 51. PSD plot for tested material in route section 06, IRE.

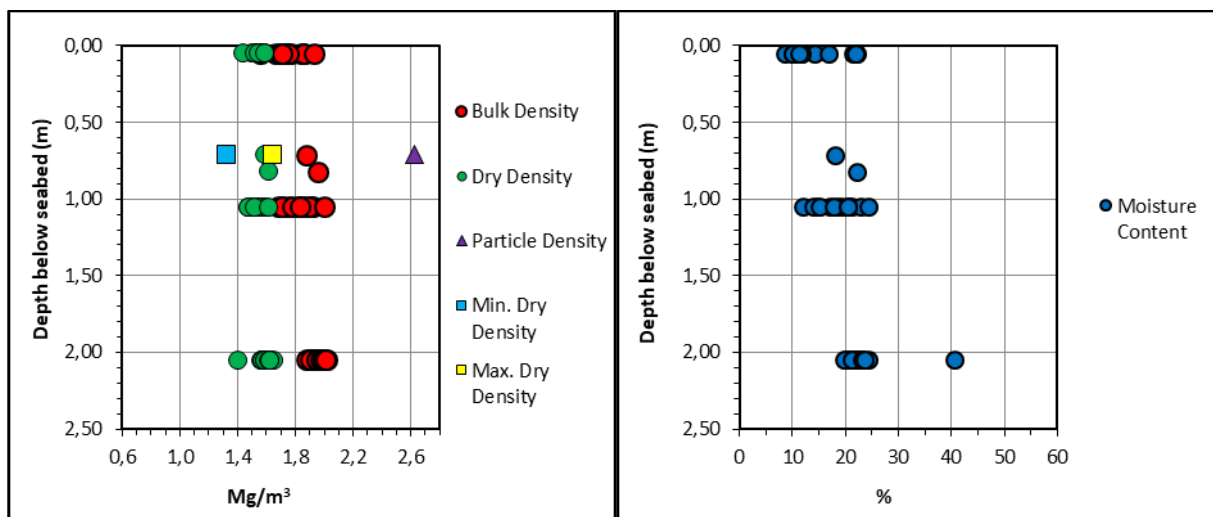
Figure 52. Summary of laboratory test data for route section 06, IRE.

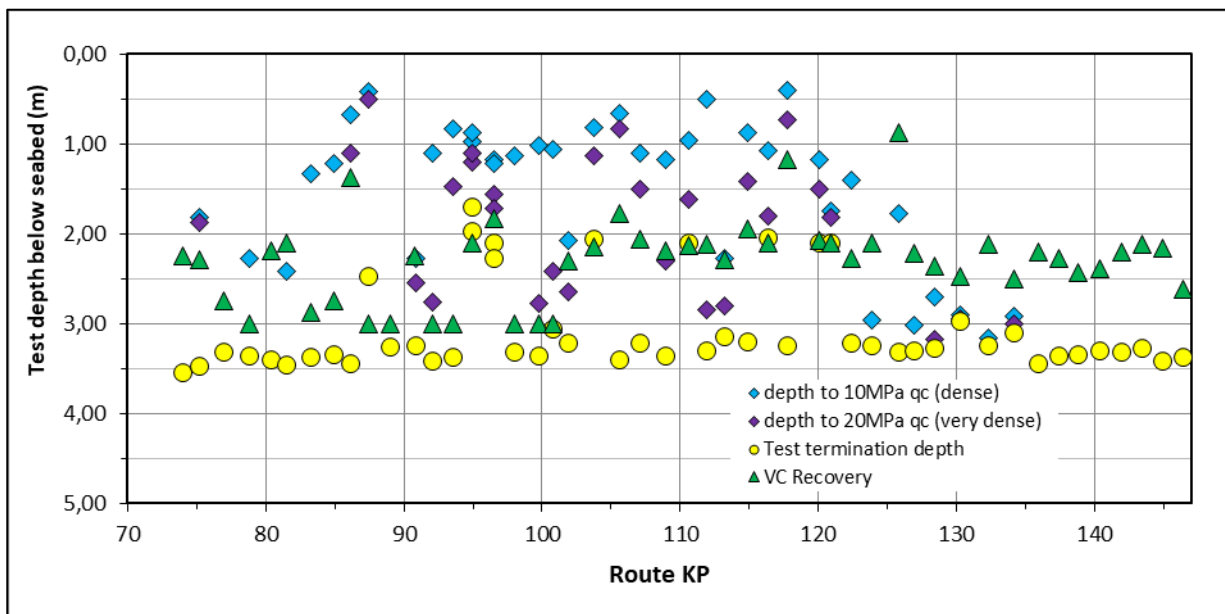
Figure 54. Summary of CPT depths and VC recovery for route sections 04, 05 & 06, IRE.

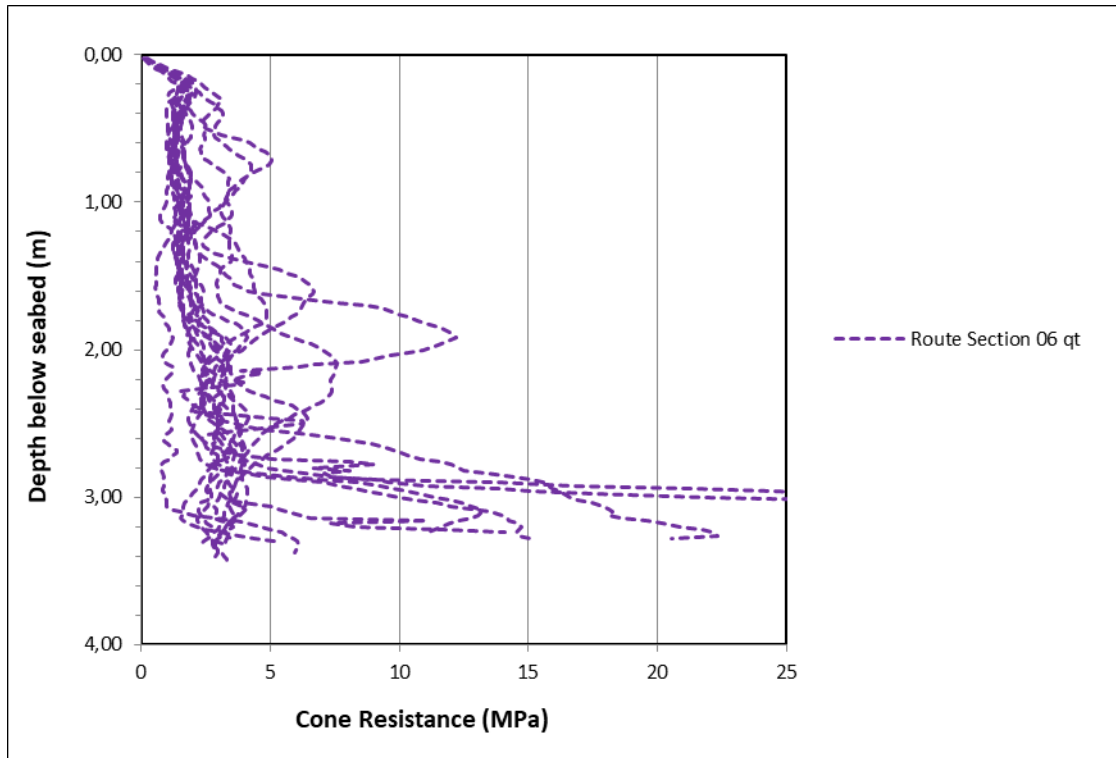
Figure 55. Plot of measured CPT cone resistance for route section 06, IRE

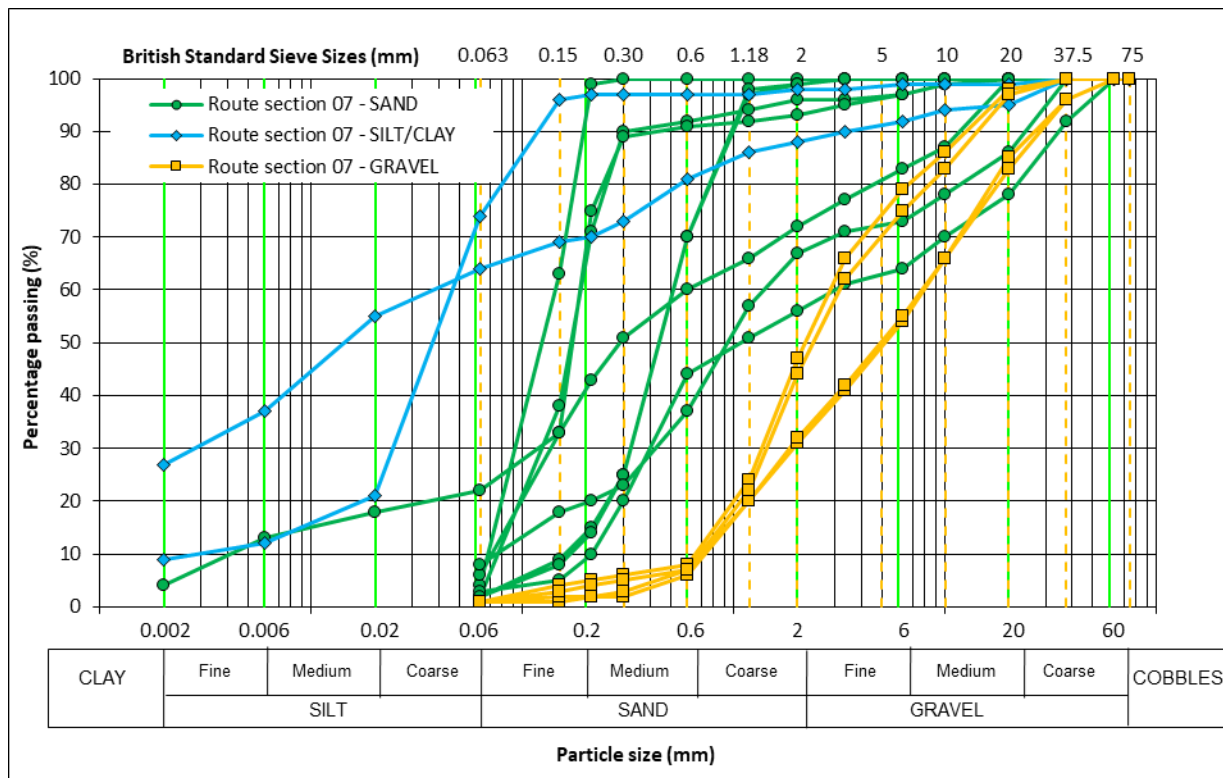
Figure 57. PSD plot for tested material in route section 07, IRE.

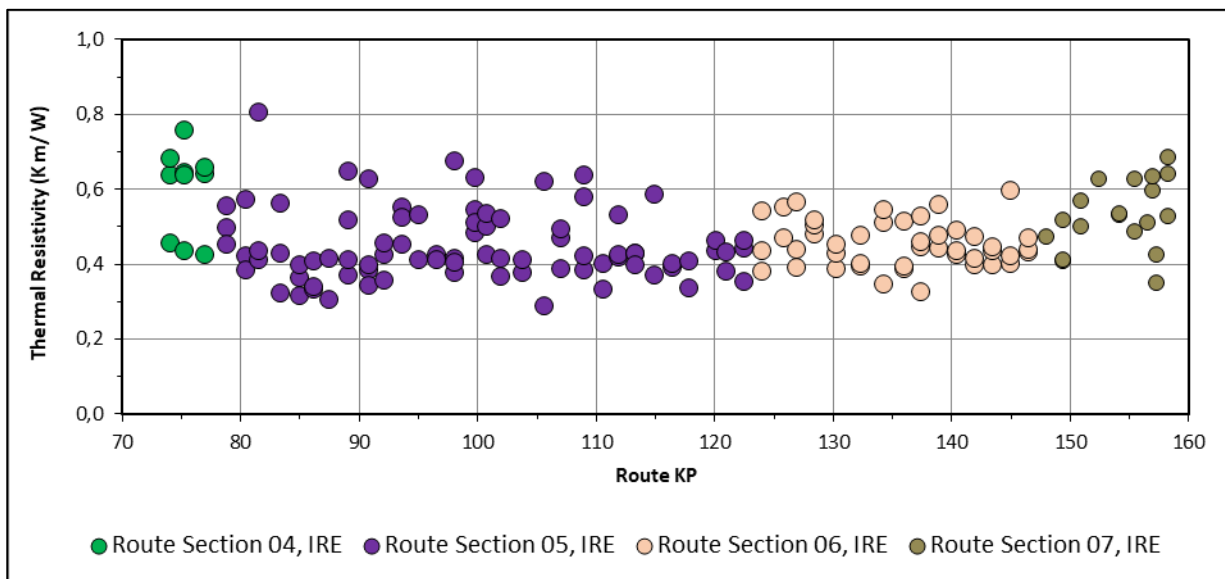
Figure 62. Plot of thermal data against route KP for the entire IRELAND section.

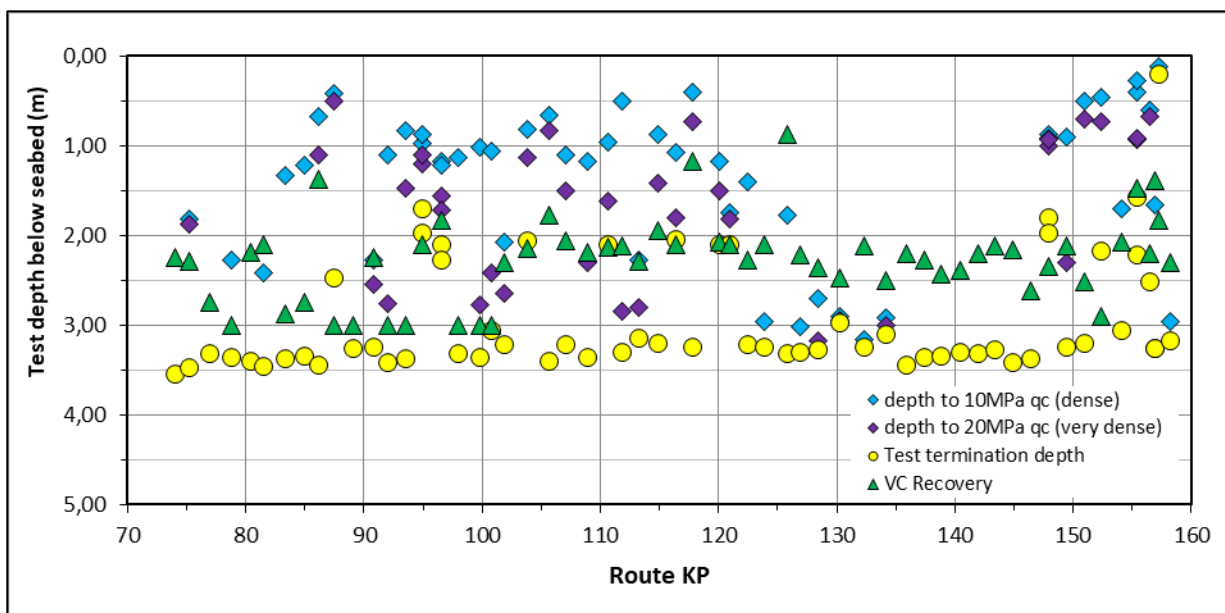
Figure 63. Summary of CPT depths and VC recovery for the entire IRELAND section.

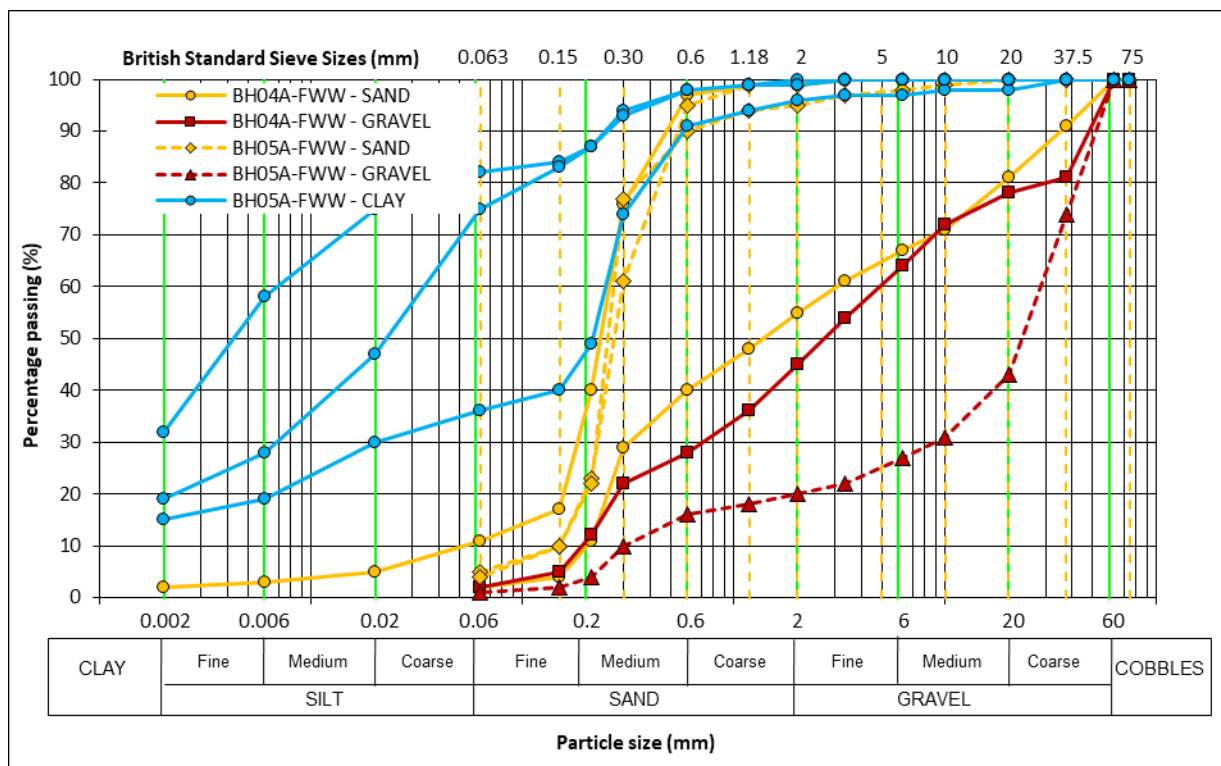
Figure 68. PSD plot for tested material from the nearshore UK boreholes.

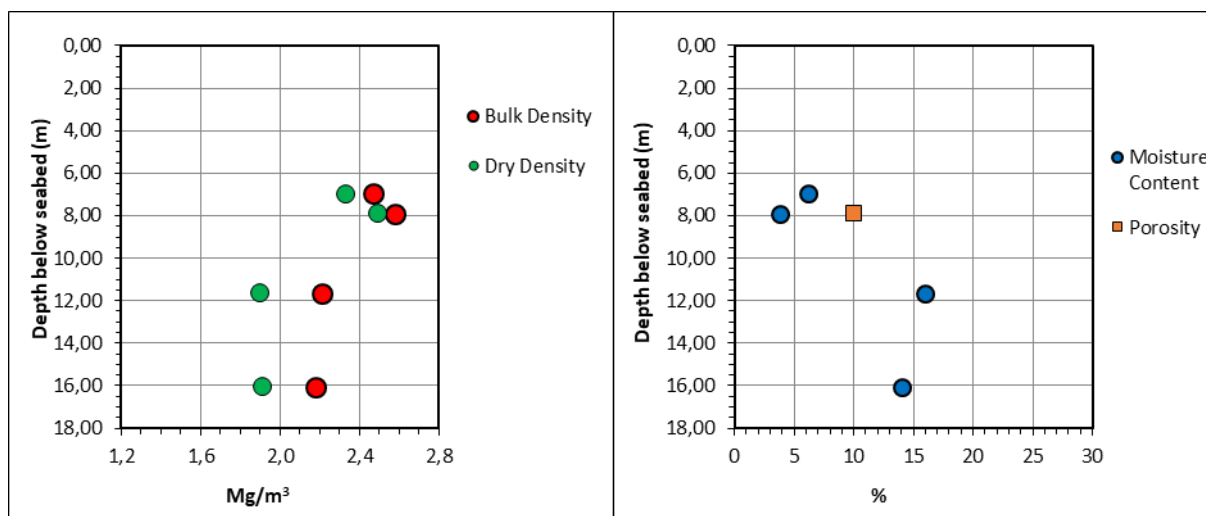
Figure 73. Summary of laboratory testing for the nearshore UK boreholes.

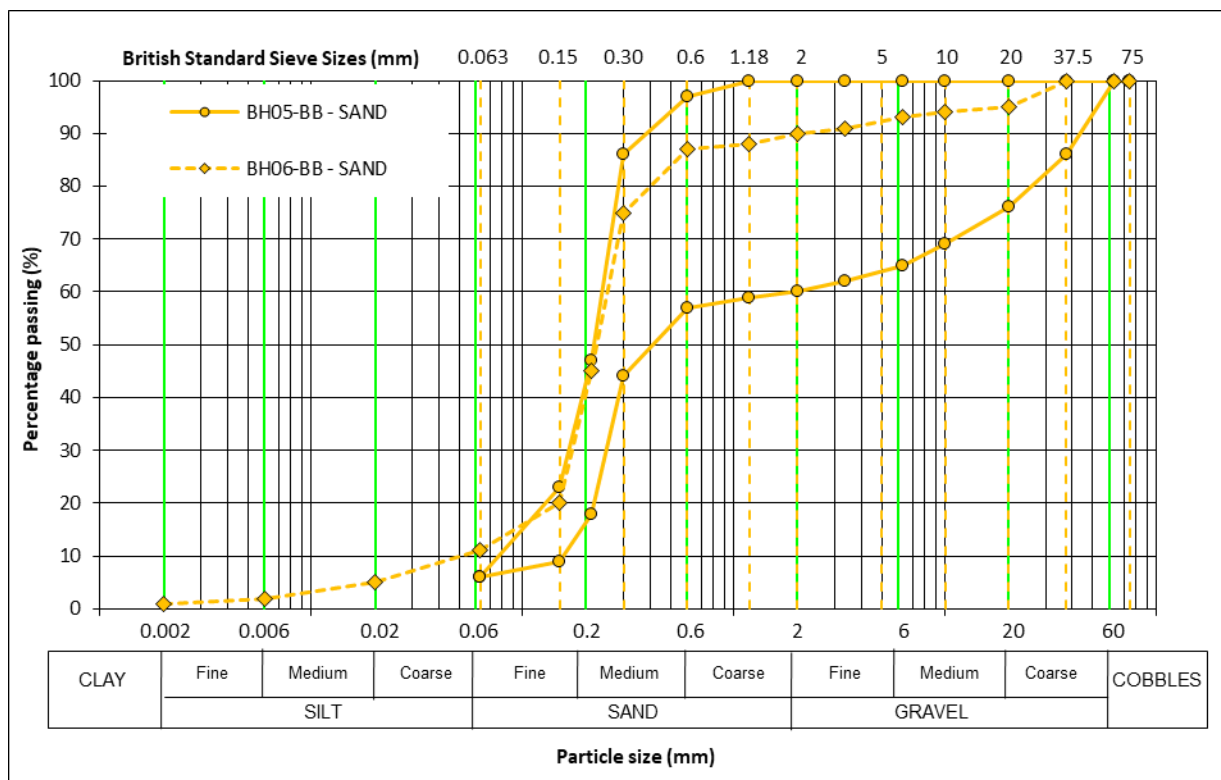
Figure 76. PSD plot for tested material from the nearshore IRE boreholes.

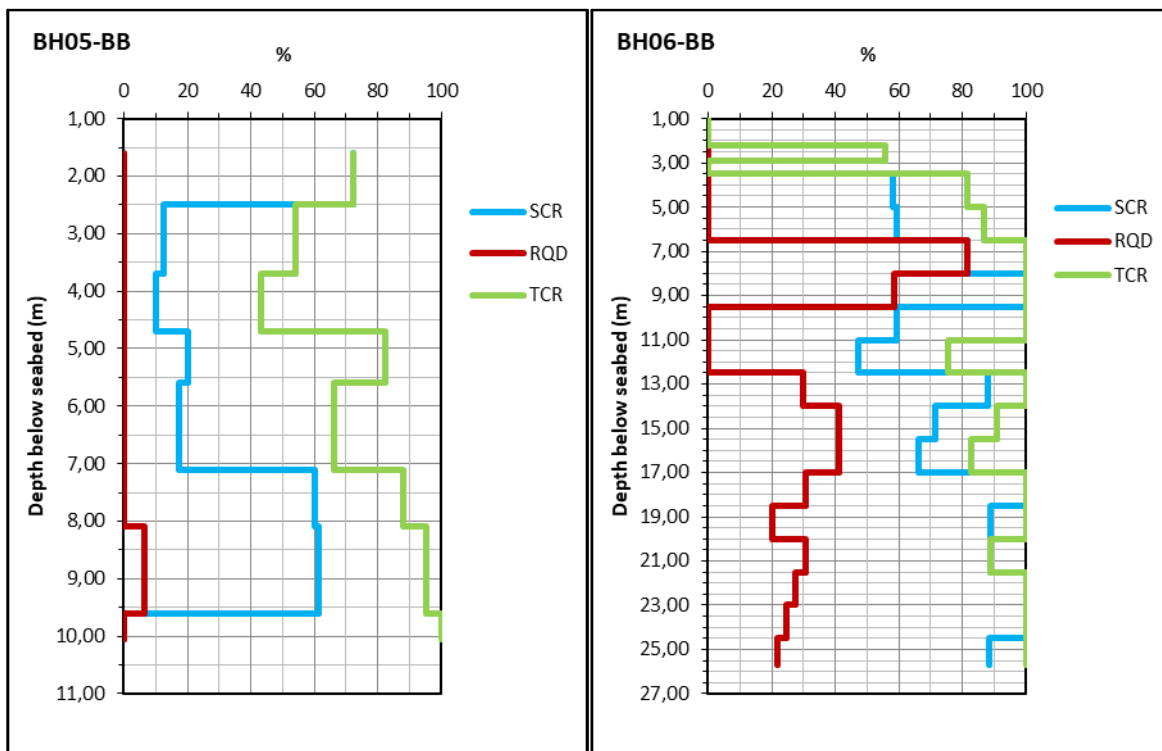
Figure 78. Plot of TCR, SCR & RQD values against depth for the nearshore IRE boreholes.

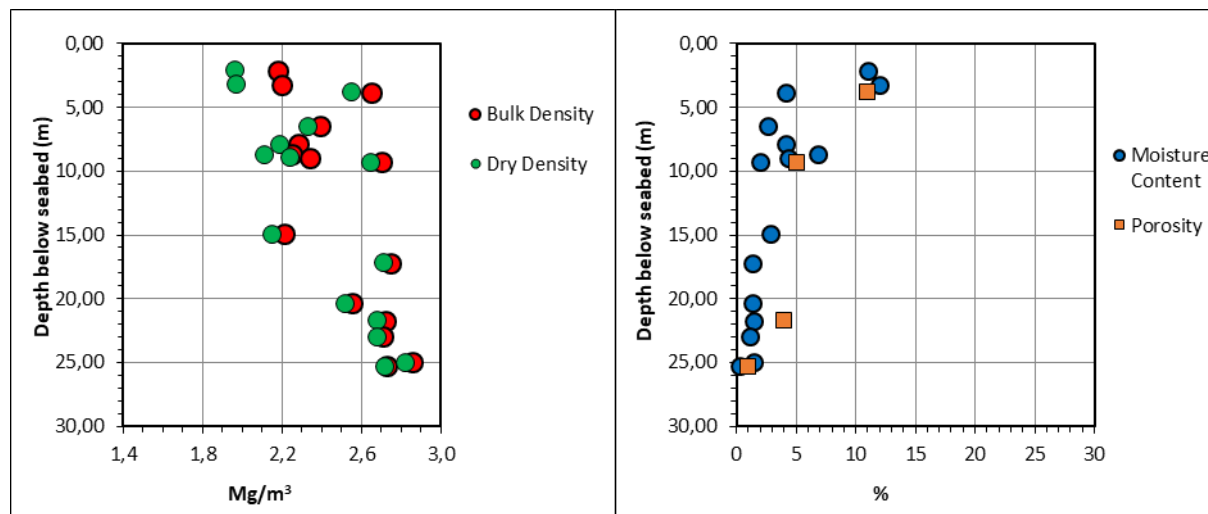
Figure 80. Summary of laboratory testing for the nearshore IRE boreholes.
