AGP18019_03

REPORT
ON THE
GEOPHYSICAL INVESTIGATION
FOR THE
GREENLINK INTERCONNECTOR,
Co. WEXFORD
FOR
GREENLINK INTERCONNECTOR LTD.

APEX Geophysics Limited was requested by ARUP on behalf of Greenlink Interconnector Ltd. to carry out a geophysical survey for the proposed Greenlink Interconnector on the Hook Head Peninsula in Co Wexford.

The Greenlink Interconnector is a proposed 500 MW HVDC electricity interconnector linking the power grid in Ireland with Great Britain. The geophysical survey was requested as part of the ground investigation to survey the ground conditions at the area of landfall for the connector cable, the cable route towards the Great Island transmission substation in Wexford and the proposed convertor substation. The cable is currently planned to lie approximately 850mm below ground level along the road sections and 1050mm along off-road sections.

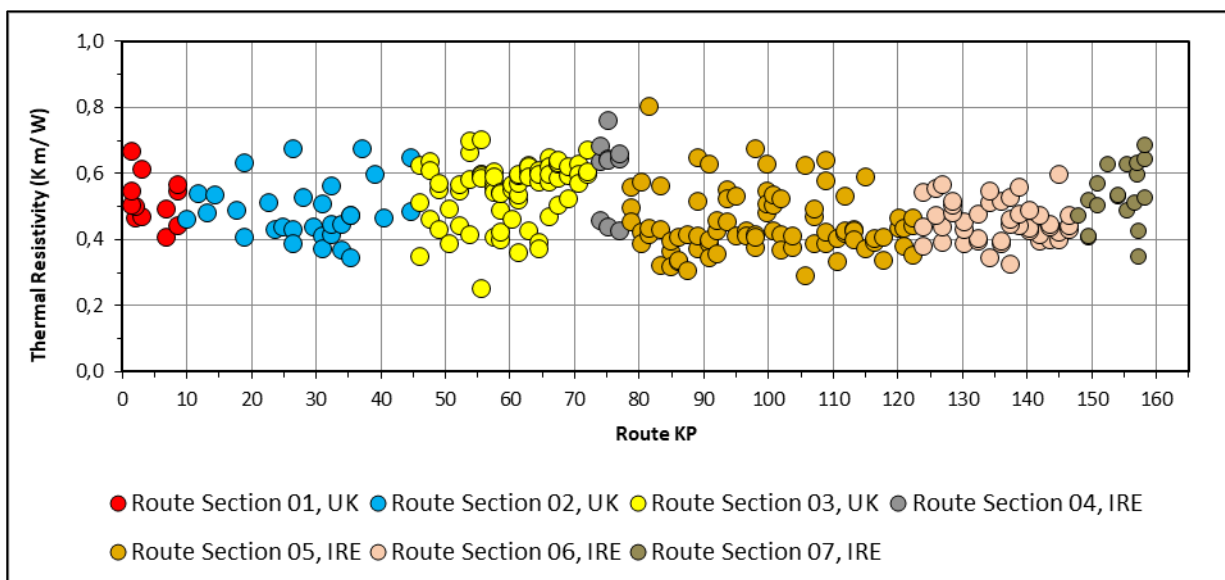
Figure 82. Summary of thermal data for the entire route.
