Aquatic Macroinvertebrate Sampling Report

Lyrenacarriga Wind Farm

Project Title: **Lyrenacarriga Wind Farm**

Document Title: **Aquatic Macroinvertebrate Sampling Report**

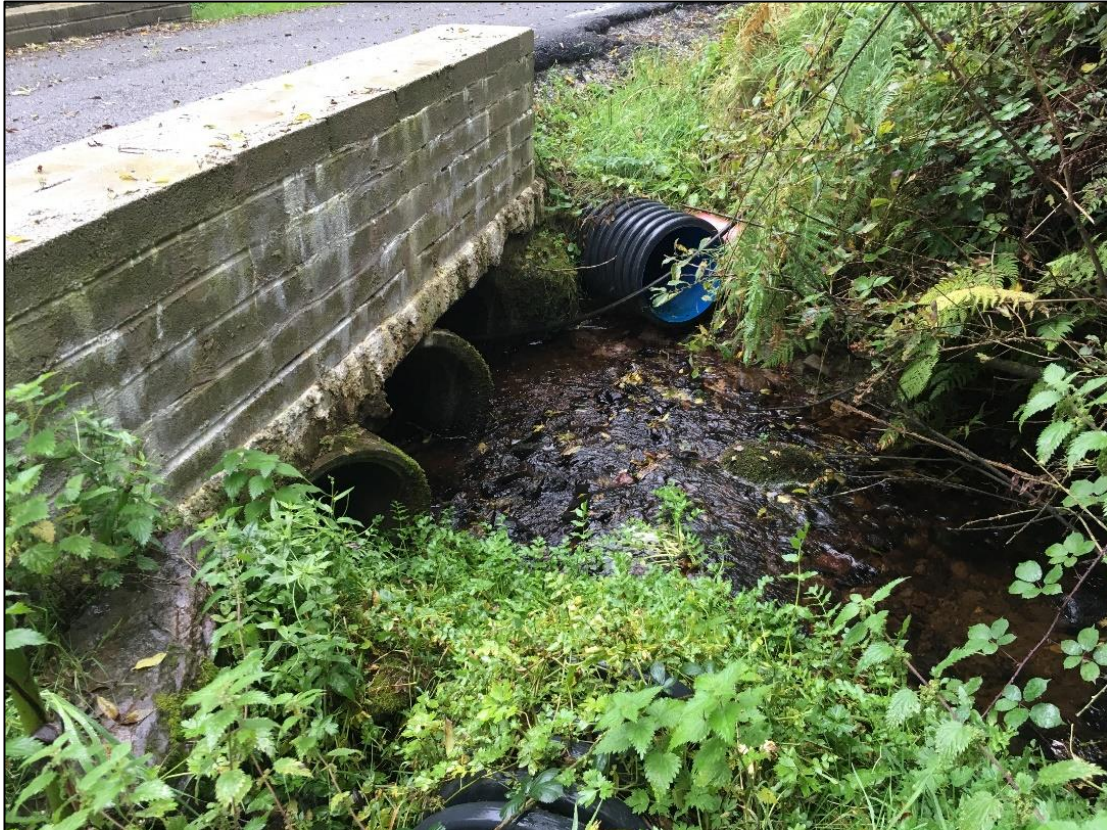
Plate 2-2 Sample Station 2 (grid ref: X 04596 85793) – Q3-4

Sample Station 2 is located within the eastern parcel, just west of Ballynatray Commons (grid ref: X 04596 85793). Tree species recorded included willows (*Salix spp.*), ash (*Fraxinus excelsior*) and hawthorn (*Crataegus monogyna*) along with ivy (*Hedera helix*). Bankside vegetation included Bramble (*Rubus fruticosus agg.*), Ivy (*Hedera helix*), nettles (*Urtica dioica*), willows (*Salix spp.*) and ash (*Fraxinus excelsior*). The river was fast flowing and slightly turbid. The substrate comprised cobble, gravel, fine gravel and silt. Instream macrophytes included fool’s watercress (*Apium nodiflorum*) and emergent macrophytes included nettles (*Urtica dioica*). Upstream land use consisted of pasture.

The Q rating assigned to the channel was Q3-4, as group A was present in small numbers, Group B was common, group C was numerous, Group D was absent and group E was scarce.

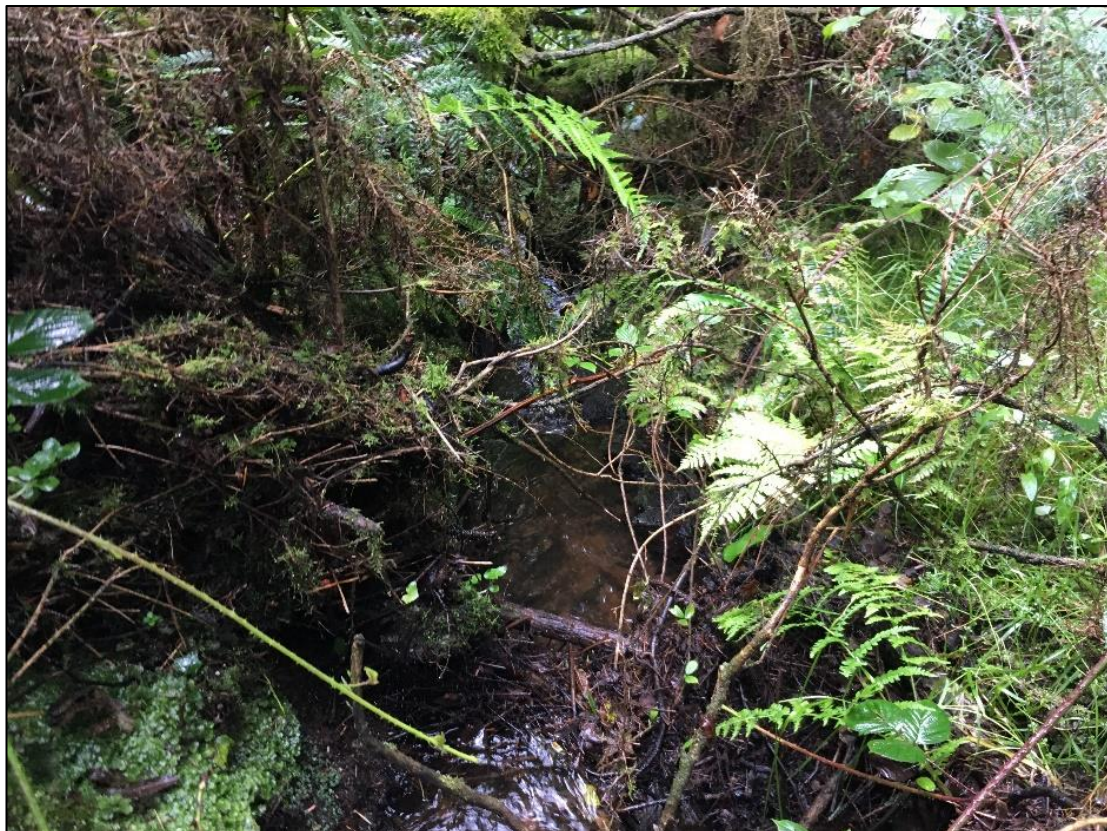
Plate 2-3 Sample Station 3 (grid ref: X 03628 87911) - Q3

Sample Station 3 is located in the eastern parcel to the north (grid ref: X 03628 87911). Tree species recorded included Sitka Spruce (*Picea sitchensis*) and willows (*Salix spp.*). Bankside vegetation included Bramble (*Rubus fruticosus agg.*), gorse (*Ulex europaeus*), willows (*Salix spp.*), ferns and Bracken (*Pteridium aquilinum*). The river was fast flowing and slightly turbid. The substrate comprised bedrock, fine gravel and silt. No instream vegetation was recorded but emergent vegetation included hair moss (*Polytrichum spp.*) and liverworts. Upstream land use consisted of conifer plantation.

The Q rating assigned to the channel was Q3. It was assigned this value as Group A and B invertebrates were absent, Group C invertebrates were common, Group D was absent and Group E had one representative.

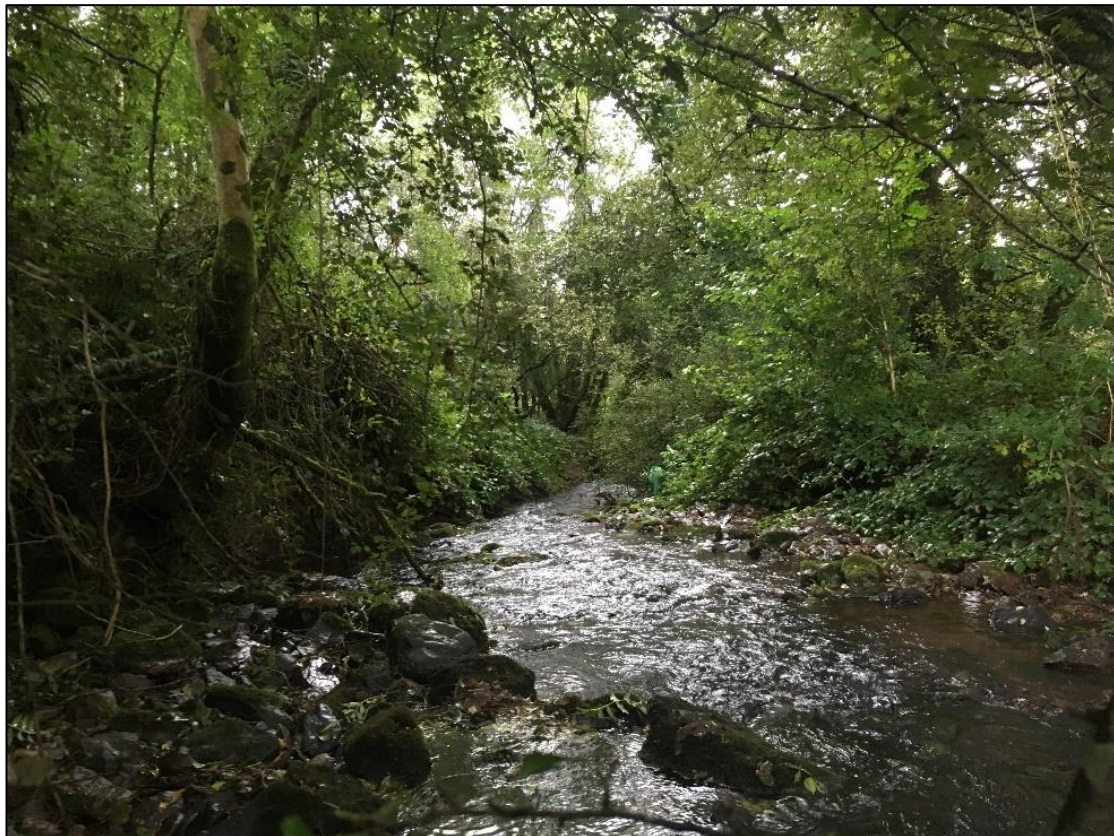
Plate 2-4 Sample Station 4 (grid ref: X 06111 83757) - Q3

Sample Station 4 is located downstream of the proposed wind farm site to the southeast (grid ref: X 06111 83757). Trees species recorded included Ash (*Fraxinus excelsior*) and Beech (*Fagus sylvatica*). Bankside vegetation included Bramble (*Rubus fruticosus* agg.), willows (*Salix* spp.), nettles (*Urtica dioica*), blackthorn (*Prunus spinosa*), and hawthorn (*Crataegus monogyna*). The river was fast flowing with no turbidity. The substrate comprised boulder, cobble and gravel. Instream vegetation recorded included mosses. Upstream land use consisted of pasture and woodland.

The Q rating assigned to the channel was Q3. It was assigned this value as Group A invertebrates were absent, Group B was scarce, Group C invertebrates were numerous, and Groups D and E were absent.
