# **ENVIRONMENTAL IMPACT ASSESSMENT REPORT**

## **APPENDICES**

**Aungierstown Substation and transmission lines  
Grange Castle South Business Park**

**January 2021**

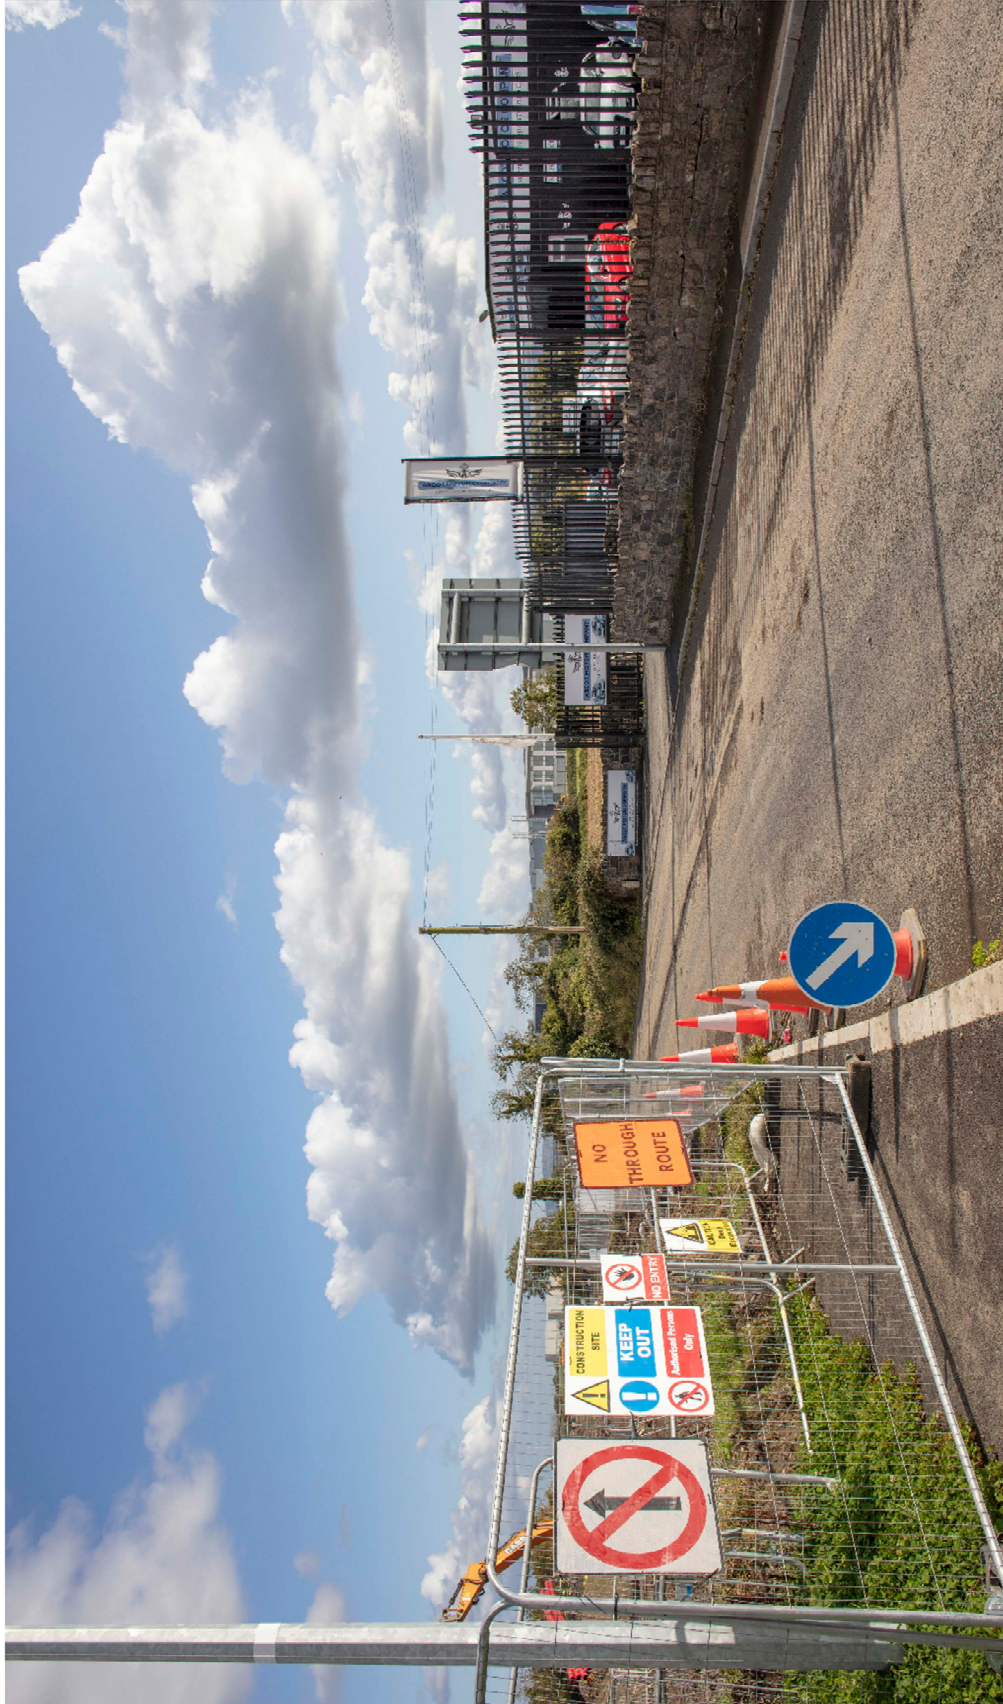
Location	Date	Field of view	35mm equivalent	Distance to site	Camera model
View 1 Existing	28-09-2020	73°	24mm	677m	Canon EOS 5DS

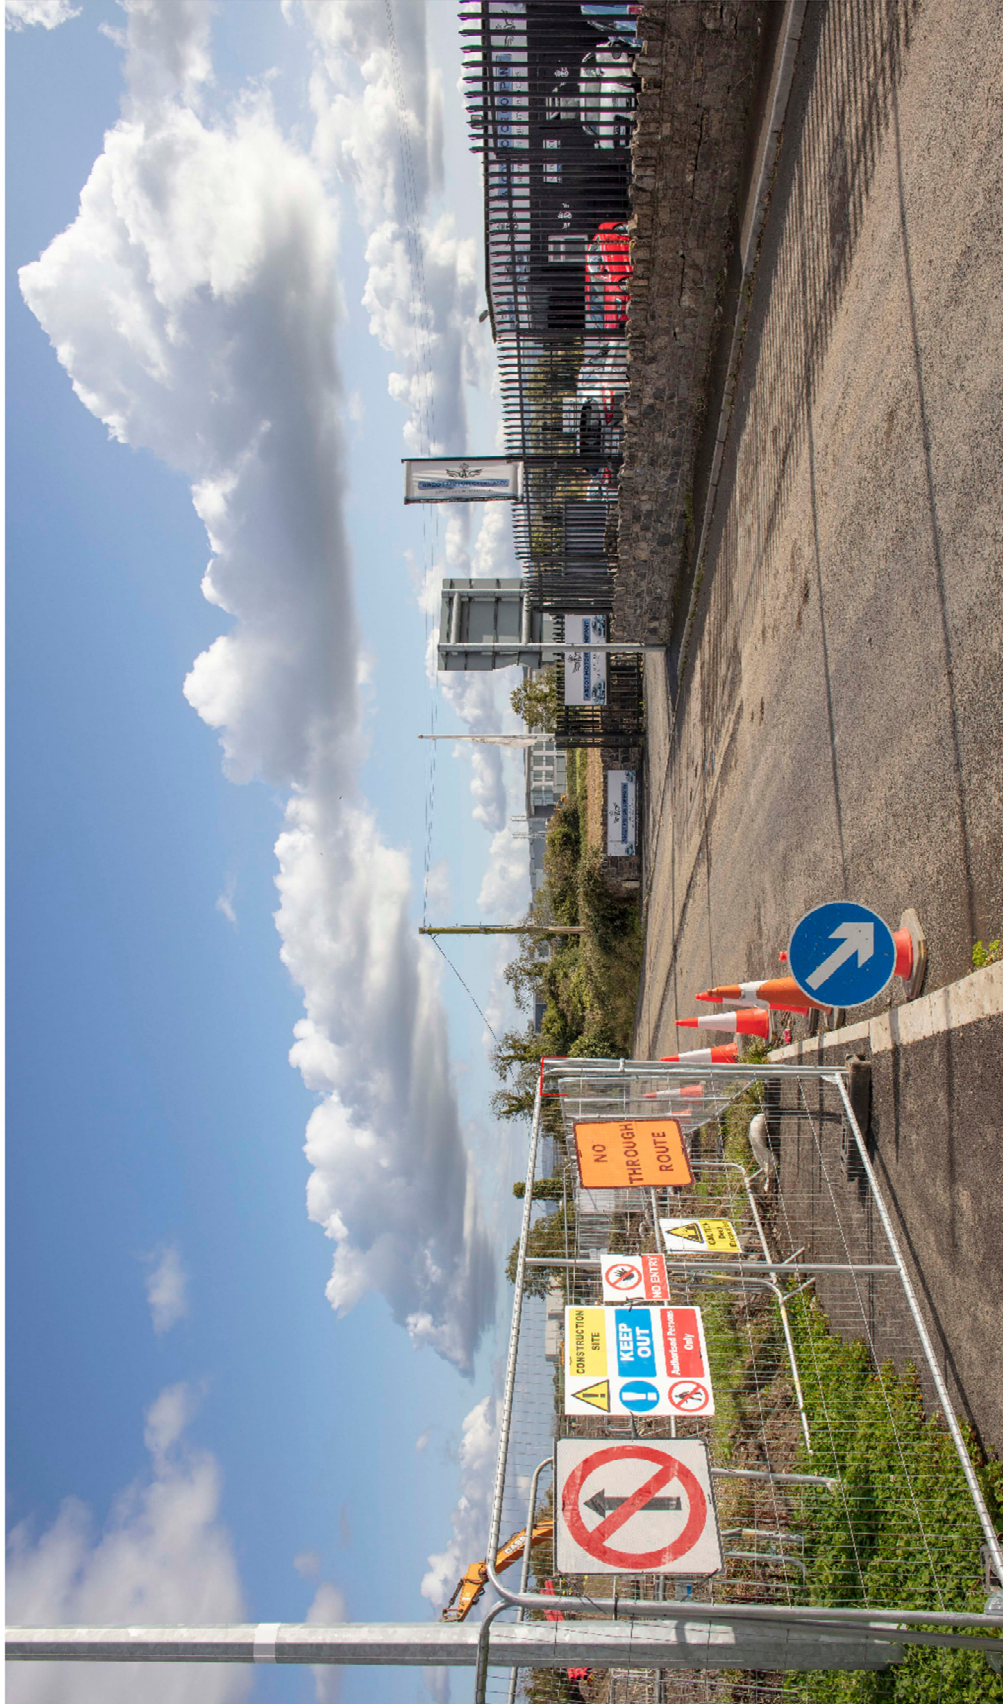
Location	Date	Field of view	35mm equivalent	Distance to site	Camera model
View 1 Proposed	28-09-2020	73°	24mm	677m	Canon EOS 5DS

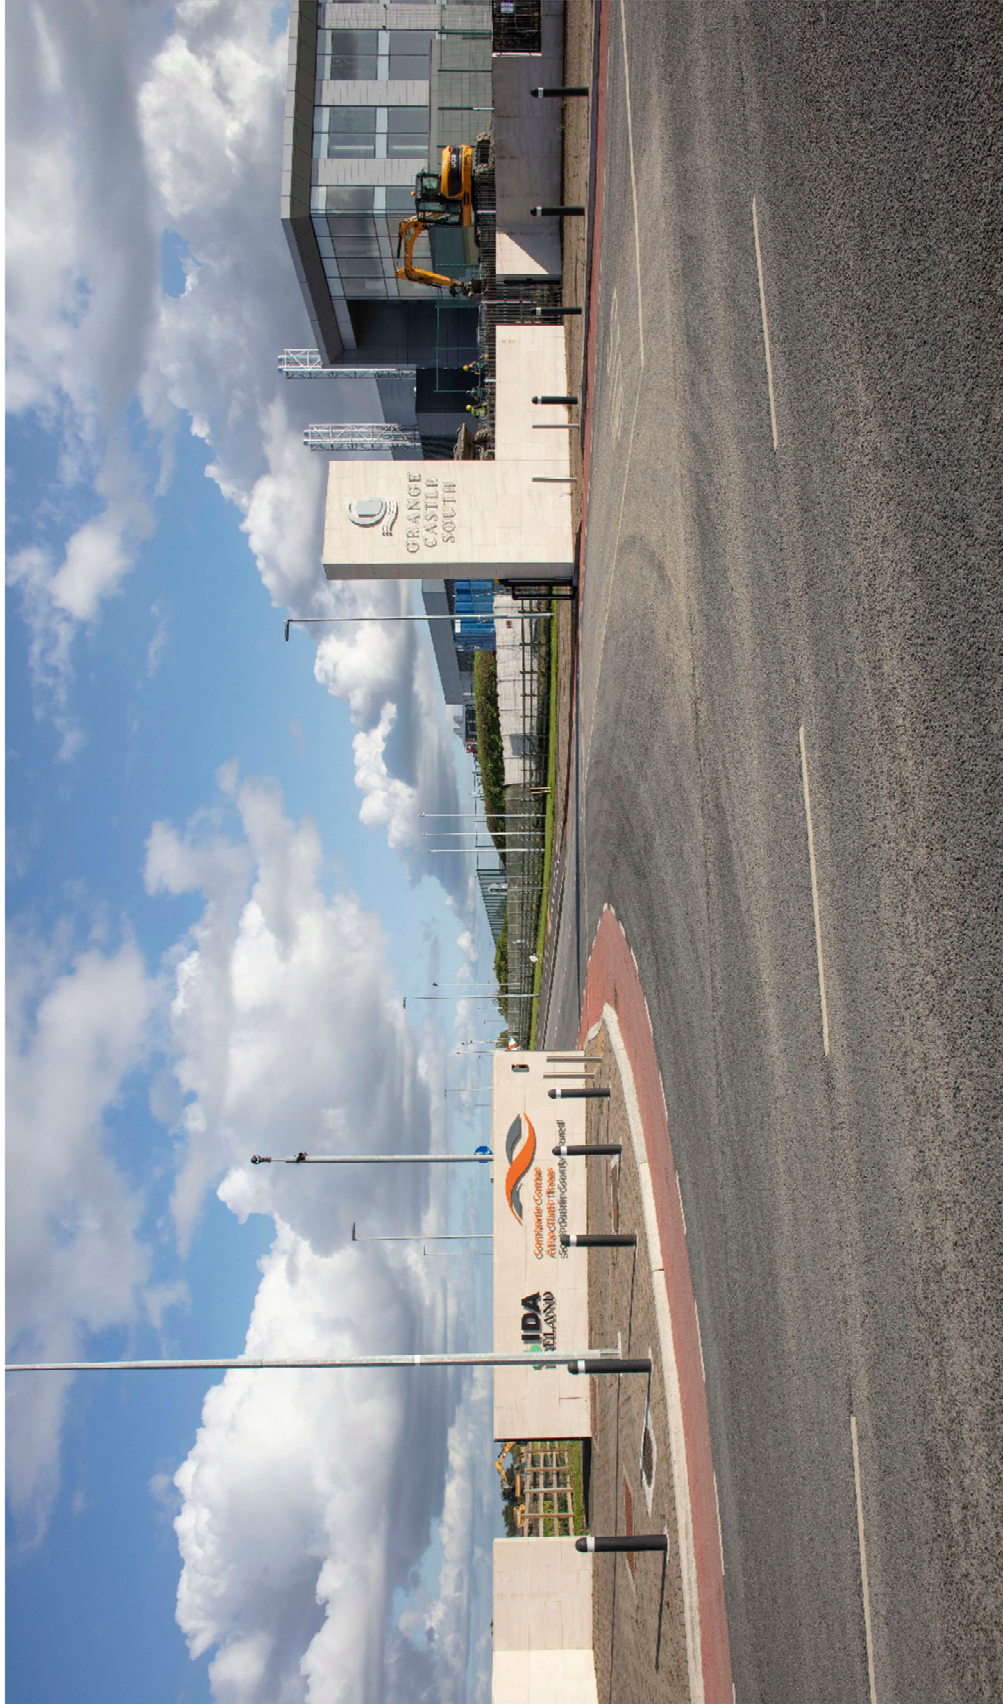
Location	Date	Field of view	35mm equivalent	Distance to site	Camera model
View 2 Existing	28-09-2020	73°	24mm	398m	Canon EOS 5DS

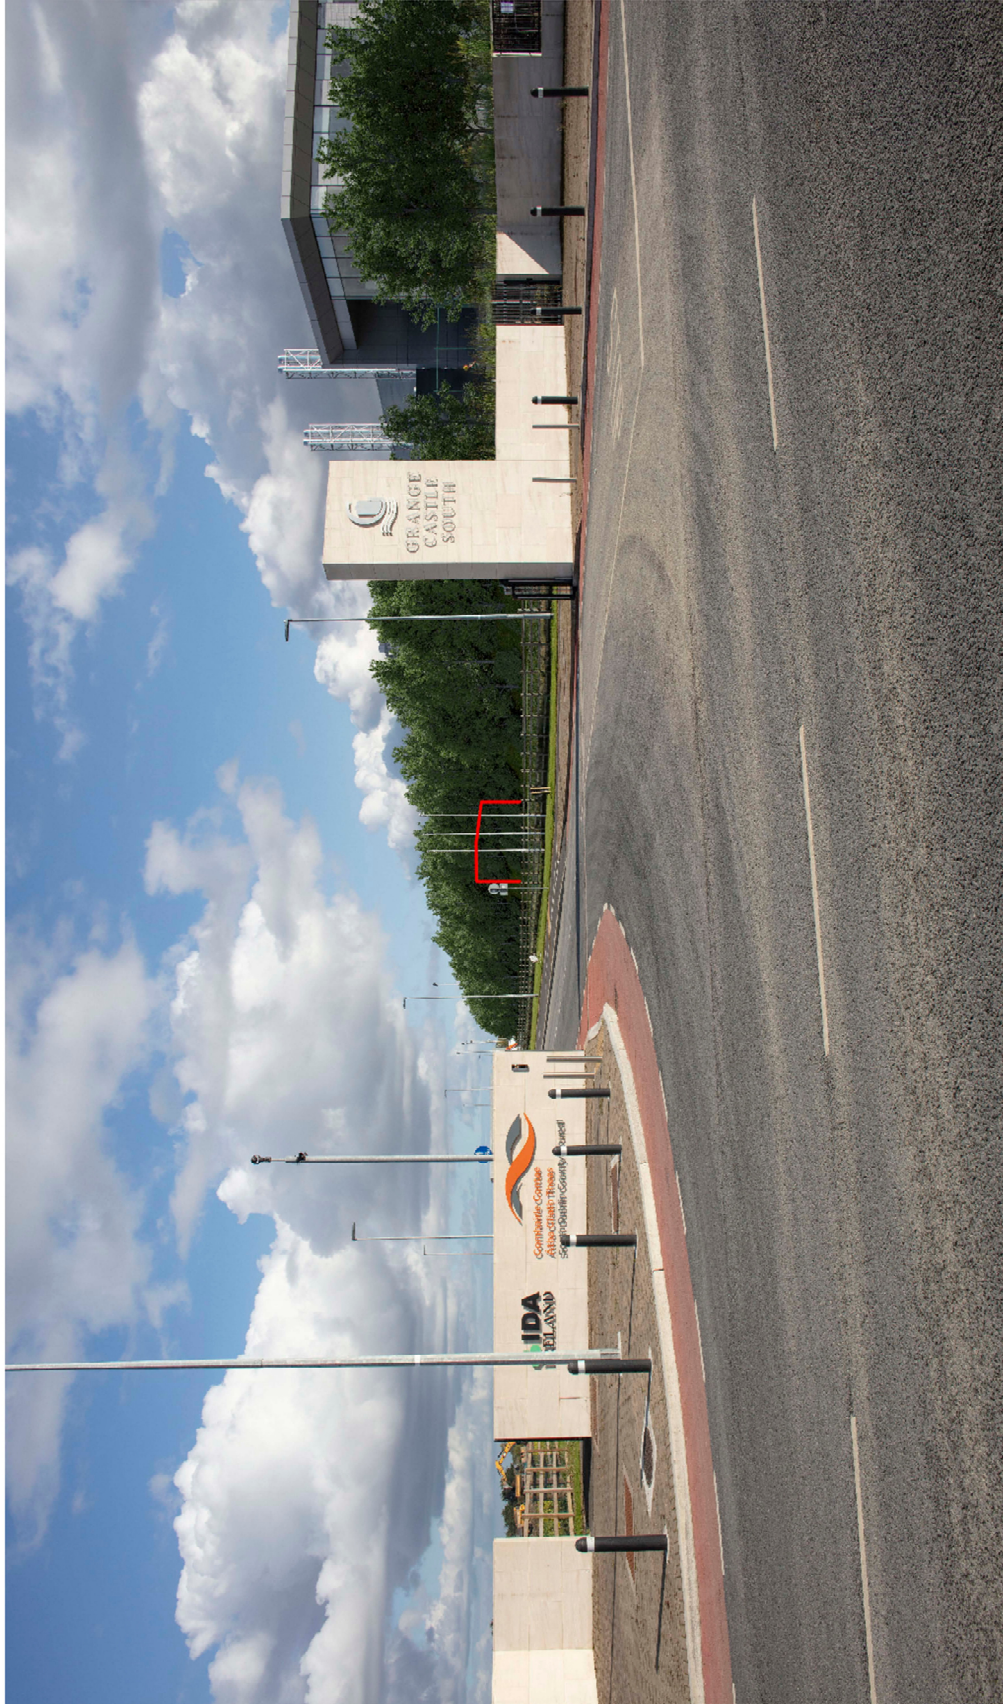
Location	Date	Field of view	35mm equivalent	Distance to site	Camera model
View 2 Proposed	28-09-2020	73°	24mm	398m	Canon EOS 5DS

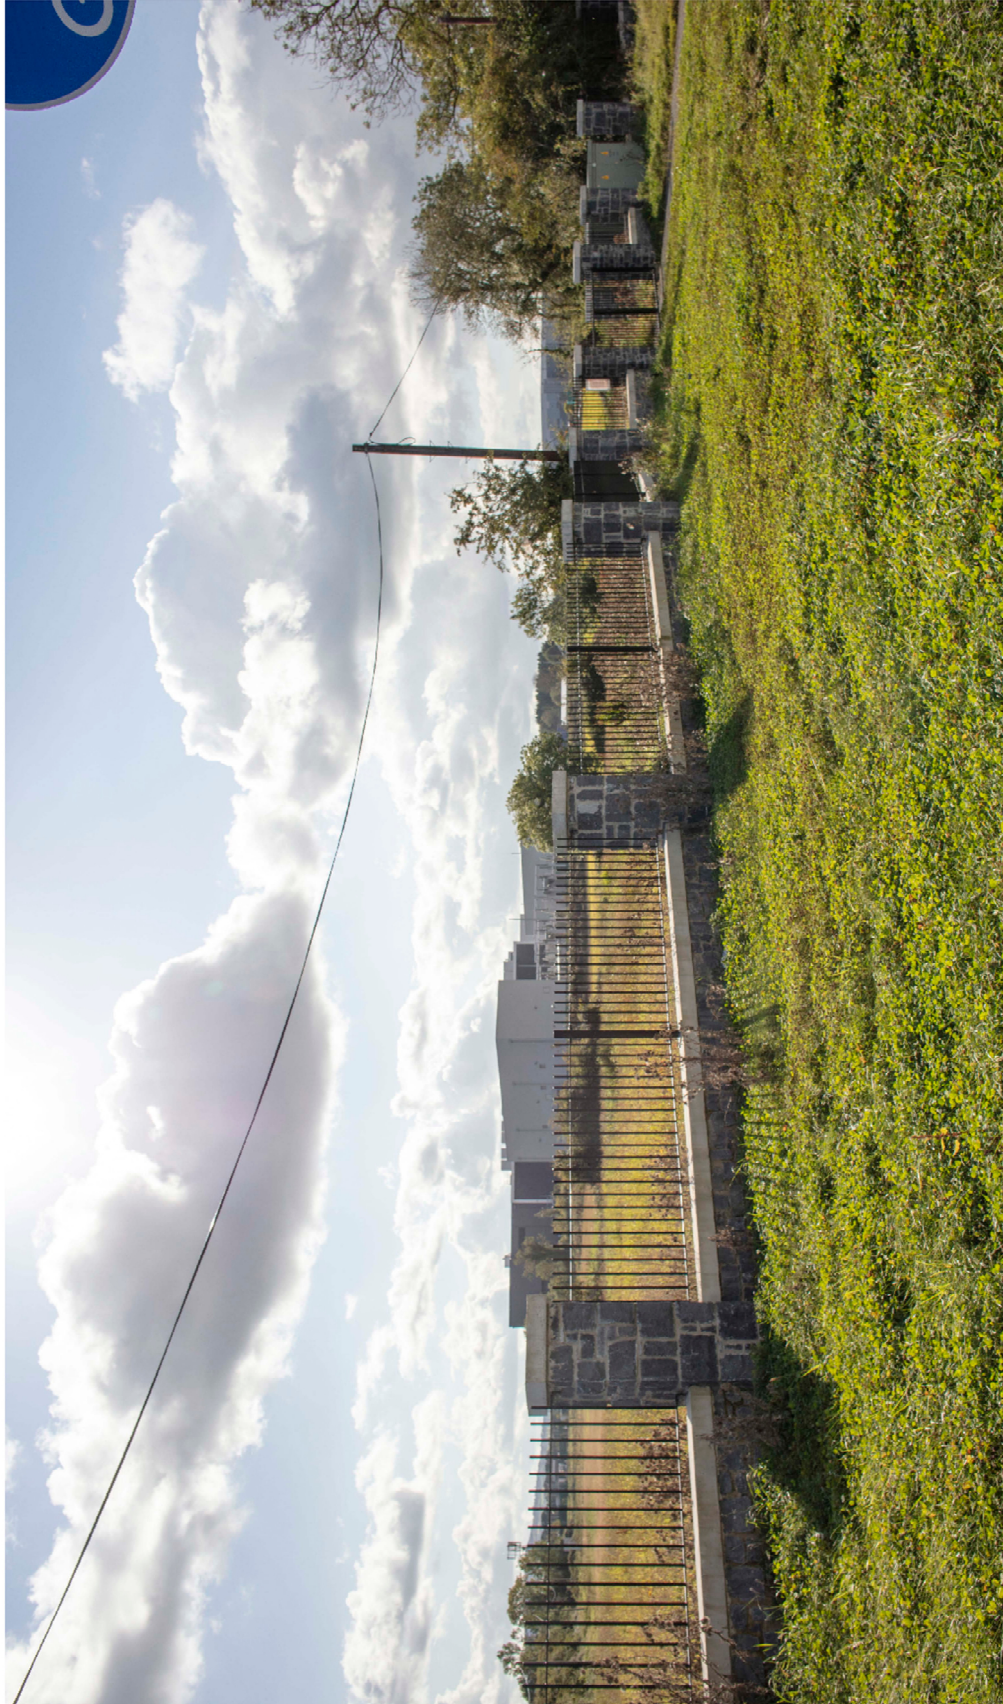
Location	Date	Field of view	35mm equivalent	Distance to site	Camera model
View 3 Existing	28-09-2020	73°	24mm	411m	Canon EOS 5DS

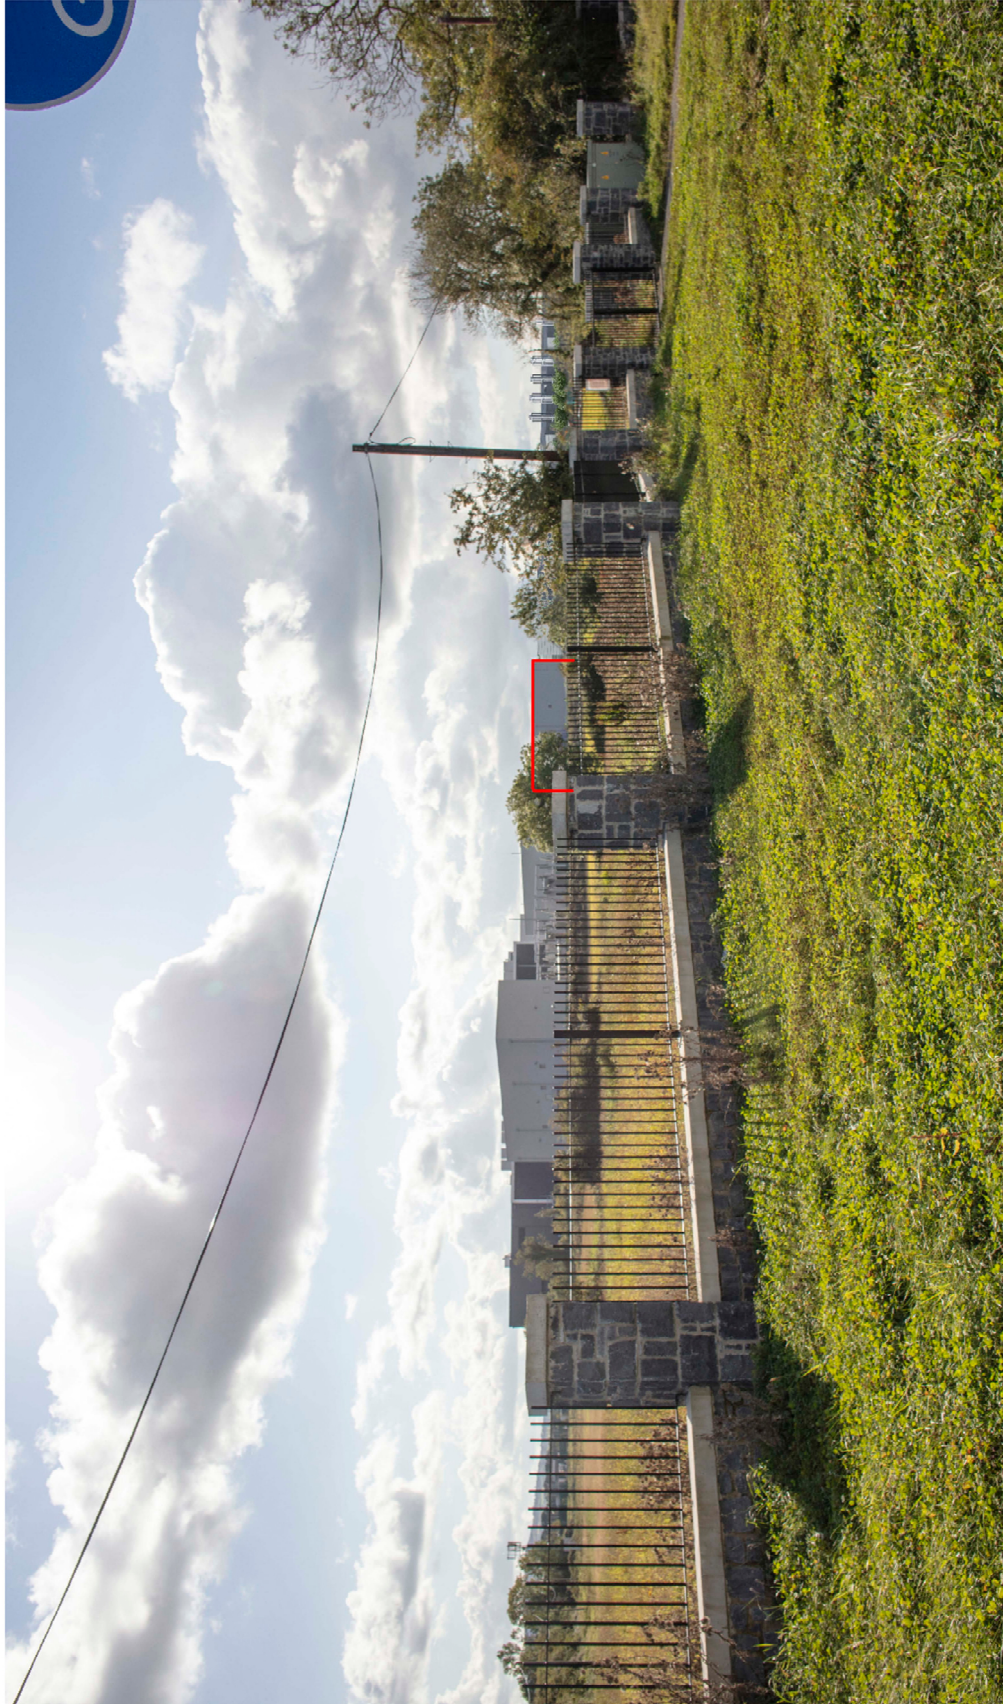
Location	Date	Field of view	35mm equivalent	Distance to site	Camera model
View 3 Proposed	28-09-2020	73°	24mm	411m	Canon EOS 5DS

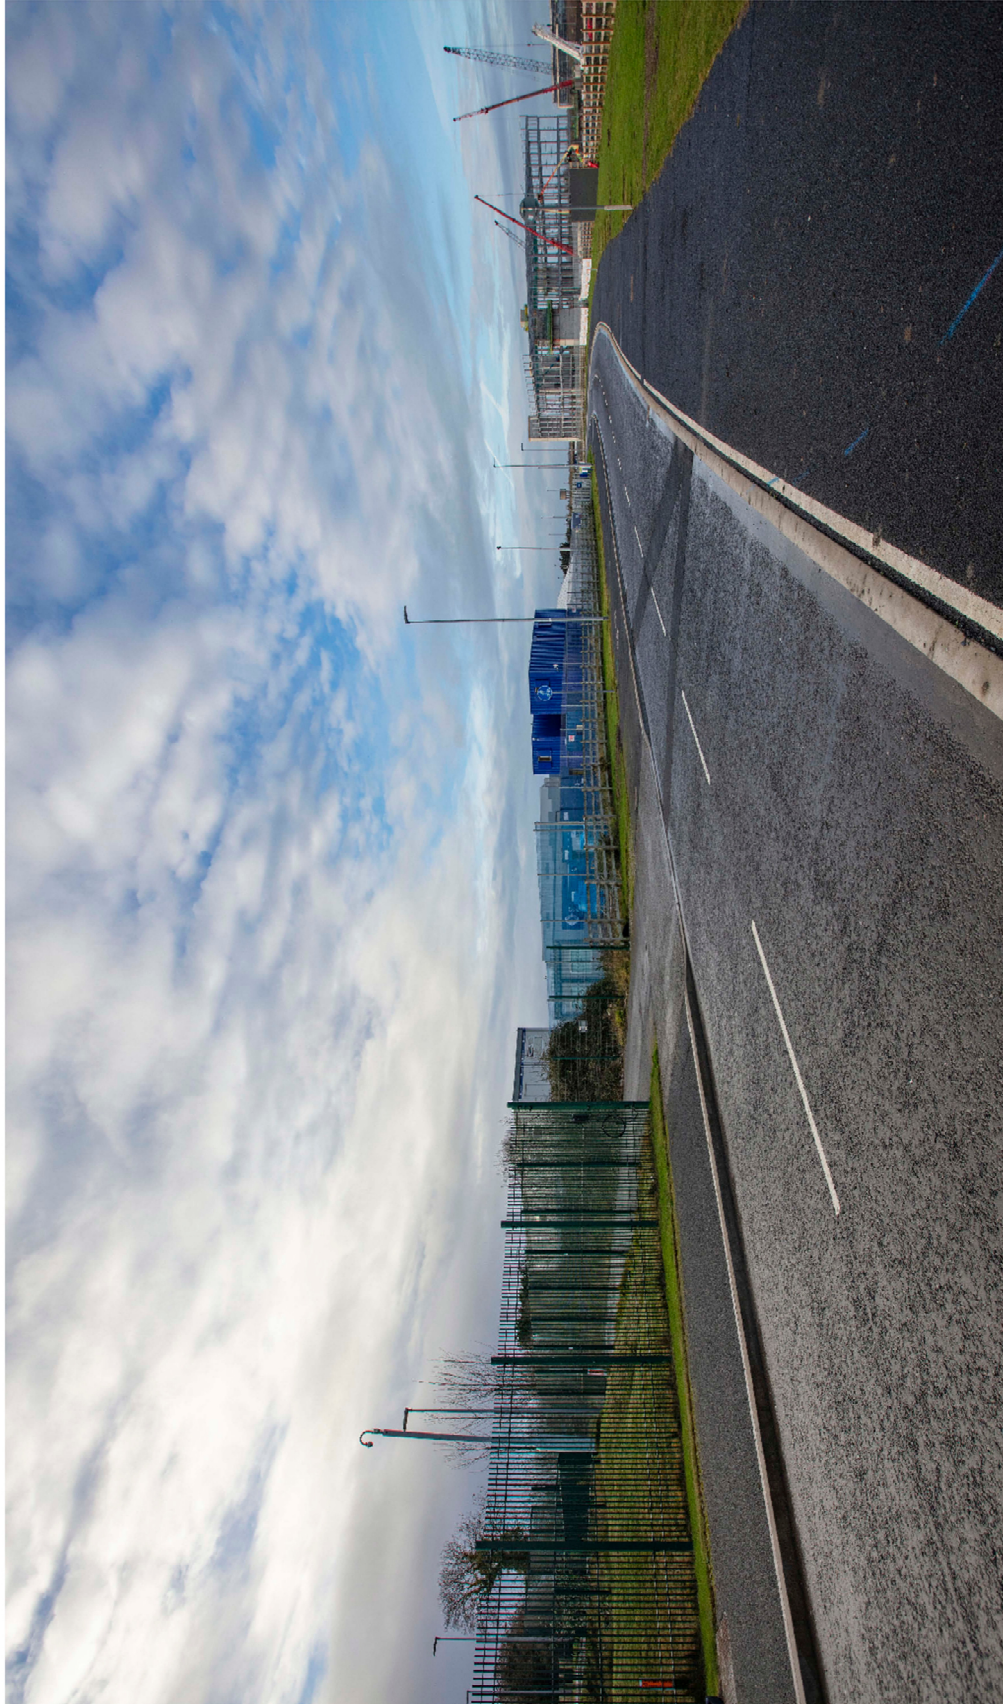
Location	Date	Field of view	35mm equivalent	Distance to site	Camera model
View 4 Existing	17-12-2020	97°	16mm	25m	Canon EOS 5DS

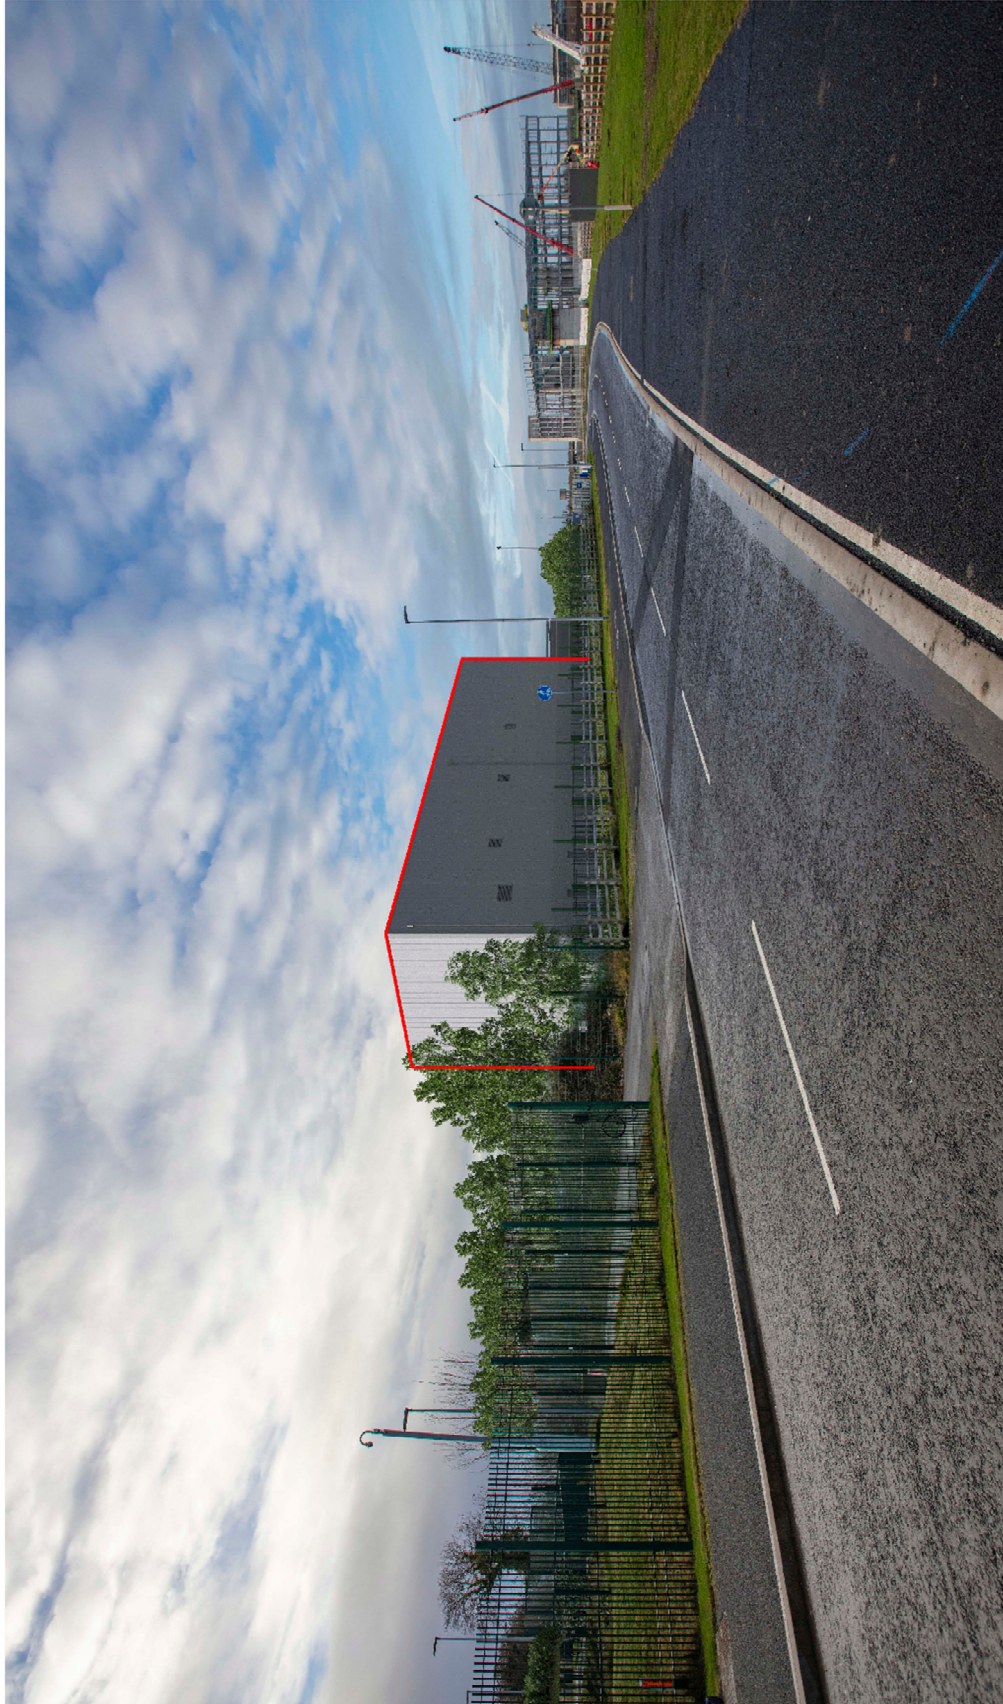
Location	Date	Field of view	35mm equivalent	Distance to site	Camera model
View 4 Proposed	17-12-2020	97°	16mm	25m	Canon EOS 5DS

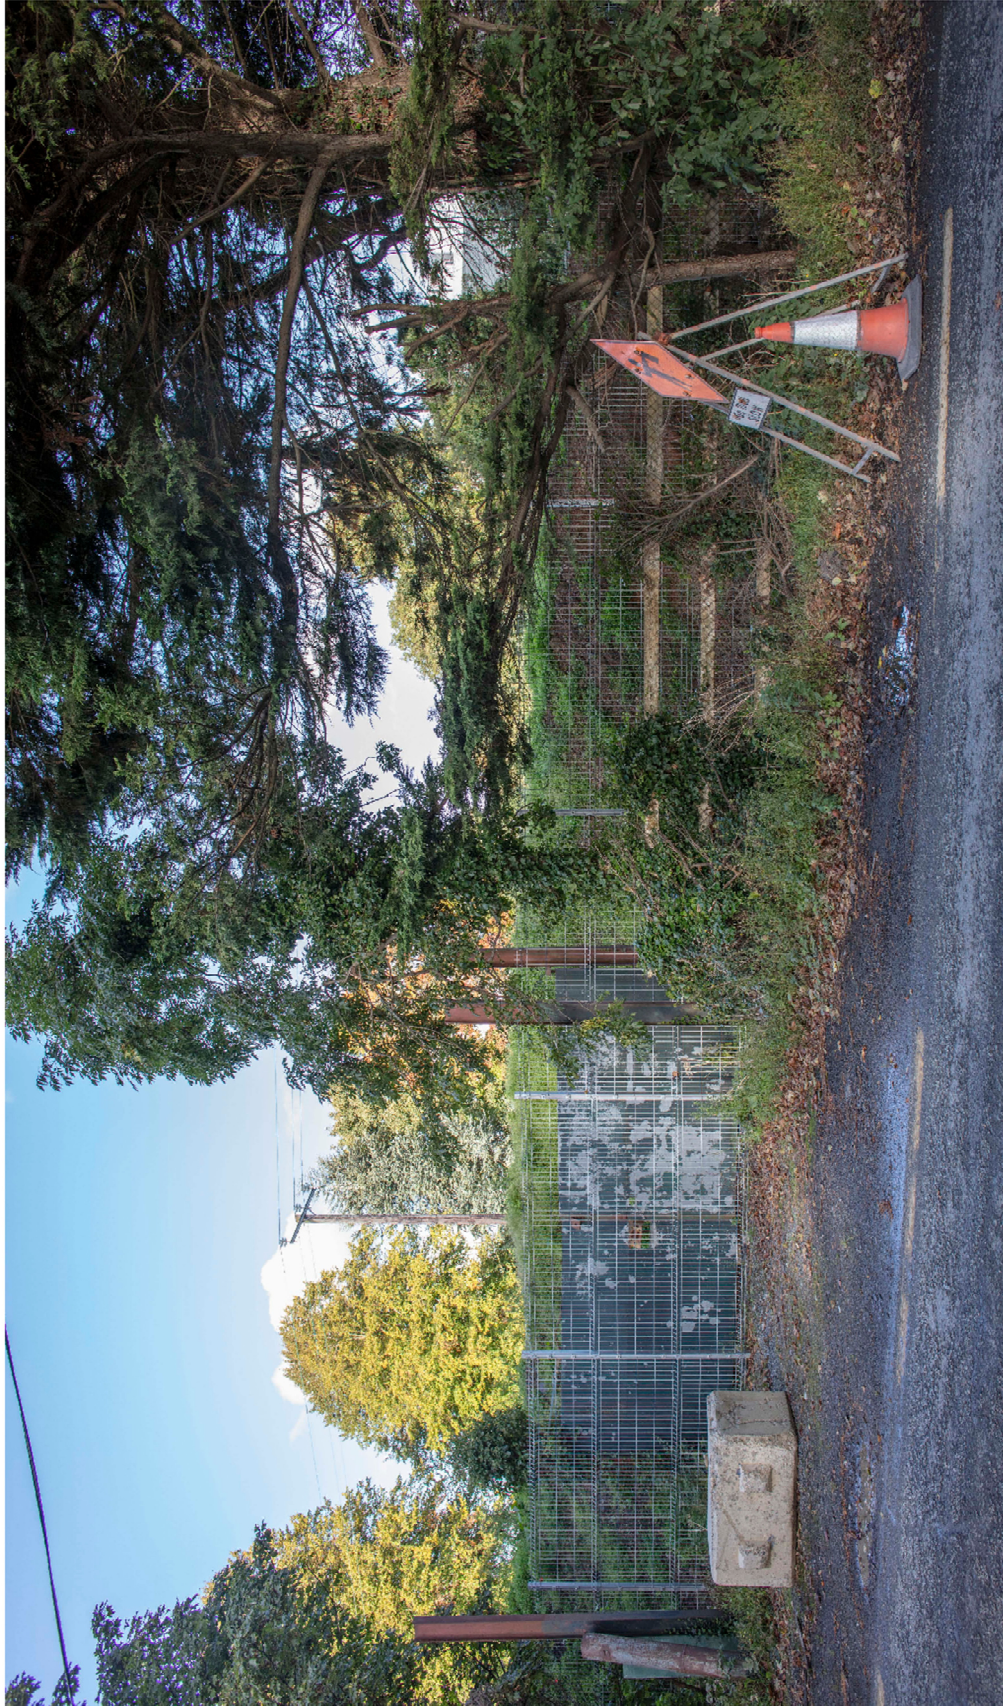
Location	Date	Field of view	35mm equivalent	Distance to site	Camera model
View 5 Existing	28-09-2020	73°	24mm	279m	Canon EOS 5DS

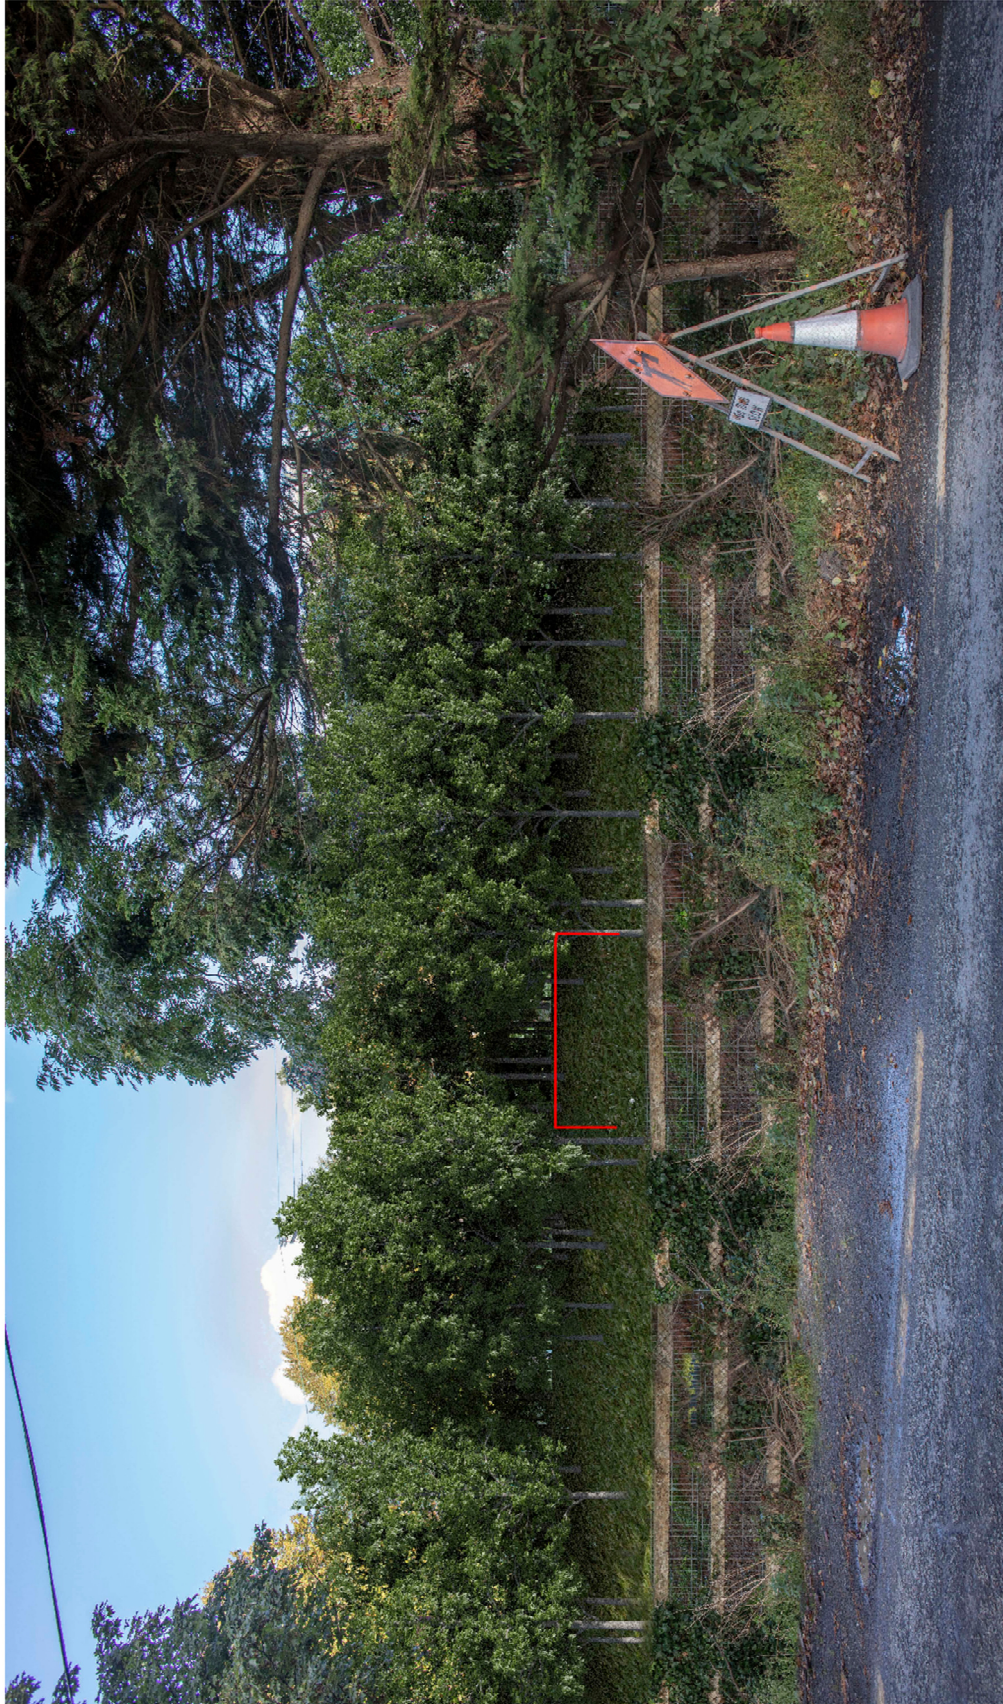
Location	Date	Field of view	35mm equivalent	Distance to site	Camera model
View 5 Proposed	28-09-2020	73°	24mm	279m	Canon EOS 5DS

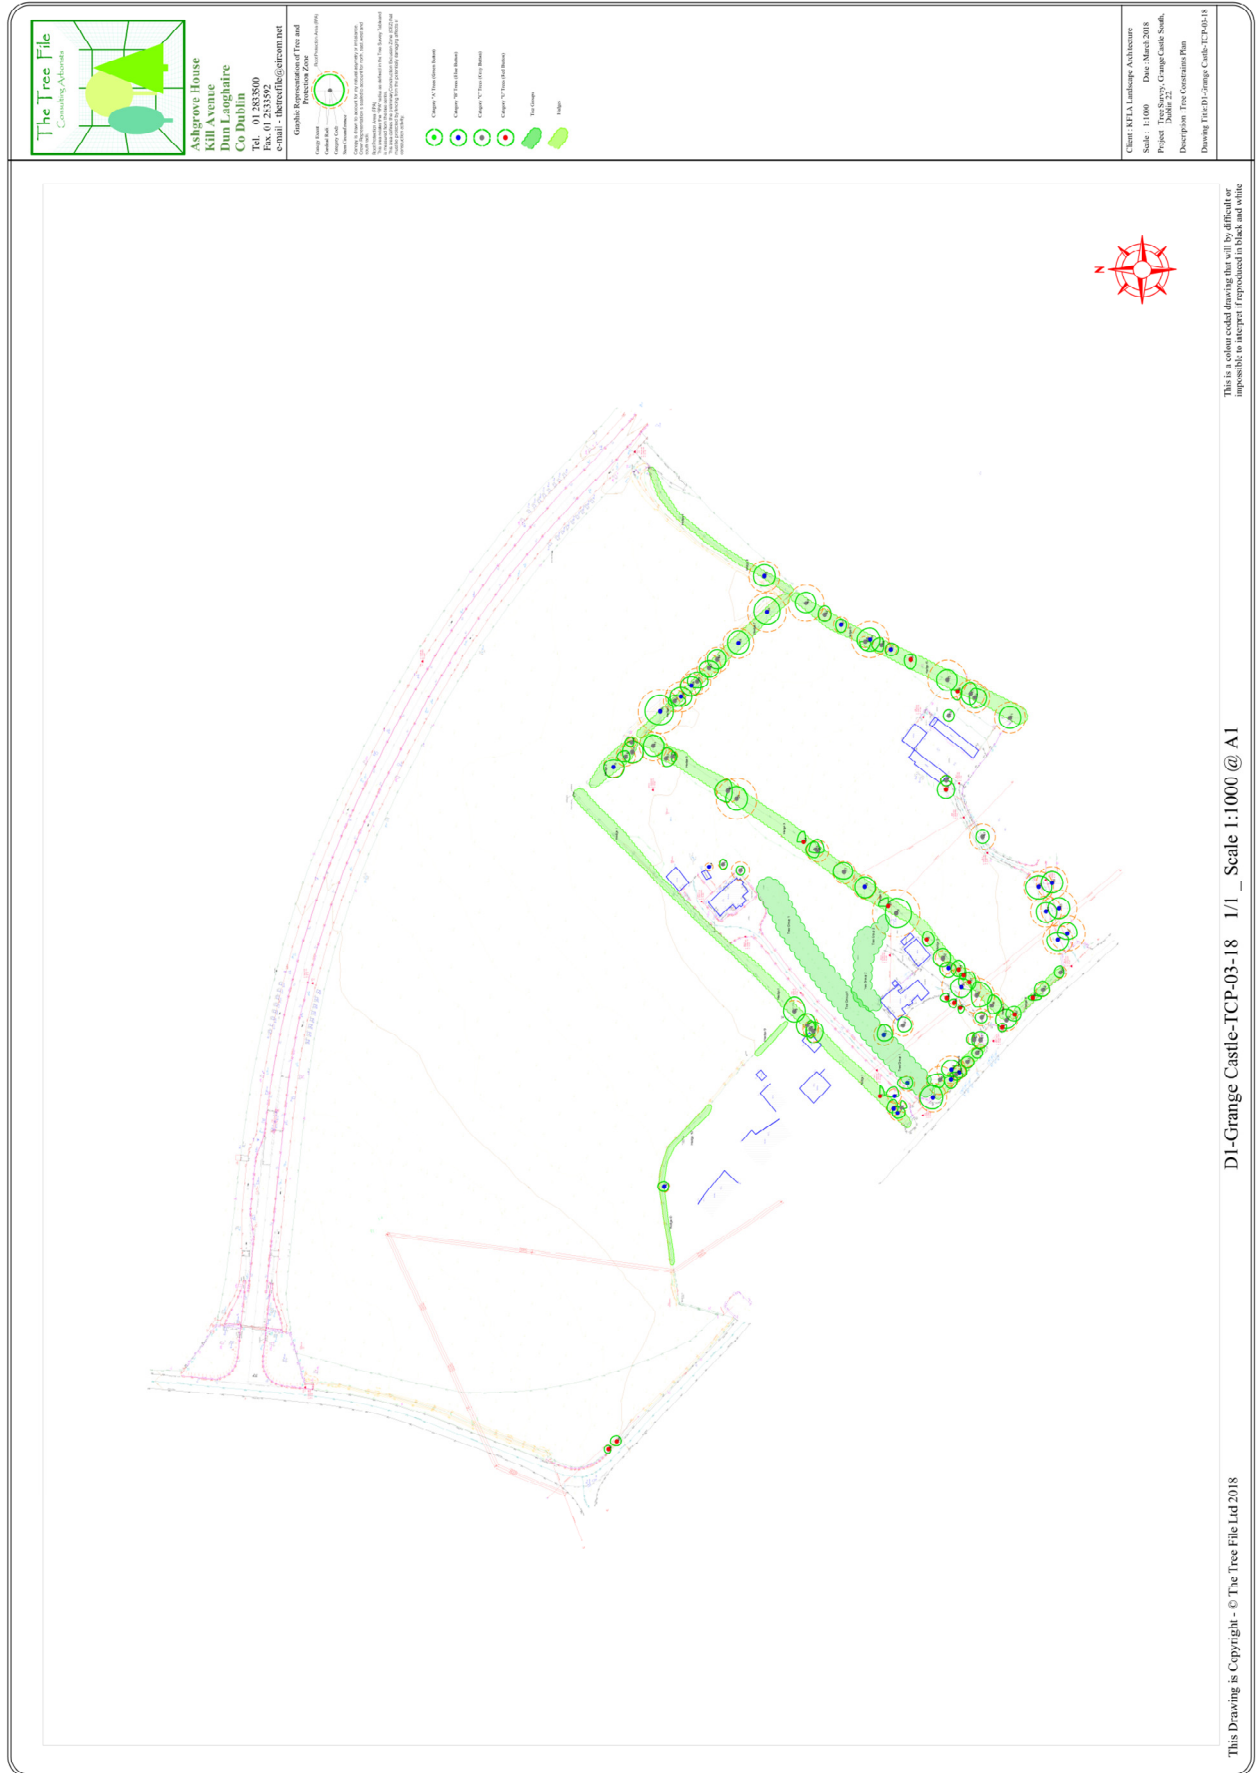
This tree report should be read in conjunction with the combined tree constraints and basic impacts plan drawing “D1-Grange Castle-TCP-03-18”. This drawing provides a graphic representation of the tree survey depicting the constraints of those trees potentially affected by work as well as categorisation their condition and potential value. Accordingly, and in line with BS5837:2012 Trees in Relation to Design, Demolition and Construction – Recommendations, this documentation does provide an invaluable “design tool” in respect of the quantification of sustainable trees within any proposed development.

The data collected has been represented in table form as “Table 1” within “Appendix 1” to this report. This appendix includes a Survey Methodology, Survey Key, Survey Abbreviations, Condition Category Definitions and a brief resume of the typical application of Tree Protection measures as defined within the above standard and as relates to the “RPA” zones defined both within the survey table and on the “TCP” drawing.

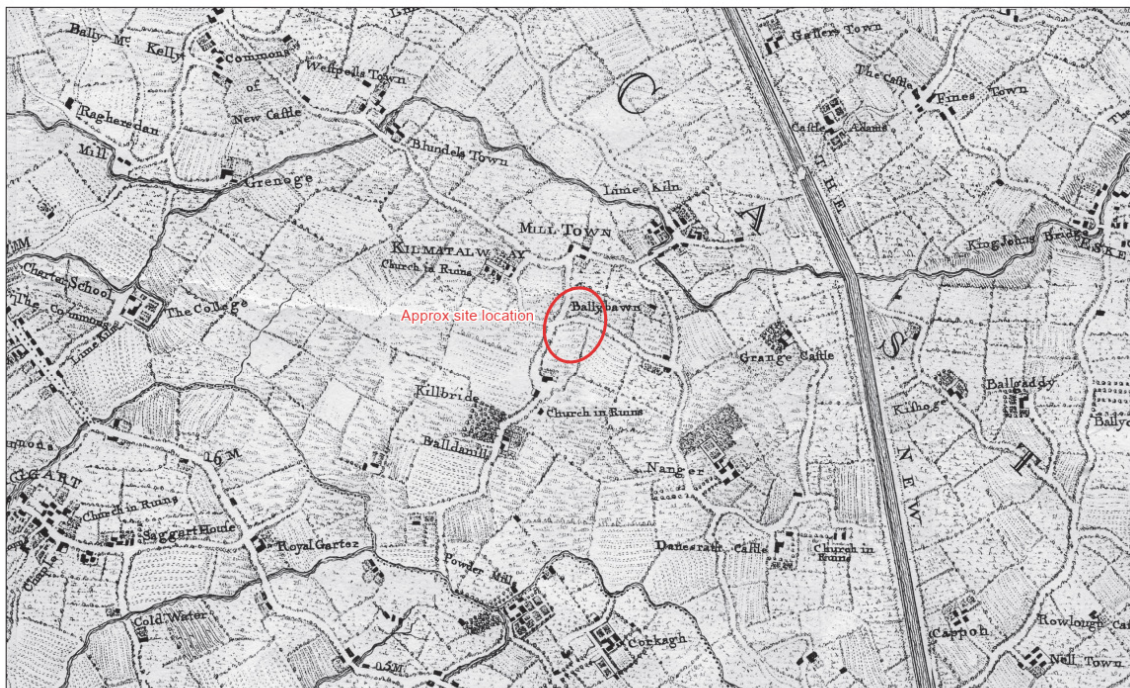
Figure 13.4 - Extract from Rocque's Map of County Dublin.
