ENVIRONMENTAL IMPACT ASSESSMENT REPORT

APPENDICES

**Peamount Substation and transmission lines
Milltown**

Feasibility assessment for the undergrounding of a 110kV cables using Horizontal Directional Drilling beneath the Baldonnel Road & Griffeen River, Clutterland, Lucan, County Dublin

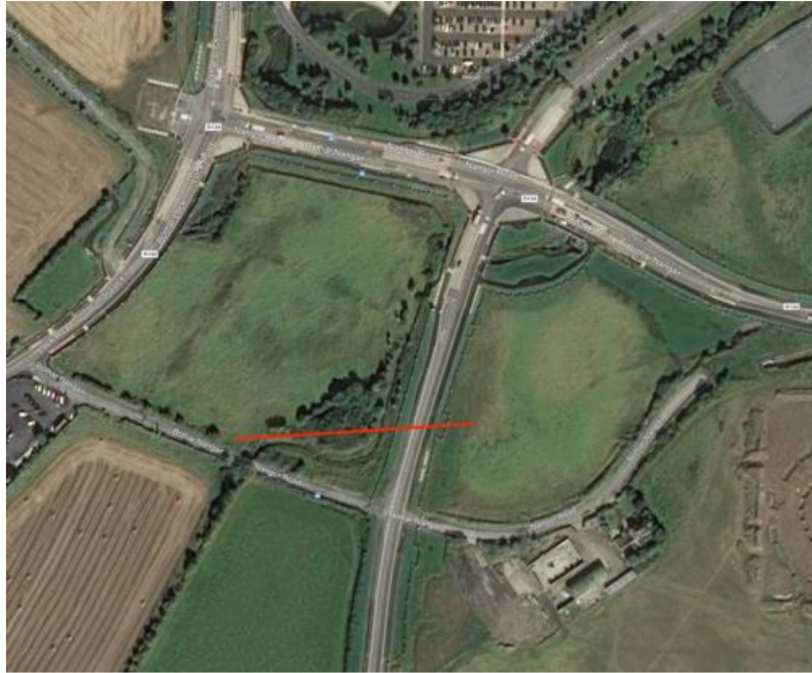
Figure 1 – Site locations

The project involves crossing beneath a single carriageway and river, Figure 1.

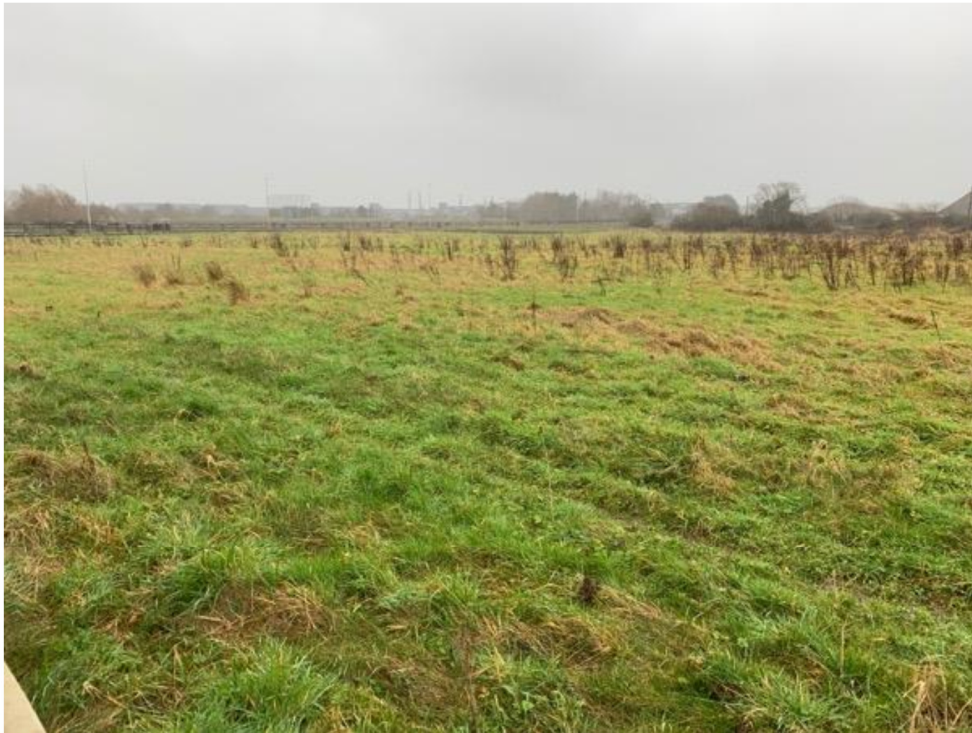
Figure 2 – Location of launch area on the east site of the Baldonnel Road

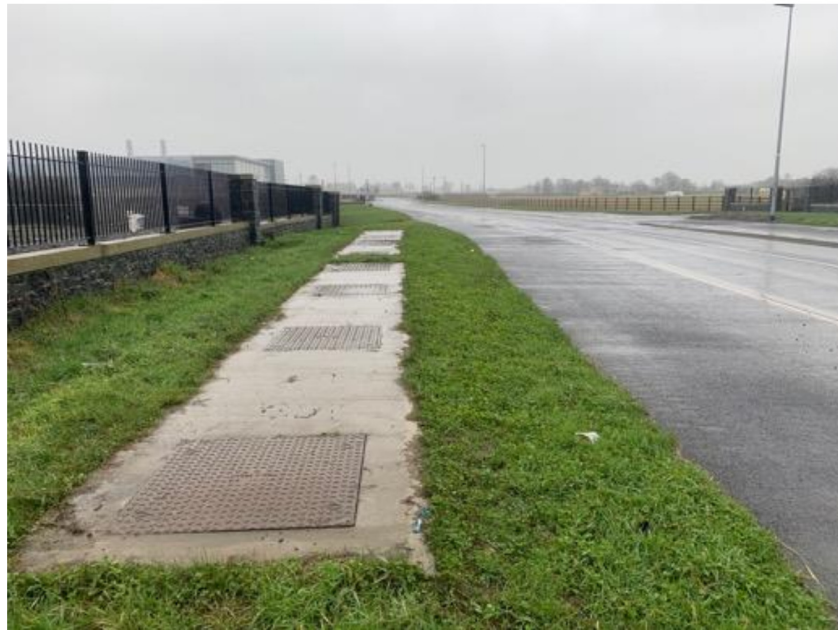
Figure 3 – Baldonnel Rd., south bound

- There is ample room to set up equipment on both entry and exit side, a hard standing will be required in the grass area. Figure 2 & Figure 5
- There is ample room for welding and stringing out the ducts.
- Access to the carriageway is only required for the steering of the pilot bore.
- The area is heavily congested with underground utilities, depths unknown, Figure 3.

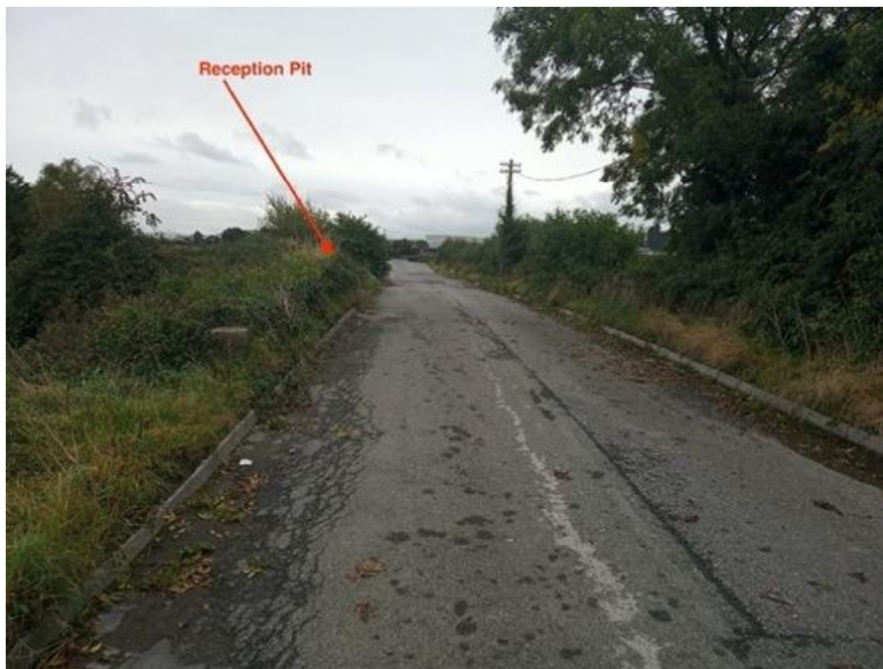
Figure 5 – Reception area on the west site of the Baldonnel Road

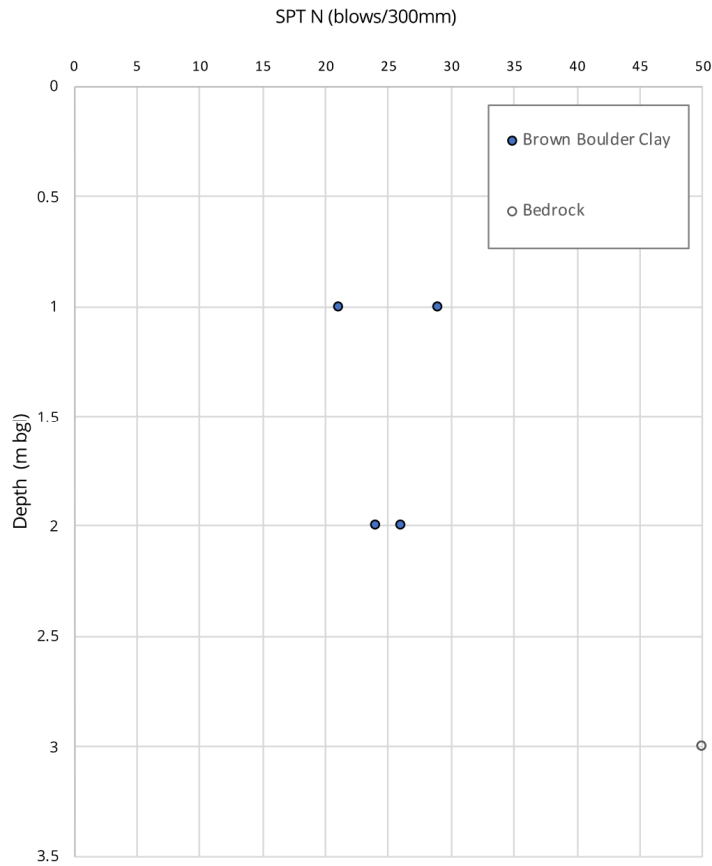
Results of SPT tests are shown in Figure 7. The SPT profile was similar between BH40 and BH41, showing strong similarity in ground profile in the two boreholes.

Figure 7 - SPT results for BH40 and BH41

BH40 found Made Ground to 0.6m bgl / 68.67mOD, being road construction material), over stiff brown slightly sandy gravelly silty CLAY with low cobble content to refusal at 3.0m bgl / 66.27mOD. Groundwater was not encountered. Rotary core follow on RC40 found strong to very strong LIMESTONE interbedded with strong MUDSTONE with some calcite veins to the termination depth of 7.0m bgl / 62.27mOD. The rock is described as fresh to slightly weathered and RQD varied from 31 to 64, indicating rock of poor to fair quality.

BH41 found 200mm of topsoil over stiff brown slightly sandy gravelly silty CLAY with low cobble content to 1.7m bgl / 67.83mOD over stiff black slightly sandy gravelly silty CLAY with low cobble content to refusal at 3.1m bgl / 66.43mOD. Rotary core follow on RC41 found very strong LIMESTONE interbedded with strong MUDSTONE with some calcite and pyrite veins to the termination depth of 6.3m bgl / 63.23mOD. The rock is described as fresh to slightly weathered and RQD varied from 40 to 43, indicating rock of poor quality.

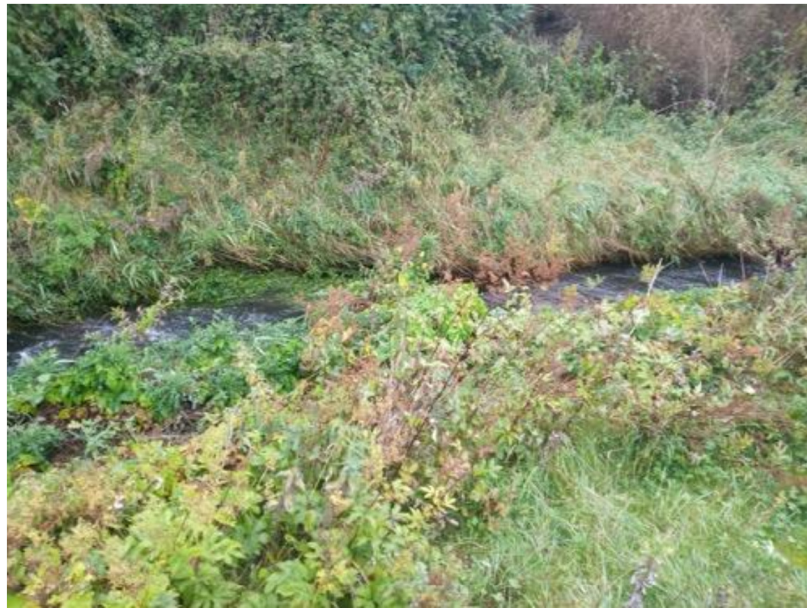
Figure 9 – Griffeen River.

The Griffeen River meanders across the site on the west side of the carriage way, Figure 9

The Griffeen River rises on Saggart Hill in South Dublin. It flows towards Lucan until it reaches the Griffeen Valley Park. It flows under the Grand Canal through a siphon system and also passes through several housing estates, Lucan Village Park and Vessey Park before reaching Griffeen Valley

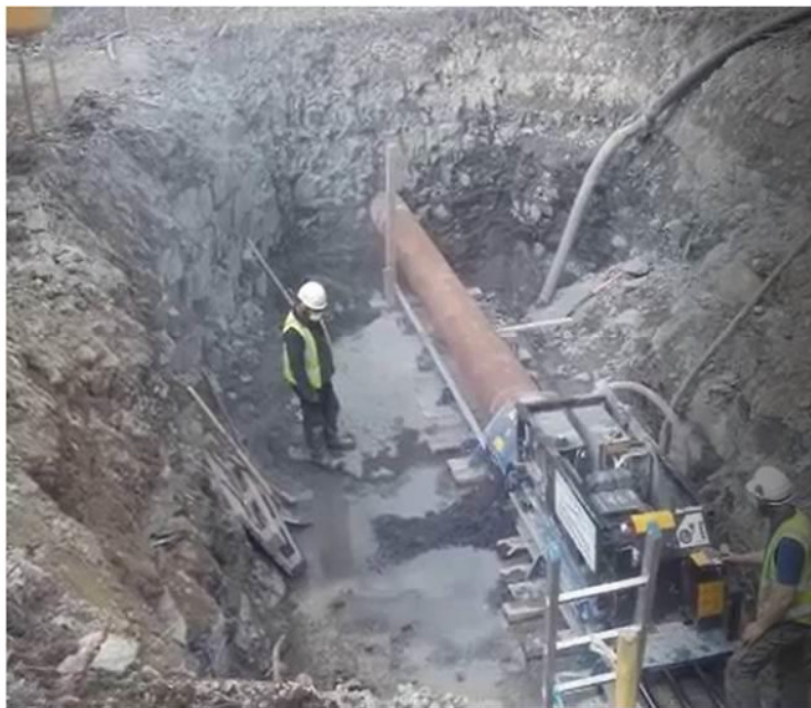
Figure 13 – Auger boring rig setting up to drill a 508mm steel casing with a DTH hammer.

DTH drilling with an auger boring rig is a trenchless method for installation of steel pipes using a simultaneous drilling/casing system. Distances of 50 m or more, and diameters of over 610 mm are achievable. The method is useful for pipe installations under railway lines and roads, where other trenchless methods have failed because of boulders, cobbles or weathered bedrock.

A pit is excavated to line and level, approximately 10 metres long and finished with a solid base.

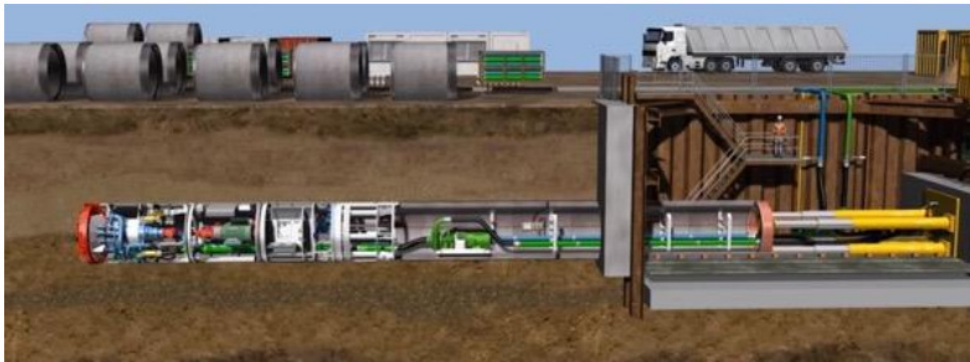
Figure 14 – Typical micro tunnelling set up.

Diameters range from 600mm upwards and distances span lengths of up to 450m for larger diameter pipes.

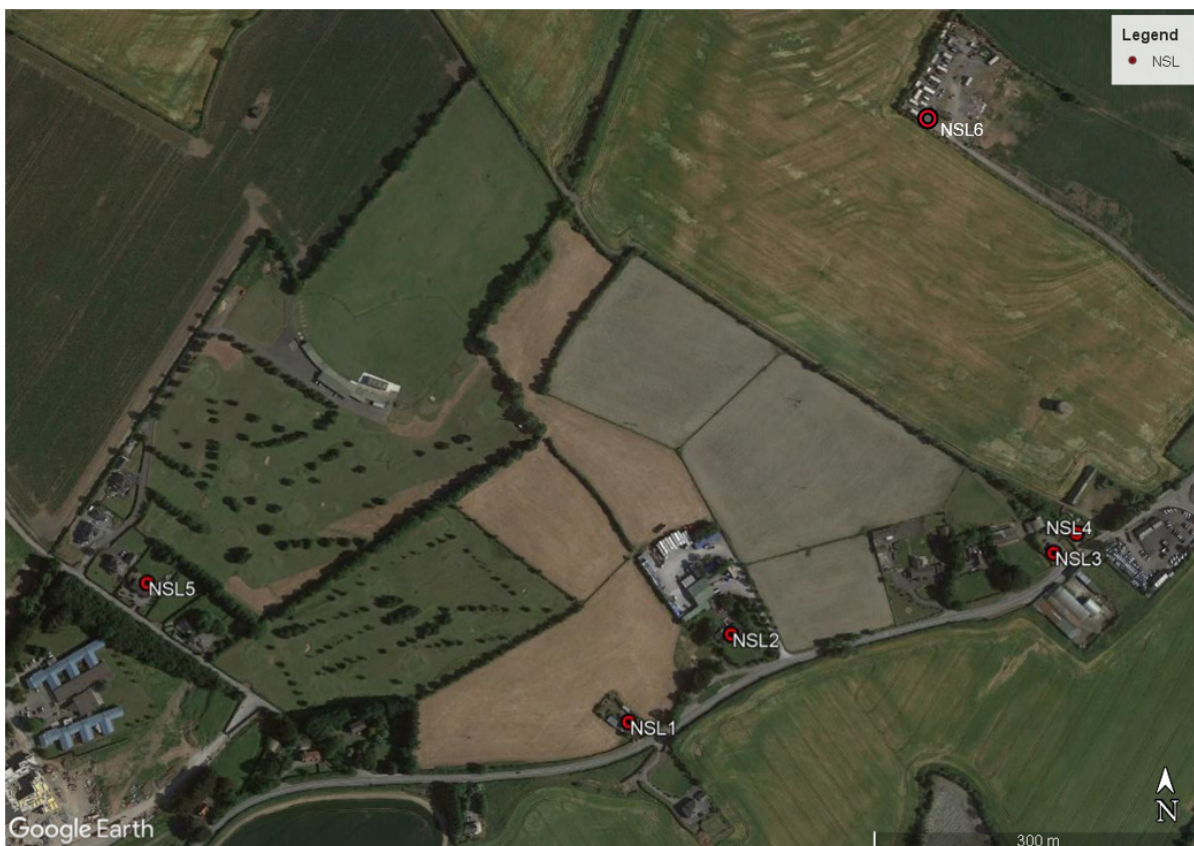
Figure A9.5.1 Sensitive Receptors

Nearby sensitive properties in the vicinity of the proposed development are summarised in Figure A9.4.1 below:

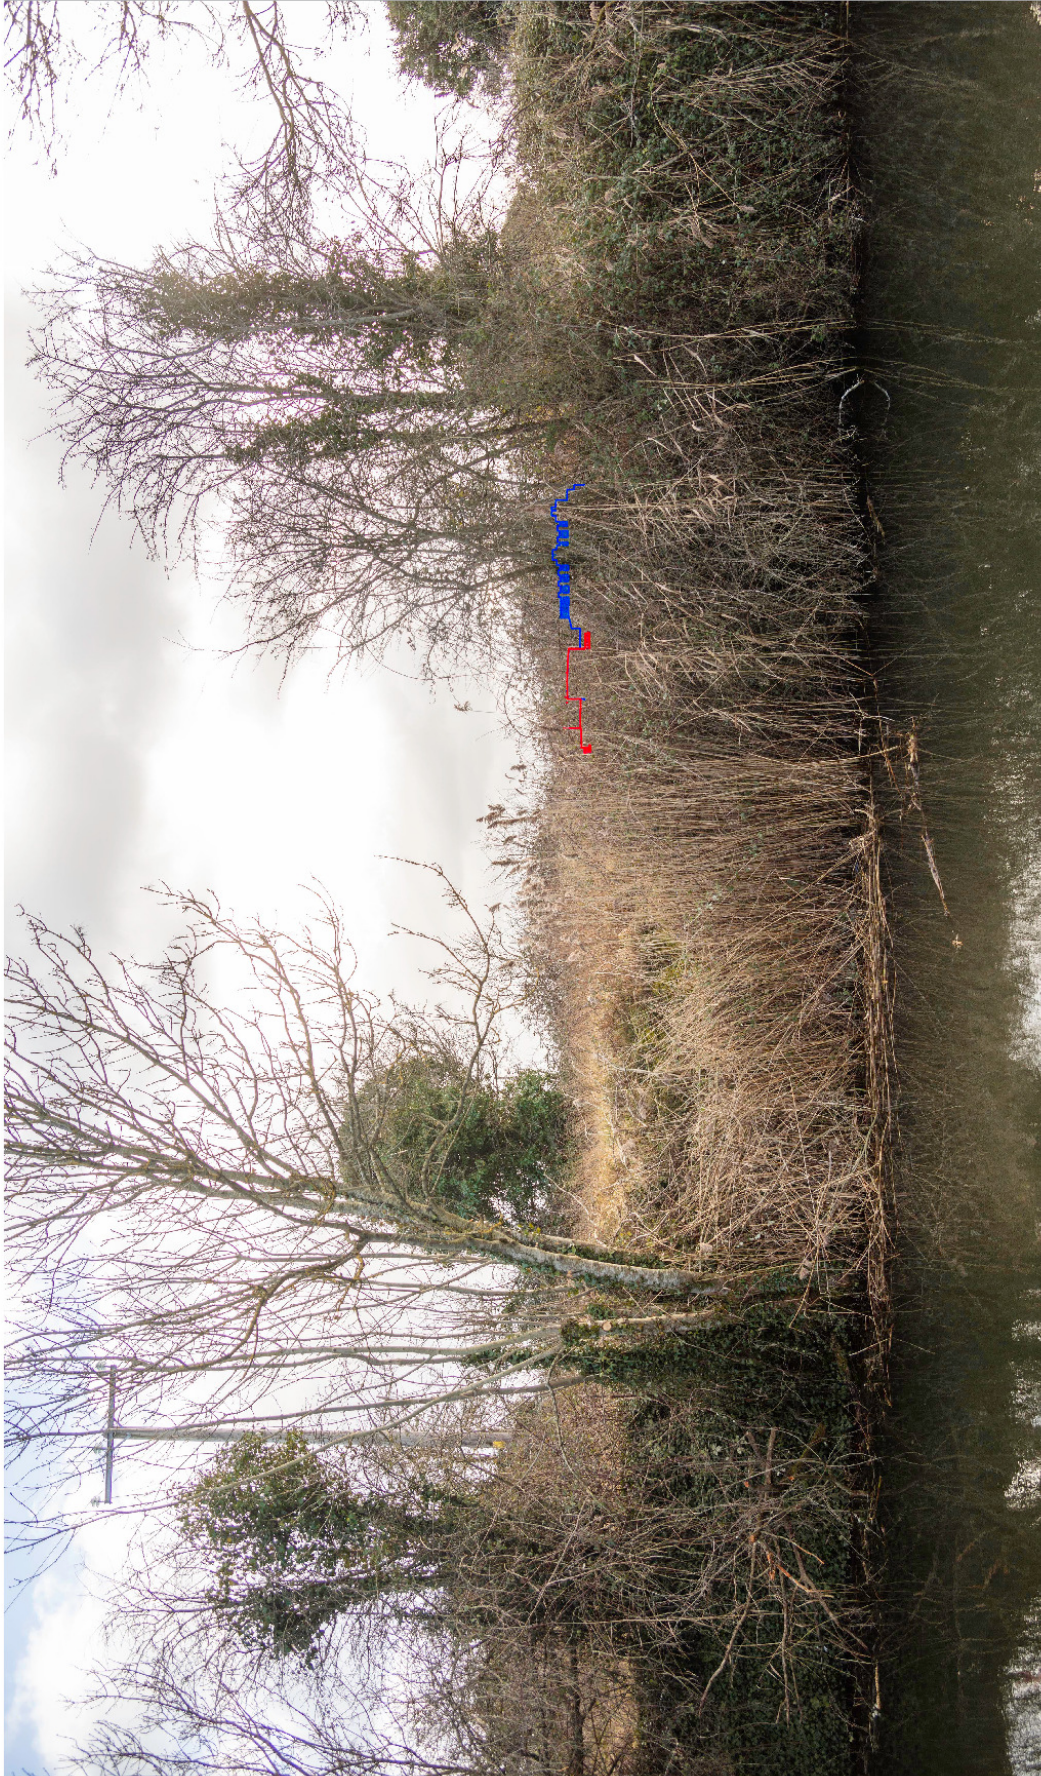
Location	Date	Field of view	35mm equivalent	Distance to site	Camera model
View 1 Proposed	04-02-2020	65°	28mm	931m	Canon EOS 5DS

showing: Proposed Development Power Generation Facility outlined in red. Permitted Development outlined in blue

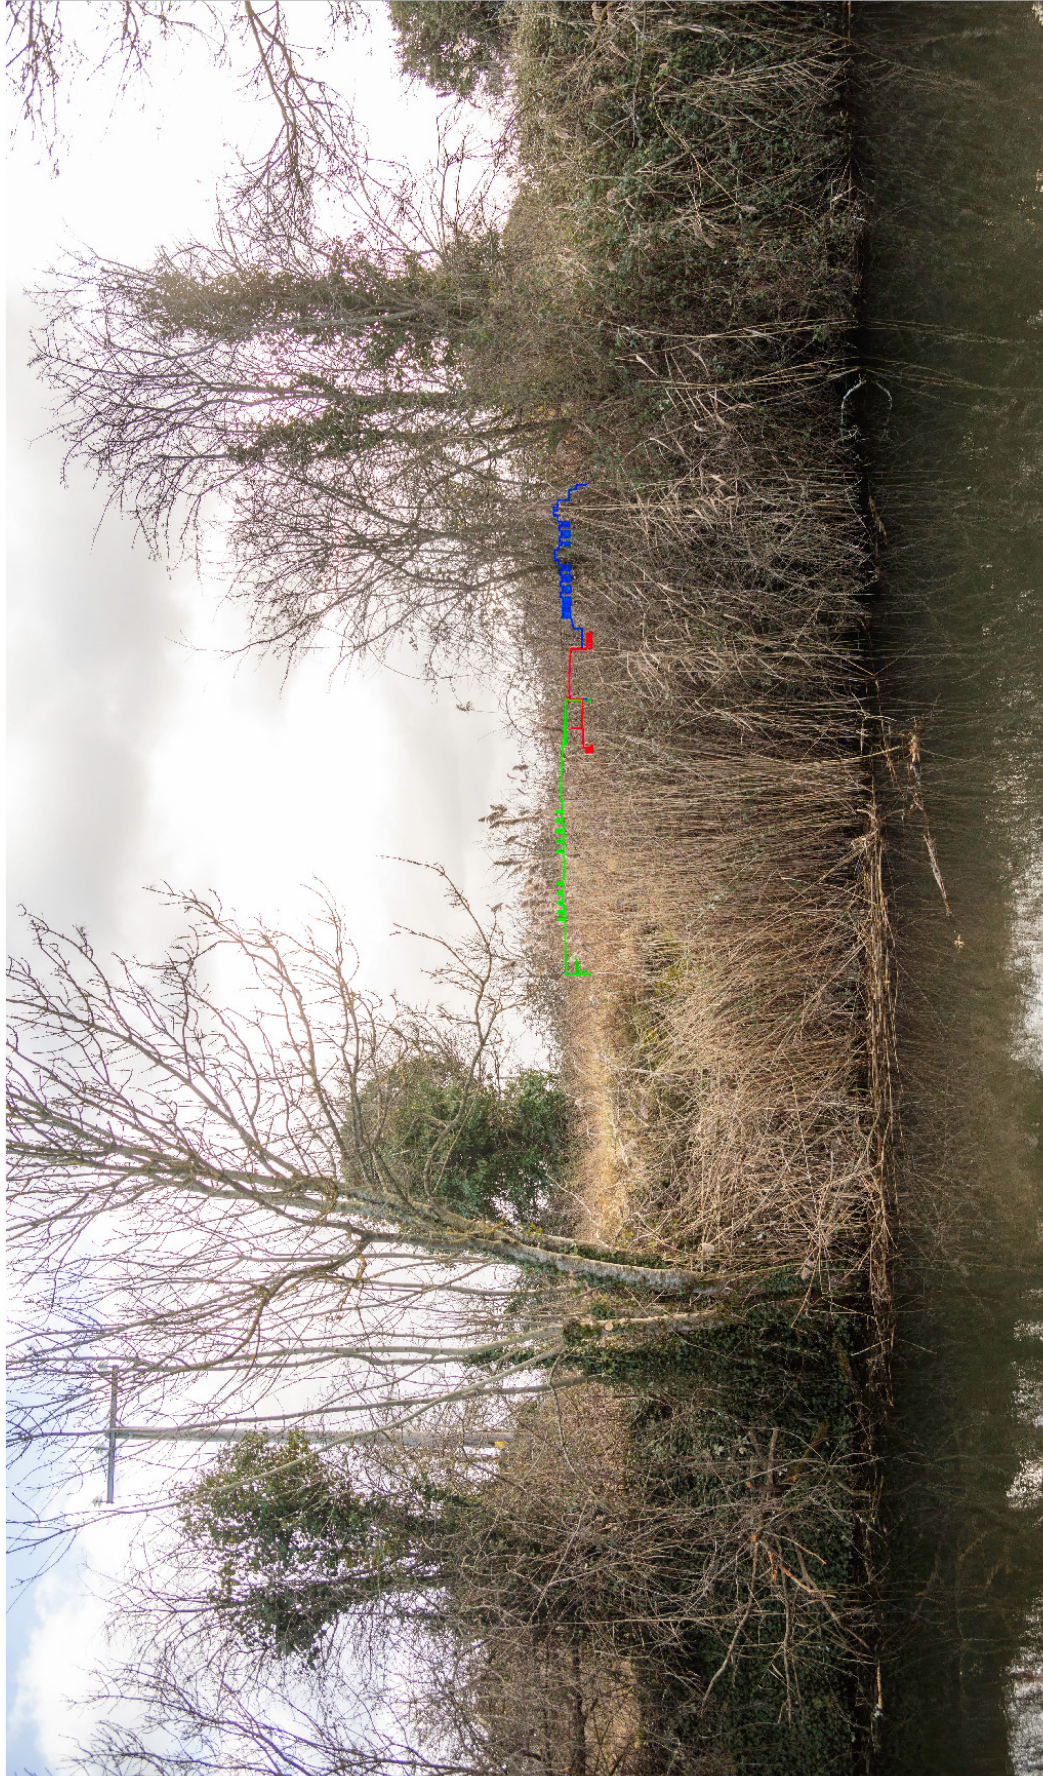
Location	Date	Field of view	35mm equivalent	Distance to site	Camera model
View 1 Proposed	04-02-2020	65°	28mm	931m	Canon EOS 5DS

showing: Proposed Development Power Generation Facility outlined in red. Permitted Development outlined in blue. Potential Future Development outlined in green

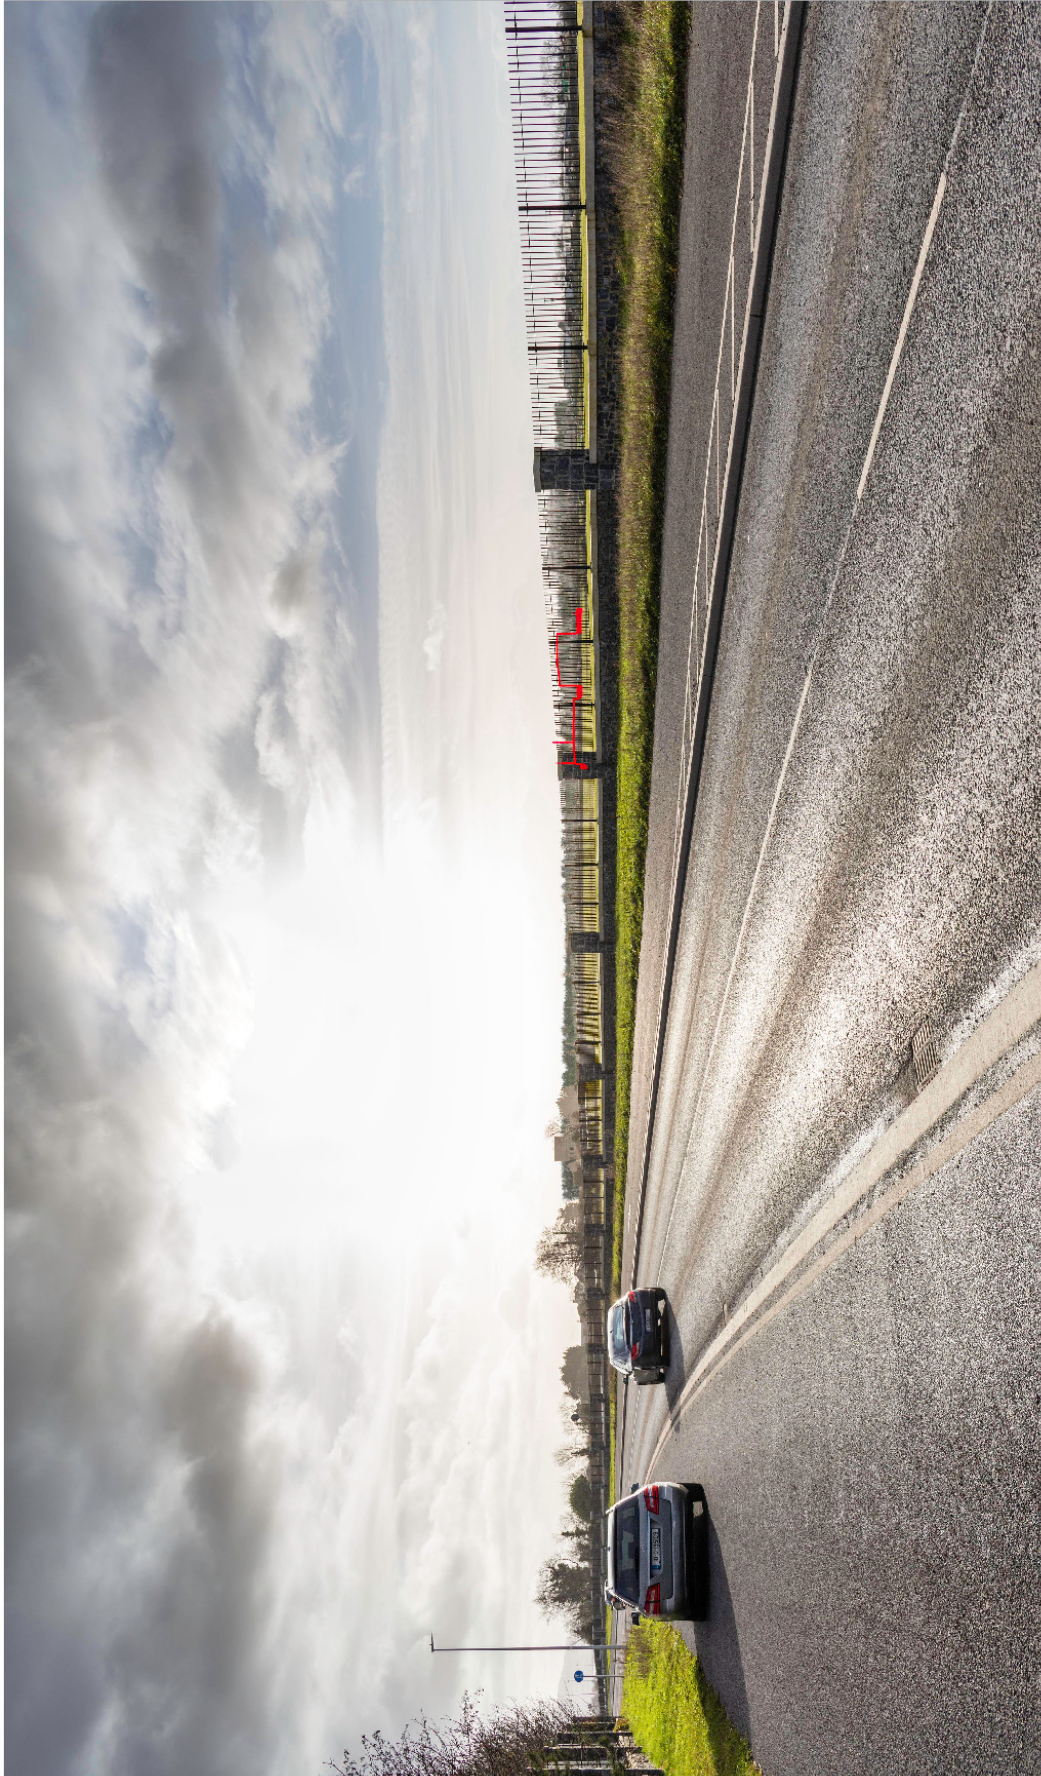
Location	Date	Field of view	35mm equivalent	Distance to site	Camera model
View 2 Proposed	04-02-2020	73°	24mm	612m	Canon EOS 5DS

showing: Proposed Development Power Generation Facility outlined in red and Permitted Development

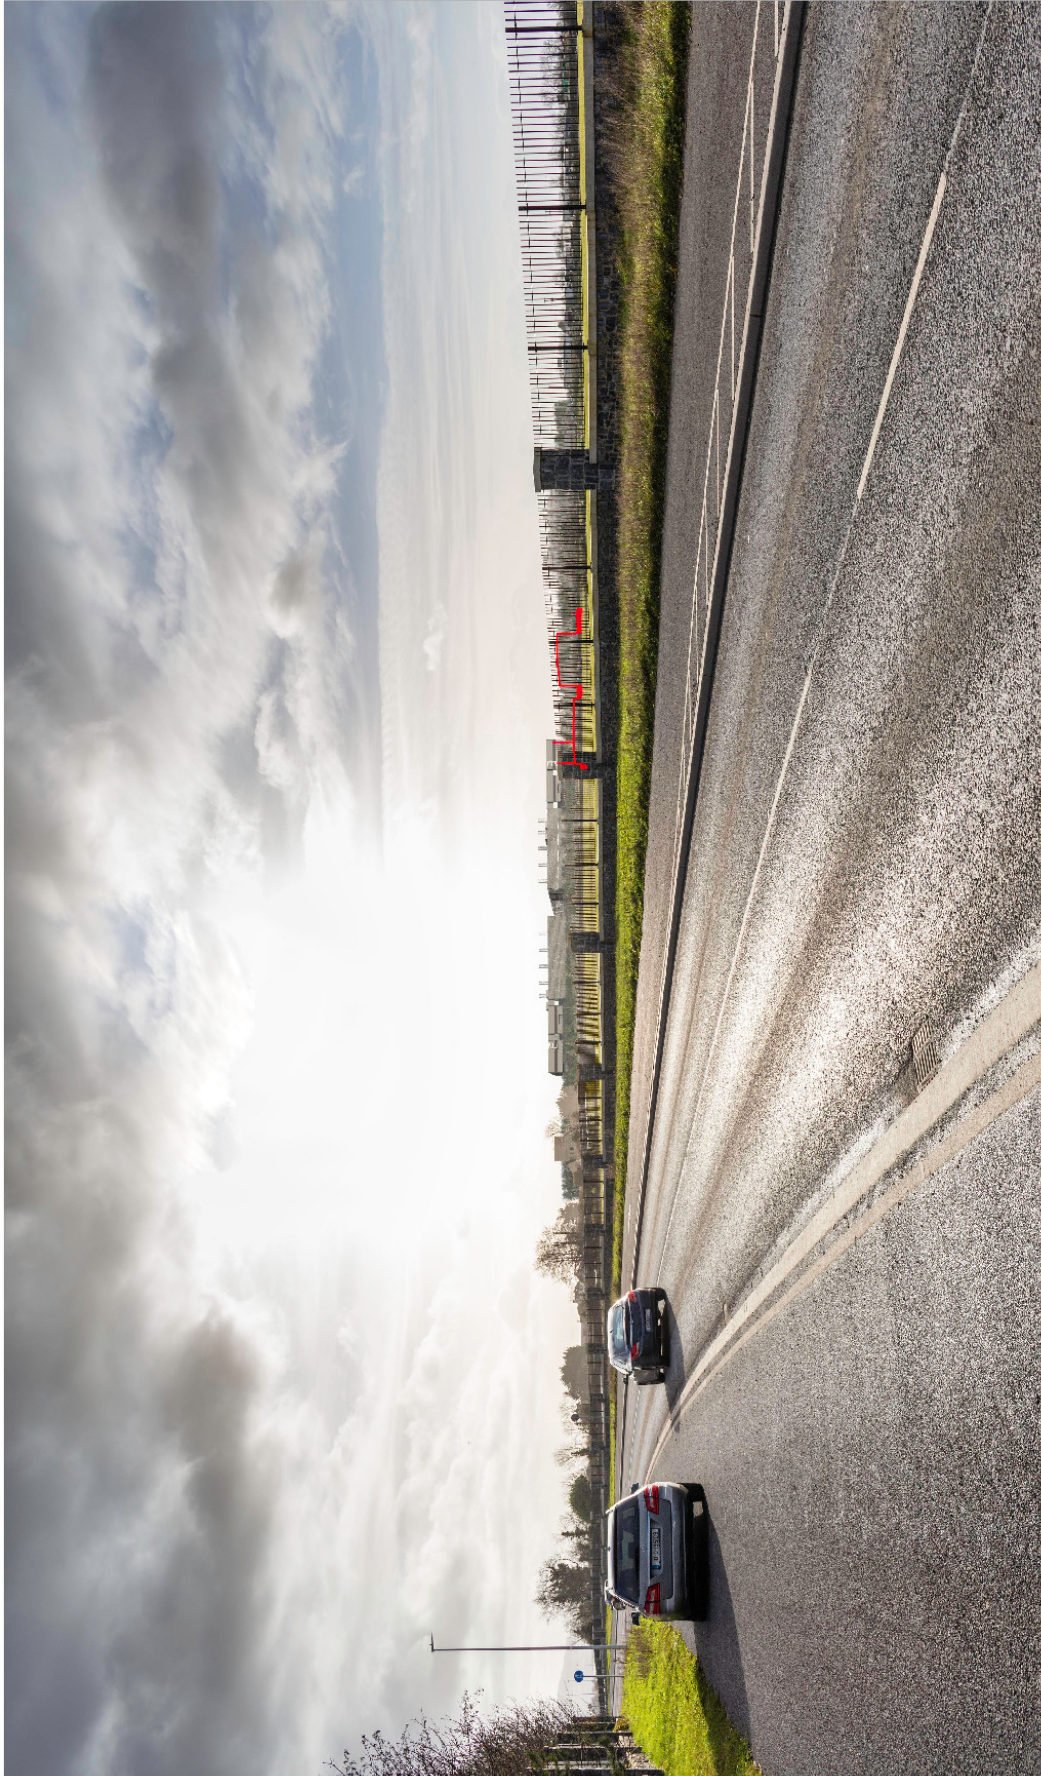
Location	Date	Field of view	35mm equivalent	Distance to site	Camera model
View 2 Proposed	04-02-2020	73°	24mm	612m	Canon EOS 5DS

showing: Proposed Development Power Generation Facility outlined in red, Permitted Development and Potential Future Development

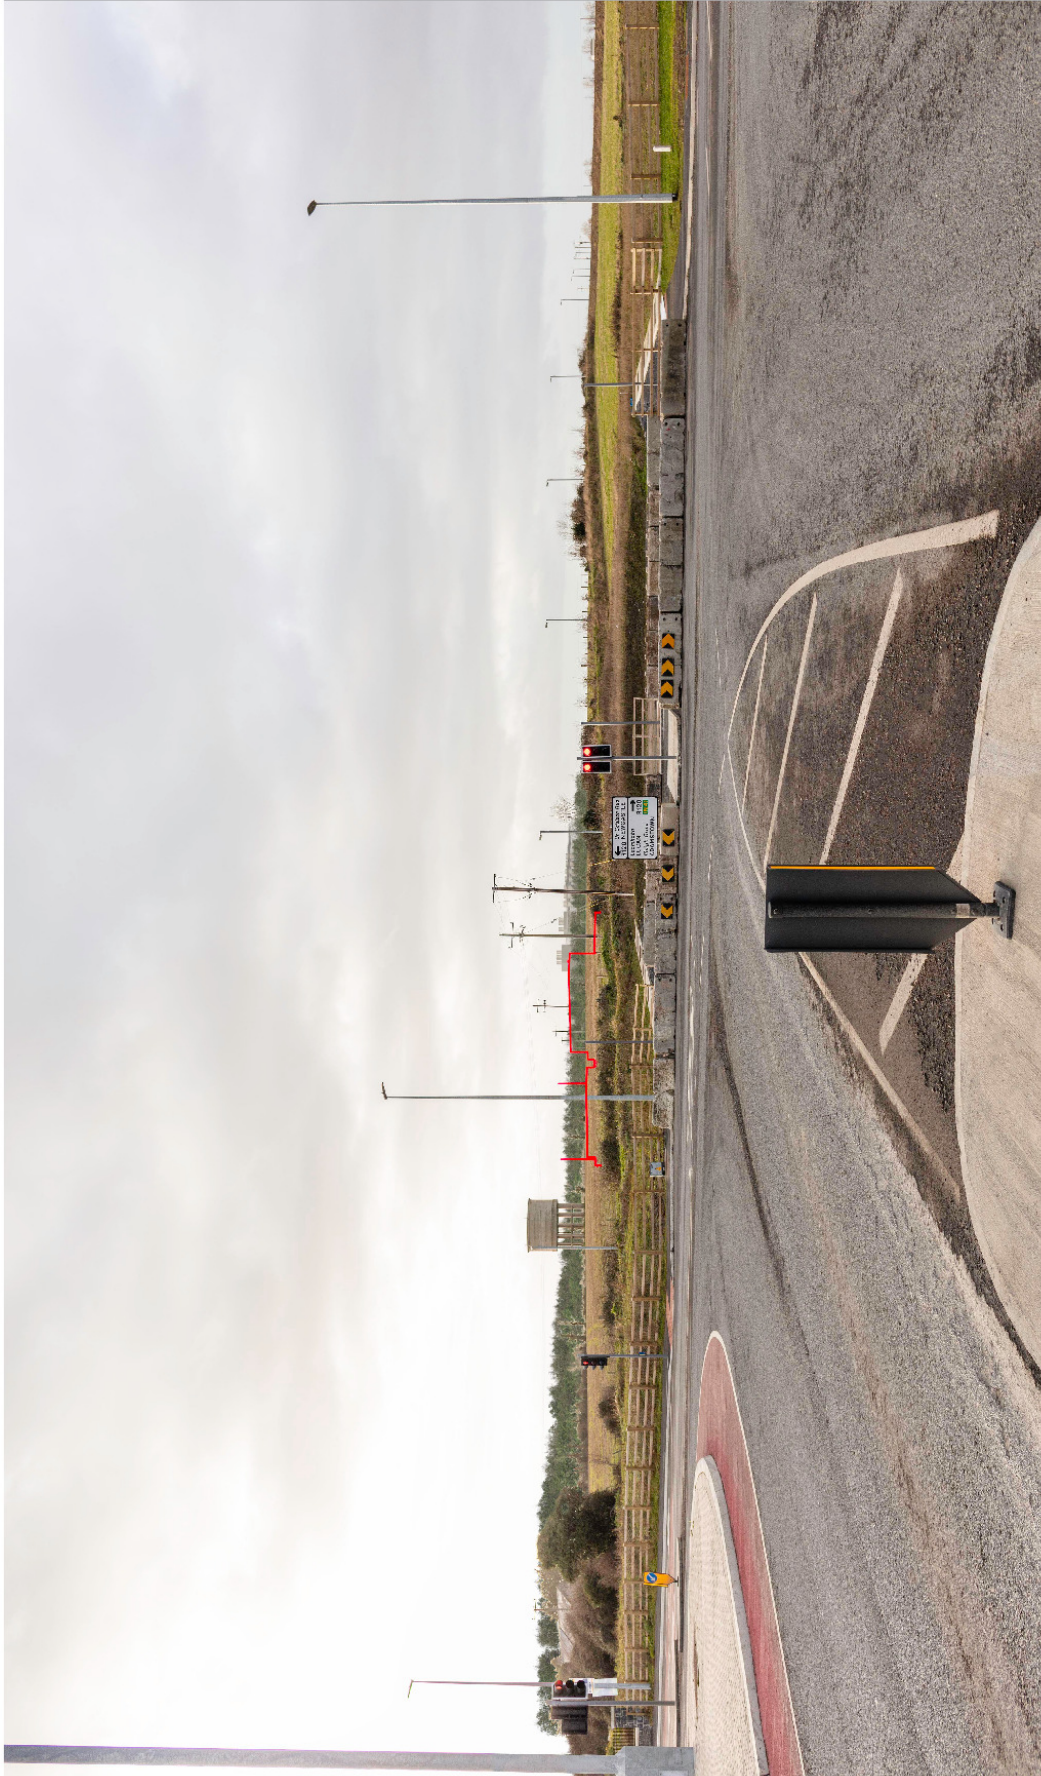
Location	Date	Field of view	35mm equivalent	Distance to site	Camera model
View 3 Proposed	04-02-2020	73°	24mm	312m	Canon EOS 5DS

showing: Proposed Development Power Generation Facility outlined in red and Permitted Development

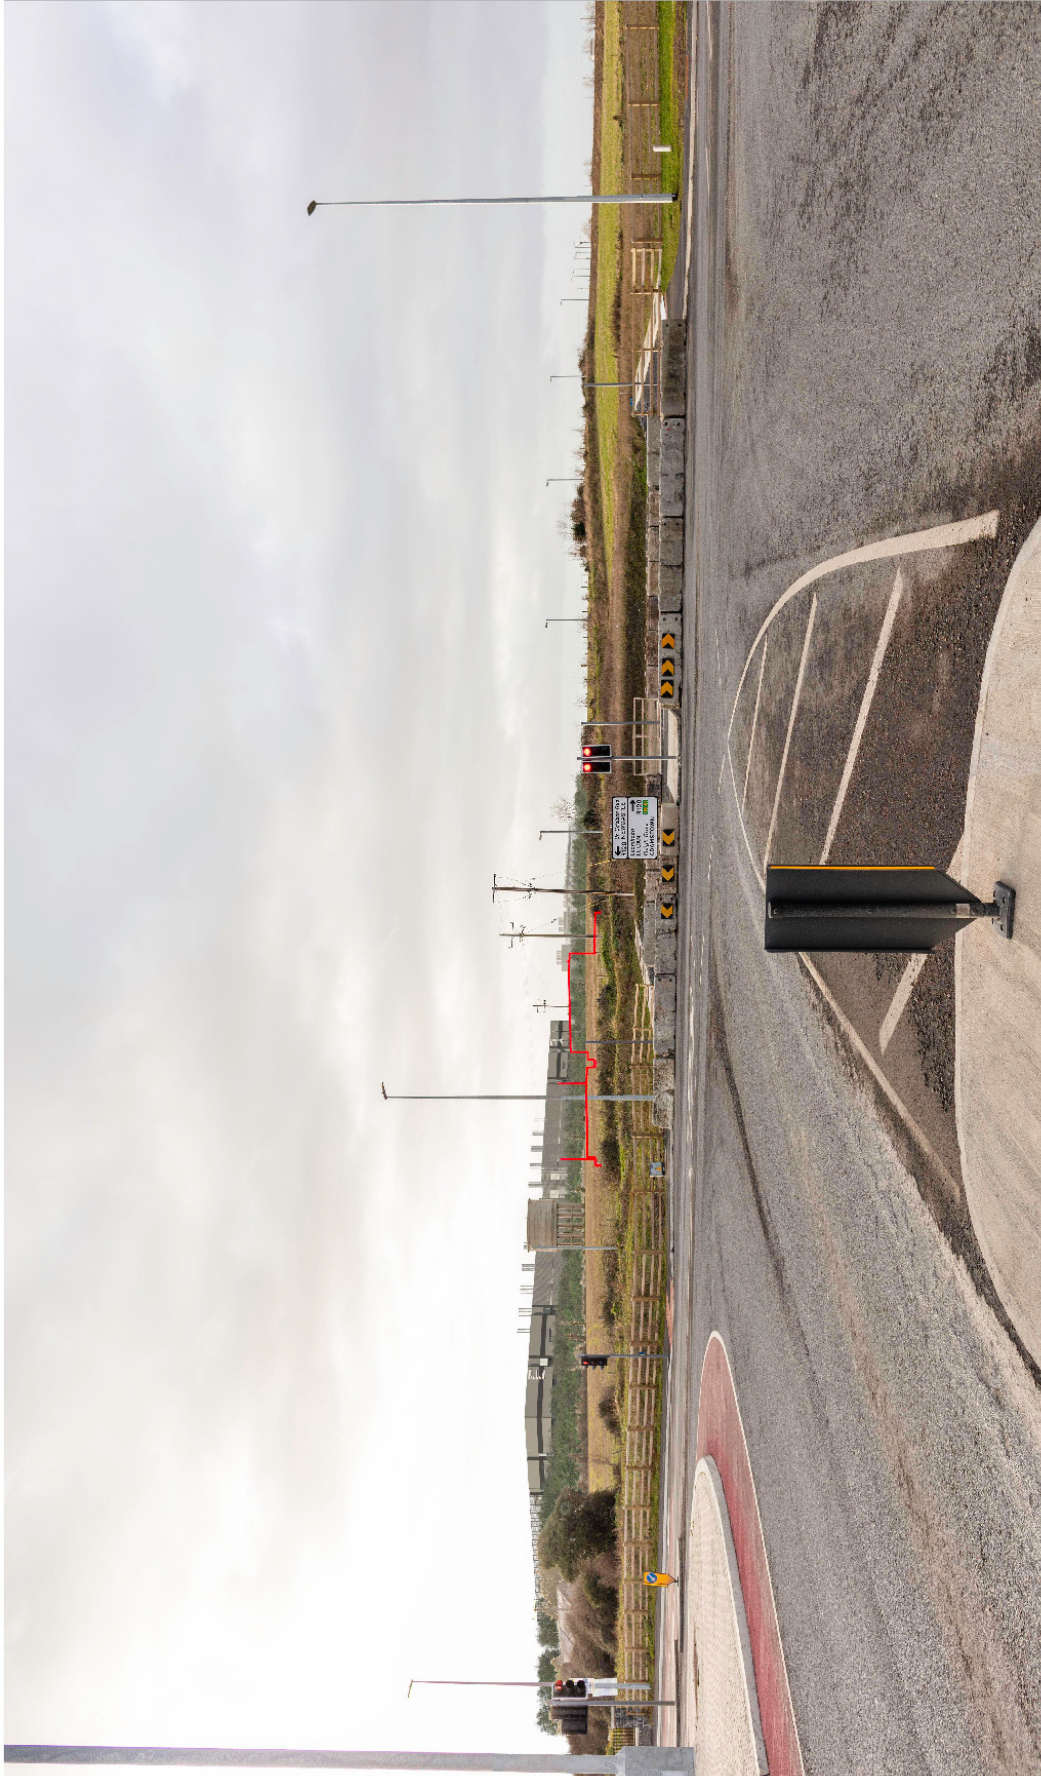
Location	Date	Field of view	35mm equivalent	Distance to site	Camera model
View 3 Proposed	04-02-2020	73°	24mm	312m	Canon EOS 5DS

showing: Proposed Development Power Generation Facility outlined in red, Permitted Development and Potential Future Development

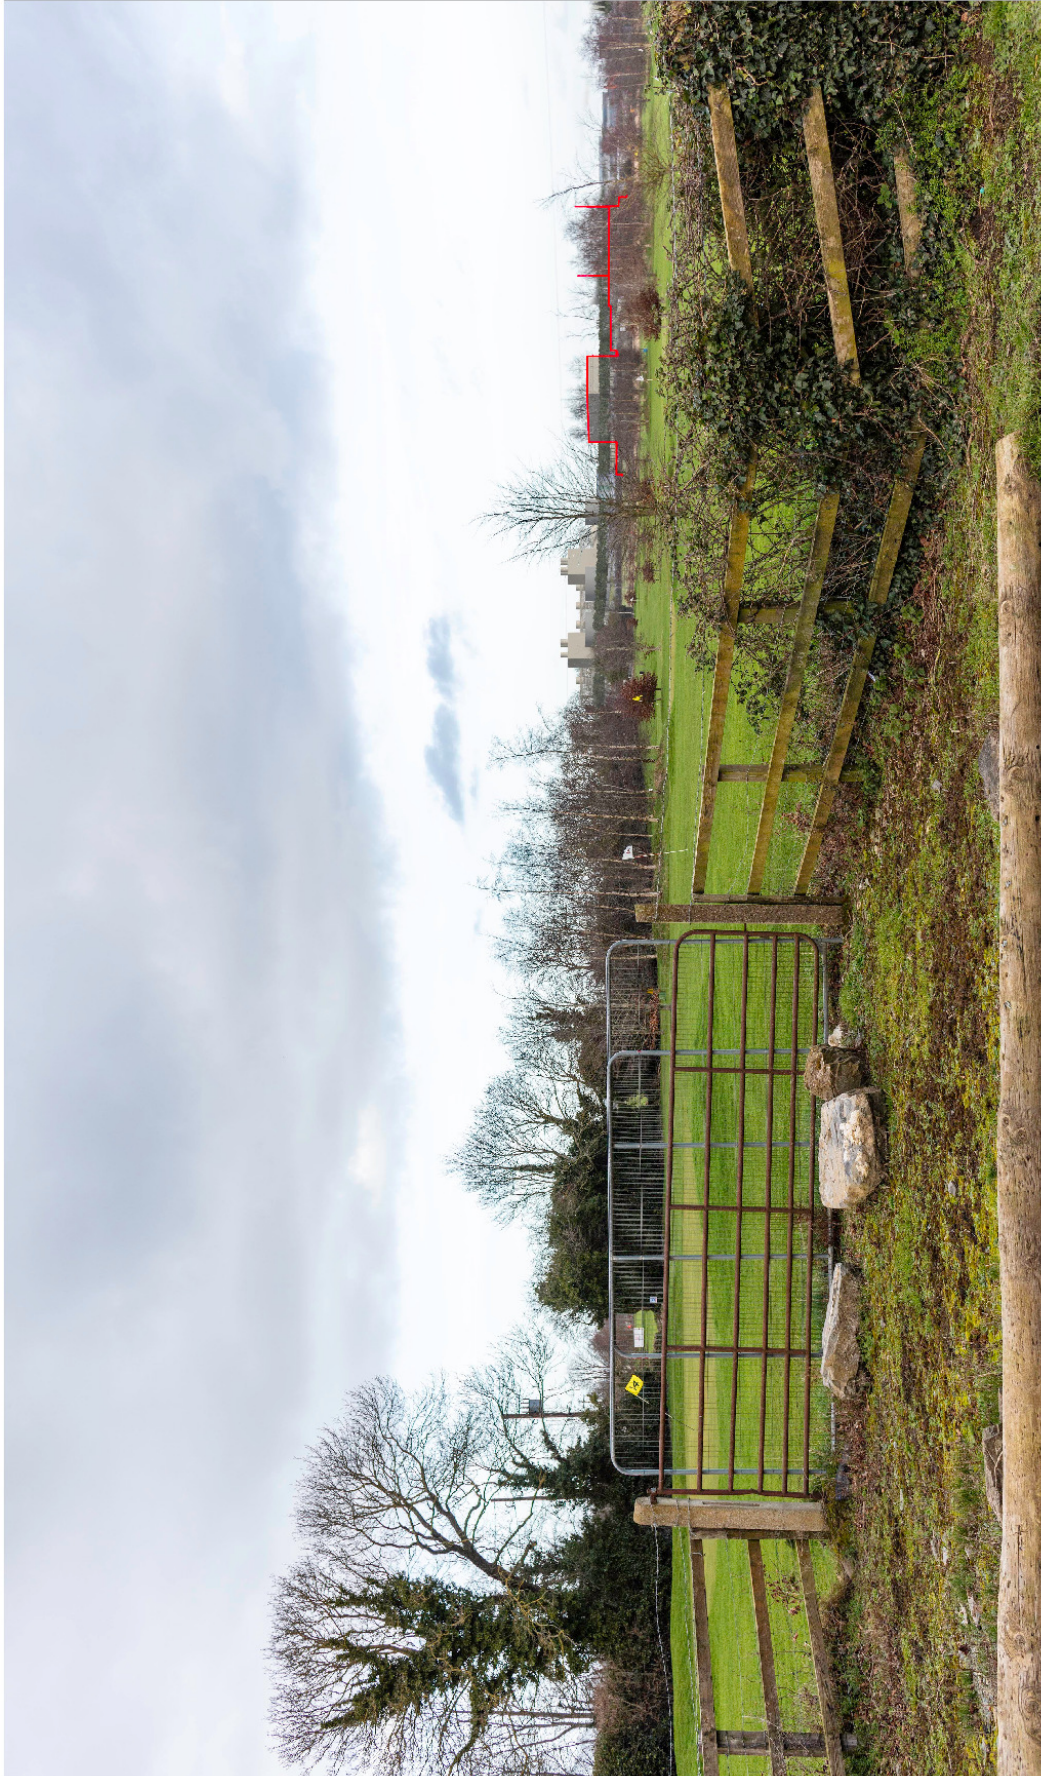
Location	Date	Field of view	35mm equivalent	Distance to site	Camera model
View 4 Proposed	04-02-2020	73°	24mm	394m	Canon EOS 5DS

showing: Proposed Development Power Generation Facility outlined in red and Permitted Development

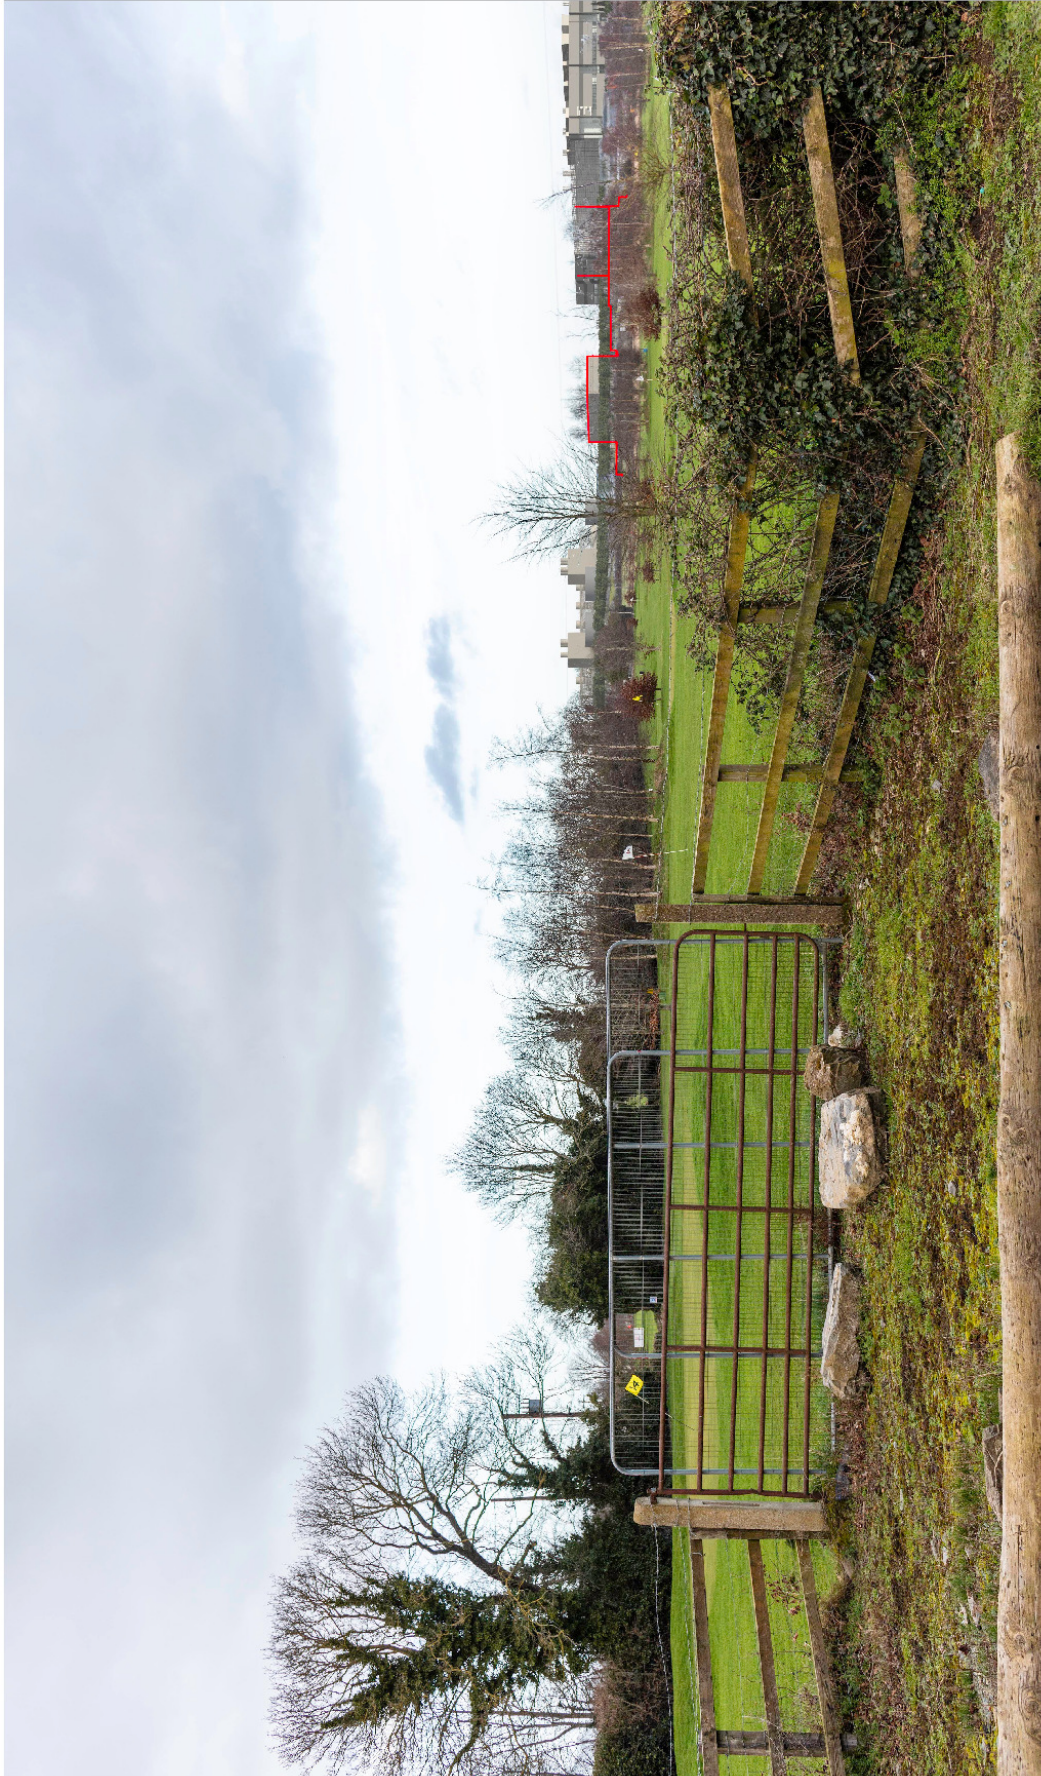
Location	Date	Field of view	35mm equivalent	Distance to site	Camera model
View 4 Proposed	04-02-2020	73°	24mm	394m	Canon EOS 5DS

showing: Proposed Development Power Generation Facility outlined in red, Permitted Development and Potential Future Development
