ENVIRONMENTAL IMPACT ASSESSMENT REPORT

APPENDICES

**Peamount Substation and transmission lines
Milltown**

Feasibility assessment for the undergrounding of a 110kV cables using Horizontal Directional Drilling beneath the Baldonnel Road & Griffeen River, Clutterland, Lucan, County Dublin

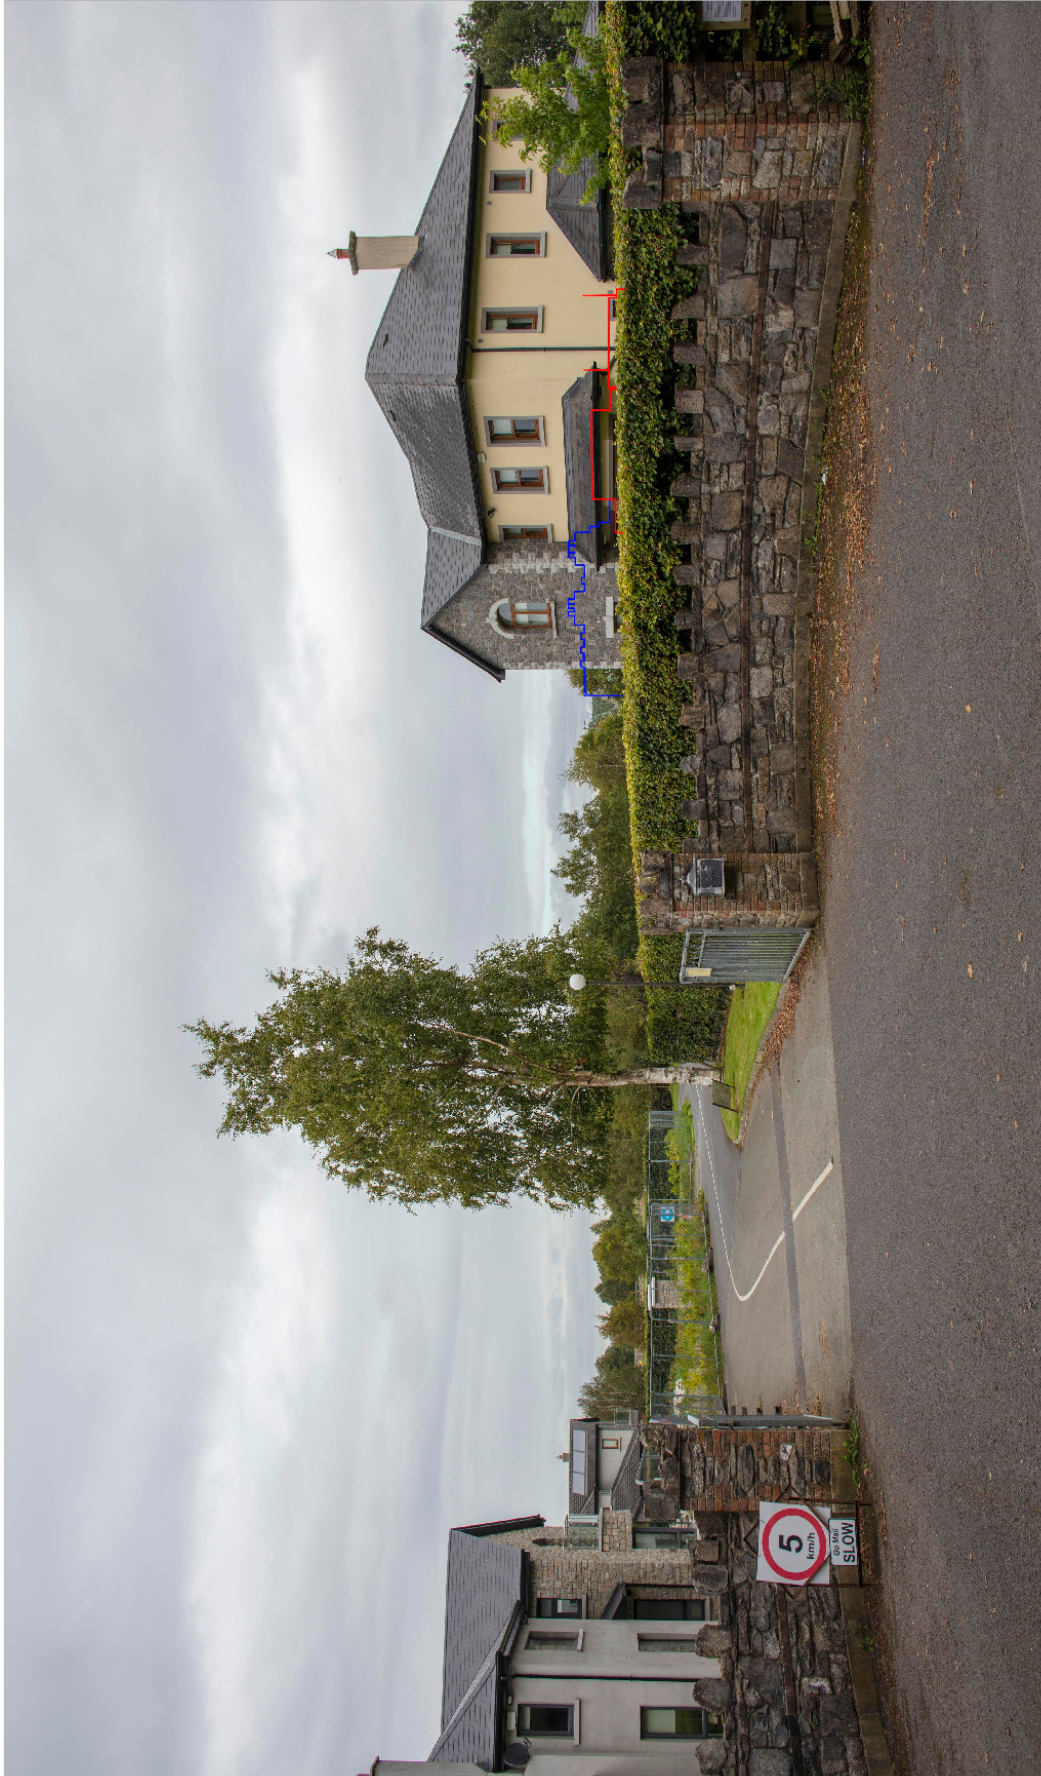
Location	Date	Field of view	35mm equivalent	Distance to site	Camera model
View 5 Proposed	24-08-2020	73°	24mm	471m	Canon EOS 5DS

showing: Proposed Development Power Generation Facility outlined in red. Permitted Development outlined in blue

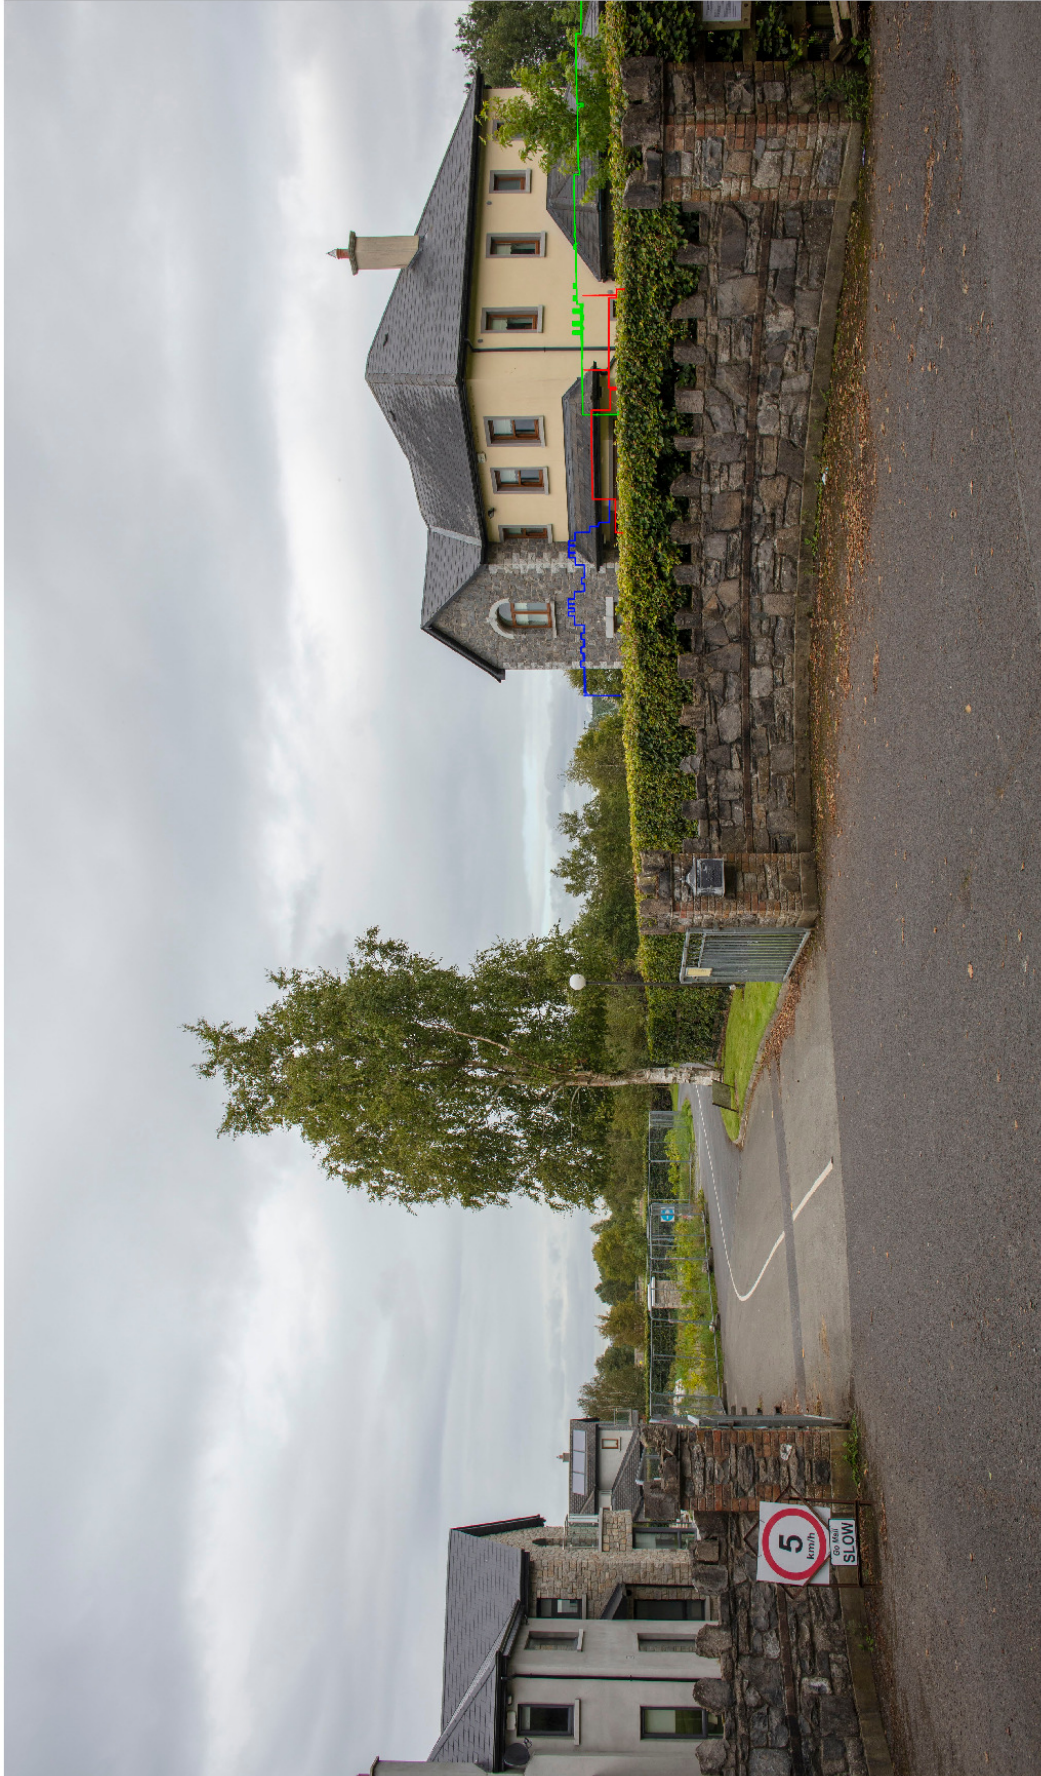
Location	Date	Field of view	35mm equivalent	Distance to site	Camera model
View 5 Proposed	24-08-2020	73°	24mm	471m	Canon EOS 5DS

showing: Proposed Development Power Generation Facility outlined in red. Permitted Development outlined in blue. Potential Future Development outlined in green

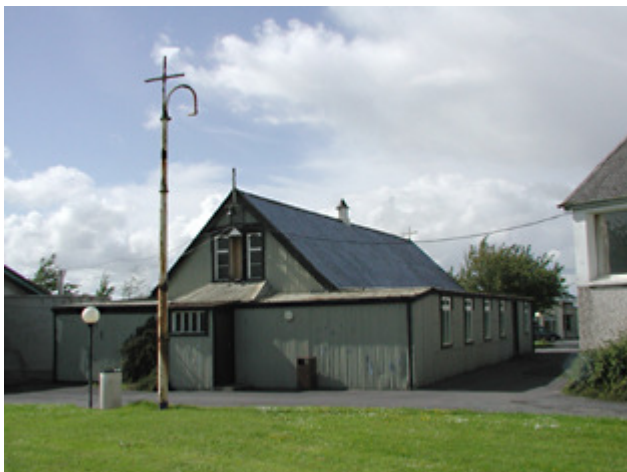
St Finian's R.C. Church, Peamount Hospital, Newcastle, South Dublin County

Reg. No.	11208017
Date	1910 - 1920
Previous Name	N/A
Townland	PEAMOUNT
County	South Dublin County
Coordinates	301221, 230786
Categories of Special Interest	ARCHITECTURAL SOCIAL TECHNICAL
Rating	Regional
Original Use	church/chapel
In Use As	church/chapel

A distinctive, unusual church, displaying an increasingly rare vernacular use of corrugated iron as a building material. Still in regular use, the church adds charm and character to the hospital grounds.

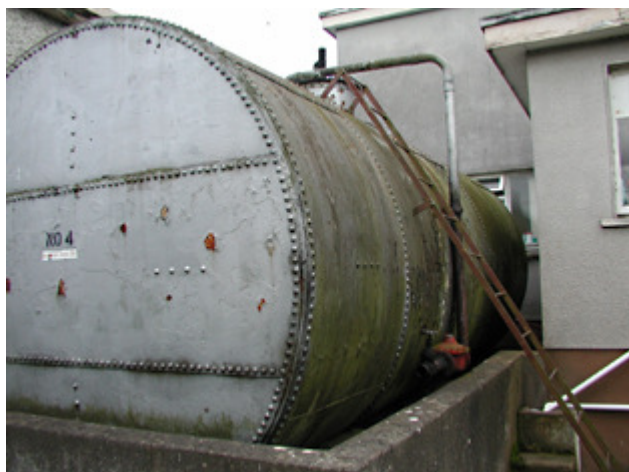
Peamount Hospital, Newcastle, South Dublin County

Reg. No.	11208019
Date	1910 - 1940
Previous Name	N/A
Townland	LOUGHTOWN UPPER
County	South Dublin County
Coordinates	301469, 230833
Categories of Special Interest	TECHNICAL
Rating	Regional
Original Use	tank/silo
In Use As	tank/silo

A vigorously articulated oil tank, still in use within the hospital grounds. An unusual intact early twentieth-century feature.

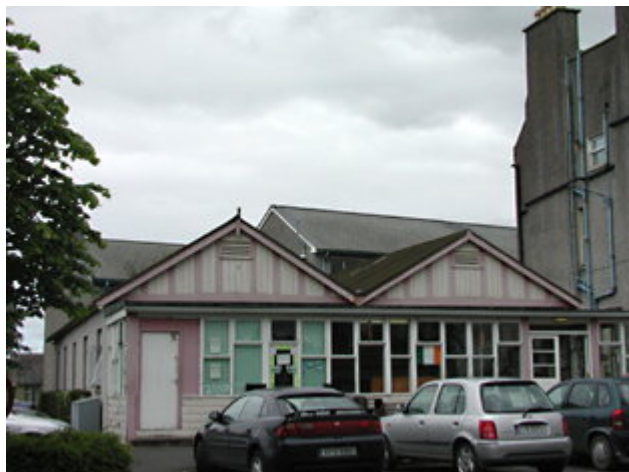
Peamount Hospital, Newcastle, South Dublin County

Reg. No.	11208020
Date	1910 - 1915
Previous Name	N/A
Townland	LOUGHTOWN UPPER
County	South Dublin County
Coordinates	301326, 230801
Categories of Special Interest	ARCHITECTURAL SOCIAL TECHNICAL
Rating	Regional
Original Use	hospital/infirmery
In Use As	restaurant
Additional Use	shop/retail outlet

This dining hall and shop preserve the form and many materials of the original temporary timber pavilions. Built as a disease control measure by the TB sanatorium, they are a valuable reminder of this phase of the history of the estate.

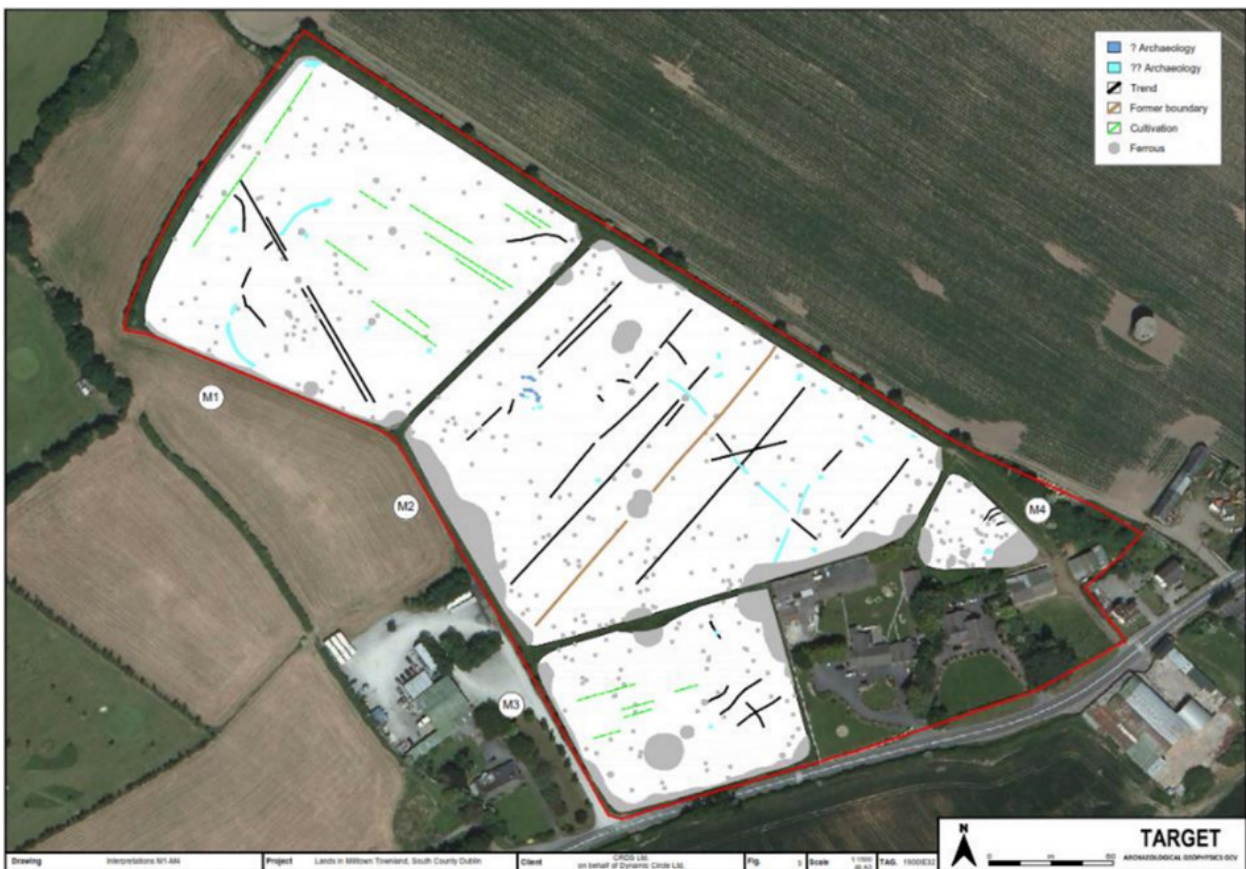
Figure 8. Summary of results of geophysical survey (source Target Ltd; License no 19R0190)

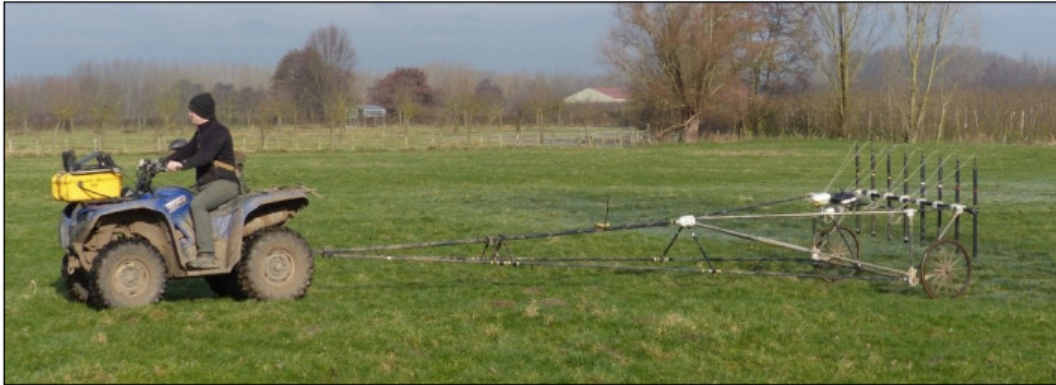
1. Advanced multi-channel magnetometer survey mapping the buried foundation of a 14th century castle (towed configuration with ATV).

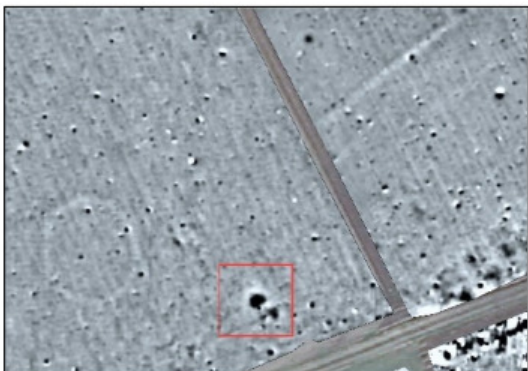
2. Results from magnetometer survey presented in greyscale format highlighting pit remains bordering an enclosure site and Roman villa.

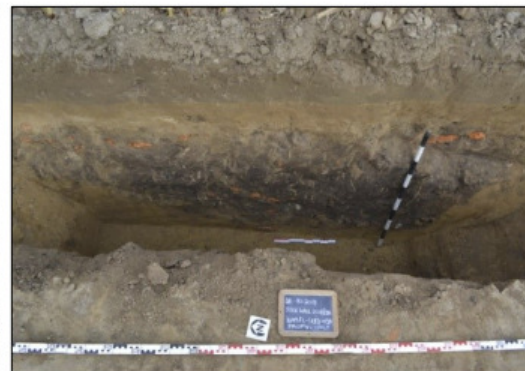
3. Burnt & fired debris revealed following excavation of pit remains bordering an enclosure site and Roman villa.

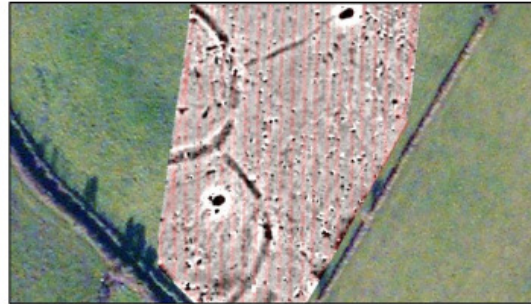
5. GPS tracks (red) highlighting lines of data collection & results from magnetometer fieldwork at a suspected burial ground.

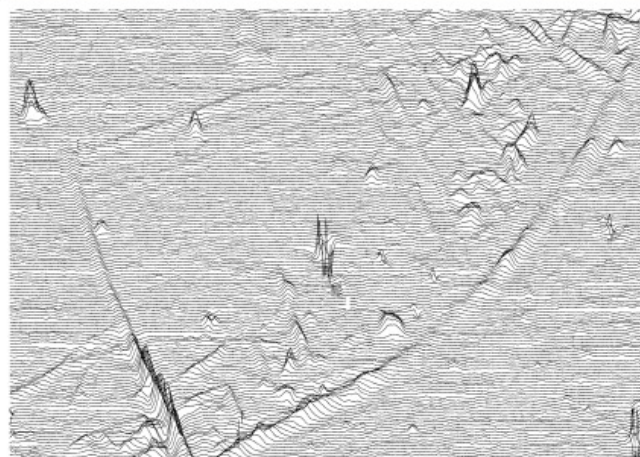
7. XY trace from survey at the site of a deserted medieval village.

XY trace plots provide a near-perspective representation of measurements along individual lines of data recorded from each of the magnetometer sensors. The XY trace format is used as a conventional method for identifying responses which derive from modern ferrous debris. The XY trace display is particularly when identifying magnetically strong anomalies indicative of buried hearths, kilns and furnaces.
