Title: **QUALITY AUDIT (Stage 1)**

**Proposed Strategic Housing Development At Carmanhall
Road, Sandyford Industrial Estate, Dublin 18.**

Report reference: **0951R01**

VERSION: **Interim (Site visit yet to be completed)**

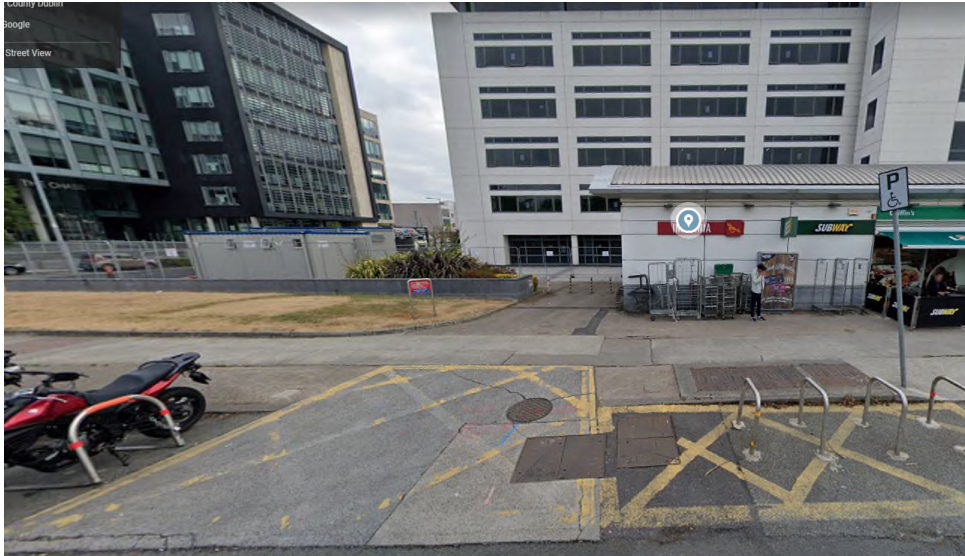
Drawing PR461030-ACM-XX-00-DR-CE-10-001 Rev C.

It is proposed to relocate the signalised pedestrian crossing on Carmanhall Road to the eastern side of the new vehicular access. The proposed location coincides with an emergency access route to the building on the opposite side of Carmanhall Road. The signal heads and location of other street furniture could block the route of emergency vehicles.

It is recommended that the crossing be located where it does not interfere with access for emergency vehicles.

3.1	Y	Y	The design team are currently engaging with Dun Laoghaire Rathdown Traffic and Parks Department to integrate the scheme proposals in with the proposed works to both Carmanhall Road and Blackthorn Road. During the detailed design stage, the issue raised will be taken into account and the necessary stakeholders consulted when preparing the final design.	Yes

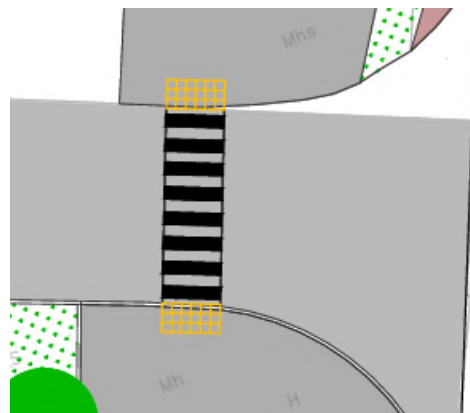
Drawing PR461030-ACM-XX-00-DR-CE-10-001 Rev C.

The uncontrolled pedestrian crossing shown on Carmanhall Road close to the Blackthorn Road junction is shown to have black and white stripes. This may lead to confusion between drivers and pedestrians. Pedestrians may think that they have priority as the striped markings resemble a controlled zebra crossing however there are no belisha beacons and drivers may assume that pedestrians will wait on the footpath until they pass. The confusion could lead to collisions.

It is recommended that the stripes be removed. Similarly the stripes on the access road to the car park should be removed.

3.2	Y	Y	The uncontrolled crossing adjacent to the Carmanhall Road / Blackthorn Road junction has had the line markings removed.	Yes
3.3	Y	Y	The design team are currently engaging with Dun Laoghaire Rathdown Traffic and Parks Department to integrate the scheme proposals in with the proposed works to both Carmanhall Road and Blackthorn Road. During the detailed design, the issue raised will be taken into account when preparing the final design.	Yes

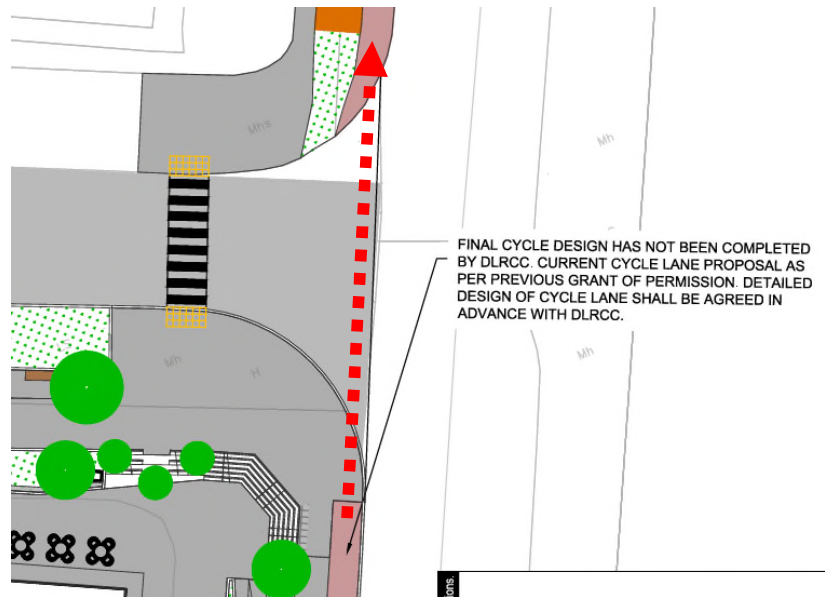
Drawing PR461030-ACM-XX-00-DR-CE-10-001 Rev C.

It is understood that the cycle design has not been completed at Blackthorn Road. There is a risk however of a discontinuity at the junction with Carmanhall Road if a cycle lane is not provided across the junction mouth. If a discontinuity occurs in the cycle lane then cyclists may opt not to use it and may stay on the carriageway where they would be at greater risk of being struck by a passing vehicle.

It is recommended that the finalised design of the cycle track does not include cyclists having to yield to traffic at the junction.

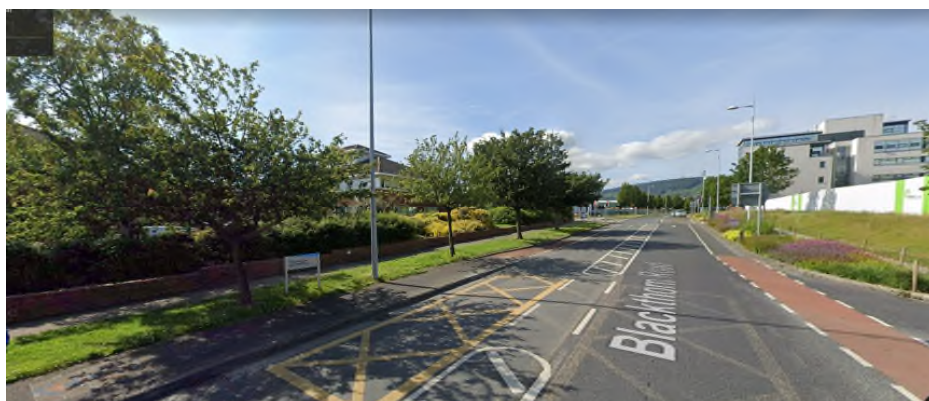
Drawing PR461030-ACM-XX-00-DR-CE-10-001 Rev C.

There is no facility for cyclists to turn right from the existing cycle track on Blackthorn Avenue into Carmanhall Road. Without an area for cyclists to wait and then get onto the carriageway to facilitate turning could result in cyclists preferring to stay on the carriageway rather than use the cycle facilities.

It is recommended that waiting facilities (jug turn or similar) and turning facilities (dropped kerbs) are provided for right turning cyclists.

3.4	Y	Y	The design team are currently engaging with Dun Laoghaire Rathdown Traffic and Parks Department to integrate the scheme proposals in with the proposed works to both Carmanhall Road and	Yes

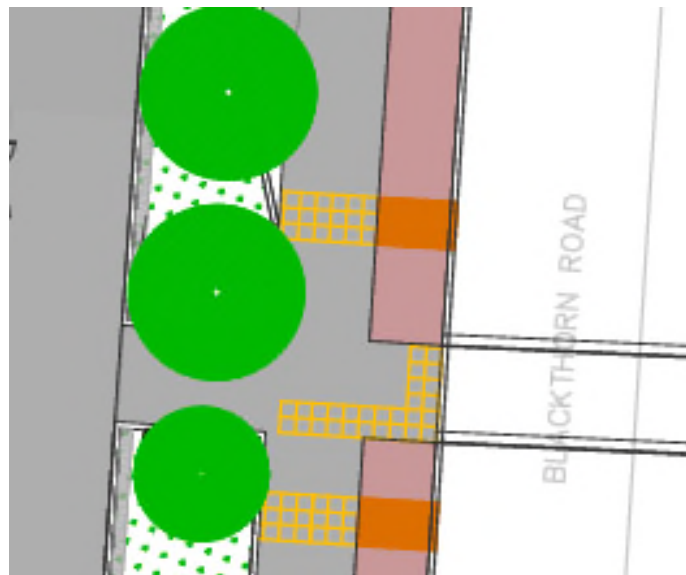
Drawing PR461030-ACM-XX-00-DR-CE-10-001 Rev C.

There is an existing signalised pedestrian crossing of Blackthorn Road on the northern side of the Burton Hall Road junction. Given the proposed cycle lane on Blackthorn Road and the anticipated increase in cycling generated by the proposed development there is a risk that the pedestrian crossing will be used by cyclists which may lead to collisions with pedestrians.

It is recommended that the pedestrian crossing be upgraded to a toucan crossing.

3.5	Y	Y	The design team are currently engaging with Dun Laoghaire Rathdown Traffic and Parks Department to integrate the scheme proposals in with the proposed works to both Carmanhall Road and Blackthorn Road. During the detailed design, the issue raised will be taken into account when preparing the final design.	Yes

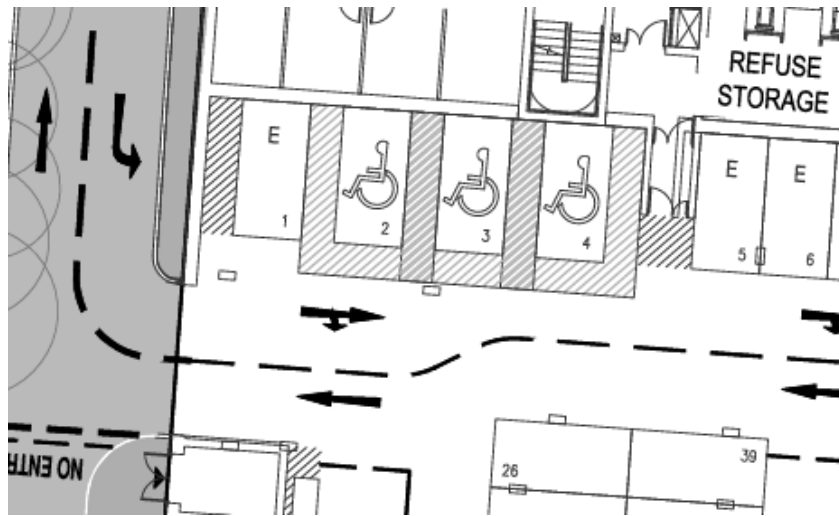
Drawing PR461030-ACM-XX-00-DR-CE-10-001 Rev C.

The buffer zone around disabled parking spaces 3, 4, 36, 49, 95 & 96 extend into the carriageway. If vehicles are travelling over this area then there will be no room for disabled users to occupy this space for accessing their vehicle.

It is recommended that the buffer zones do not overlap with the driving aisle as per the guidance provided in Part M of the Building Regulations.

3.6	Y	Y	The car park layout has been revised from 2 way to 1 way which ensures that adequate space is provided to ensure that vehicles will avoid the buffer areas	Yes

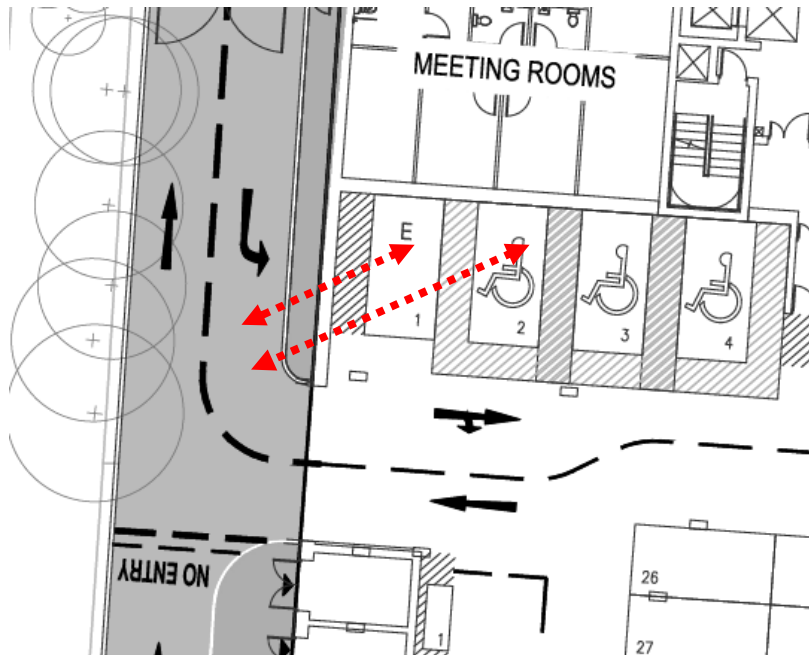
Drawing PR461030-ACM-XX-00-DR-CE-10-001 Rev C

It is unclear if drivers exiting EV space no. 1 and disabled space no. 2 will have suitable visibility to vehicles entering the car park. Without suitable visibility there is a risk of rear-end collisions.

Ensure that there is sufficient visibility for drivers exiting these spaces.

3.7	Y	Y	An ope is to be provided along the wall to the west of car parking space no. 1 to ensure that drivers can observe vehicles reversing from these spaces.	Yes

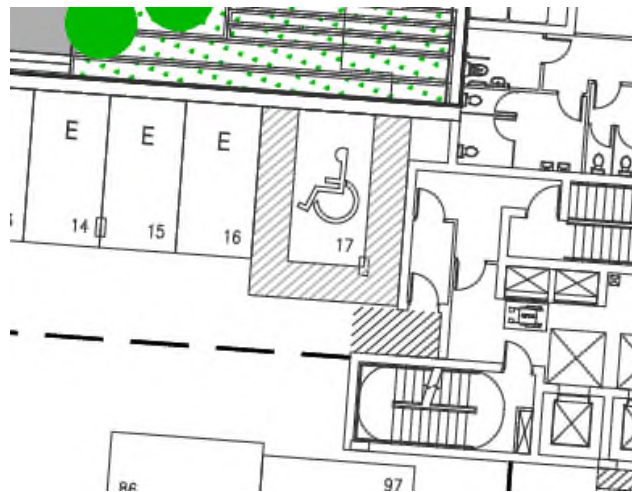
Drawing PR461030-ACM-XX-00-DR-CE-10-001 Rev C.

It is unclear if a driver using disabled parking space no. 17 would be able to exit from this space without colliding with the stair core.

It is recommended that disabled space no. 17 be relocated. The potential of limited neck movement of drivers should be taken into account when locating disabled parking bays.

3.8	Y	Y	An autotracking assessment has been undertaken of these spaces and the scheme drawings have been updated accordingly	Yes
3.9	Y	Y	Cycle lane has been continued at this location	Yes

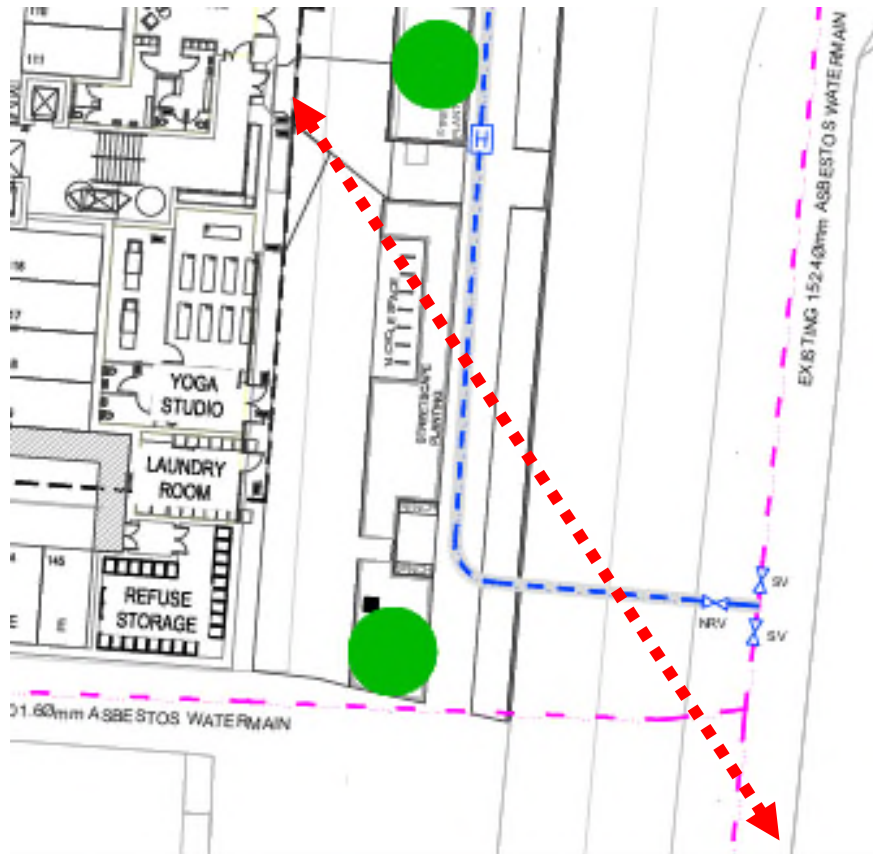
Drawing PR461030-ACM-XX-00-DR-CE-10-001 Rev C.

There will be a pedestrian desire line from the access to the development beside the Gym to the bus stop on the opposite side of Blackthorn Road. There is no signalised crossing of Blackthorn Road along this desire line.

It is recommended that a signalised pedestrian/toucan crossing be incorporated into the traffic signals at the southern side of Blackthorn Road/Burton Hall Road junction.

3.10	Y	Y	The design team are currently engaging with Dun Laoghaire Rathdown Traffic and Parks Department to integrate the scheme proposals in with the proposed works	Yes

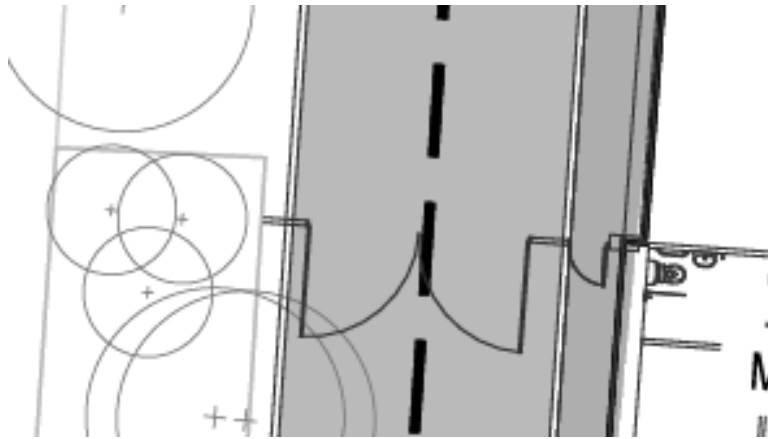
Drawing PR461030-ACM-XX-00-DR-CE-10-001 Rev C.

There is a risk that the posts for the gates at the entry to the car park could be scraped by passing vehicles as two vehicle try and ‘squeeze’ past at the local narrowing of the effective carriageway width.

It is recommended that the gate posts be kept outside the carriageway.

3.11	Y	Y	Gate posts have been set back at this location as specified.	Yes
3.12	Y	Y	The design team are currently engaging with Dun Laoghaire Rathdown Traffic and Parks Department to integrate the scheme proposals in with the proposed works to both Carmanhall Road and Blackthorn Road. The crossing has been moved to take account of the gullies at this location with the gully on the north side of Carmanhall Road to be relocated upstream of the crossing as requested.	Yes

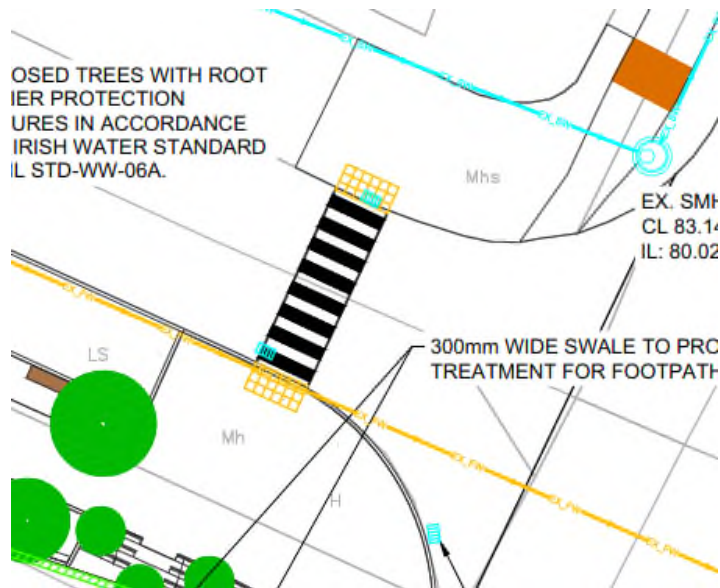
Drawing PR461030-ACM-XX-00-DR-CE-10-0502 Rev C.

There are existing road gullies shown at the uncontrolled pedestrian crossing of Carmanhall Road. This could lead to trips and falls for pedestrians especially for those with narrow heels.

It is recommended that the gullies be moved outside the crossing area.

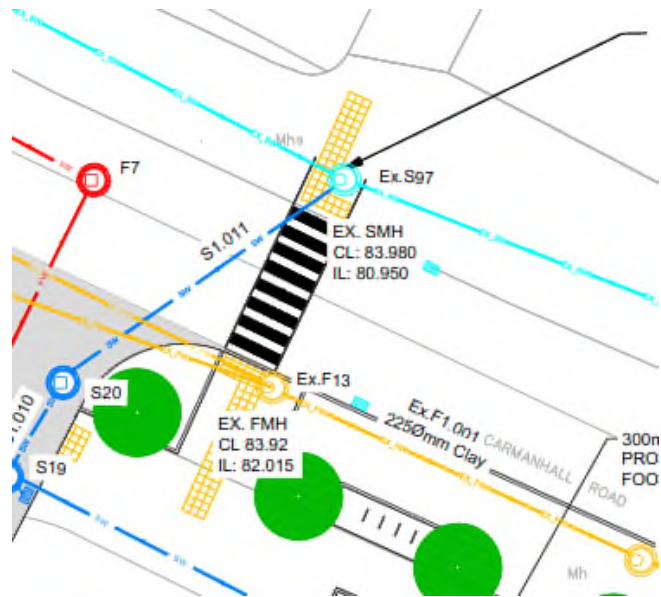
Drawing PR461030-ACM-XX-00-DR-CE-10-0502 Rev C

There is a risk that the provision of dropped kerbs at the proposed signalised pedestrian crossing on Carmanhall Road could lead to surface water ponding at the crossing which in turn could lead to slips and falls particularly in wet or icy conditions.

It is recommended that the gullies be provided upstream of the crossing area.

3.13	Y	Y	The design team are currently engaging with Dun Laoghaire Rathdown Traffic and Parks Department to integrate the scheme proposals in with the proposed works to both Carmanhall Road and Blackthorn Road. During the detailed design, the issue raised will be taken into account when preparing the final design.	Yes

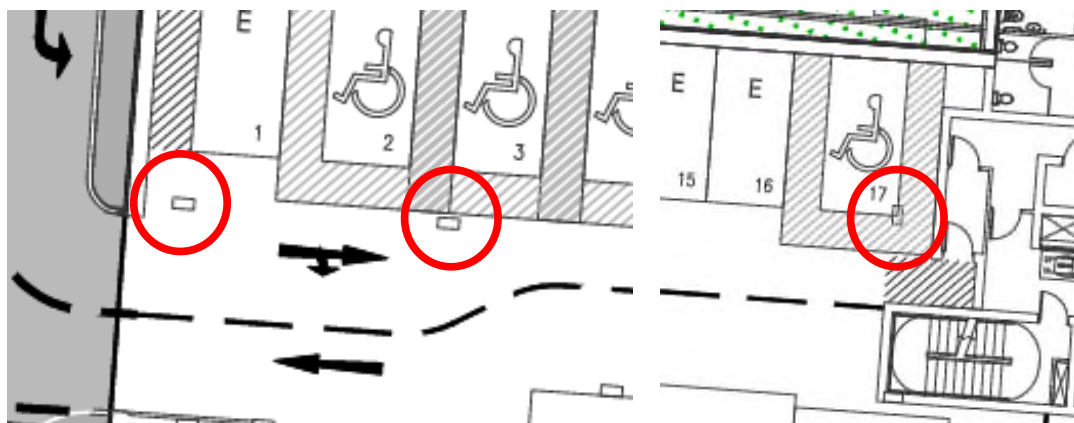
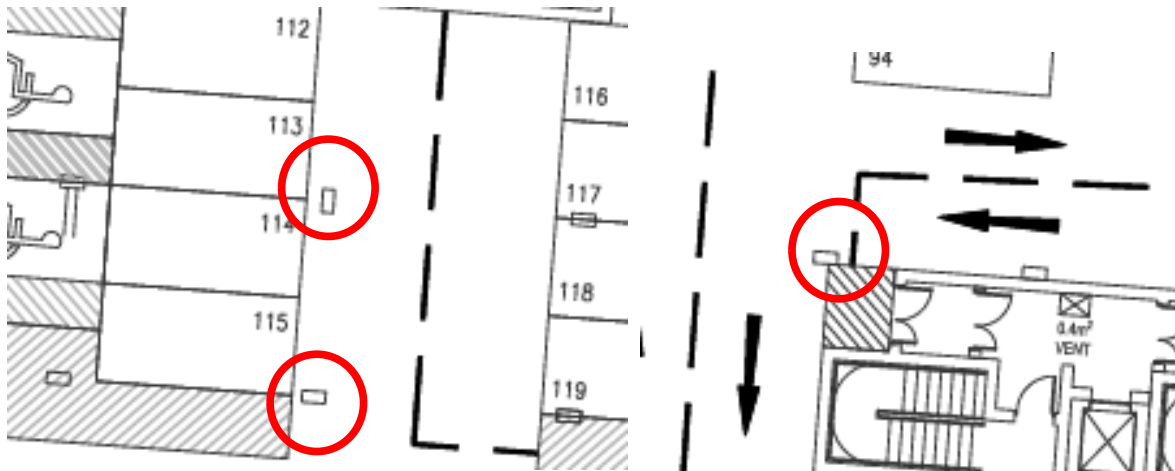
Drawing PR461030-ACM-XX-00-DR-CE-10-001 Rev C.

Some structural columns appear to be within the parking spaces and carriageway of the car park. These would be hazards for parking and driving on the aisles.

It is recommended columns are not within parking spaces and within the carriageway of the car park.

3.14	Y	Y	An autotracking assessment has been undertaken and these spaces have been checked to ensure that vehicles can enter and exit safely. Columns have been relocated and the car park has been altered to a one-way only	Yes
