REFERENCE DOCUMENTS for PROPOSED LARGER TURBINES AND MET MASTS AT UPPERCHURCH WINDFARM for EIAR 2021 and AA 2021

- **2018 UWF Replacement Forestry EIA Report - Volume C4: EIAR Appendices (Part 3 of 3)**
 - Appendix 11.1 – Survey of Existing and Proposed Watercourse Crossing Locations

Upperchurch Windfarm Replacement Forestry (UWF Replacement Forestry)

UWF Replacement Forestry EIA Report (EIAR)

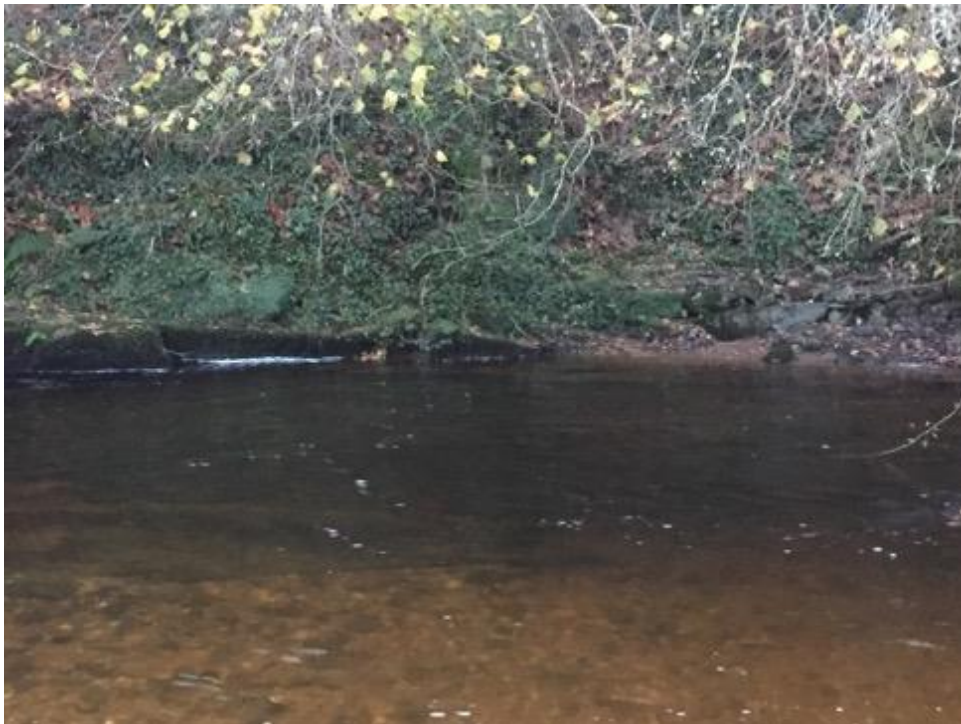
Figure 1 – Outcropping bedrock on the eastern river bank.

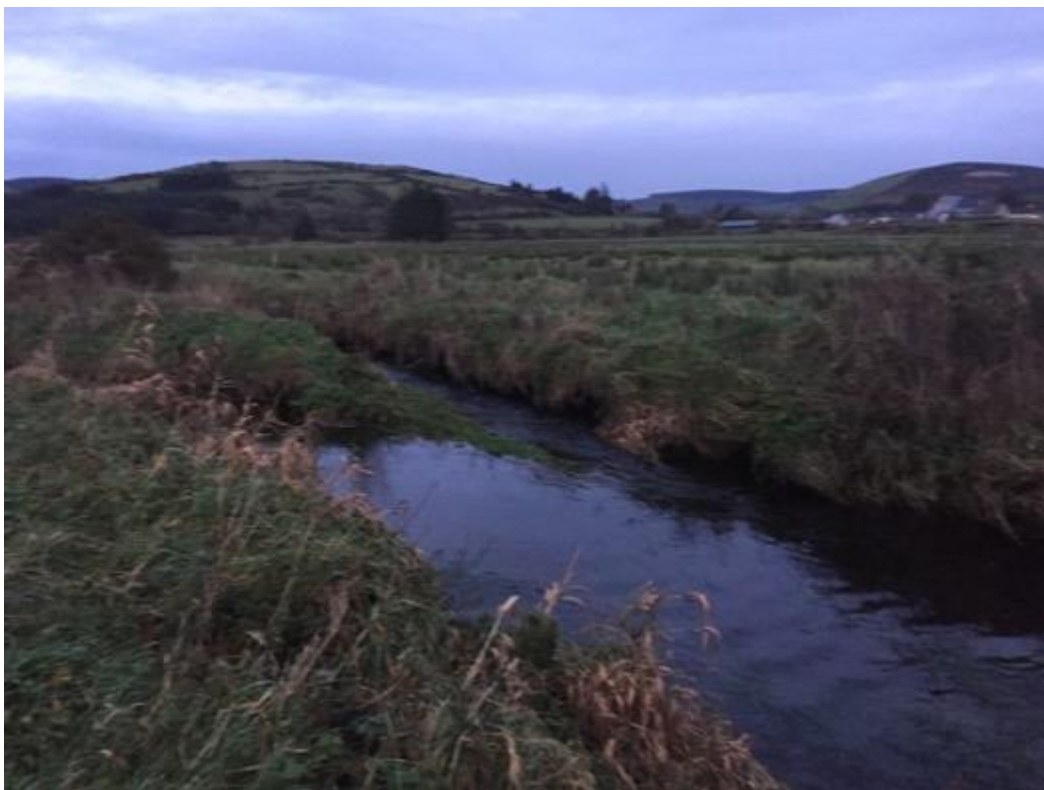
Figure 5 – Shallow narrow water way, observed from the western bank.

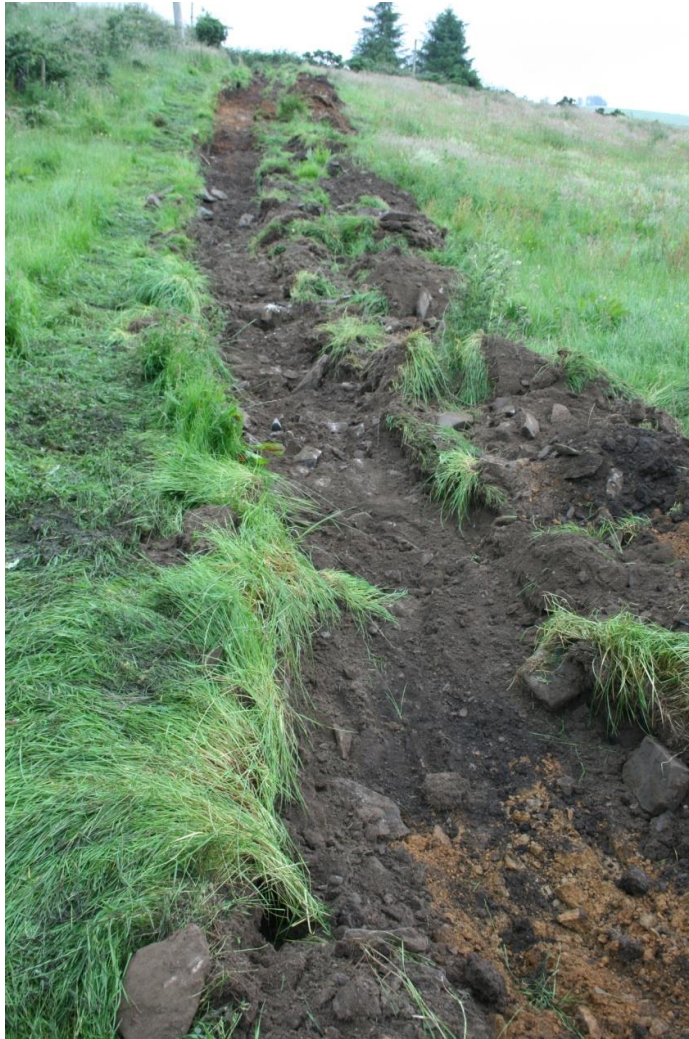
Figure 7: Trench 2 from the southwest. Spread of mixed demolition rubble visible in the foreground

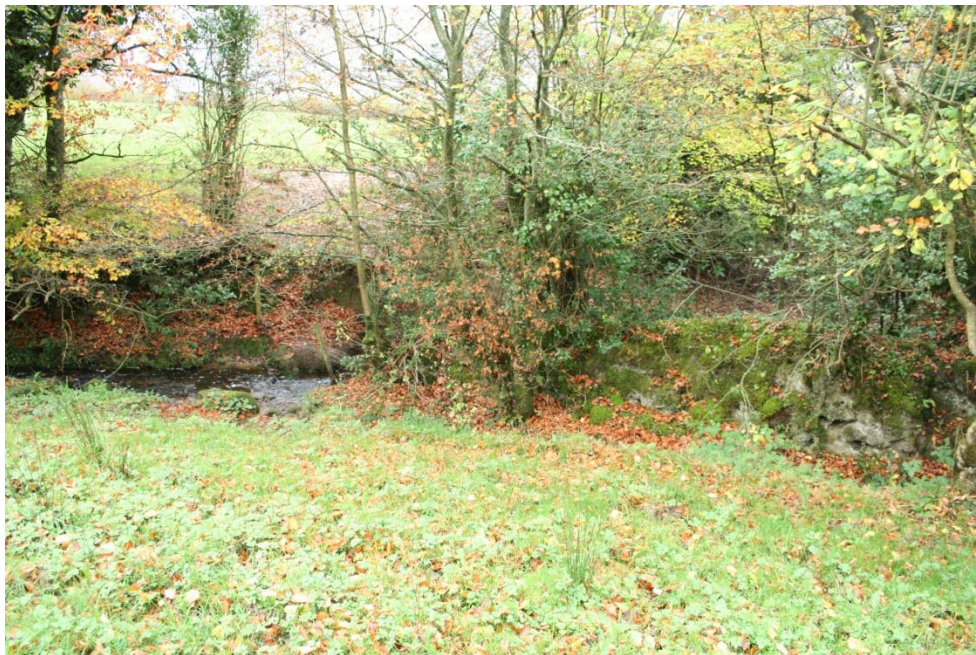
Figure 4: Stream at eastern end of S001
