Appendix C – Archaeological Reports

- Archaeological Assessment Report on XC187, XC201, XC209, XC215 & XC219;
- Archaeological Assessment Report on XC212;
- Historic Building Survey at XC219.

Archaeological Assessment
Level Crossings
XC219 Clashnabuttry Co. Cork
XC215 Shinanagh Co. Cork
XC209 Ballyhay Co. Cork
XC201 Thomastown Co. Limerick
XC187 Fantstown Co. Limerick

Author: Colm Flynn
Job No: 1571-10-100
Client: Roughan & O'Donovan / Iarnród Eireann
Date: July 2011

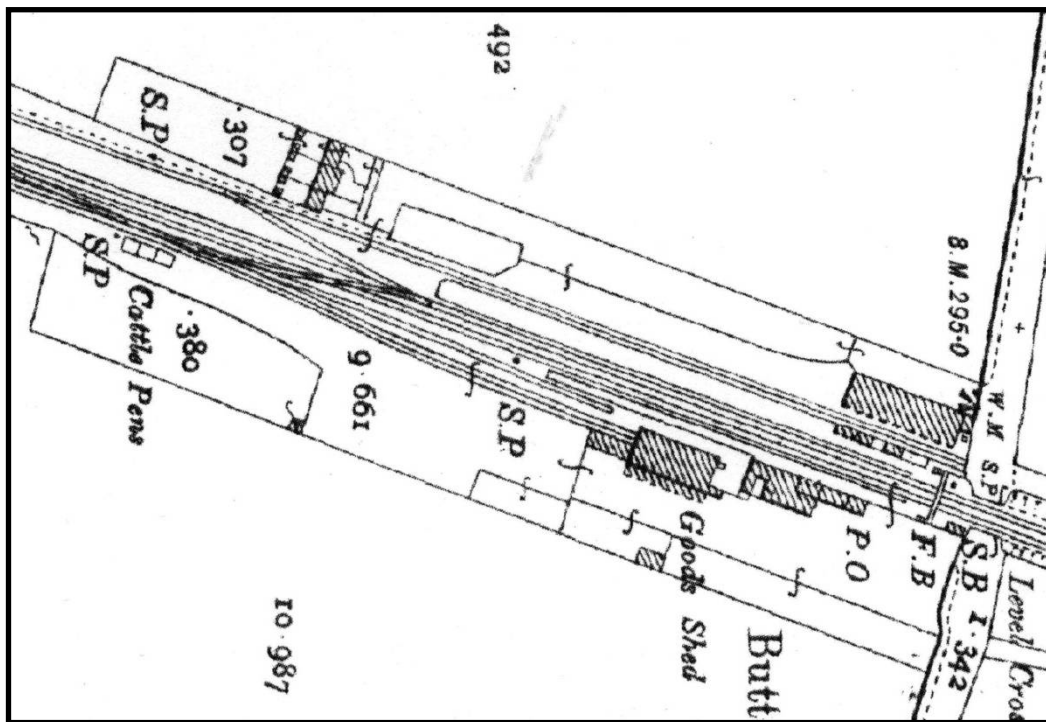
Figure 2: Detail of Buttevant Station, 1904, turned with west at the top

The station complex began at the level crossing at the northern end, seen at left in the map extract above, and extended southwards over a distance of about 220 metres, this area, extending in width to about 67 metres, was fenced off from the surrounding land. On the down side of the line, to the east of the track, lay the main station building, facing directly onto the down platform, and with a narrow projection extending northwards towards the level crossing. The northern end of this projecting structure is marked "P.O" on the map, denoting that it was a post office. To the south of this was a goods shed, with a siding running northwards into the western side of the shed. A second short siding lay between this siding and the main line, with a narrow section of the platform to the south of the station.

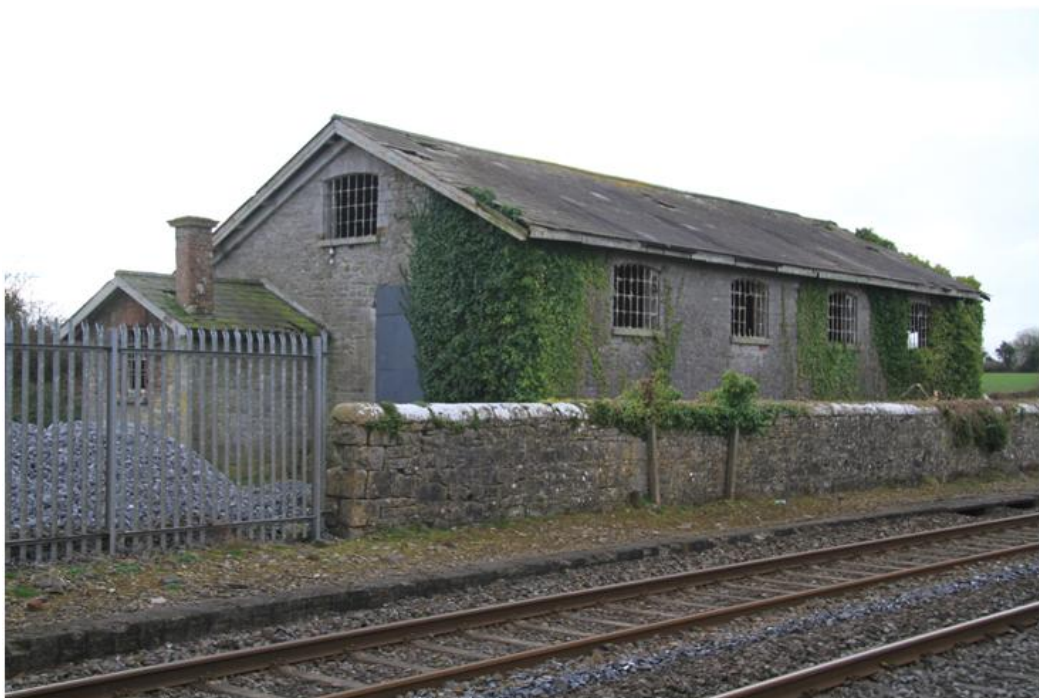
Plate 1: Goods shed on eastern side of line

The goods shed on the eastern side of the line is single-storey with gable ends and is constructed of coursed rubble limestone. The roof is slated on the western side, while the covering has been replaced with corrugated iron on the eastern side, set on timber boarding. Against the northern gable of the shed there is a projecting single-storey structure that appears to have been an office associated with the shed as it gains access only from within the shed and has no independent doorway – though it is possible that a blocked up ope on the eastern side may have been a door, provided there were steps or a higher ground level adjacent originally. The roof of this structure has a covering of slate and has been reduced in pitch, as is seen in the scar of the original pitch on the gable end of the shed. The building is lit by small-paned cast iron clerestorey windows on the western side and the gable ends. On the eastern side there are three pairs of large timber doors to permit access for goods being loaded or unloaded. The eastern slope of the roof projects over this loading area to form a canopy.

The masonry of this building appears to be in reasonable condition. The canopy has lost most of its timber sheeting and its corrugated iron covering. The doors are in poor condition and some are boarded up. The glass in the windows has been broken, though the cast iron sashes appear to be intact.

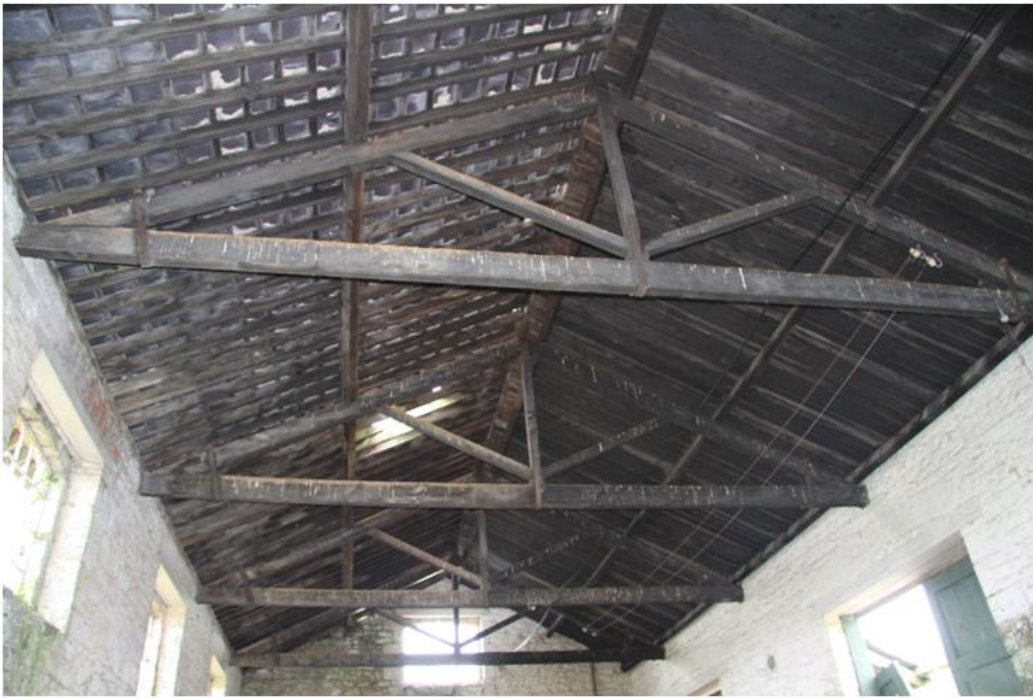
Plate 4: Internal roof structure of goods shed

The roof of the goods shed is a single span, achieved by means of king-post trusses carrying purlins to support the rafters and roof covering. The floor within this shed was of timber and is now missing, with parts of joists remaining, and part of the masonry supporting structure.

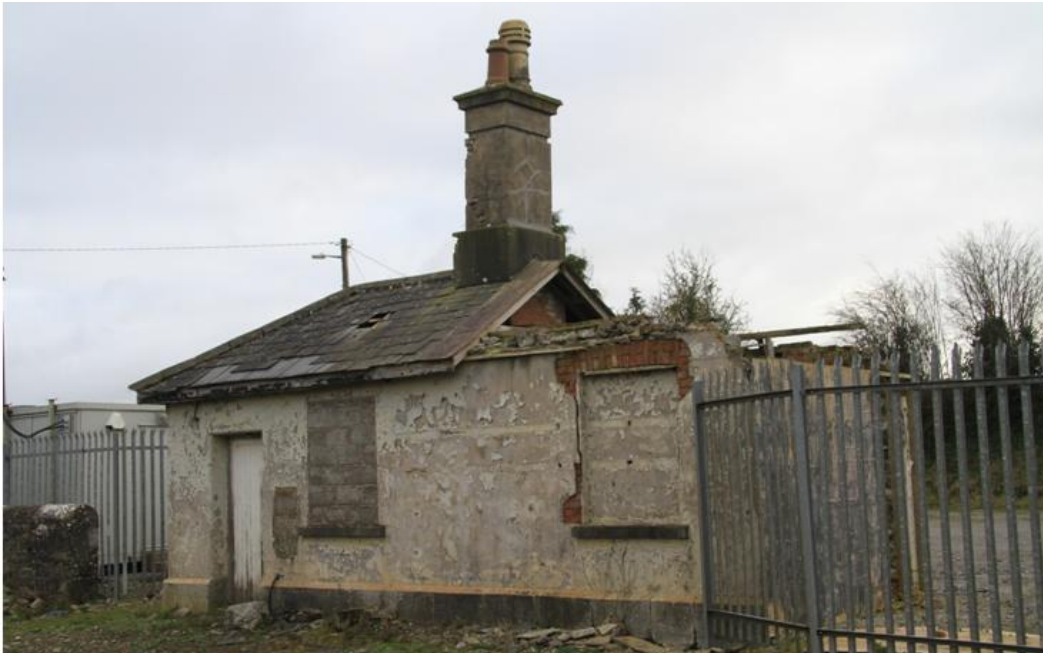
Plate 6: Single-storey building on eastern side of track, seen from south-west

The small structure adjacent to the station platform on the eastern side of the track has been noted above as having been a post office at some time. This building is divided into two, the northern part being roofed, but in poor condition, while the southern part is in ruins.

This building had two windows facing the down platform, both now blocked up. The northern portion was accessed via a doorway leading from the down platform.

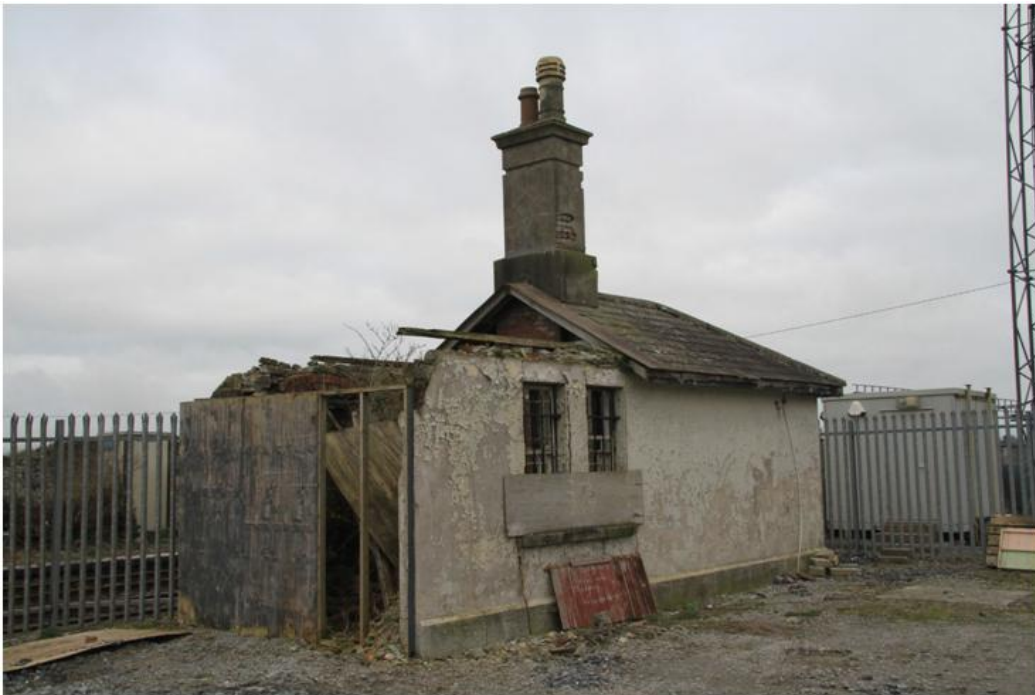
Plate 8: Single-storey building seen from south-east

This building is constructed of red brick and rubble stone, rendered, ruled and lined externally, and rising off a chamfered plinth of hammer-dressed limestone. The slate roof on the northern portion is in poor condition and missing some slates. The roof of the southern portion is missing. A tall chimney stack rises from the centre of the building, with a corbelled top to the stack and with two chimneypots. The southern end wall of the building is missing, and the maps show that it was originally attached to the main station building. The entrance to the southern part of this building would have been from the south, as no doorway survives in the surviving eastern, western and northern walls.

Internally the northern section is plastered with timber sheeted wainscoting. The floor is timber boarded, but rotten, and the ceiling has been replaced with hardboard or similar material. The interior of the southern section appears to have been similar, but is now derelict. There is a cast iron fireplace in the northern section, the southern section having a hearth in a chimneybreast of brick, while the fireplace is missing. In both sections the windows had timber architraves and shutters and the surviving windows on the eastern elevation are timber sliding sashes.

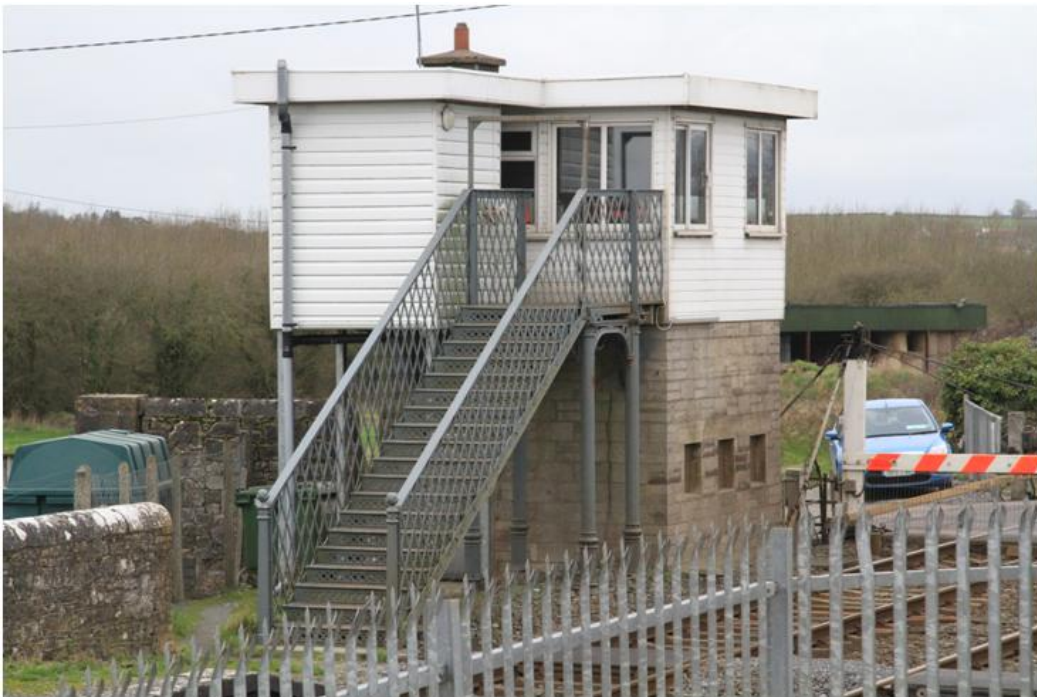
Plate 9: Signal box, with iron stairs

As noted in the historical background, the original signal box was on the eastern side of the line, adjacent to the level crossing. This is now gone, and the present signal box is a newer structure, built in about the 1980s, on the western side of the line. This has a base constructed of concrete blocks at ground floor level and a boarded upper floor, with a flat roof. A chimney projects above the roof level.

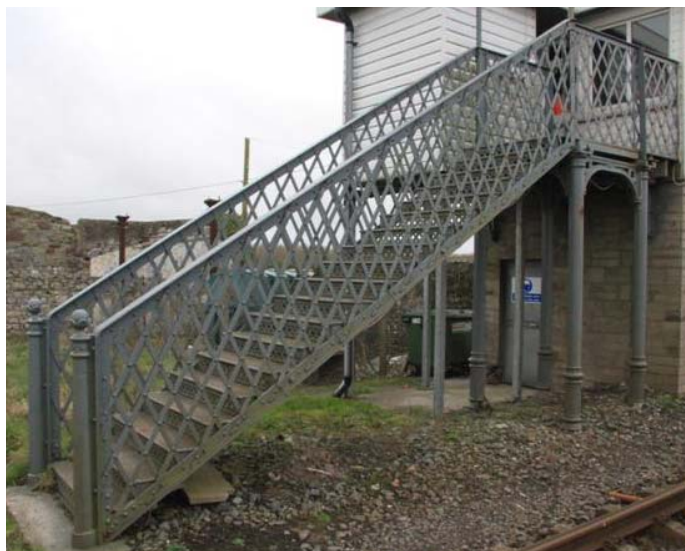
Plate 10: Stairs to signal box, taken from footbridge

The stairs to the upper level are external and of a combination of cast iron and wrought iron. Cast iron columns support wrought iron runners and cast iron steps, with a balustrade of wrought iron having newels of cast iron. This is a surviving section of the footbridge that crossed the line adjacent to the level crossing while the station was in use. The newels carry the maker's name "E. Manisty Dundalk". Edward Manisty was an engineer who acquired the Dundalk Iron Works in 1878. In 1894 he began to manufacture iron footbridges for railways, as many rail companies were at that time replacing their timber footbridges. The company closed upon the death of Edward Manisty in 1928, which dates the bridge to some time between 1894 and 1928.

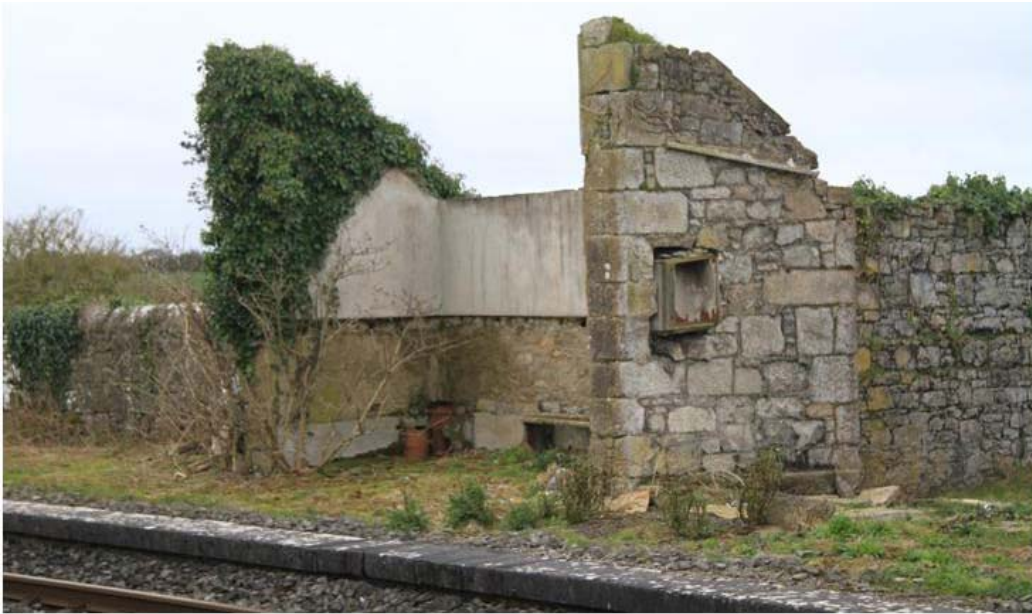
Plate 11: Shelter on up platform

The original station building may have had a waiting room for passengers, or at the very least a canopy over the platform to provide shelter. This would have served the down platform, for passengers heading towards Mallow and Cork. The Ordnance Survey map of 1904, reproduced above, shows various structures on the up platform, only one of which survives, and this is in a state of ruin.

This structure is constructed of rubble stone, with dressed quoins. It had a monopitch roof, now missing, with the slope towards the rear, away from the track. The front of the structure was open and faced the railway. Internally, the lower section of the building was faced with wainscoting, probably timber sheeting as in the former post office building on the opposite platform. Above the wainscoting the walls are plastered. In the northern wall there is a timber-lined ope.

A timber bench is set against the rear wall inside the shelter, though now rotten.

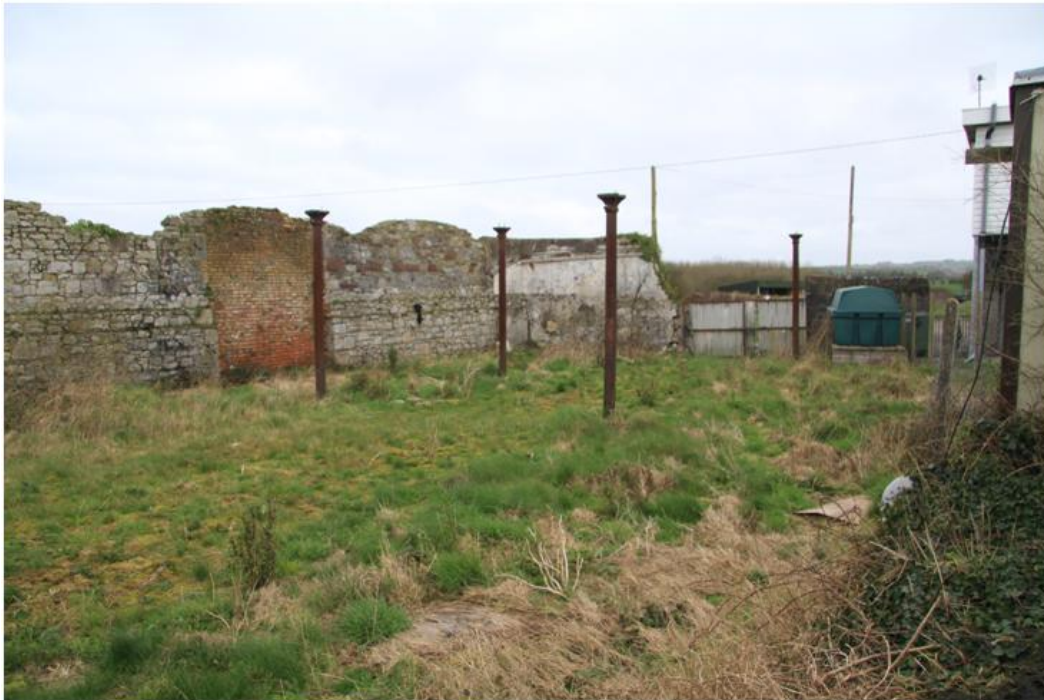
Plate 13: Western goods shed, seen from the south-east

At the western side of the station there is the remnants of a second goods shed. This was seen in the Ordnance Survey map of 1904 as a rectangular structure with an open front facing a siding that extended a significant distance to the south. The shed was close to the public road at its northern end.

The view of the shed seen above is from the station platform to the south east of the shed. The siding ran from the bottom centre of the photograph towards the oil tank in the background. The two columns on the right represent the open front of the building facing the siding. The rear wall survives to the west, but with the upper part missing. Part of the northern wall survives, as does the southern wall. The masonry walls of the shed are constructed of coursed rubble limestone with some brick detailing. A substantial panel of brick in the centre of the western wall appears to represent a large ope that was stopped up during the time that the railway was in use. The surviving northern wall is plastered on its internal face, above a certain level, suggesting that this was the office area, and that the lower part of the wall was wainscoted. The roof is entirely missing, both the covering and the structure. The two lines of cast iron columns suggest that the roof was held on trusses of some kind, though whether timber, as in the eastern shed, or wrought iron is not known. It is noted that the king post trusses in the eastern shed do not require columns, suggesting that the western shed had wrought iron trusses. A marked difference in the nature of the stonework in the upper part of the western wall, as compared with the lower part, suggests that this wall was raised significantly at some point, and suggests that the western shed was a later addition to the structures at the station; this could explain the difference in structure between the eastern and western sheds, as wrought iron was not as widely used in the 1840s when the station was built, as it was to become later.

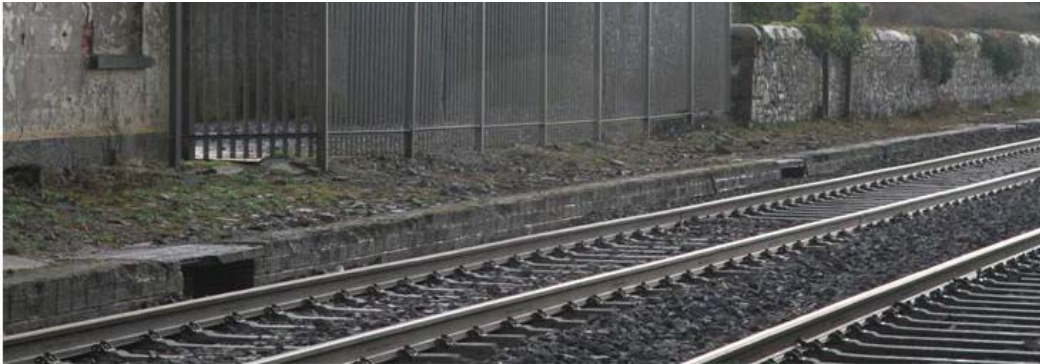
Plate 16: Down platform in northern part of station

As noted in the historical background, there were platforms serving the main line at this station and others serving sidings to the east and west. The latter are now missing, apart from a short section of platform to the south of the eastern goods shed, now partially missing. There are still platforms on either side of the main line. On the down side of the line the platform has an uneven surface of hardcore and is bounded alongside the track by a plinth wall of concrete blocks. This is not the original platform. The southern portion of this platform, adjacent to the eastern goods shed, the original platform survives, with limestone slab copings.

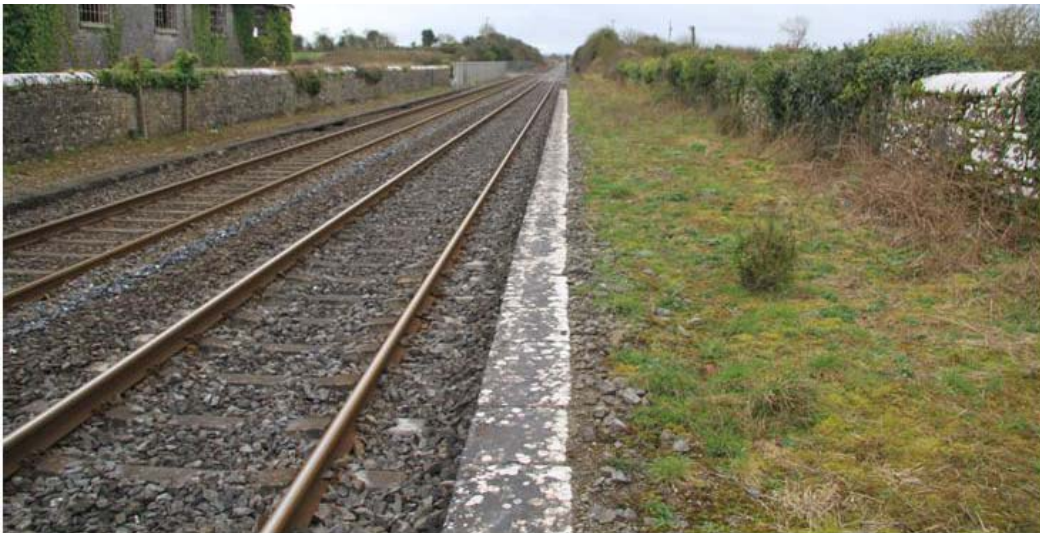
Plate 17: Up platform, with southern part of down platform visible at left

On the up side of the line, on the western side of the station, the platform survives with a rubble plinth wall carrying limestone slab copings.

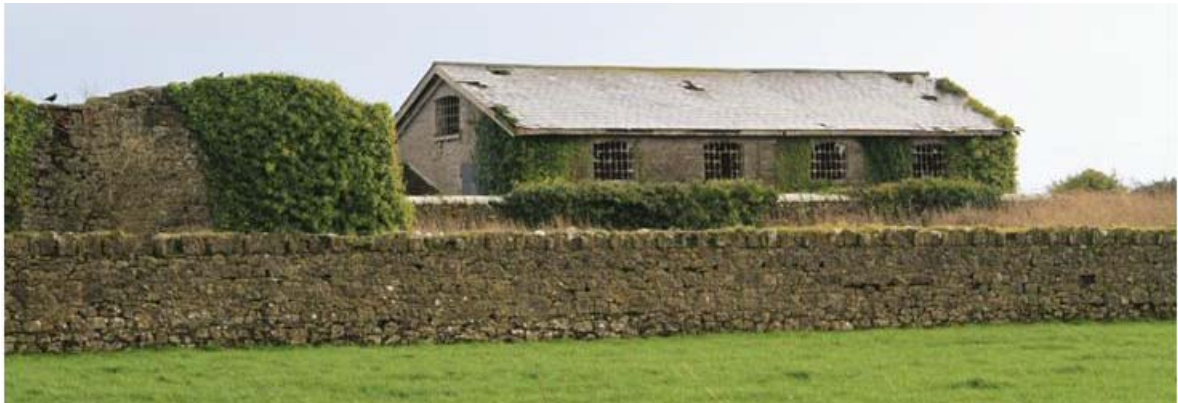
Plate 18: Western boundary wall

In the view above, the western boundary wall may be seen, with the western goods shed at left and the eastern goods shed at rear. Between the boundary wall and the eastern shed the wall at the rear of the up platform is seen.

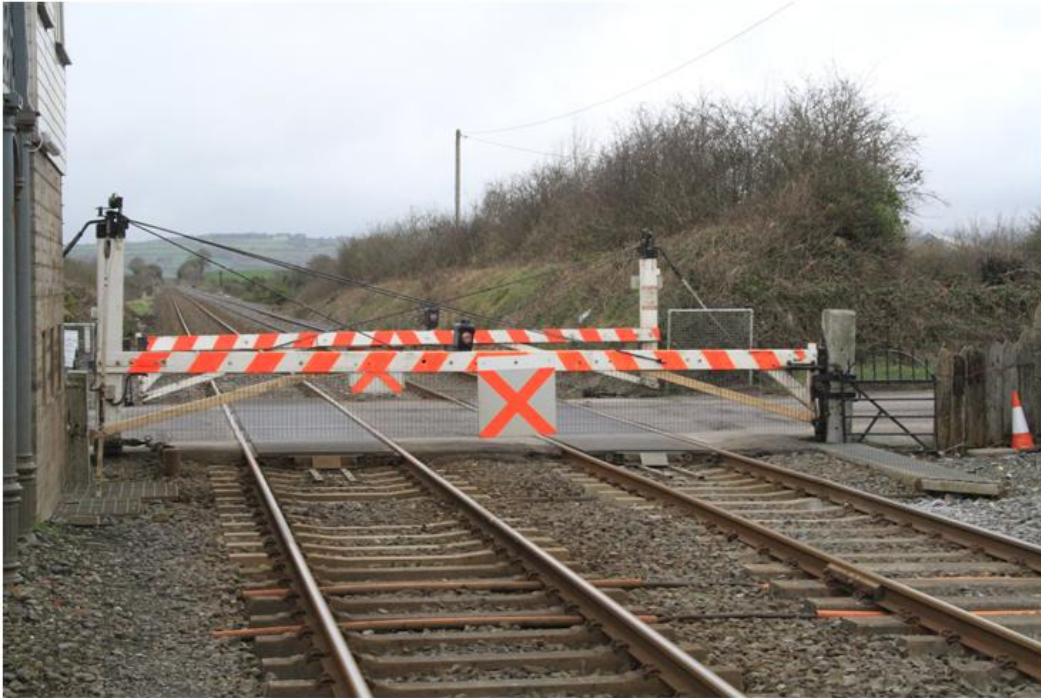
Plate 19: Level crossing gates

The level crossing at Buttevant is a manned crossing, with gates closing off the railway track and maintaining the access for the public road to cross the line except when required for railway traffic.

The gates are of timber, with a pair of boards crossing the entire width of the line, stayed by steel rods held on the hinge post of the gates. A red light is carried at the centre of each gate, facing the track.
