Peat Stability Report

**PEAT STABILITY REPORT FOR THE PROPOSED
DERNACART WIND FARM, CO. LAOIS**

DECEMBER 2019

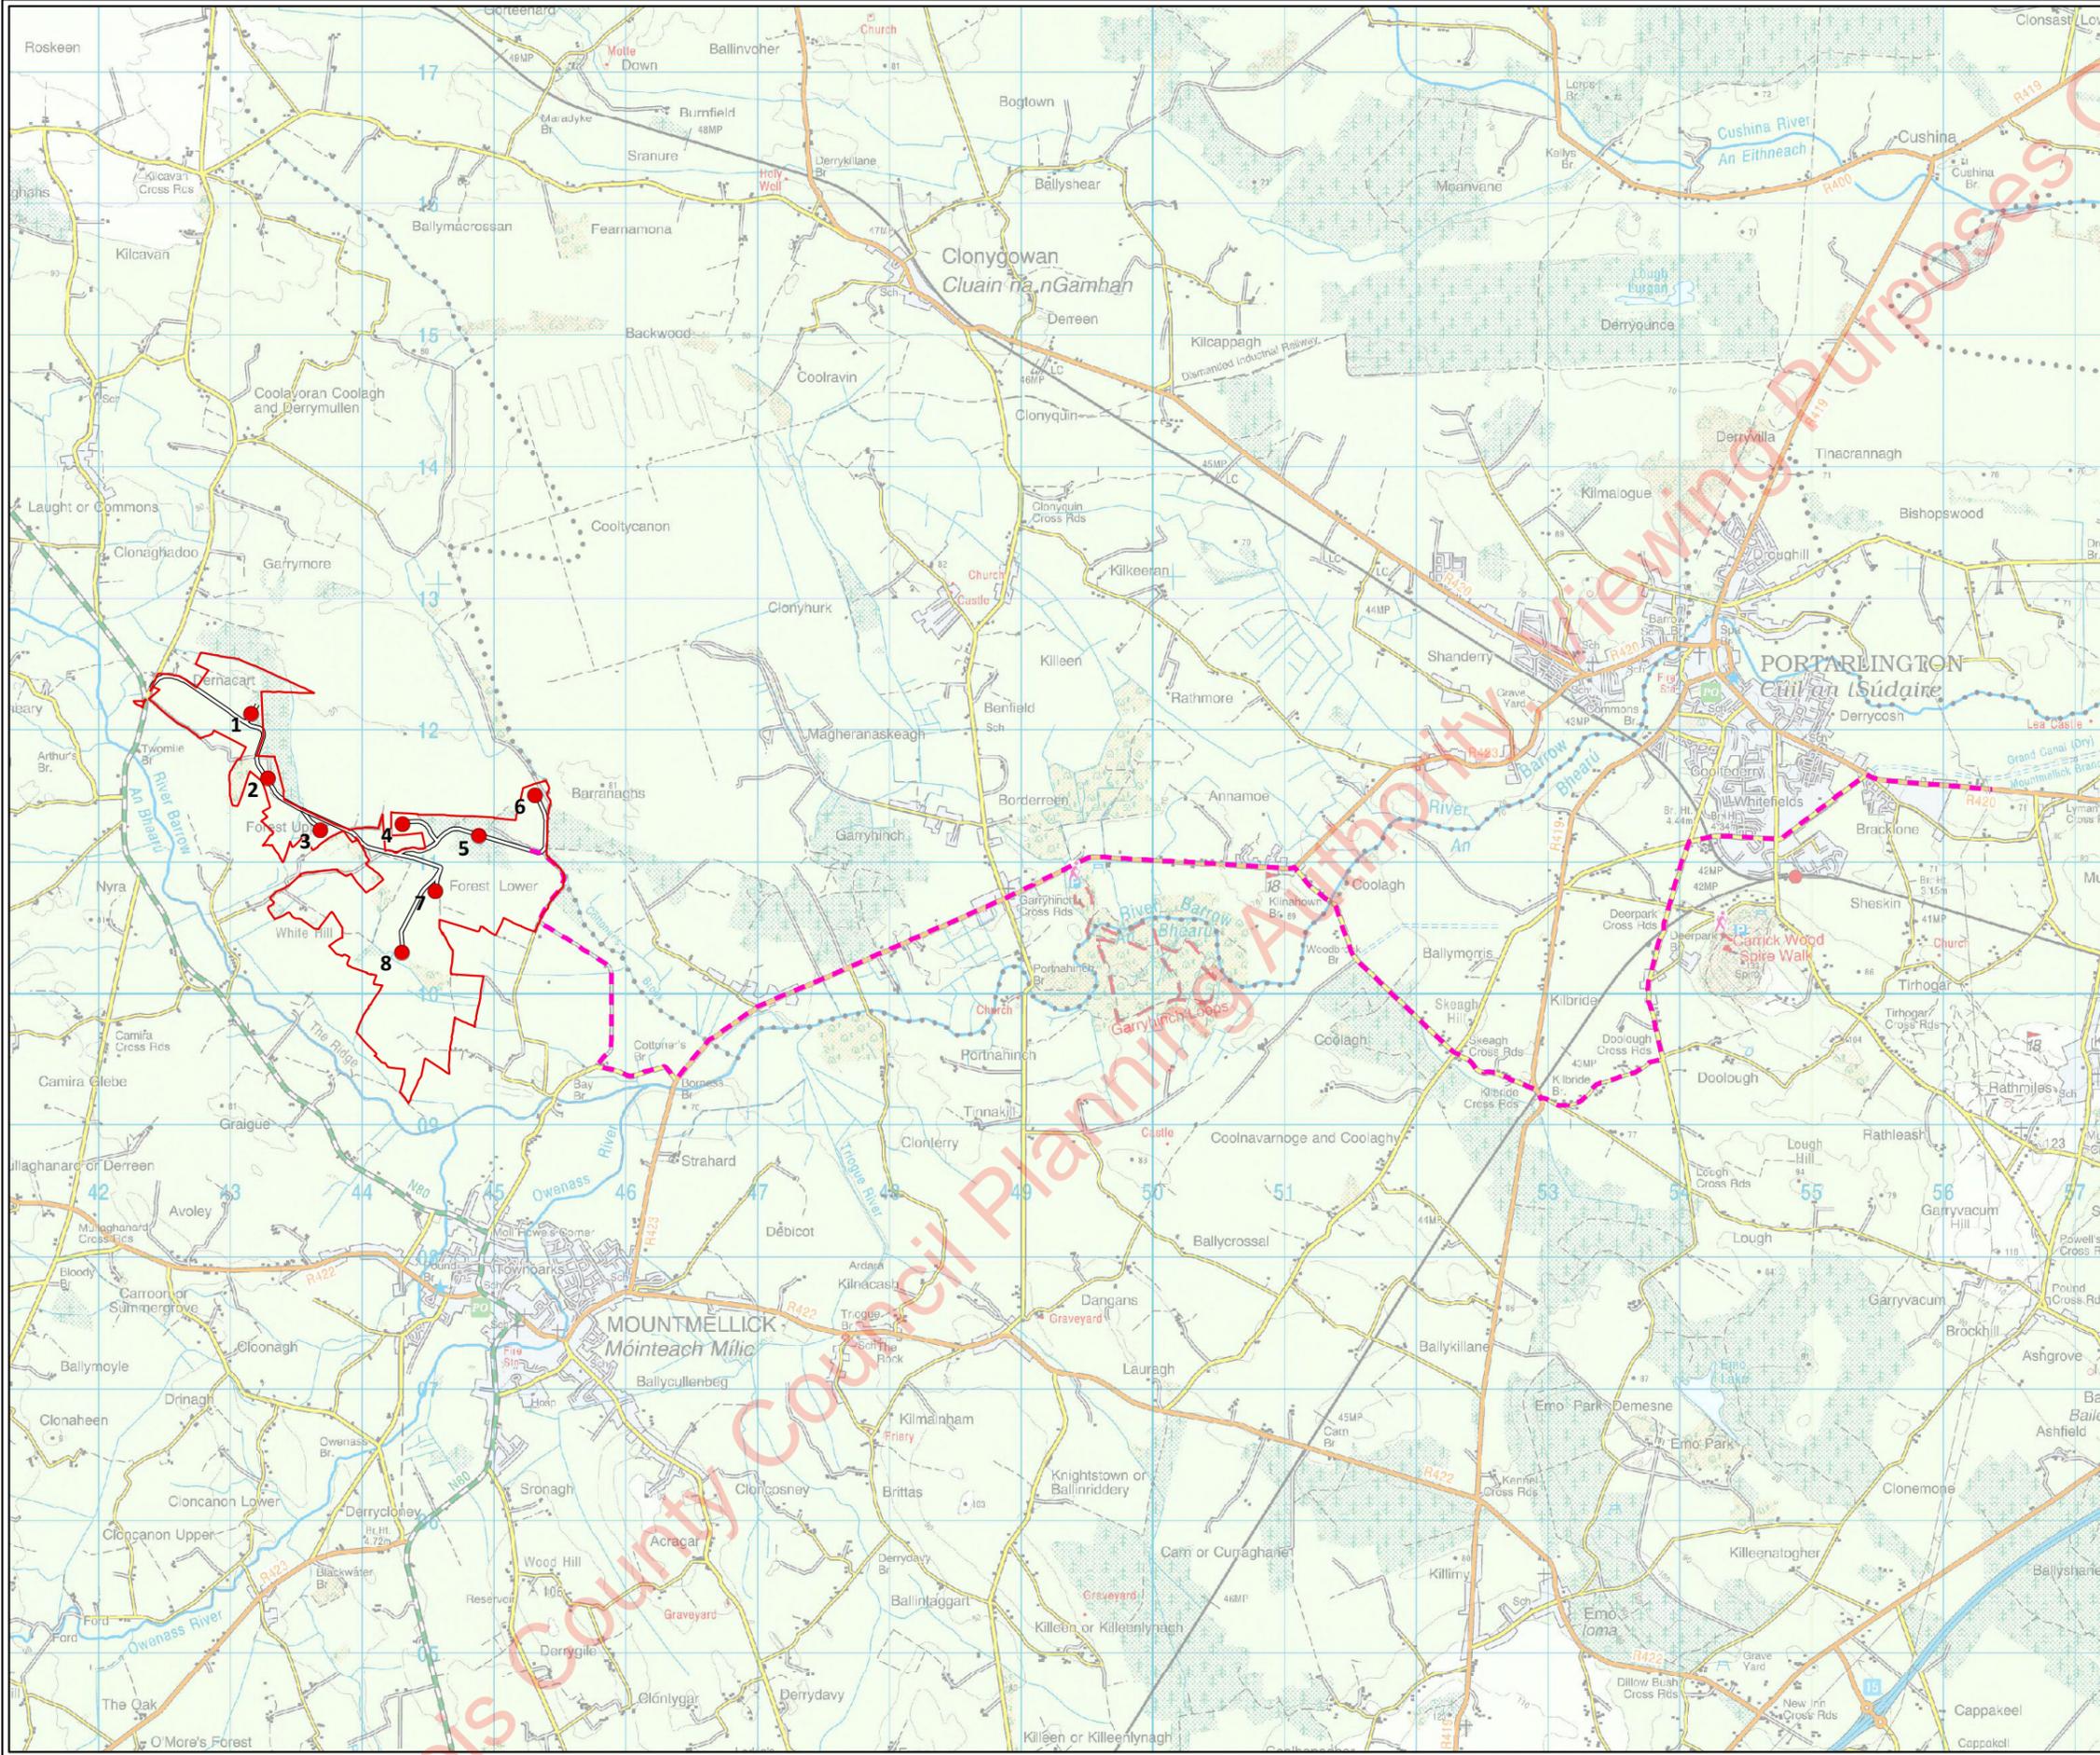
| FIGURE NO: | 1.1 | |

- Proposed Turbines
- Proposed Site Boundary
- Proposed Cable Route
- Proposed Access Tracks

| TITLE: | Site Location | |

Statkraft proposes to develop the Dernacart Wind Farm which is located in Co. Laois. It is proposed to supply the power from Dernacart Wind Farm to the Irish electricity network via underground cable to the proposed substation at Bracklone, Co. Laois. This report details the Peat Stability Assessment undertaken at the proposed site and is based on a detailed walkover and intrusive surveys of peat deposits within the study area. Figure 1.1 displays the location of the site.

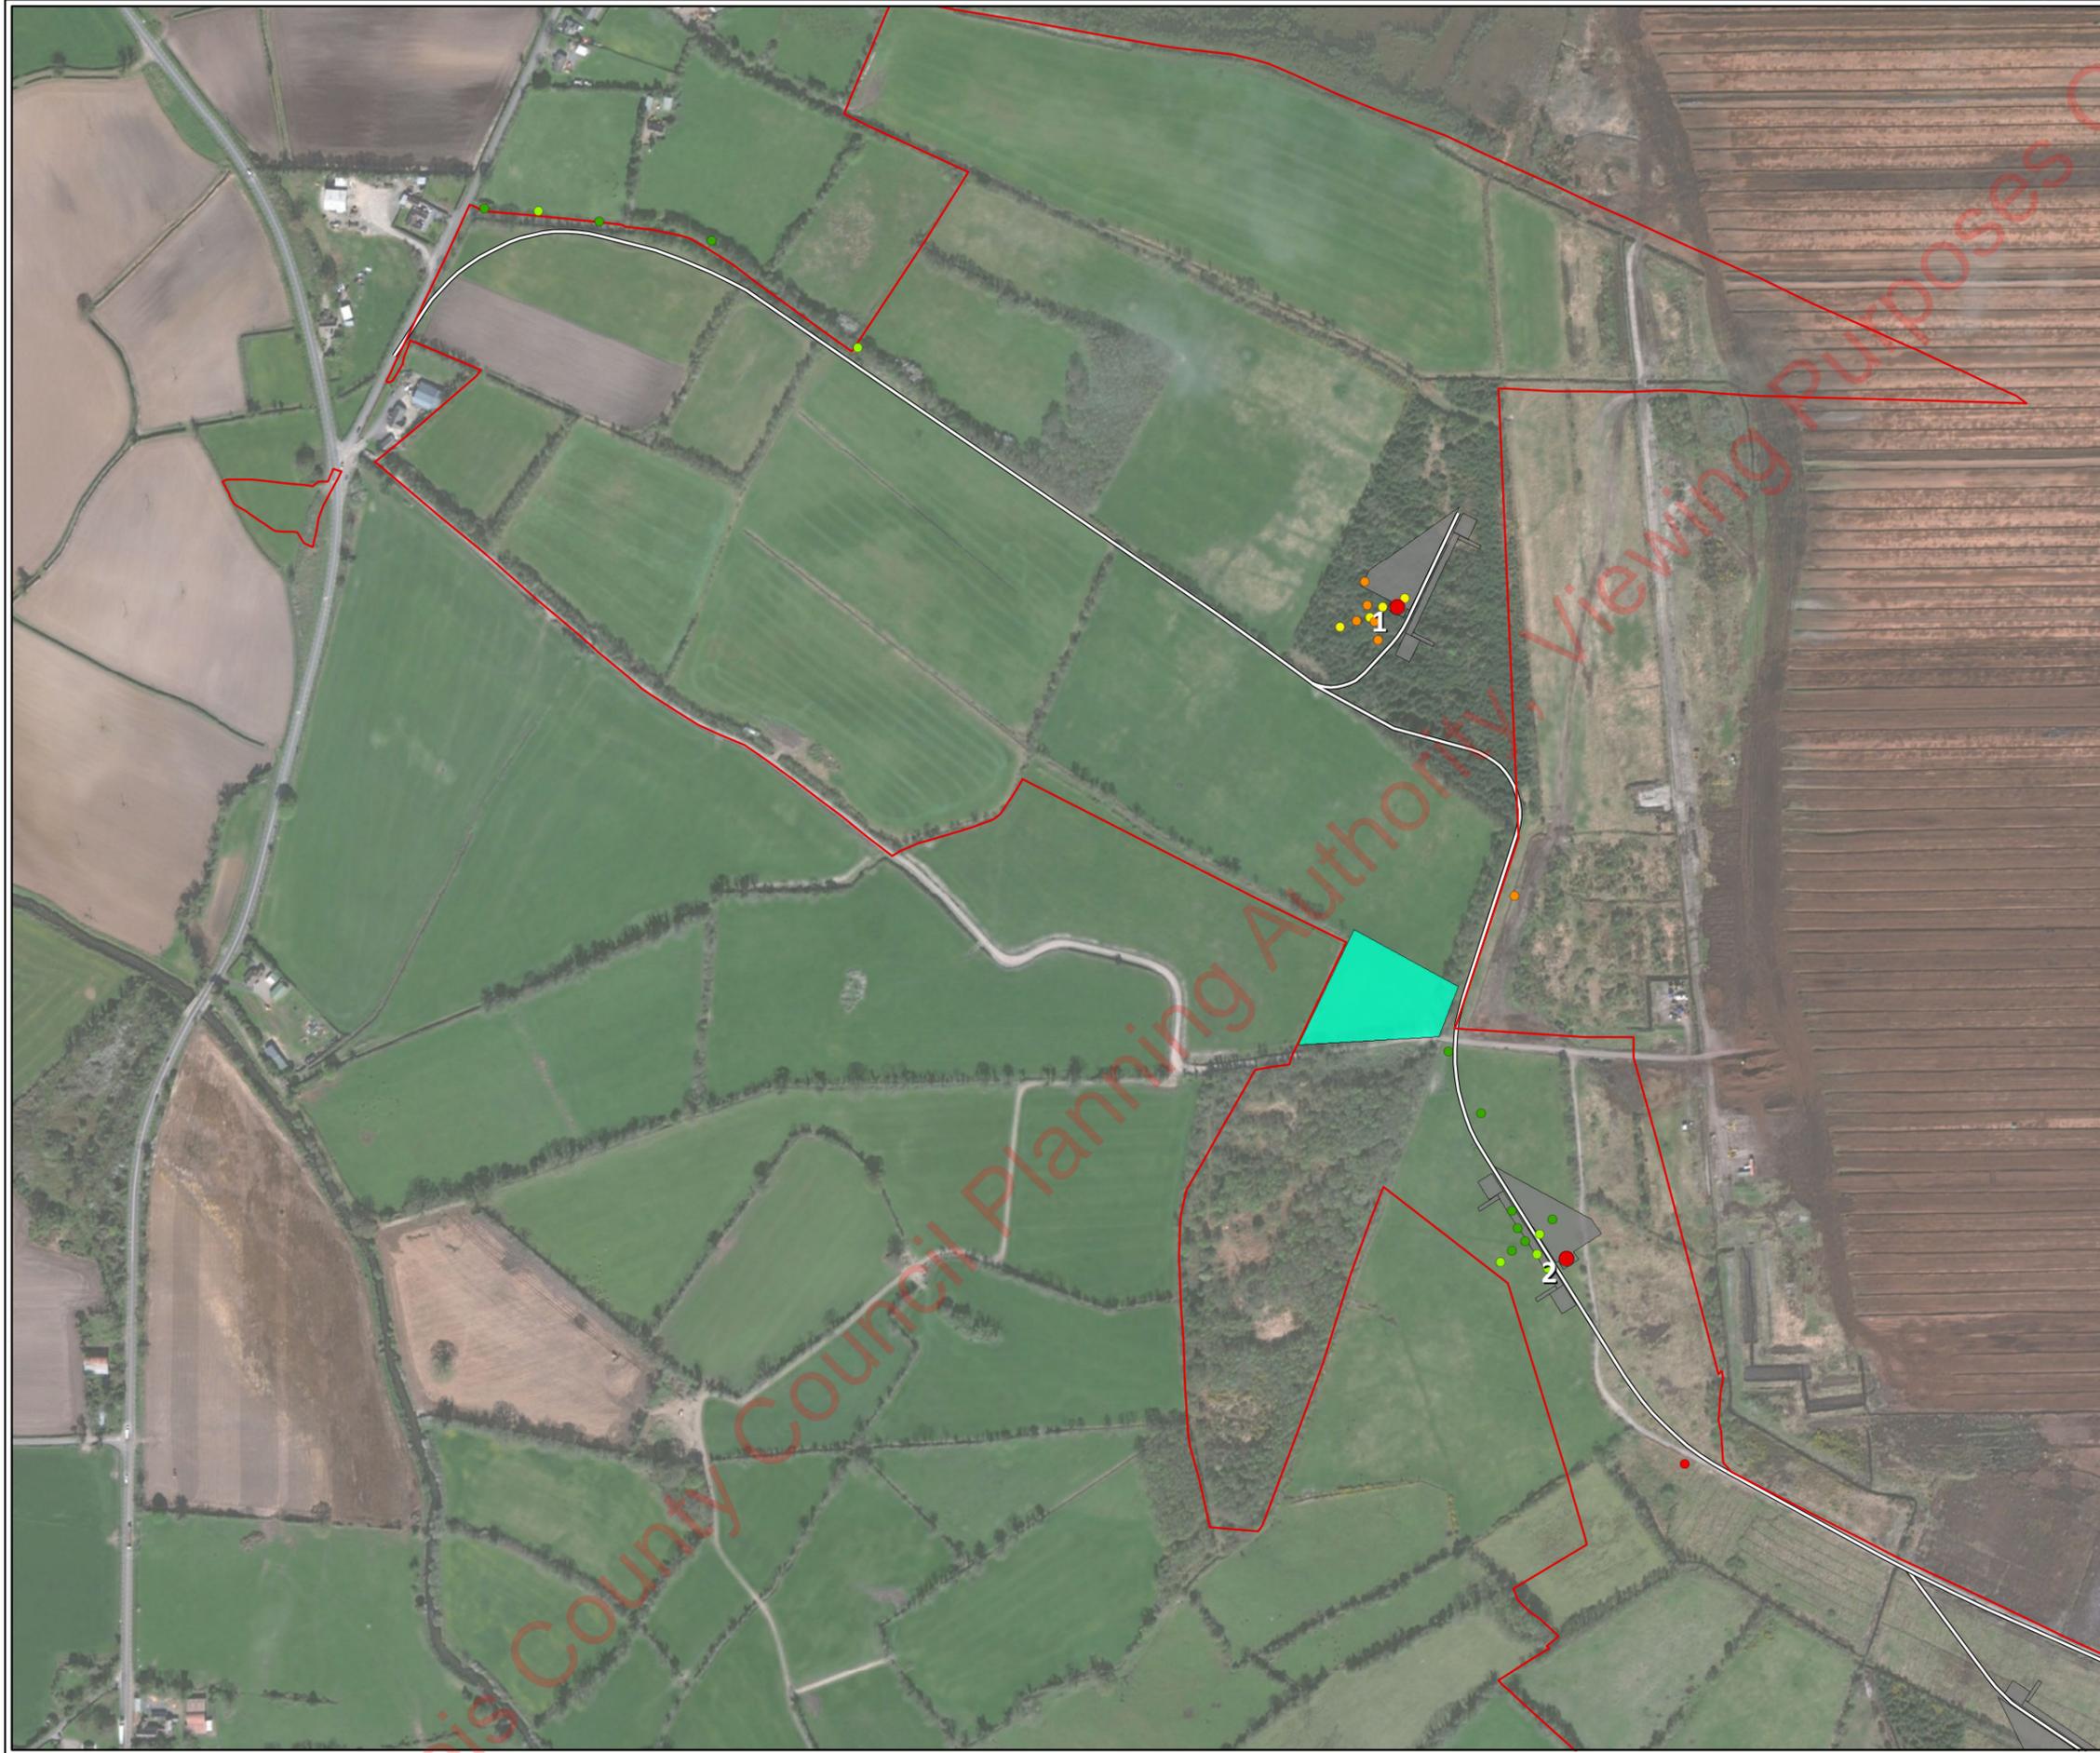
| TITLE: | Peat Depth | | |

- Proposed Turbines
 - Proposed Site Boundary
 - Proposed Turbine Hardstanding Areas
 - Proposed Temporary Compound
 - Proposed Access Tracks
- Peat Depth (m)**
- 0.10 - 0.20
 - 0.21 - 0.50
 - 0.51 - 0.80
 - 0.81 - 1.20
 - 1.21 - 1.60

Figure 3.1 presented an overview of the peat depths encountered across the site.

The assessment and preliminary ground investigations found extensive cut peat across the site with an average depth of 1.0m. The maximum peat depth recorded was 1.6m and the minimum peat depth was 0.2m.

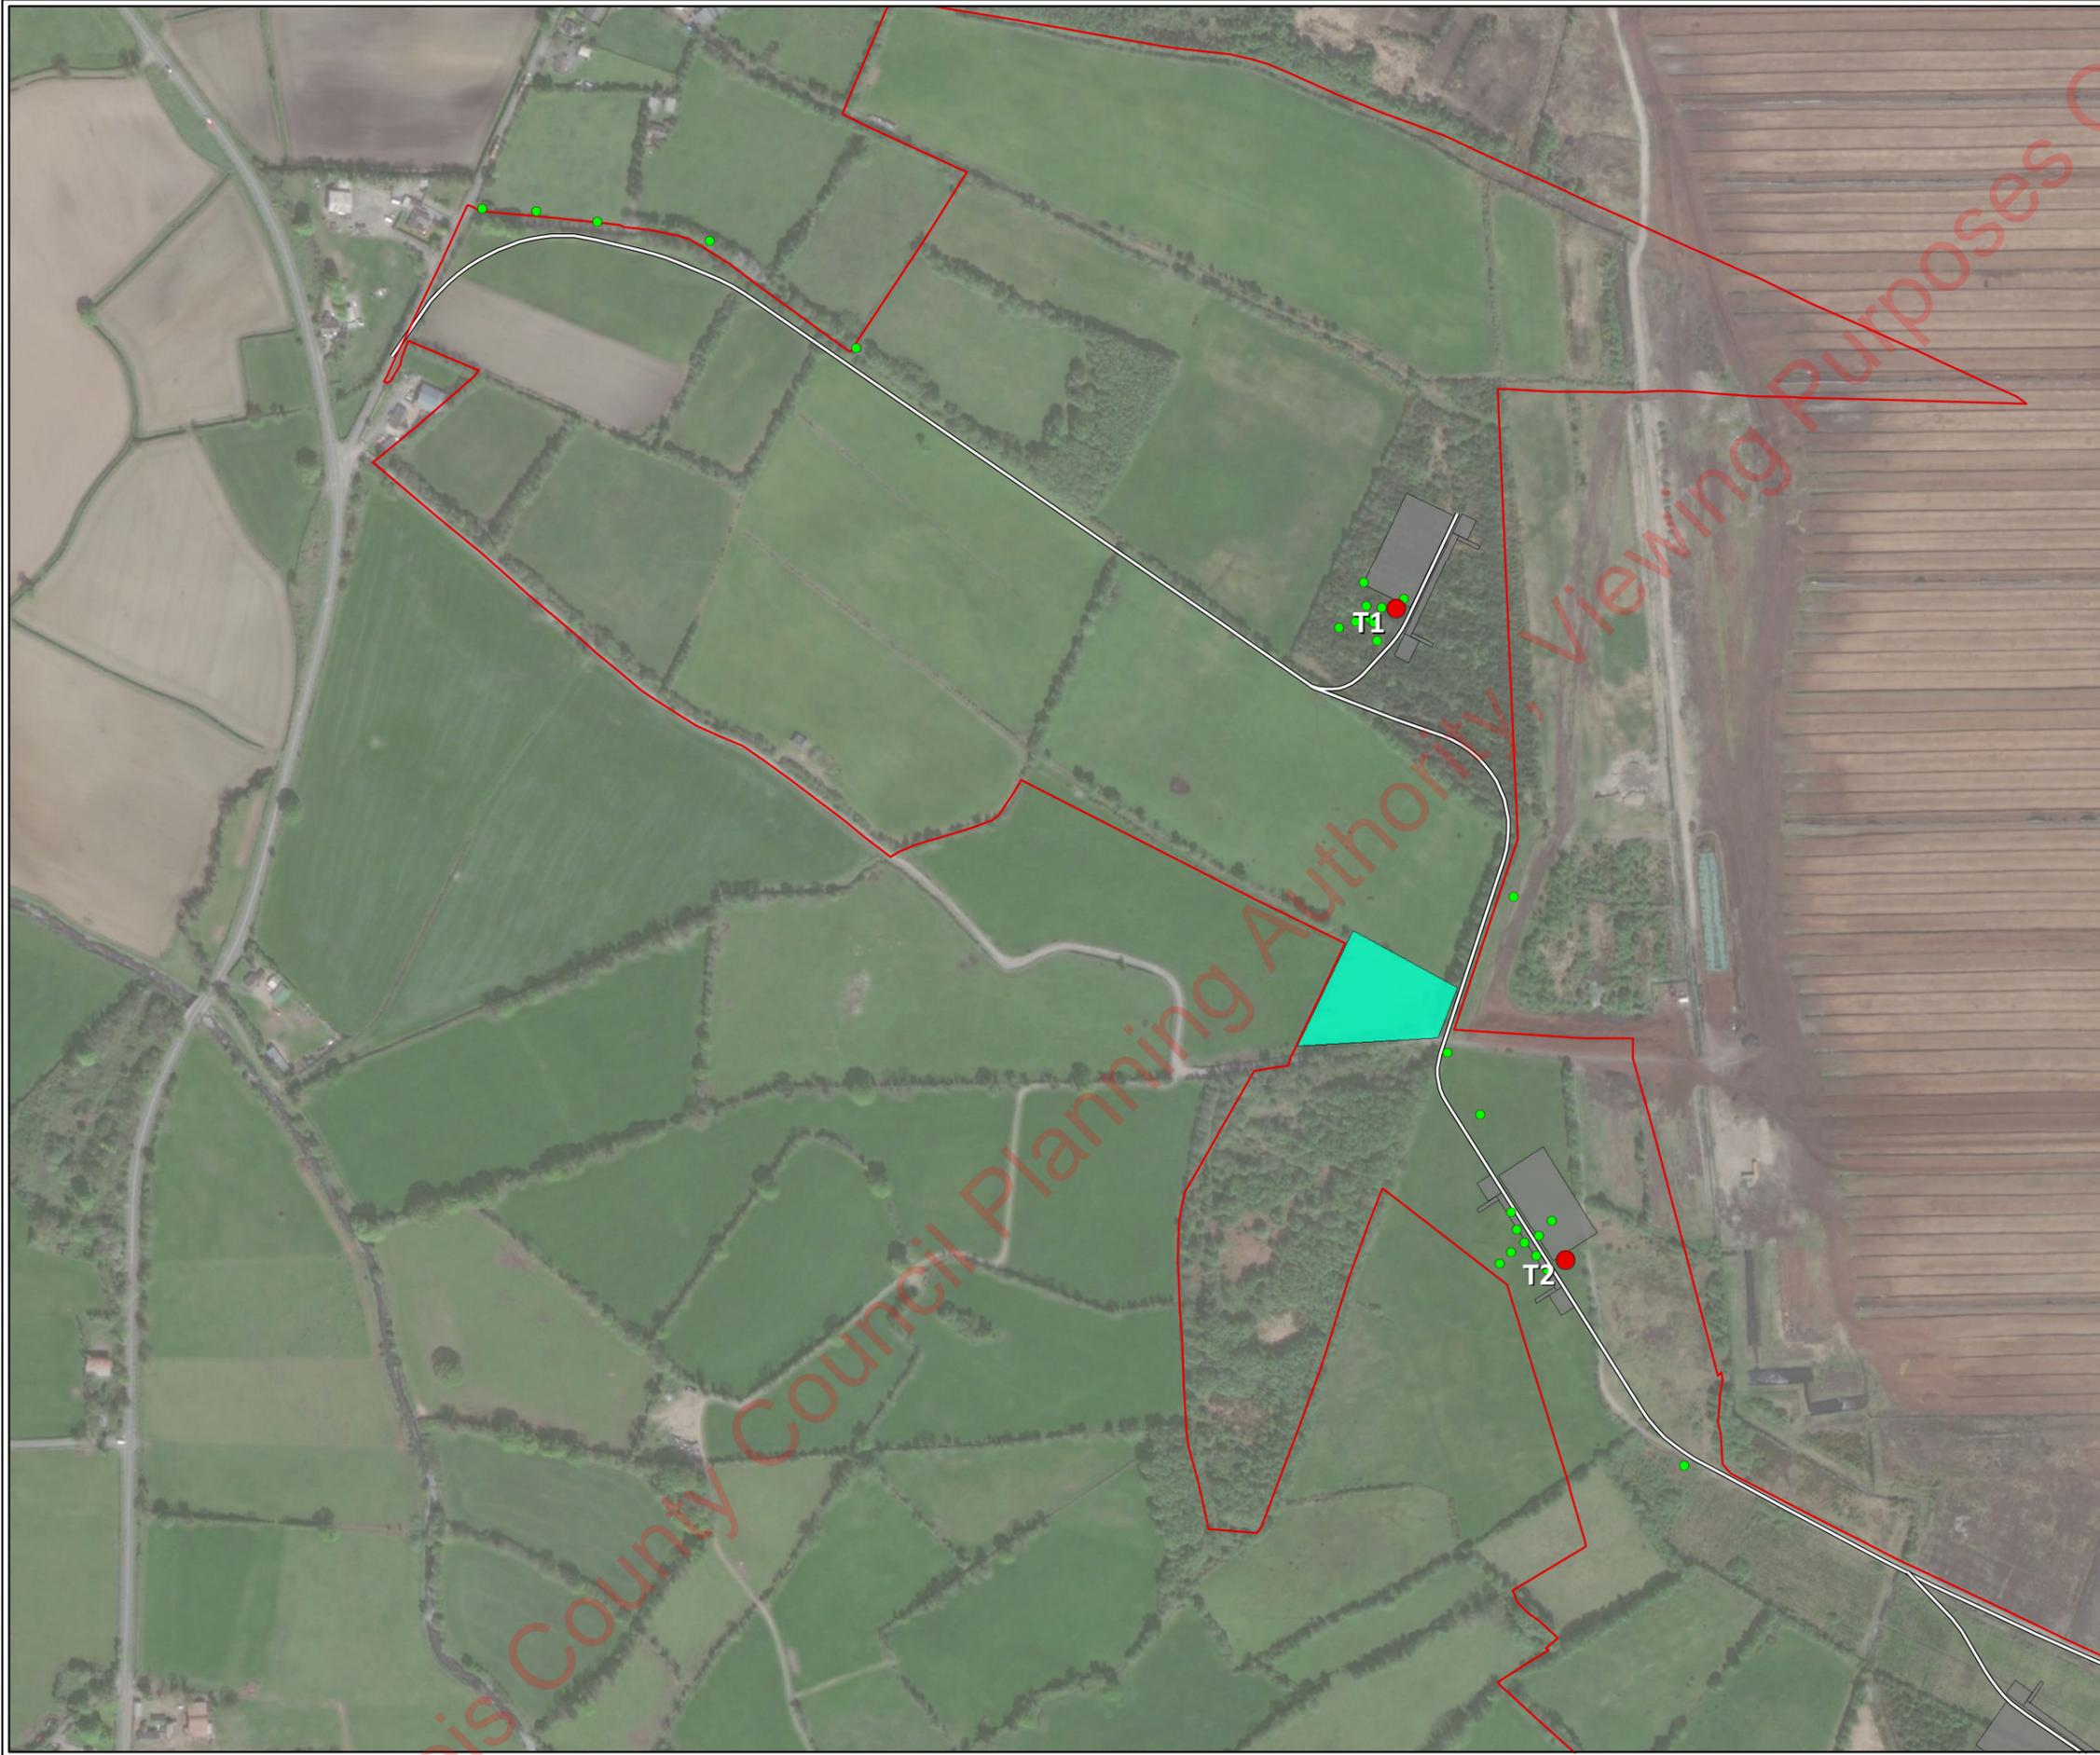
| TITLE: | Factor of Safety | |

- Proposed Turbines
 - Proposed Site Boundary
 - Proposed Access Tracks
 - Proposed Turbine Hardstanding Areas
 - Proposed Temporary Compound
- Factor of Safety**
- 0 < 1.0
 - >= 1.0 < 1.3
 - >= 1.3

Calculated safety ratios when an additional design load of 20kPa is included in the analysis gave rise to lower safety ratios as shown in Table 5.2. No FoS results are recorded below 1.0 with the lowest surcharged FoS of 12.8 recorded at probe location T04.

Figure 5.1 displays the results of the Factor of Safety analysis plotted within the site boundary.
