Site Specific Flood Risk Assessment

Charlestown Place SHD, Charlestown Place and St Margaret's Road, Charlestown, Dublin 11.

Ref: 1726-FRA-R2

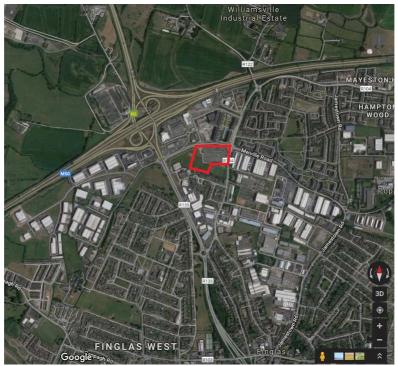
Fig 1 – Site location map (Extract from www.google.com)

The subject site is approximately 3.31 Hectares in size and is located off the Finglas Road/North Road close to the M50 and Junction 5, specifically at Charlestown Place Road/St Margaret's Road (R104) junction, refer to Figure 1. The site currently contains a carpark used as an overflow from the adjacent Charlestown Shopping Centre. The site is bounded to the North by Charlestown Place, to the South by recreational lands, to the East by St Margaret's Road (R104), and to the west by industrial lands.

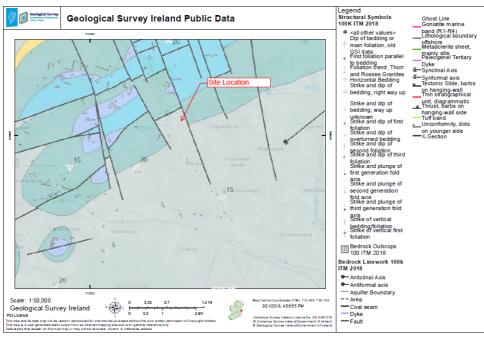
Fig 2 - Geological Survey (Extract from www.gsi.ie)

In relation to the site geology, records in the Geological Survey of Ireland website show that the subsoil within the site and surrounding area consists of Dark limestone & shale (calp). The underlying bedrock is classified as the Lucan Formation, refer to Figure 2, and the associated groundwater vulnerability classification varies in between 'moderate' and 'high' as shown on Figure 3 below.

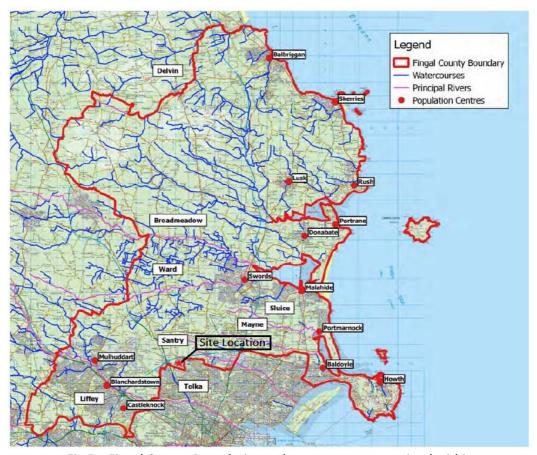
Fig 5 – Fingal County Boundaries and watercourses contained within (Extract from FCC Development Plan 2017-2022)

The SFRA document contains a map with the watercourses and principal rivers located inside the Fingal County Boundaries. Figure 5 below shows the subject site location within Fingal County boundaries and its proximity to existing waterbodies.

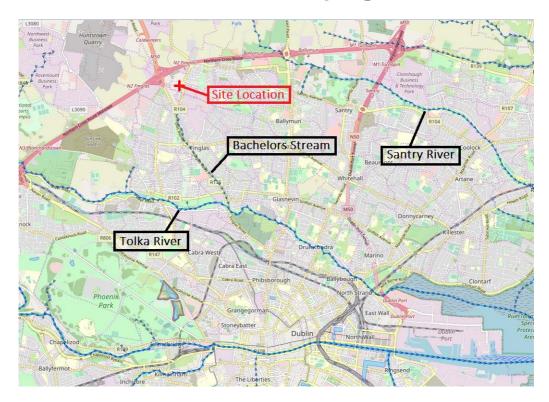
Fig 6 - Existing Waterbodies (Extract from www.gis.epa.ie)

The website operated by the Environmental Protection Agency also provides information about water features such as river networks. Figure 6 displays the area surrounding the subject site. The only waterbody within 1km radii of the site is the Bachelors Stream, also known as Finglas River, which is located approximately 600m from the Southern boundary of the site. The level at the start of the stream is about 4m lower than the subject site. This stream then flows from North to South and discharges into the principal river Tolka, which is located 22m lower than the site level in question.

As mentioned at Section 2 of this report, there is only one waterbody within 1km of the site which is the Bachelor's Stream (Finglas River). Because the subject development land is positioned at a higher level than the flood risk, and the predictive flood maps highlight the site is not in the flood extent, it is therefore the opinion of Pat O'Gorman & Associates that the risk of fluvial flooding on this site is low.

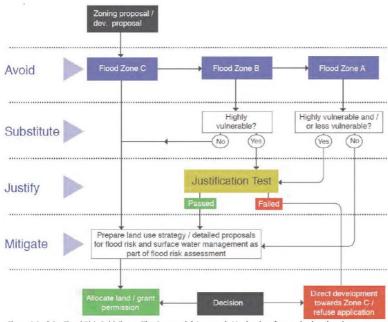
Fig 8 – Sequential Approach

When assessing the flood risk associated with this site, each developer is obliged to carry out the sequential approach for a proposed development, as per shown in Figure 8. If the proposed development is situated in a Flood Zone C, the justification test is not required. If the site is located in Flood Zones A or B the need for a Justification Test depends on the vulnerability of the proposed development. For all cases, it is still required that flood risks are assessed and a surface water management strategy is provided.

Figure 3.2 of the Flood Risk Guidelines - The Sequential Approach Mechanism for use in the planning proces

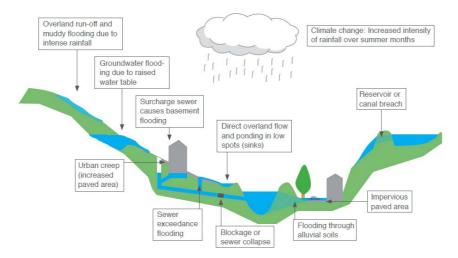
Fig 9 - Potential Sources of flooding

The geographical location of a site affects its vulnerability to flood sources. These sources are wide-ranging as shown in Figure 9.

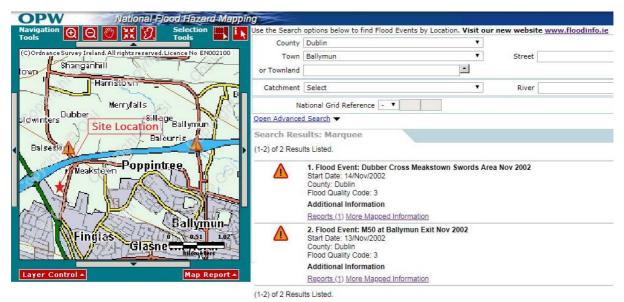
Fig 10 – Recorded Flood Events (Extract from www.floodmaps.ie)

Historic flooding information was collected from OPW National Flood Hazard Mapping for the subject development and its immediate surroundings, refer to Figure 10. The nearest flood event happened in October 2002 close to the townland of Meakstown which is located around 650m to the North East of the subject site. See Appendix 5.1 for Flood Report where it is stated that the Dubber Cross pumping station was flooded with surface water from a nearby ditch.

Another flood event was recorded in November 2002 on the M50 at the Ballymun Exit around 2.6km away from the development in question. Appendix 5.1 presents the Report on Flooding in Fingal Area. It is said that severe flooding occurred on this occasion but remedial measures to road drainage have already been undertaken.

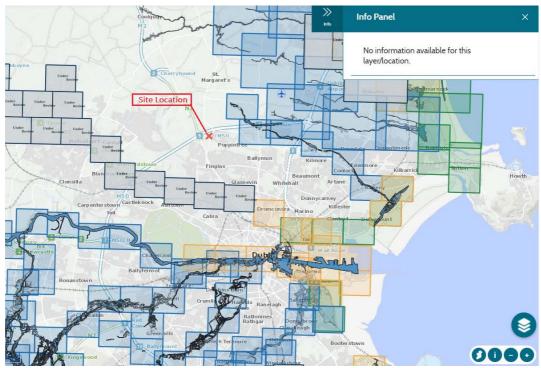
Fig 11 - Fluvial Flood Extents and Areas Further Assessed (Extract from www.floodinfo.ie)

The Flood Mapping shows the subject site is situated outside the predicted 1:100 flood zone, which means site is in Flood Zone C. See Appendix 5.2 for PFRA Flood Extent mapping. The surroundings of the subject lands were not identified as an area at risk of significant flooding by the OPW, which means it was not included in the Areas for Further Assessment of the CFRAM study. Most up-to-date Fluvial Flood Extents mapping extracted from floodinfo.ie website confirms this information, as per shown in Figure 11.

The SFRA document also endorses the site is located in Flood Zone C, refer to Appendix 5.3 for SFRA Flood Extent mapping. The flood zones contained in this document were derived from FEFRAM study and the Tolka Flooding Study mapping. These maps are the most comprehensive flood maps produced for Fingal since the introduction of the Guidelines and the Flood Directive.

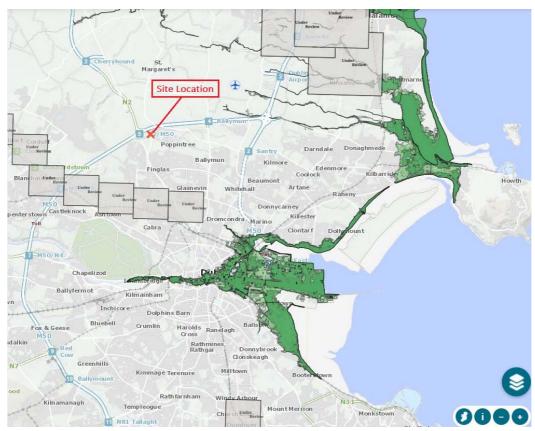
Fig 12 - Coastal Flood Extents (Extract from www.floodinfo.ie)

Figure 12 below shows the most recent Coastal Flood mapping extracted from the floodinfo.ie website operated by the OPW. The subject site is situated in Flood Zone C in regards to Coastal Flooding.

Given the distance to the coast and the elevation of the site it is the opinion of Pat O' Gorman and Associates that the risk of coastal flooding is extremely low.

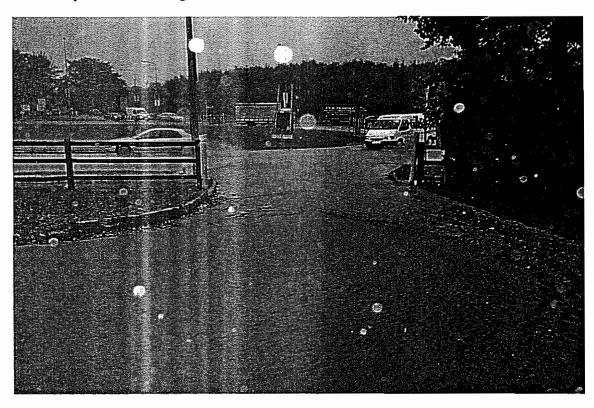
The surface water screens in property are unable to take the volume of surface water and overflowed (see Area Engineer report 10/2/01), this in turn floods the Little Chef. In order to prevent flooding of Little Chef the surface water is diverted on to Dublin/Belfast Road as can be seen from photographs. The Drainage Section provided sandbags to the Little Chef.

Flooding of Dublin/Belfast Roundabout at Little Chef

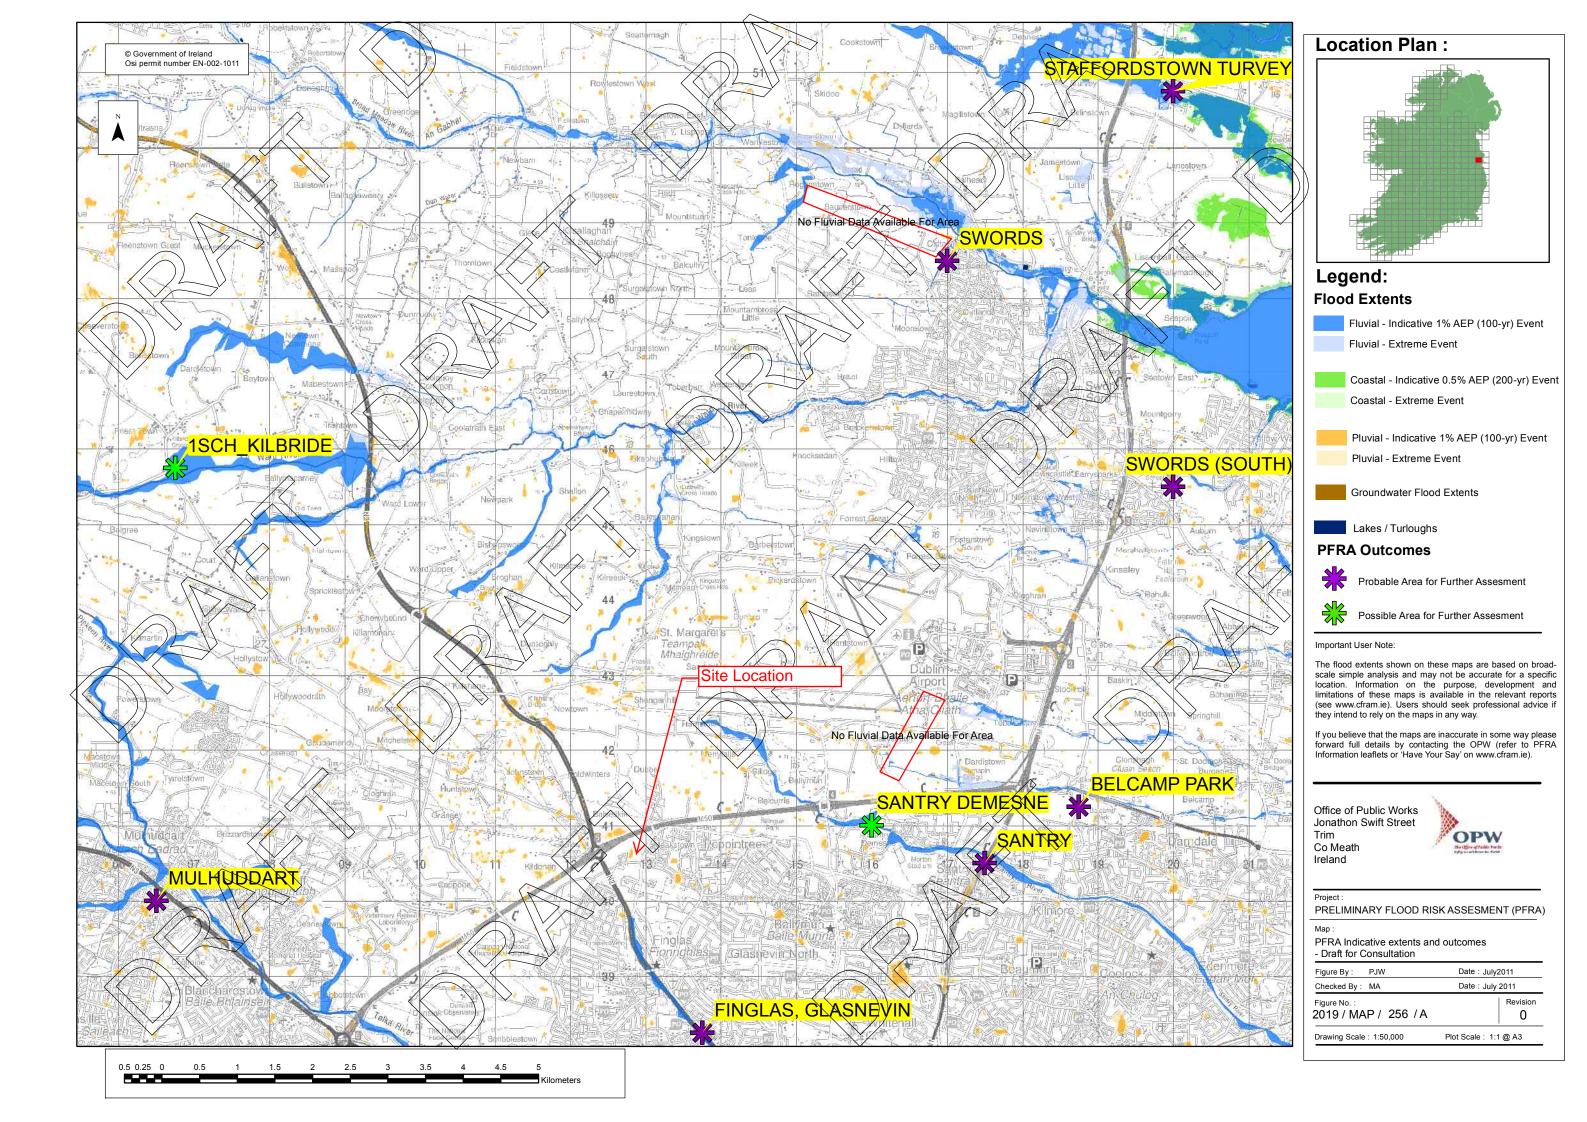
PFRA Fluvial, Coastal, Pluvial and Groundwater Flood mapping

The PRFA mapping mentioned in Section 3.2.1 and shown in Appendix 5.2 also provides the predicted 0.5% AEP Coastal Flood Extents. It is easily identified that the subject site is located further inland in comparison to the Coastal Flood Extent.

The PFRA mapping mentioned previously and provided in Appendix 5.2 shows the subject site is located in the 1% AEP Pluvial Flood Extent.

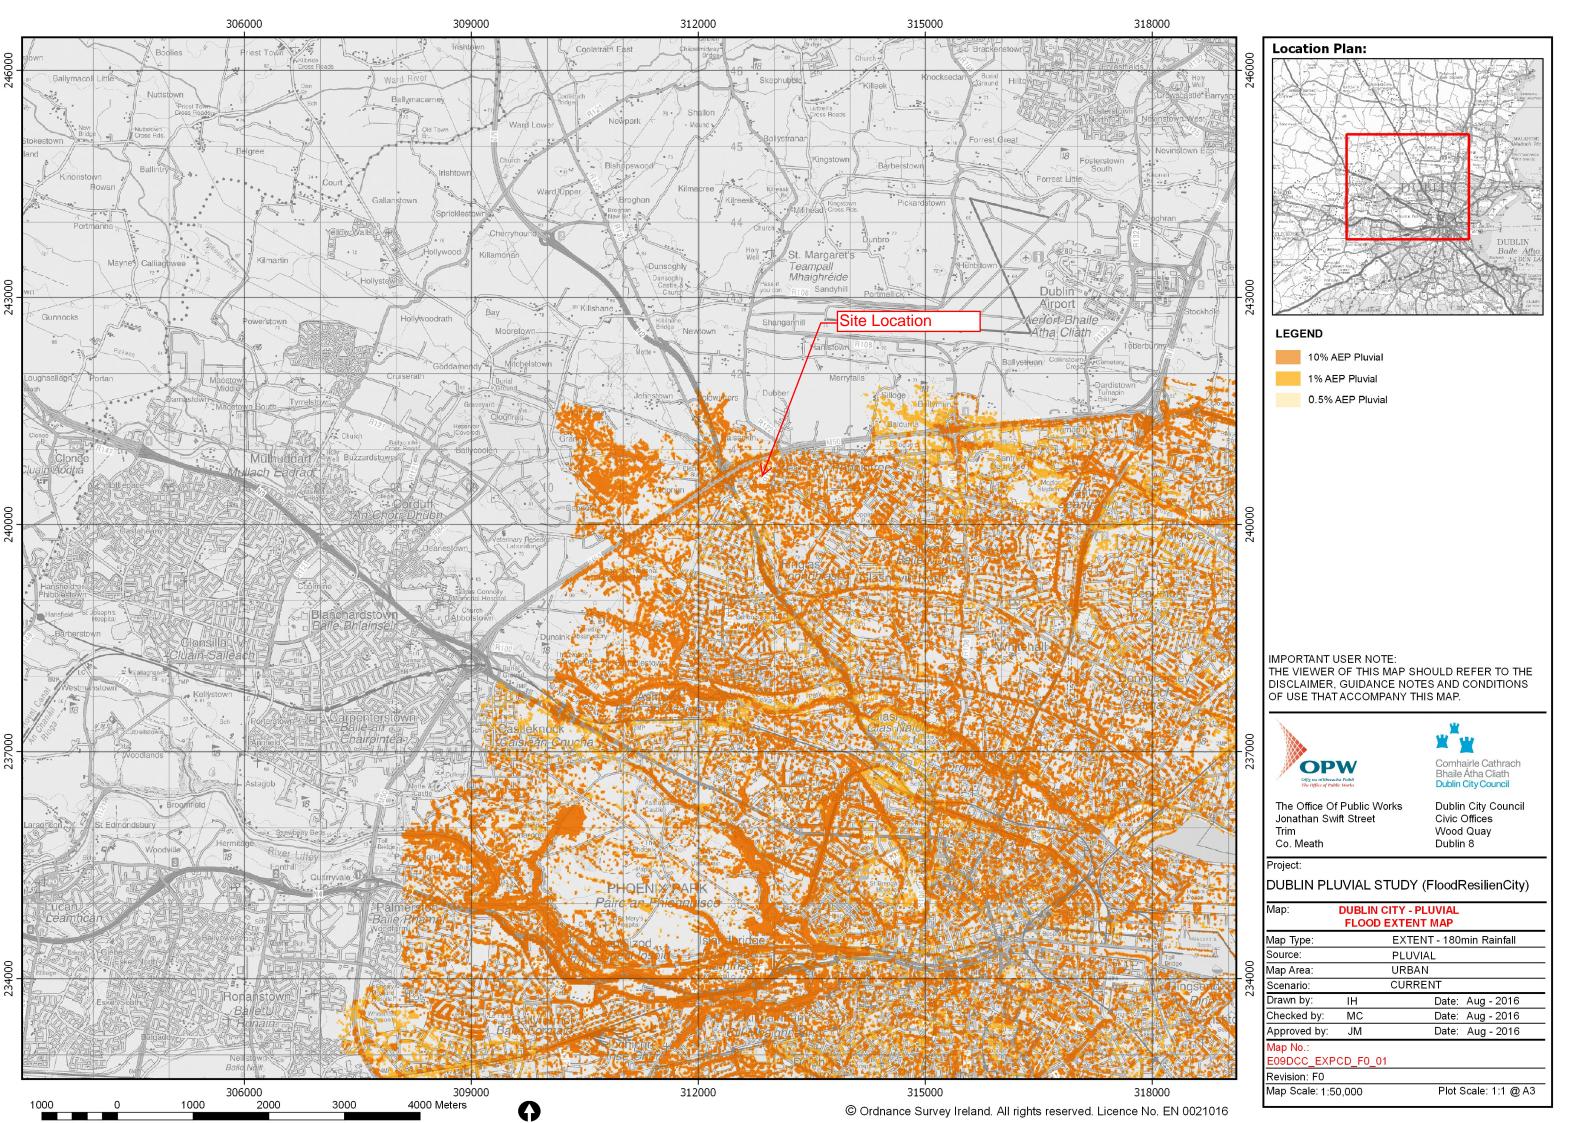
OPW Dublin Pluvial Study mapping

Appendix 5.4 presents the most up-to-date Pluvial Flood Extent mapping extracted from floodinfo.ie website in which the subject site is located within the 1% AEP Pluvial Flood Extent (1 in 100 year event) and the 10% AEP Pluvial Flood Event (1 in 10 year event).

Regarding the pluvial water that falls in the surrounding areas, the existing drainage network recorded under the Charlestown Place Road and the St Margaret's Road should be able to cater for the surface water from the public roads. It is thus our opinion that the risk of pluvial flooding on this site is low.
