Charlestown Place SHD

Quality Audit - Stage 1

Puddenhill Property Limited

February 2021

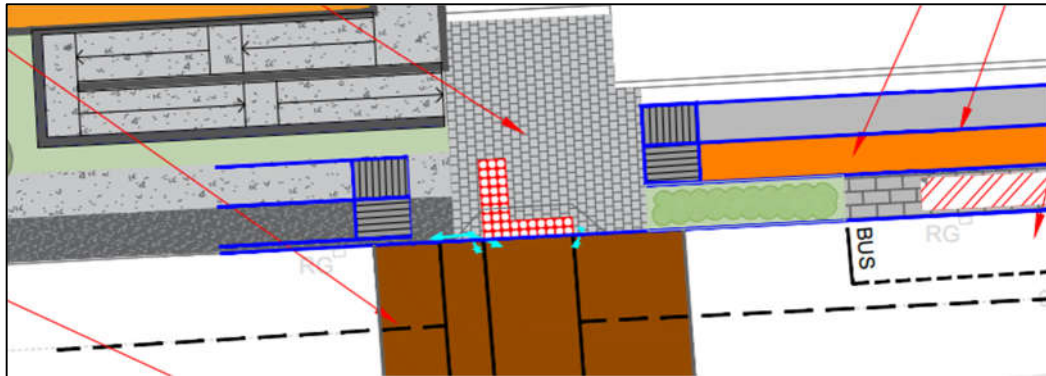
Figure 2-1 – Northern approach to the Charlestown Place crossing

Location: At the Northern approach to the Charlestown Place crossing

The alignment of the pedestrian and cyclist facilities either side of the shared crossing could result in collisions as users move from their desire lines to continue on their respective paths. This could lead to an increase in pedestrian and cyclist collisions resulting in injuries.

The Design Team should consider realigning the cycle track and footpath facilities on the east approach facilitate desire lines.

2.1	Y	N	To address this item, the layout has been amended to introduce the interface between the shared area and cycle track / footpath earlier on both approaches so as to allow pedestrians and cyclist more space and time to mix with one another in advance of the crossing. This will facilitate users to be familiar with one another's movement and desire lines and reduce potential conflict.	Y

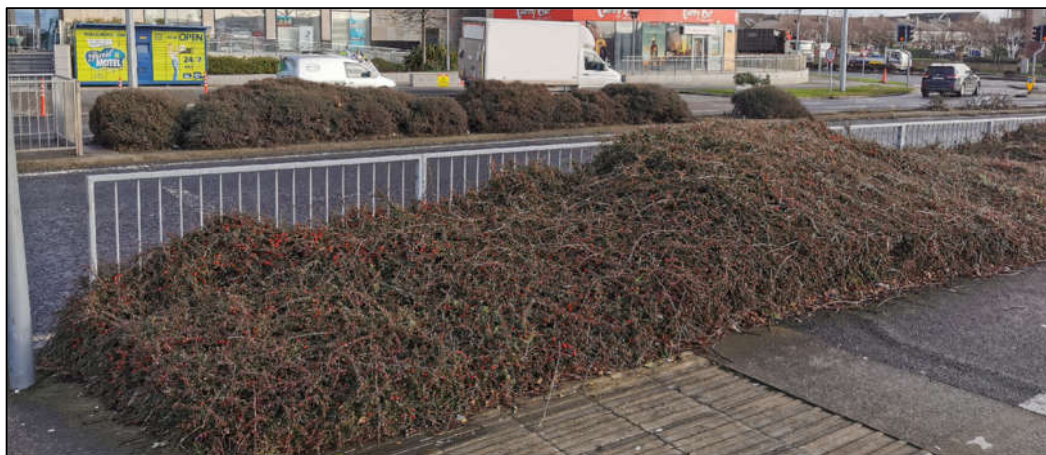
Figure 2-2 – Hedge Rows at the Charlestown Place Crossing

Location: At the Charlestown Place Crossing

During the site visit it was noted that the hedge rows in the vicinity of the Charlestown Place crossing were growing unkempt. Unkempt hedge rows reduce visibility between vulnerable road users at crossing and vehicles on the carriageway. In the event of out of order signals at the junction, VRU's would use the crossing as an uncontrolled crossing and this could result in potential pedestrian vehicle conflicts due to poor visibility. This could result in serious or fatal VRU injuries.

The Design Team should consider protocols for ensuring the maintenance of the hedgerows to provide sufficient visibility at the crossing.

2.2	Y	Y	The design will specify appropriate low ground cover (basic ivy) planting which typically does not grow above 300-400mm within the central median. It should be acknowledged that there are no barriers proposed which can encourage overgrowth. This will ensure visibility can be maintained.	Y

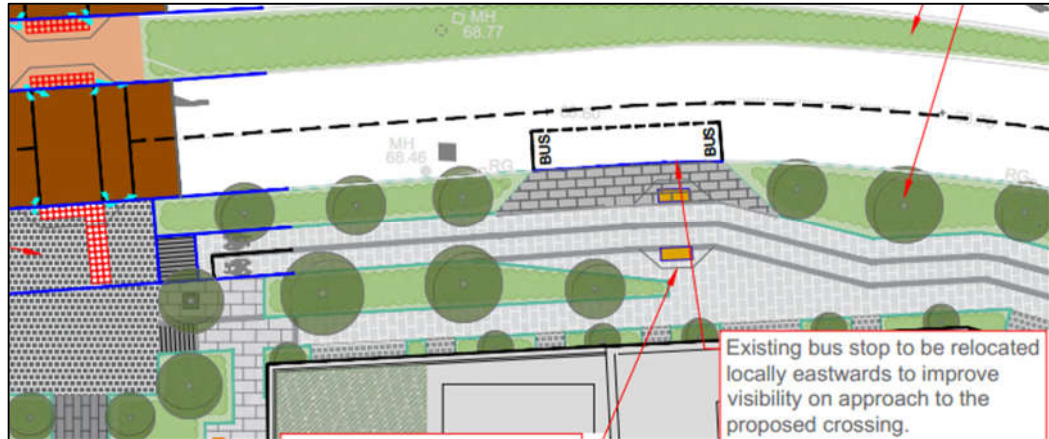
Figure 2-3 – Bus Stop on the Westbound Carriageway of Charlestown Place

Location: At the Bus Stop on the Westbound Carriageway of Charlestown Place
Passengers boarding/alighting at the bus stop may, if coming from our going to the crossing, chose to follow the direct desire line which would take them through the cycle track. This could lead to an increase pedestrian and cyclist collisions resulting in injuries.

The Design Team should consider rearranging the cycle and footpath facilities so as to encourage pedestrians away from utilising the cycle track.

2.3	Y	N	To address this item, the design will be amended to place the main footpath directly adjacent the cycle track.	Y
2.4	Y	N	Similar to the measure put forward in 2.1, the layout will be amended to introduce the interface between the shared area and cycle track / footpath earlier on both approaches so	Y

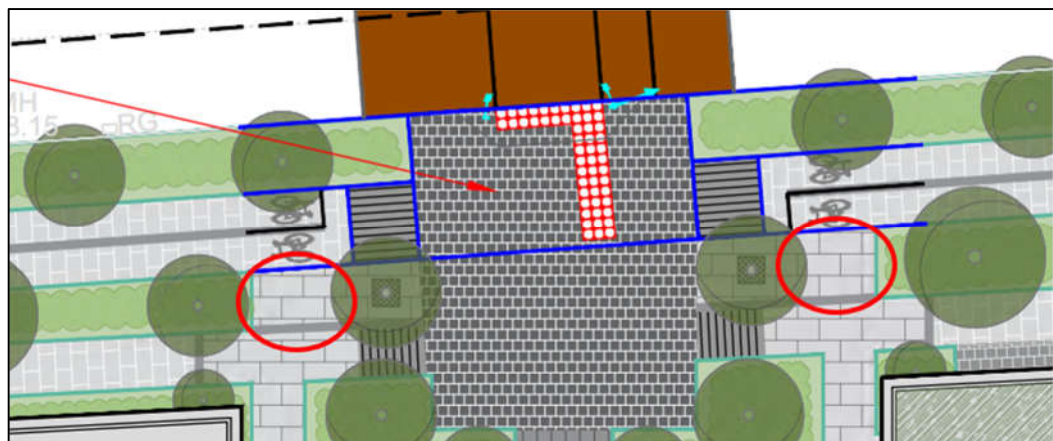
Figure 2-4 – Southern approach to the Charlestown Place crossing

Location: At the Southern approach to the Charlestown Place crossing
Breaks in the line of vegetation as pictured in Figure 2-4 below may lead pedestrians into the path of cyclists utilising the cycle track. This could lead to an increase pedestrian and cyclist collisions resulting in injuries.

The Design Team should consider planting at this location to restrict pedestrian movement in the cycle track and encourage a desired approach to the crossing.

as to allow pedestrians and cyclist more space and time to mix with one another in advance of the crossing, and associated urban space. This will facilitate users to be familiar with one another's movement and desire lines and reduce potential conflict.	
2.5	Y	Y	The crossing location and associated tactile paving will be relocated southwards to line up with the desire line between the pedestrian and cycle tracks on either side of the street.	Y
2.6	Y	Y	The design will specify appropriate low ground cover (basic ivy) planting which typically does not grow above 300-400mm adjacent the junction radii. The proposed trees, whose canopies will be specified to lie approximately 2m above ground level, lie outside of the required visibility splays and this will be demonstrated on the engineering drawings.	Y

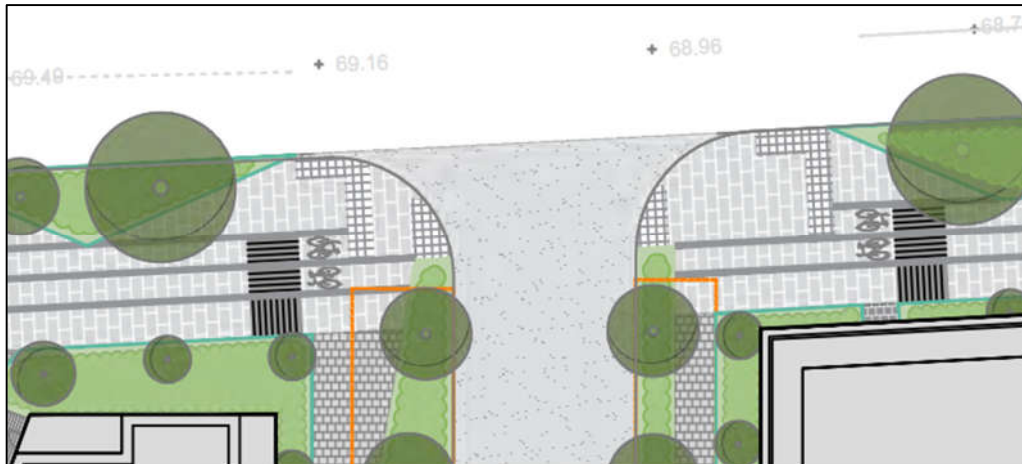
Figure 2-5 – Northern approach to the Charlestown Place crossing

Location: At the Southern arm of the Charlestown Place junction

The crossing on the southern arm of the Charlestown Place junction is off the main desire line. Cyclists and pedestrians looking to cross at this location may choose to carry out a more direct crossing which could result in slips, trips and falls into a live trafficked carriageway resulting in injuries. In addition, the crossing position creates a conflict between pedestrians and cyclists as pedestrians may cross into the cycle path for a direct route to the crossing resulting in conflicts with cyclists.

The Design Team should consider setting back the crossing in line with the crossing desire line.

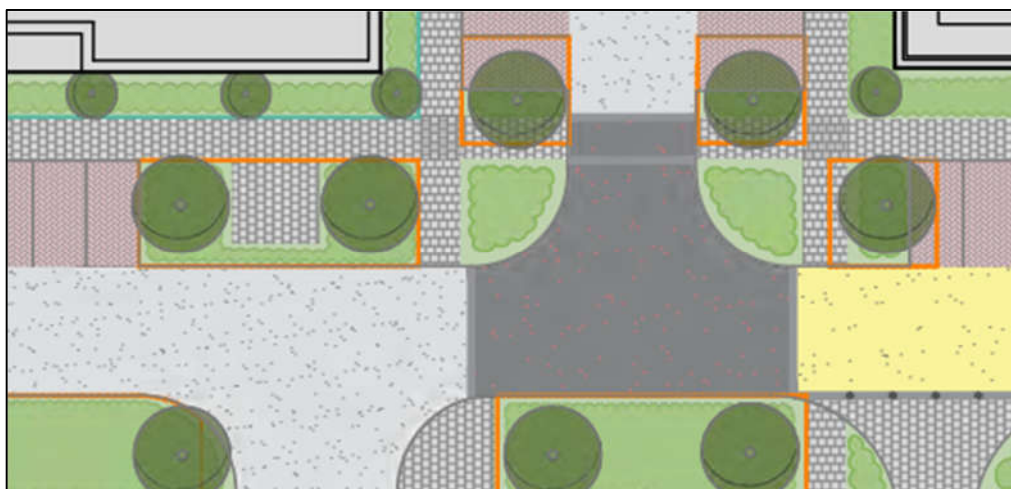
Figure 2-6 – Example of Visibility Obstruction at Junctions throughout the proposal

Location: At Junctions throughout the proposal

The proposal describes the location of tree planting in close vicinity to several of the junctions throughout the scheme. Vehicles manoeuvring the junction or utilising the car parking spaces may have their views obstructed by the trees. This could result in side impact or rear end type collisions which may cause material damage, serious or fatal injuries.

The Design Team should ensure visibility splays are maintained.
