11 Archaeological, Architectural and Cultural Heritage

This is the Archaeological, Architectural and Cultural Heritage chapter of the Arklow Flood Relief Scheme (FRS) EIAR. This chapter of the EIAR describes the baseline archaeological, architectural and cultural heritage environment and identifies the likely significant impacts (positive and negative) on this environment, associated with the site preparation, construction and operation phases of the proposed scheme.

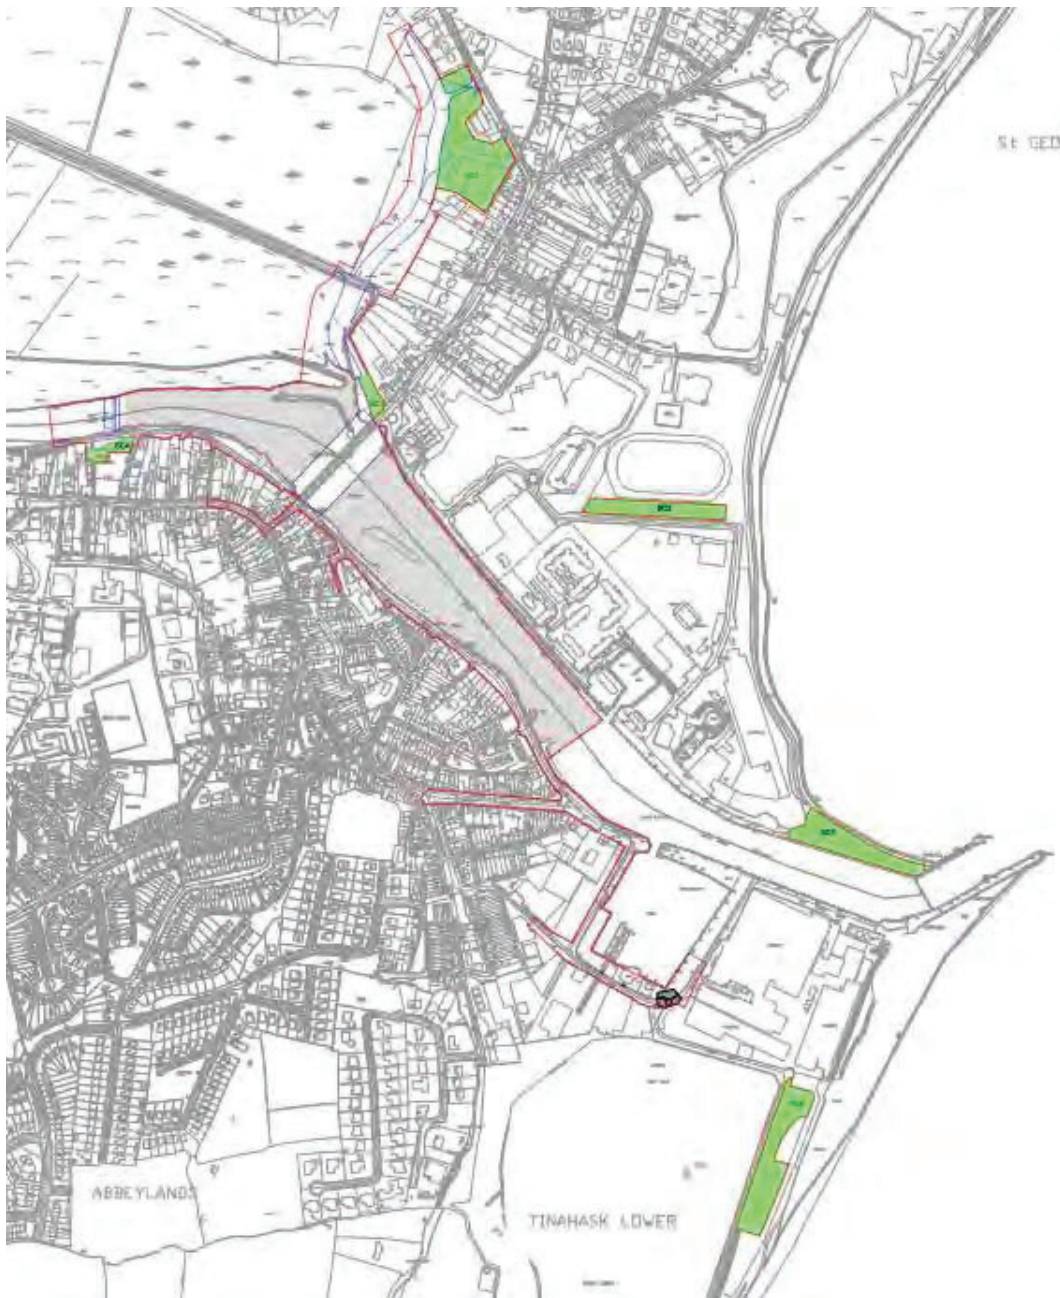
Figure 11.1: Study Area (extracted from drawing no 1065 in Appendix 4.1). Not to scale.

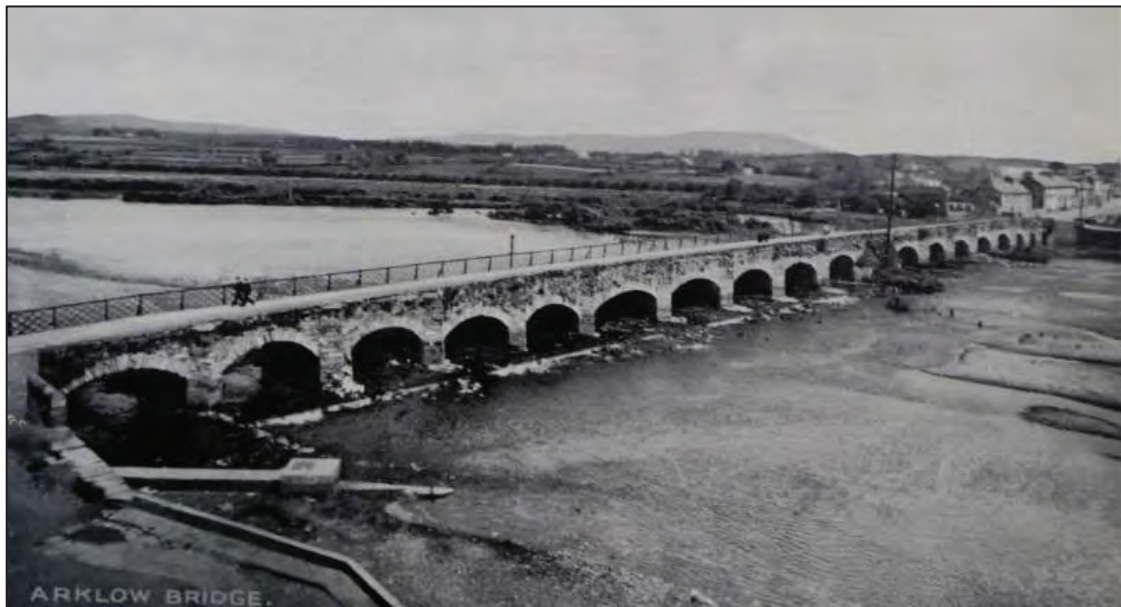
Figure 11.8: Photo of Arklow Bridge, date unknown, taken from the South Quay showing the bridge in advance of the modern interventions., showing the wrought iron pedestrian pathway and oil lamps

The bridge presents as a nineteen-arch, stone-built, road-bridge over the Avoca River. It has a large central pier with cutwaters to both the north and south sides of the other smaller piers. The arches have roughly dressed voussoirs with areas covered in cement render above. The low parapet is also cement rendered and is topped with c. 1960s replacement metal railings (NIAH 2020).

In 1959, it was widened in order to cope with increasing traffic levels. As a result, the upstream elevation of the bridge is disguised and replaced by the presence of three concrete uprights which support the modern decking. This reinforced concrete substructure accommodates an additional carriageway and a footpath on either side of the bridge.

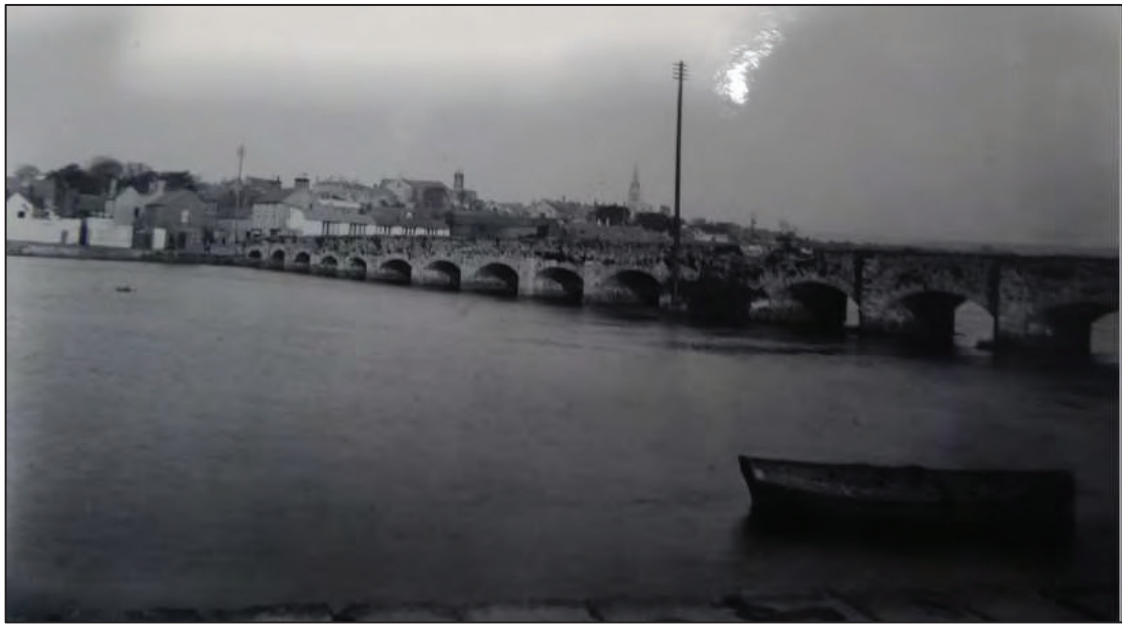
Figure 11.9: Photo of Arklow Bridge, date unknown, taken from the North Quay showing the bridge in advance of the addition of a reinforced concrete structure

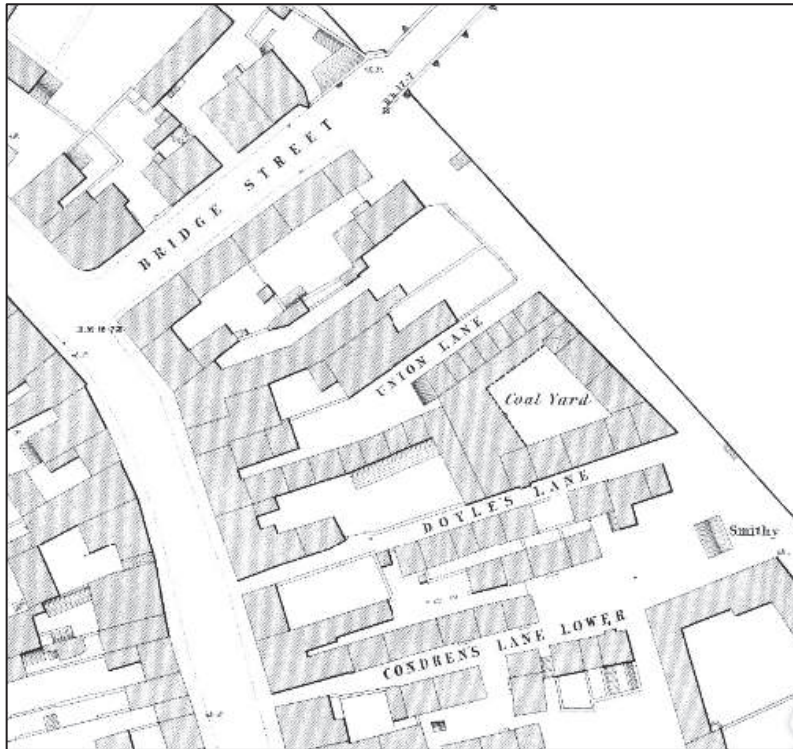
Figure 11.10: 1885 OS Map of Arklow 1:500 scale (Sheet XL.16.18) showing the line of the south quays but development to the south of Arklow Bridge

The south quay is first shown and annotated on the 1885 OS Map of Arklow, 1:500 scale (Sheet XL.16.18 and 16.24), (**Figures 11.10 and 11.11**) and again on the 1910 25-inch revised OS mapping. By all accounts, the south quay was constructed at a later stage to the north quay which began in 1814 (see cartographic section of the report). The north quay will not be disturbed by the proposed works while sections of the south quay wall will be preserved in-situ and buried beneath the proposed flood infrastructure.

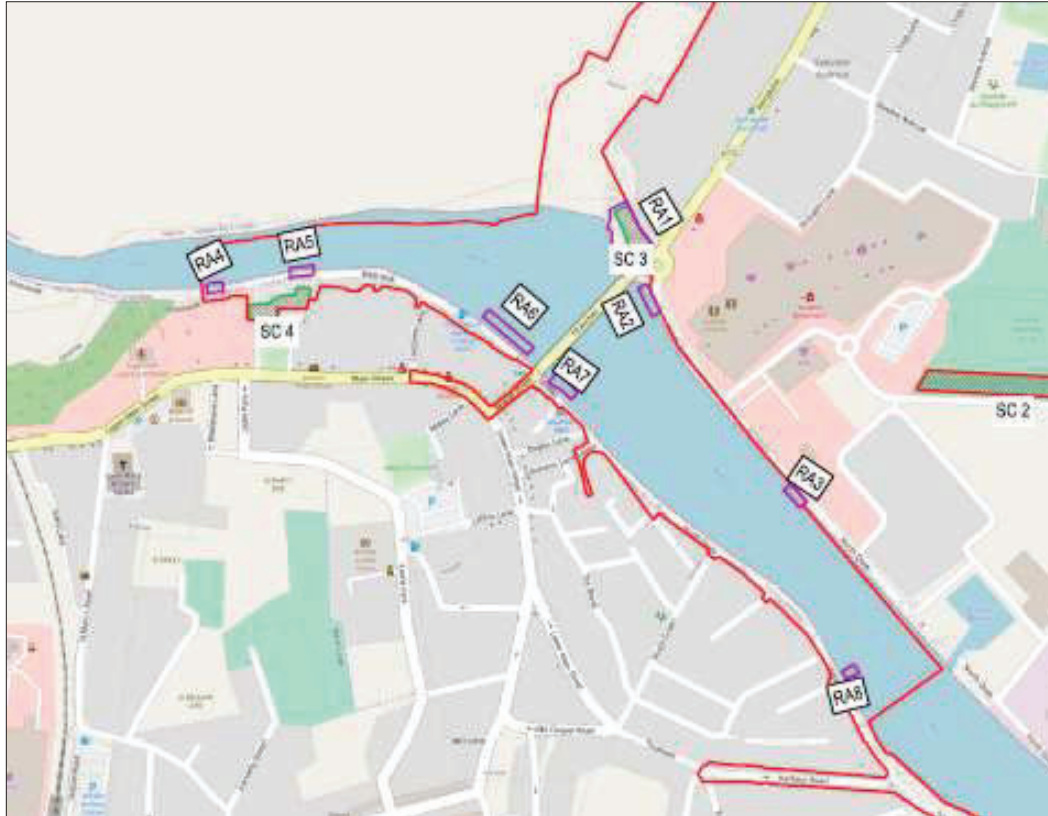
Figure 11.45: River Access Locations (extracted from Figure 5.3 of Chapter 5 -refer to Fig 5.3 for more details) Not to scale. Extracted from Drawing No 1003

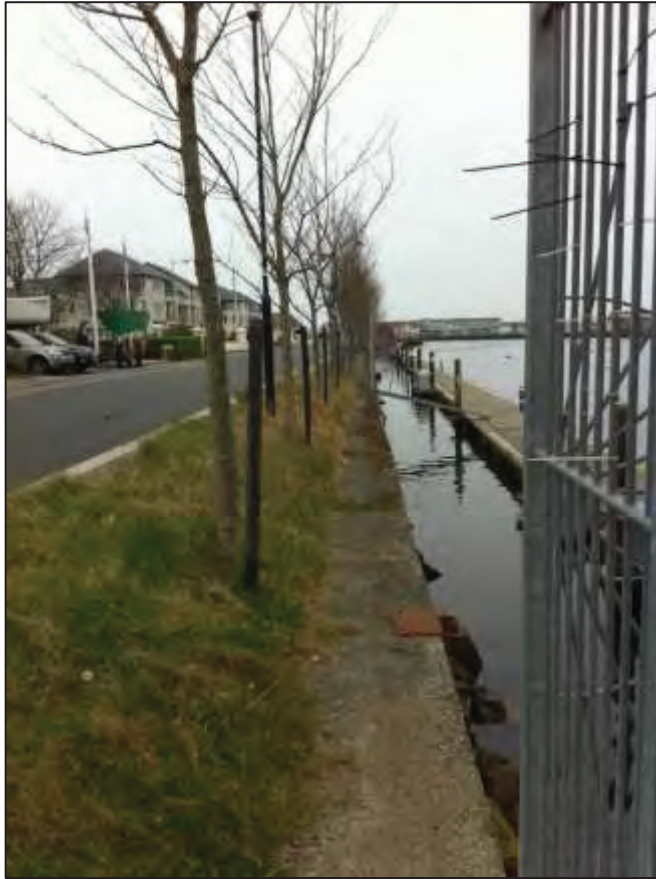
Figure 11.49: View of North Quay at RA3

RA3 is located on the north quay and examination of the quay side will have to take place in advance of the river access works to establish the presence of original quay material (**Figure 11.45**). At this location, a concrete caisson solution marks the North quay. There are galvanized gangways to access the floating pontoon (**Appendix 11.6**, ADCO, Brady, Plate 25 and 26).

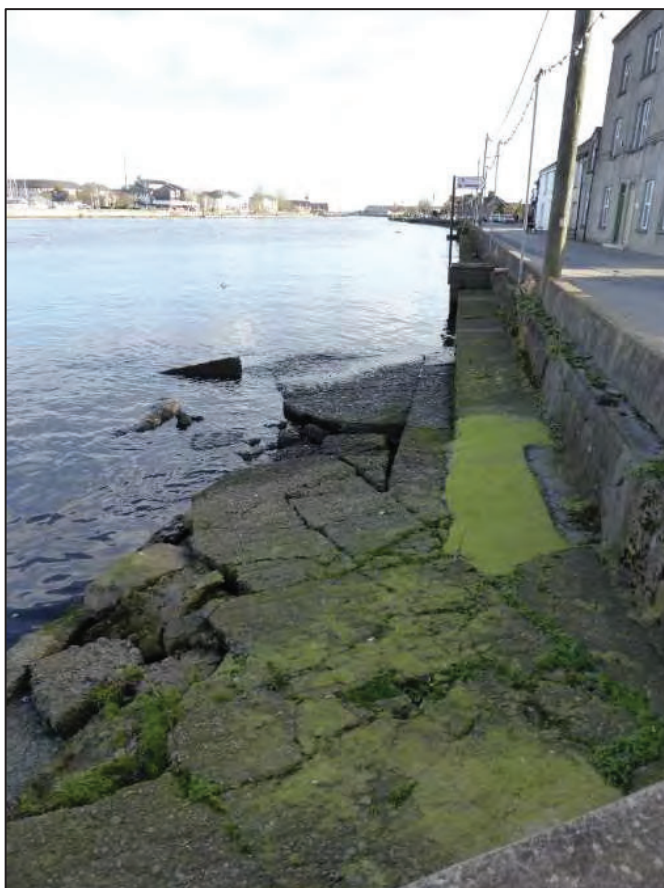
Figure 11.54: Looking southeast from Arklow Bridge towards RA7 and ruined concrete slipway at Coal Quay
