Proposed Strategic Housing Development  
“Kenelm”  
Deer Park  
Howth  
Co. Dublin

**VOLUME III**  
APPENDICES TO ENVIRONMENTAL IMPACT  
ASSESSMENT REPORT

# **DAYLIGHT AND SUNLIGHT ANALYSIS**

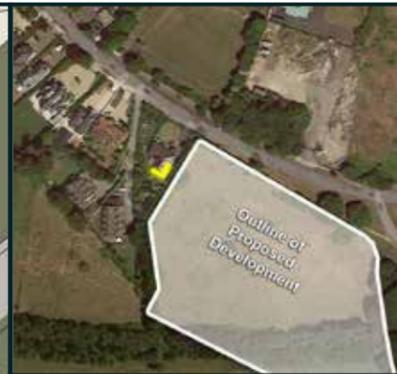
Highlighted areas indicate the position of assessed windows on Tig Bhríde.

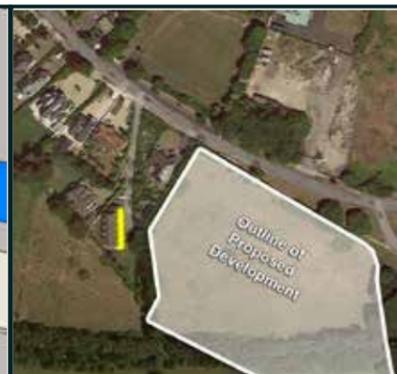
Highlighted areas indicate the position of assessed windows on Windwood.

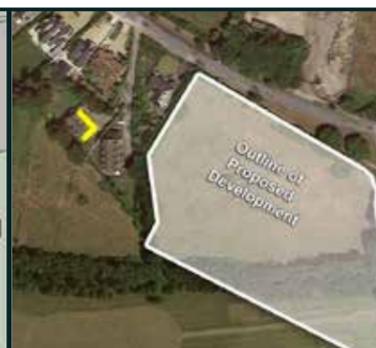
Highlighted areas indicate the position of assessed windows on Kincora Lodge.

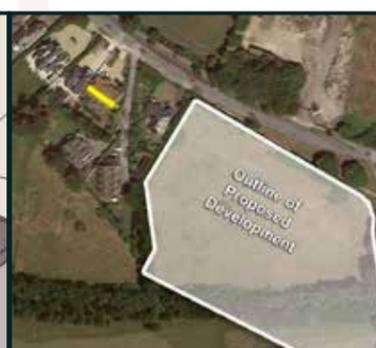
Highlighted areas indicate the position of assessed windows on Baltray.

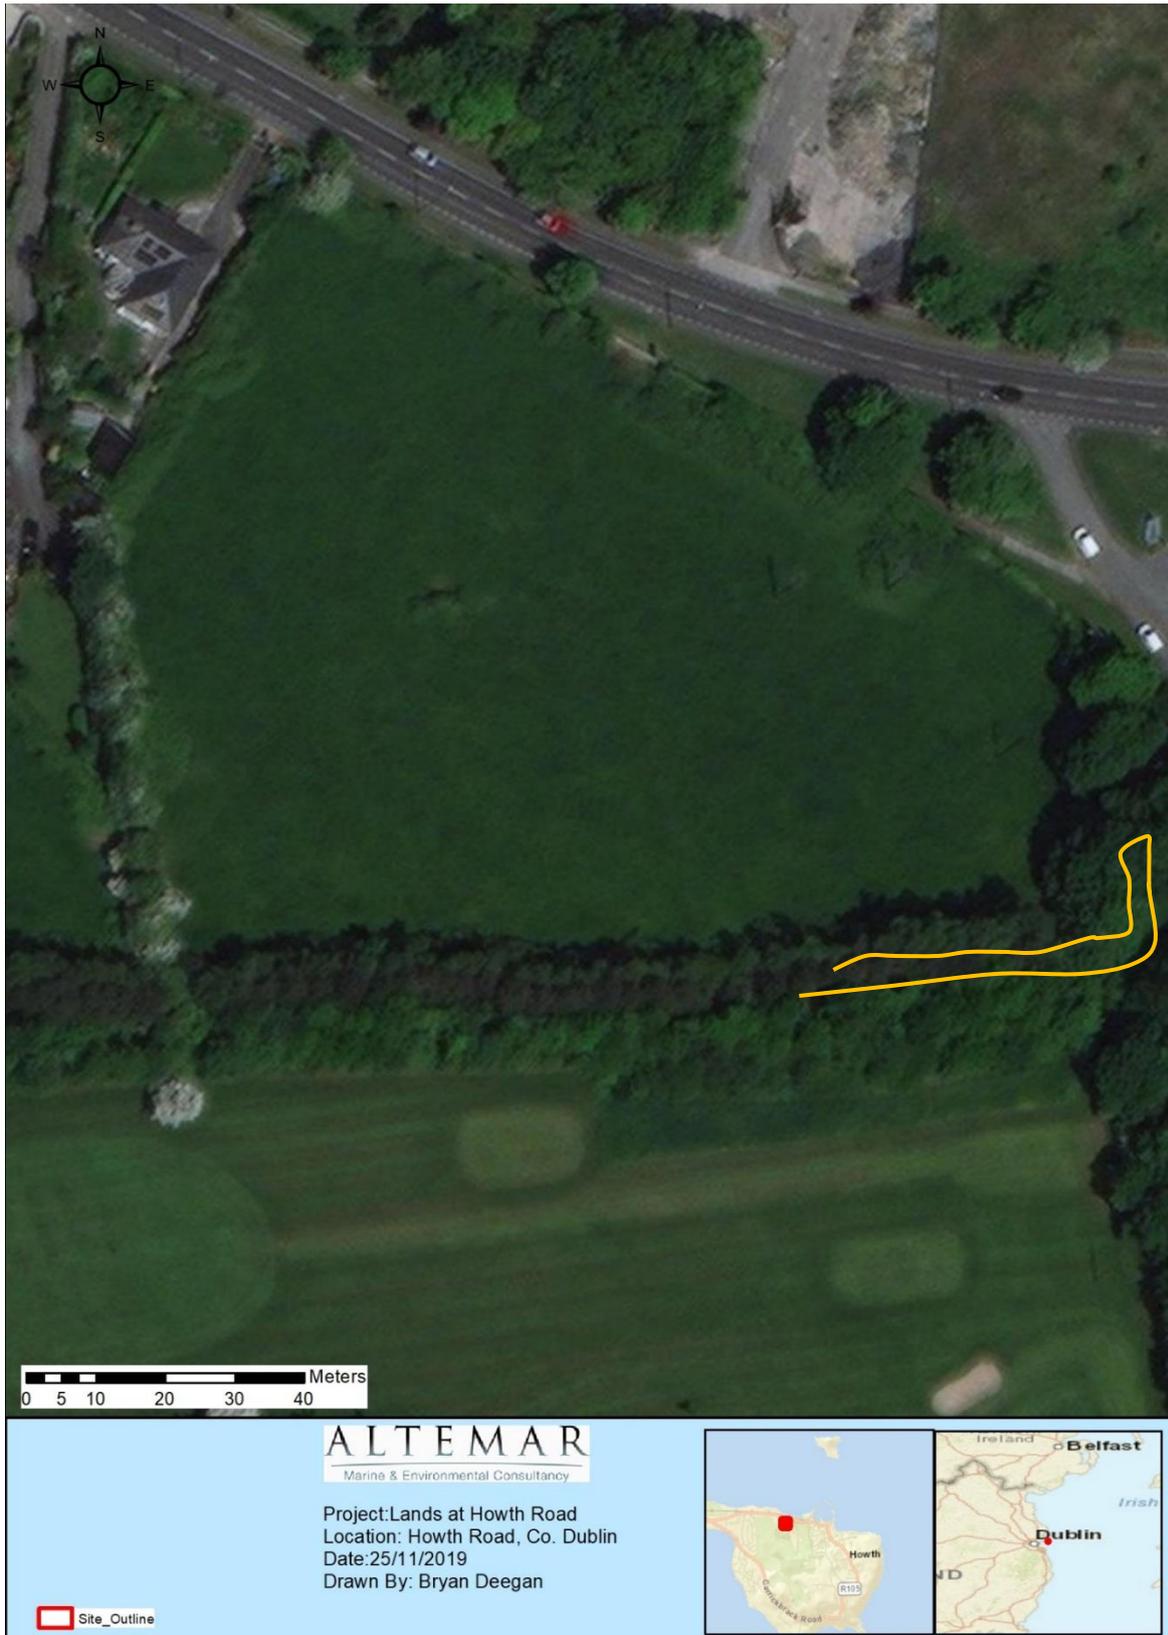
Two bats (soprano pipistrelle) were noted foraging on site along the field boundaries seen in Figure 2. No bats were detected emerging from any of the onsite trees.

**Figure 2.** Soprano pipistrelle feeding activity (yellow) and two Ash of bat roosting potential.

No buildings or structures of roosting potential were present on site. In relation to bat roosting potential the site was poor. The site comprised of a field surrounded by mature hedgerows. The trees within the immature woodland area, that is to be removed, were relatively young and did not possess features of bat roosting potential e.g, cracks, crevices etc. The hedgerows were of poor roosting potential due to the small size of the trees across the majority of the hedgerows. No cracks or hollows were noted in the trees. However, the treeline along the road to Howth Castle was large and mature and was likely to possess features of bat roosting potential.

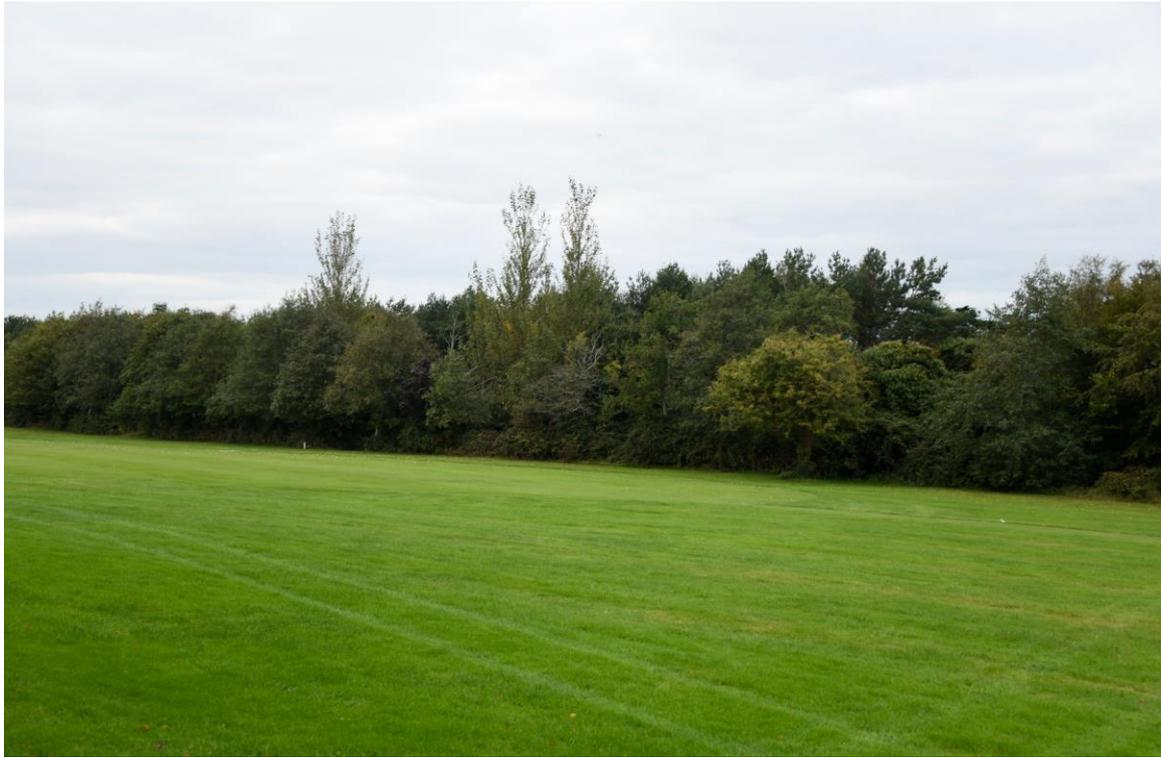
Plate 1. Immature Woodland (section to be removed).

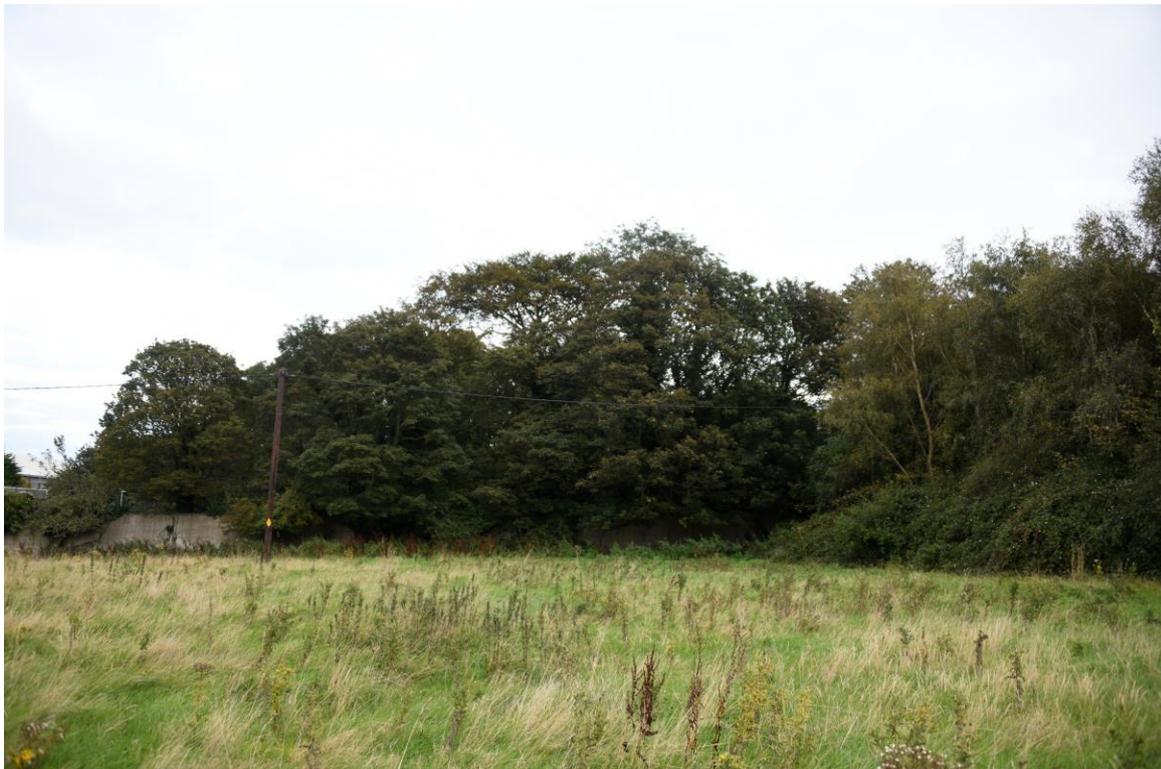
Plate 2. Mature treeline (to be retained).

As no evidence of a bat roost was noted onsite, no mitigation measures in regard to these animals are needed during the proposed works. There is also no requirement for a *National Parks and Wildlife Service* derogation licence application to allow the planned works. The exterior treelines to the east must be retained (Plate 2). Additional planting of native hedgerows should be planted where possible, forming linear features and dimly lit foraging corridors where possible.

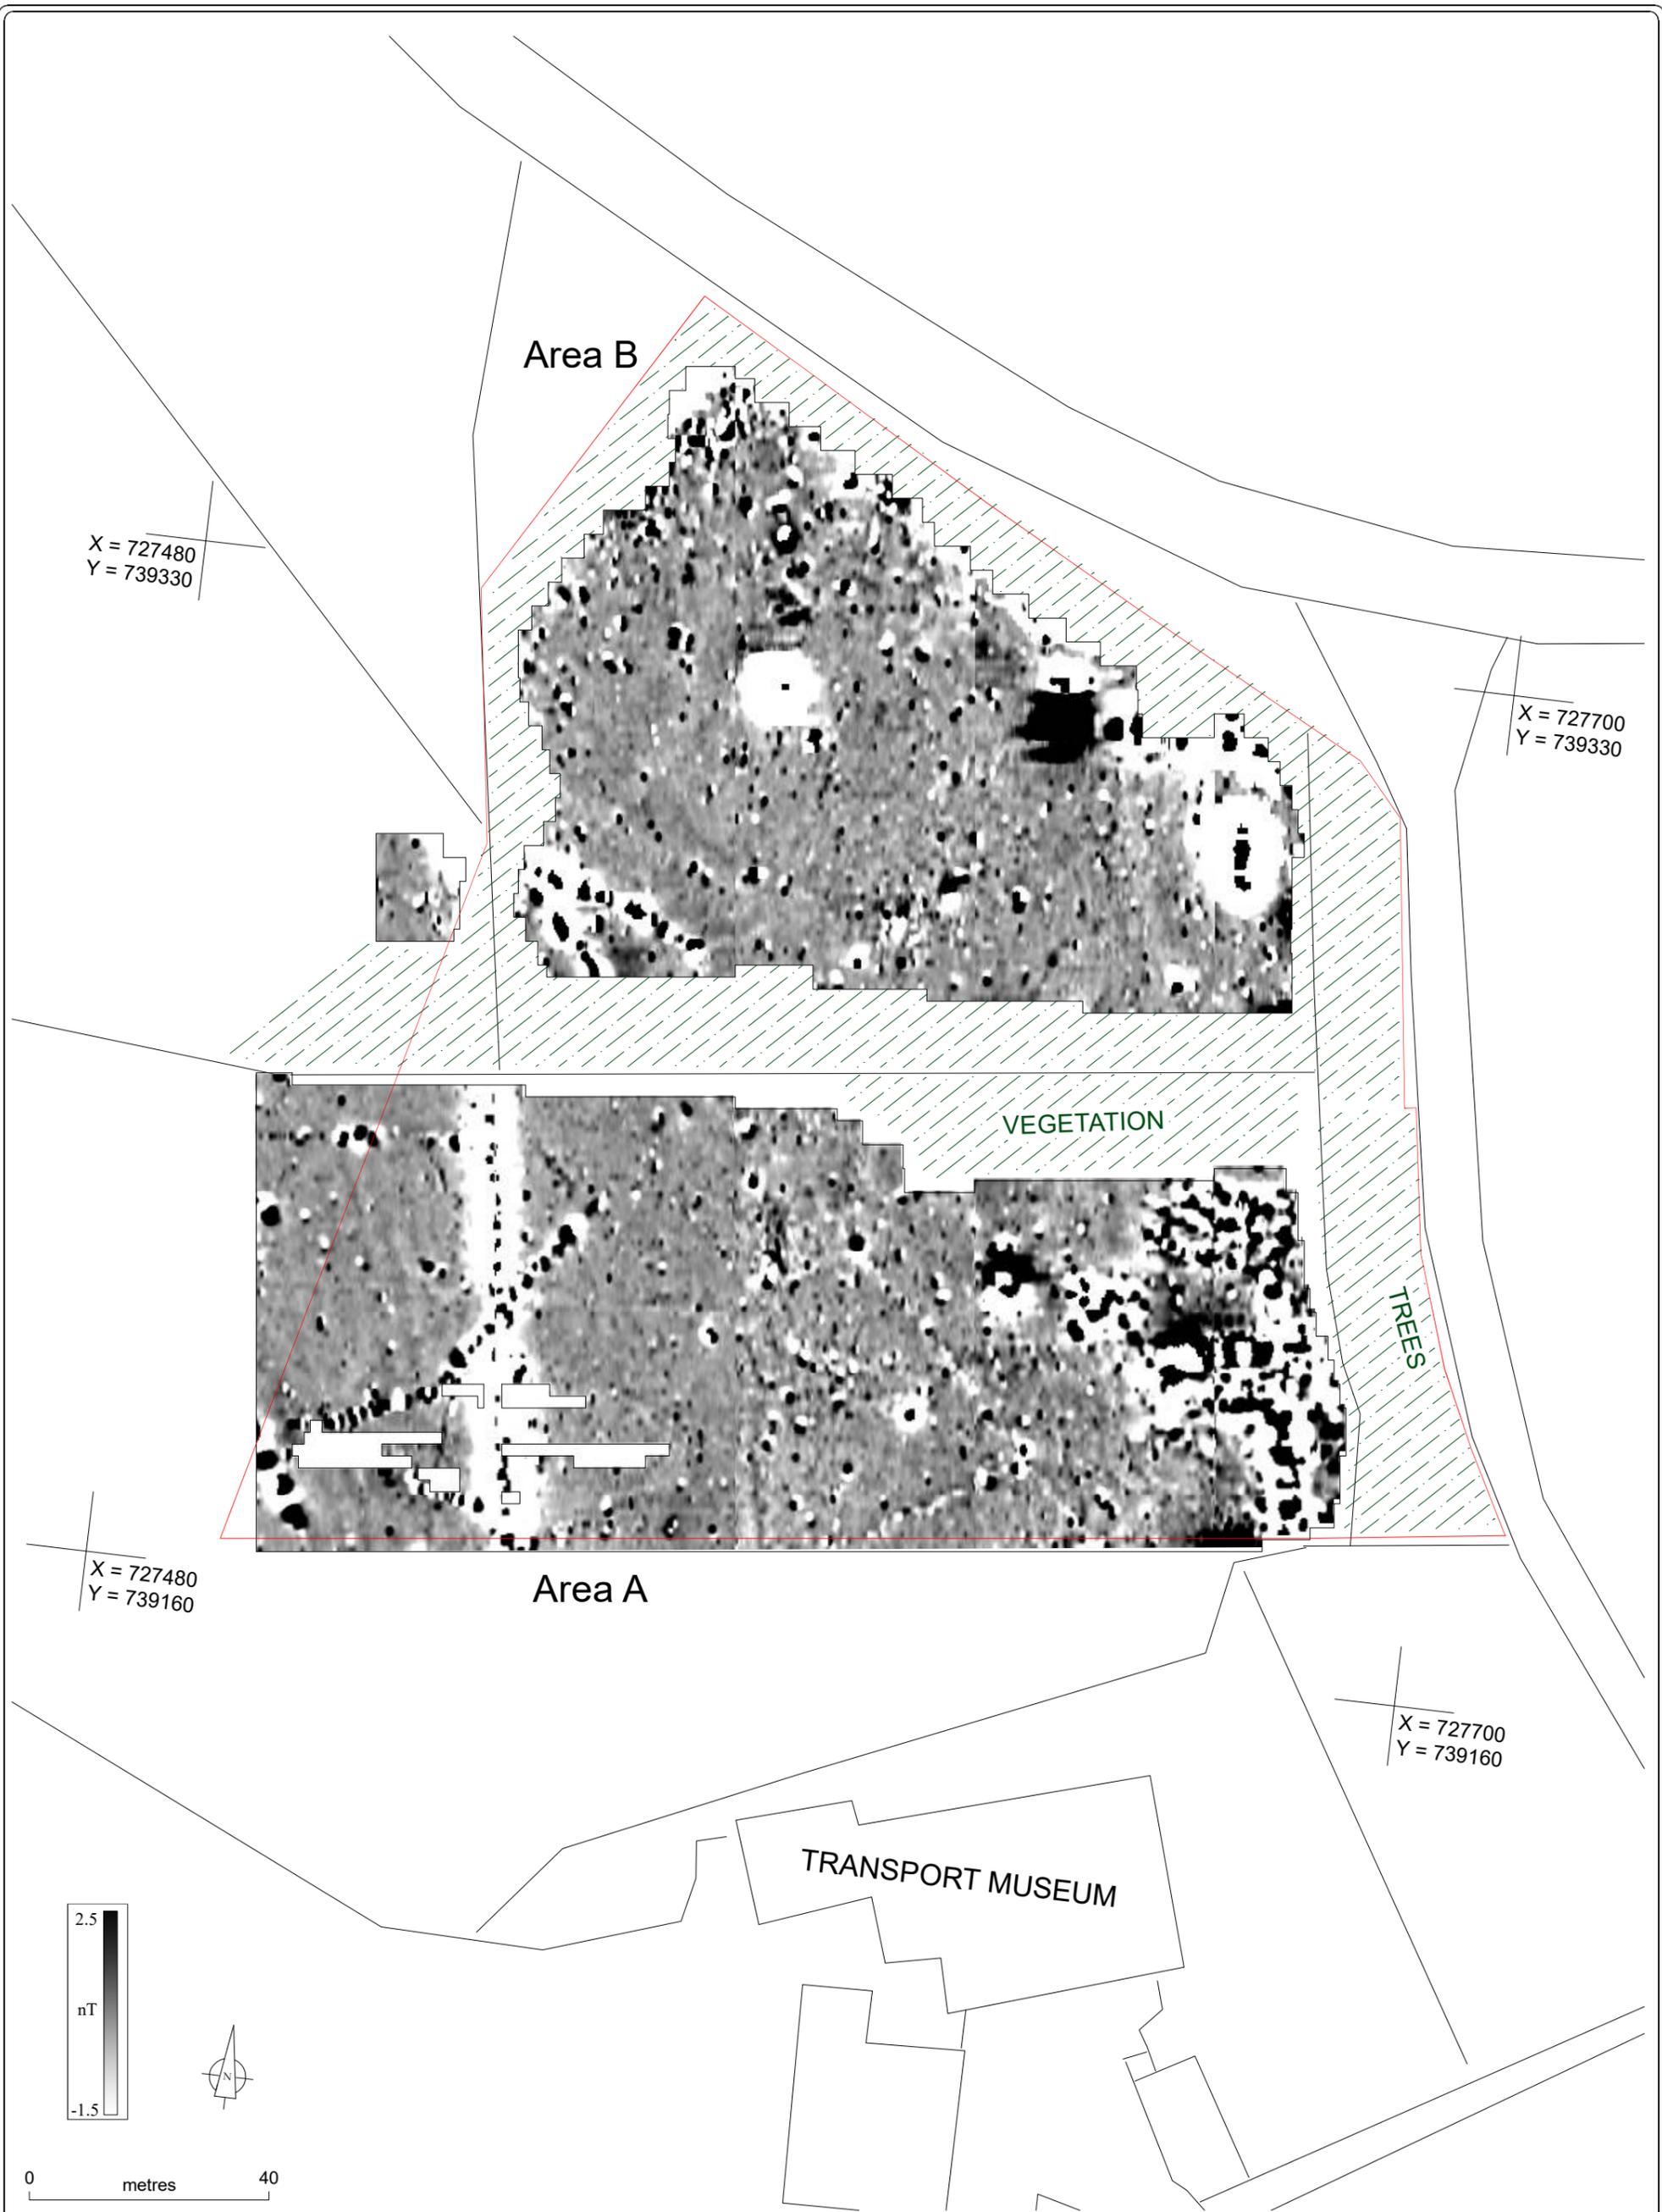
Figure: 1

- 1.2 The application area is contained within the north-eastern corner of Deer Park Golf Course (Area A) and a small field (Area B) to its north. Howth Castle and the National Transport Museum are located to the south and the site is bounded to the north by the Howth Road. Domestic dwellings lie immediately west of Area B. Figure 1 presents the site and survey location at a scale of 1:2,000.

<b>Figure</b>	<b>Description</b>	<b>Paper Size</b>	<b>Scale</b>
Figure 1	Site & survey location diagram	A4	1:2,000
Figure 2	Summary greyscale image	A3	1:1,000
Figure 3	Summary interpretation diagram	A3	1:1,000

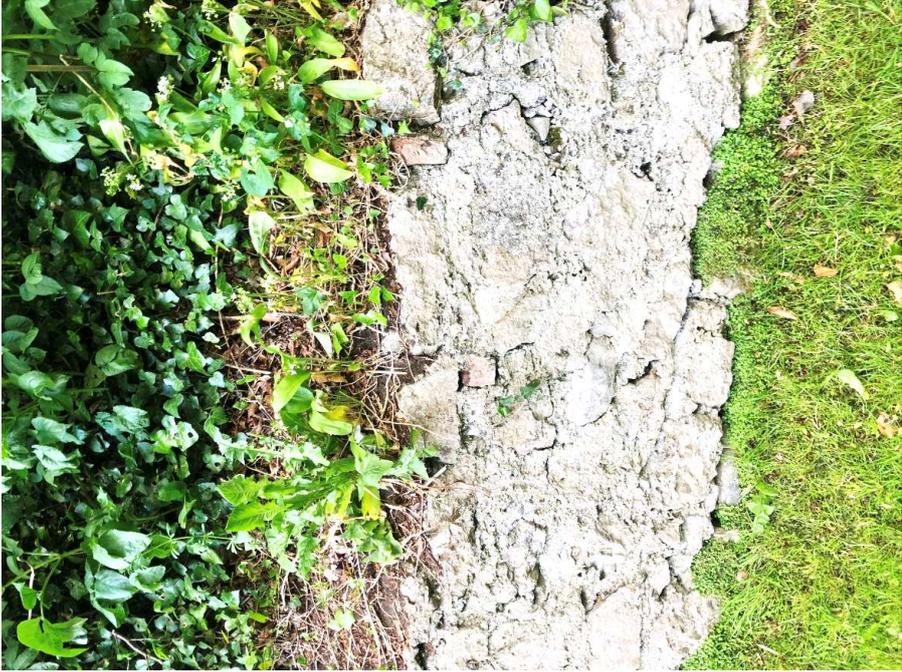
17. Detail view of the historic boundary wall

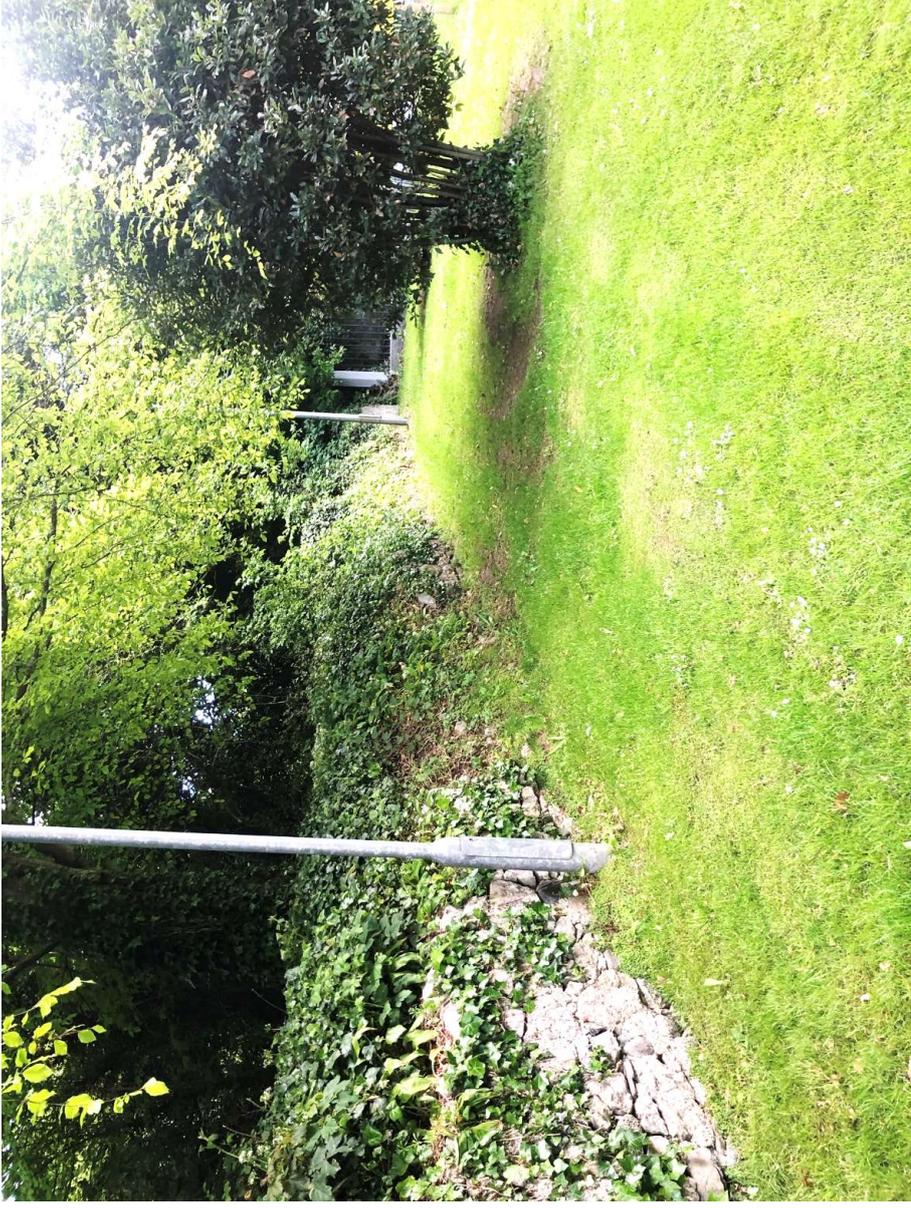
18. View along the boundary wall along the entrance avenue

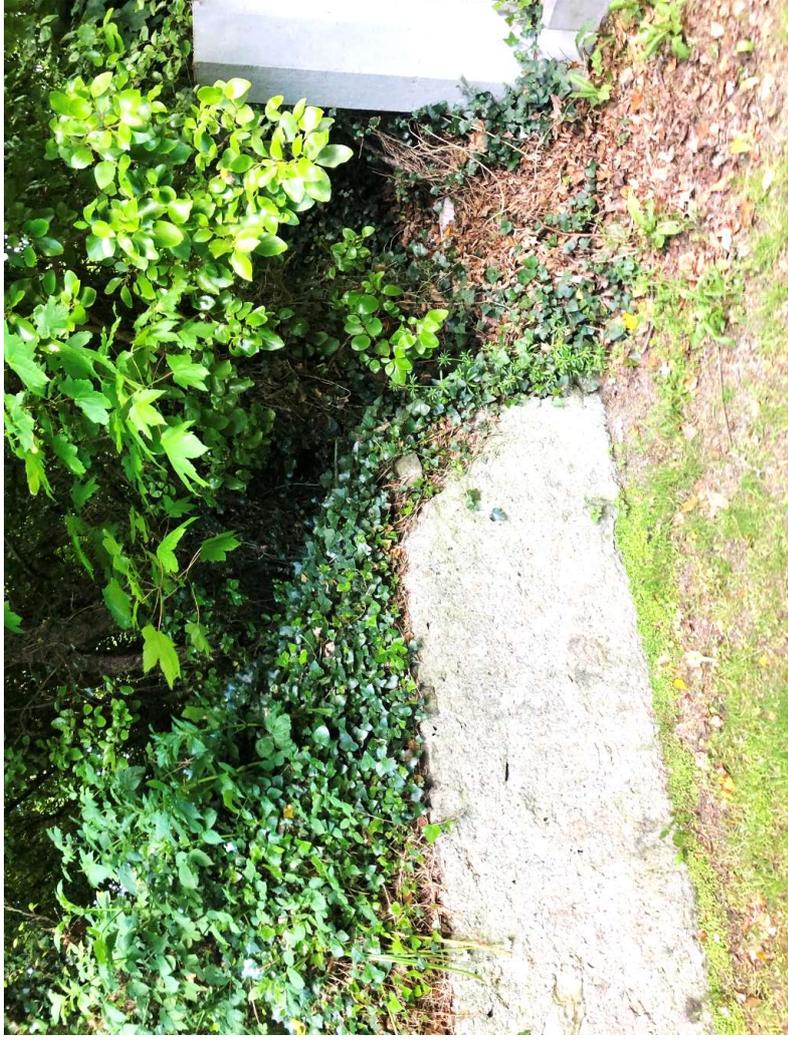
20. View of the junction between the historic boundary wall and the Entrance Gates to Howth Castle

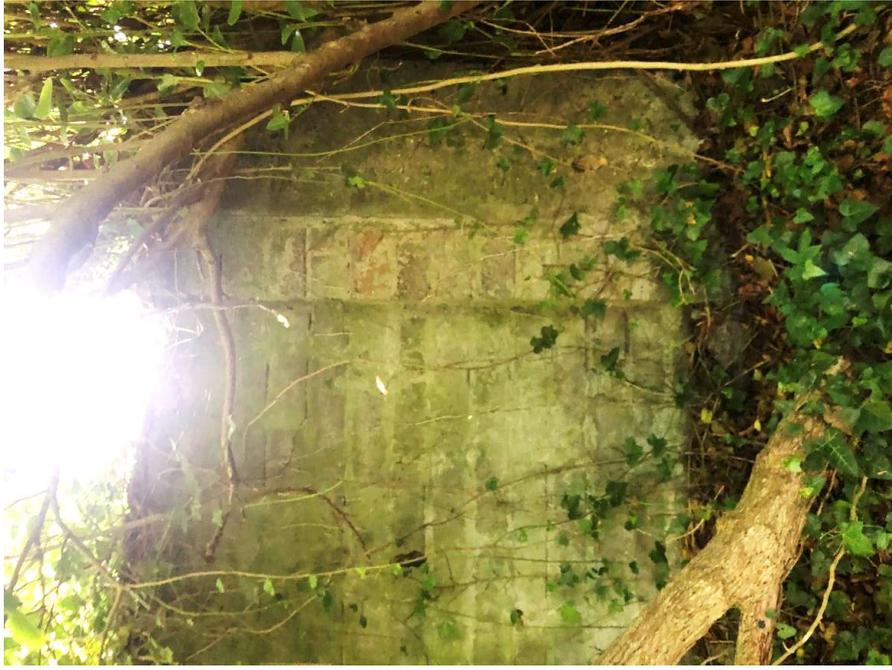
25. Modern blockwork replacement boundary wall

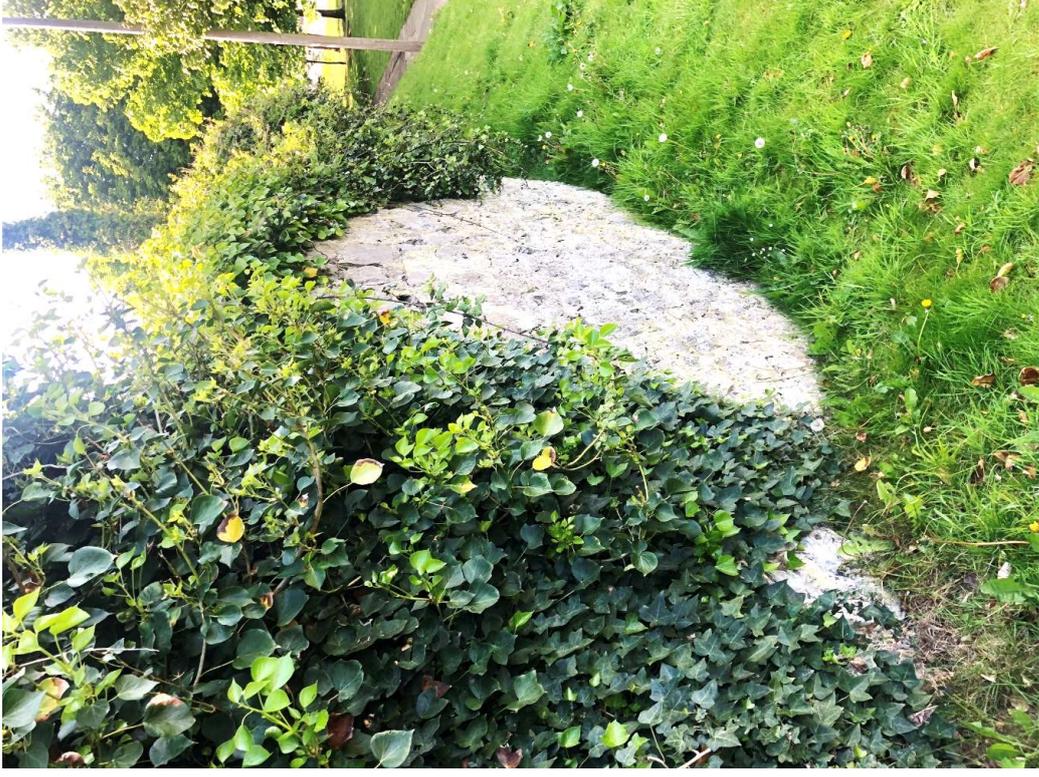
29. View of the historic boundary wall at the north-eastern section of the subject site

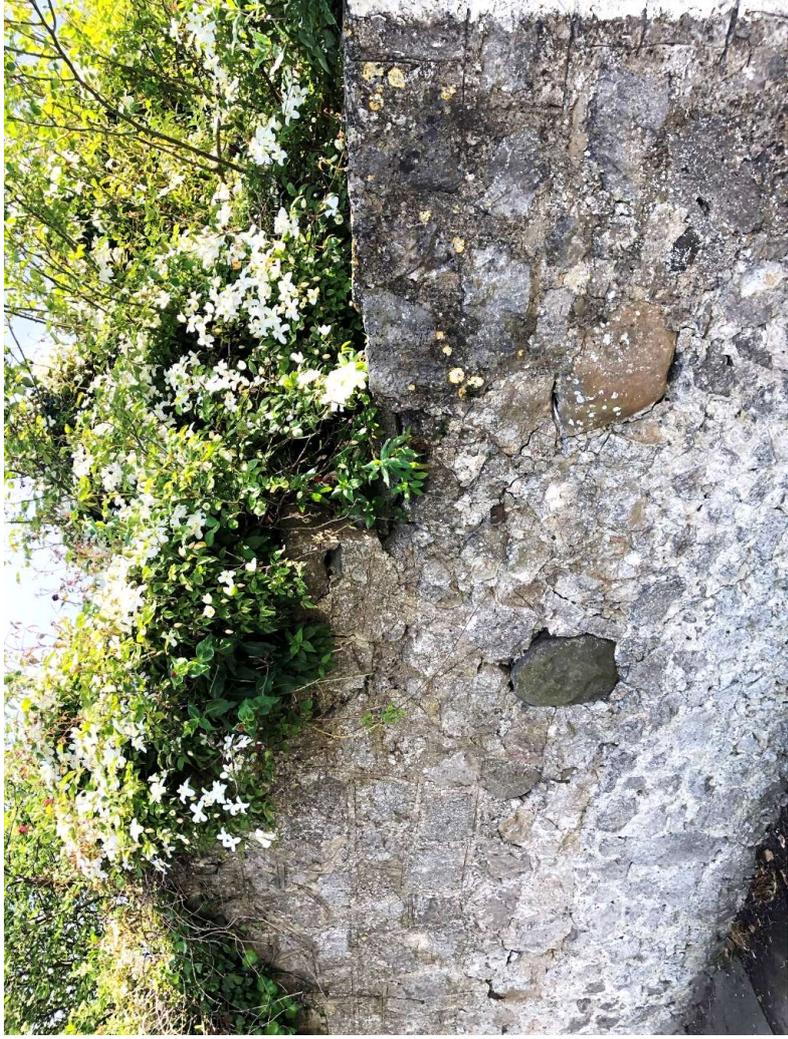
47. Detail view of the boundary wall to the northern boundary of the subject site, showing the change of height of the wall in this area

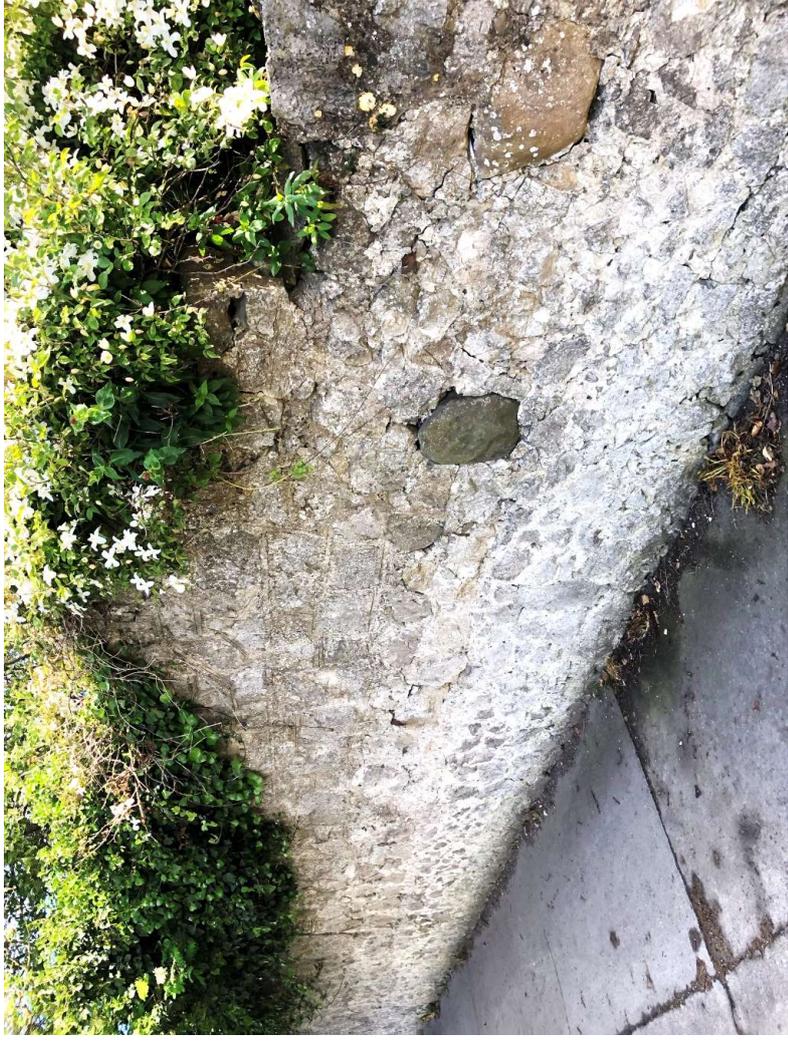
48. Detail view of the boundary wall to the northern boundary of the subject site, showing the change of height of the wall in this area

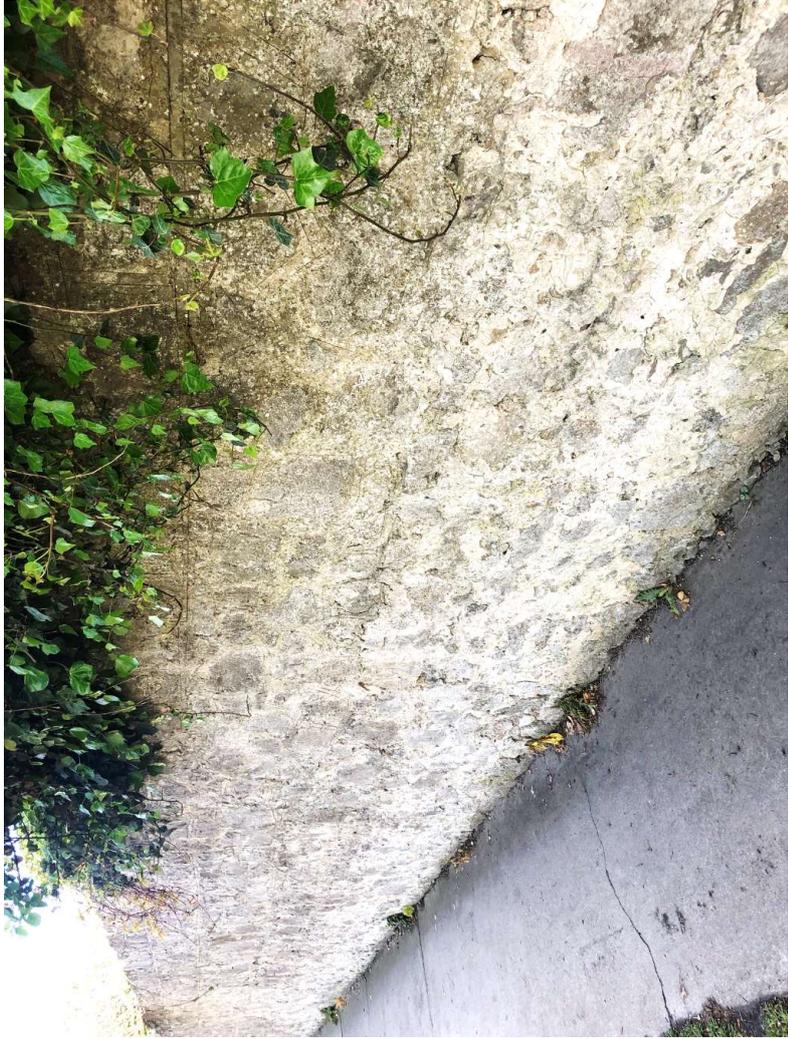
49. Detail view of the boundary wall to the northern boundary of the subject site

It is proposed to dismantle a section of the demesne boundary wall in order to enable the construction of two entrances to the development. The subject wall is of coursed random rubble construction mainly Calp limestone, the upper section which has been rebuilt and repointed. The masonry construction is generally limestone laid and originally pointed with a non-hydraulic lime mortar mix. The wall is designated a protected structure. The evidence of later rebuilding can be seen by the variation in stone and workmanship. The wall is partly supported on a grassed bank and at this point its foundations are not known. In places the concrete capping is in poor condition and will require replacement in stonework.

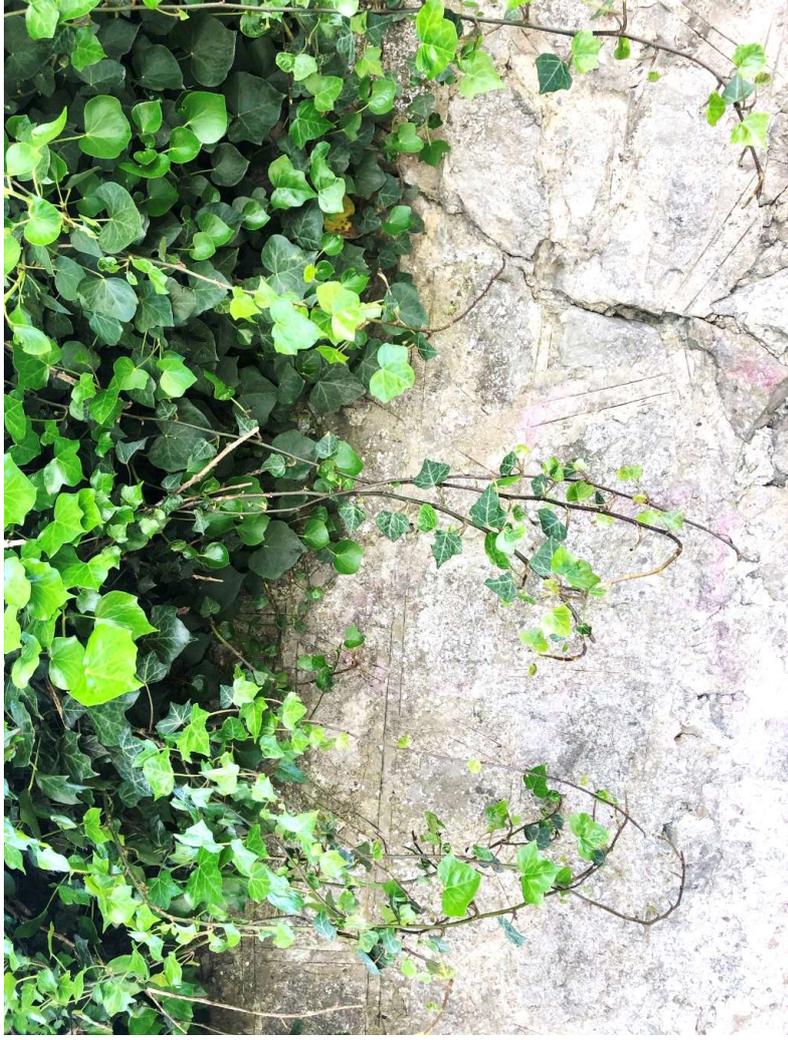
50. Detail view of the boundary wall to the northern boundary of the subject site

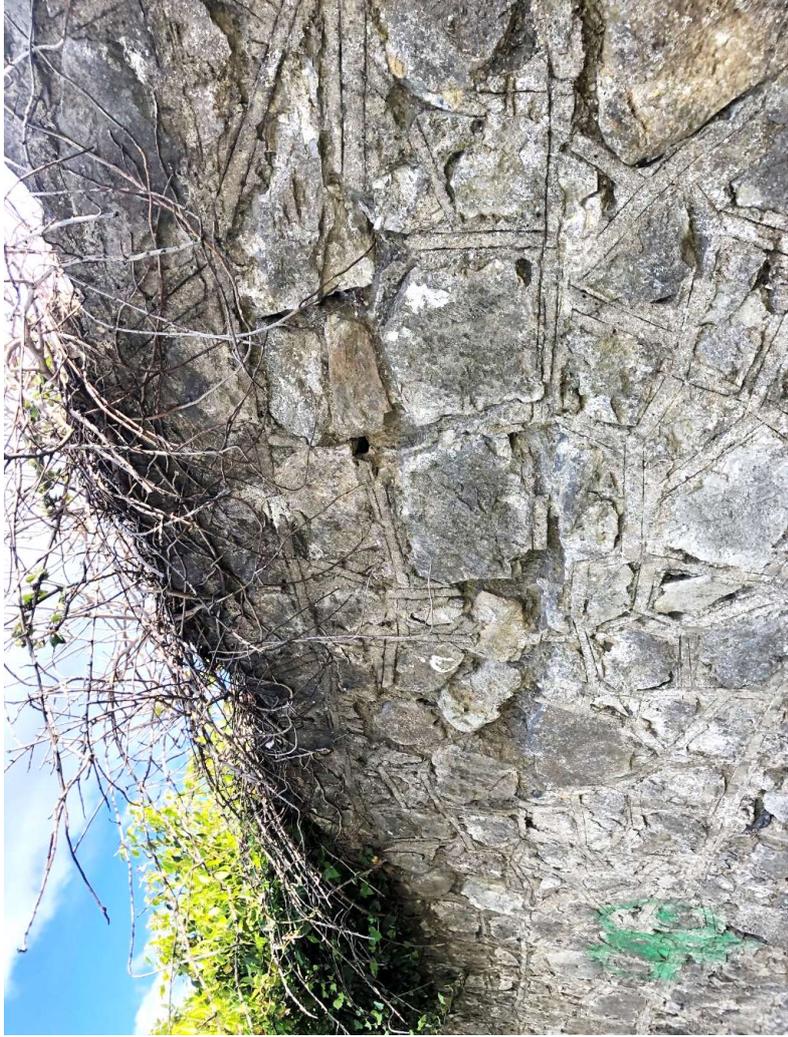
51. Detail view of the boundary wall to the northern boundary of the subject site

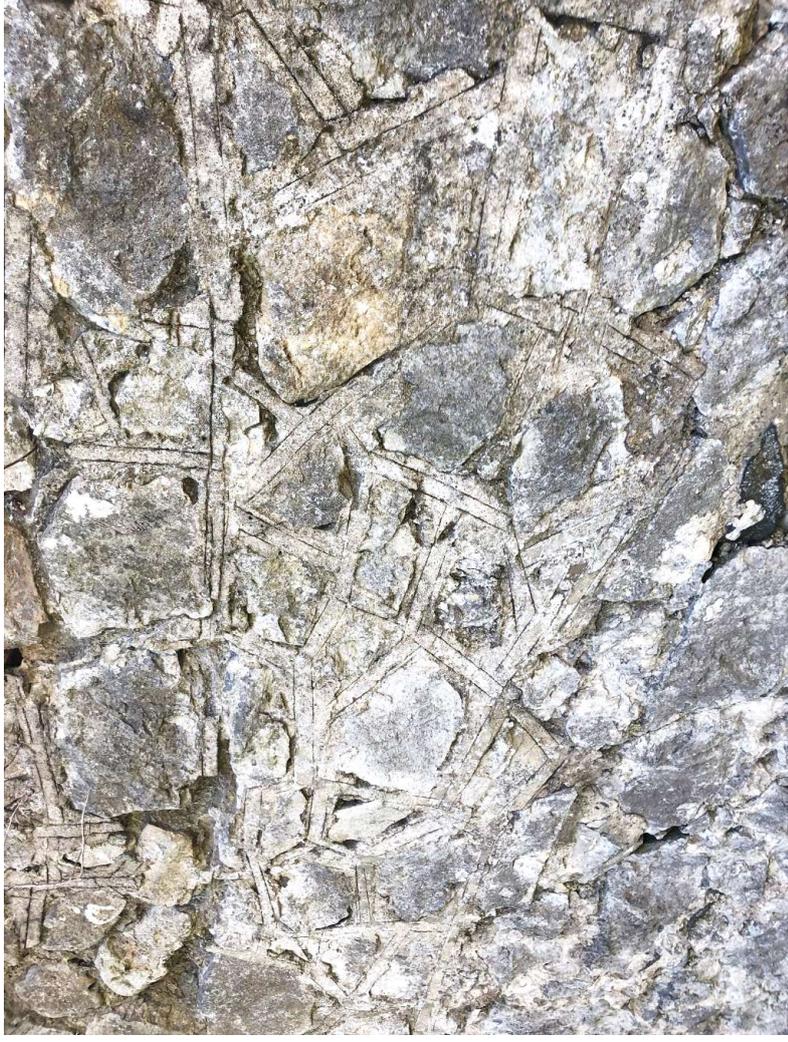
52. Detail view of the boundary wall to the northern boundary of the subject site

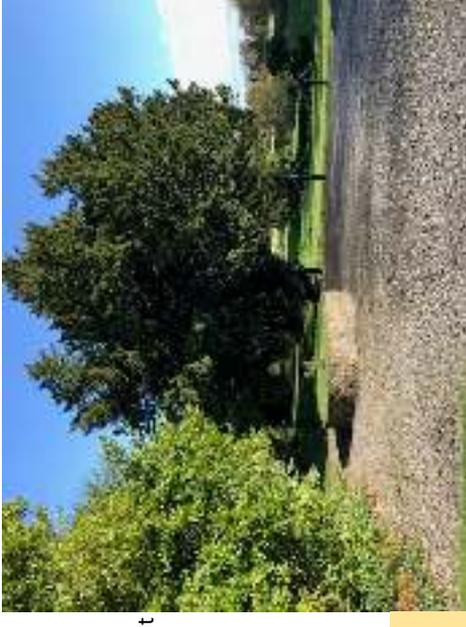
The Family Tree, an elm, – commemorated by this stone walled bed in its original position and indicated in the Birds eye view in front of the castle.

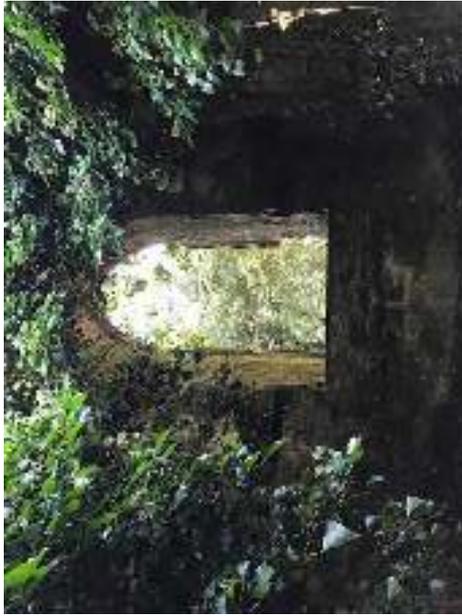
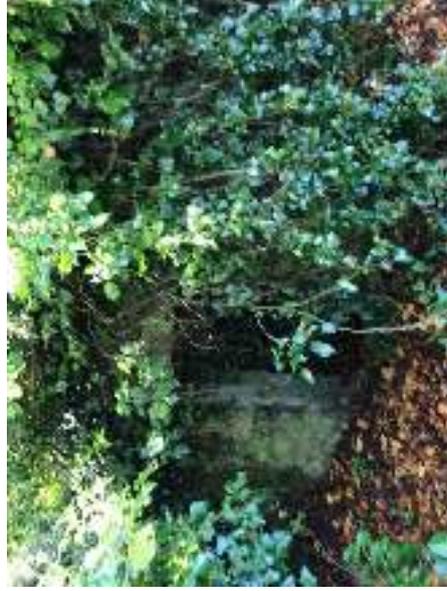
Left : ruins of the chapel  
Centre: the Ice House  
Right: Detail from bird's eye view of the demesne with the chapel indicated adjacent to the deer park.

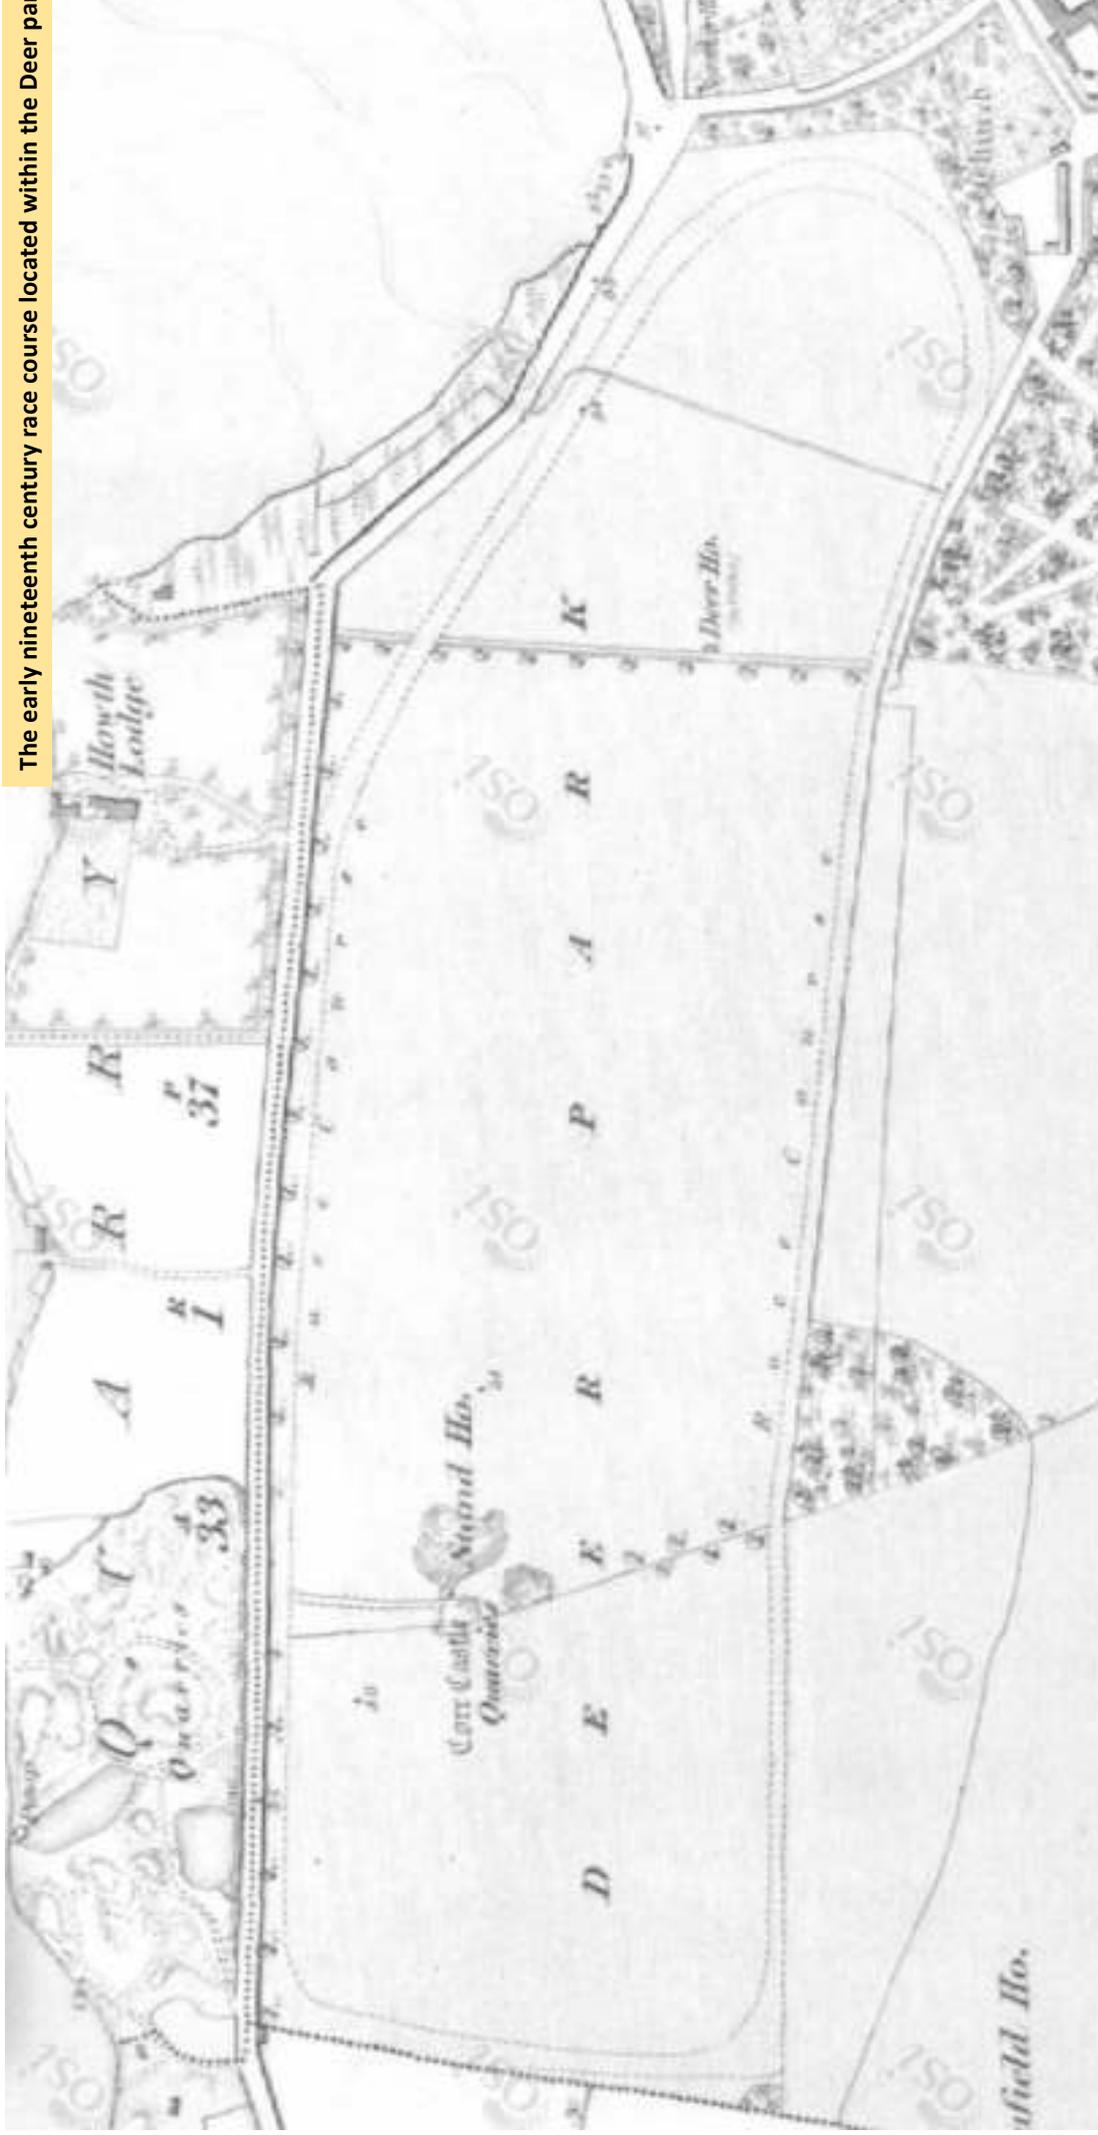
The early nineteenth century race course located within the Deer park

Ordnance Survey map showing the race course located within the Deer Park. Corr Castle was used as a grandstand and two quarries are shown, either side of the demesne wall. The site of the proposed development is located within the eastern sweep of the race track. The course was known as *Howth Park Racecourse* and ran from the backgate lodge of the castle on Carricbrack Road down to the corner of the grounds of Seafield House (now Santa Sabina school) and North broadly along the route of Offington before circling Corr Castle and returning up along the Howth Road.

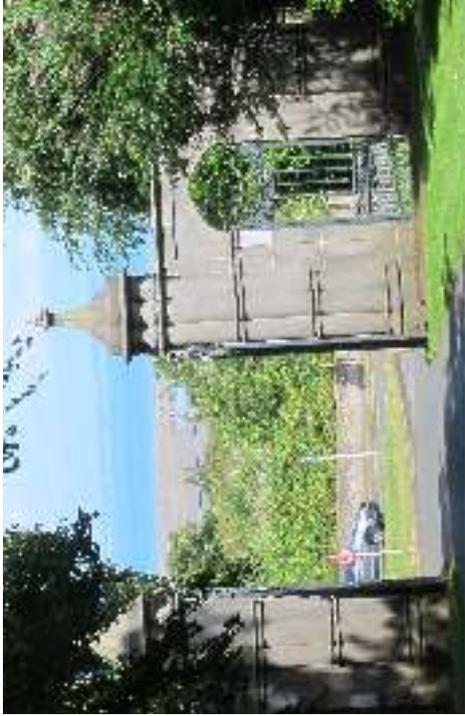
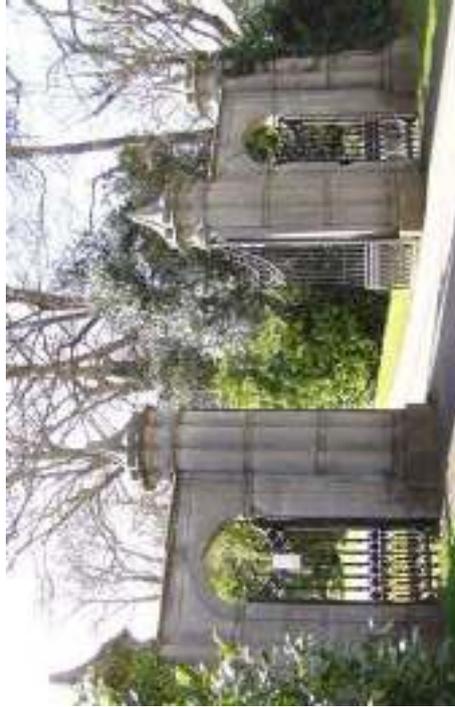
The main entrance gate from within the demesne

The main entrance gates to Howth Demesne

The third earl was a passionate horseman. From the winnings of his top racehorse Peep O'Day Boy he built the main entrance gates and lodge. The architect of the gates at Howth in 1840 was Richard Morrison who was carrying out alterations to the castle and stables. An almost identical screen by Morrison is seen at Lismore Cathedral and another example at Portumna Castle. The 3<sup>rd</sup> Earl, Thomas St Lawrence, had married Lady Emily de Burgh daughter of the earl of Clanricarde from Portumna 1826.

The influence of Batty Langley's 1747 *Gothic Architecture*, improved by rules and proportions is seen in the design. It consists of a four pillared Gothic screen constructed with ashlar limestone and containing arched postilion gates. The octofoil cluster columns support concave cappings decorated with foliated friezes and originally crowned with floral finials. The central columns act as gate piers to the main entrance gates with cast iron gates, while the pedestrian gates are housed within the arches. Only ruins remain of the gate lodge which was a Tudor Revival cottage with a steeply pitched roof featuring diagonally set stone chimney stack, saw tooth slating, hip knobs and fretted barge boards. A gabled breakfront porch with gabled porch contained the front door.

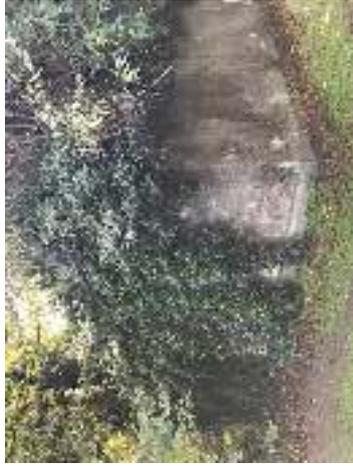
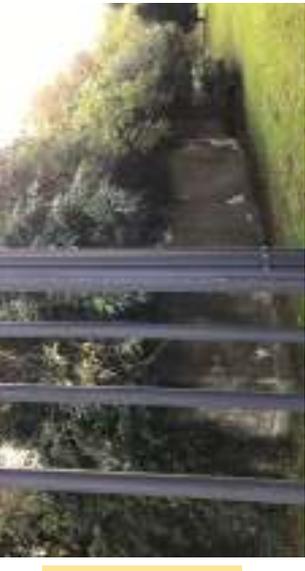
The ruined gate lodge at the east entrance.

The main entrance gates to Howth Demesne

At the south entrance the gate lodge built in 1837 has been demolished. All that remains on Carrickbrack Road is a mid Georgian gate screen of V-jointed rusticated pillars with ball finials and festoon friezes.
