Proposed Strategic Housing Development  
“Kenelm”  
Deer Park  
Howth  
Co. Dublin

**VOLUME III**  
APPENDICES TO ENVIRONMENTAL IMPACT  
ASSESSMENT REPORT

# **DAYLIGHT AND SUNLIGHT ANALYSIS**

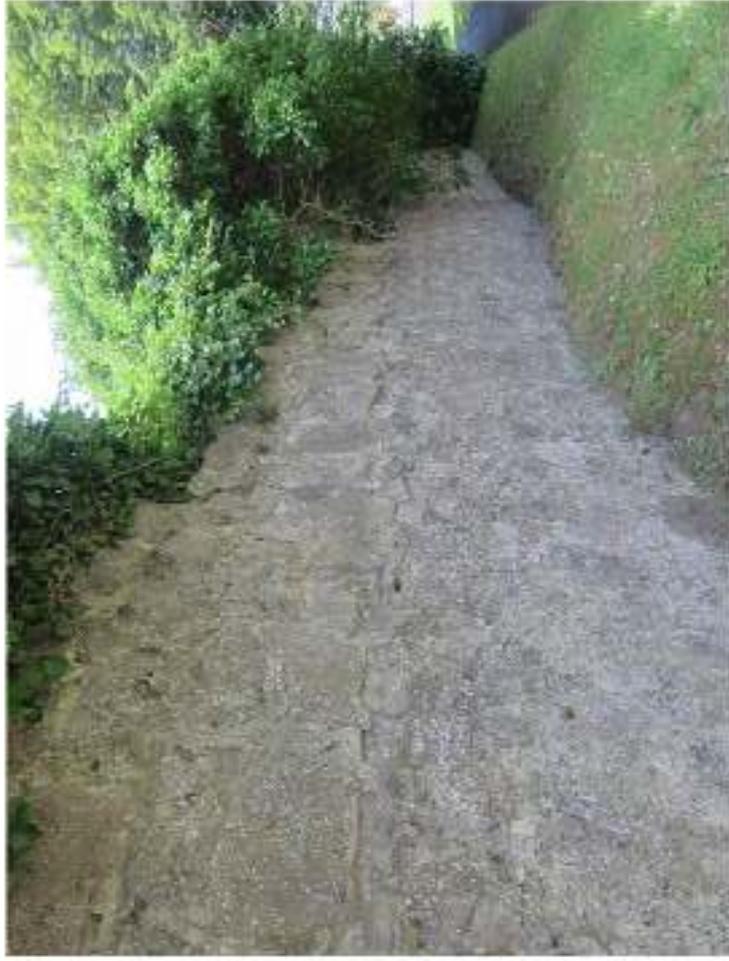
The demesne wall, Howth Road, the upper section of which has been rebuilt.

The conservation challenge will be to maintain the balance between the necessary interventions and retention of historic fabric in as far as possible, carrying out honest repairs to the demesne wall, making sure that decay is halted and that the wall is stable and safe. The approach to any intervention, from a small repair to structural works, is based on the principle that the new material will behave in the same way as the original.

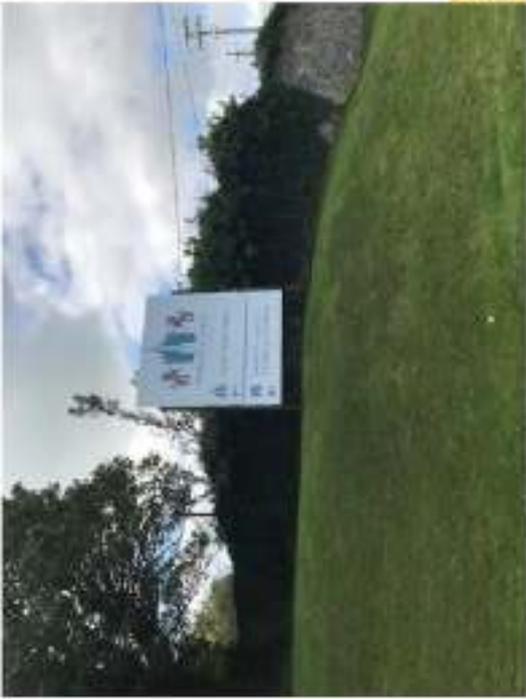
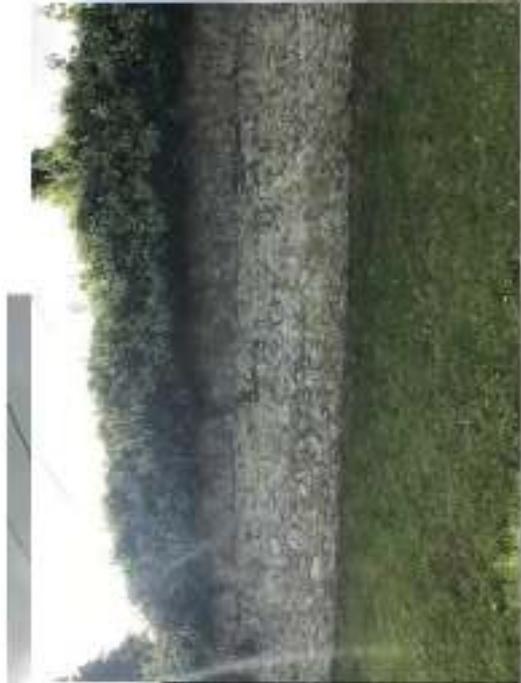
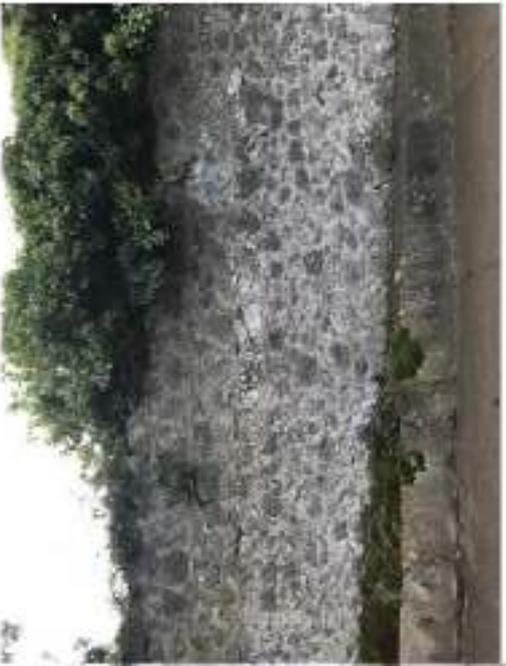
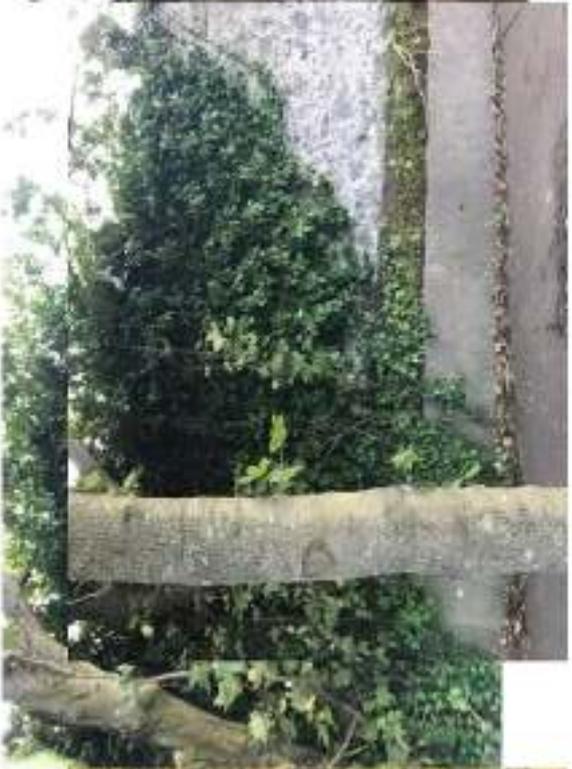
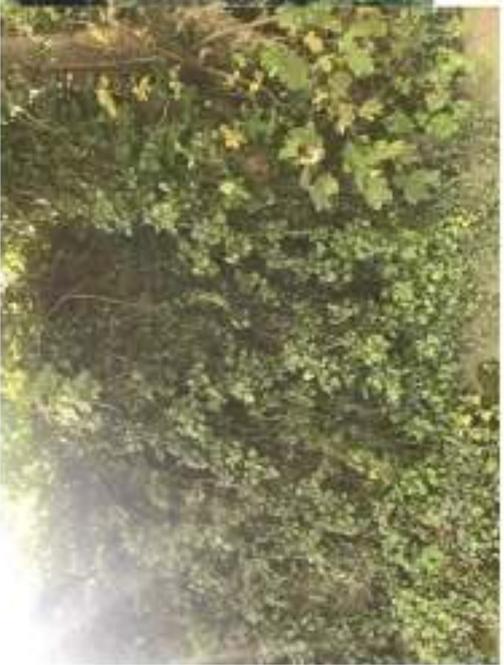
**5.3 Photographs of the demesne wall boundary of the site fronting Howth Road**  
The photographs are taken in sequence to illustrate the construction of the demesne wall.

Following the removal of the ivy presently covering the wall a full measured survey will be carried out to include dimensional information on the wall including length, depth, height and relative levels. Rectified photography will be used to identify the construction materials. It will inform the strategy for the entrance provision and the making-good of the wall. In advance of these works an assessment will be made as to the ecological value of the wall. A condition survey of this section of the historic demesne wall will also be carried out by the structural engineers.

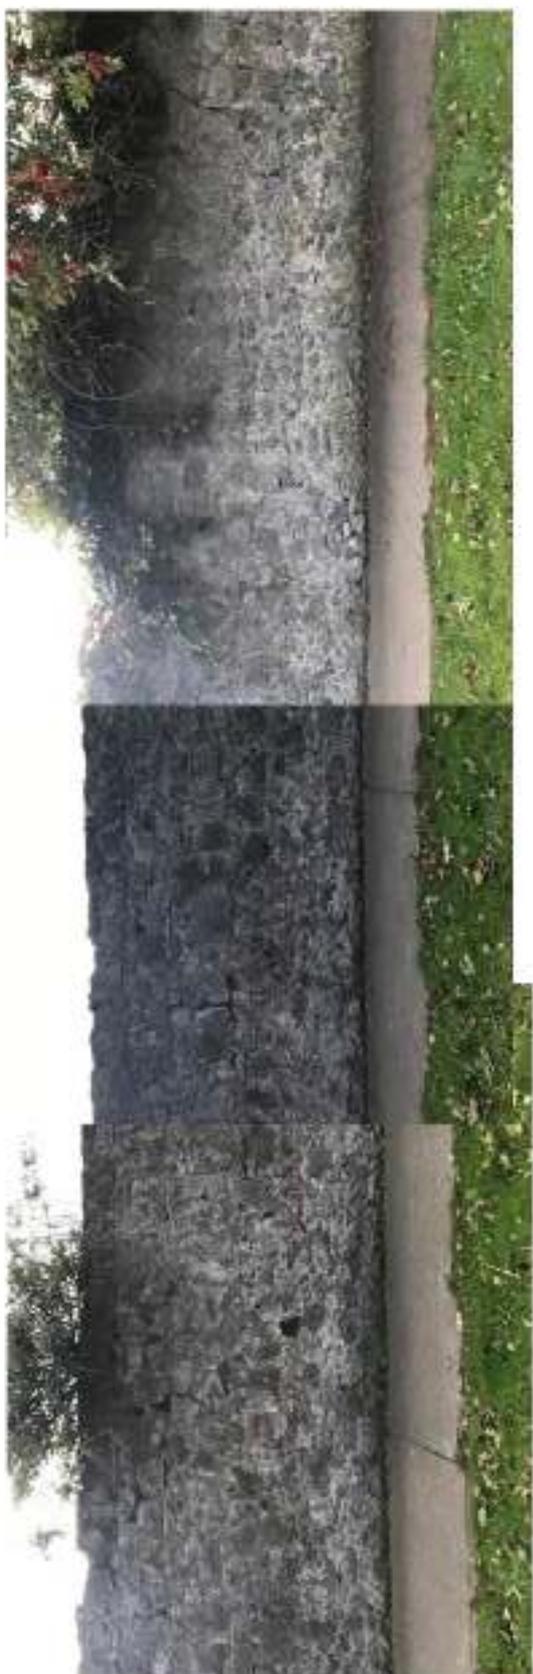
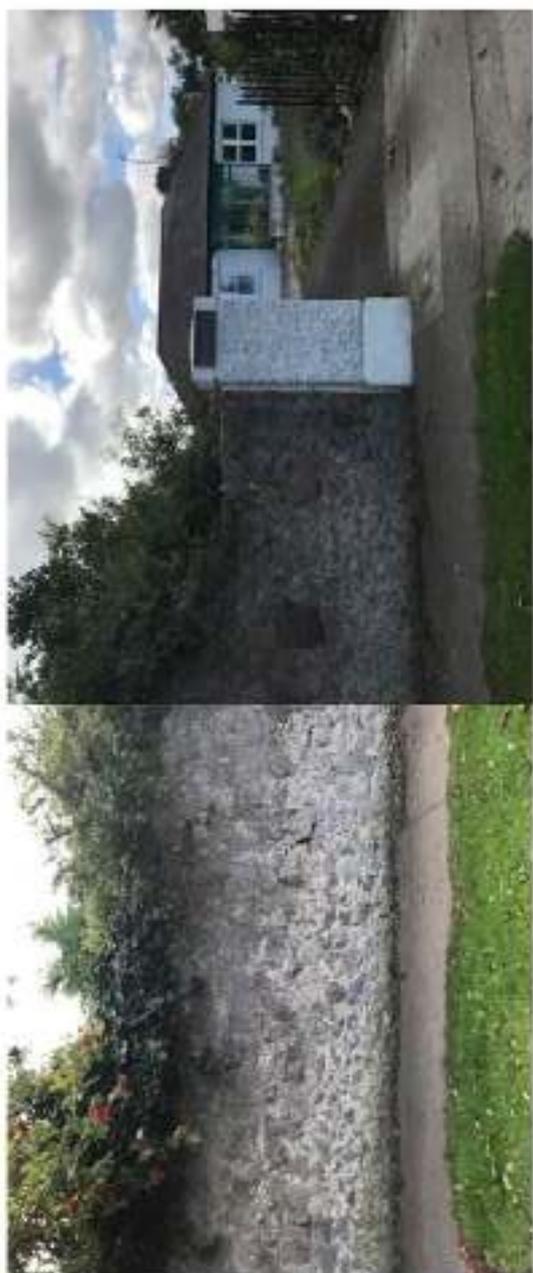
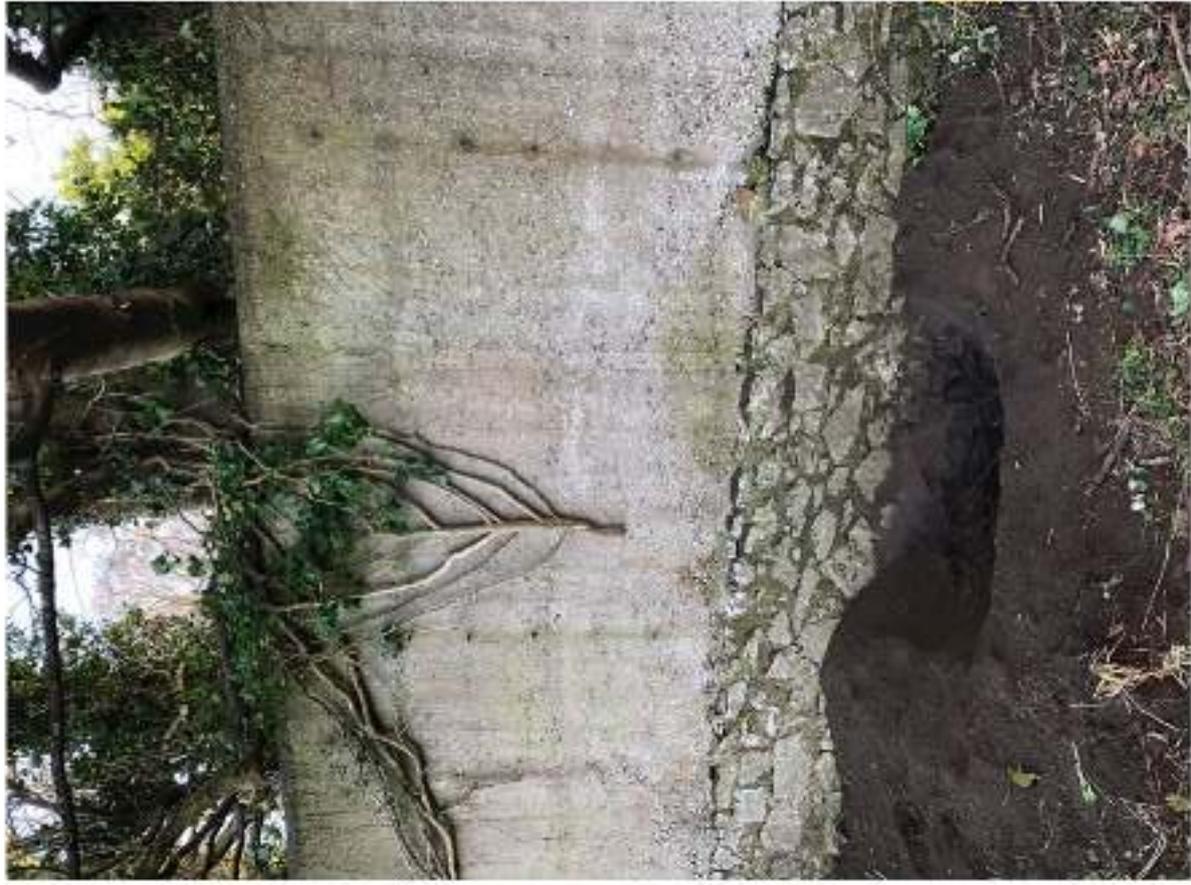
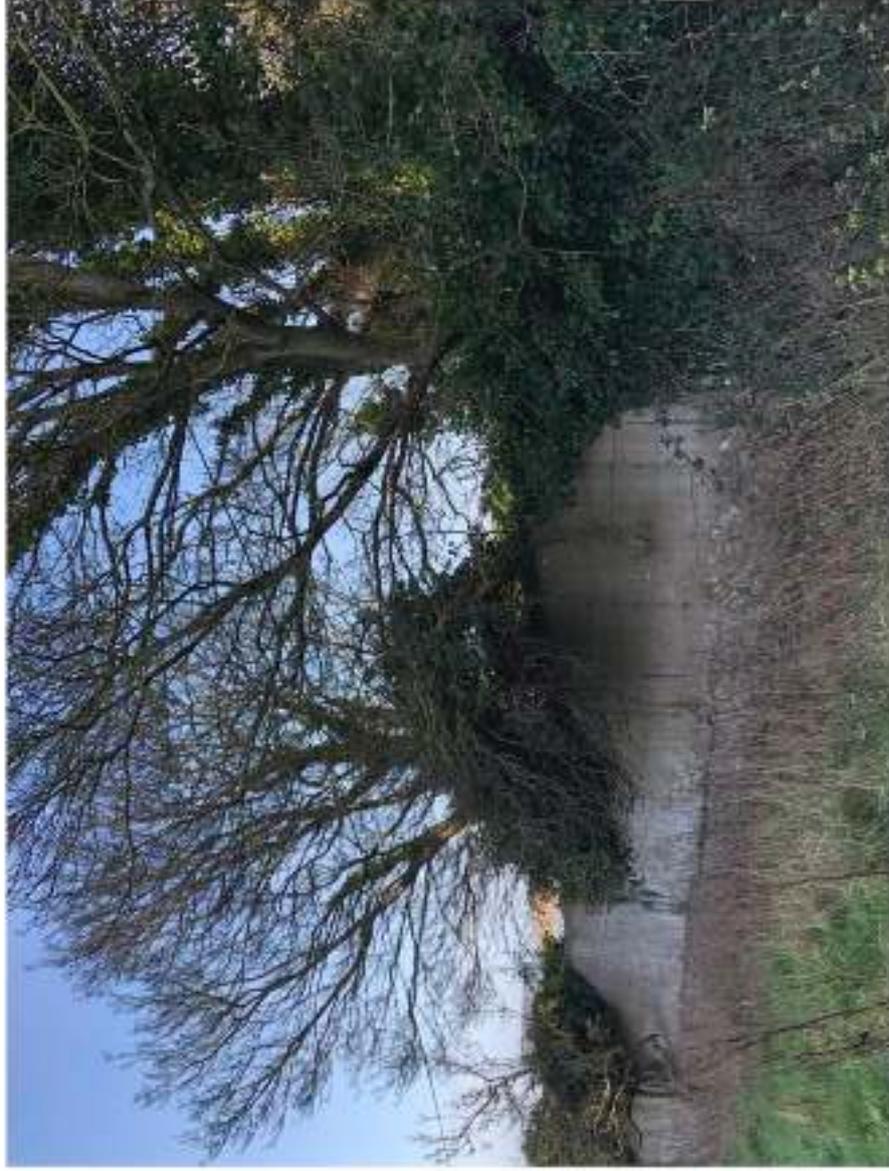
The wall along the boundary between the site and the castle within the entrance gates is mainly of modern poured concrete construction supported by remnants of the original wall at base.

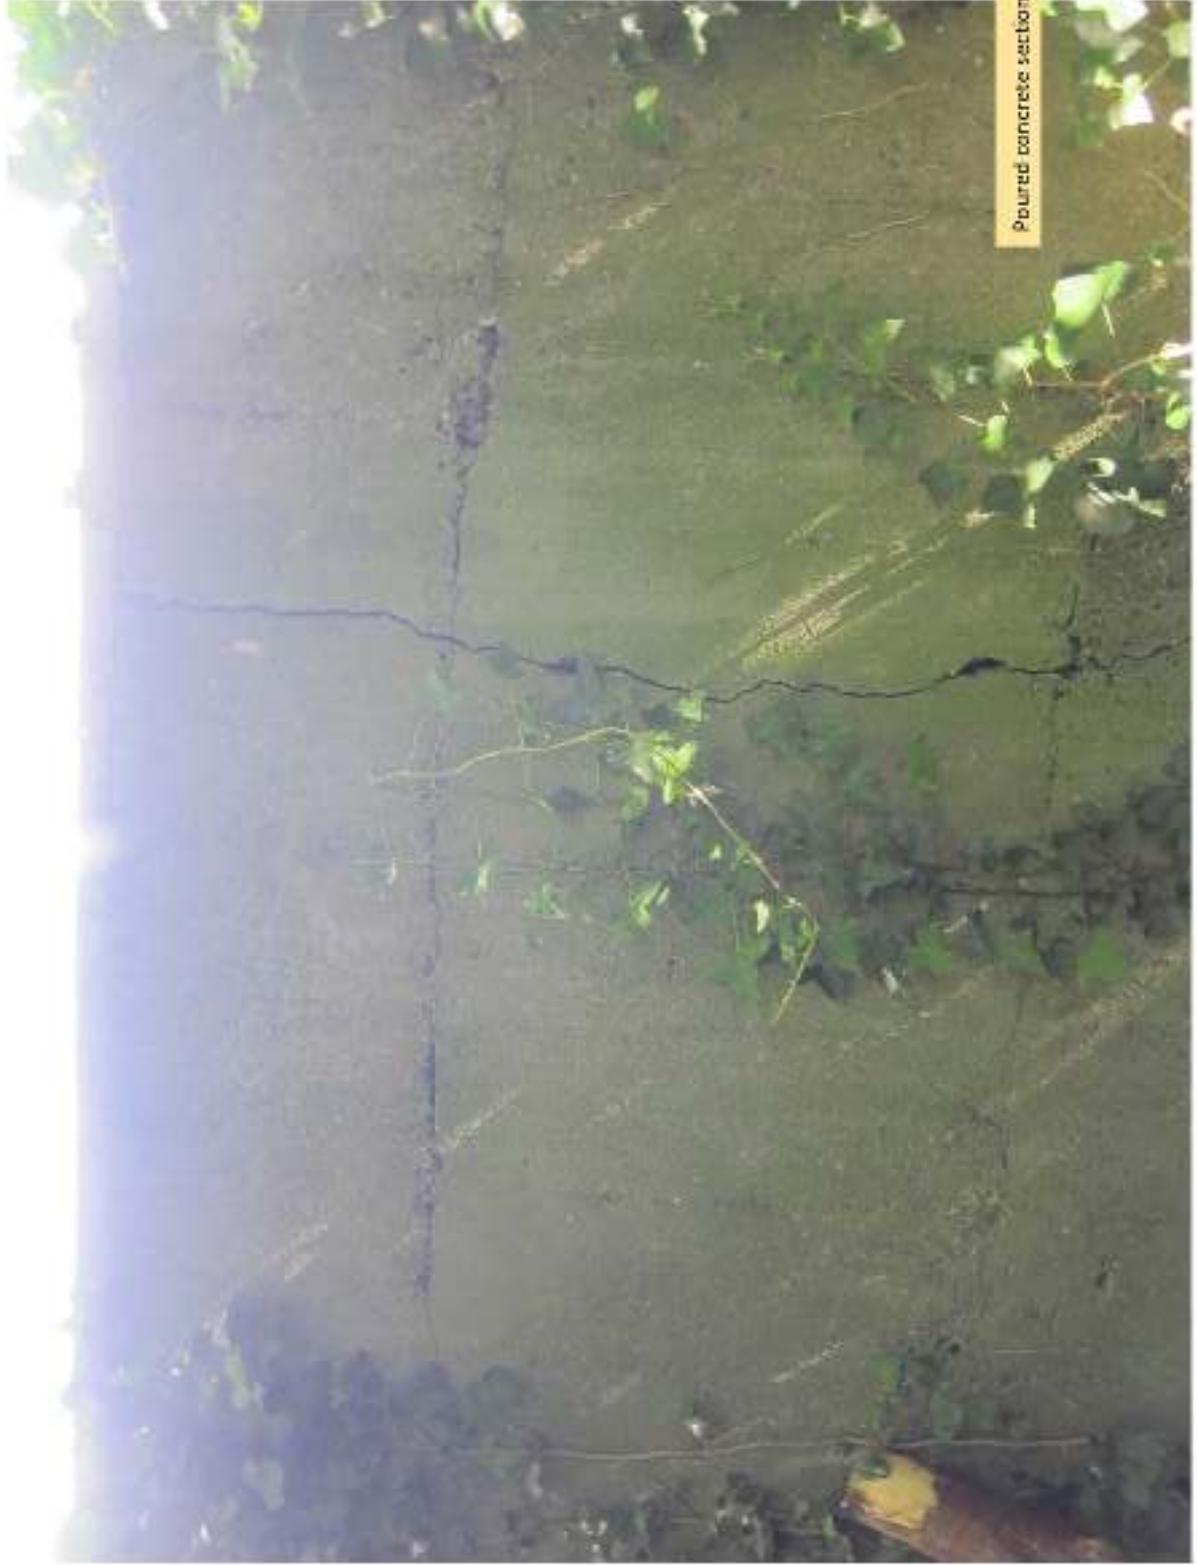
Poured concrete section of boundary wall between the avenue and the site

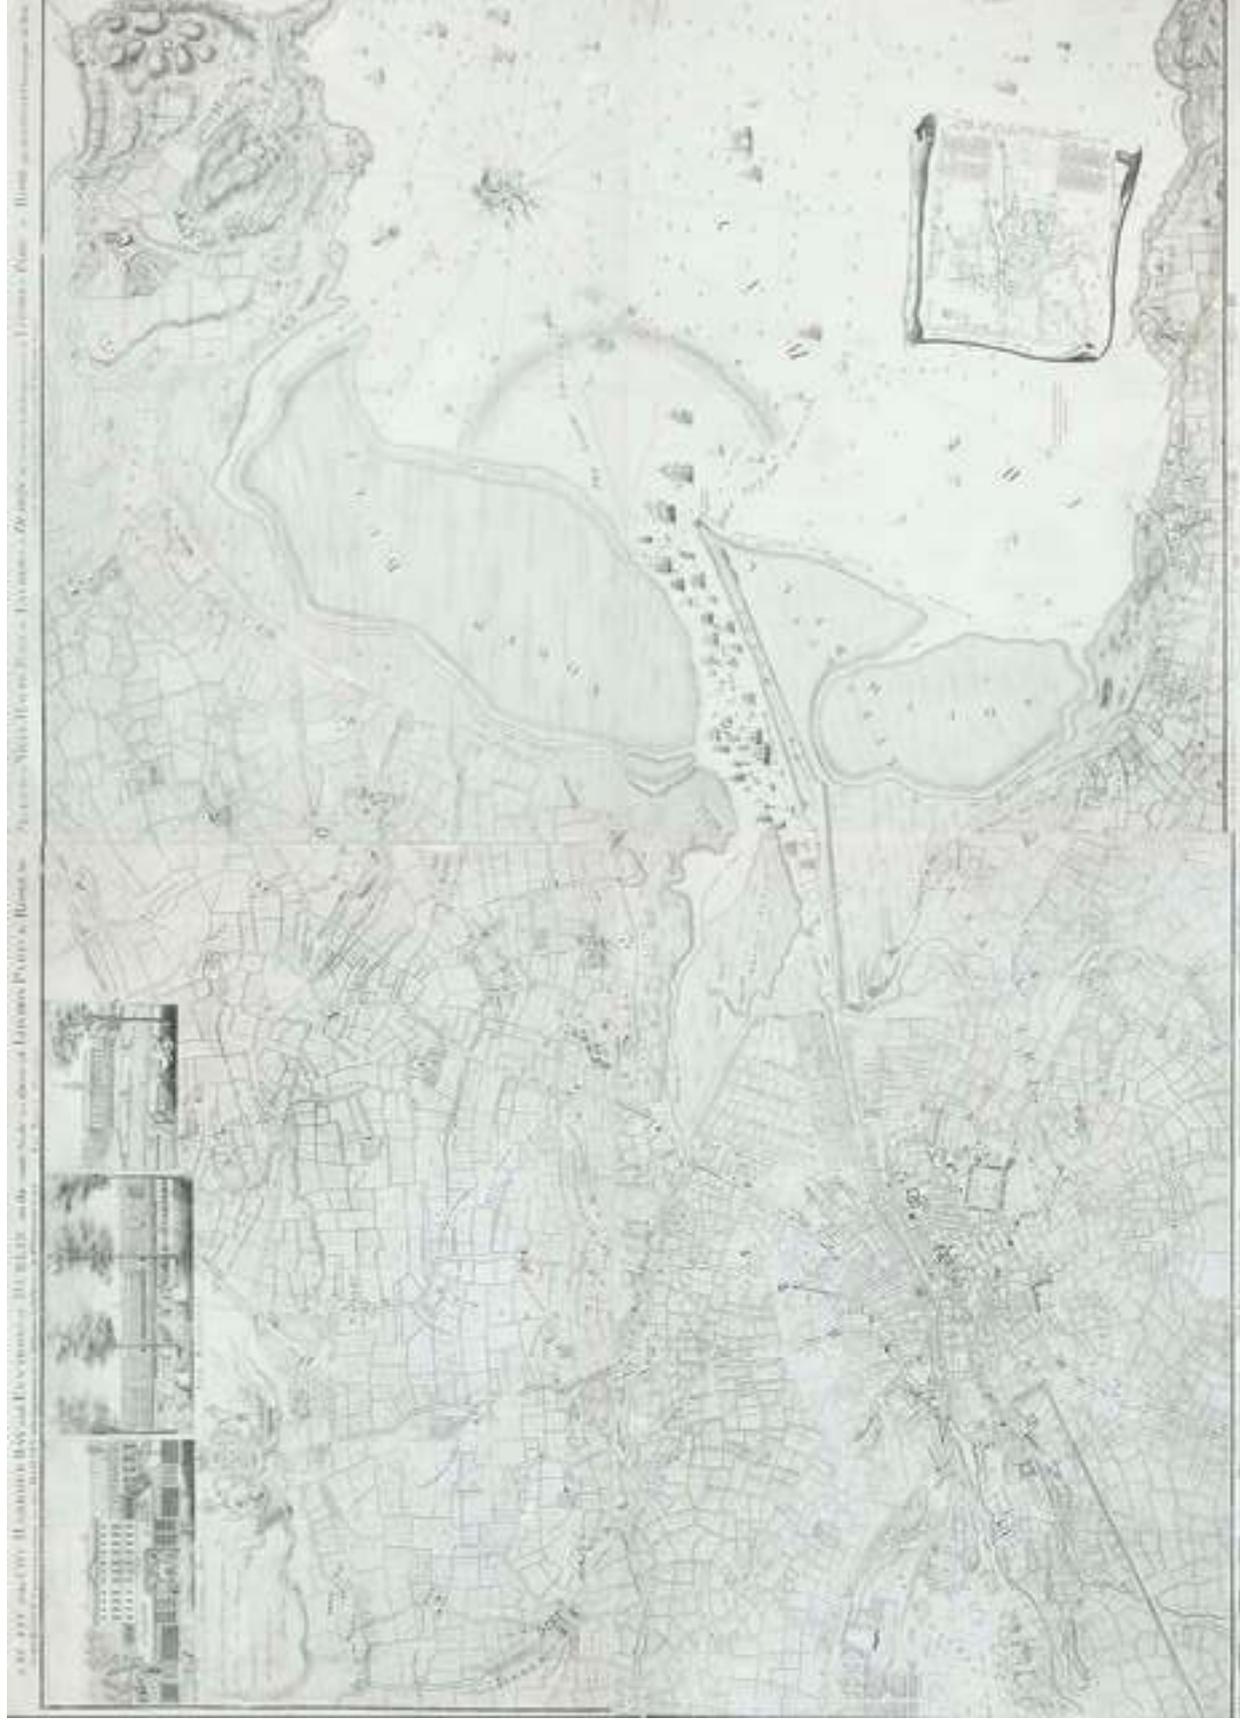
A Survey of the City Harbour Bay and Environs of Dublin on the same scale as those of London Paris & Rome By John Rocque Chorographer to his Royal Highness the Prince of Wales. 1773

Howth Castle  
John Rocques Map of Dublin 1757

*'The early historic maps show how the grounds of Howth Castle were laid out with formal gardens, ponds, tree-lined entrance avenue, and views framed by dense copses of trees which were intersected by pathways. The aerial photograph shows that many of these designed features have survived from at least the 18th century to the present day, although not in their full glory. The walled garden remains, which once housed a Beech Hedge Garden set out in the 17th century. The moat in front of Black Jack's Well is an artificial pool formed in the early 18th century, while the approach to the castle was planted with Irish yews in the late 19th century. Further south are the Rhododendron Gardens, and close to these a portal tomb.'*  
Text ACA

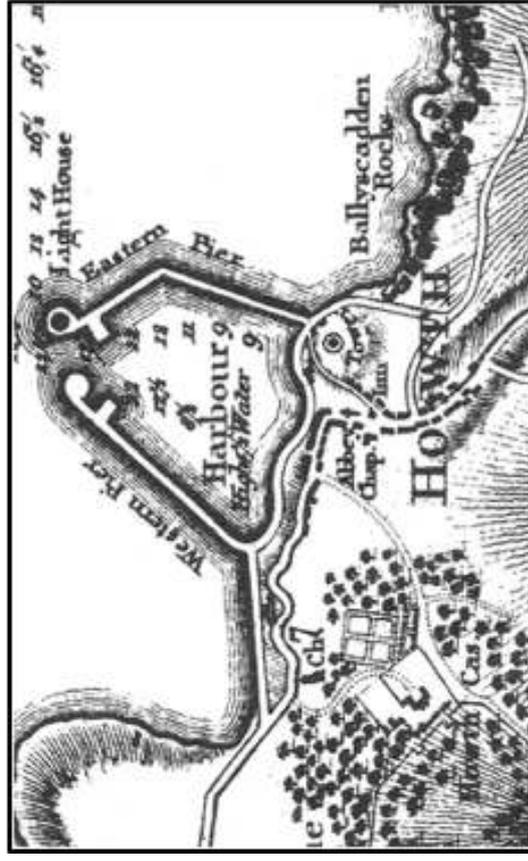
Detail from the John Taylor map of 1816 indicating an avenue connecting directly to Howth harbour

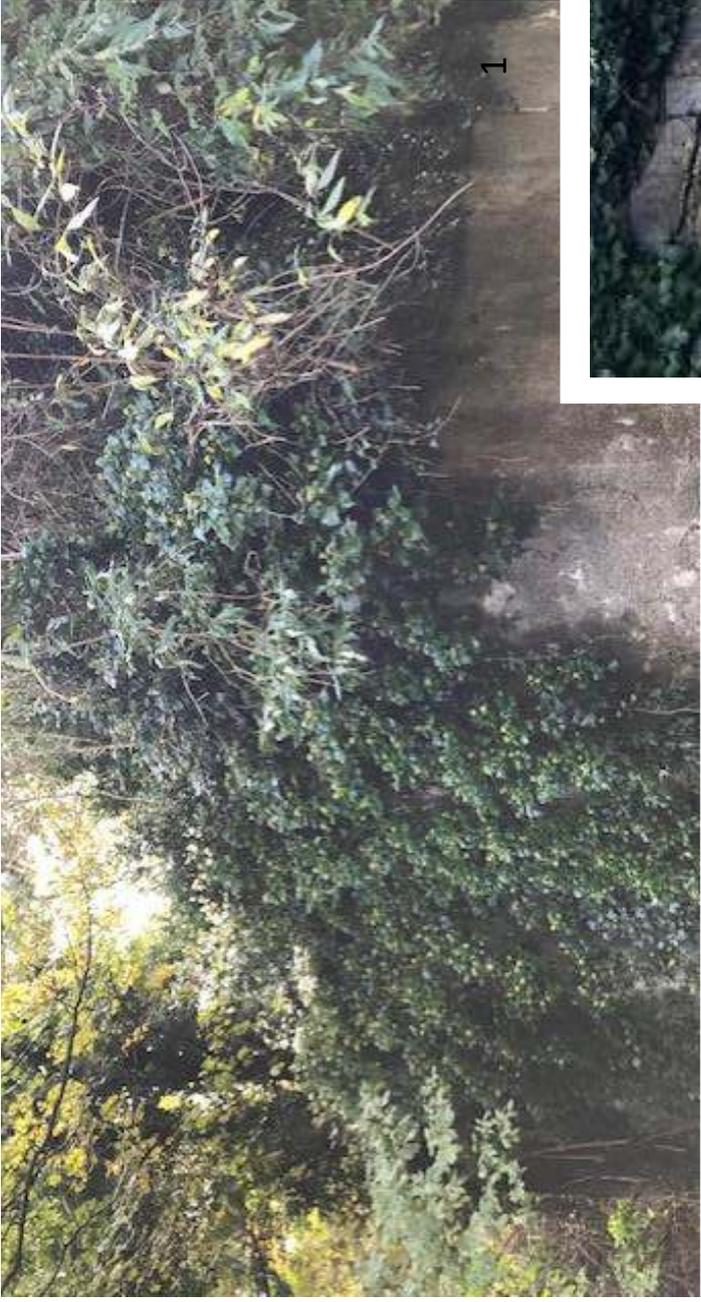
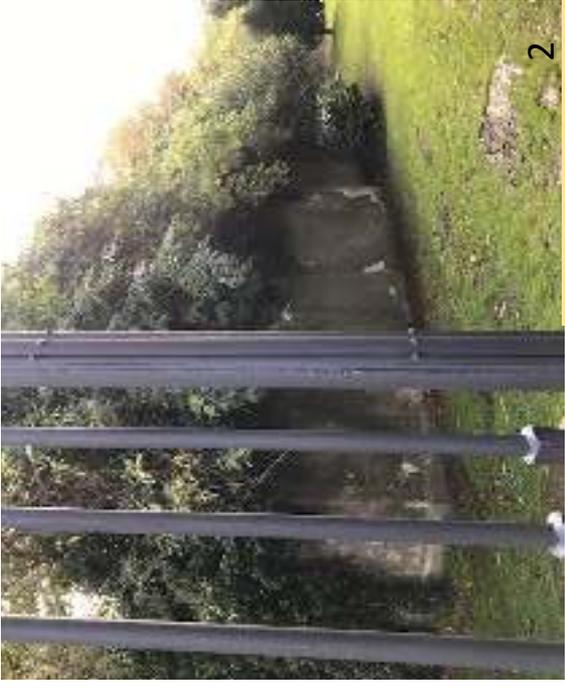
1. Ruins of gate lodge
2. Gate lodge
3. Demesne wall
4. Entrance gates

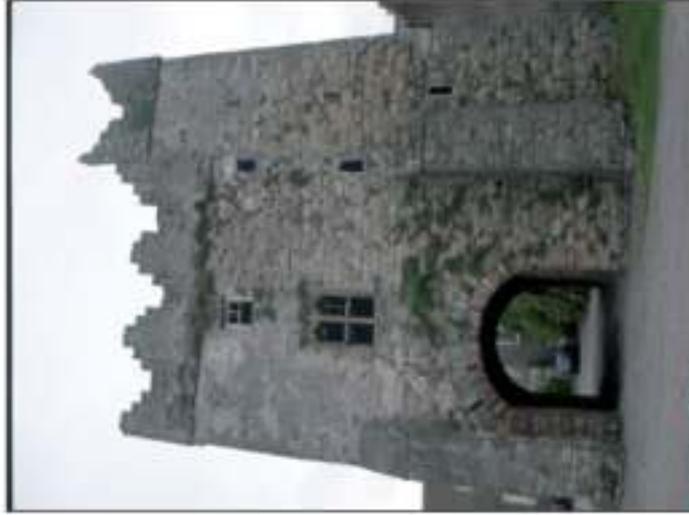
**11358059**

<b>Reg. No.</b>	11358059
<b>Date</b>	1400 - 1500
<b>Previous Name</b>	N/A
<b>Townland</b>	HOWTH DEMESNE
<b>County</b>	Fingal
<b>Coordinates</b>	327867, 239047
<b>Categories of Special Interest</b>	ARCHITECTURAL ARTISTIC ARCHAEOLOGICAL HISTORICAL
<b>Rating</b>	National
<b>Original Use</b>	castle/fortified house

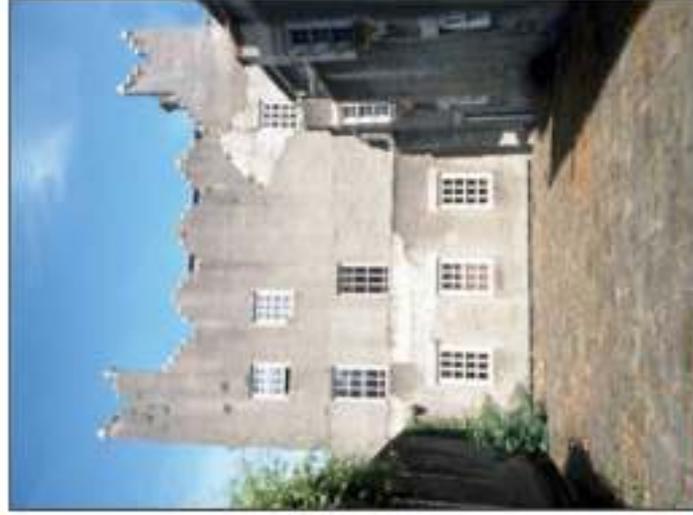
11358057

Attached four-bay three-storey medieval tower house with dormer attic, c.1525, with turret attached to north-east. Renovated c.1650. Renovated and openings remodelled, 1738. Renovated with dormer attic added, 1910.

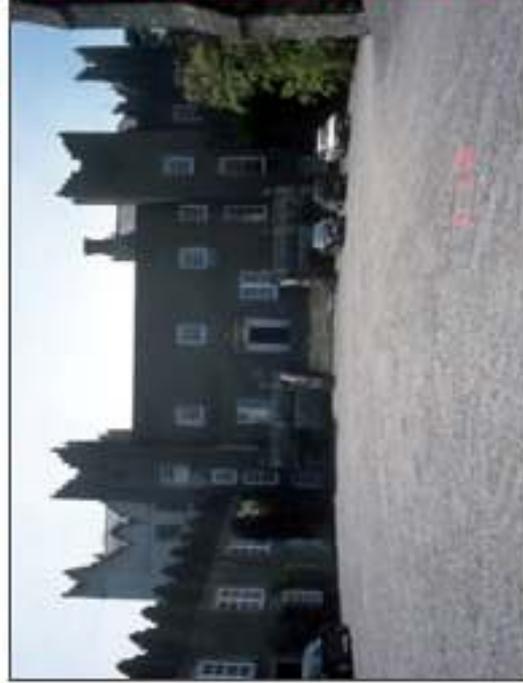
11358054

Attached six-bay two-storey over basement late-medieval house, c.1650. Comprising four-bay two-storey central block flanked by single-bay five-storey square plan crenellated turrets. Renovated 1738, with openings remodelled and terrace added. Renovated, 1910, with interior remodelled. ROOF: Double pitched slate set behind crow stepped parapets. WALLS: Roughcast render with mouldied string course to top floors of turrets. OPENINGS: Timber sash windows and remodelled window openings, 1738. Timber panelled door set in rusticated cut stone Doric doorcase, 1738. Several window openings remodelled, 1910.

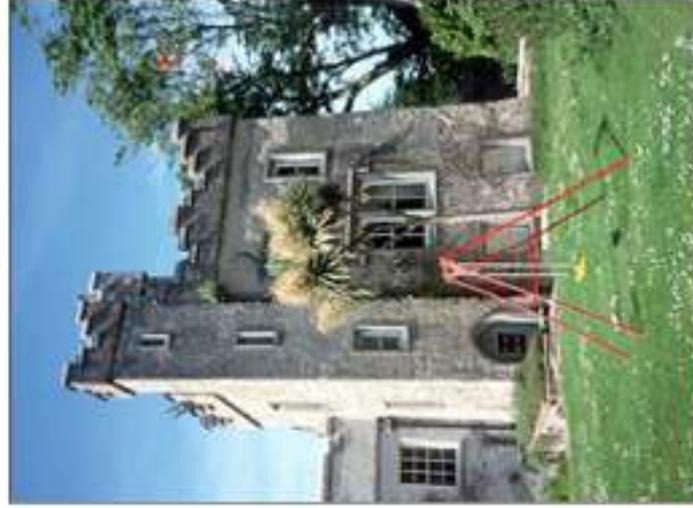
11358050

Attached three-bay three-storey rubble stone medieval tower house, c.1400, with base battier and crenellated parapet. Single-bay five-storey crenellated entrance turret on a square plan to centre. Renovated c.1825. Renovated and refenestrated c.1910. ROOF: Crow-stepped crenellated parapet and chimney. WALLS: Random rubble stone, with some render c.1825. OPENINGS: Square headed window openings with limestone chamfered architraves and replacement fixed timber windows c.1910. Mullioned window, c.1825, to south elevation. Lancet openings to top floor of entrance turret, with replacement diamond leaded windows, c.1910, to lower floors. Limestone doorcase with replacement timber panelled door, c.1910, to entrance turret.

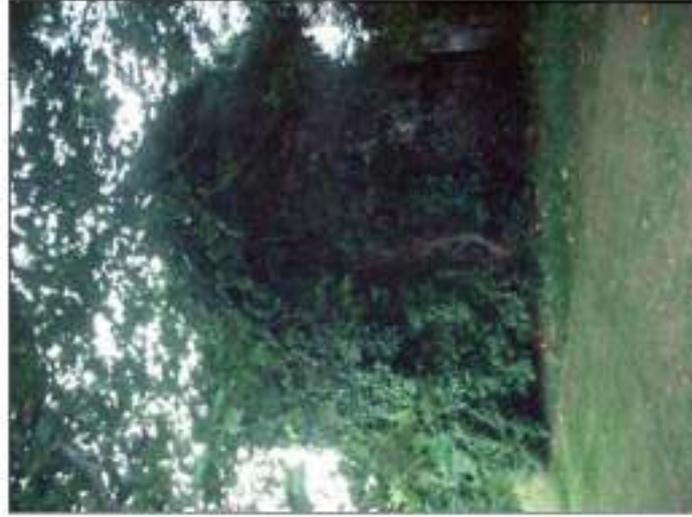
11358062

Single-bay two-storey rubble stone building, c.1750, on a circular plan, possibly originally a dovecote. Now disused and partly derelict. Attached to rubble stone wall, c.1840, on an L-shaped plan, around a kitchen garden.

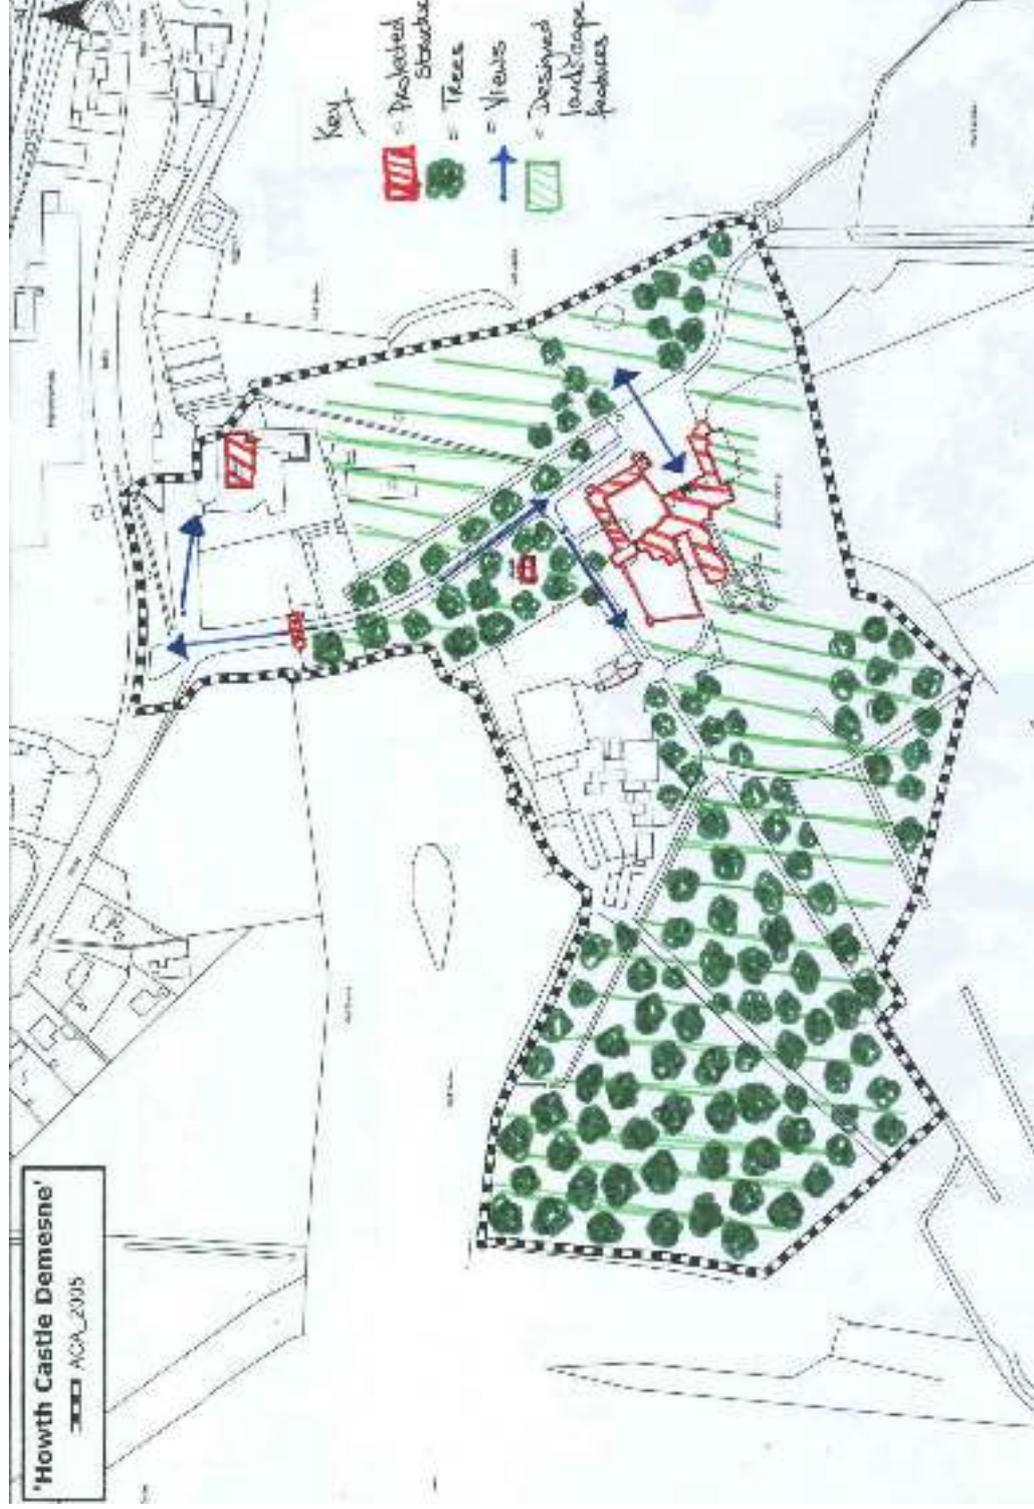
Map of Architectural Conservation Area indicating views to be preserved

The proposed development will have no impact on the view towards the castle from the avenue, or of the front and rear of the castle or the view along the Howth Road towards St Mary's Church from within the ACA.

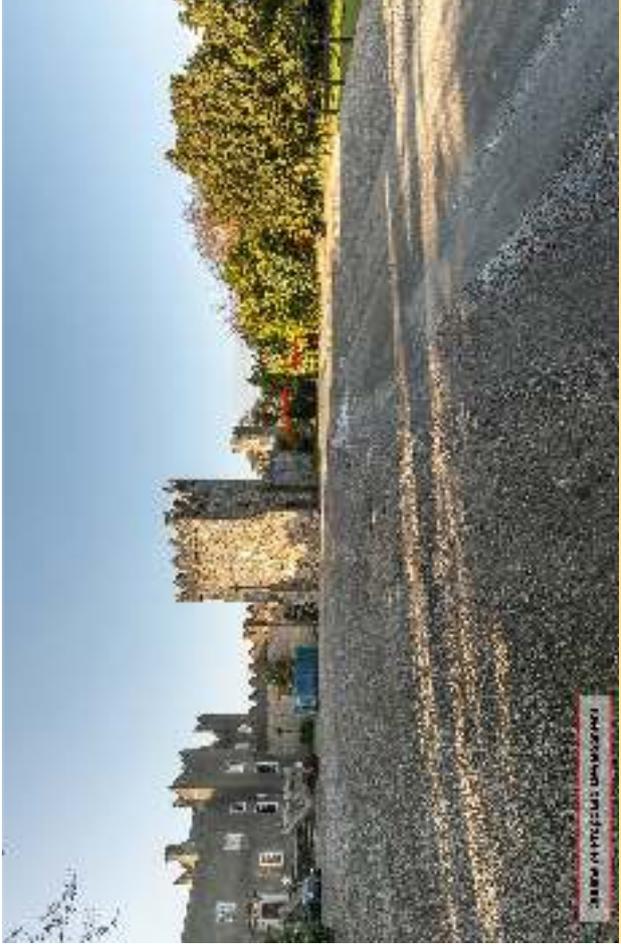
View 11 from Modelworks. No visual impact

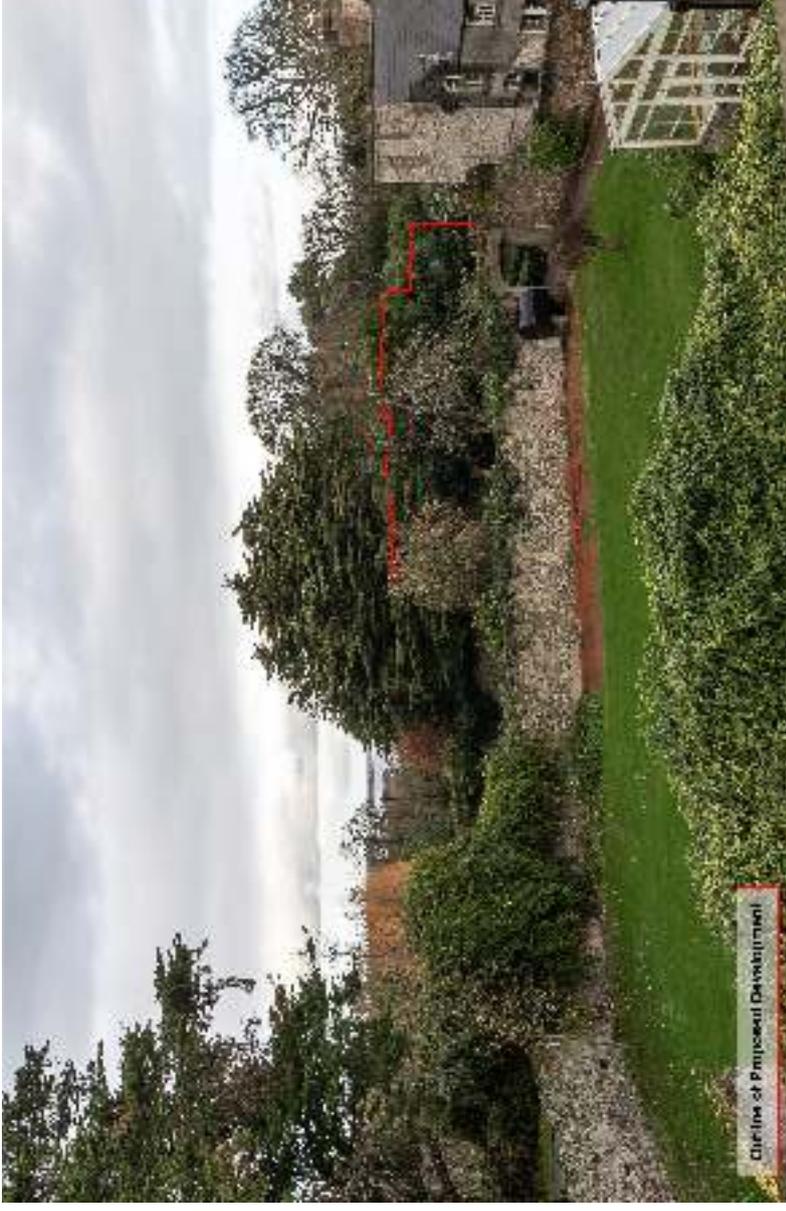
View from upper window of the castle. Protected view. No visual impact

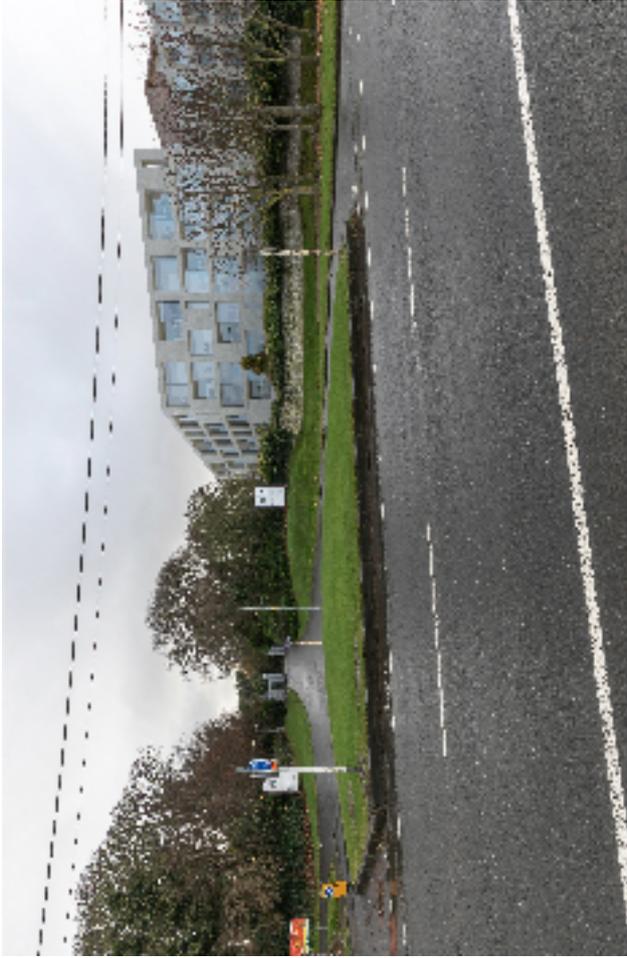
View towards the main entrance gates. Significant visual impact

Whilst the red line appears to emphasise the development, in reality the impact would be greatly reduced by the planting between the site and the avenue which and this will be increased by the landscape proposals.

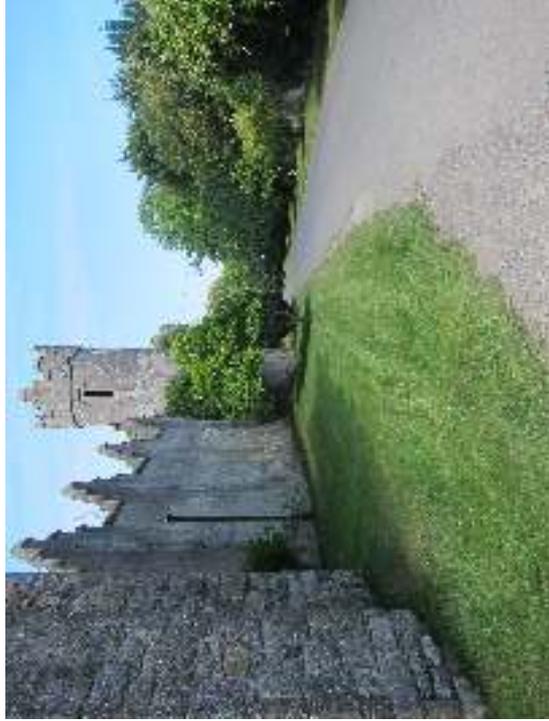
View along avenue north of the stable yard, preserved view in the Architectural Conservation Area  
No visual impact from the proposed development.

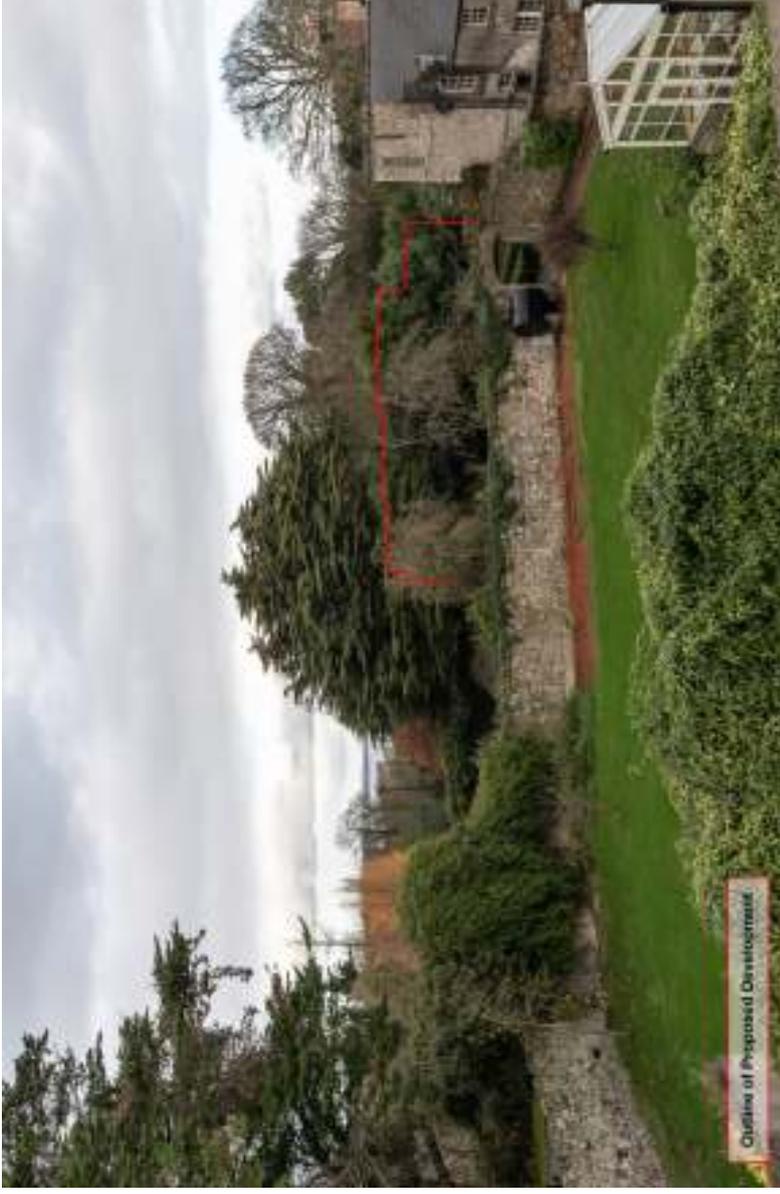
View 13 by Modelworks, view from upper storey of the castle. No visual impact from the proposed development

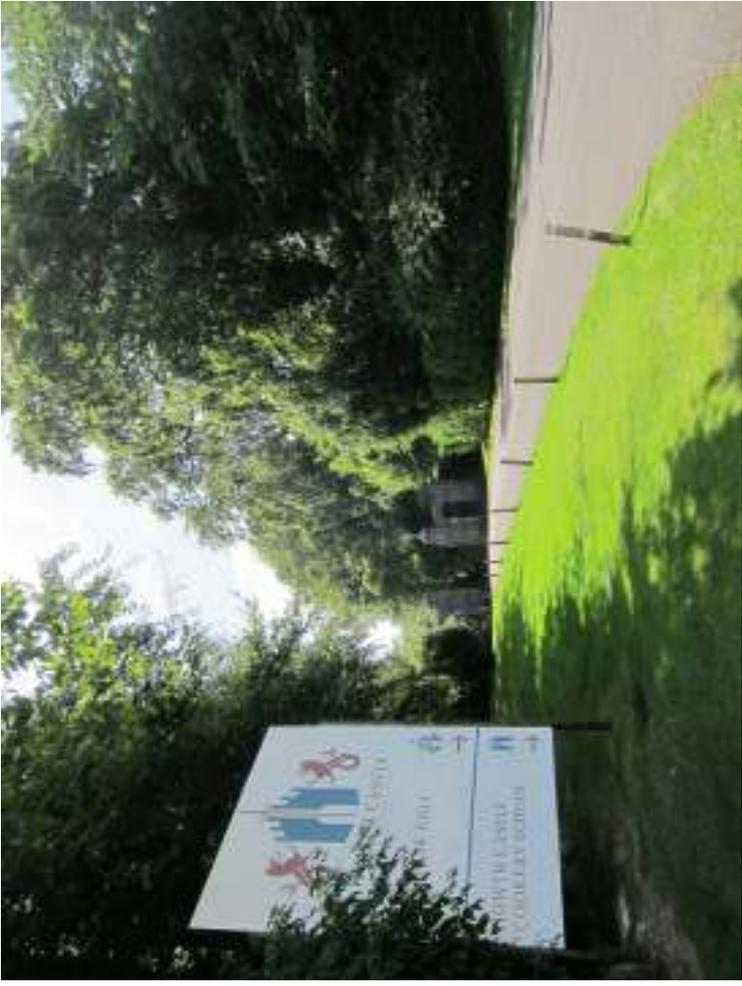
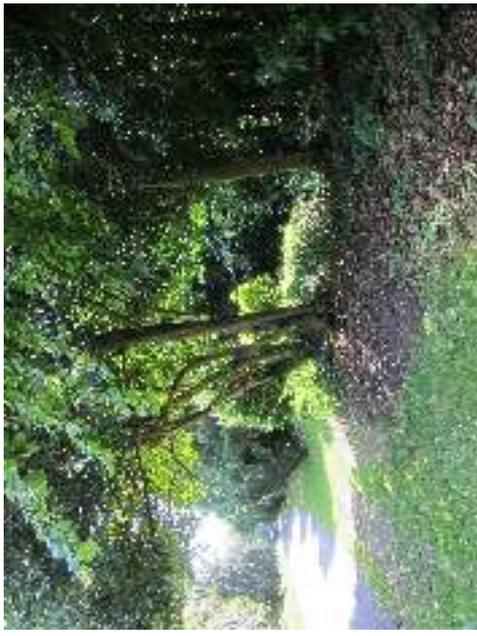
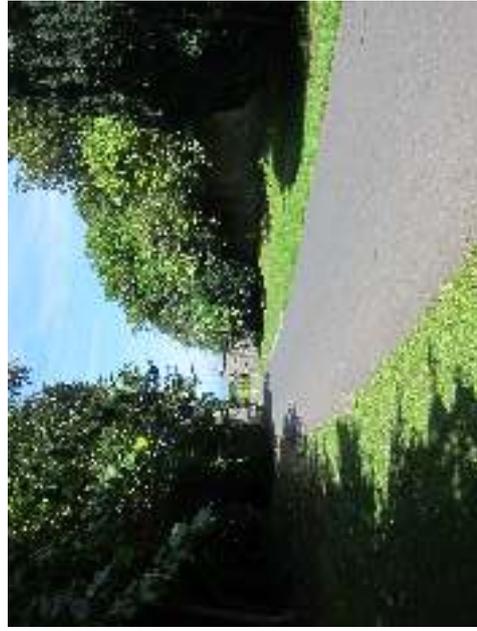
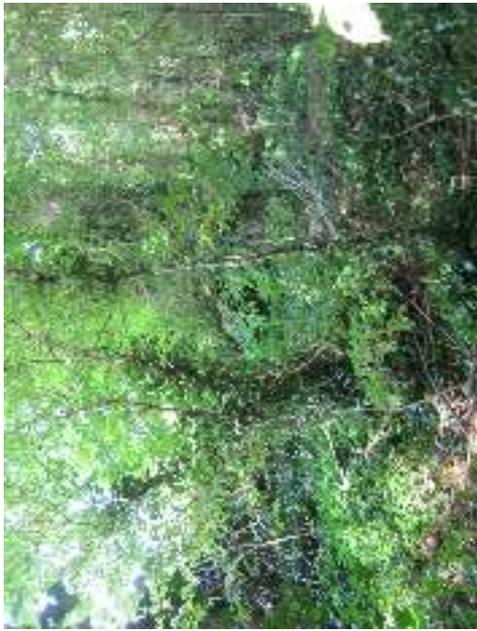
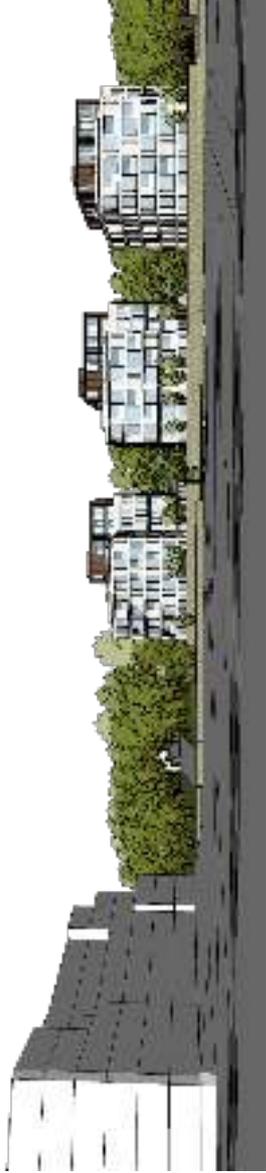
The proposed development view of the development from within the Techcrete site. The main entrance and avenue is screened to varying degrees from the proposed development by trees
