Proposed Strategic Housing Development  
“Kenelm”  
Deer Park  
Howth  
Co. Dublin

**VOLUME III**  
APPENDICES TO ENVIRONMENTAL IMPACT  
ASSESSMENT REPORT

# **DAYLIGHT AND SUNLIGHT ANALYSIS**

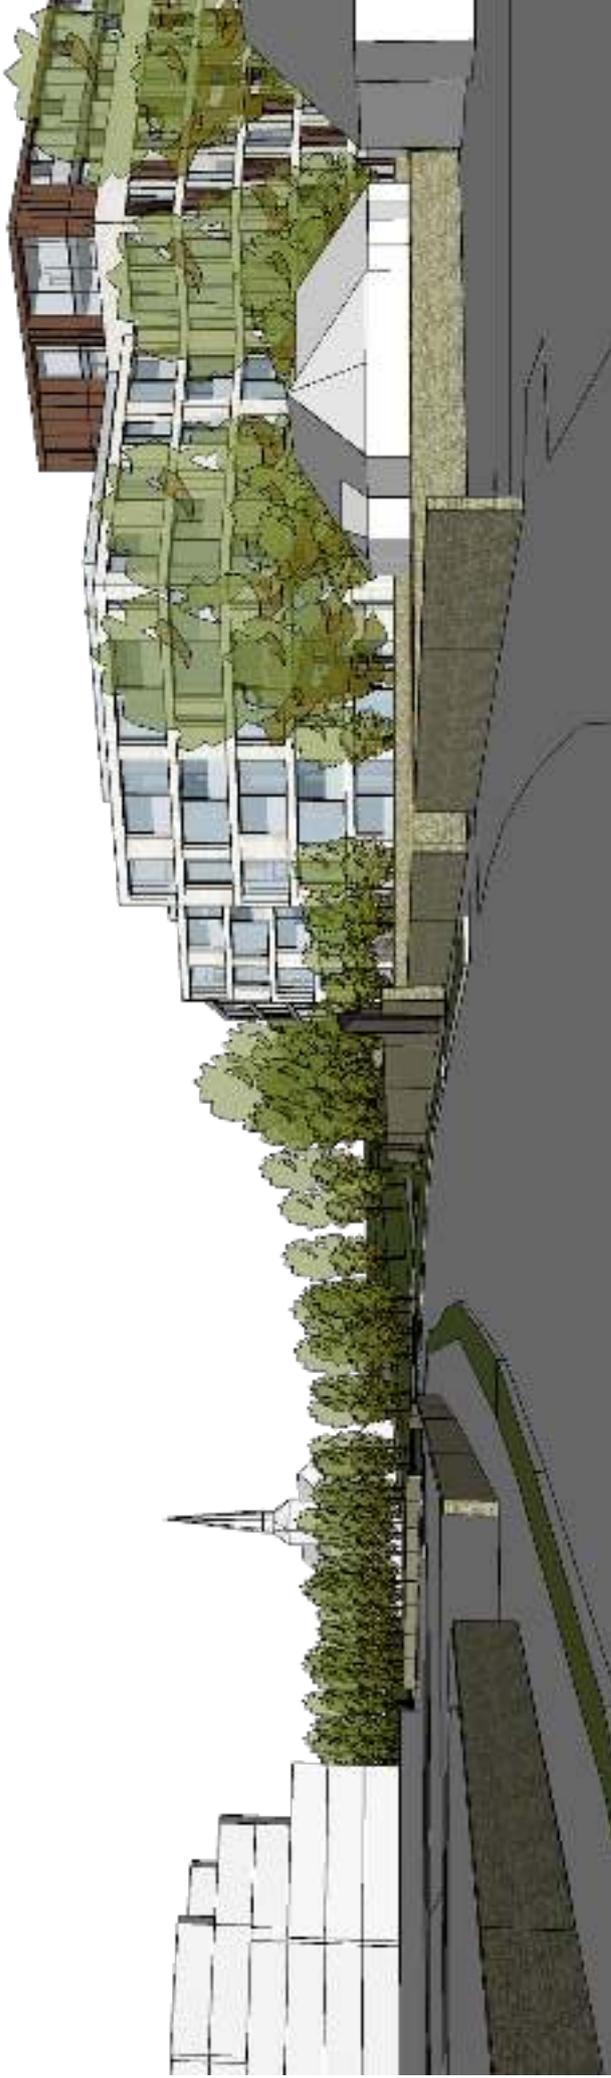
This computer generated image of the proposed development on the Howth Road shows the focus of the vista as the spire of St Mary's Church while the buildings on the Techrete and Glenveagh site are intended to form a gateway to Howth village and harbour and the announcement of more intensified destination after the residential ribbon development from Sutton Cross..

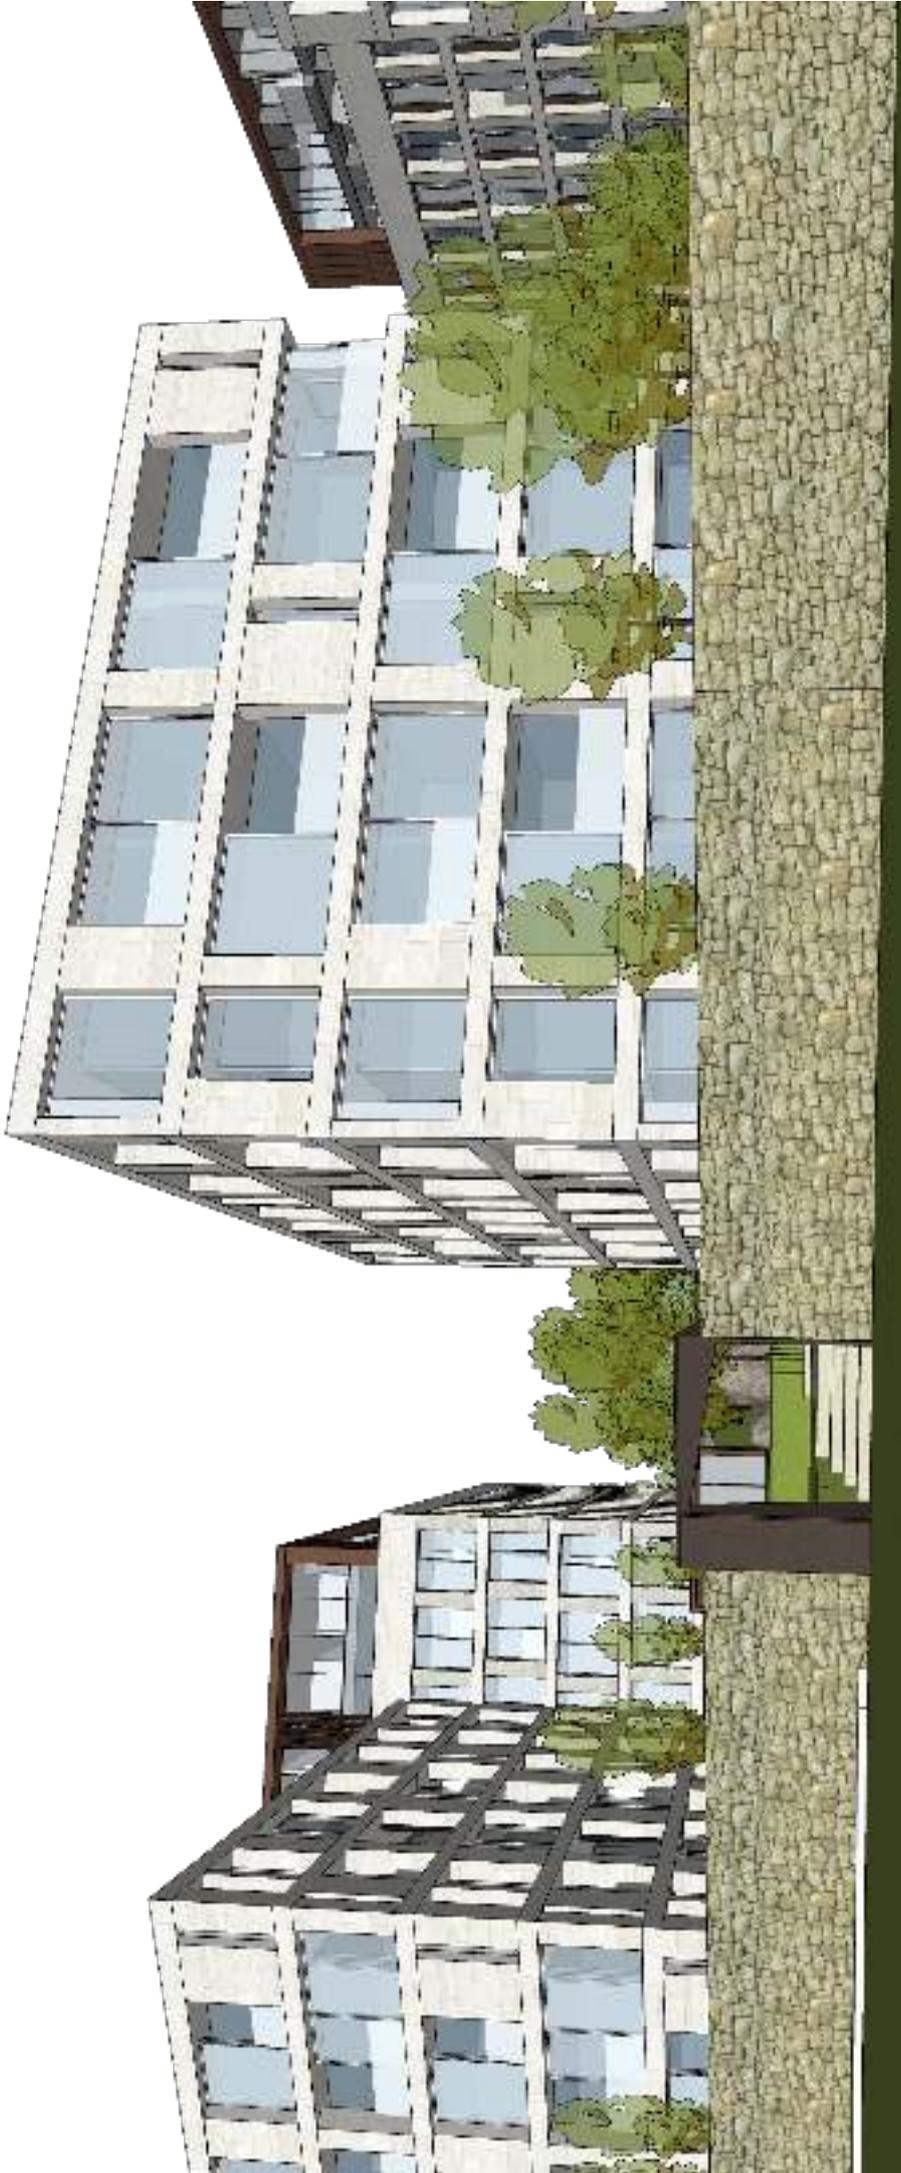
The pavilion layout of the three blocks allows glimpses of the tree belt that forms the background of the site. In developing the design concept the blocks have been reduced in height to five storeys along the boundary with Howth Castle and the Howth Road. The eastern pavilion has been distanced insofar as was possible.
