# Strategic Housing Development, For Alterations to Shoreline GA1 Lands at Baldoyle, Dublin 13

Environmental Impact Assessment Report  
(EIAR) - Volume 3 Appendices

### 6769\_RP01\_Environmental Impact Assessment Report (EIAR) - Volume 3 Appendices

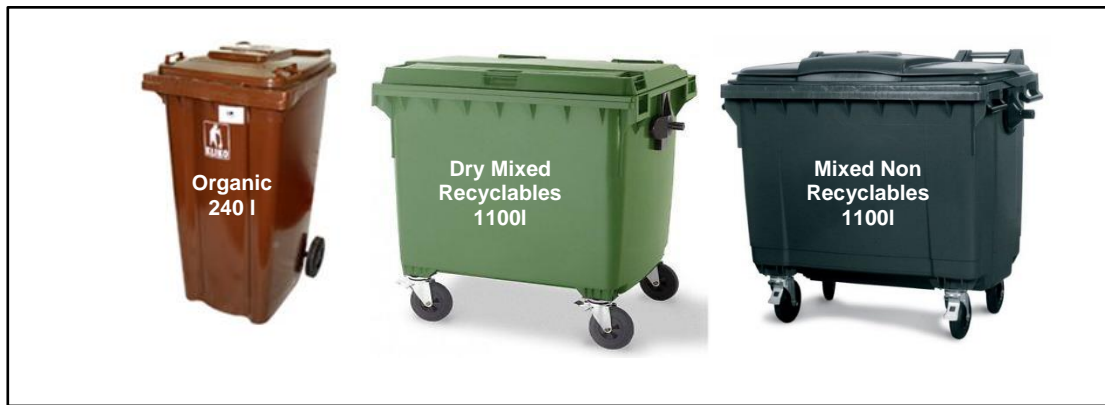
The types of bins used will vary in size, design and colour dependent on the appointed waste contractor. However, examples of typical receptacles to be provided in the WSAs are shown in Figure 5.1. All waste receptacles used will comply with the IS EN 840 2012 standard for performance requirements of mobile waste containers, where appropriate.

**Figure 5.1** Typical waste receptacles of varying size (240L and 1100L)
