**Viewpoint 1 West from Knockacarrigeen, Belclare.**

**Fig 9.3**

**Cartron Quarry, Tuam, Co Galway**

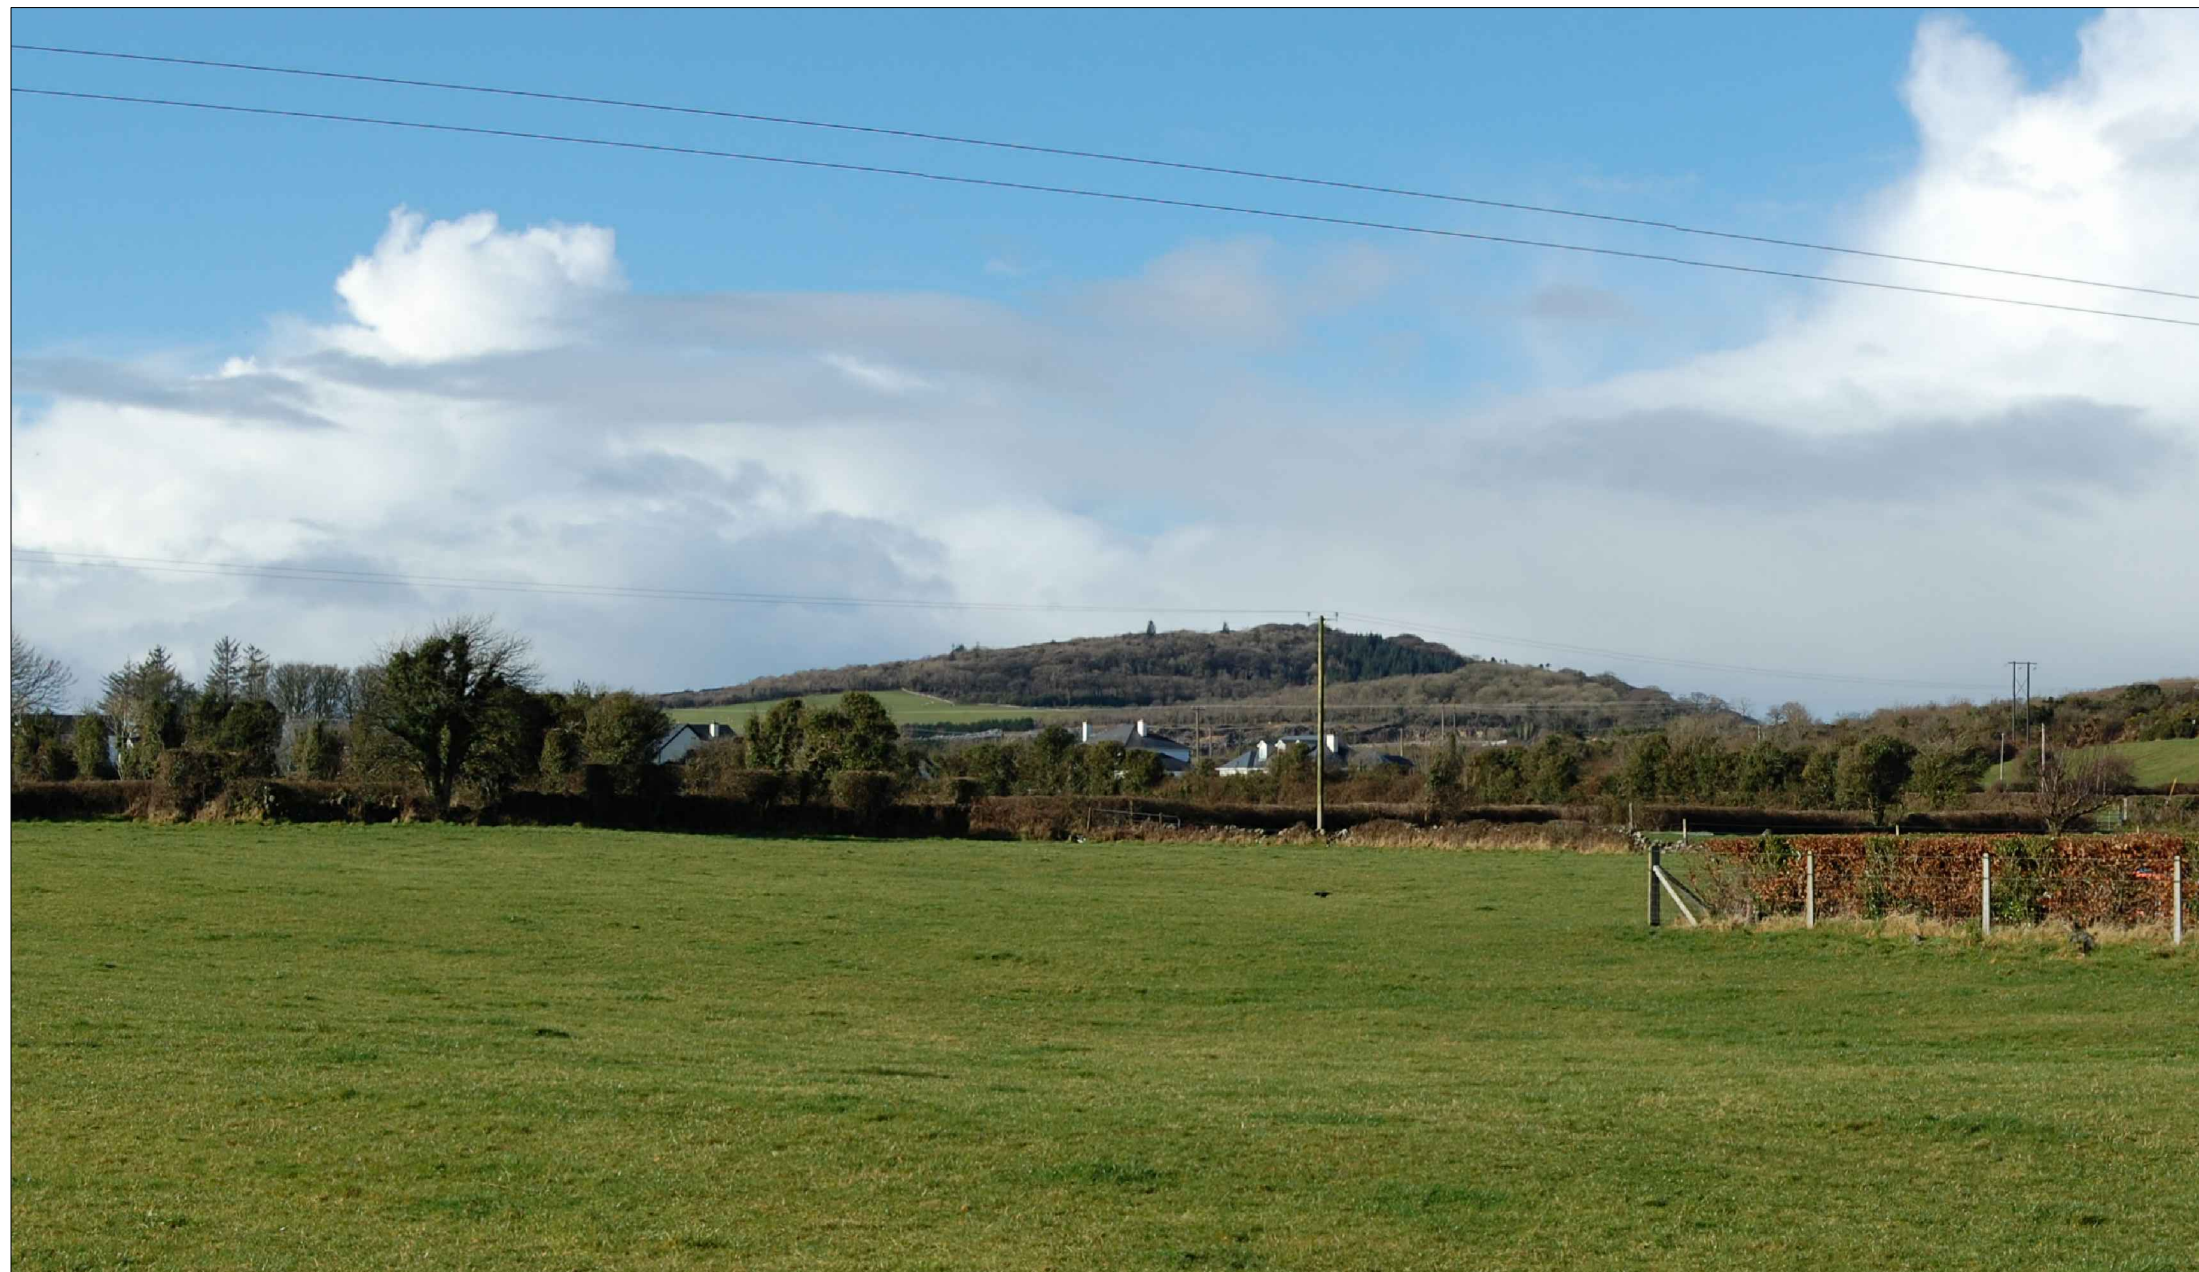
Photo Viewpoint 1

**Location:** Cartron  
**Viewpoint 1**  
 Distance to Site Boundary: 1236m  
 Horizontal Angle of View: 90 Degrees

View West from minor road in Townland of Catherhugh - The views across farmland are drawn towards the raised feature of Knockmaa Hill. A small clustering of houses and electric poles add a built element to this rural view. The majority of quarrying visible from this viewpoint relates to the adjoining Mortimer Quarry. Partial views of the subject quarry are visible from this viewpoint although little relating to unauthorised works.
