**Viewpoint 2 Northwest from Ballaghbaun, Belclare.**

**Fig 9.4**

**Cartron Quarry, Tuam, Co Galway**

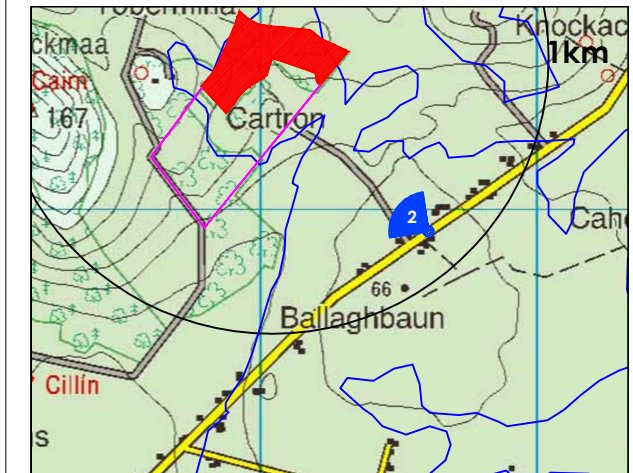
Photo Viewpoint 2

View Northwest from minor road in Ballaghbaun, across farmland between groups of residential properties aligning the road. Knockmaa Hill is a visual focal point, however the existing quarry operations (particularly the Northern faces of Mortimers Quarry) are clearly visible. The boundaries of both quarries are marked by the distinct band of Leylandii hedge. There are no views relating to the unauthorised development works.

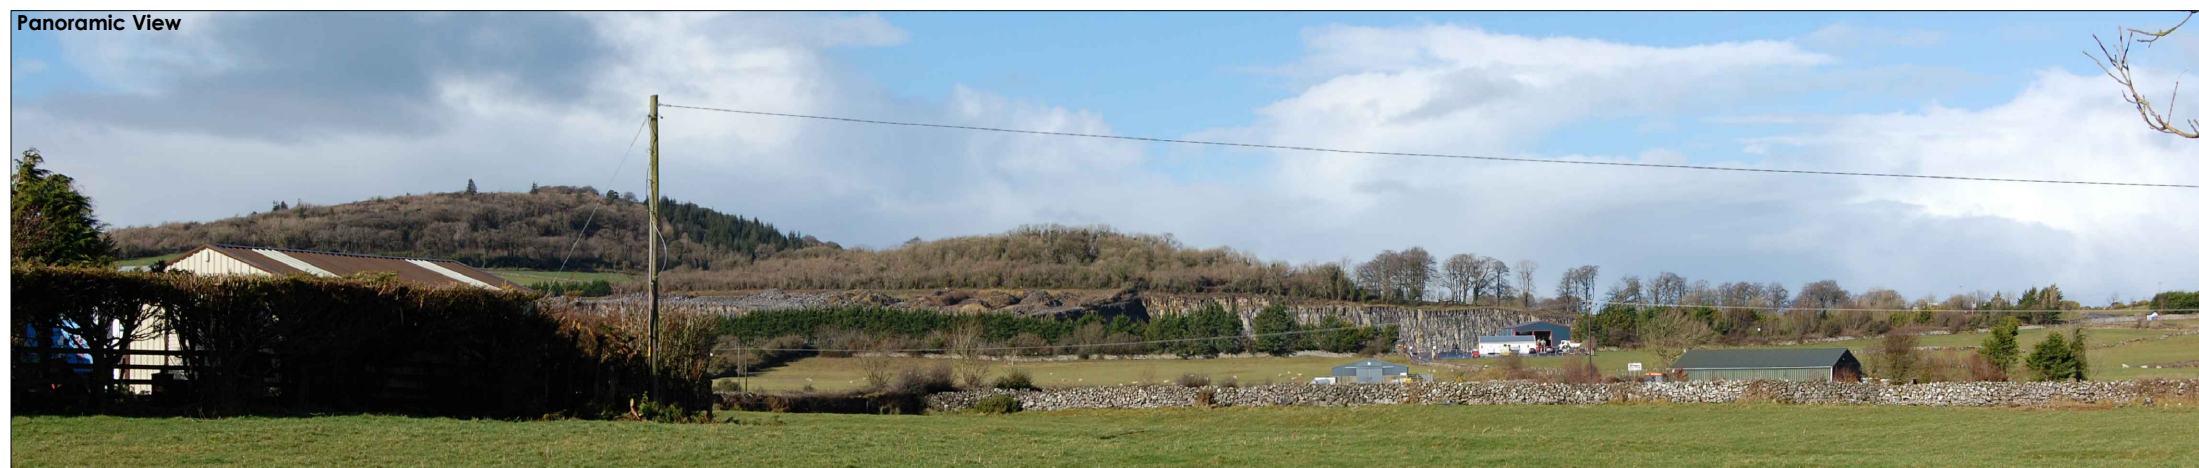
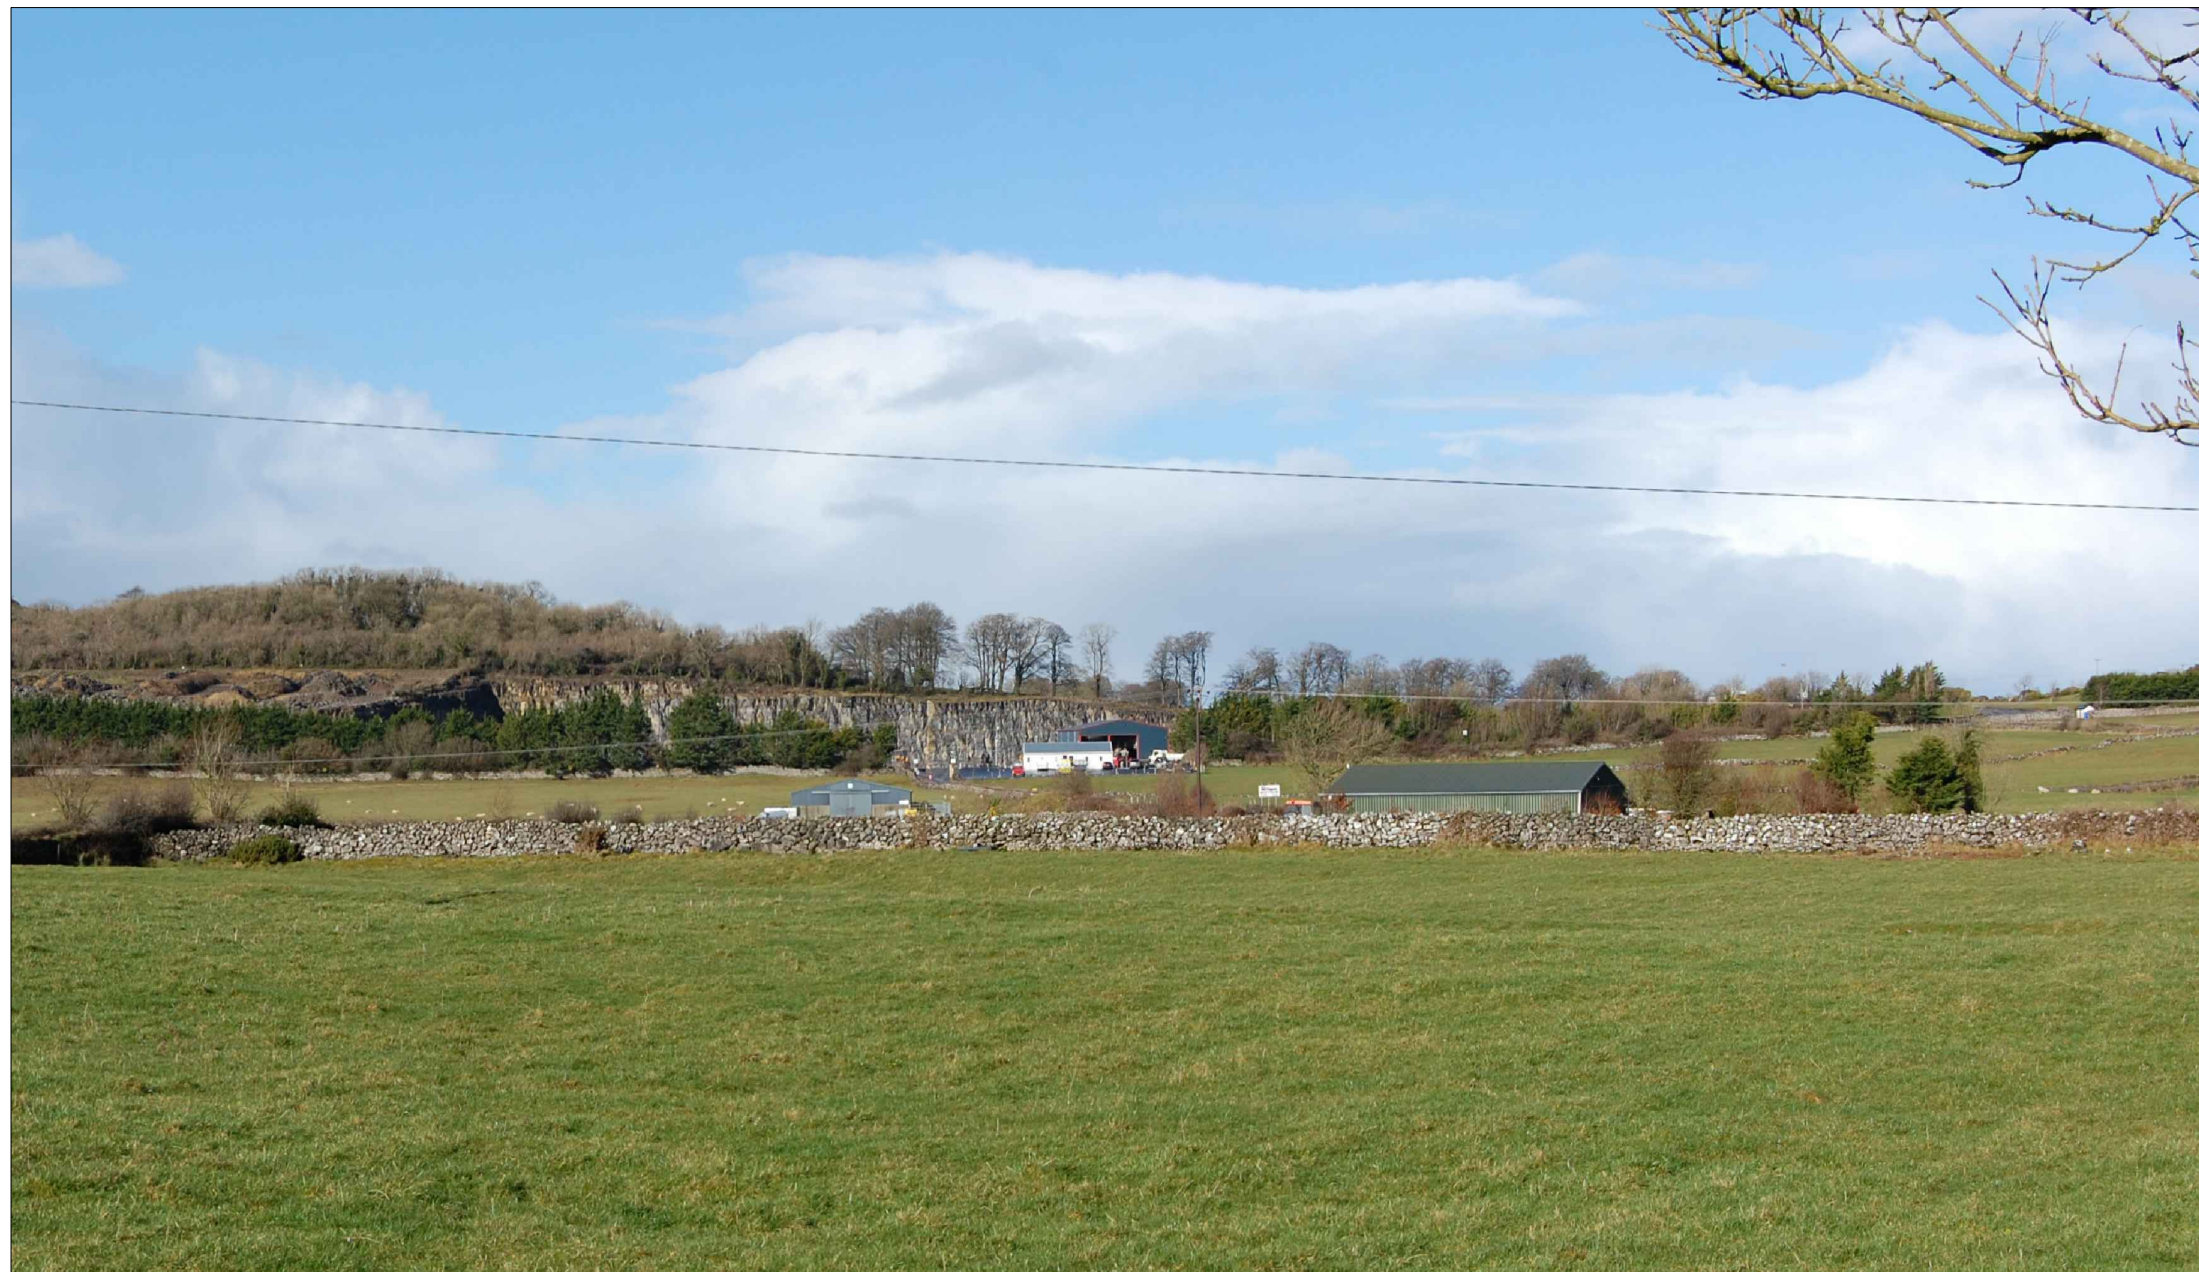
**Location:** Viewpoint 2  
 Distance to Site Boundary: 699m  
 Horizontal Angle of View: 90 Degrees

Landscape & Visual Effects Viewpoint	Baseline Landscape & Visual Sensitivity	Magnitude (Unauthorized Elements)	Impacts Occurred (Jan 2015 to Jun 2019)	Impacts Occurring Jun 2019 to Present)	Expected to Occur (with Remediation/Restoration)
2	Medium - Low (Landscape) High (Visual)	Very Low Very Low	Negligible Minor	Negligible Negligible/None	Moderate (Beneficial) Minor (Beneficial)
<b>client</b> McTigues	<b>date</b> May. 21	<b>scale</b> NTS@A3	<b>by</b> pjm	<b>notes</b> Image represents an eyelevel impression of view at monocular distance of 30cm
