Viewpoint 3 North from Ballaghbaun, Belclare.

Fig 9.5

Cartron Quarry, Tuam, Co Galway

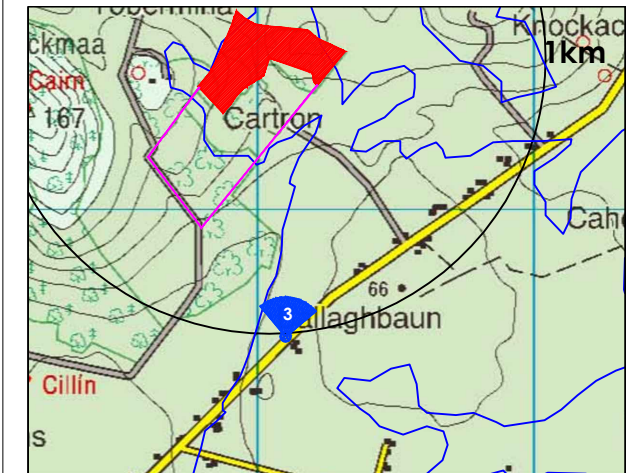
Photo Viewpoint 3

Location: Viewpoint 3
 Distance to Site Boundary: 936m
 Horizontal Angle of View: 90 Degrees

View North from minor road in Ballaghbaun, across farmland opposite a residential property. Knockmaa Hill is a visual focal point, however the existing quarry operations(particularly the Northern faces of Mortimers Quarry) along with its incongruous Leylandii boundary hedging are clearly visible. There are no views relating to the unauthorised development works from this viewpoint.
