Viewpoint 4 Northeast from Carheens, Belclare.

Fig 9.6

Cartron Quarry, Tuam, Co Galway

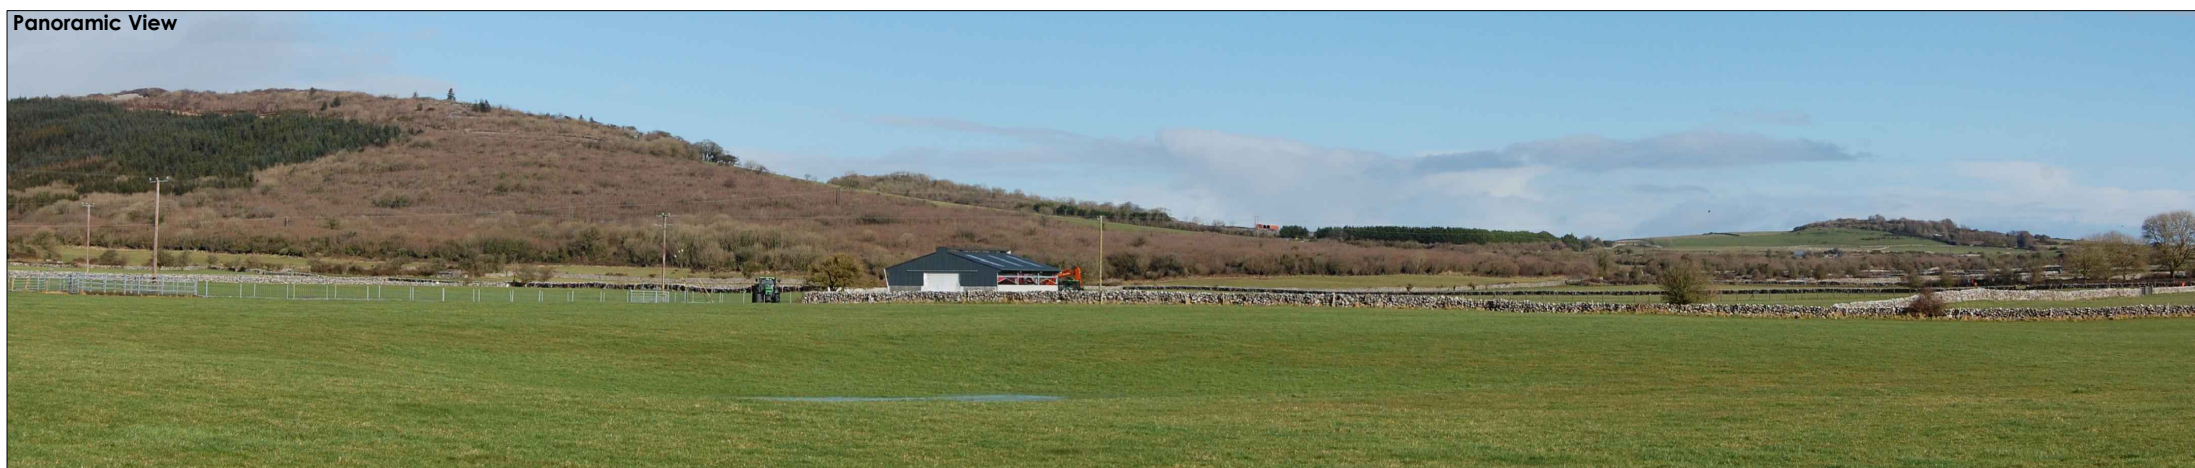
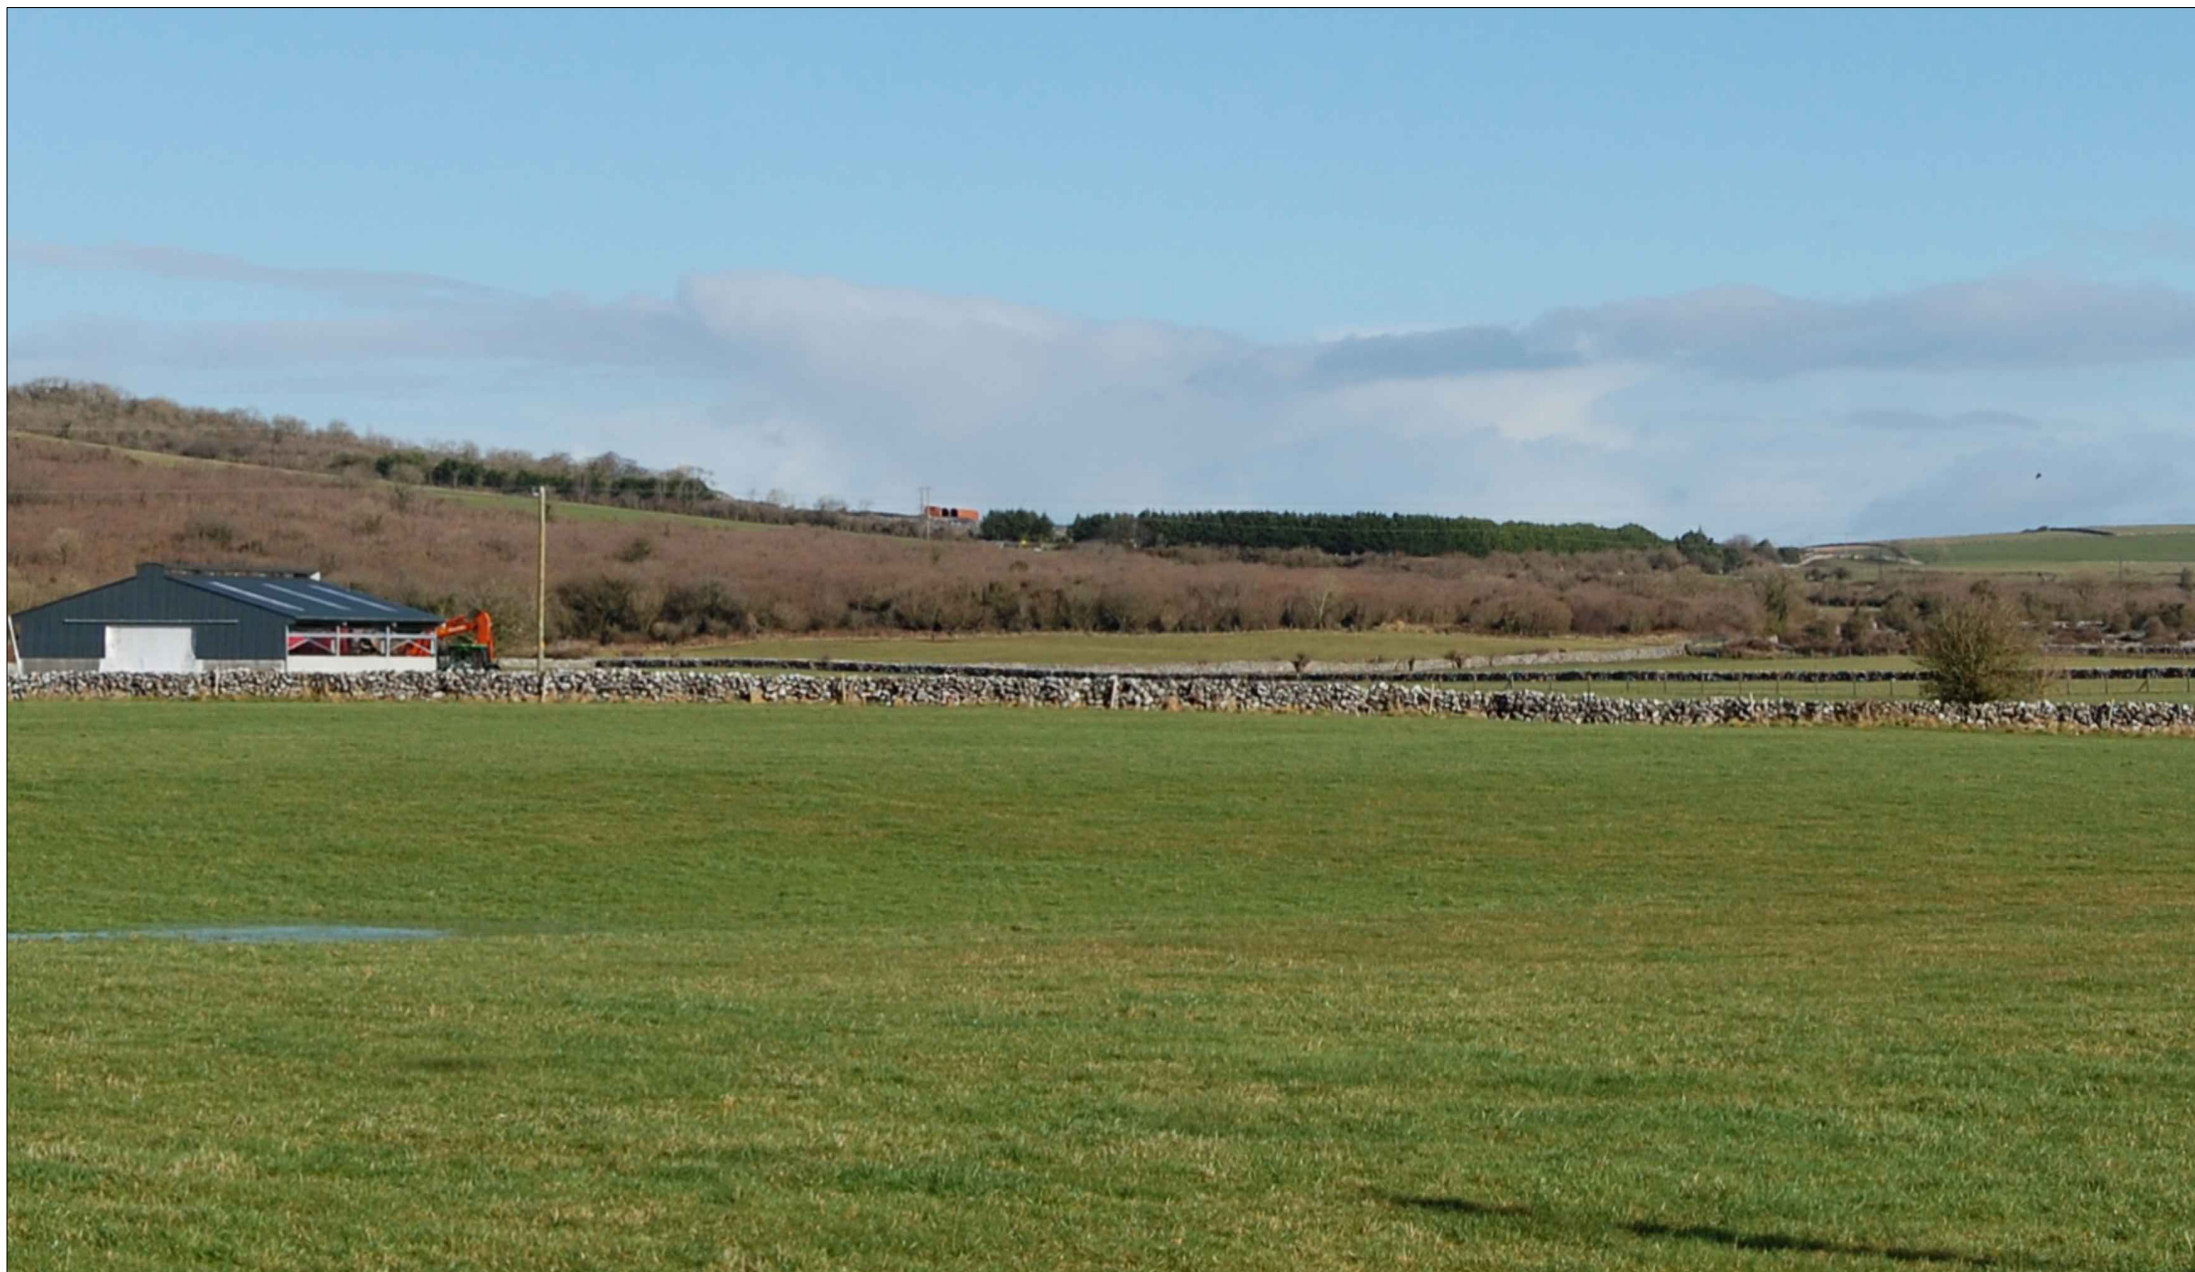
Photo Viewpoint 4

View Northeast towards subject site from minor road adjacent to residential properties. Knockmaa Hill is a visual focal point. Operational areas of both quarries are not visible from this viewpoint however the incongruous Leylandii boundary hedging are clearly visible. There are no views relating to the unauthorised development works from this viewpoint.

Landscape & Visual Effects Viewpoint	Baseline Landscape & Visual Sensitivity	Magnitude (Unauthorized Elements)	Impacts Occurred (Jan 2015 to Jun 2019)	Impacts Occurring Jun 2019 to Present)	Expected to Occur (with Remediation/Restoration)
4	Medium - Low (Landscape) High (Visual)	Very Low Very Low	Negligible Minor	Negligible Negligible/None	Moderate (Beneficial) Minor (Beneficial)
client McTigues	date May. 21	scale NTS@A3	by pjm	notes Image represents an eyelevel impression of view at monocular distance of 30cm
