Viewpoint 5 East from Knockmaa.

Fig 9.7

**Cartron Quarry, Tuam, Co Galway**

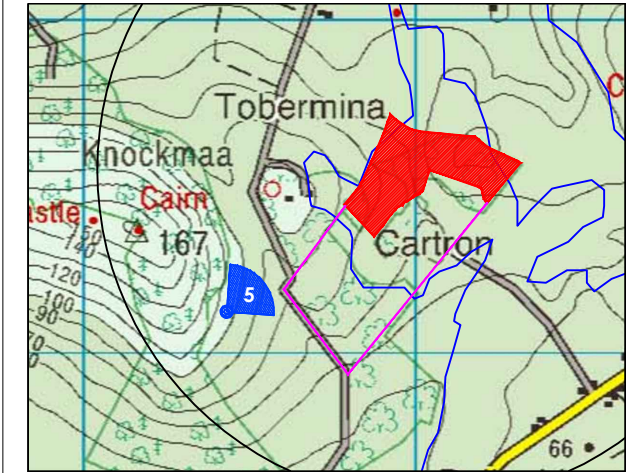
Photo Viewpoint 5

View East towards subject site from lands to the eastern side of Knockmaa. Whilst this location is not frequented by the public, it presents an open elevated view of the subject site. All other viewpoints on Knockmaa are well screened by existing woodland cover. Operational areas of both quarries are clearly visible from this viewpoint, however although elevated there is no visibility of unauthorised development.
