**McTigue Quarries Ltd
Cartron Quarry, Tuam**

**REMEDIAL ENVIRONMENTAL IMPACT ASSESSMENT
REPORT**

to accompany a Planning Application for Substitute Consent for the continuation of quarrying operations and associated ancillary development and the unauthorised continued use of buildings, structure, plant and machinery

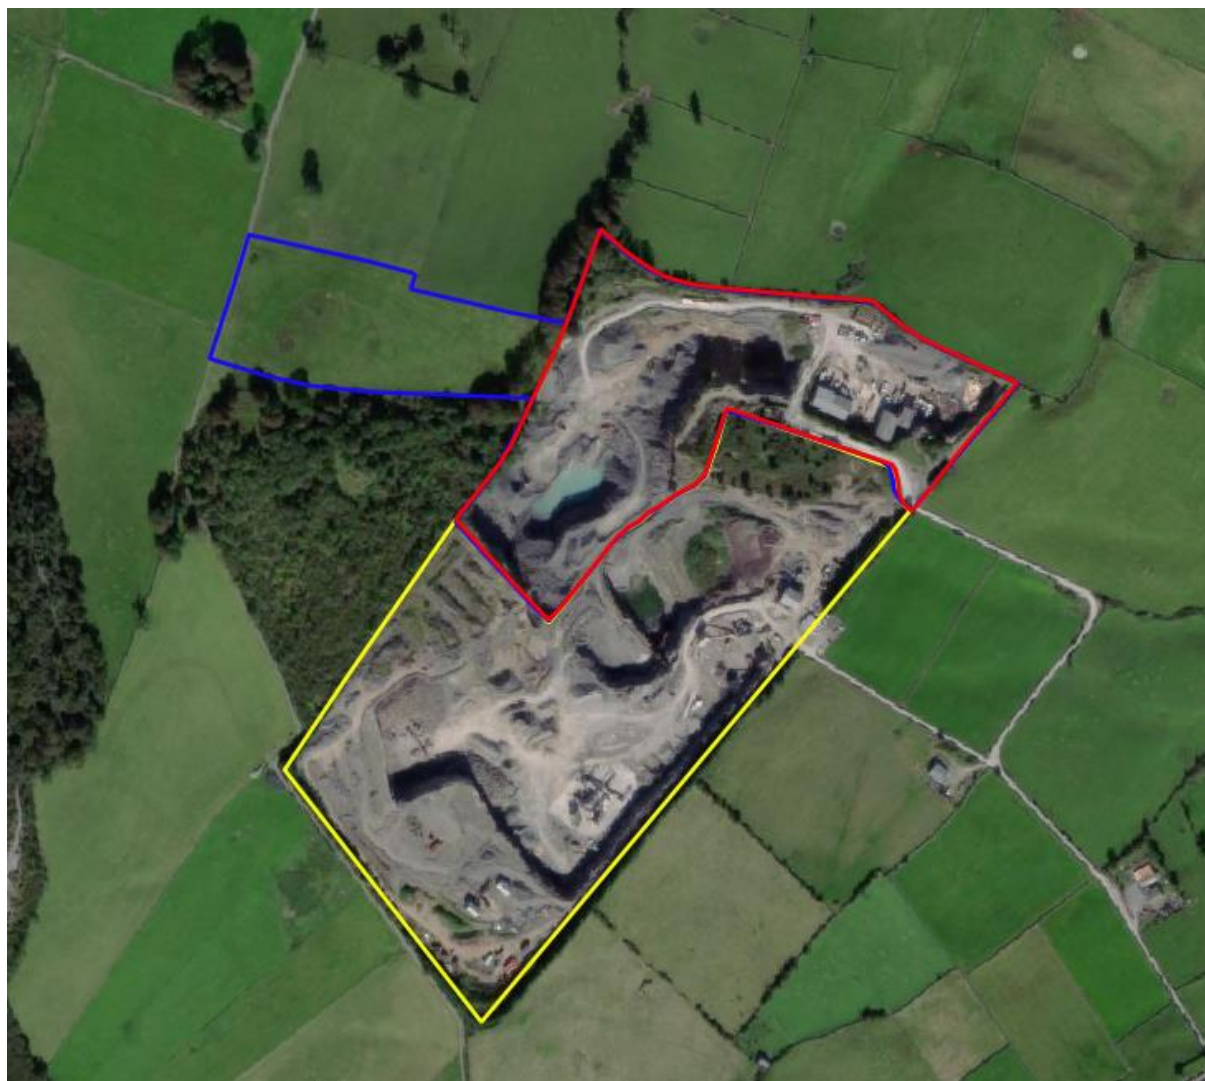
Figure 1.1 Application Area, landownership and adjacent quarry

The site is located in the Townland of Cartron some 7 kilometres to the south west of Tuam. The site is comprised of a c. 8.46ha L-shaped limestone quarry. The site is bounded to the north, east and south by agricultural fields. Immediately to the west lies another quarry, known Mortimer's Quarry. The location of the site's application area (shown in red), the Applicant's landownership (shown in blue) and the extents of the adjacent quarry, known as Mortimer's Quarry (shown in yellow) can be seen from Figure 1.1 overleaf.

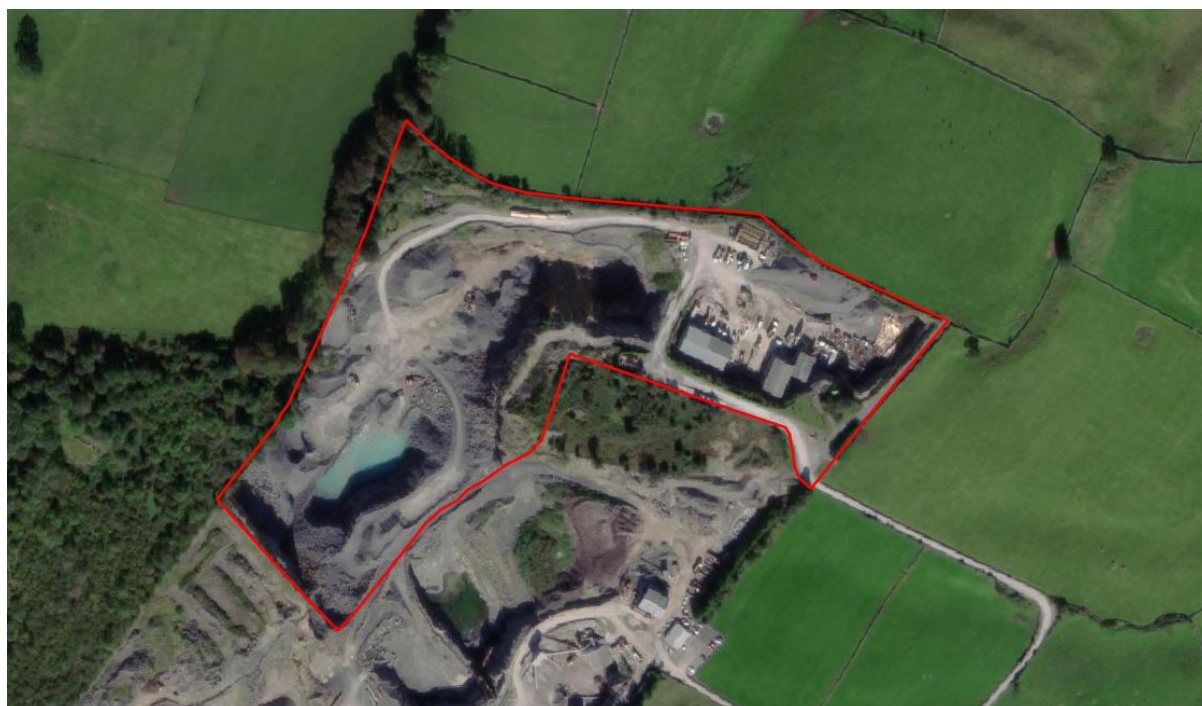
Figure 3.1 Substitute Consent Application Area

As previously outlined, the site is located in the Townland of Cartron some 7 kilometres southwest of Tuam. The site is bounded to the south by Mortimer's Quarry, and to the north, east and west by agricultural fields. The precise location of the site's application area can be seen from Figure 3.1.

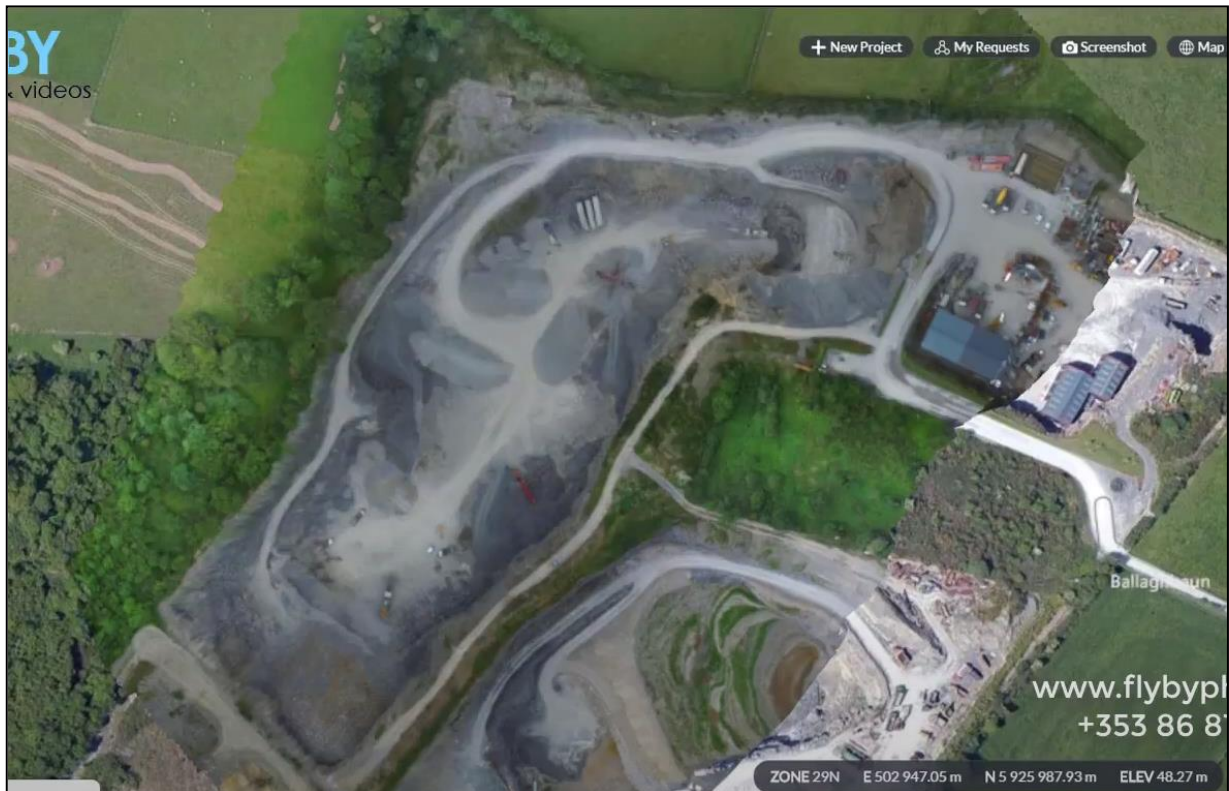
July 2016

The above aerial image produced by local business 'flybyphotos' shows the extent of quarrying operations in July 2016. The image shows how quarrying operations have progressed generally in a southern direction from that approved via the SC.

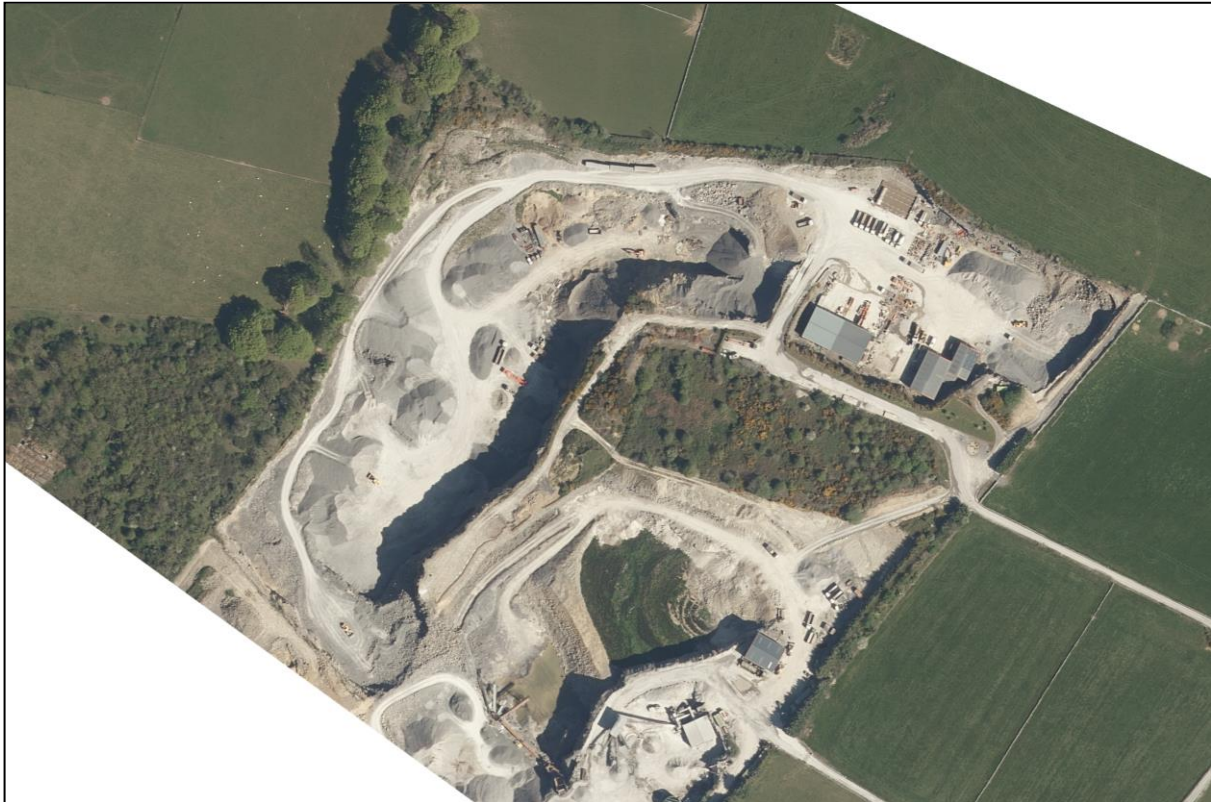
The aerial image from 2017, obtained from Ordnance Survey Ireland shows the extent of quarrying operations in 2017 (exact month unavailable). The image shows how quarrying operations have generally continued in the southern part of the quarry. Face progression is also evident in the north eastern part of the site, to the east of the structures/ buildings.

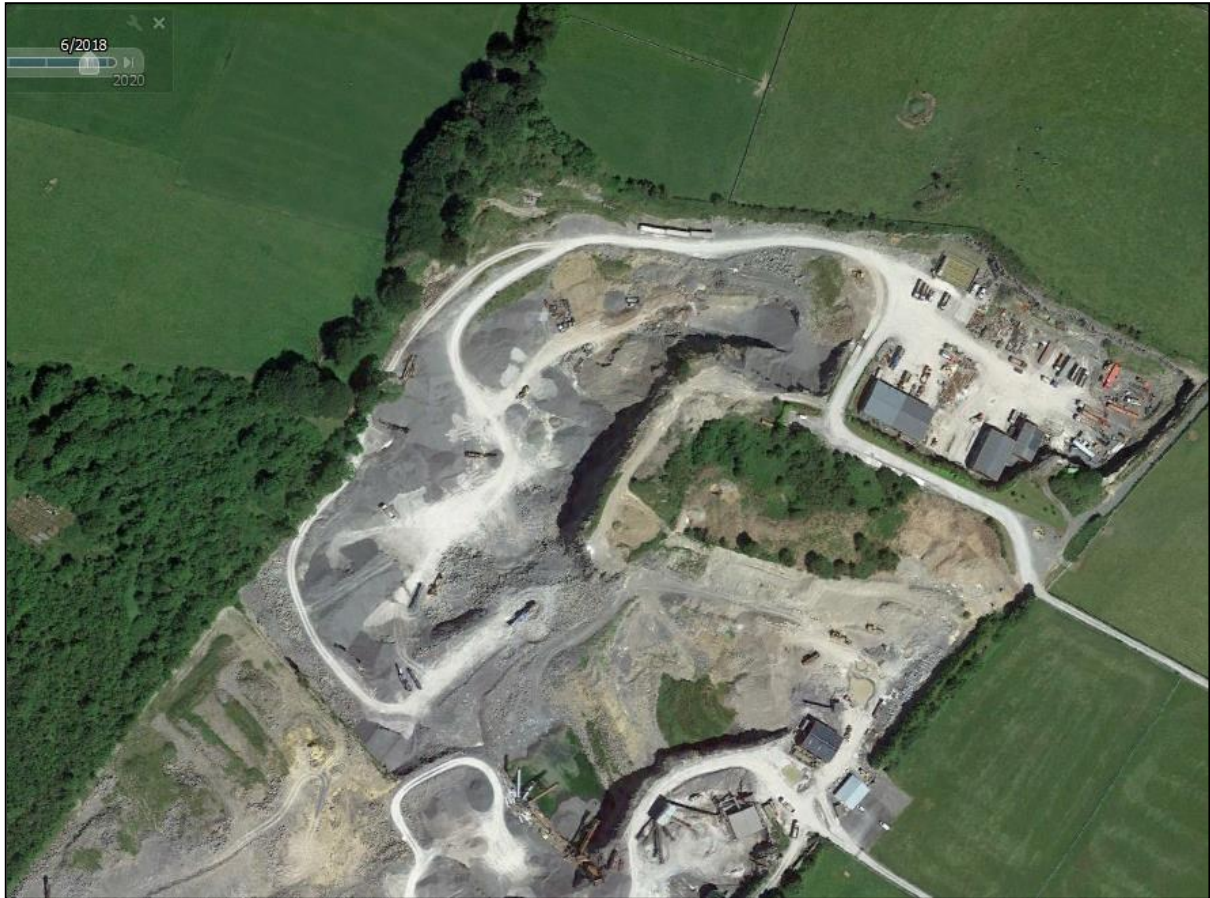
The Google Earth imagery from June 2018 shows the extent of operations in 2018. The images shows that quarrying operations have been generally focussed in the south eastern part of the quarry with mineral extraction focussed along the eastern boundary of the quarry.

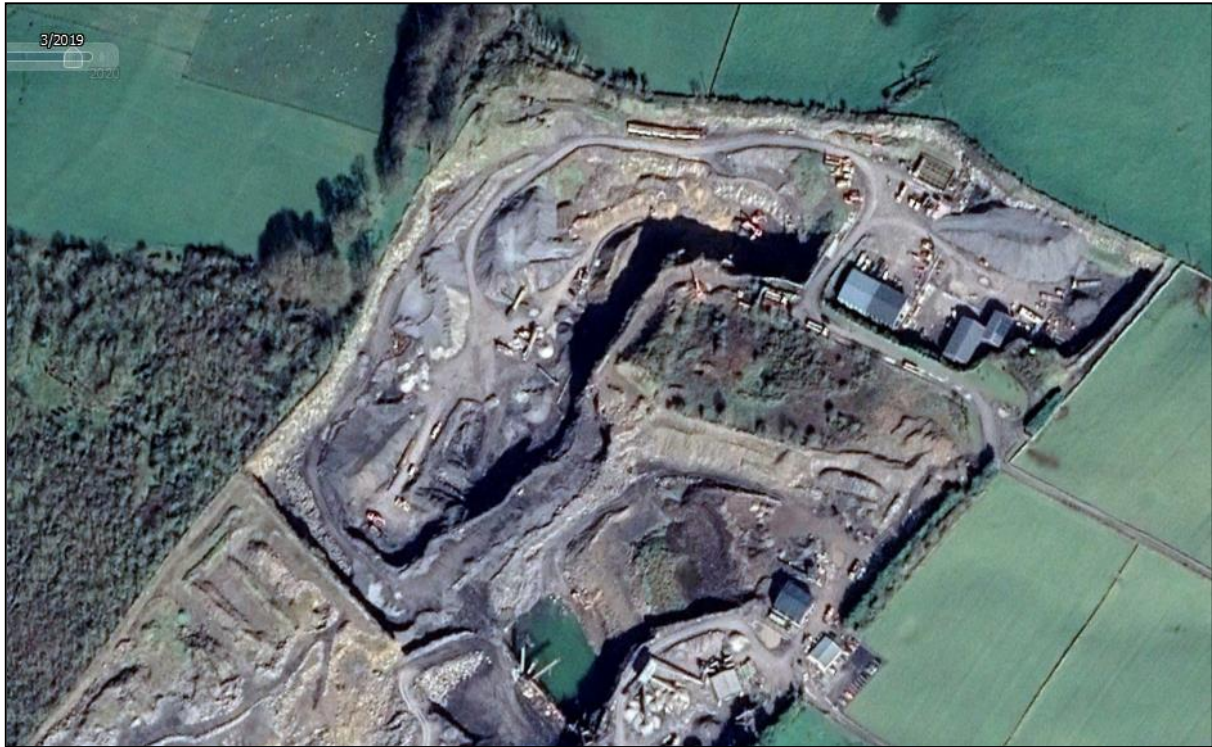
Google Earth imagery from March 2019 shows the extents of quarrying operations in March 2019, c. 3 months prior to the cessation of mineral extraction. The image shows that quarrying has been concentrating primarily in the southern part of the quarry void, with an additional sinking of the quarry floor evident in the south eastern part of the void.

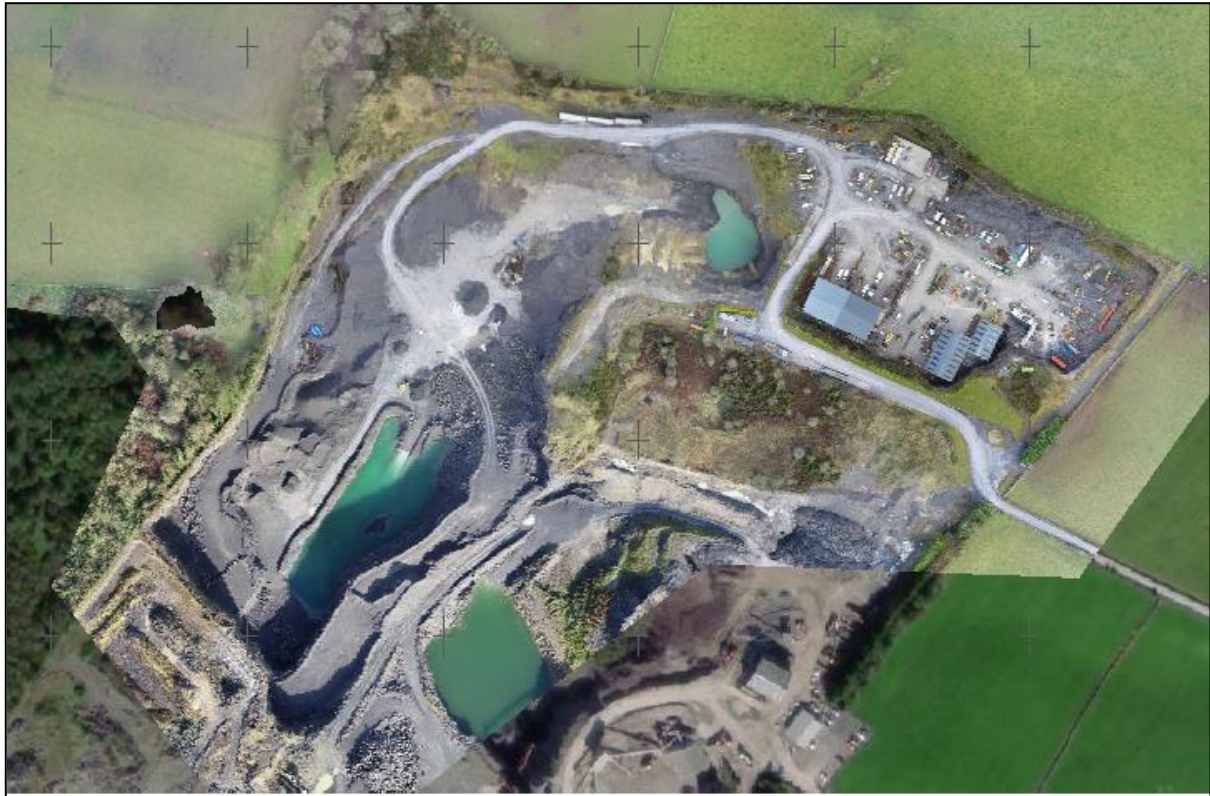
February 2021

The final image reflects the georeferenced Orthophotography, collected as part of the UAV Topographic Face Update Survey of the site undertaken by Quarryplan in February 2021. This accurately records the physical extent of the mothballed quarry operations. The image reflects the extent of quarrying operations to date at the site and the continued use of the buildings and structures in the north eastern part of the quarry site. Further detail on the present extent of workings are shown in the accompanying Topographical Survey and Cross-Section drawings which accompany the SC application.

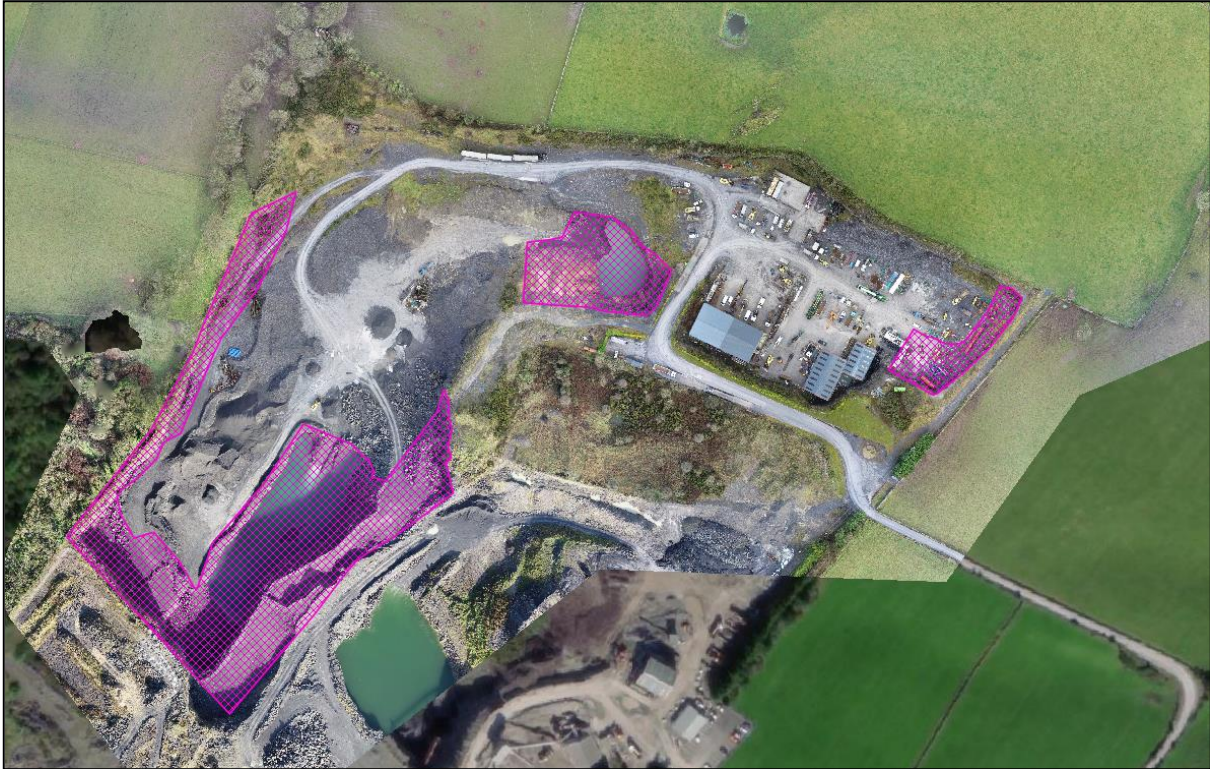
Areas of Face Progression/ Quarrying Operations Summary

For ease of reference, the main areas of face progression/ quarrying operations as displayed via the preceding chronology are shown hatched in magenta in the above image. The image demonstrates that operations have been focussed in 3 main areas of the quarry: the southern boundary; the central part of the site in the quarry floor; and the north eastern face.

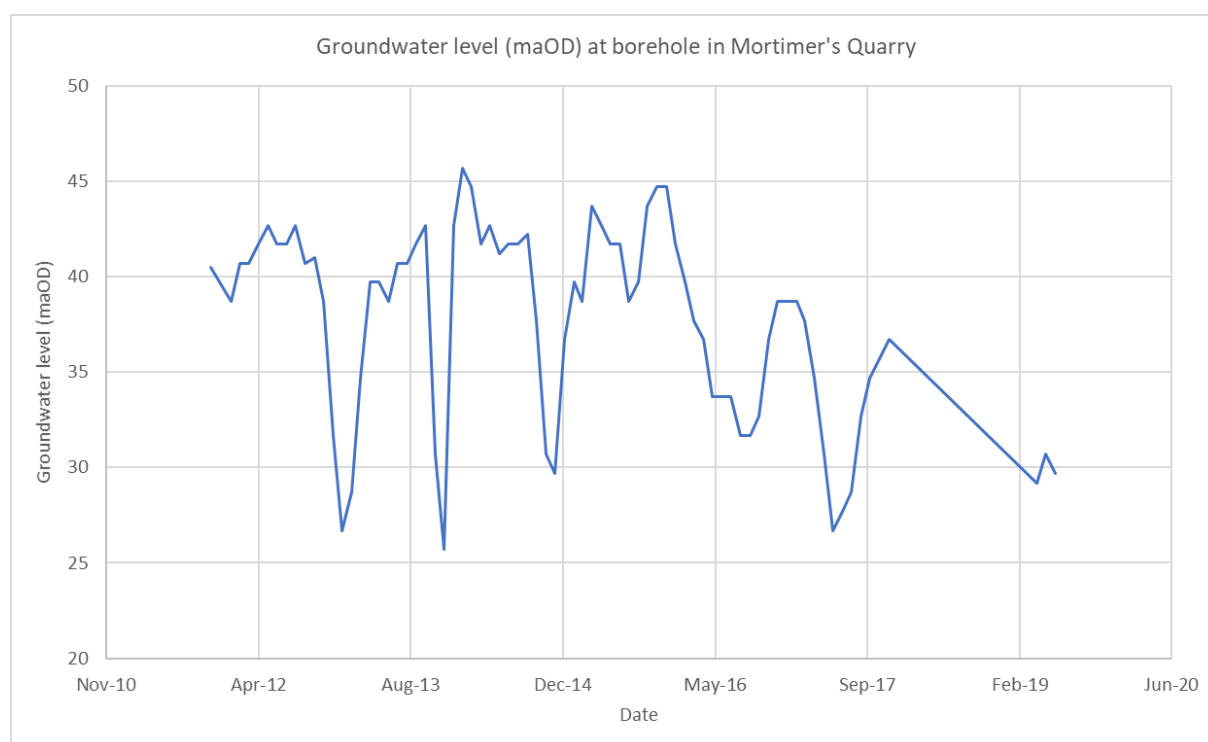
Figure 6.5 Groundwater Hydrograph

Mortimer's Quarry has a domestic well, which was installed for use at a neighbouring dwelling house. The well is installed at the eastern boundary of Mortimer's Quarry. It is understood that the well was drilled to approximately 140 mbGL and that the pump was installed at approximately 80 mbGL. The owner has provided groundwater level measurements taken at this well between September 2009 and June 2019, generally collected on a monthly basis, as required by conditions attached to the planning permission for the Site. The local datum (100 m) has been converted to Ordnance Datum (65 maOD at best estimate). This has informed calculation of groundwater levels as follows: minimum 25.7 maOD; average 37.6 maOD; and maximum 45.7 maOD. The hydrograph is presented below:

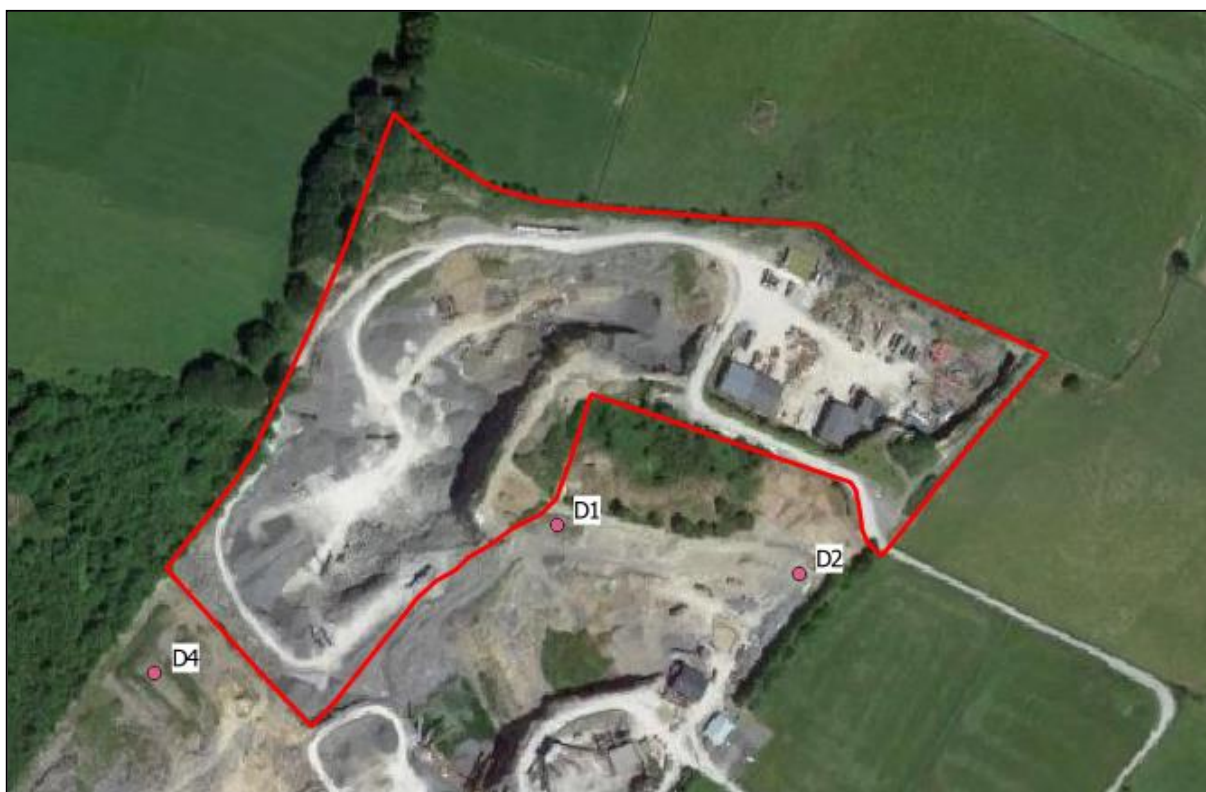
Figure 7.1 Dust Monitoring locations proximate to shared Boundary

The monitoring reports submitted to Galway Co. Co. for the adjacent quarry details how deposition monitoring is undertaken at 4 locations along at the site boundaries of Mortimer’s Quarry. Three of the locations (D1, D2 and D4) are located along or within close proximity to the shared boundary with the application site as shown at Figure 7.1 below.

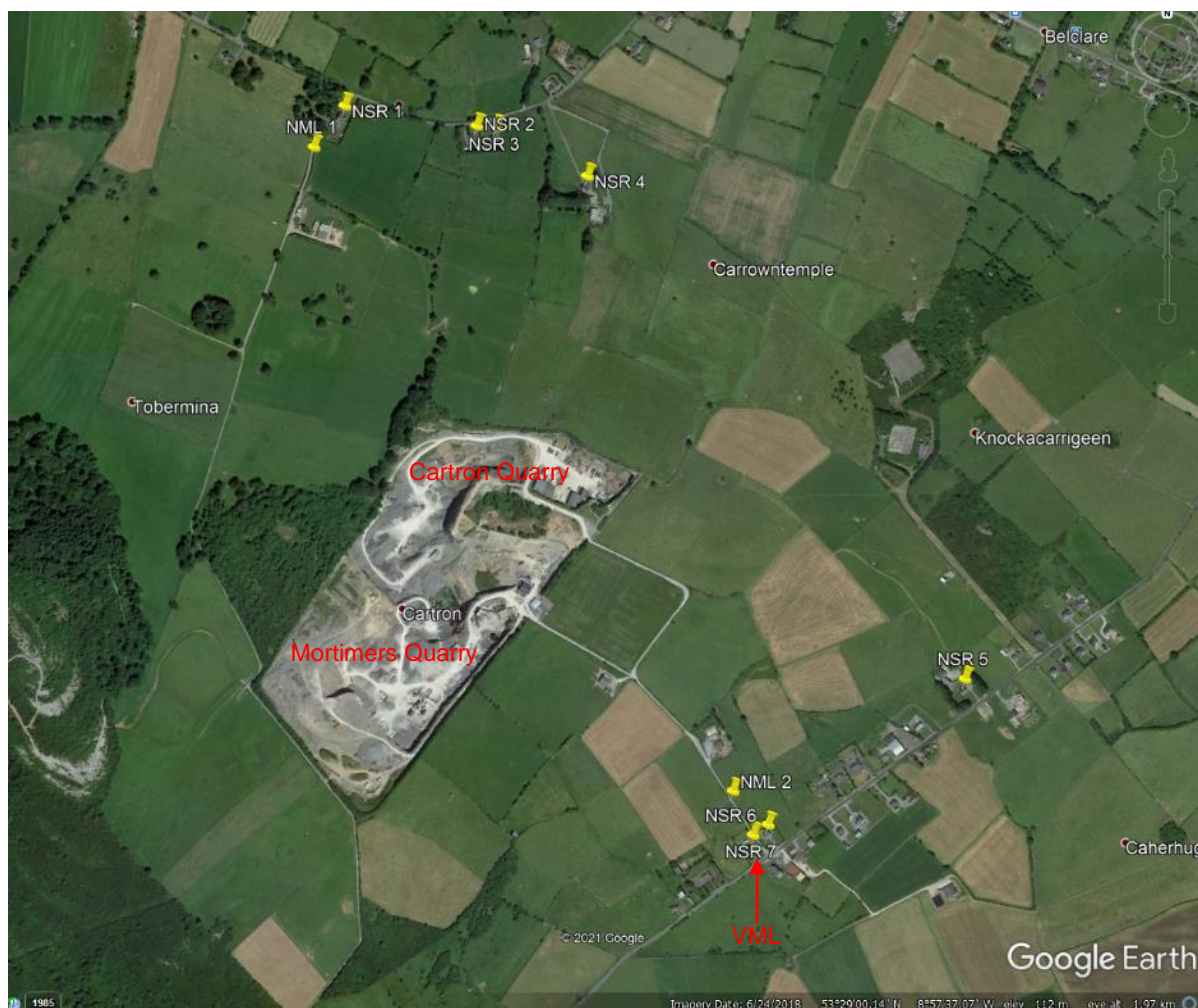
Figure 8.1: Noise Monitoring Locations (NML 1 & 2), Vibration Monitoring Location (VML) and Noise Sensitive Receiver (NSR 1- 7) locations included in the noise prediction model.
