5.0 SOILS, LAND AND GEOLOGY

This Chapter of the rEIAR considers and assesses any potential impacts resulting from quarrying related activities that have been carried out at the Site on the surrounding land, soils and geology.

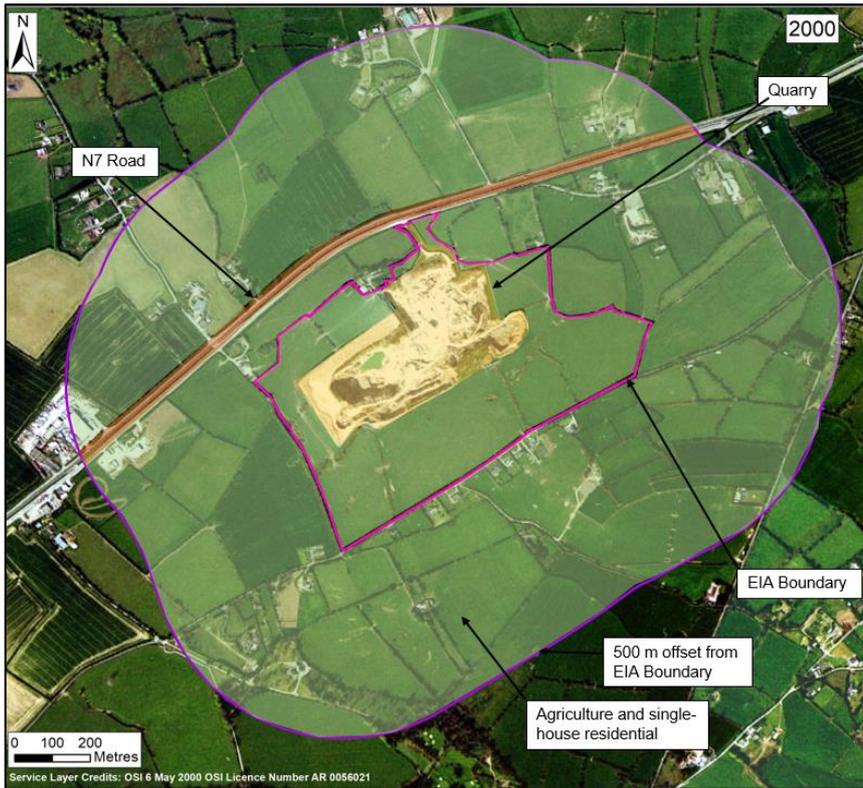
Figure 5.4: Land use during 2000 based on OSI aerial photography.

Between the period 1990 and 2021 the N7 road and agricultural and single-house residential land use has remained unchanged. Some additional housing is accommodated in the landscape during this period but the overall land use remains unchanged. Based on available aerial imagery and contour mapping, the extraction area expanded from an initial ca. 10.1 ha in 1991 (Figure 5.2) to the current ca. 28.8 ha. The extraction area expanded over this period first in a westerly direction up to 2000, then both western and eastern expansion occurs between 2000 and 2020 (Figure 5.2 to Figure 5.8).

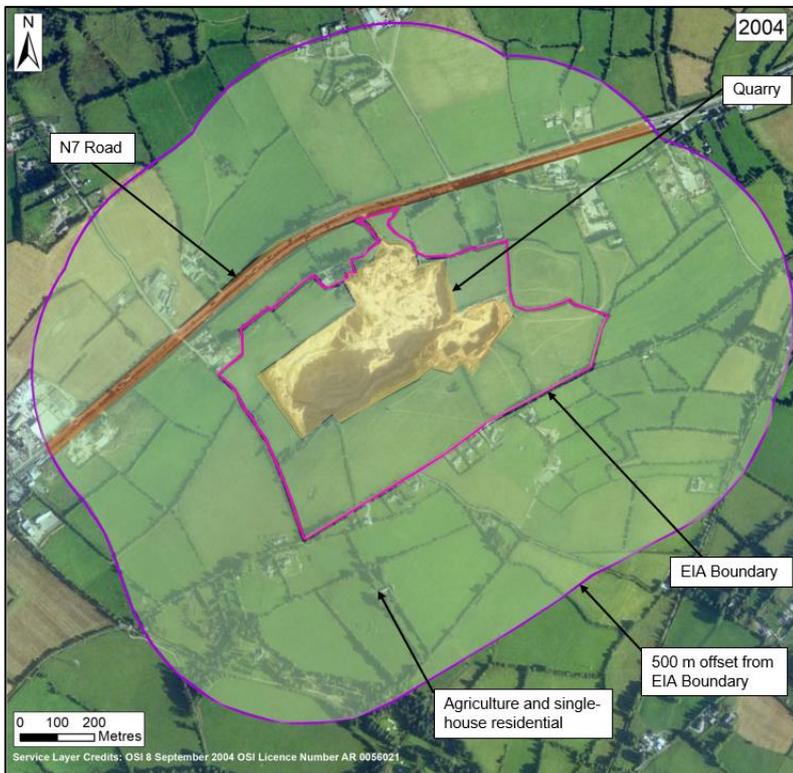
Figure 5.5: Land use during 2004 based on OSI aerial photography.

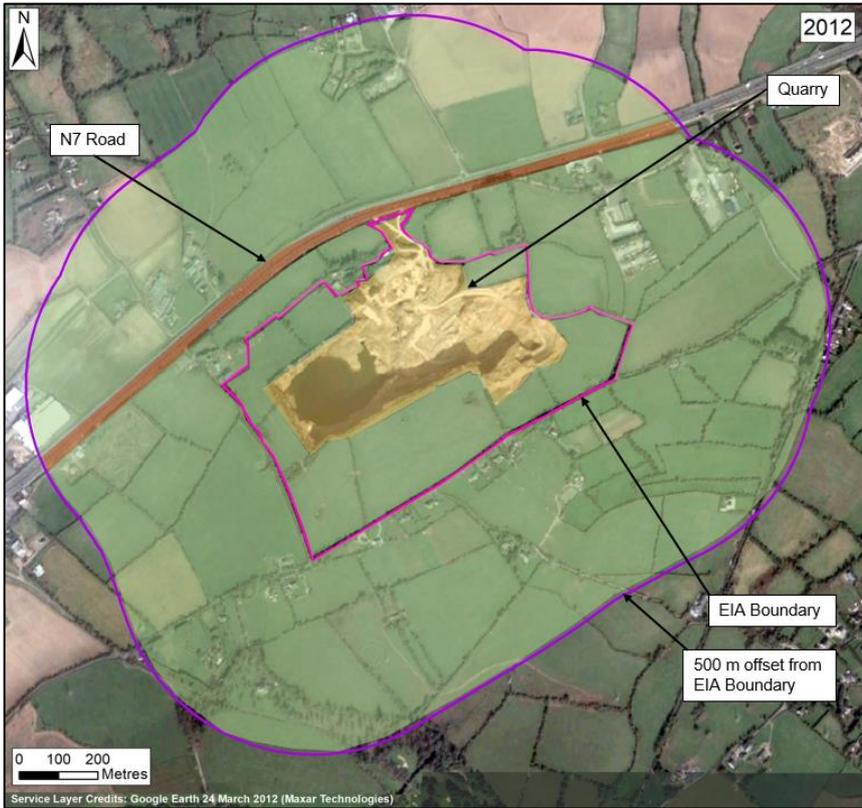
Figure 5.6: Land use during 2012 based on Google Earth aerial photography.

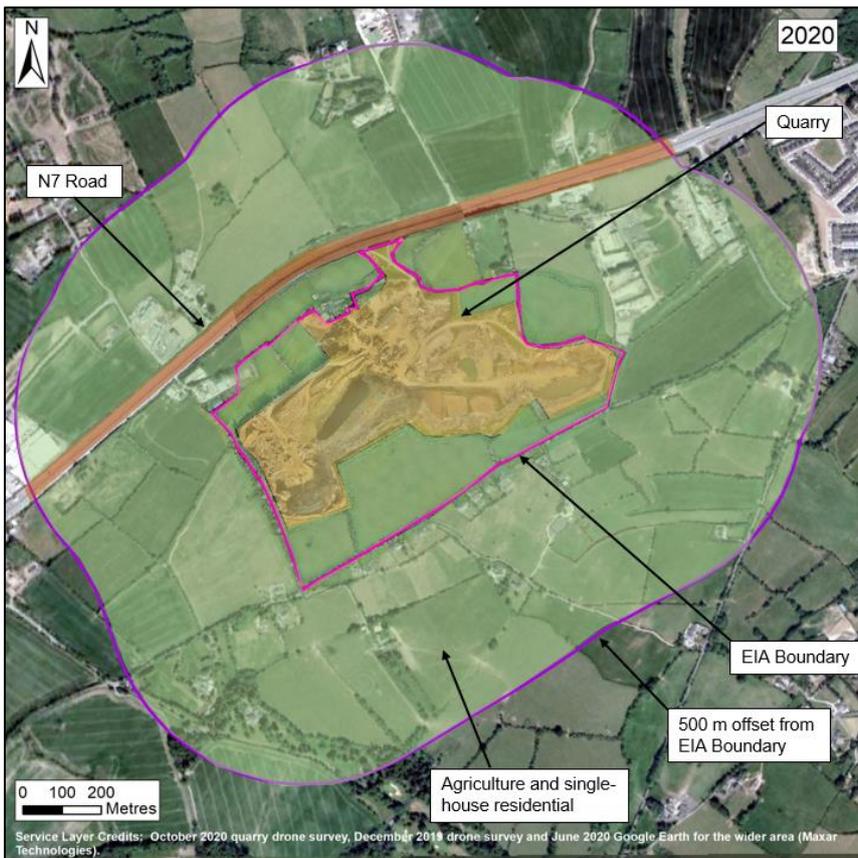
Figure 5.8: Land use during 2020 based on Google Earth aerial photography, a December 2019 drone survey of the quarry and an October 2020 drone survey of the quarry.

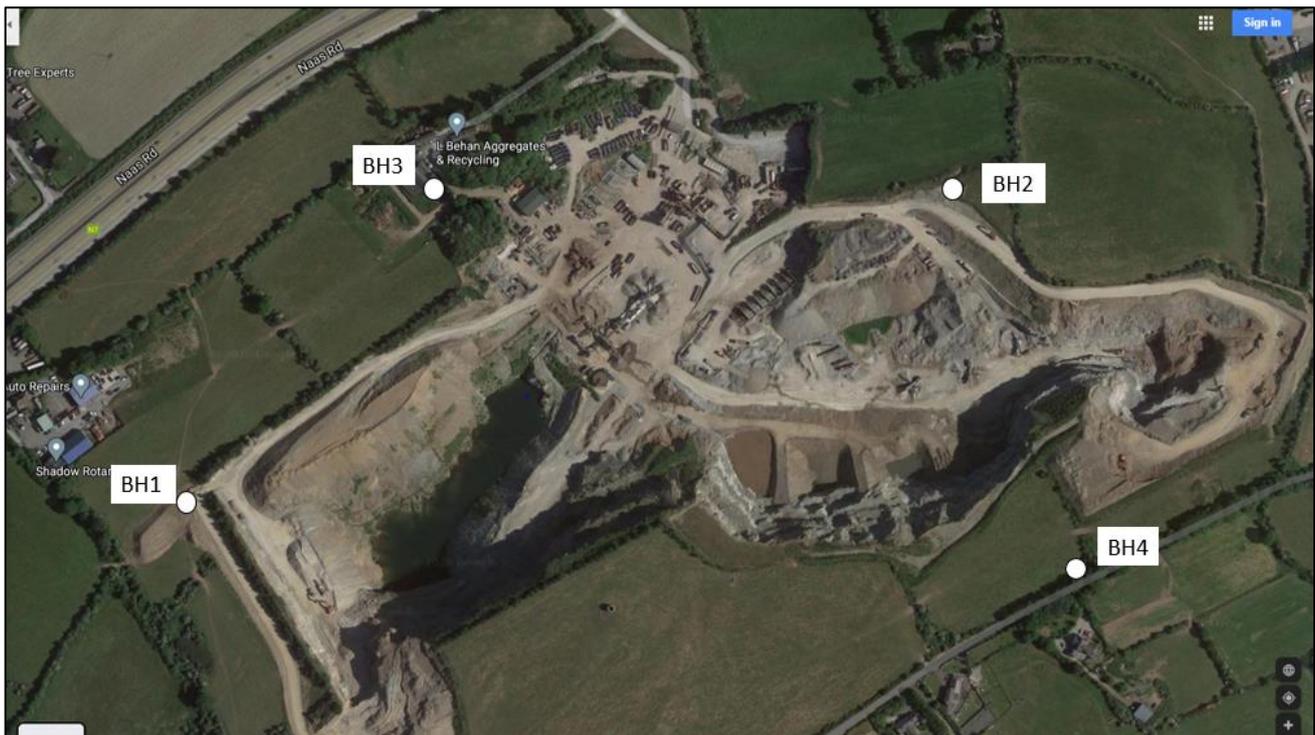
Figure 5.14: Location of boreholes drilled in March 2020 on the Site.

Four wells were installed in March 2020 (Figure 5.14), borehole logs for these wells identified a very thin soil cover (ca. 0.5 – 1 m thick) before encountering the bedrock interface composed of a weathered/fractured greywacke which becomes very competent with depth. The very thin soil thickness observed in the boreholes is in line with the GSI's subsoil mapping which identified bedrock at surface over the majority of the Site and it is also in line with the GSI's low score for overburden potential as no sand and gravel or aggregate potential has been identified on the Site.
