6.0 WATER

This chapter of the Environmental Impact Assessment Report (EIAR) provides an assessment of the hydrological (surface water) and hydrogeological (groundwater) aspects of the Windmill Hill Quarry (the 'Site') in support of the 37L application for continuation and extension of quarrying activities at the Site. The assessment characterises the pre-extension baseline conditions and gives consideration to the potential effects of extension and restoration upon the surrounding surface water and groundwater environments.

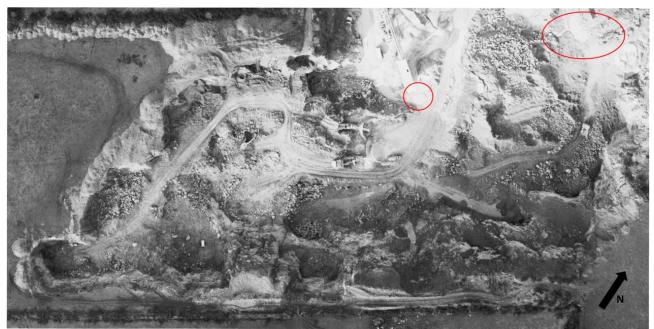
Figure 6.8: Area of Extraction Activities in 1991 (southern extent of Site, quarry floor is ca. 158-160 mAOD). Circled areas indicate potential locations of ponded water. Source of aerial imagery: Ordinance Survey Ireland.

Whilst it is considered likely that small quantities of groundwater seepages may have been encountered within fractures or bedding planes at the southern extent of the quarry (which would have been operating below the elevation of upgradient groundwater), there is no evidence of groundwater pooling (Figure 6.8). It is therefore thought that any seepage volumes were small and recharged to unsaturated ground close to the quarry face. There are two small areas where ponded water may potentially be observed on the 1991 aerial photography (circled red on Figure 6.8); however, these are considered to be areas of rainfall runoff collected at a topographical low point (area circled in red t), and therefore not groundwater.

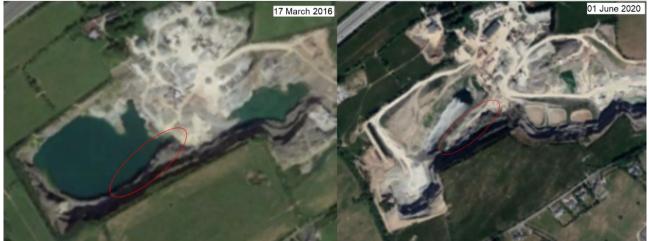
Figure 6.9: West Pond Area in 2016 and 2020. Circled Area = Bench ca. 160 mAOD. Source of Aerial Imagery: Google Earth.

In 2016, it can be seen that substantial flooding of the west pit had occurred. A bench in the southern pit wall can be seen in both 2016 and 2020 aerial photography (Figure 6.9) and is estimated from the 2020 topographical survey to be at an elevation of ca. 160 mAOD (Figure 6.10).

The ponded water level is estimated from the 2016 aerial photography to be at an elevation approximately 5 m below this bench (ca. 155 mAOD). It is not known whether pumping was employed at this time, however, given the unsaturated nature of the quarry in 1990, which had an elevation of ca. 158-160 mAOD, this pond elevation is likely to represent unmanaged (i.e. rest) groundwater. This water elevation of ca. 155 mAOD represents the elevation that the groundwater is expected to rebound to in the post-pumping restoration phase.

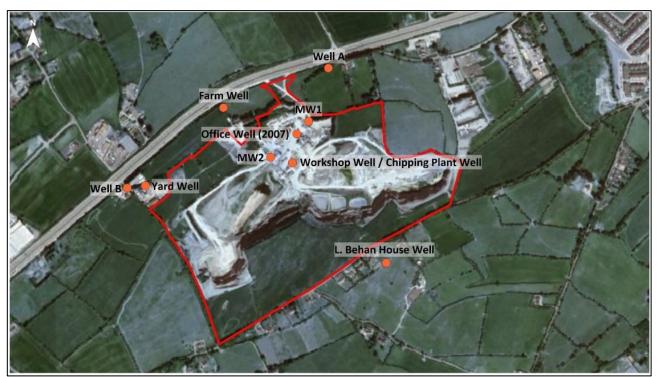
Figure 6.11: Location of Groundwater Wells Within and Immediately Adjacent to the Site 2006 to 2018 (Source of Aerial Imagery: Google Earth. Year: 2020).

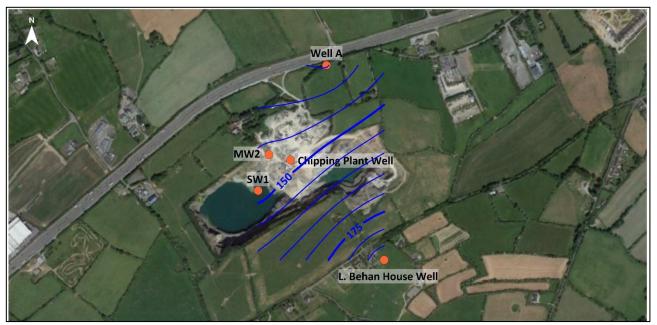
contours show a consistent drop across the Site and do not show evidence of groundwater drawdown in the area of the western pit. It is inferred that the water in the pond is likely to be reflective of the groundwater table with contribution from ponding rainfall during precipitation events.

Figure 6.12: Groundwater Elevation Contours, Including West Pond Water Elevation (SW1), April 2018 (aerial imagery from 2016). Groundwater elevations given in mAOD.

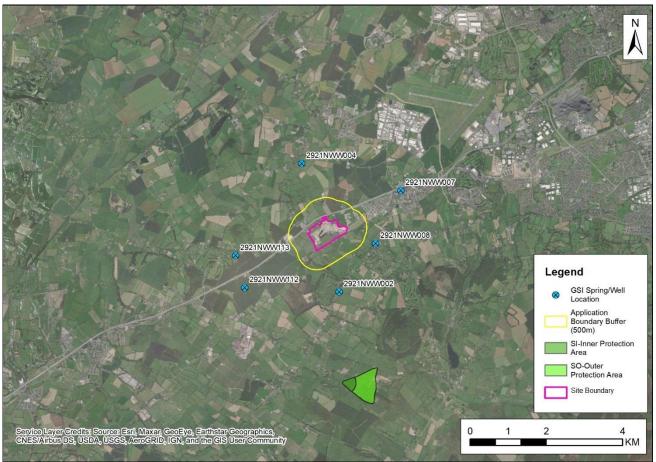
Figure 6.17: Regional Groundwater Source Protection Zones, Abstraction Boreholes and Springs (after GSI, 2021).

On a regional scale, GSI mapping (2021) indicates that there are no groundwater source protection zones within the Site boundary. The nearest groundwater source protection zones are located approximately 3.8 km to the south of the Site - the Kilteel Group Water Scheme (See Figure 6.17; GSI, 2021).
