PRE-DEMOLITION BAT SURVEY REPORT

Parkgate Street Development,
42A Parkgate St. Dublin

APRIL 2021

RUIRSIDE DEVELOPMENTS LIMITED

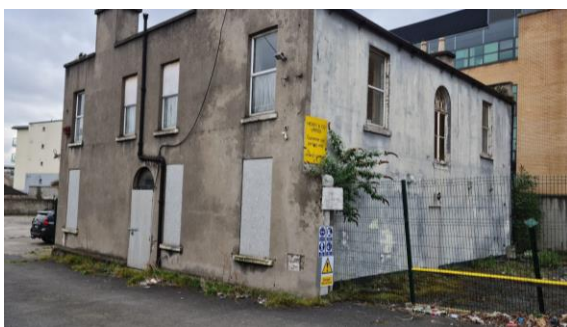
Plate 3-1: Building 1 Parkgate

Building 1 is a plastered stone construct with a damaged slated roof. The downstairs windows are boarded up. Potential access points for bat are through some open windows upstairs, along with numerous gaps in the roof and eaves. All areas of the building was searched including curtains, chimneys and roof spaces, with particular attention given to searching the basement. Despite a thorough examination no evidence of bat usage was found.

The survey revealed that the basement of Building 1 is not used by wintering bats. A thorough search of the building was conducted however no evidence of roosting bats were found.

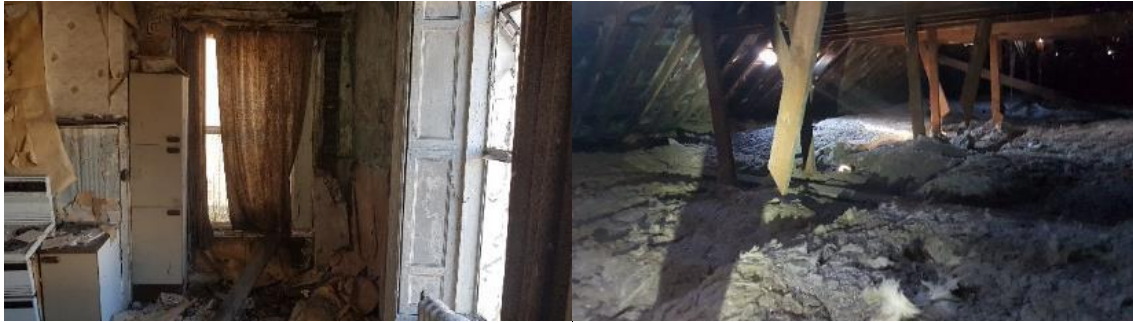
Plate 3-3: Internal view

Plate 3-4: Attic space
